## Minnesota Drive Ramps Micro Surfacing Experimental Feature

January 2024

**Publication Number:** FHWA-AK-RD-4000(181), HFHWY00123

13. ABSTRACT (Maximum 200 words)  During the 2020 construction season, the Alaska DOT&PF Central Region installed its first application of micro surfacing at 17 locations on Minnesota Drive ramps in the city of Anchorage. This treatment offers the potential to be a more economical solution to the typical mill and fill hot mix asphalt (HMA) treatment used to address rutted roads.  Micro surfacing has not been used on roads in Central Region due to poor historical Prall testing (ATM 420) that is used to simulate studded tire wear. A new formulation of micro surfacing was evaluated in 2016 with significantly improved performance on the Prall test. This formulation uses fine aggregate and a high residual binder content with a PG64-40 modified asphalt binder and between 6%-8% SBS polymer. This is a very high percentages of both binder and polymer for a micro surfacing treatment.  There were difficulties encountered during construction with break and set times that made the micro surfacing prone to flushing and deformation rutting immediately after constr

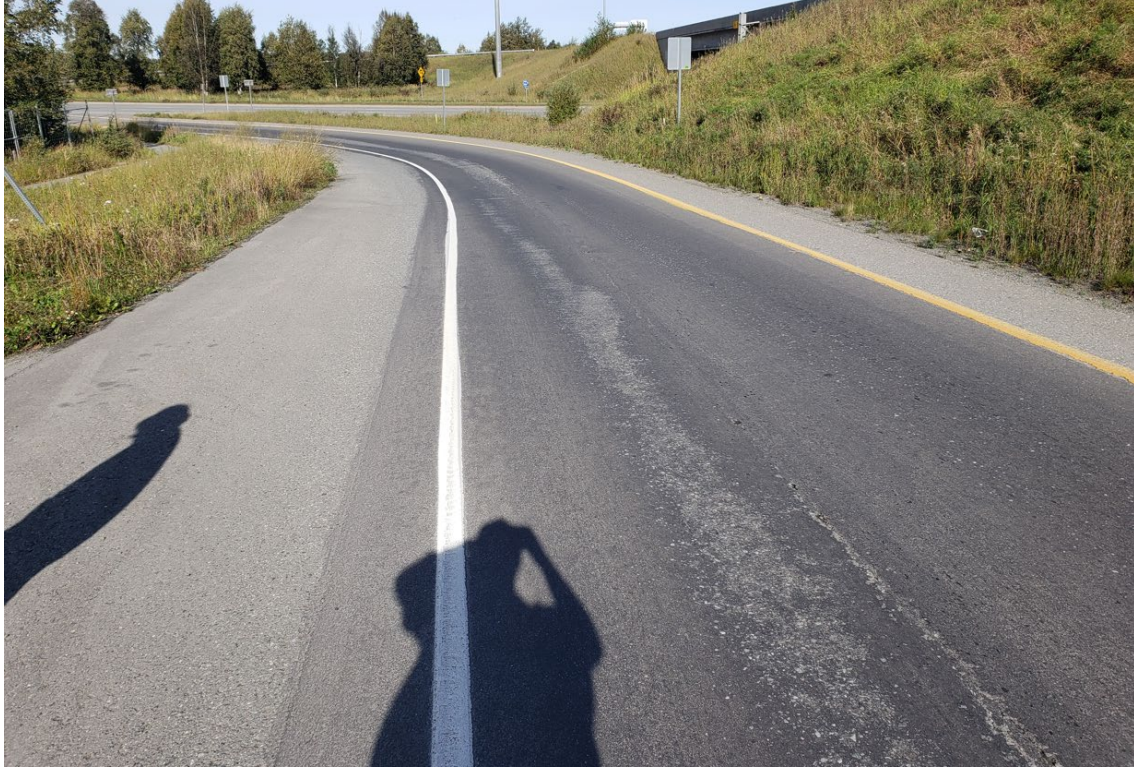
There is significant plow and studded tire damage in the initial curve and going up the hill. It drops to moderate wear for the rest of the ramp where some of the underlying HMA is visible. The high severity joint crack reflected through and has begun to severely spall.

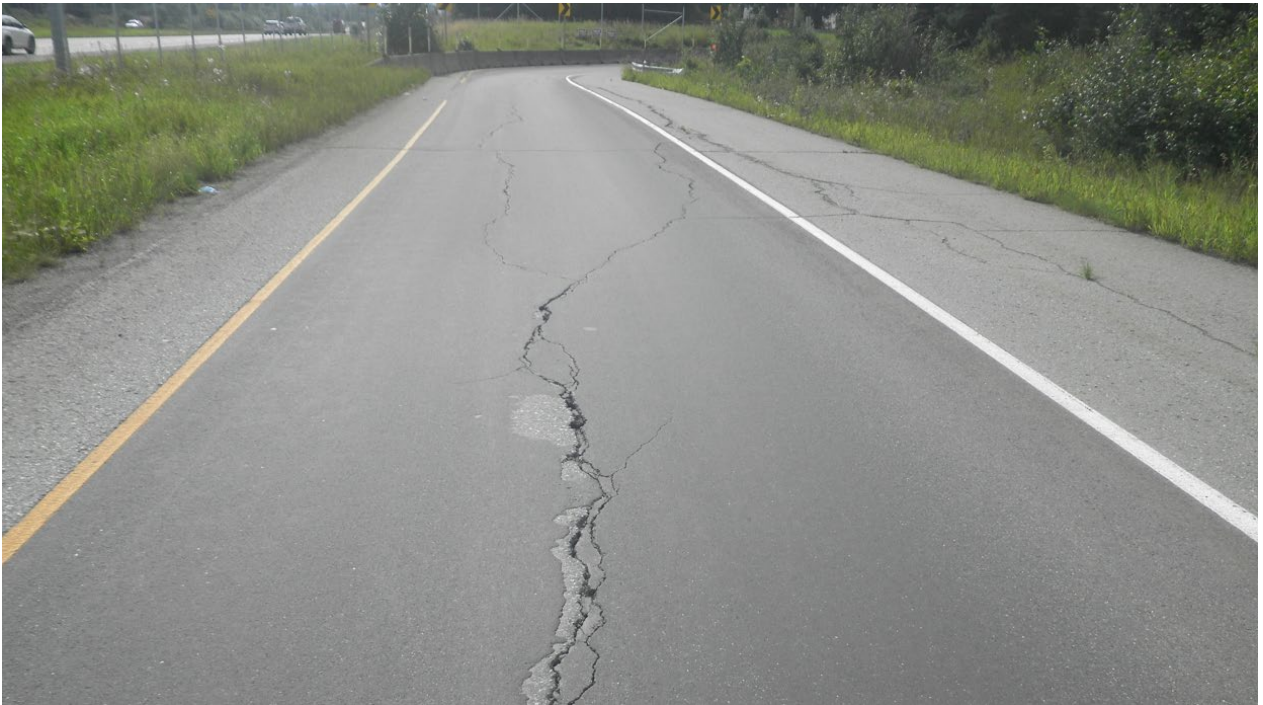
The ramp remains in poor condition with an increased amount of surfacing worn off the center of the road from plows.

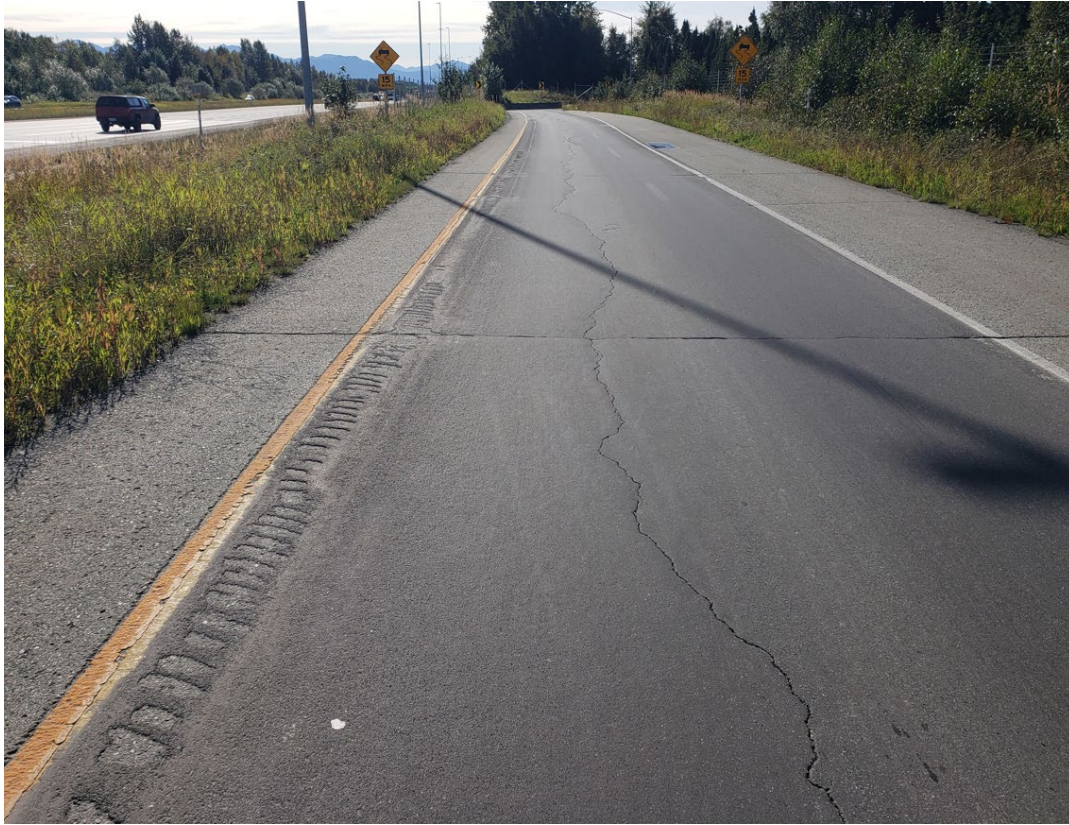
The ramp remains in similar condition to the prior year with significant plow damage and reflective cracking.

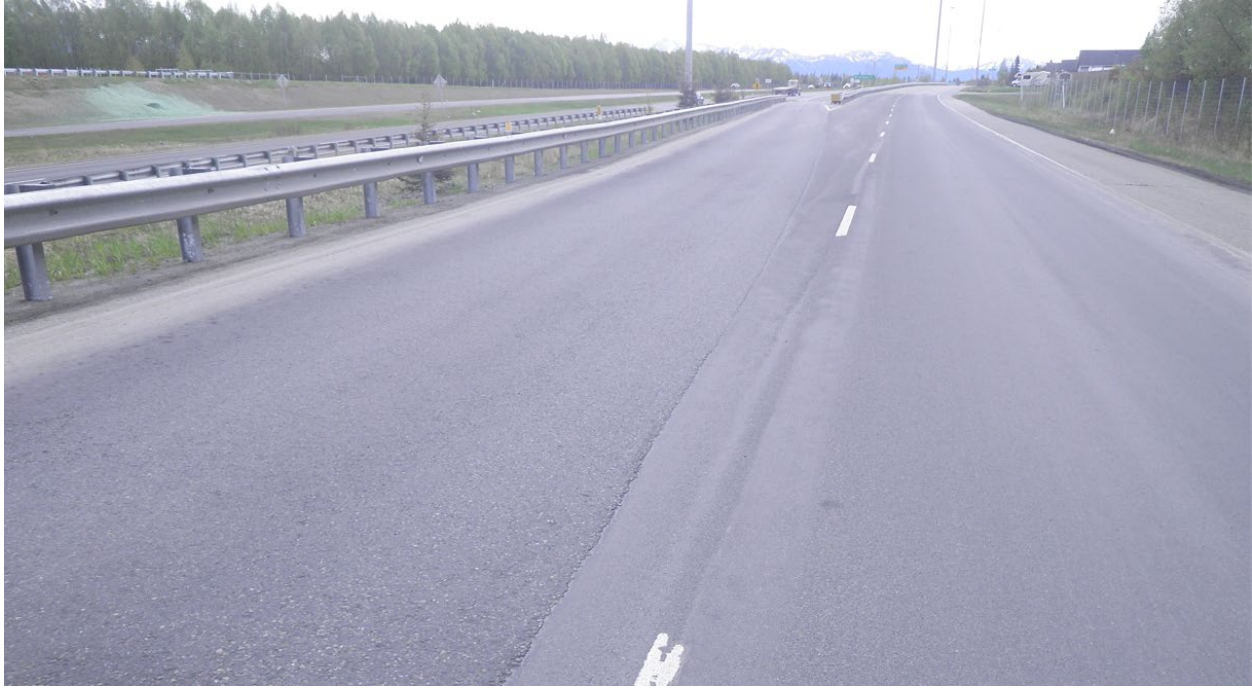
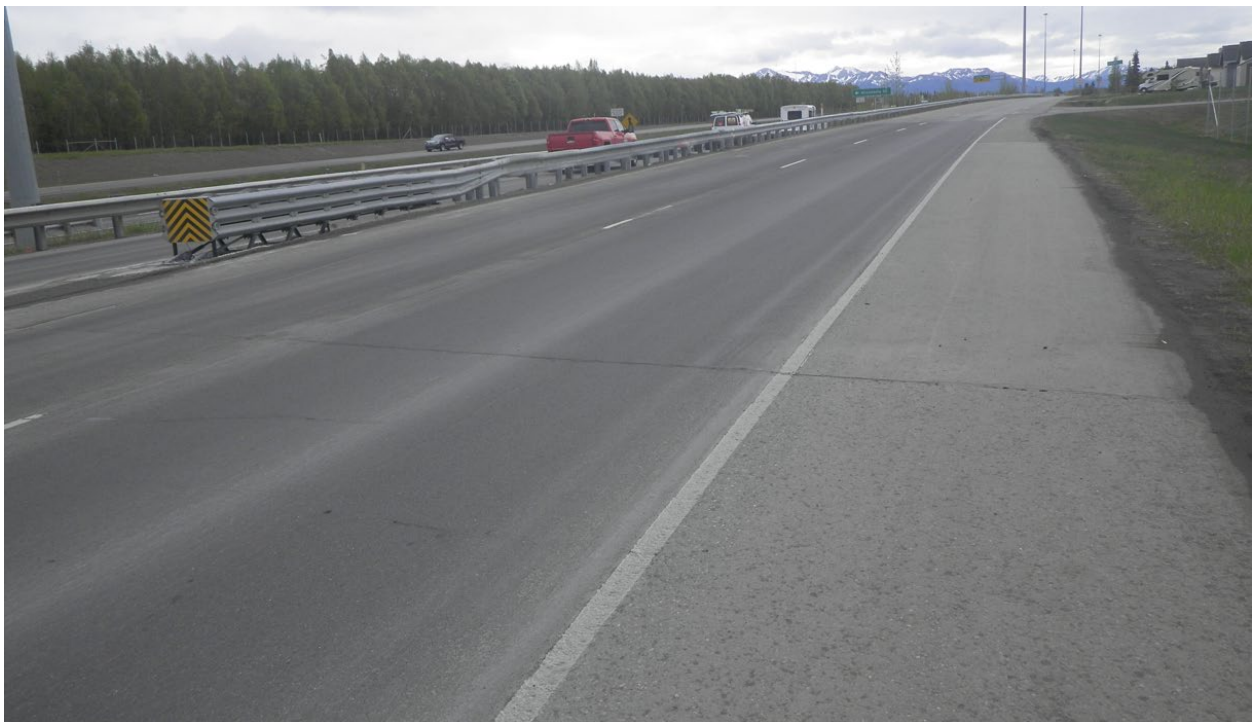
The photo below provides a comparison of the removal area (left) with hot mix, while the microsurfacing remains on the right. The ramp remains in overall good condition with some plow damage on transverse cracks that have reflected through the microsurfacing.

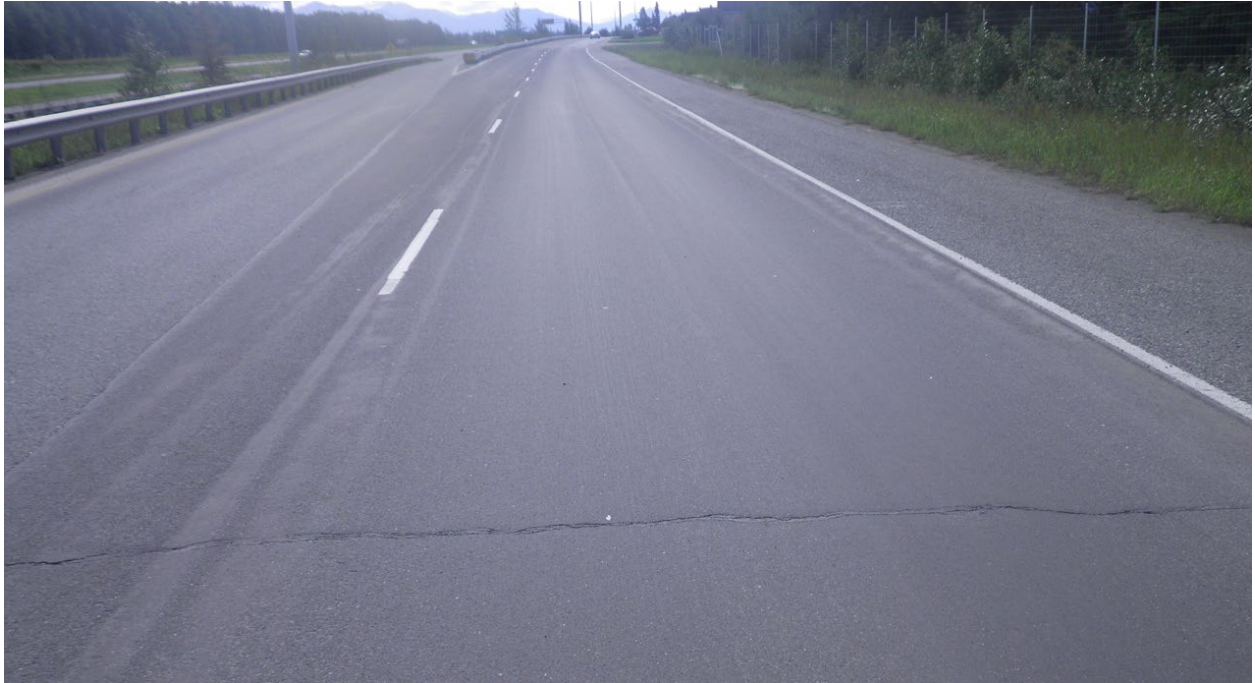
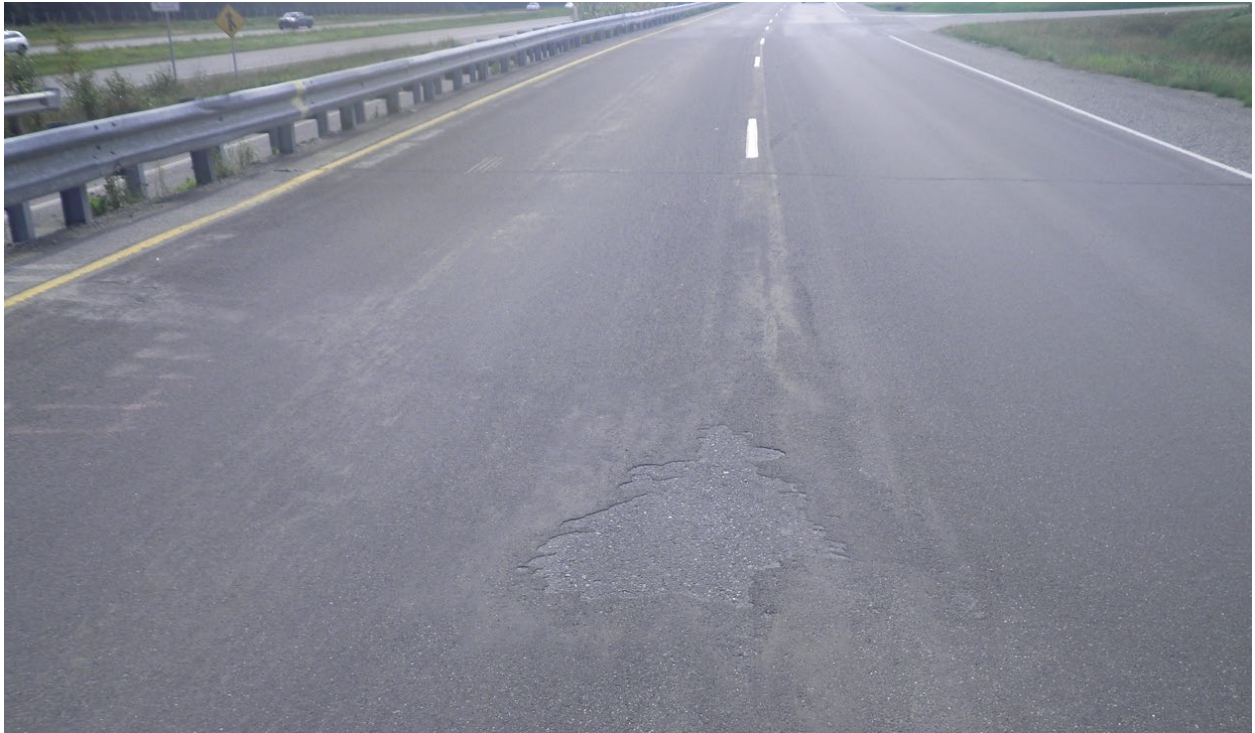
The ramp remains in good condition outside of one location near the end of the application where the plowed removed a portion along the centerline.

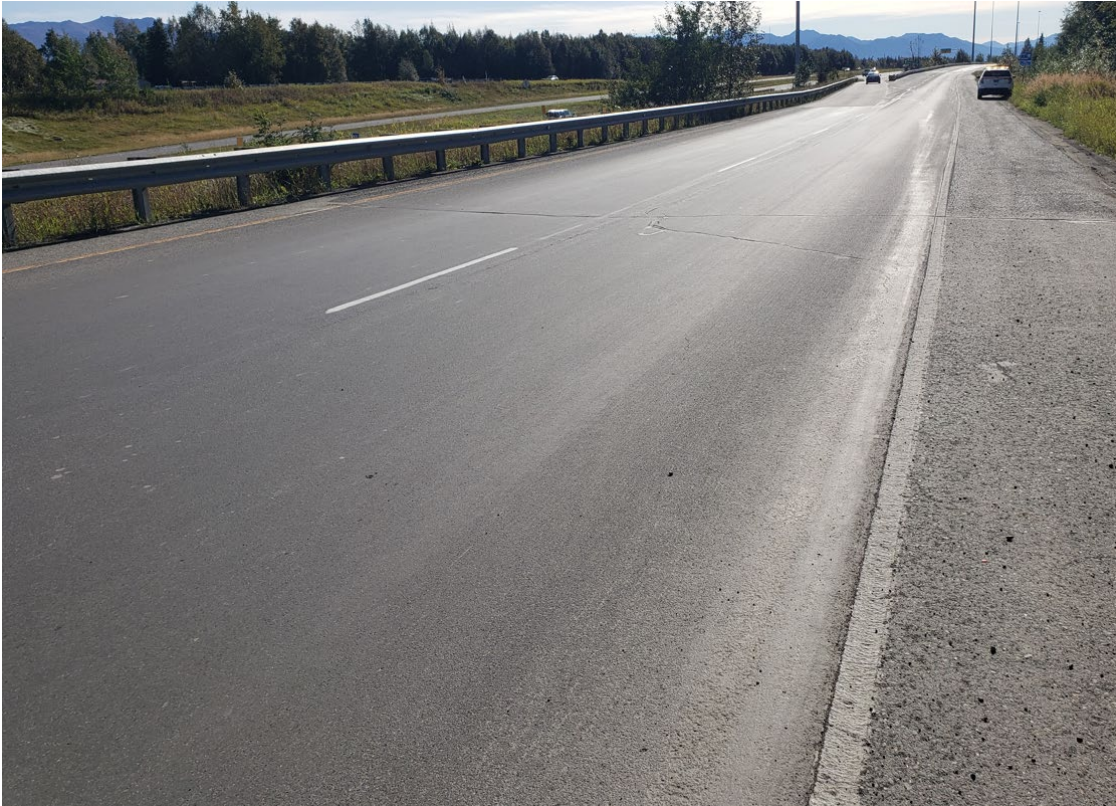
Outside of some isolated wear at the start of the ramp and one moderate severity transverse crack the ramp remains in good condition.

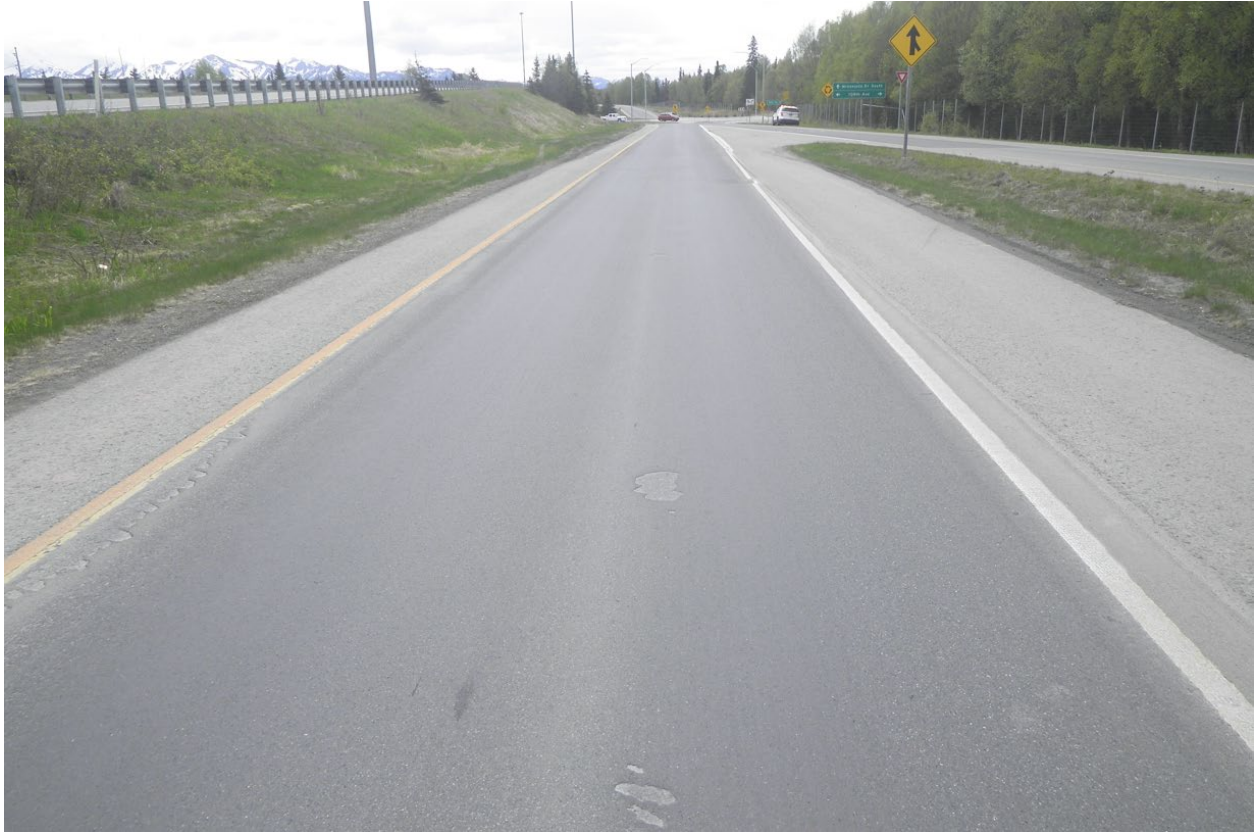
The ramp has some plow damage along the left-hand side and centerline of the off ramp and transverse cracks reflected through the microsurfacing. The ramp remains in moderate to good condition.

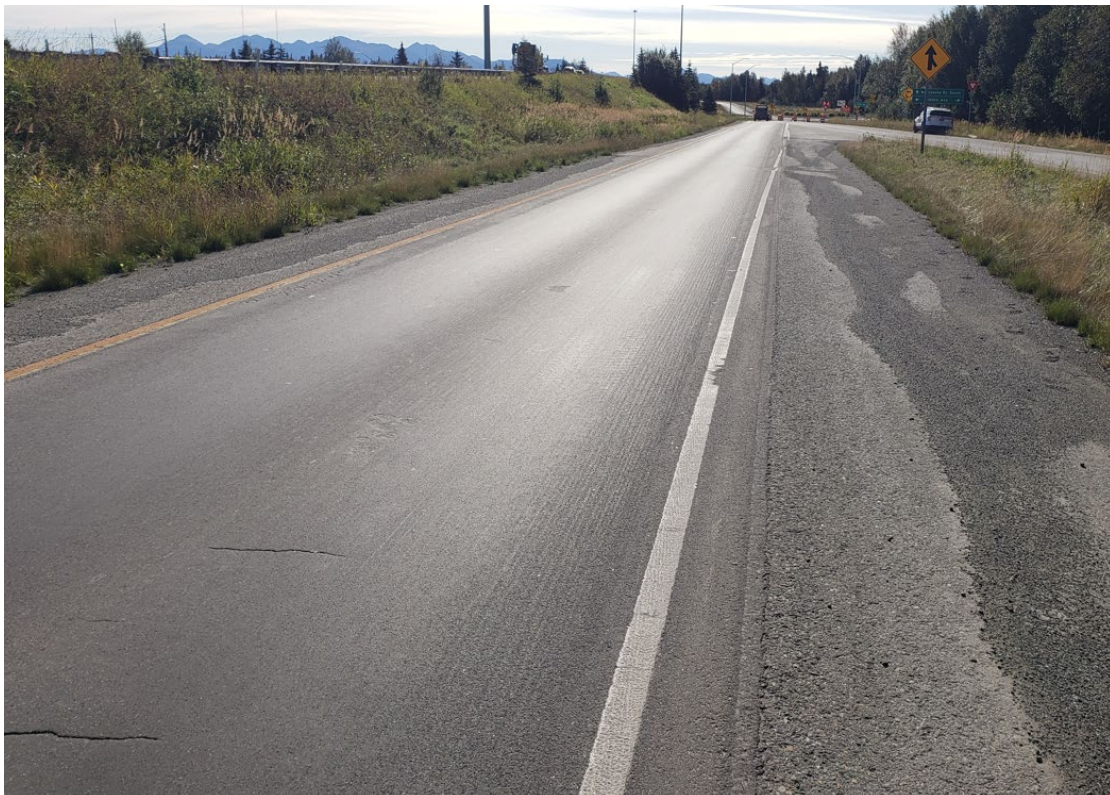
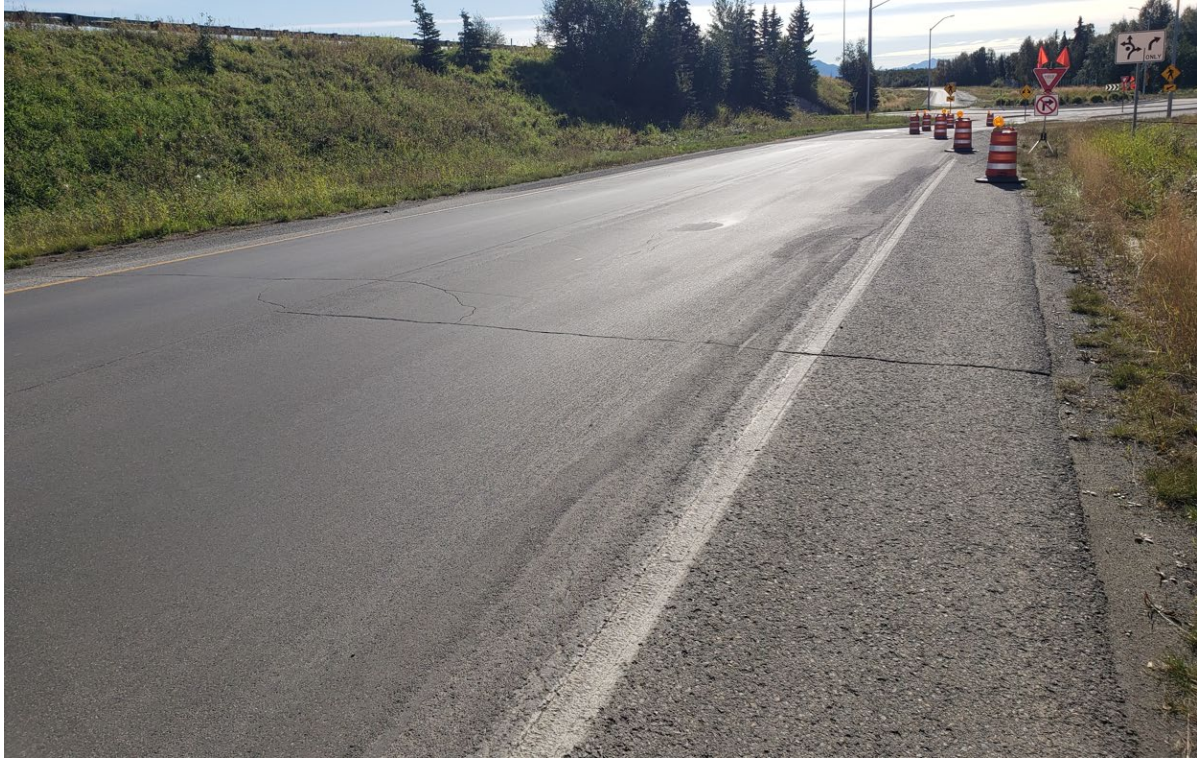
There is some isolated plow damage and reflective cracking, but the ramp remains in moderate to good condition.

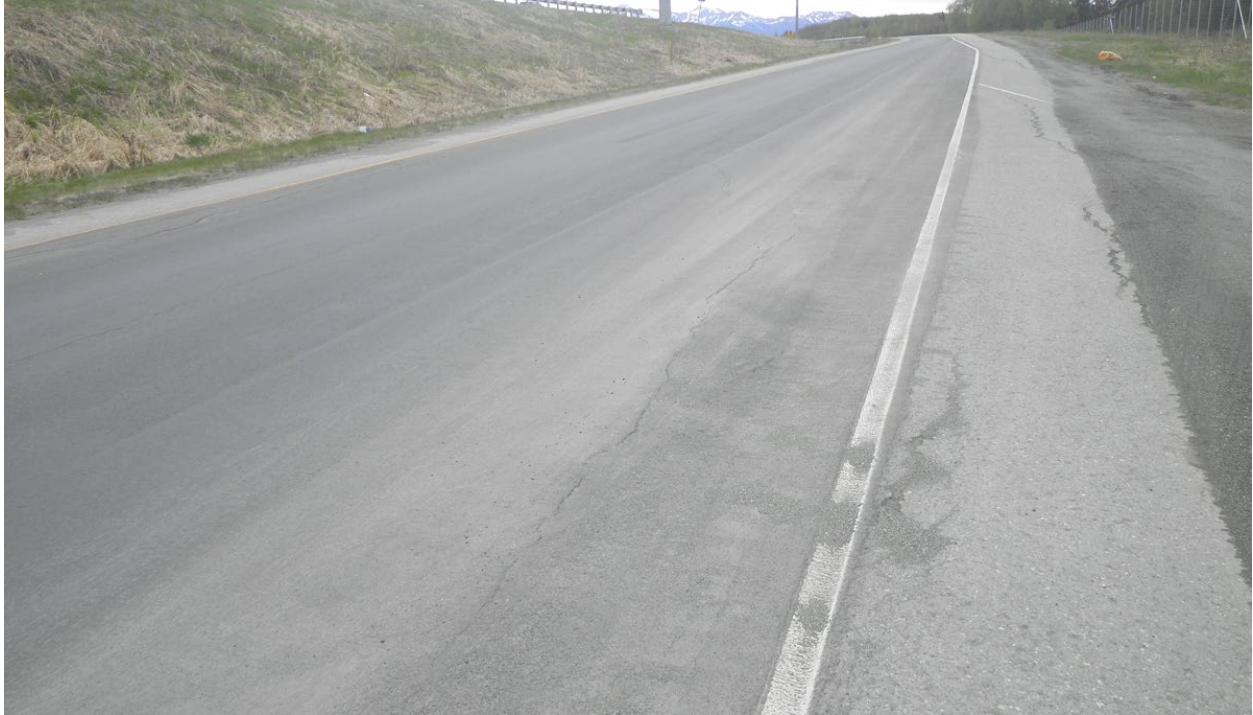
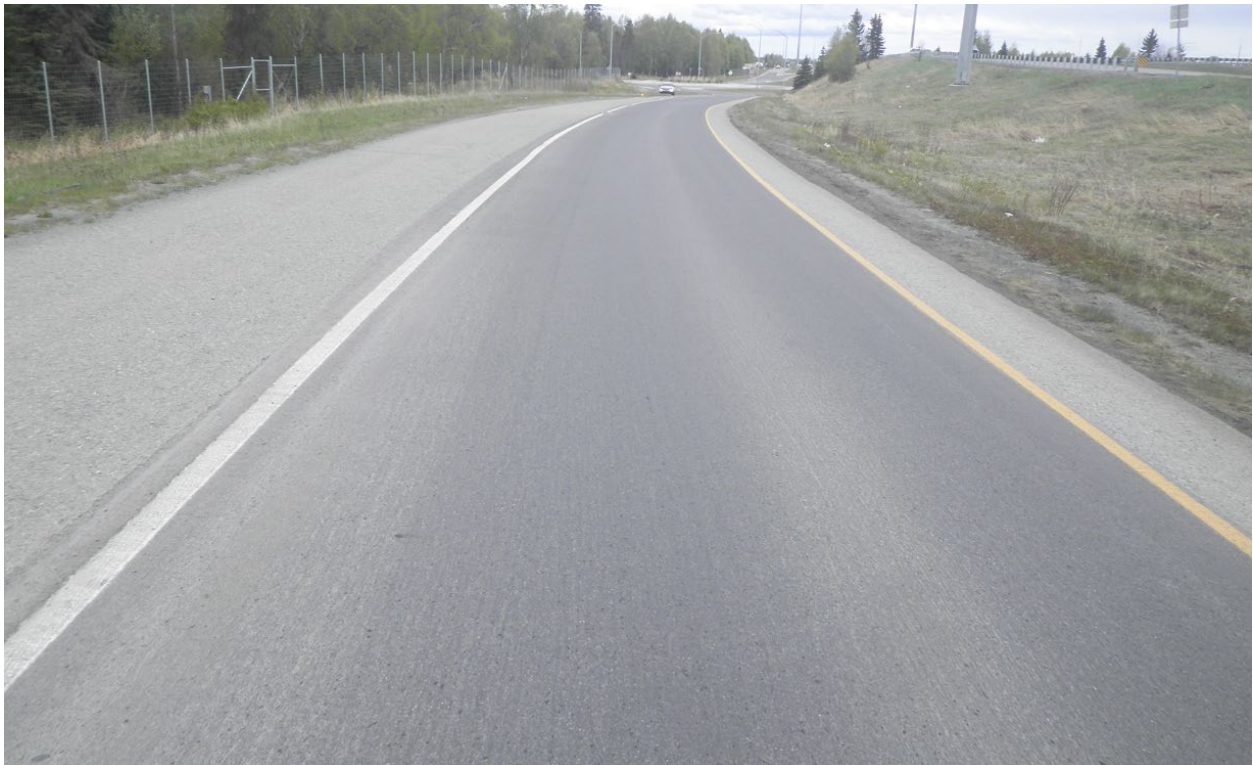
The high severity longitudinal cracking reflected through the microsurfacing near 100<sup>th</sup> Avenue, but it remained at low severity. Transverse cracks reflected, but overall, the ramp remains in good condition outside of the distress near 100<sup>th</sup> Avenue.

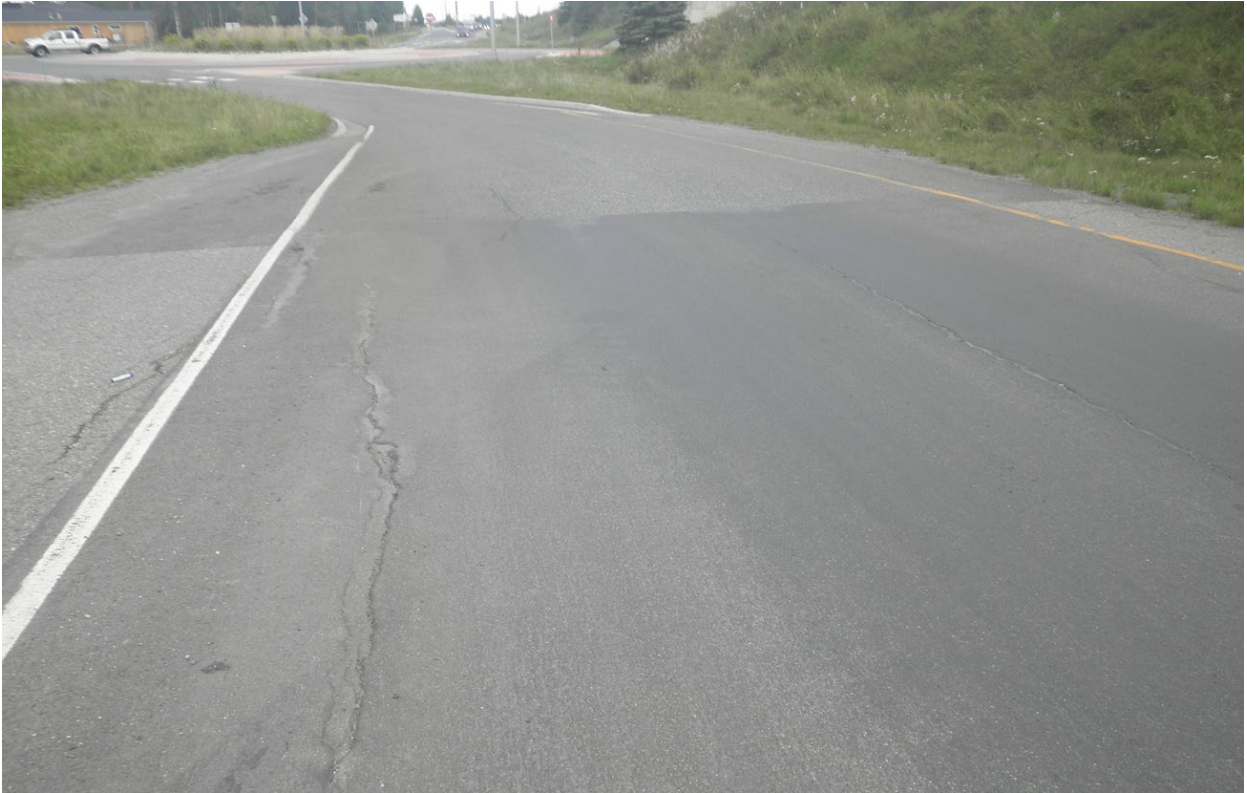
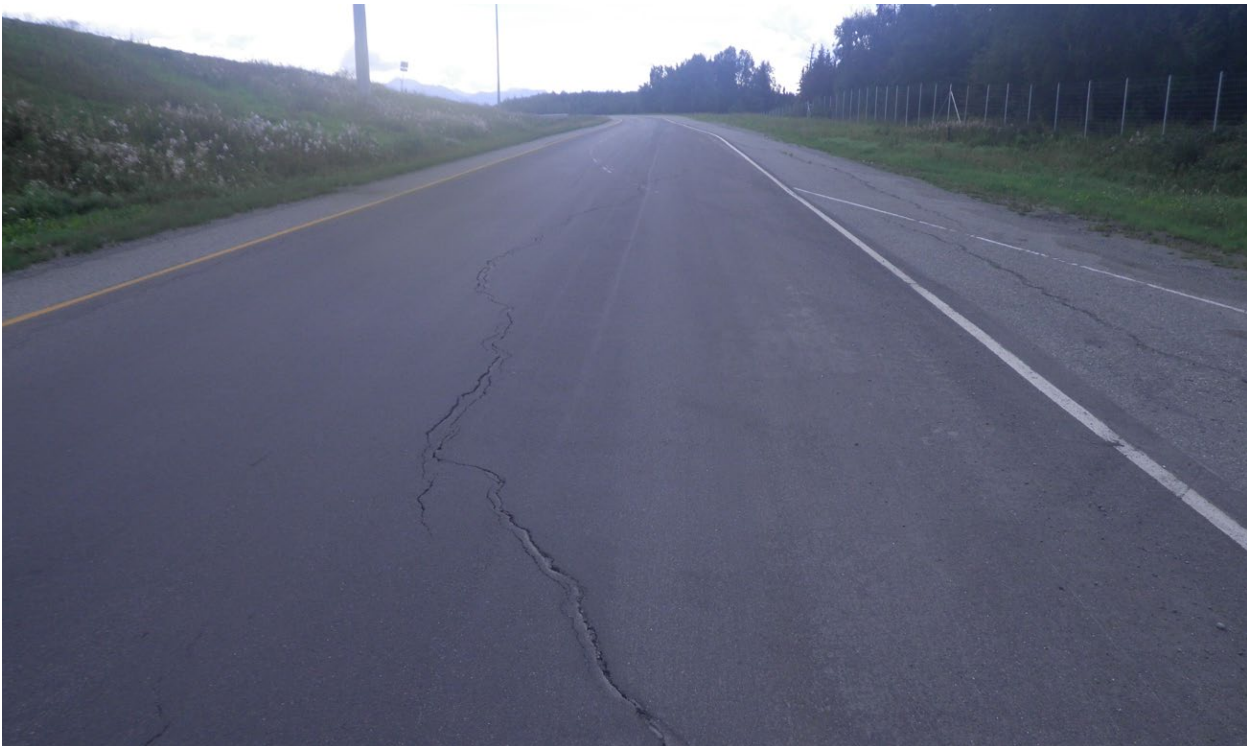
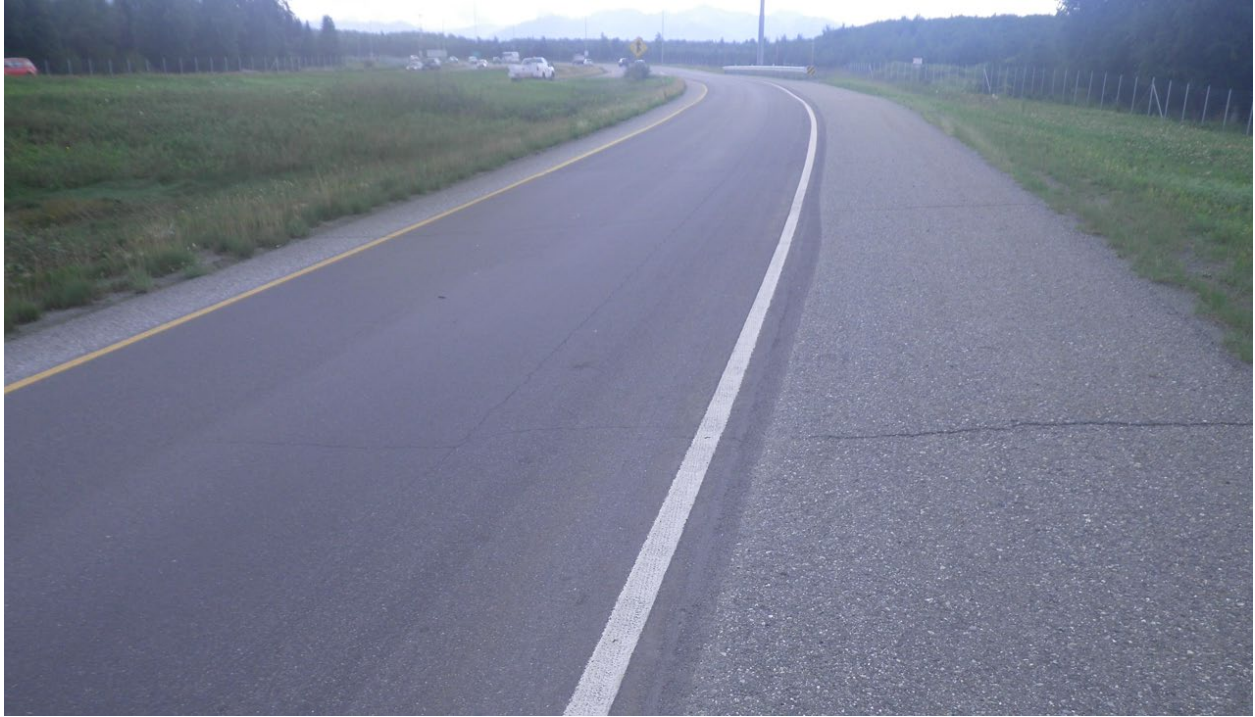
There are significant cracks at 100<sup>th</sup> Avenue, but the ramp remains in good condition outside of that and isolated plow damage.

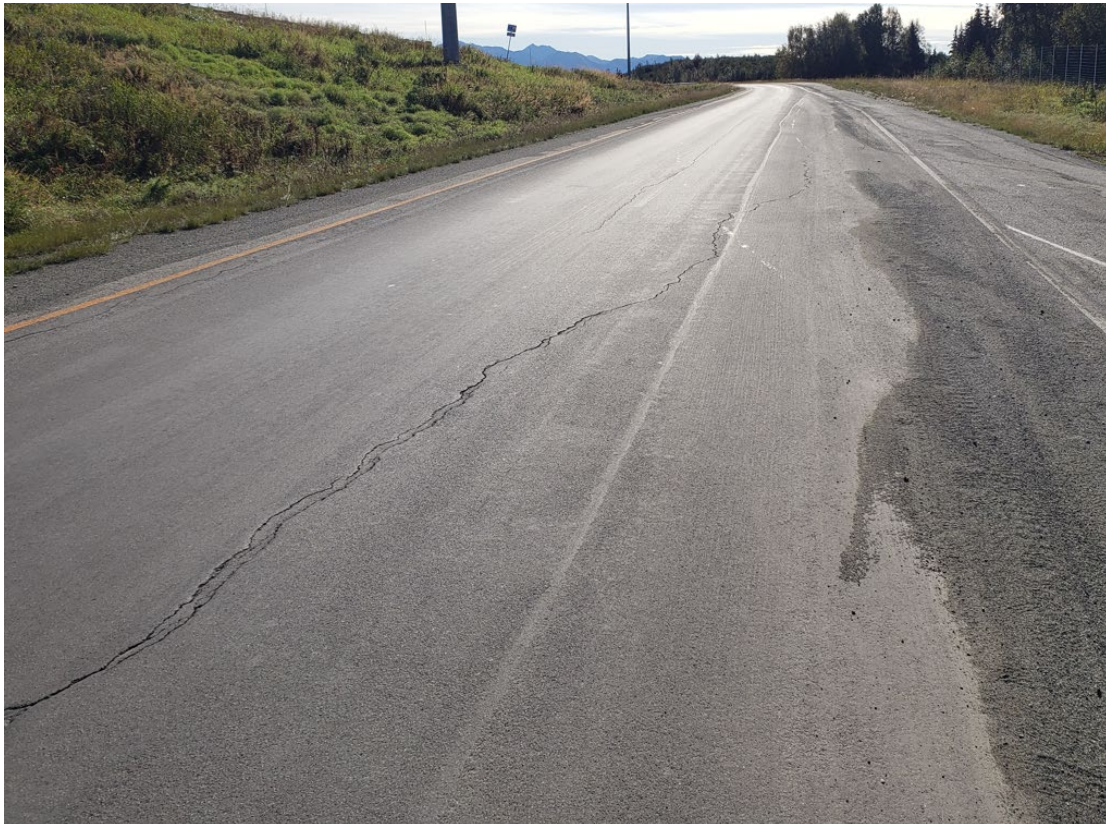
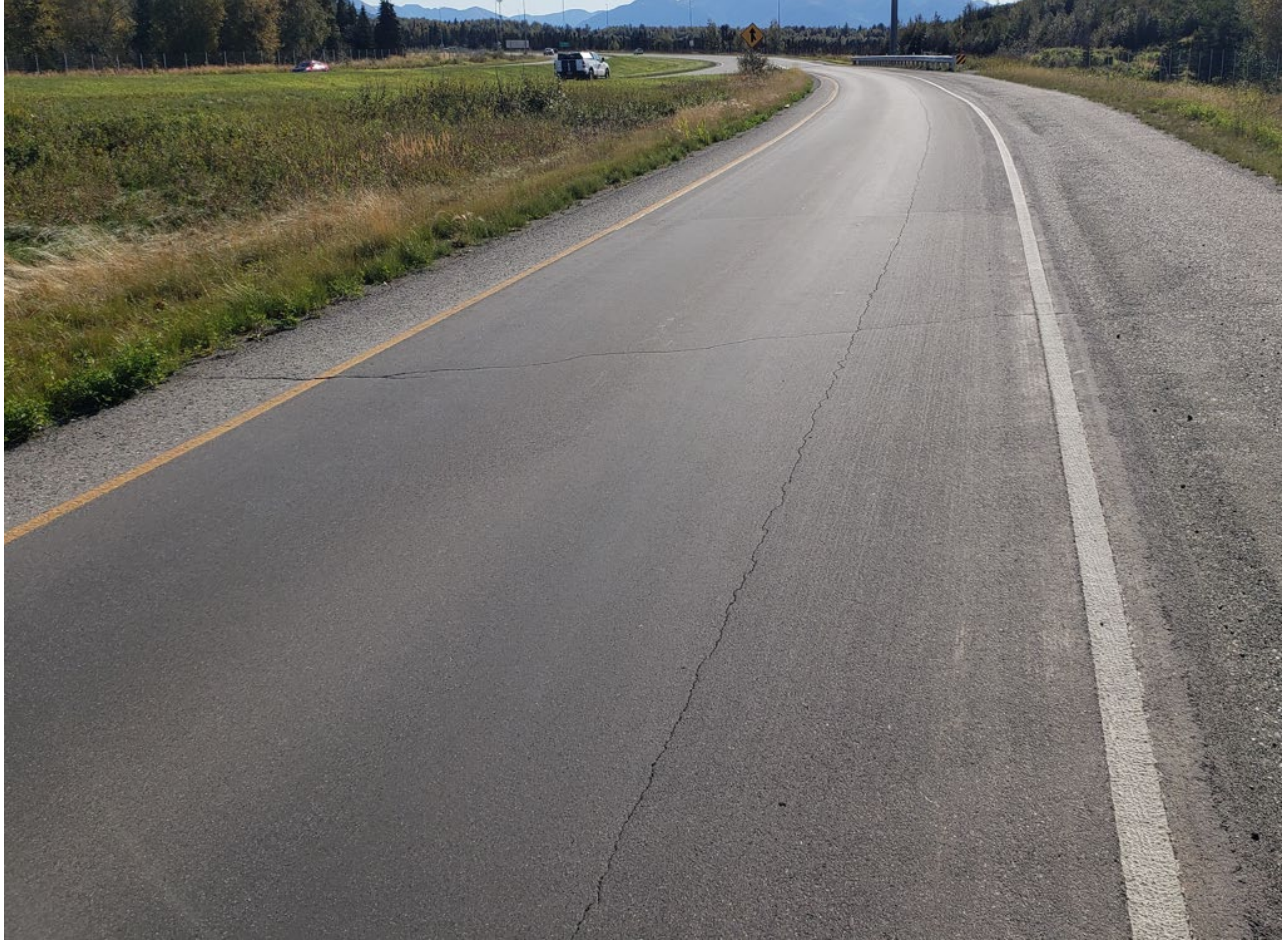
The ramp remains in similar condition to the prior year with significant cracking at 100<sup>th</sup> Avenue, but in good condition outside of that.

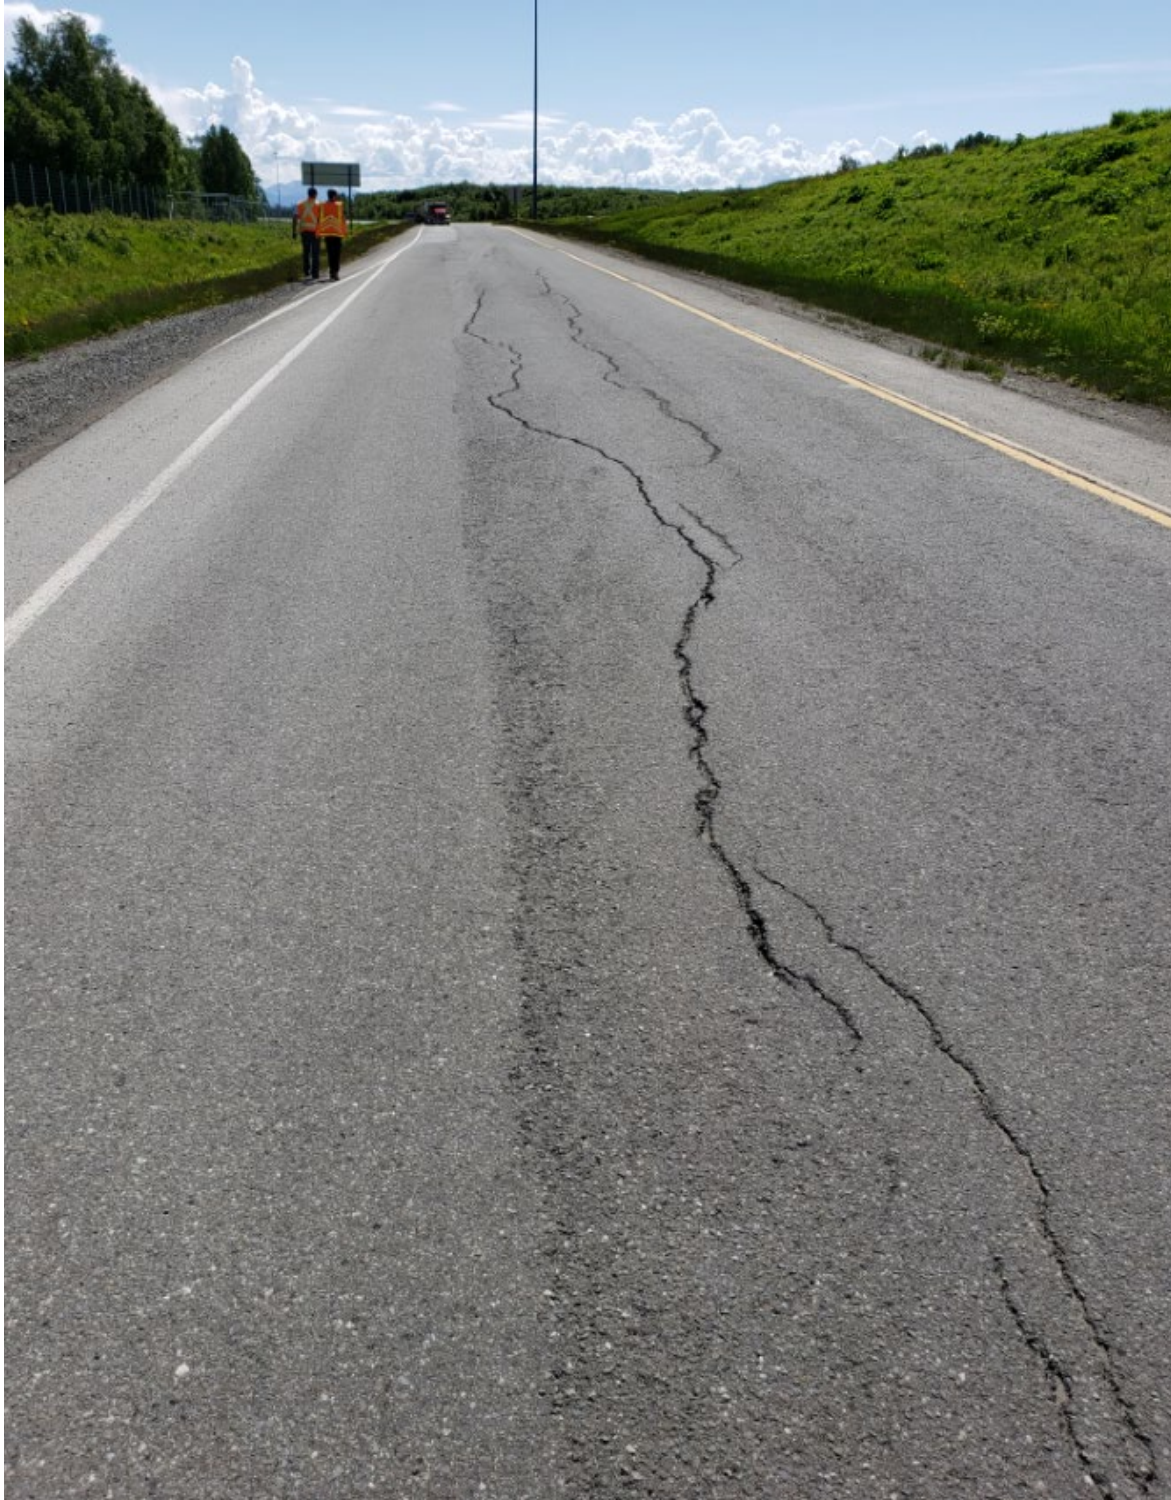
Near the beginning of the ramp there was low severity transverse cracking and raveling, but closer to 100<sup>th</sup> Avenue there was high severity longitudinal cracking.

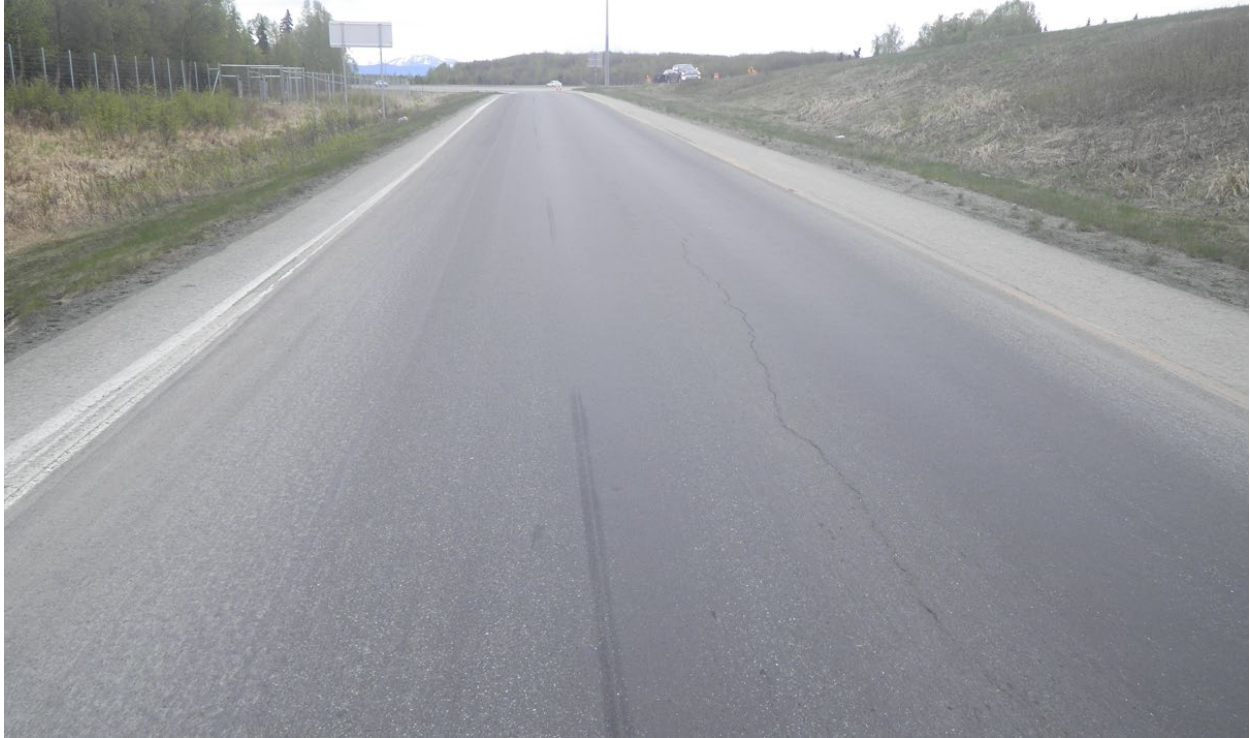
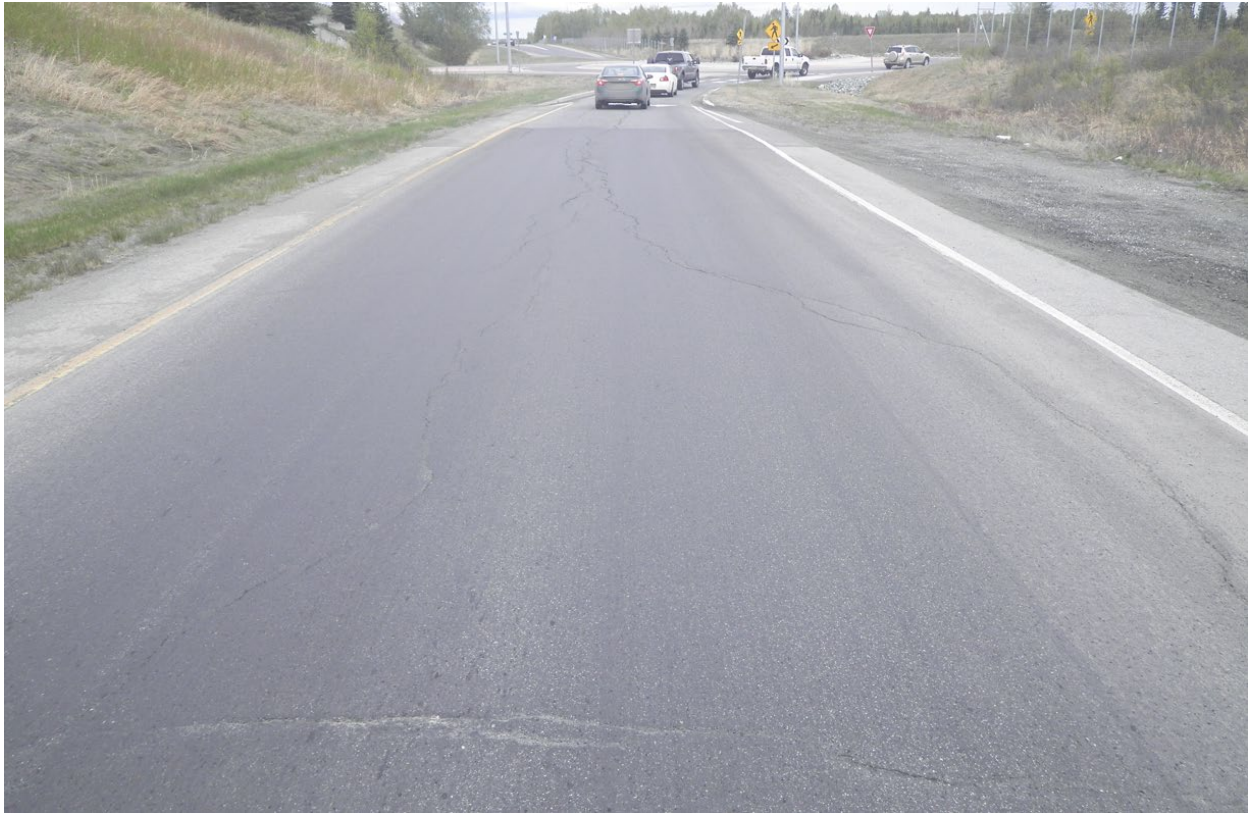
The beginning of the ramp remains in good condition with some low severity reflective cracking, but near 100<sup>th</sup> Avenue the major cracking reflected and is in poor condition at the cracks. Some flushing was present on the ramp with a slight loss of friction.
