## Minnesota Drive Ramps Micro Surfacing Experimental Feature

January 2024

**Publication Number:** FHWA-AK-RD-4000(181), HFHWY00123

13. ABSTRACT (Maximum 200 words)  During the 2020 construction season, the Alaska DOT&PF Central Region installed its first application of micro surfacing at 17 locations on Minnesota Drive ramps in the city of Anchorage. This treatment offers the potential to be a more economical solution to the typical mill and fill hot mix asphalt (HMA) treatment used to address rutted roads.  Micro surfacing has not been used on roads in Central Region due to poor historical Prall testing (ATM 420) that is used to simulate studded tire wear. A new formulation of micro surfacing was evaluated in 2016 with significantly improved performance on the Prall test. This formulation uses fine aggregate and a high residual binder content with a PG64-40 modified asphalt binder and between 6%-8% SBS polymer. This is a very high percentages of both binder and polymer for a micro surfacing treatment.  There were difficulties encountered during construction with break and set times that made the micro surfacing prone to flushing and deformation rutting immediately after constr

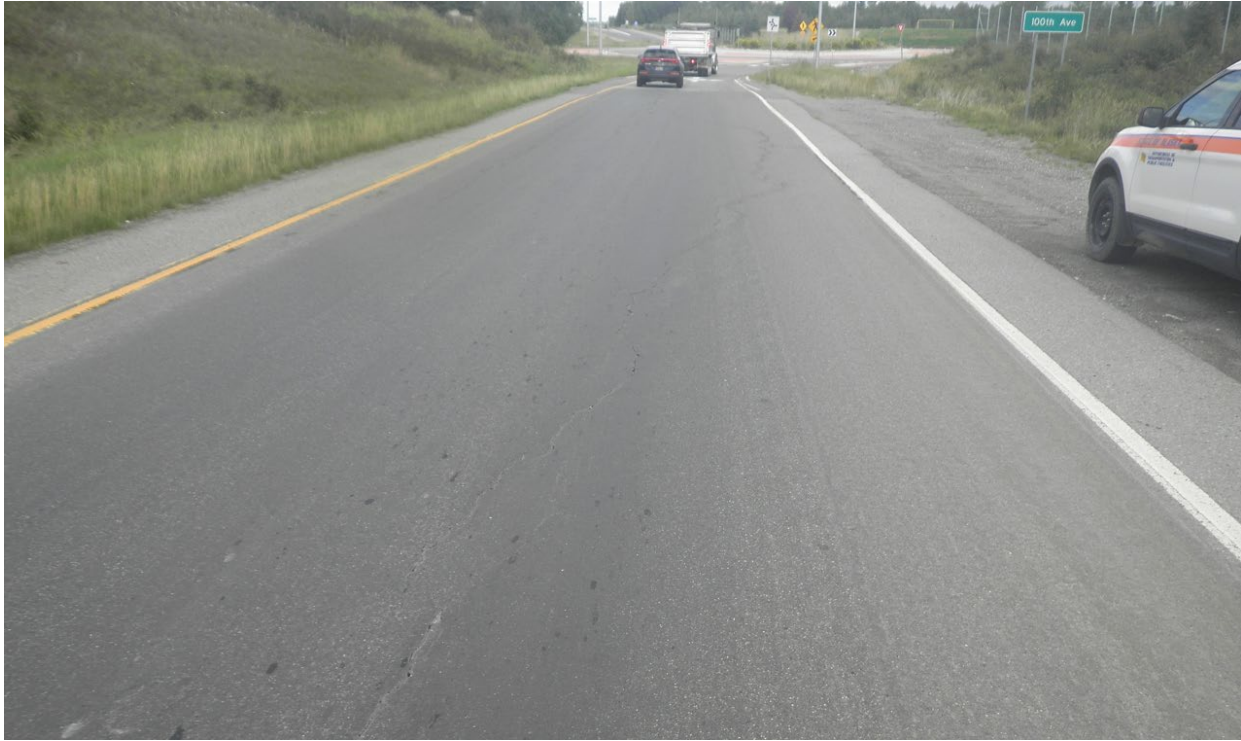
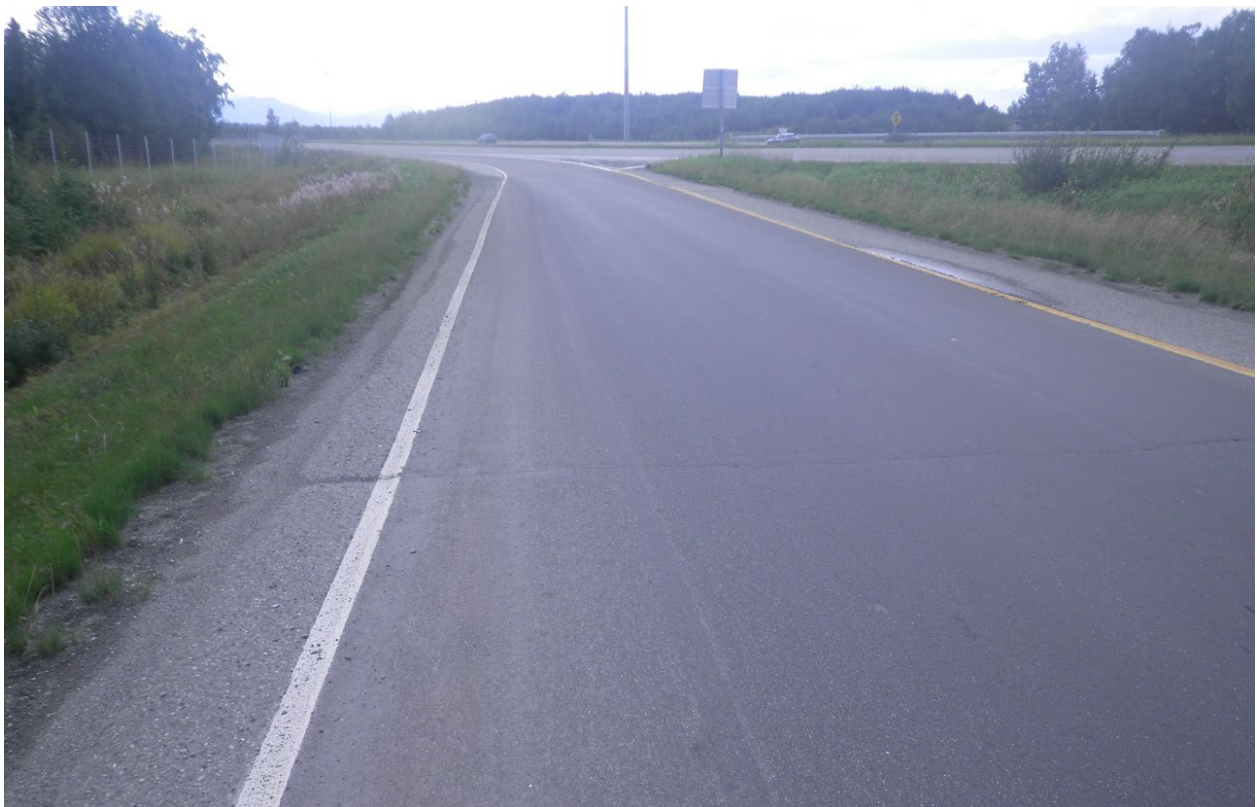
There was significant reflective cracking adjacent to 100<sup>th</sup> Avenue with some flushing, but outside of the area next to 100<sup>th</sup> Avenue the ramp remains in moderate to good condition.

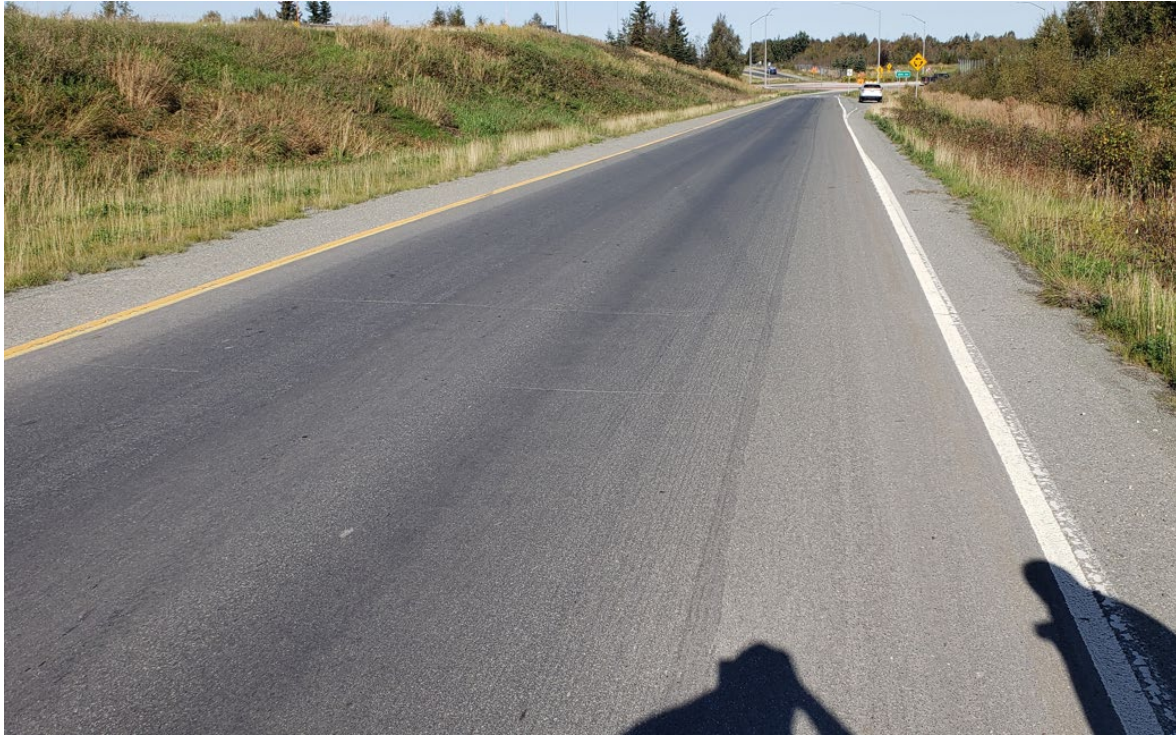
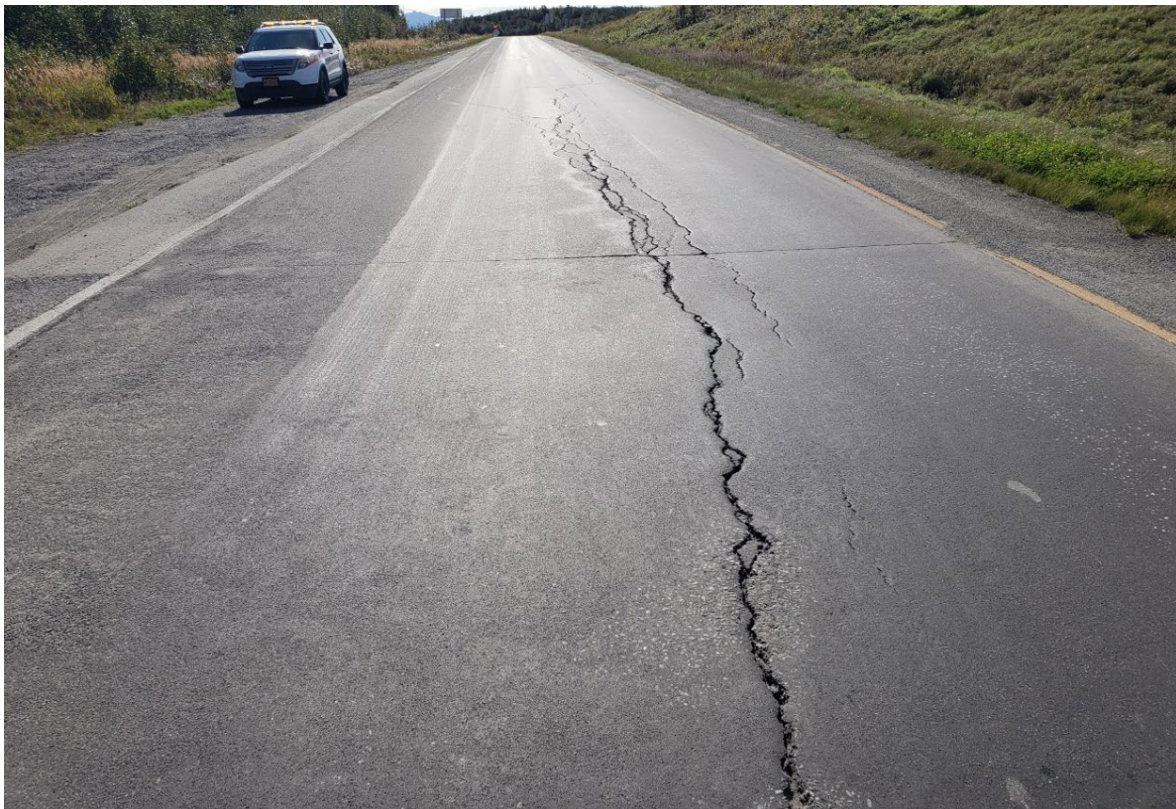
The ramp condition adjacent to 100<sup>th</sup> Avenue is poor from the severe reflective cracking and some flushing but is in moderate to good condition outside of that area.

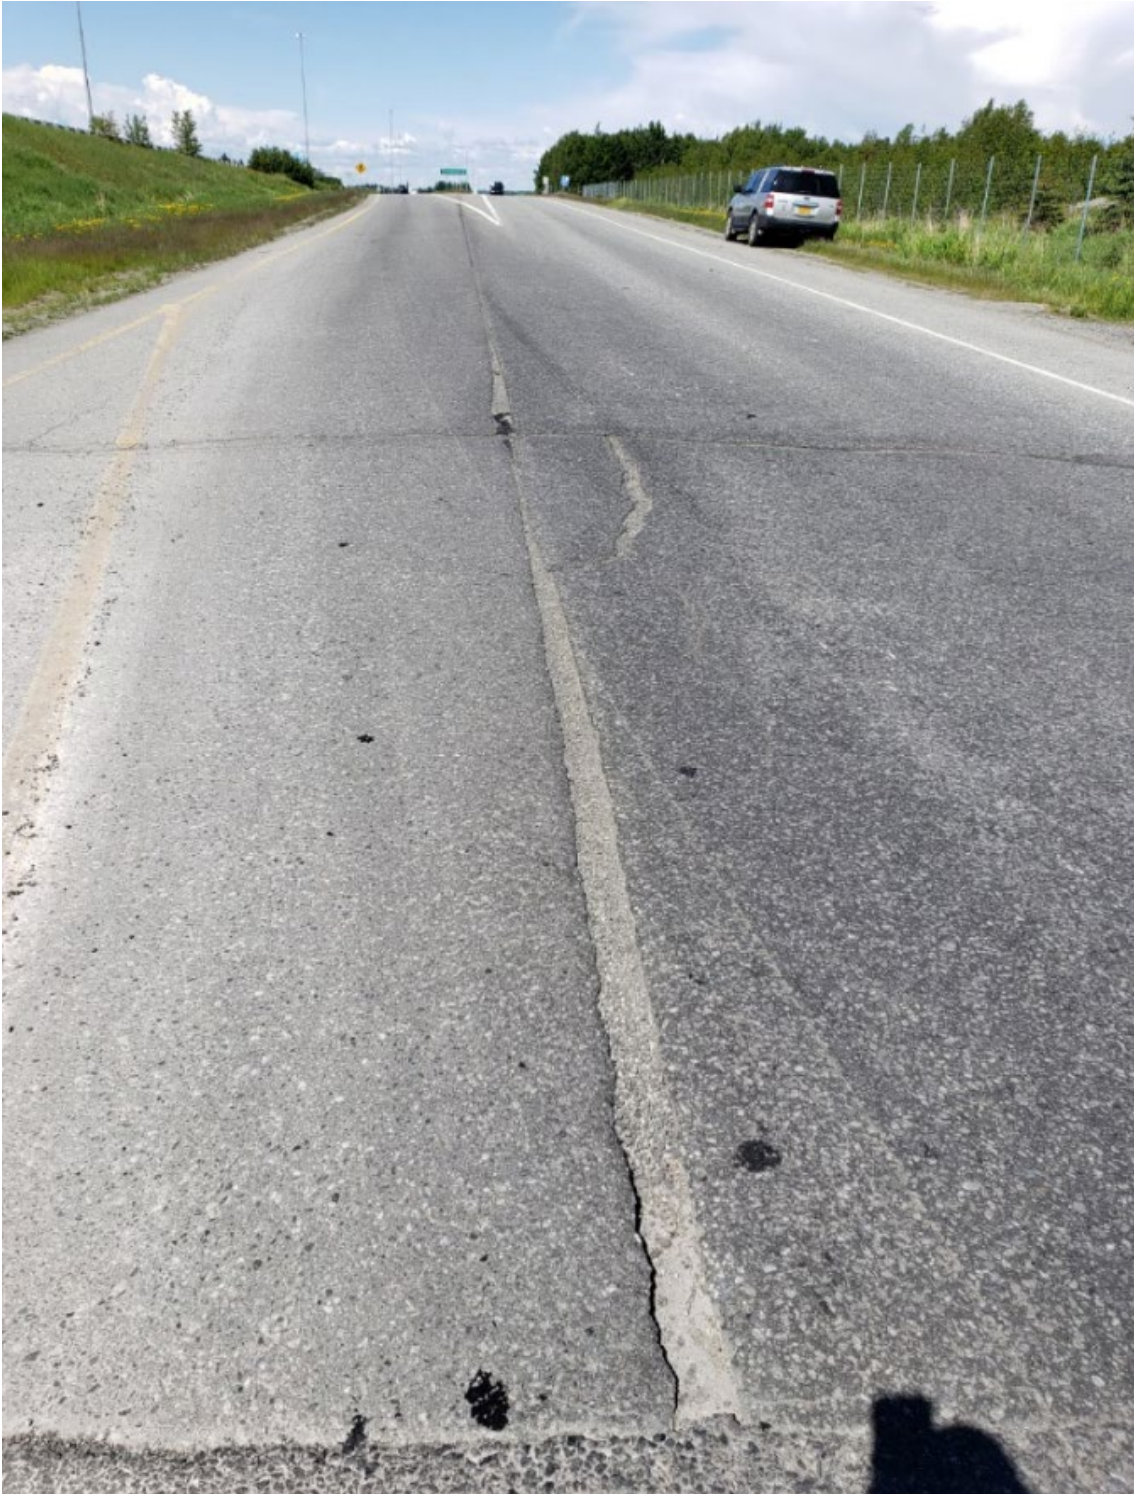
There is moderate longitudinal and transverse cracking near 100<sup>th</sup> Avenue with isolated potholes and some high severity transverse cracking where the ramp merges into Minnesota Drive.

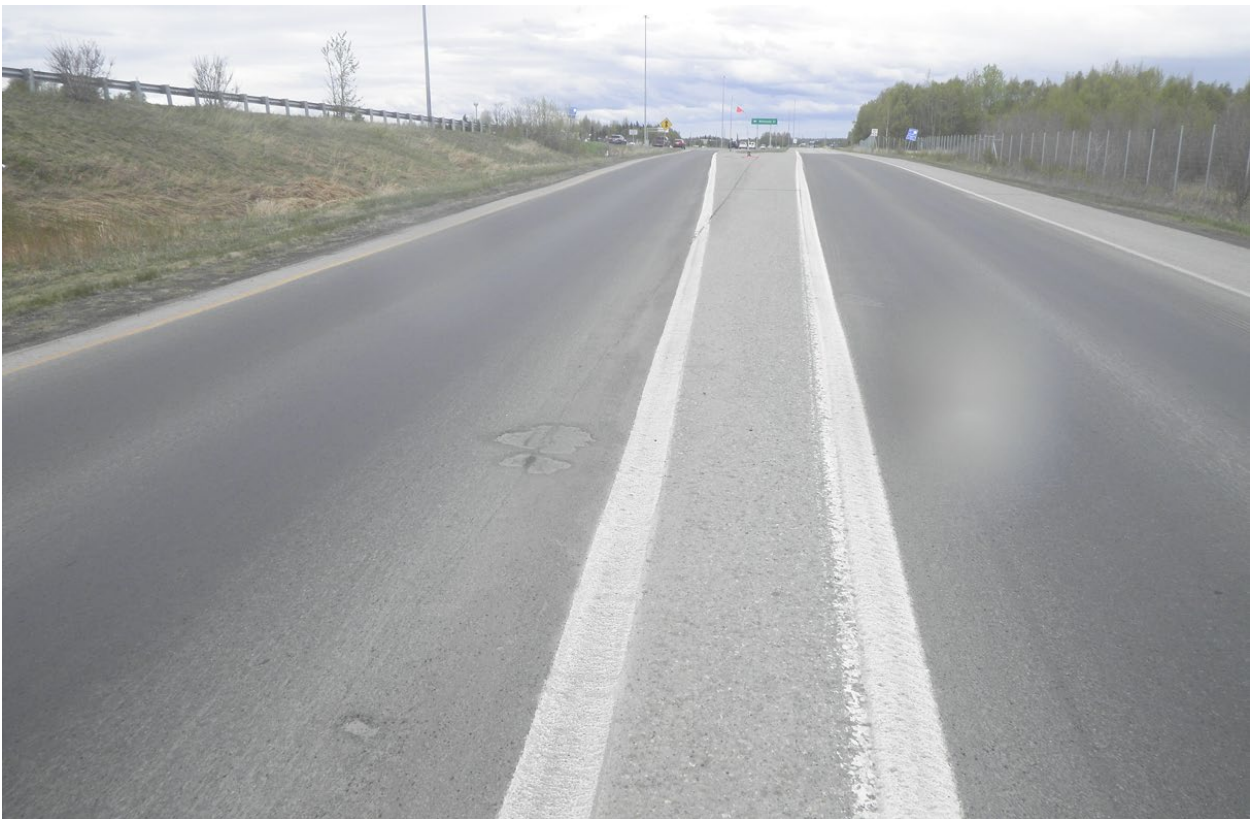
This ramp is in moderate condition from some plow damage at the end of the lanes and reflective transverse cracking.

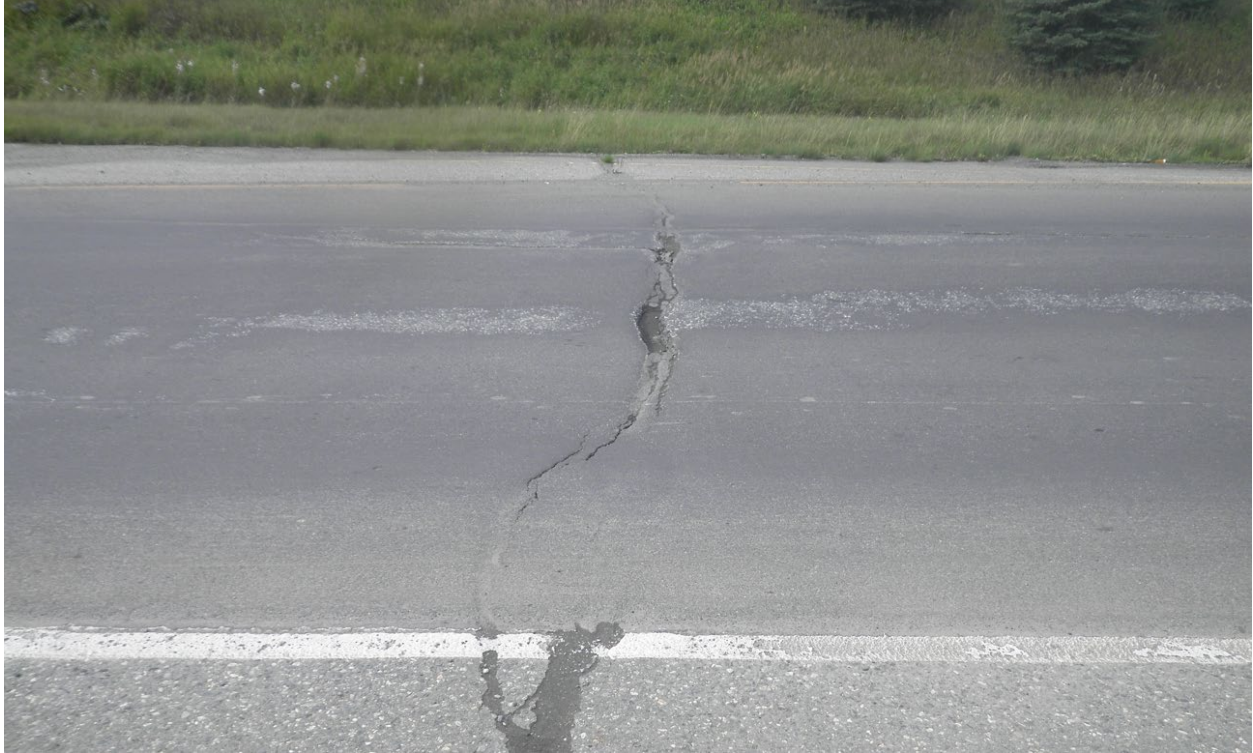
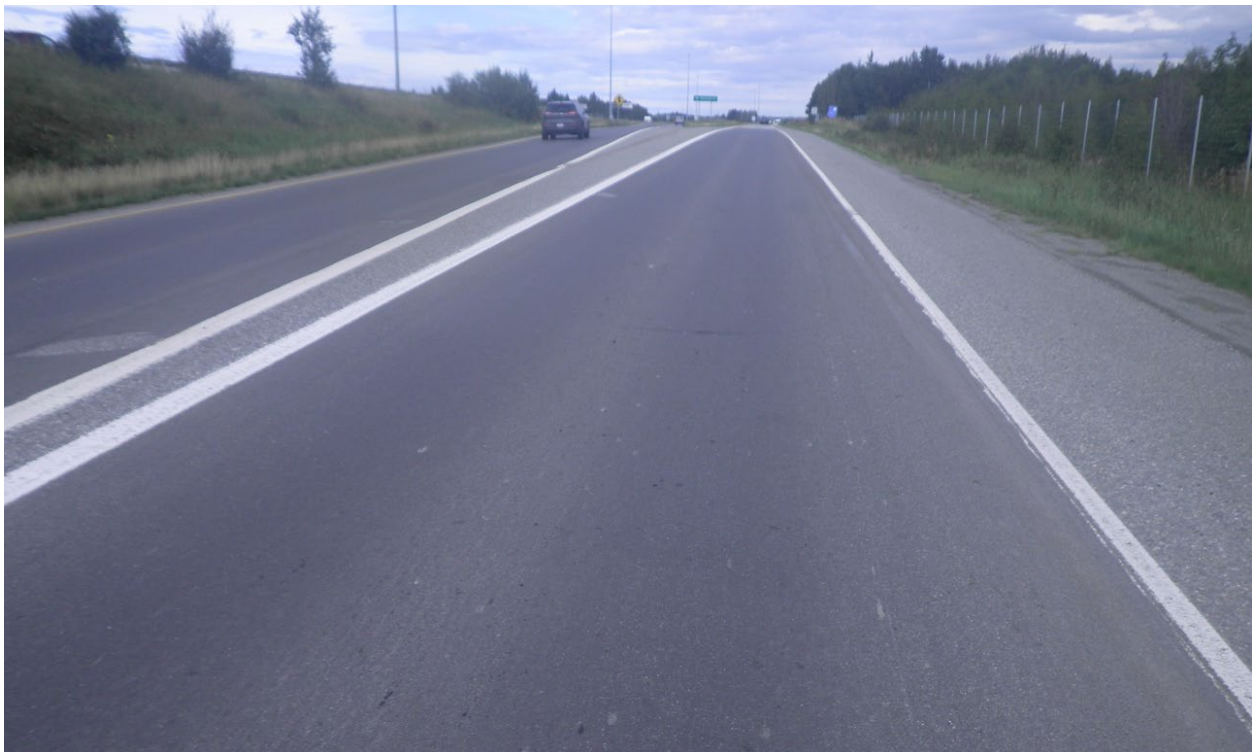
There is a severe transverse crack near the beginning of the application that has opened up. Plow damage can be seen where there was likely high down pressure that abraded the surfacing treatment and ripped out the material sealing the underlying crack.

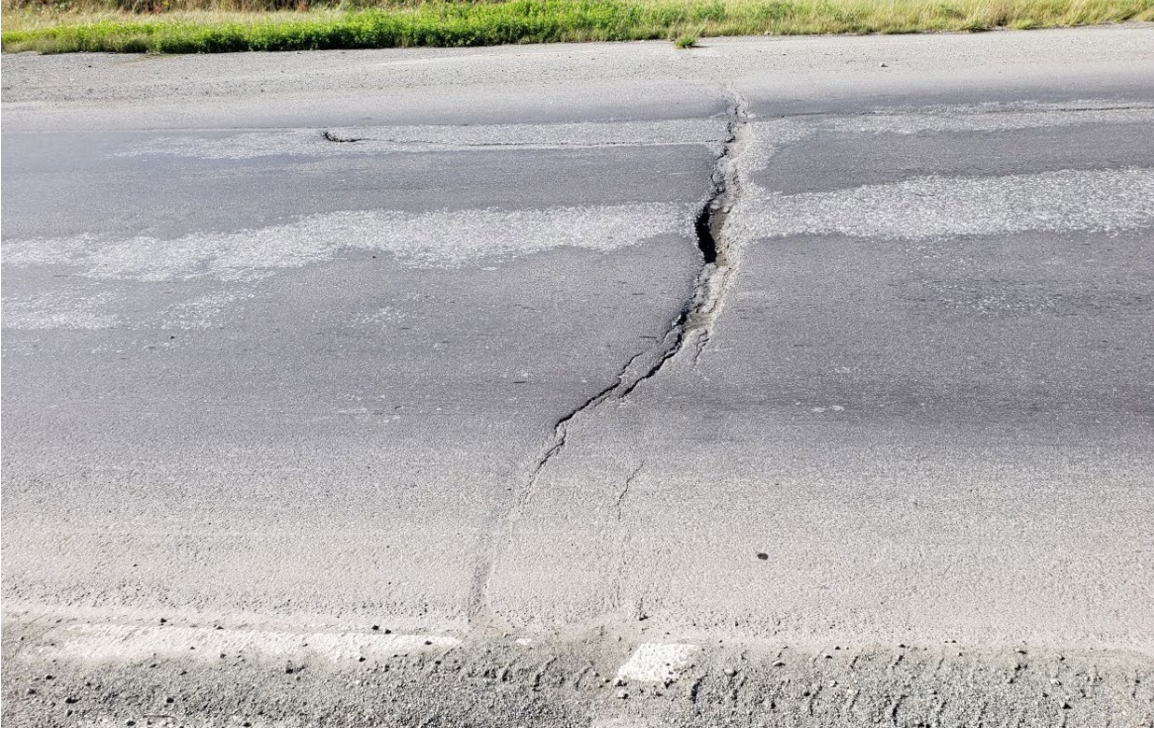
The severe transverse crack has continued to see increase in wear and there is slight spalling around transverse cracks. There is also some isolated plow damage farther down the ramp.

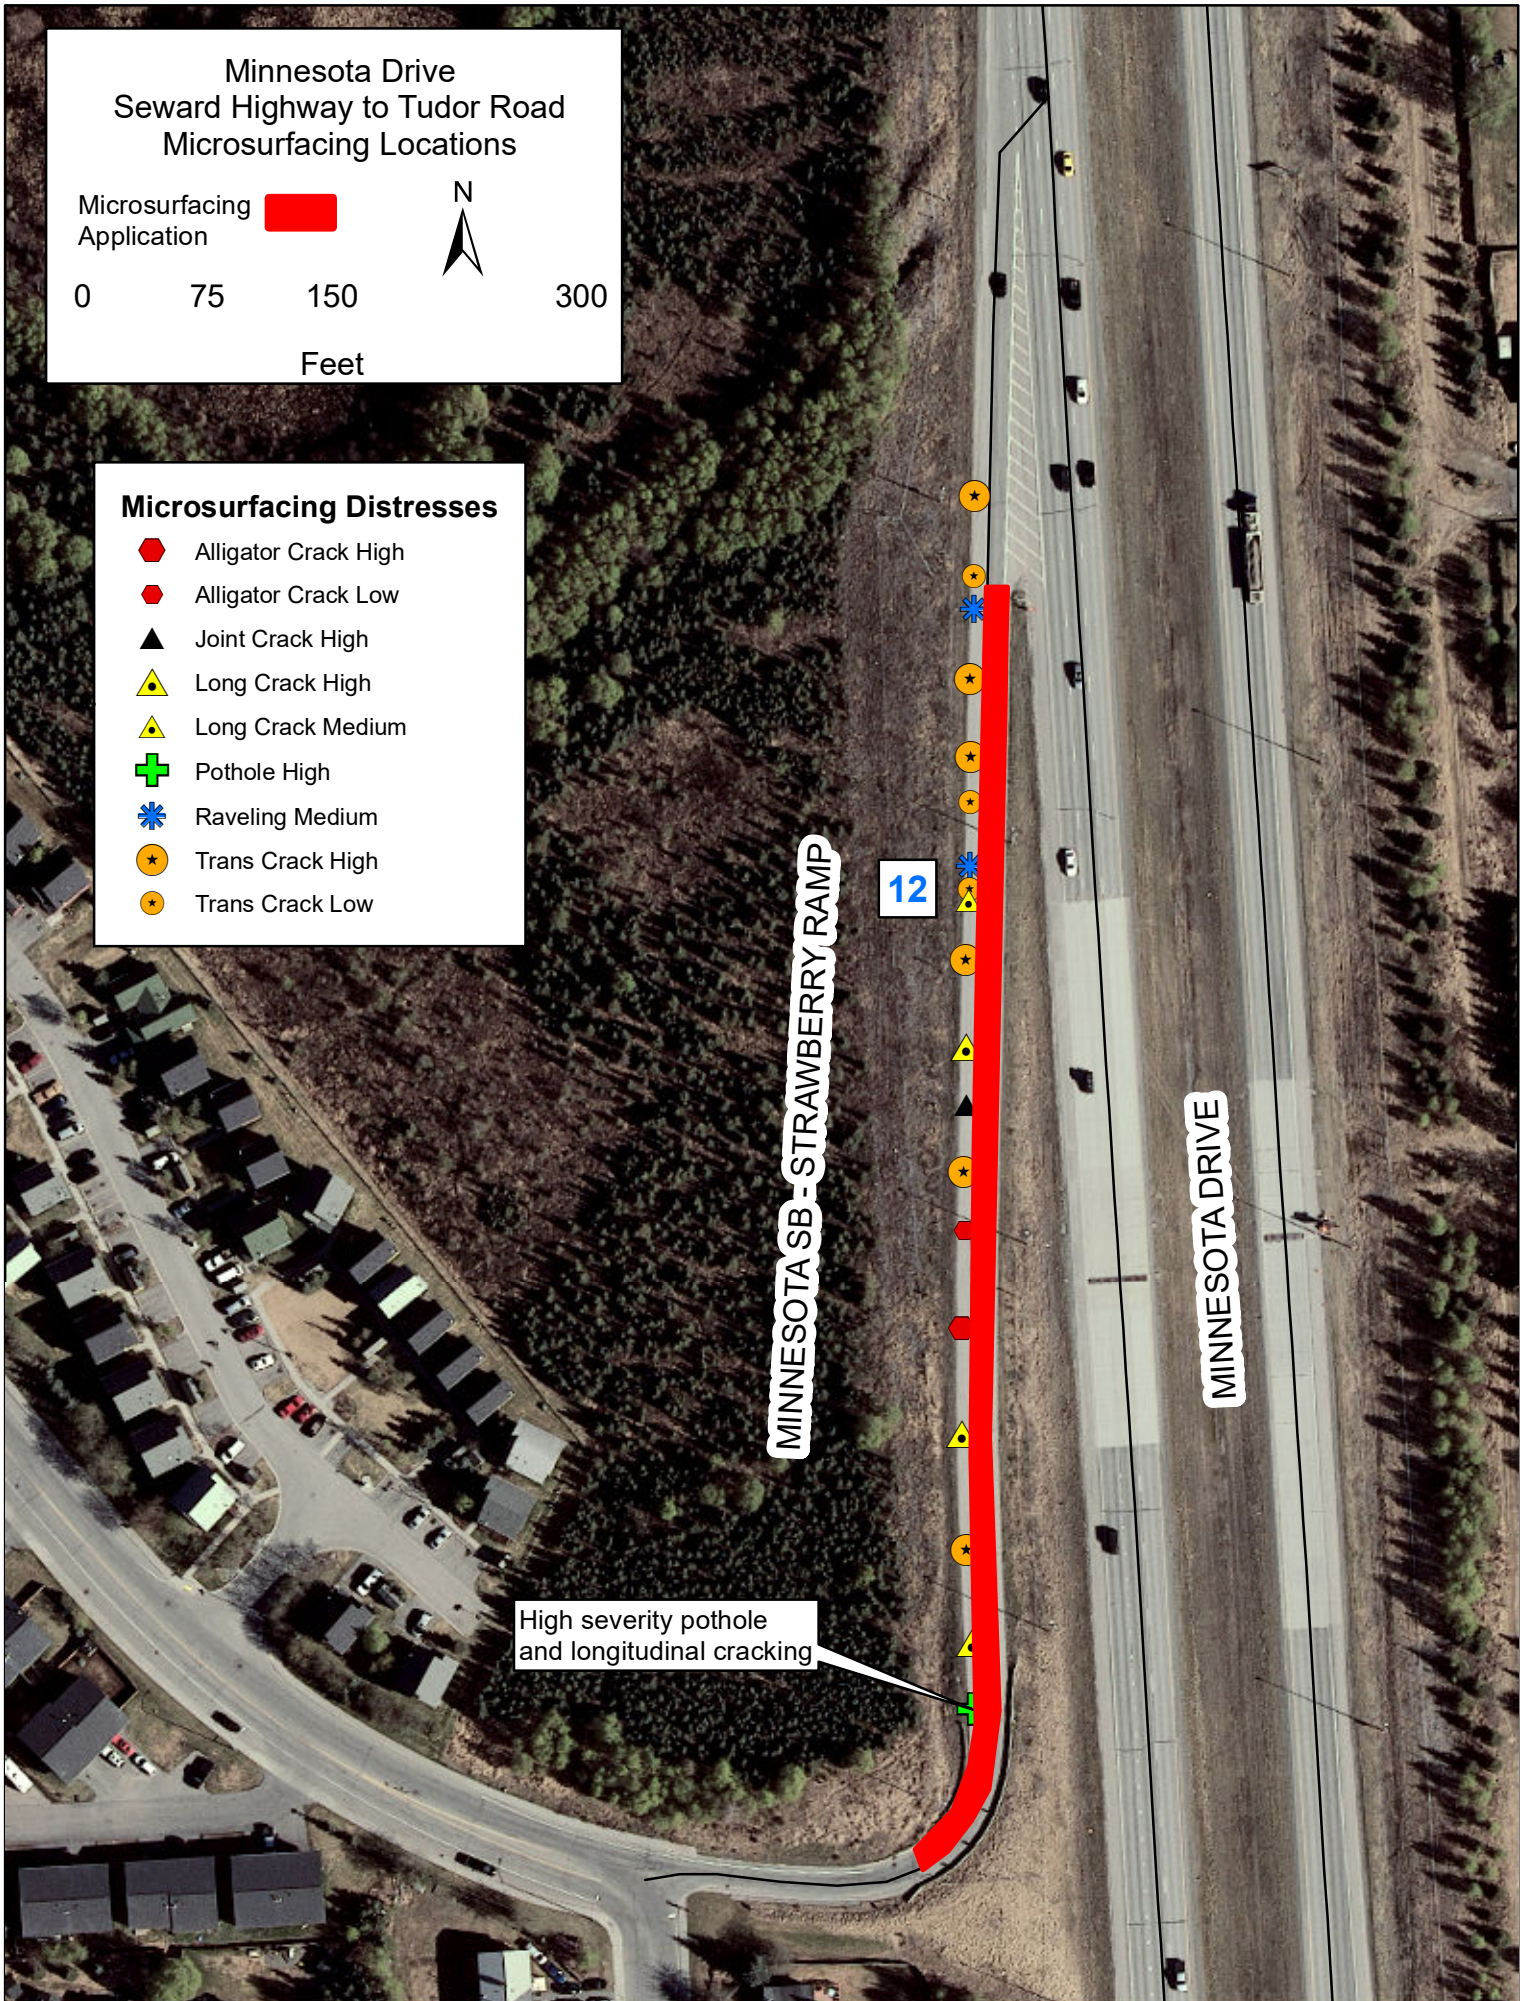
High severity pothole and longitudinal cracking

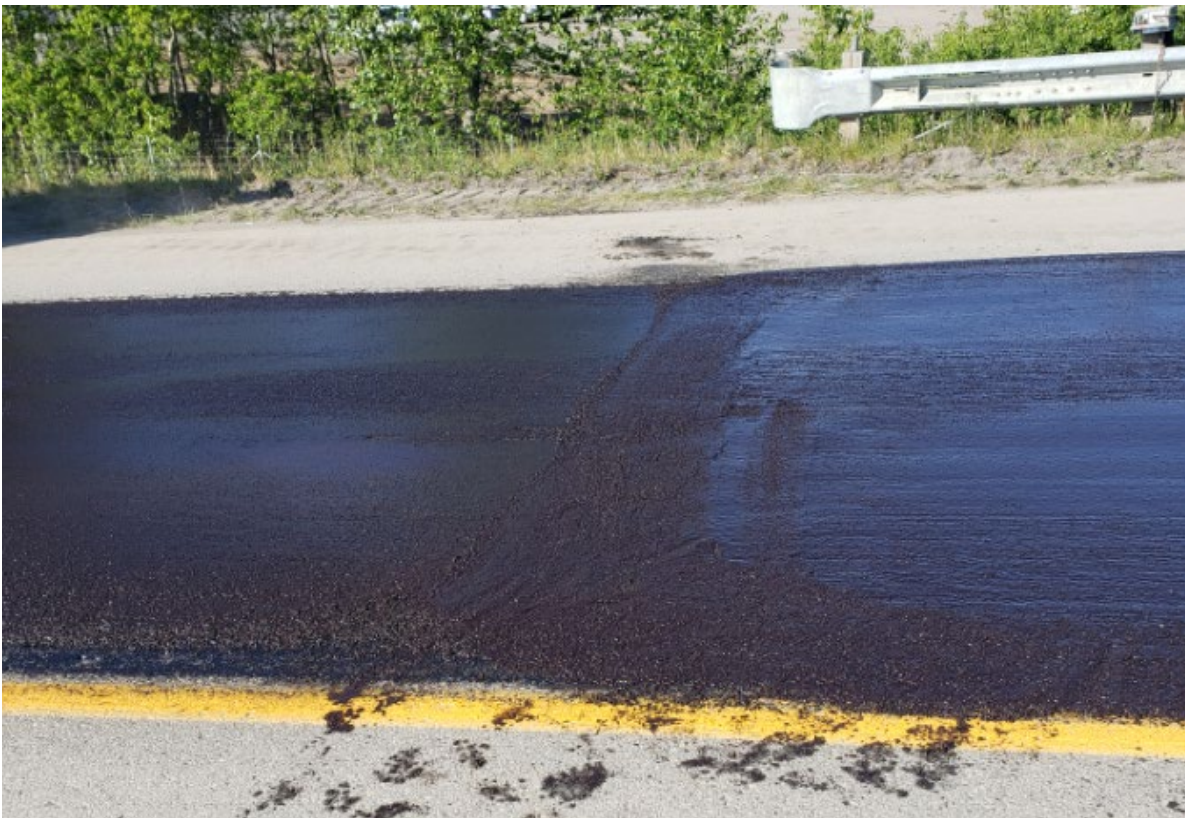
Ramp 1 – Hand worked portion at the joint where the aggregate bin ran out on the first Macropaver and the second Macropaver took over application while it was refilling.

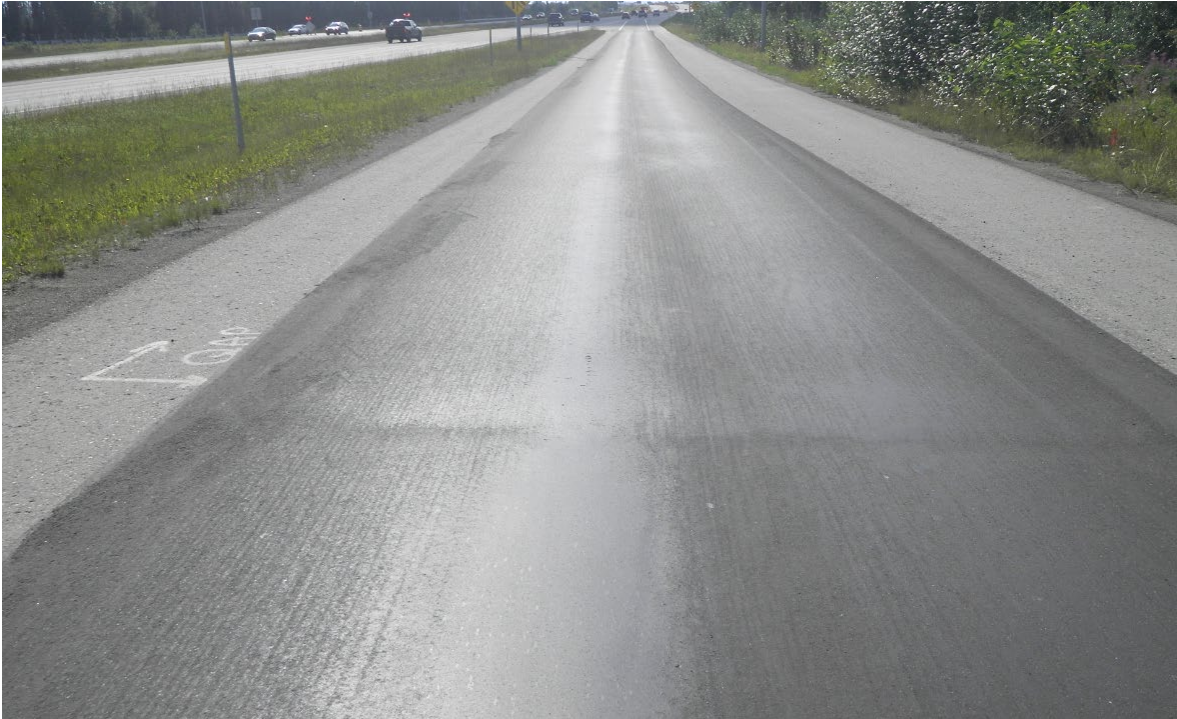
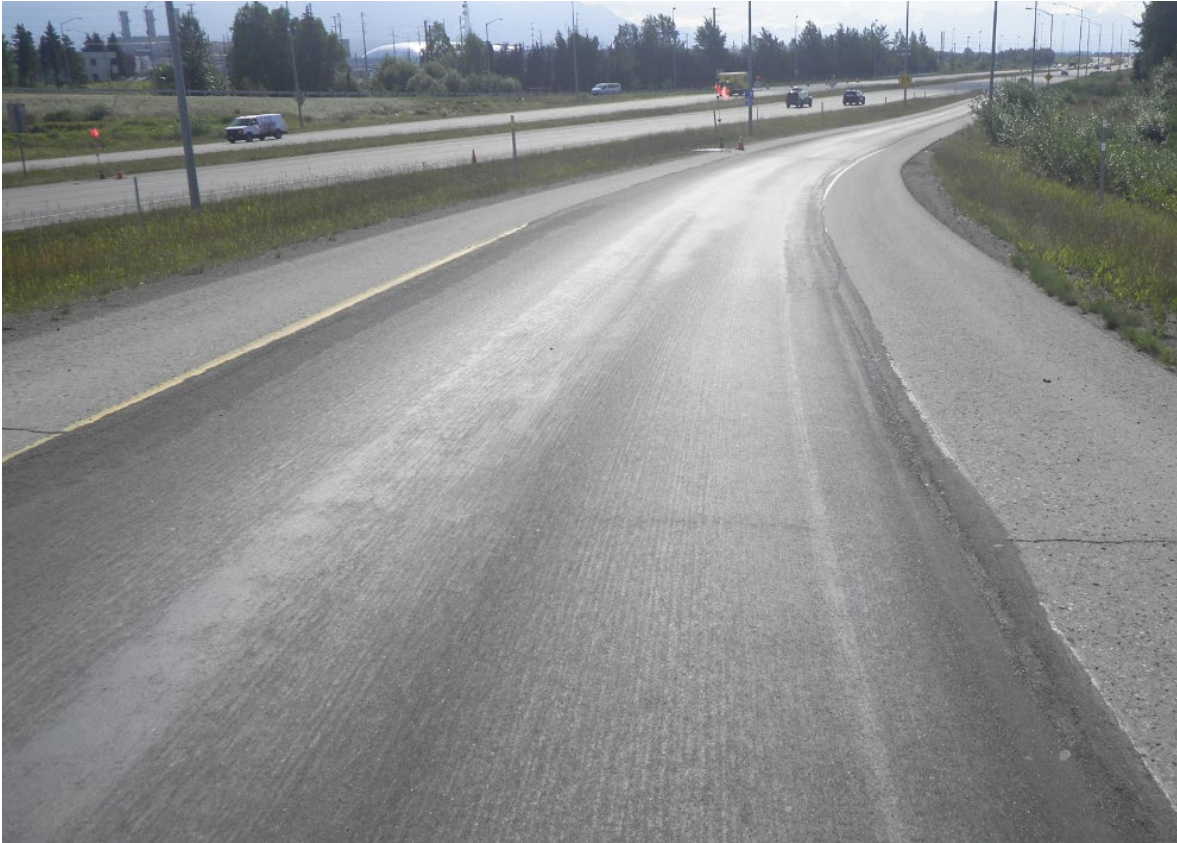
On August 10<sup>th</sup> construction determined there had been a loss of friction on Ramps 1, 2, 5, 10 and 13 and friction testing were performed to confirm this. The locations with flushing and loss of friction are shown on the following pages. Ramp 1 is below.

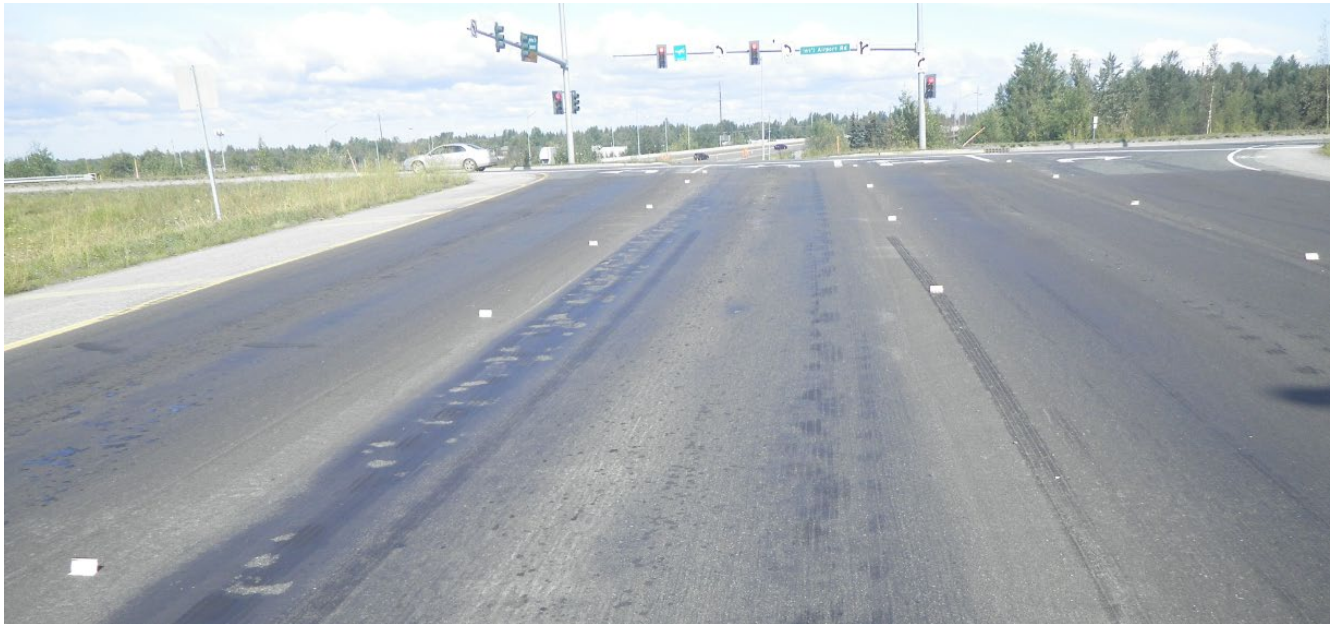
The flushing distress and pickup by traffic can be observed on Ramp 2

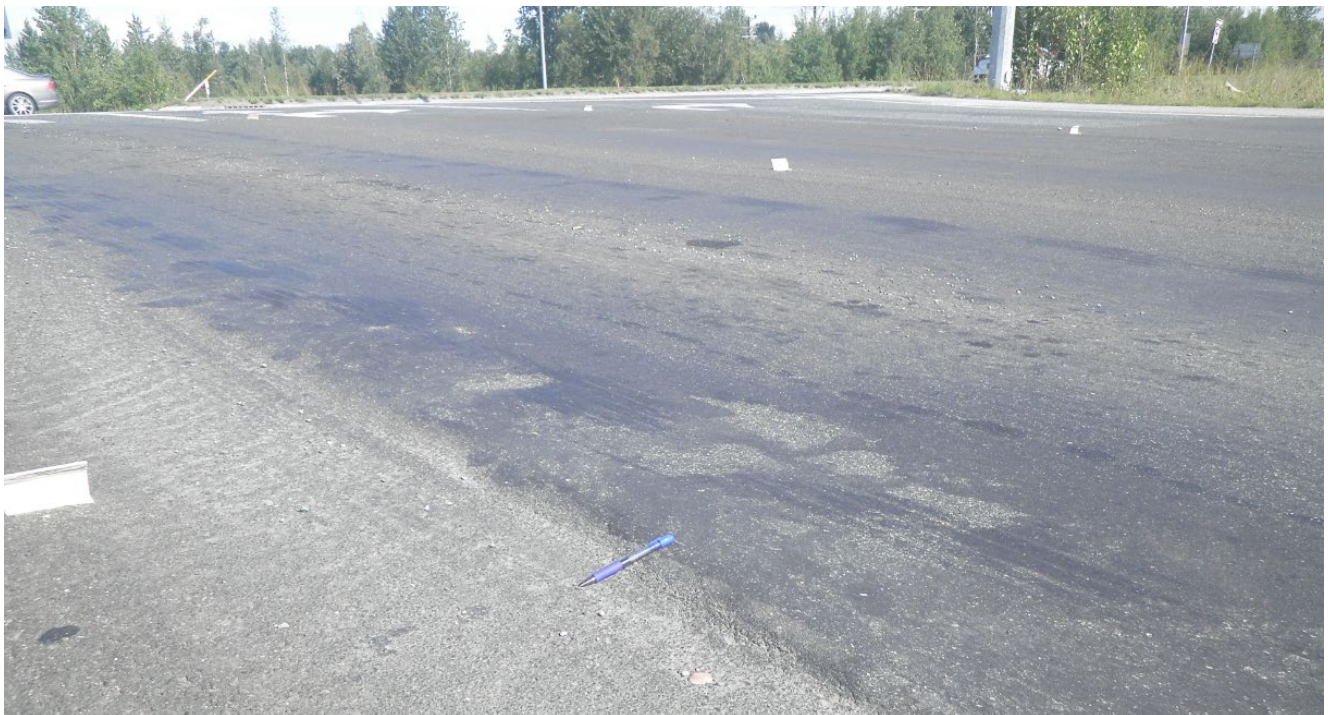
The deformation of the micro surfacing created a hump where the pen is placed in the photo below. This deformation was not observed on any other ramps where flushing was present, likely because Ramp 2 is the only ramp that has static loading on the micro surfacing.
