Project Summary Report FHWA/MT-23-006/9757-705

EVALUATION OF THIN POLYMER OVERLAYS FOR BRIDGE DECKS

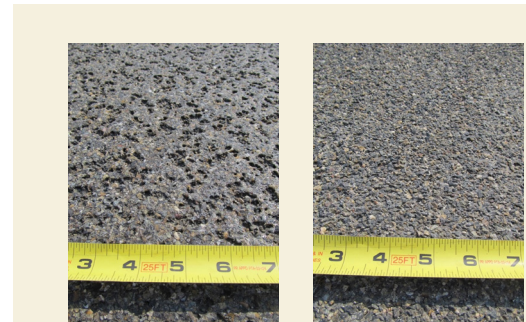
- Aggregate pop-out and areas of surface polishing (Figure 3);
- Reflective cracking and spalling around some older partial-depth repairs;
- Few small pop-out spalls on the order of one or two inches in diameter (Figure 4);
- Local deterioration of the HFSTs at bridge ends;
- Occasional delaminations under sound HFST areas where no cracking was present; and
- Occasional delaminations adjacent to cracks in the HFST.

Figure 3: Close-up photographs of (a) the wheel path and (b) the shoulder of the HFST on Bridge 1367 in the Missoula District in 2022.

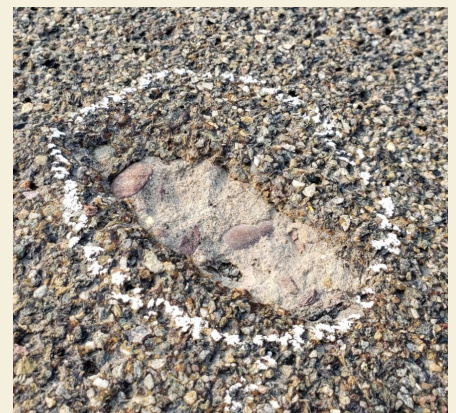
Figure 4: Close-up photograph of a small pop-out spall in the HFST on Bridge 1367 in 2020.
