Investigation of High Mast Illumination Pole Handhole Cracking

Report Number: KS-24-02 • Publication Date: March 2024

The University of Kansas

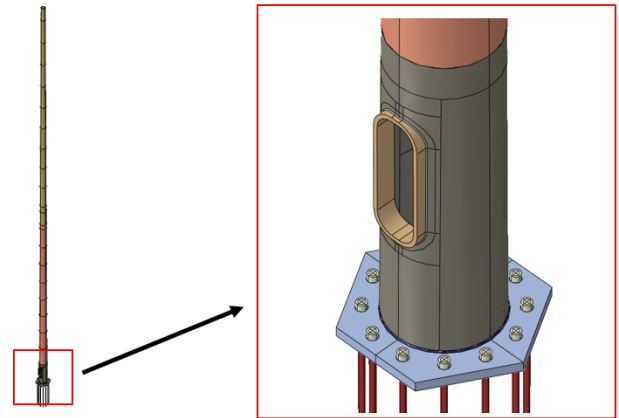
*Finite Element Model of HMIP Original Design
(pre-2019)*
