Report No. UT-24.05

REPAIR OR STRENGTHENING OF BRIDGE DECKS WITH PARTIAL-DEPTH PRECAST DECK PANELS

Utah Department of Transportation
Research & Innovation Division

**Final Report
January 2024**

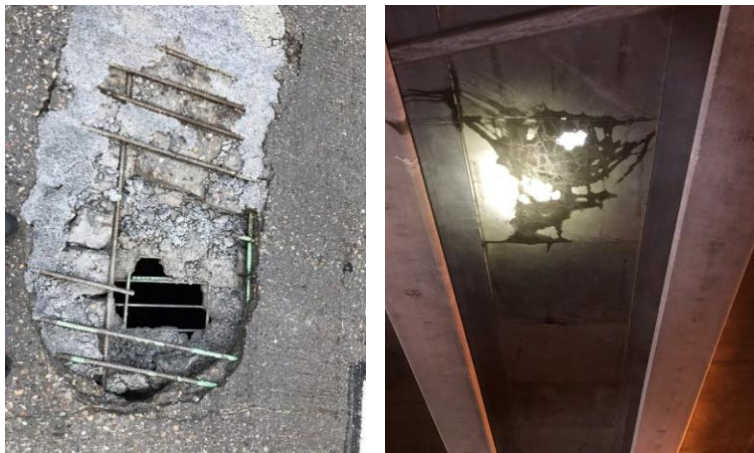
The I-15 over 800 South bridge in Salt Lake City, Utah, experienced an unexpected blow-through, requiring an emergency closure and repair, on March 24, 2019, as shown in **Fig. 1.1**. After inspection, it was determined that other sections of the deck were in danger of a similar failure. The likely cause of failure was delamination and deterioration of the interface between the cast-in-place section and precast section. The Utah Department of Transportation (UDOT) developed a repair plan, which consisted of removing complete sections of the deck and replacing the damaged concrete with a rapid-hardening hydraulic cement concrete mix. Three lanes were closed over the 800 South bridge, and the bridge was re-opened on March 25, 2019. Although this is a viable repair method, it significantly impacts traffic and is a high-cost repair method.

Figure 1.1 Blow-through of deck panel at I-15 and 800 South bridge (credit: UDOT)

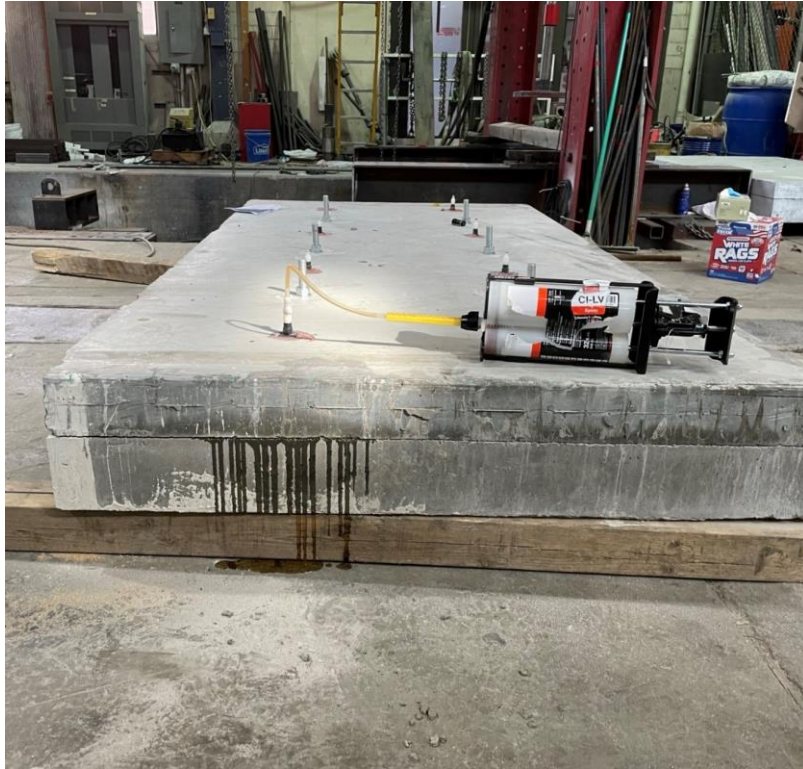
Figure 3.18 Epoxy injection leaking from panel.

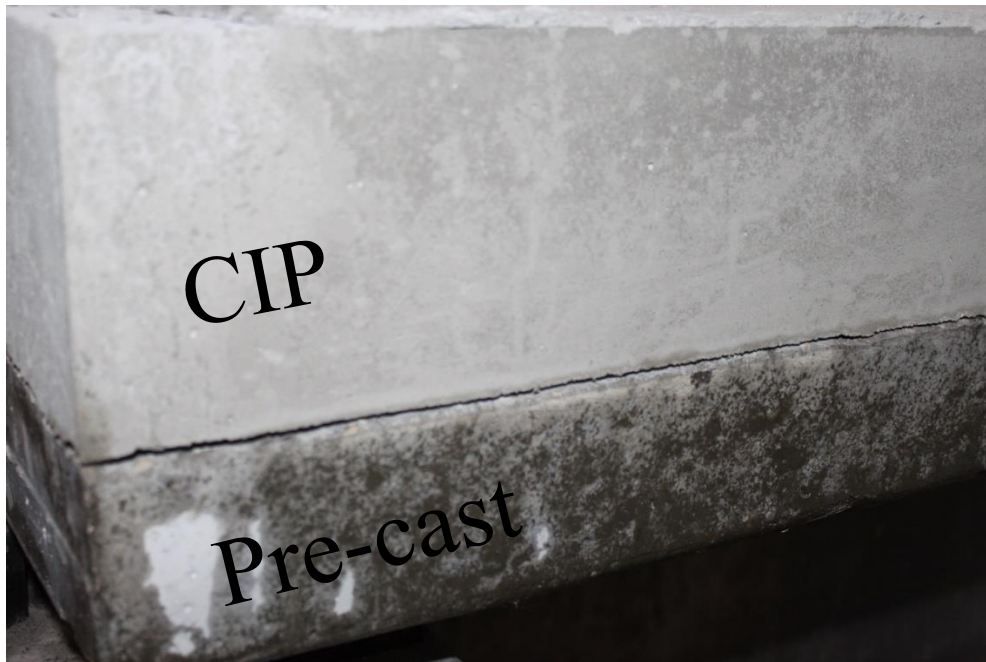
The LVDT plot in **Fig. 5.4** indicates that internal delamination started at an applied displacement of 0.5 in. due to the reduction in stiffness at that point in time. It is also at this point that small cracks began forming on the underside of the precast panel.

Figure 5.2 Control specimen delamination at 1.2 in. of displacement. (Location: northwest)

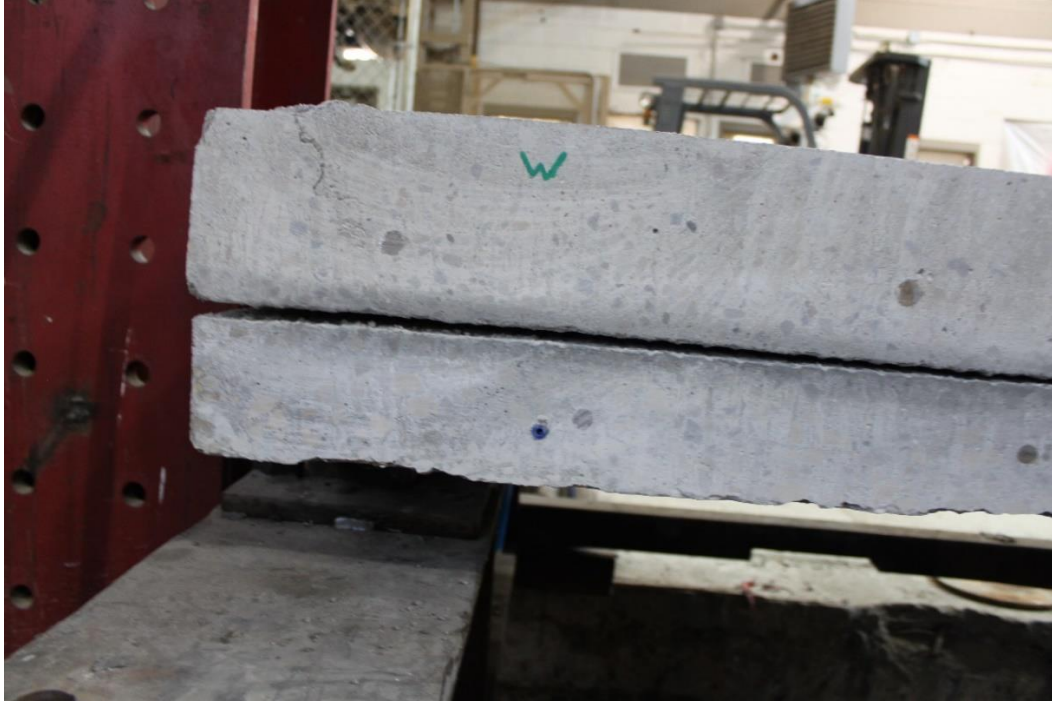
The deck panel with the epoxy injection retrofit resisted the displacement imposed by the hydraulic actuator until the epoxy bond between the precast section and CIP section of the panel failed. The initial delamination at the north and south extremes is shown in **Fig. 5.6**. The epoxy retrofit demonstrated perfectly composite behavior for the first cycle of 0.4 in. Once the epoxy bond had failed, the panel behaved almost identically to the panel without any retrofit from *Section 5.1*. Bond failure occurred at only the north side of the panel while the south end remained completely bonded; this type of failure created a large displacement in the north LVDT as shown in **Fig. 5.7**. The panel with epoxy bond was able to endure a maximum load of 63 kip before delamination, indicated in the hysteresis curves of **Fig. 5.8**. The precast and CIP sections of the panel continued to separate after the epoxy failure. **Fig. 5.9** demonstrates just how much the panel was able to separate; the gap measured almost 0.5 in. when the applied displacement was 4.0 in. During the test it was observed that the CIP section of the panel was deflecting laterally as shown in **Fig. 5.10**; this behavior was anticipated but the displacement was large.

*Figure 5.9 Delamination of epoxy retrofit deck panel at applied displacement of 4.0 in.
(Location: northwest)*

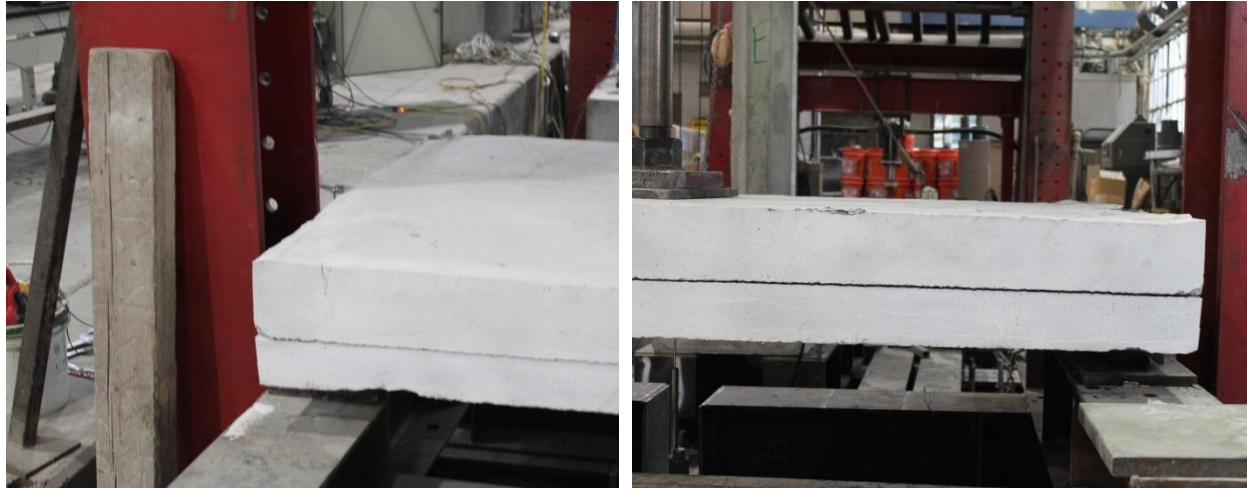
The deck panel with the proprietary mechanical shear anchors had severe delamination prior to testing as shown in **Fig. 5.12**. In fact, the CIP section and precast section of the panel were entirely separate, which is a very extreme condition. The deck panel began to show evidence of cracking along the midspan at an applied displacement of 1.6 in., as shown in **Fig. 5.13**, but the delamination was restrained by the anchors and did not become critical.

Figure 5.12 Shear anchor retrofit deck panel initial delamination. (Location: left; southeast, right; northeast)

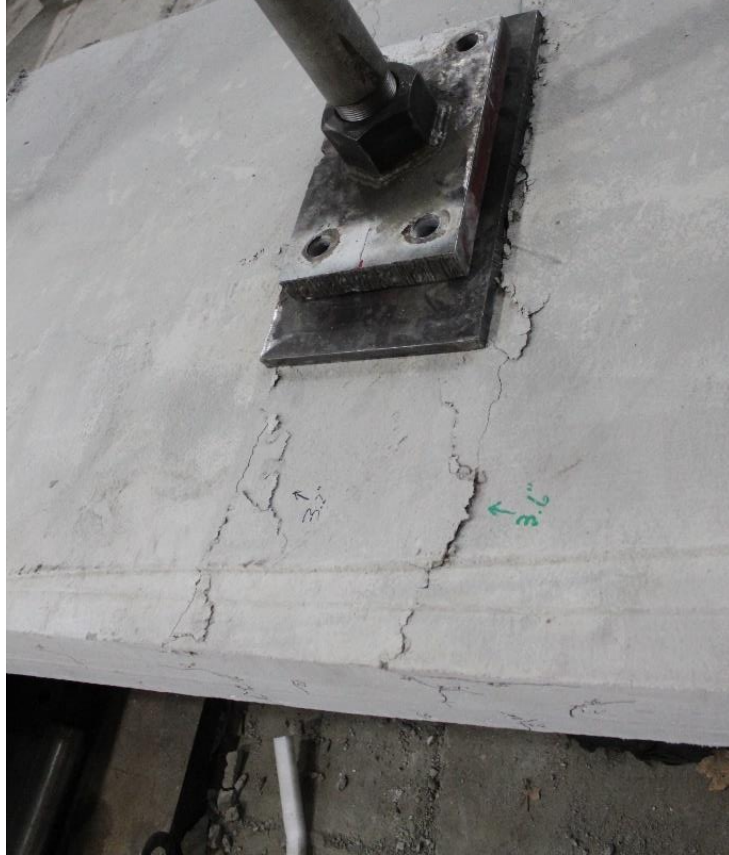
With increased load, no delamination was observed, and the concrete of the CIP section of the panel began crushing at a displacement of 3.2 in., as shown in **Fig. 5.14**. Even with the concrete compression failure at the top surface of the panel, the proprietary mechanical shear anchors maintained composite action of the system.

Figure 5.14 Shear anchor retrofit deck panel compressive failure after applied displacement of 3.6 in. (Location: top, mid-span)

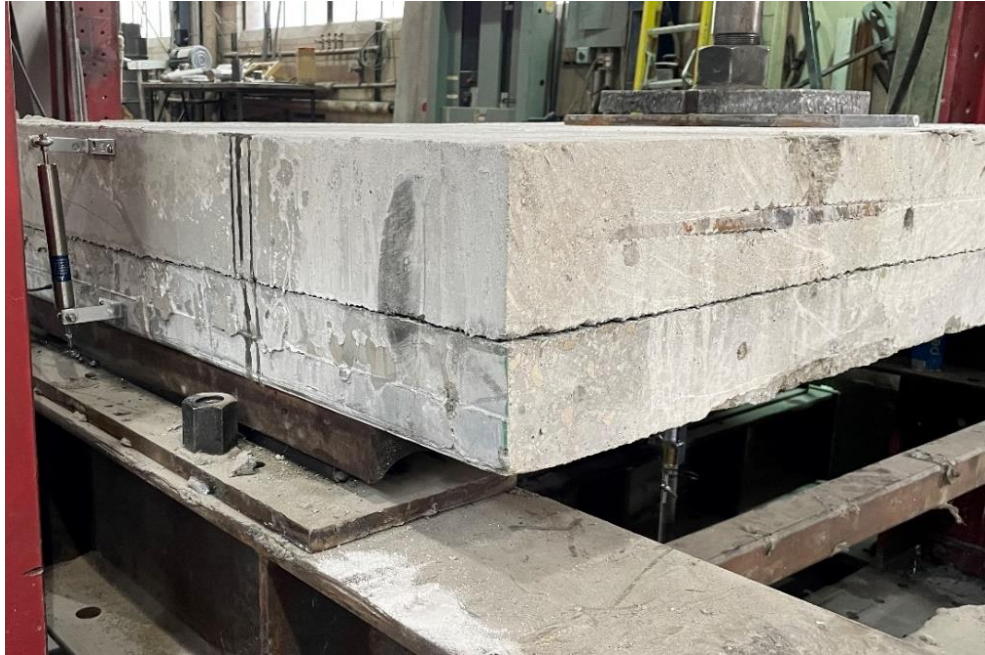
The deck panel specimen retrofitted with CFRP strips had an initial delamination of approximately 0.25 in., as shown in **Fig. 5.17**. At an applied 1.0-in. vertical displacement, the deck panel showed similar cracks to the control panel along the face of the CIP section of concrete, as shown in **Fig. 5.18**. At a 2.0-in. applied displacement, flexural cracks became visible in the precast panel as seen in **Fig. 5.19**. The test panel performed similarly to the unmodified specimen until a displacement of 1.2 in. At that point, tension in the CFRP strips had become large enough to resist further deflection at midspan. However, the additional strength provided by the CFRP was not sufficient to eliminate delamination. The CFRP strips did not fracture but, as **Fig. 5.20** shows, the CFRP strips debonded from the precast panel. **Fig. 5.21** shows that the north and south LVDTs were recording significantly different displacements, indicating delamination is occurring. Even with the additional flexural benefits provided by the CFRP strips, the specimen could not resist delamination in the presence of the increased horizontal shear forces.

Figure 5.17 CFRP retrofit deck panel initial delamination prior to testing. (Location: southeast corner)

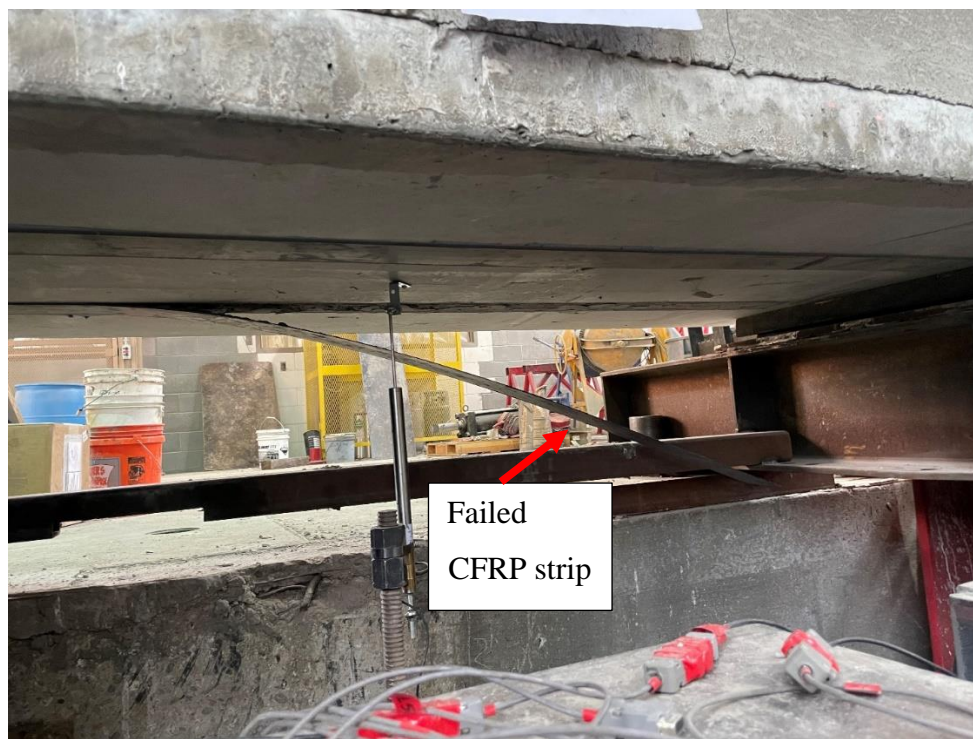
At 2.4 in. of applied displacement, the bond of the CFRP strips to the precast panel had deteriorated and this bond could no longer support additional deflection. The failure was catastrophic and is shown by the sharp drop in load in **Fig. 5.22**. The CFRP retrofitted panel behaved similarly to the unmodified panel except for the increased strength, as shown in **Fig. 5.23**.

Figure 5.20 East CFRP bond failure at applied displacement of 2.4 in.

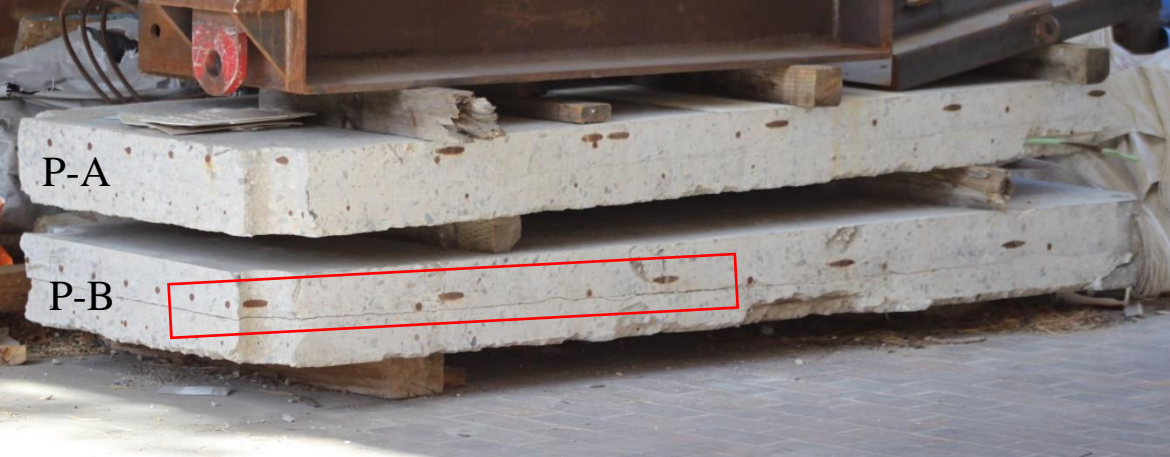
Initial inspection of the salvaged panels indicated that panel P-B had severe delamination between the cast-in-place and precast deck sections (Fig. 6.3). Panel P-A did not have the same delamination and appeared to be intact (Fig. 6.4). No abnormalities in the precast panel were observed, and the CIP decks of both panels appeared to be intact without any significant cracking.

Figure 6.3 Comparison of salvaged panels.

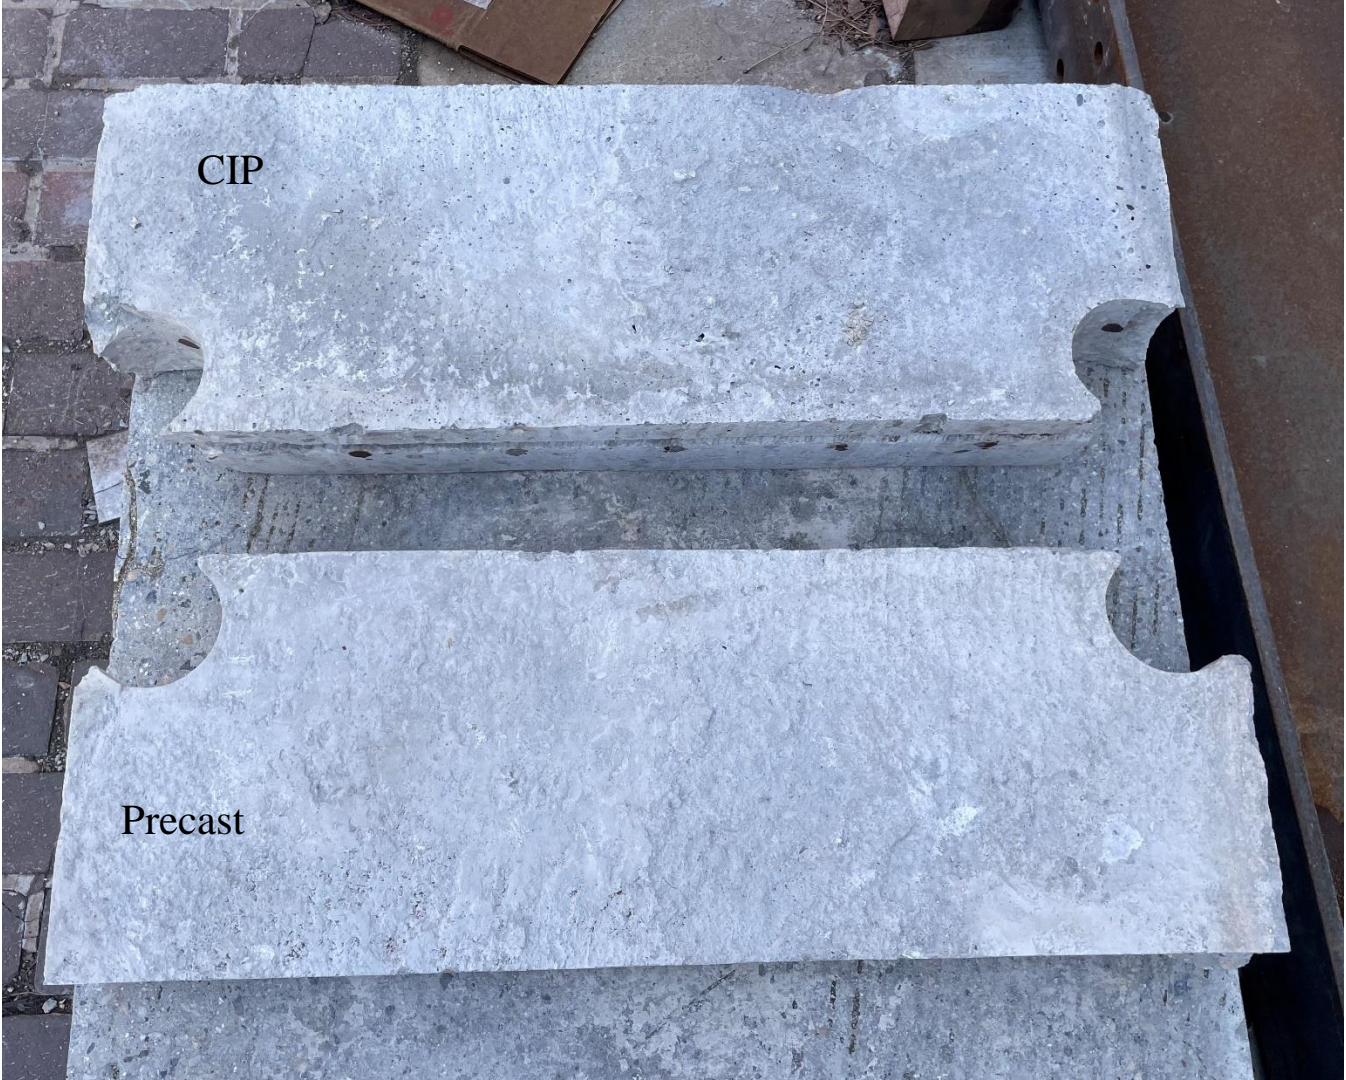
panel P-B had not bonded to the precast deck at all (Fig. 6.5). Separating the CIP deck from the precast deck of the cut section also revealed a chalky substance indicating a possible surface contaminant.

Figure 6.5 Cut section of P-B separated exposing mating interface between panels.

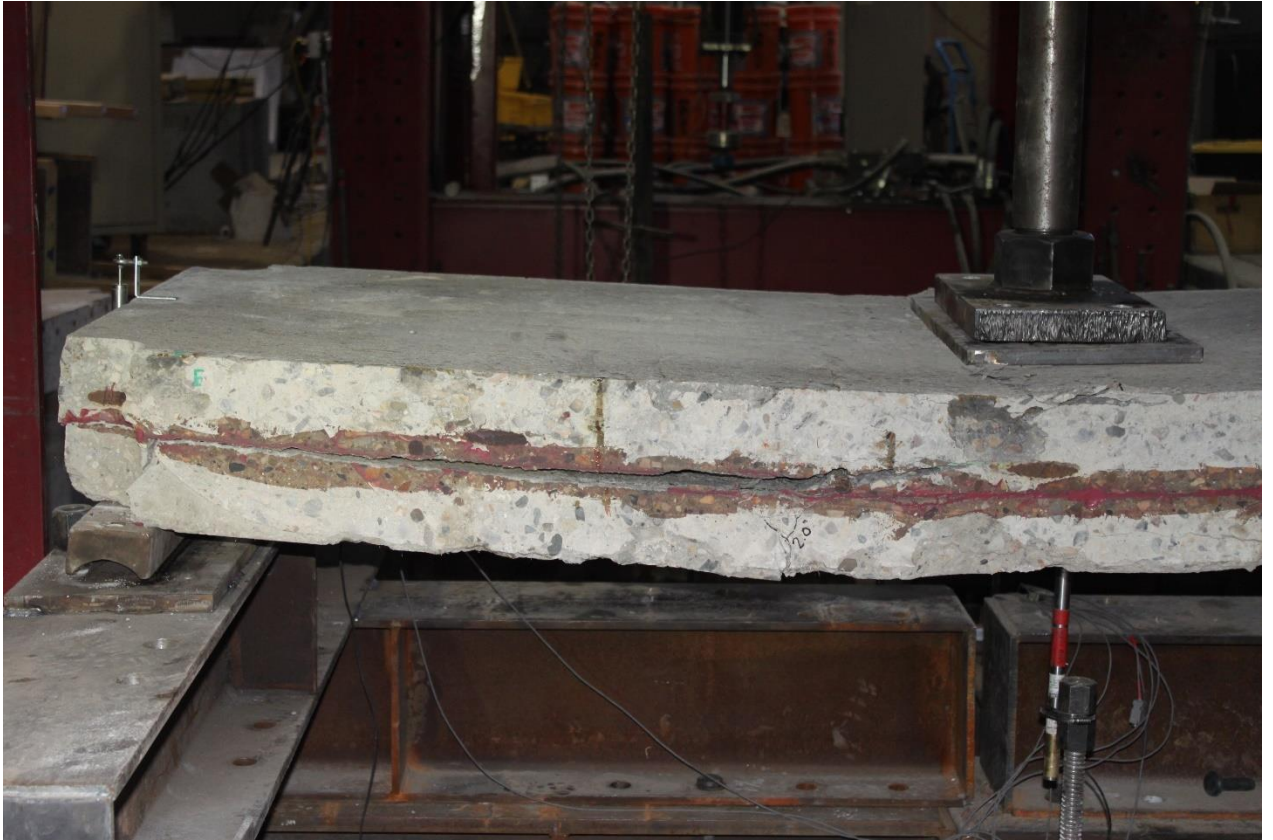
Panel P-B was tested using the second loading protocol that was developed and is outlined in *Section 4.2*. Similar to other tests, small flexural cracks appeared at midspan. No observable delamination was recorded at the north and south extremes until epoxy bond failure. The epoxy failed at the south end of the panel, as shown in **Fig. 6.12**. Failure occurred at 2.5 in. of applied displacement and 45.3 kip force. The hysteresis curve in **Fig. 6.13** indicates that no significant drop in panel stiffness occurred until 1.2 in. of applied displacement.

Figure 6.12 Epoxy bond failure of P-B after 2.5 in. of applied displacement. (Location: southeast)
