Publication No. FHWA-RD-93-108
July 1994

Testing of Small and Large Sign Support Systems FOIL Test Numbers: 92F020 and 92F021

This test report contains the results of two crash tests performed at the Federal Outdoor Impact Laboratory (FOIL) in McLean, Virginia. The tests were performed on a small sign support system, one at 20 mi/h (8.9 m/s), test 92F020, and one at 60 mi/h (26.8 m/s), test 92F021. The vehicle used for these tests was the FOIL's reusable bogie vehicle. The purpose of these tests was to evaluate the low-speed and high-speed safety performance of a dual post, wooden six by eight with concrete foundations, sign support system. The performance evaluation was based on the latest requirements for breakaway supports as specified in Volume 54, Number 3 of the Federal Register dated January 5, 1989. These criteria specify, in part, that the occupant change in velocity must be 16 ft/s (4.9 m/s) or less, that the significant test article stub height remaining after impact be no more than 4 in (101.6 mm), and that there can be no occupant compartment intrusion.

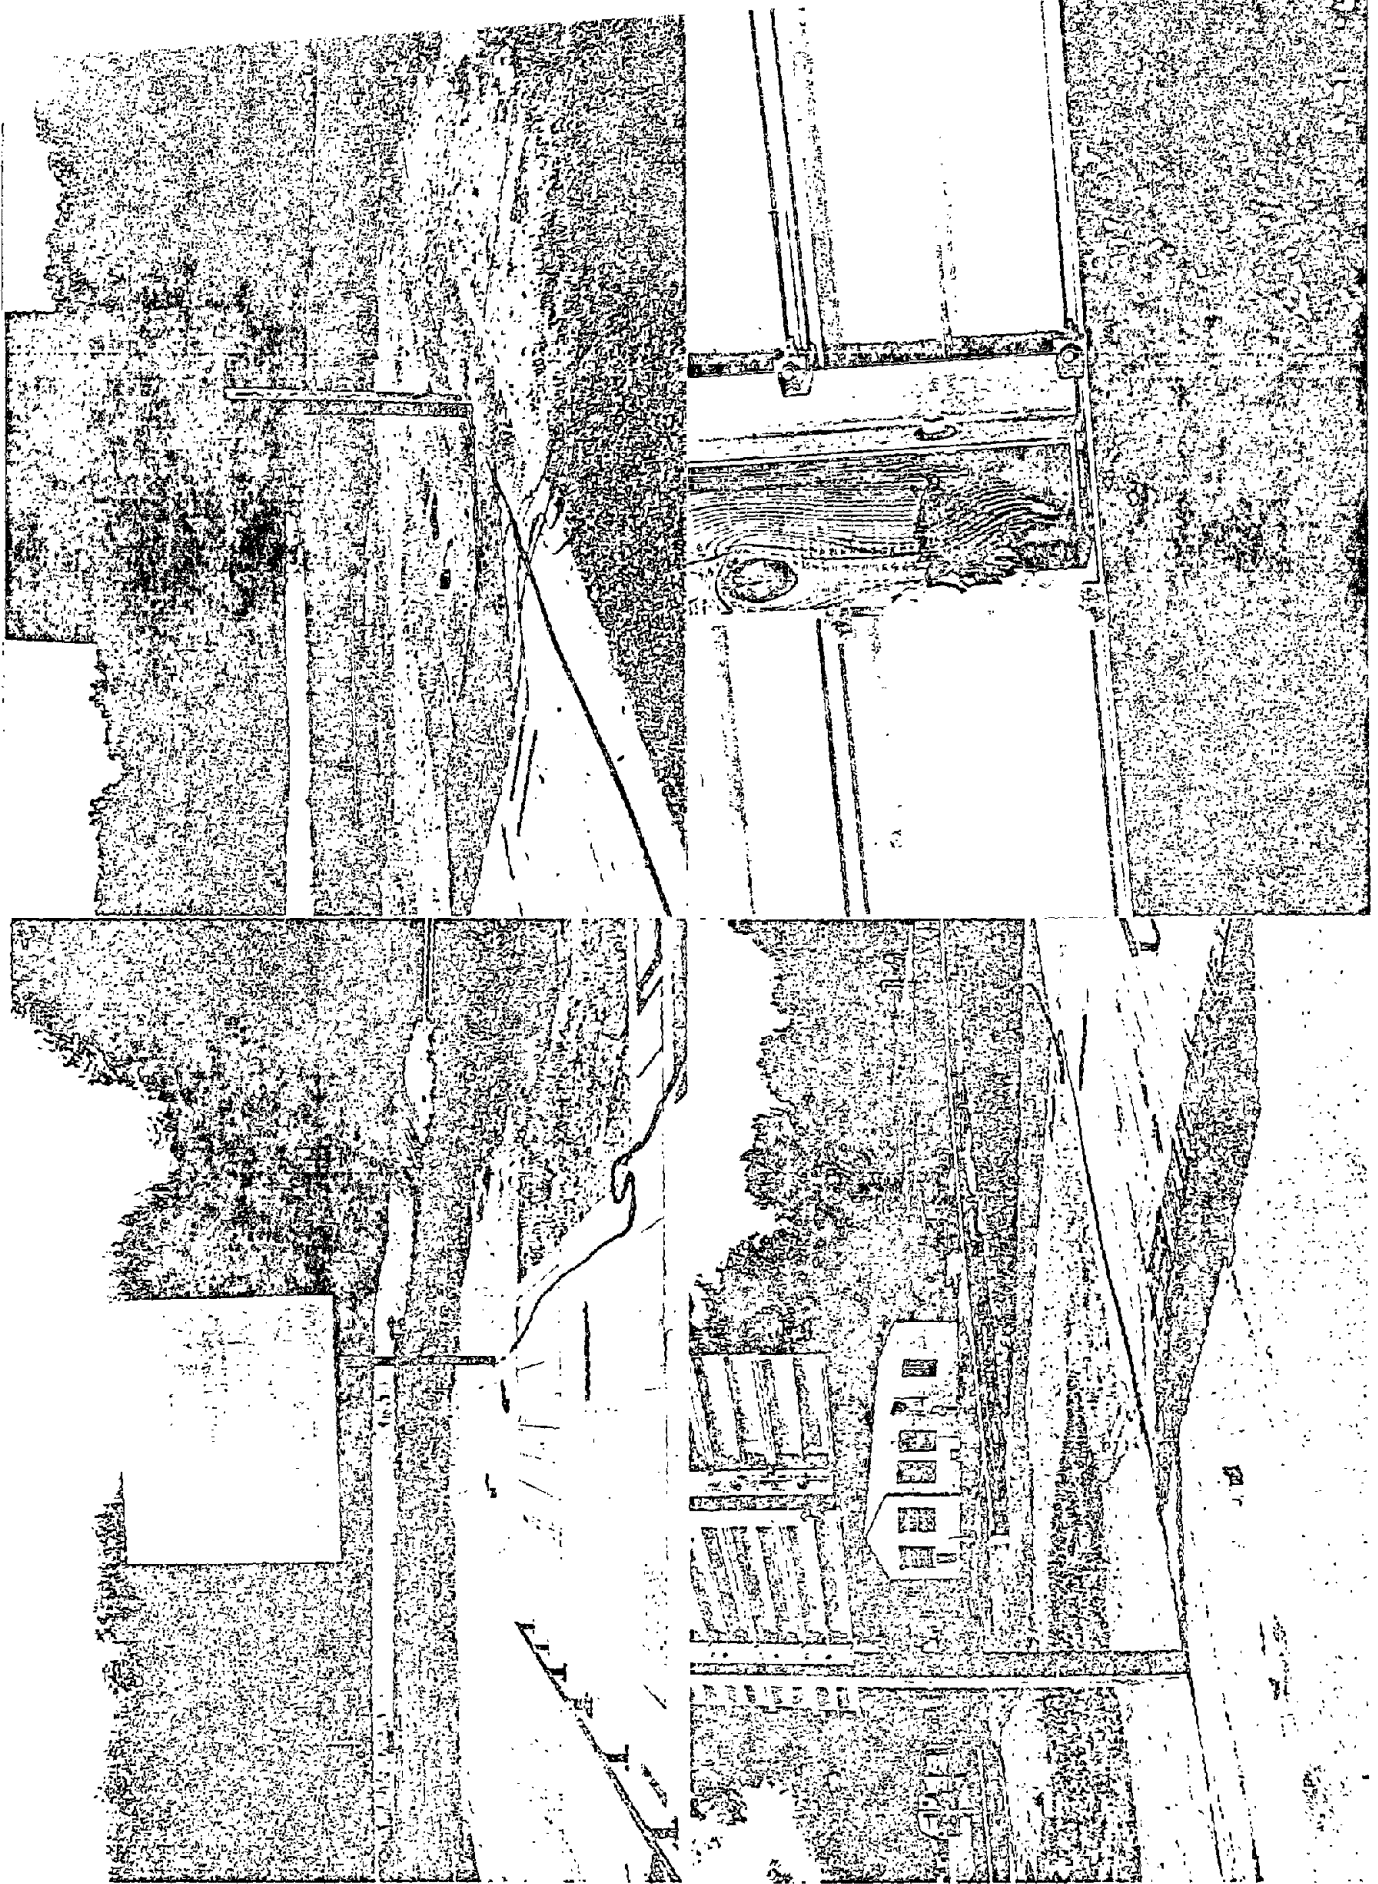
Figure 23. Post-test photographs of test corner

Damage to the bogie vehicle consisted of crushed honeycomb material. The damage was to expendable material and not to structural elements of the bogie vehicle. The crush measured after the test and was measured to be 14.8 in (375.9 mm). None of the sign components would have impaled an occupant compartment had the vehicle been an automobile rather than the bogie vehicle.

Damage to the sign support consisted of one fractured wood post. The right sign post remained upright and was fully supporting the sign panel. The panel was in good condition after the test. The embedded concrete footers remained stationary during the test.
