Evaluating Arkansas Weathering Steel Bridge Performance

Yessenia Gonzalez E.I.
Ernie Heymsfield Ph.D., P.E.

University of Arkansas - Fayetteville
Department of Civil Engineering

Final Report

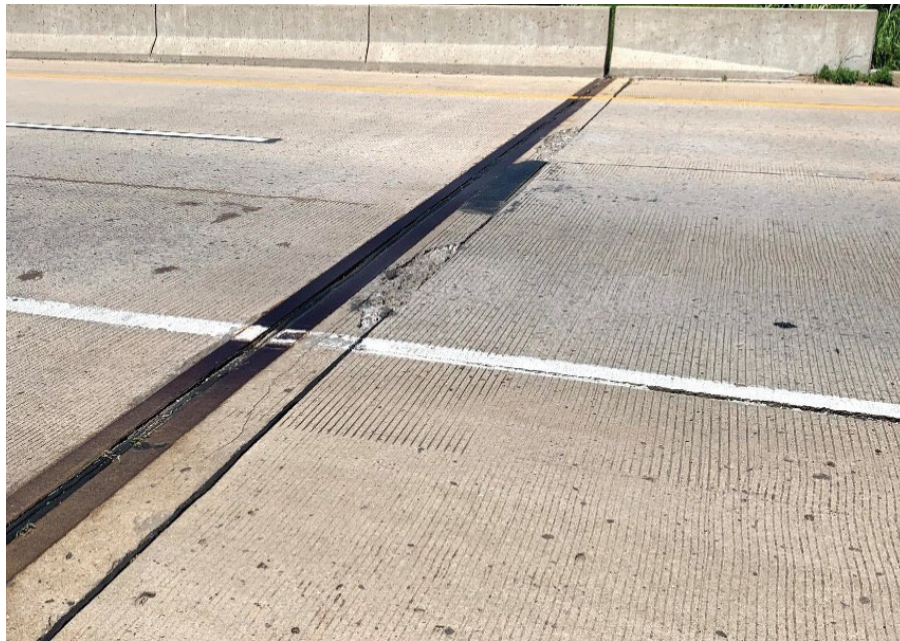
Precipitation results in bridge deck runoff. Expansion joint openings and cracks (**Figure 12**) cause precipitation runoff to contact bridge girders. This runoff may include deicing chemicals during wintry precipitation, which accelerates corrosion (Bao et al. 2021). Corrosion is most apparent at girder ends below the deck joints adjacent to abutments. This was substantiated during the bridge inspections conducted in this research study. Many of the inspected bridge girders at the abutments displayed significant oxide film degradation with CS 4.

Figure 12. Bridge Deck Expansion Joint

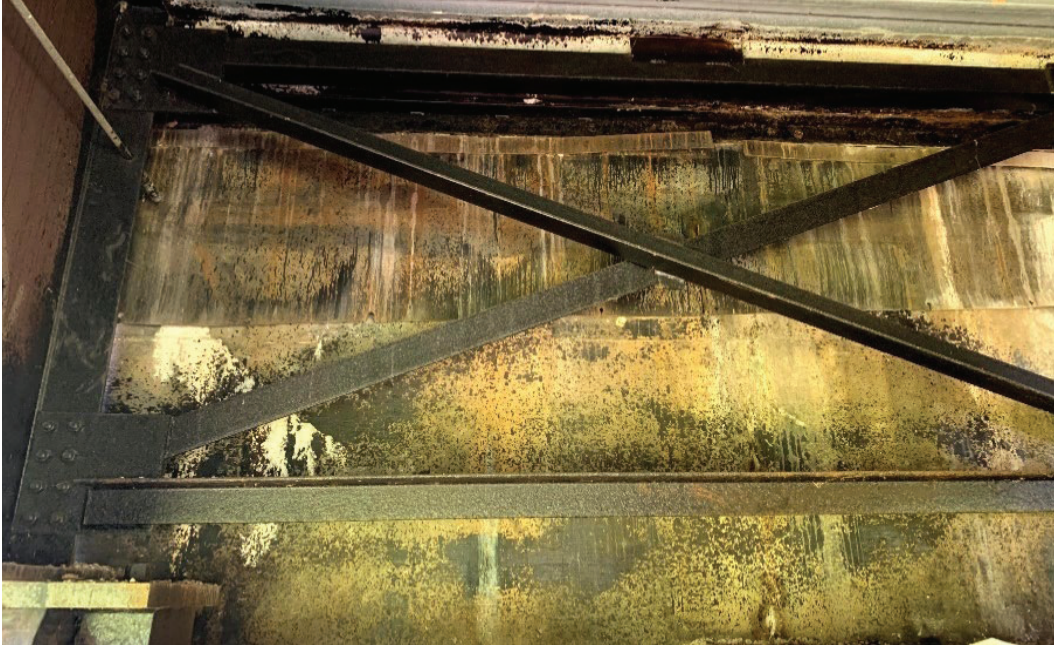
Figure 13 shows an example of a bridge girder at an abutment area experiencing significant corrosion. A rust inhibitor was applied to the girder to delay rust development. However, this treatment did not decrease the corrosion rate. **Figure 14** is a close-up of the area, showing large rust flakes and girder pits measuring 3/16 inch (4.8 mm).

Figure 13. Rust Inhibitor at End Abutment

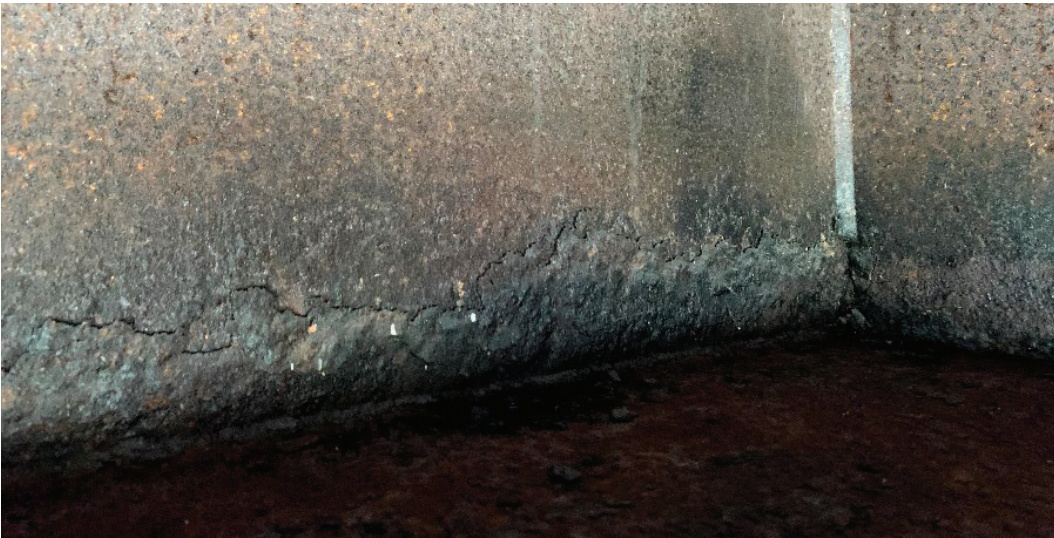
Figure 14. Rust with Rust Inhibitor

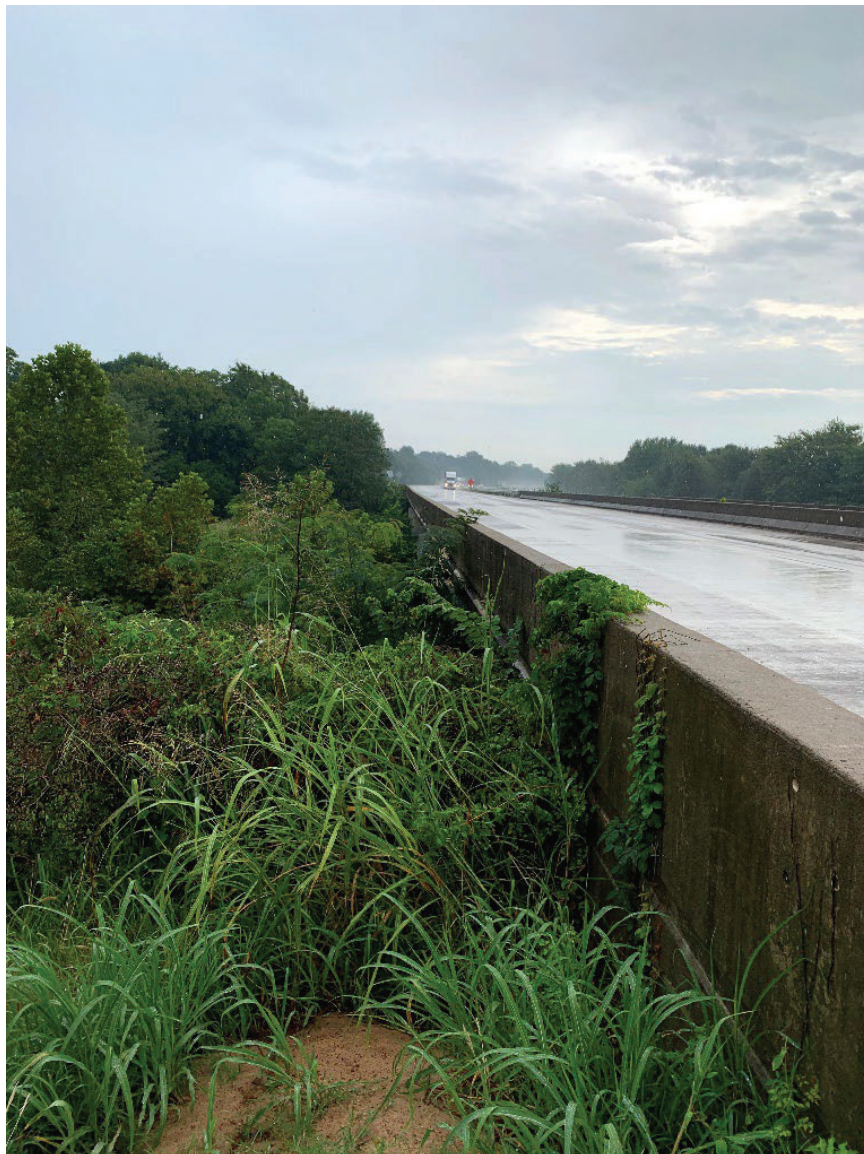
Uncontrolled vegetation at a bridge site restricts air circulation, resulting in high humidity, captured moisture, and long-term wetness. Due to uncontrolled vegetation, the patina does not form properly, and the UWS corrosion rate is similar to that of bare carbon steel (Wong 2010). **Figure 19** displays uncontrolled vegetation surrounding the bridge structure. The vegetation at the bridge site leads to the steel superstructure experiencing long-term wetness and limited air circulation. Generally, vegetation in urban areas is normally better maintained than in rural areas.

Figure 19. Bridge A6820 Enclosed with Vegetation

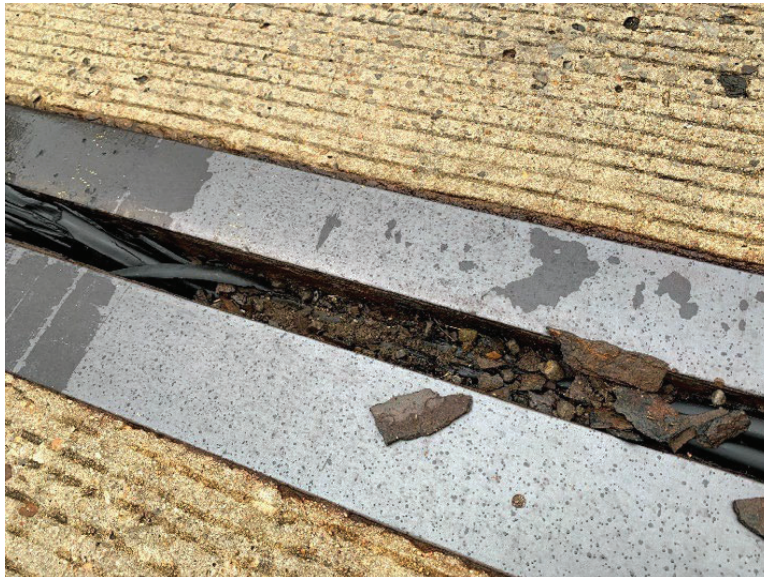
Bridge inspections at UWS bridges require recording girder surface condition and potential oxide film degradation initiators. Patina performance is best identified through patina adherence (NSBA 2022). However, patina texture and patina color should be considered. ARDOT bridge inspectors use the ARDOT Bridge Inspection Manual (ARDOT 2022), which satisfies AASHTO's Manual for Bridge Element Inspection specifications (AASHTO 2019). Bridge inspections are conducted using a hands-on visual inspection approach. For steel corrosion at UWS bridges, the inspection focuses on ranking the CS of the patina based on its visual characteristics, including flake size, color, texture, and adherence to the steel. Consequently, a mechanical lift system or ladder is often required to gain access for inspecting bridge elements (ARDOT 2022). Additional inspection tools include a geologist hammer, brush, and pit depth gauge. A routine inspection is performed on a two-year cycle. The bridge inspection process includes recording the bridge deck expansion joints that are dislodged, clogged, or deteriorated. Deteriorated strip seal expansion joints collect debris and provide runoff water mixed with deicing chemicals passage to the UWS superstructure, as shown in **Figure 22**.

Figure 22. Corrosion and Debris Collected in the Expansion Joint

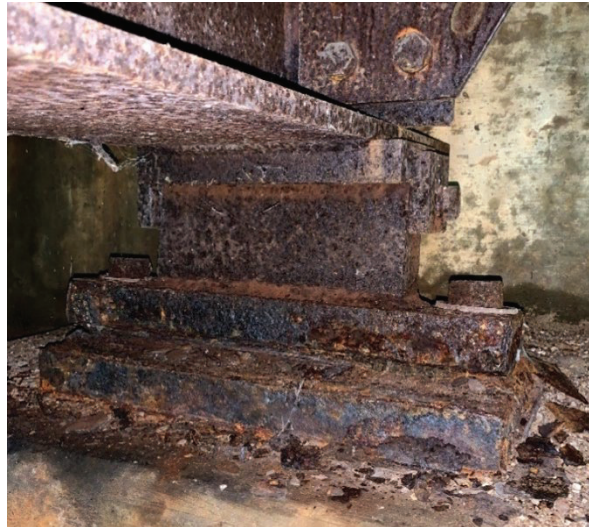
Bridge girder bearings beneath deteriorated bridge deck expansion joints are a common location for significant deterioration, as shown in **Figure 23**.

Figure 23. Bearing Corrosion: CS 4

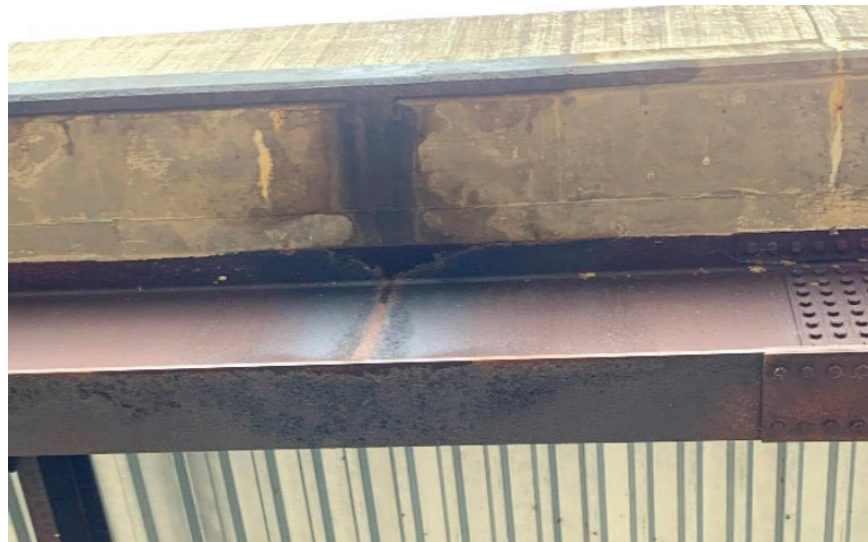
Figure 24. Girder Corrosion due to Improper Deck Drainage

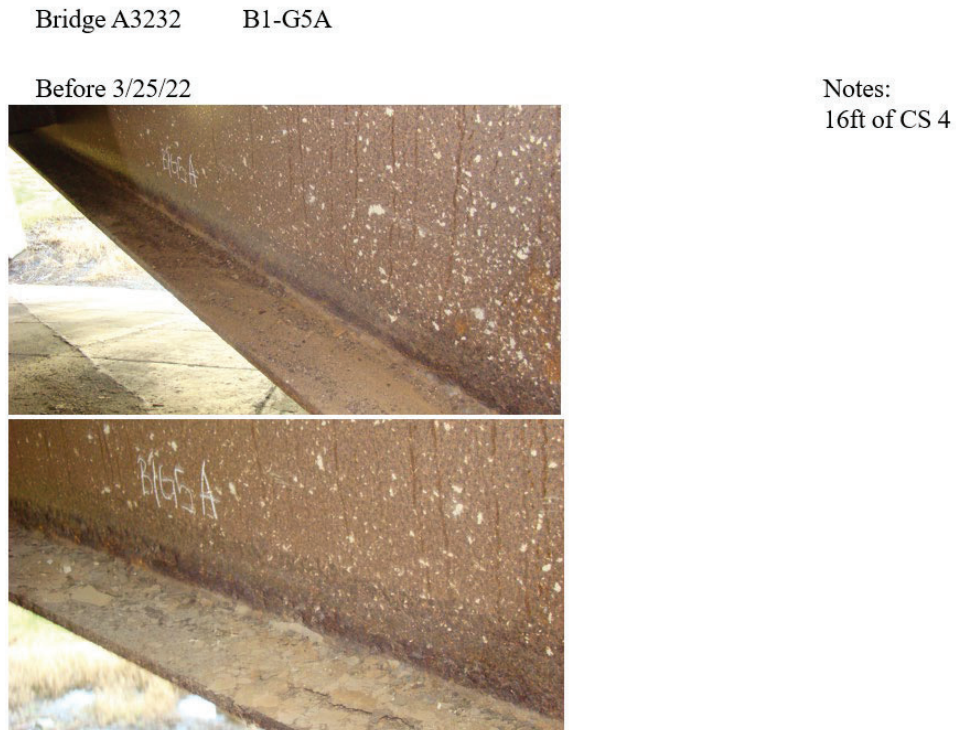
Various testing approaches were tried in order to establish a preliminary UWS inspection protocol. The testing methods included visual inspection, tape adhesion testing, eCHLOR* extract testing, and photography. The patina performance and condition were recorded using photos and notes. Assigning the oxide film CS was based on color, texture, and rust flake size. The major objective of this March bridge inspection tour was to develop a protocol that would ensure consistent visual oxide film rating throughout the ARDOT Districts. During the March tour, bridge girder condition was documented to study oxide film degradation rates among bridge inspections. These photos and notes were organized in files to be used as reference for future bridge inspections, **Figure 37**.

Figure 37. Before and After Cleaning Rust Flakes

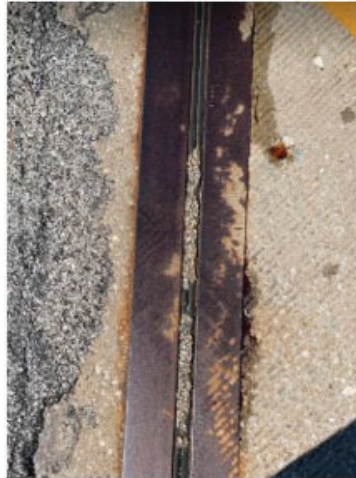
(a) Asphalt in Joint Sealant

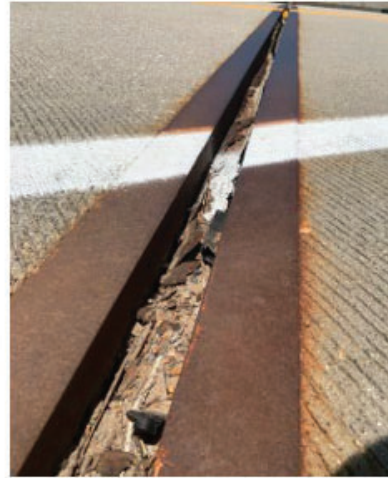
(b) Damaged Sealant and Debris

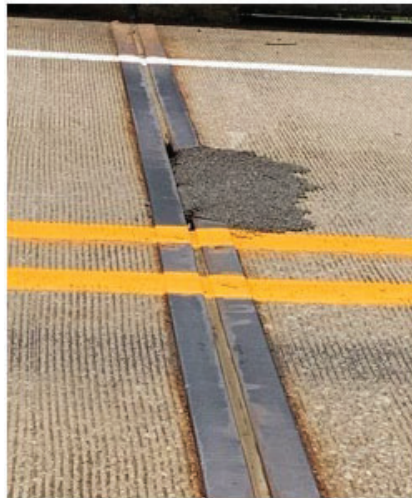
(c) Asphalt Damage

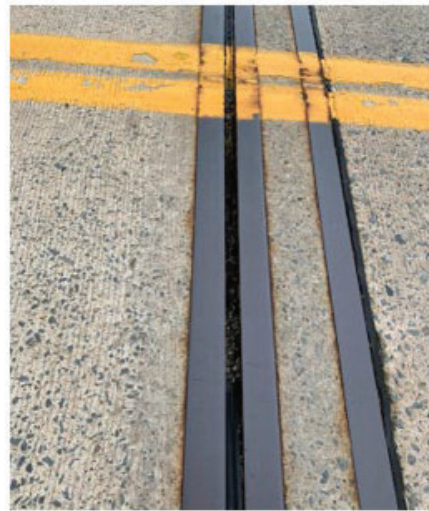
(d) Missing Sealant

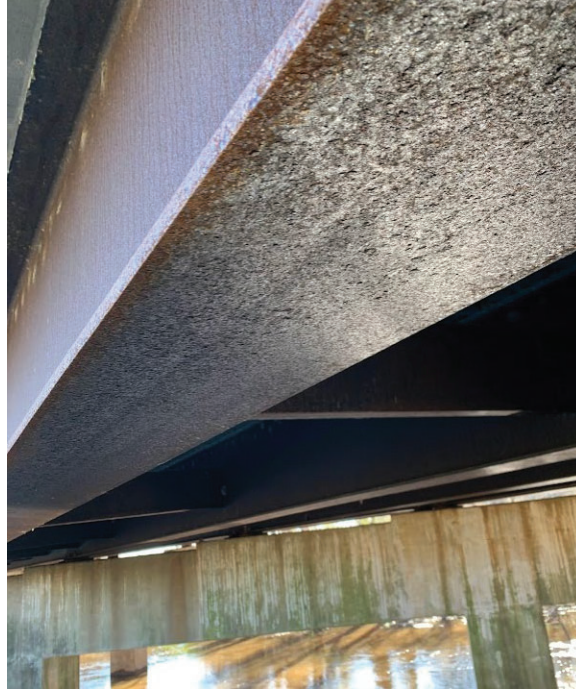
Afterward, the bridge deck was inspected from below to verify if the issues above it correlated with compromised girder conditions below it. For four of the six bridges, CS 1 and CS 2 were present at most bents and within the spans; CS 4 was identified at limited locations. Bridge 06609 in Woodson displayed CS 4 at only Bent 5, Bay 1, but displayed CS 1 and CS 2 at the remaining bays and bents. This correlated well with the damaged expansion joint right above the deteriorated section. Some contributing factors to corrosion include the bridge slope and surrounding water. Bridge 06609 displayed similarities to the other bridges that were inspected during this March inspection tour. When the girders and bays were analyzed, it was noted that the bridge girders were primarily experiencing CS 2 oxide film degradation and that severe CS 3 and CS 4 were limited to small girder sections, as shown in **Figure 40**, **Figure 41**, and **Figure 42**.

Figure 40. Bridge 02312: CS 2 Under Flange

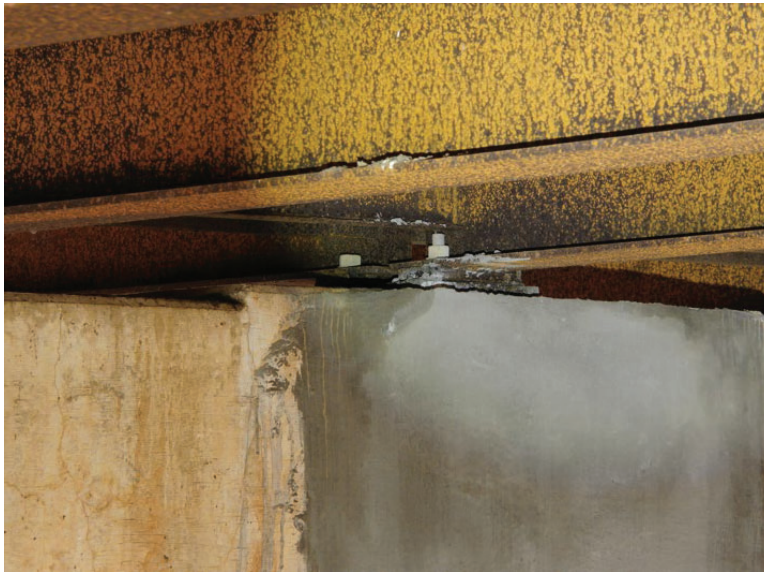
Figure 42. Bridge 05812: CS 2

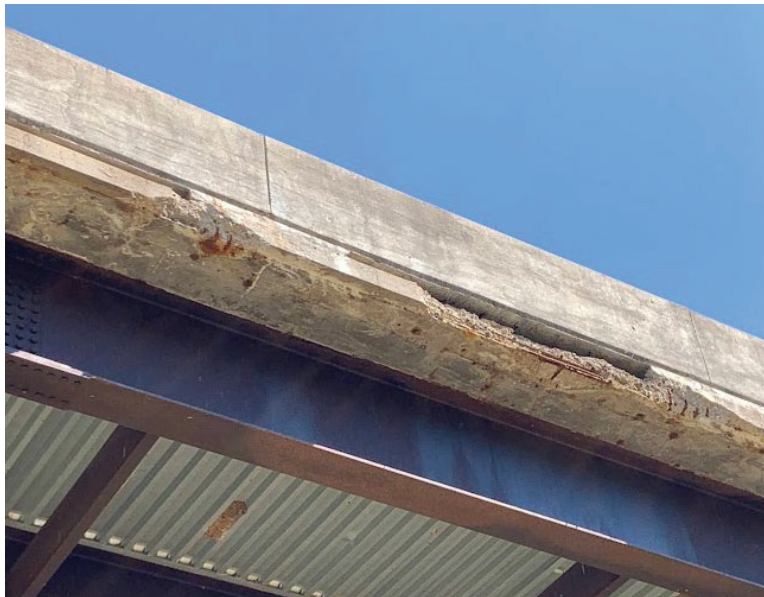
Figure 45. Bridge 06371: CS 2 and CS 3 on Web

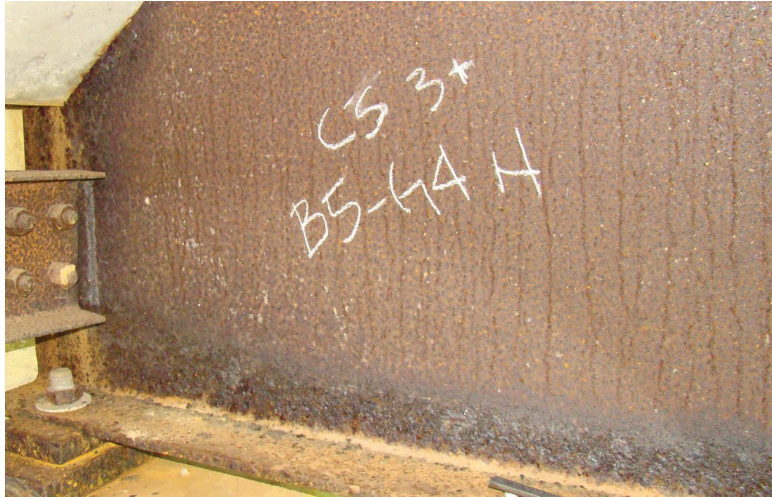
Figure 46. Bridge 06319: CS 3 +

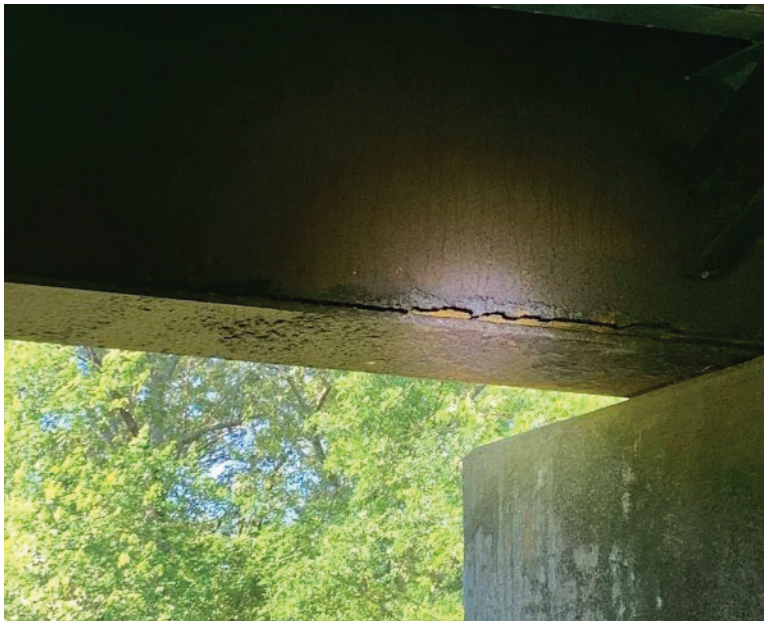
Figure 48. Bridge 06319: CS 3 and CS 4 near End Abutment

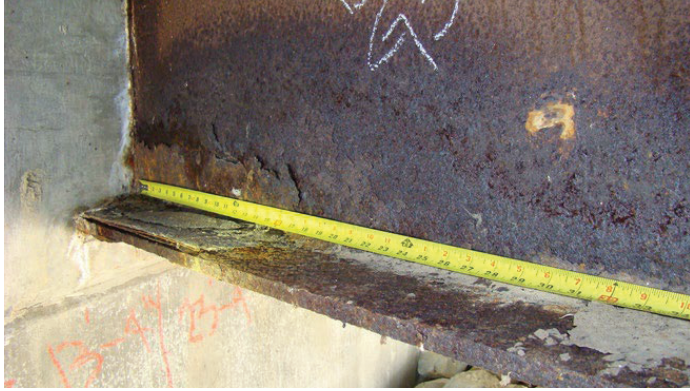
(a) Efflorescence at Girder-Abutment

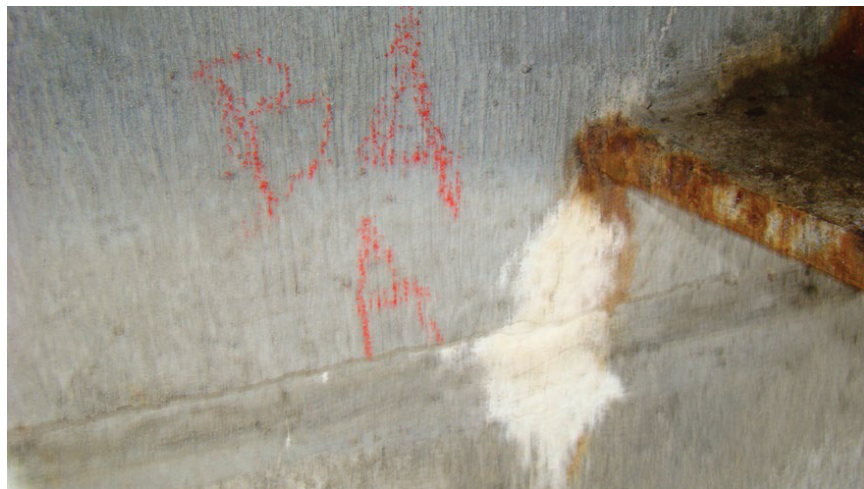
Figure 56. Bridge 07335, Bent 4, Girder 4, Efflorescence Close-up

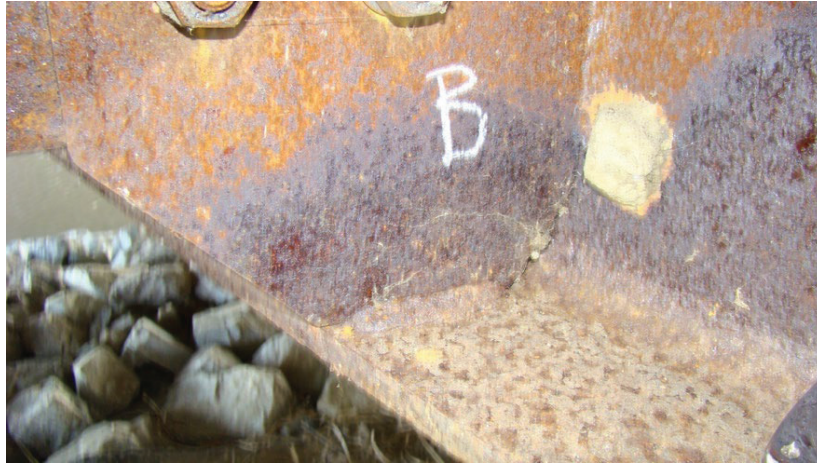
Figure 57. Bridge 07335, Bent 4, Girder 4, Corrosion at Diaphragm Connection

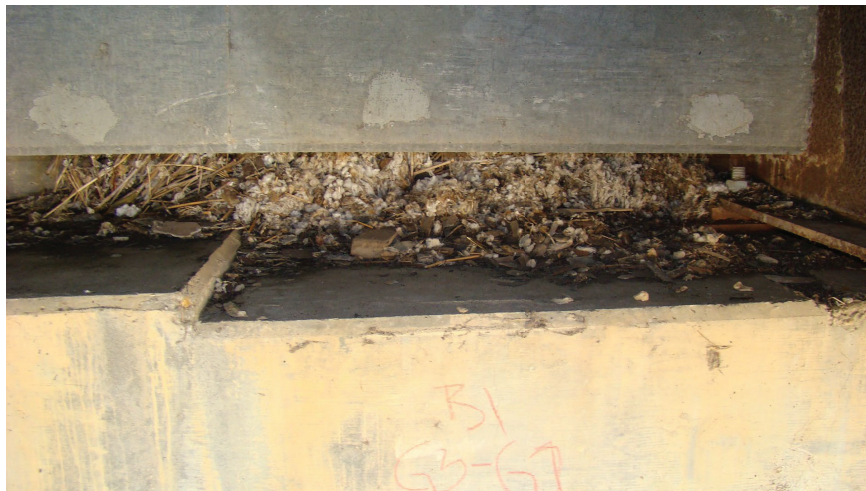
Figure 63. Debris at South Abutment (Bent 1)

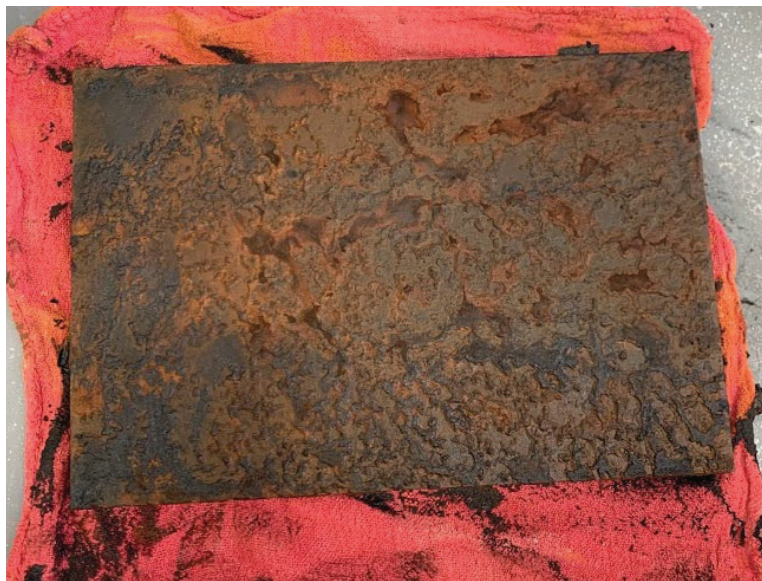
Figure 70. Horizontal Weathering Steel Plate After Eight Weeks
