**bridge deck  
drains** final report

AUGUST 1982

1. Report No. FHWA/CA/SD-81/15		2. Government Accession No.		3. Recipient's Catalog No. <b>P88 3 203570</b>	
4. Title and Subtitle Bridge Deck Drains				5. Report Date August 1981

16. Abstract  This report evaluates the drainage on some 25 viaduct type structures. The maintenance problems are discussed and methods of reducing the plugging of the drains are suggested.  Recommendations are made for design specifications to significantly reduce future maintenance costs from drain plugging.

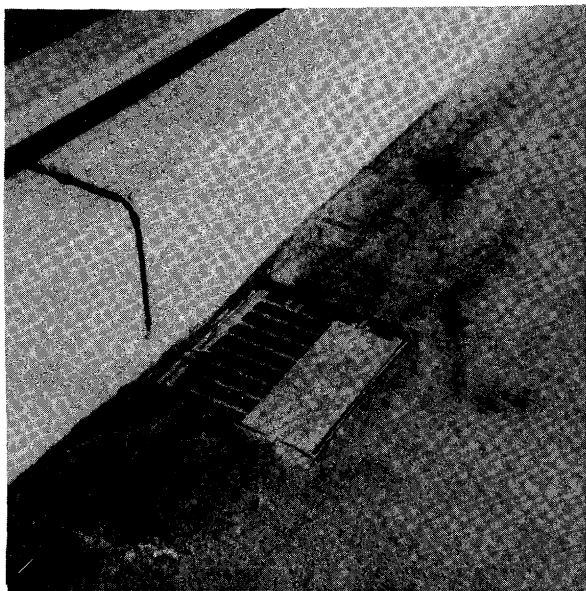
Fig. 1  
Grand Ave OH (Br 24-288R/L)  
Test Drain - hand packed from top  
with damp debris.

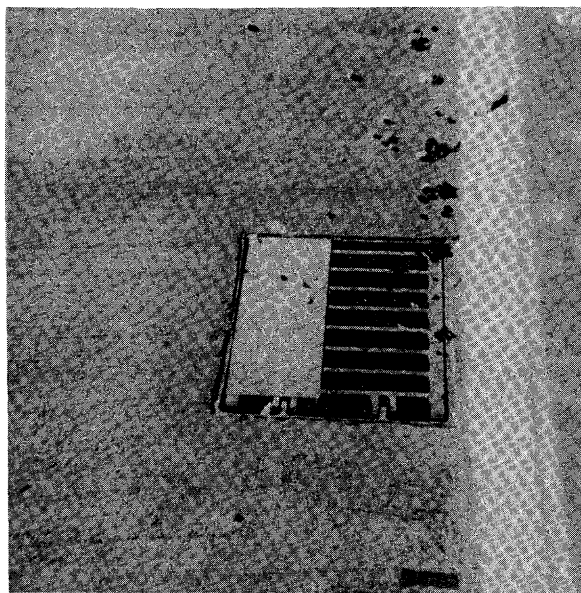
Fig. 2  
Grand Ave OH (Br 24-288R/L)  
Test Drain - After first rain. drain  
ran freely, no plugging.

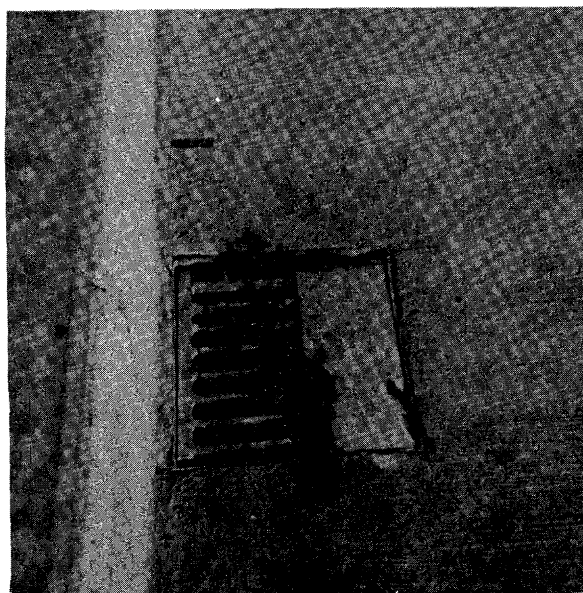
Fig. 3  
Grand Ave OH (Br 24-288R/L)  
Test Drain - later in same winter season.  
Drain still flowing.

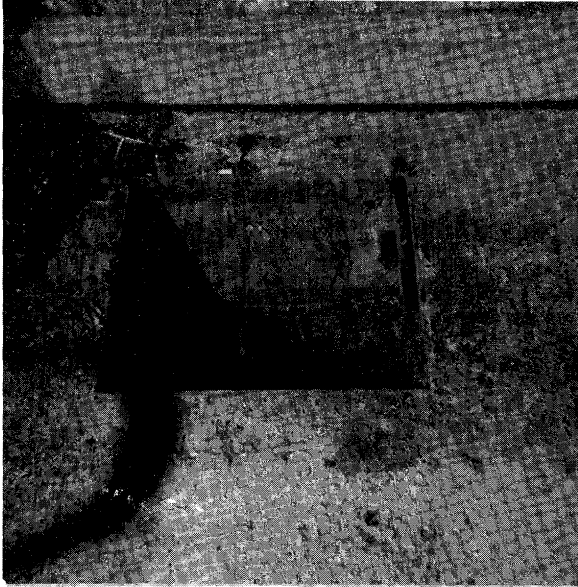
Fig. 5

Alemany Interchange (Br 34-70)  
Typical deck drain - note center pipe  
and sloping sides.

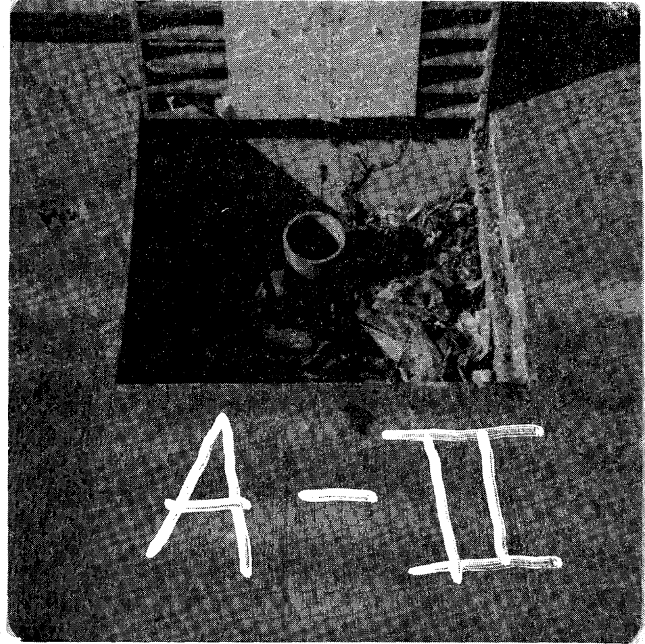
Fig. 6

Alemany Interchange (Br 34-70)  
Vertical pipe extension.

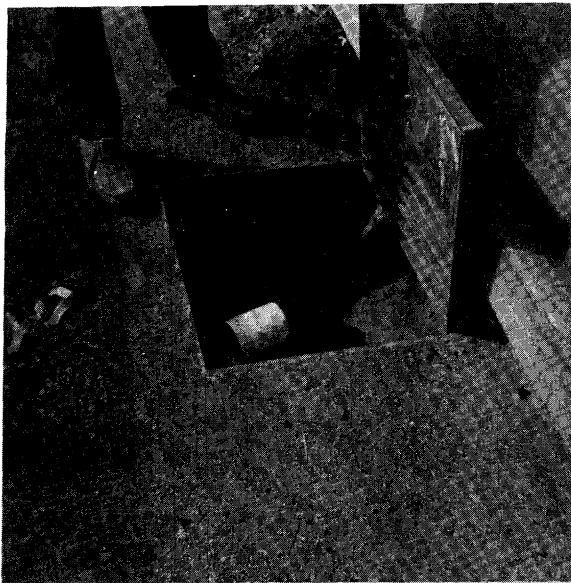
Fig. 7

Alemany Interchange (Br 34-70)  
Side inlet pipe extension.

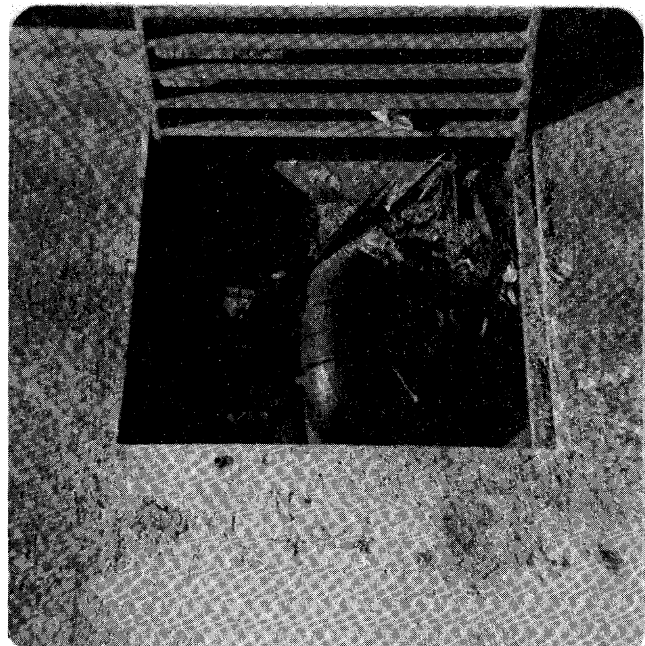
Fig. 8

Alemany Interchange (Br 34-70)  
Inverted "U" pipe extension.  
Note length of sticks which  
got through grate.

The inverted "U" (siphon) extension was the least successful, possibly because of leaks at the connection with the existing pipe reduced the siphon action and the inlet to this extension was more often buried in debris.

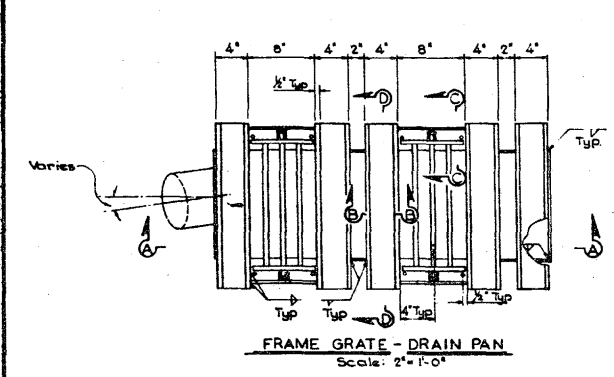
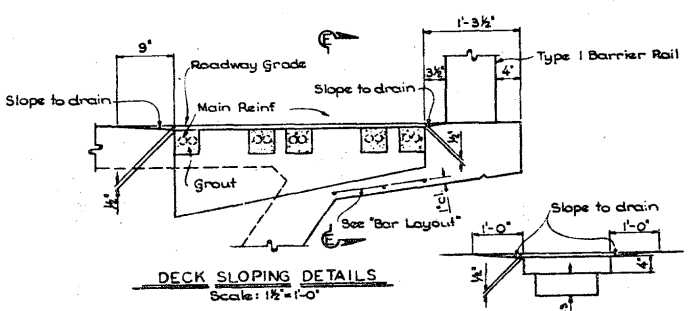
B-1

1. The annual cost of cleaning some 1728 drains in the Sacramento Area in 1975 was \$8.08 each.
2. The "fixed" baffle plates on Fort Sutter Viaduct cause more plugs than they cure (See Detail on Page B-1). The sticks which often cause plugs at the pipe inlet cannot be reached by hand. The four drains where the baffle plates were cut out can be cleared easily and do not plug much more often than those with the plates.

11. Maintenance foremen are very opposed to "Y" connections because it makes clearing drain lines far more difficult. They would like a separate line from each drain to the ground.
12. In Sacramento plugging is often caused by rice hulls and wood chips which are mixed with dirt and sand. Grain truck spills which result in wheat growing out of a box with extensive matted roots are not uncommon.
13. If new flushing systems are installed the valves should be on the deck so the "flushing" action can be observed and the situation of a spray rebounding into traffic can be avoided.
14. There was unanimous agreement that all welded in baffle plates should be removed as they interfere too much with drain cleaning.
