Report No. FHWA-RD-79-62

DEBRIS PROBLEMS IN THE RIVER ENVIRONMENT

March 1979
Final Report

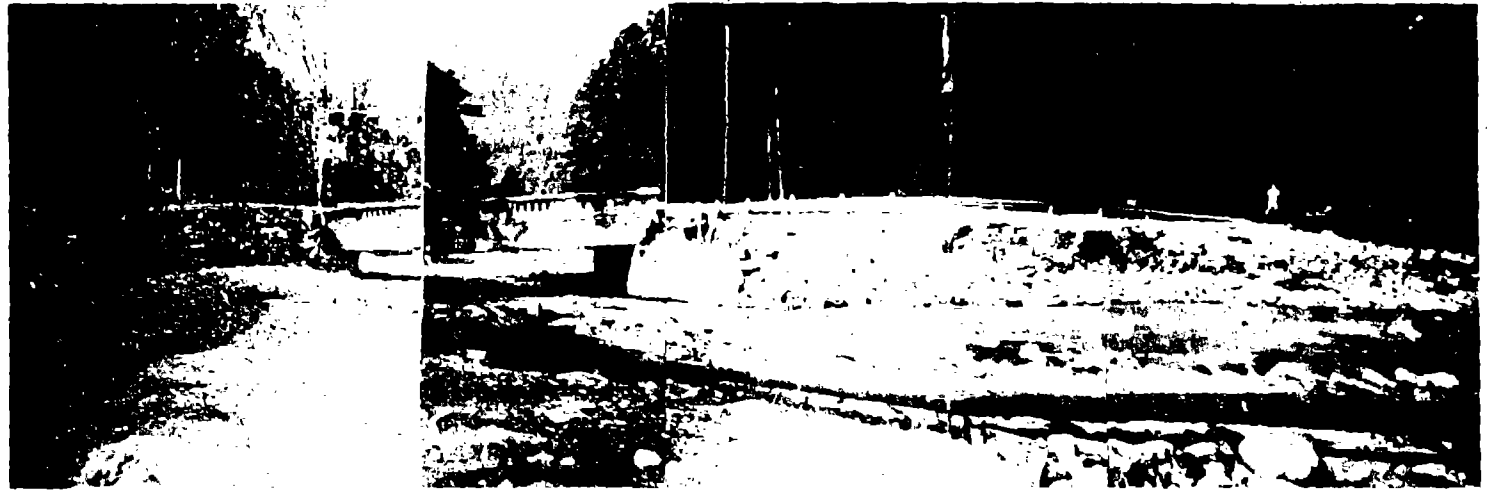
Figure 1 A Bridge on Big Bear Creek, Lycoming County, Pennsylvania, after Destruction.

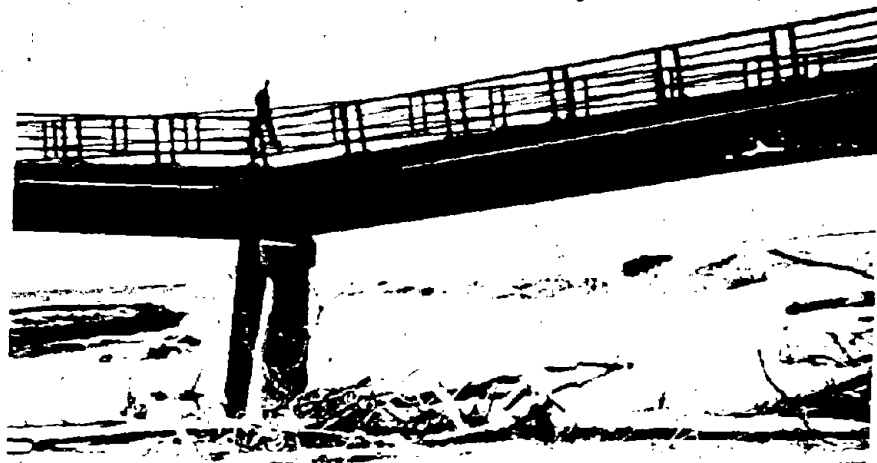
Debris accumulations around a pier may pose a problem when the flow is intensified on the pier foundation soils. A bridge over McCraney Creek in Pike County, Illinois, composed of two 15-meter spans supported with a rectangular pier at the center of the stream was subjected to this type of damage. During a flood in 1973, debris accumulated around the pier in large amounts. The diving flow near the pier was intensified and scour caused settlement of the pier as shown in Figure 2. Since the bridge was located at a bend, lateral erosion of the channel created a destructive flow condition which further intensified scour at the pier. As with most bridge failures, this demonstrates that no stream hazard usually operates alone. However, debris often plays an important if not the main role in the destruction of bridges.

Figure 2 A Bridge on McCraney Creek, Pike County, Illinois

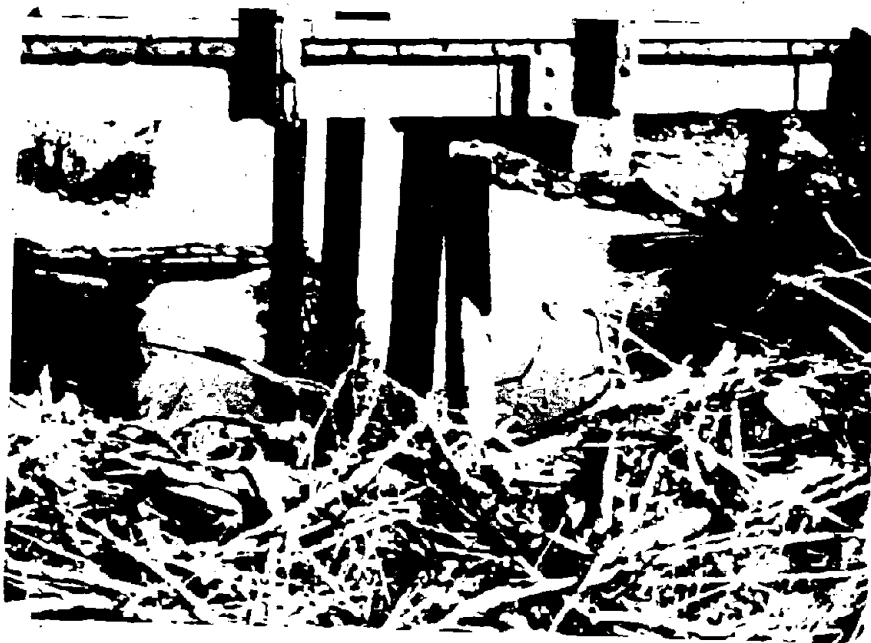
Figure 3 A Bridge on the Bayou Plaquemine, Acadia County, Louisiana

A 41-meter timber bridge across the Bayou Plaquemine in Acadia County, Louisiana, is built on treated timber trestles. During a flood in 1977, one timber pile was broken, as shown in Figure 3, probably due to the impact force of debris. This pier damage cost the state \$2,000. For economical reasons, timber open-pile bents have been used often in Louisiana, and thus this type of destruction has been observed frequently in this state. Open-pile bents below a bridge over the Bayou Macon and a bridge over the Tensas Bayou were reported requiring yearly repair of damage caused by debris impact.
