**NCHRP REPORT 350 ASSESSMENT OF
EXISTING ROADSIDE SAFETY HARDWARE**

Contract No. DTFH61-97-C-00039
Project No. 404211-F

Sponsored by
U.S. Department of Transportation
Federal Highway Administration

November 2000

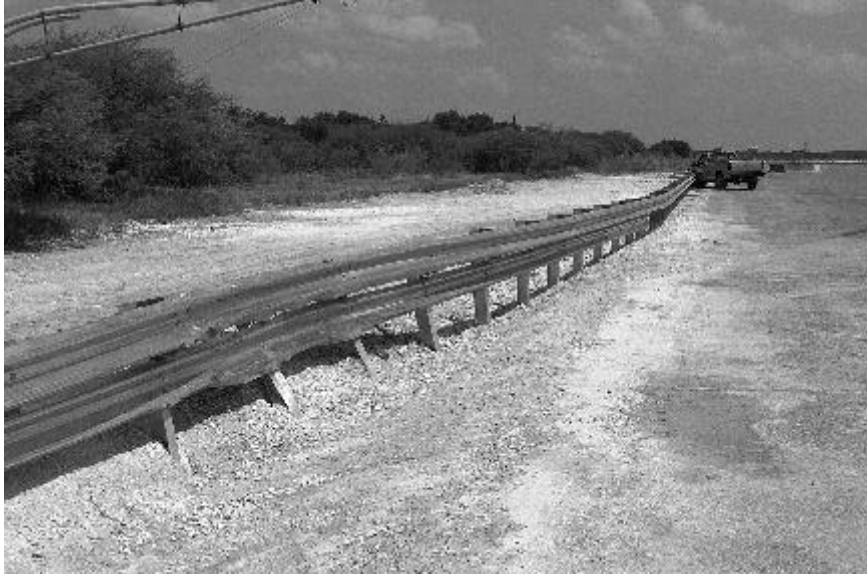
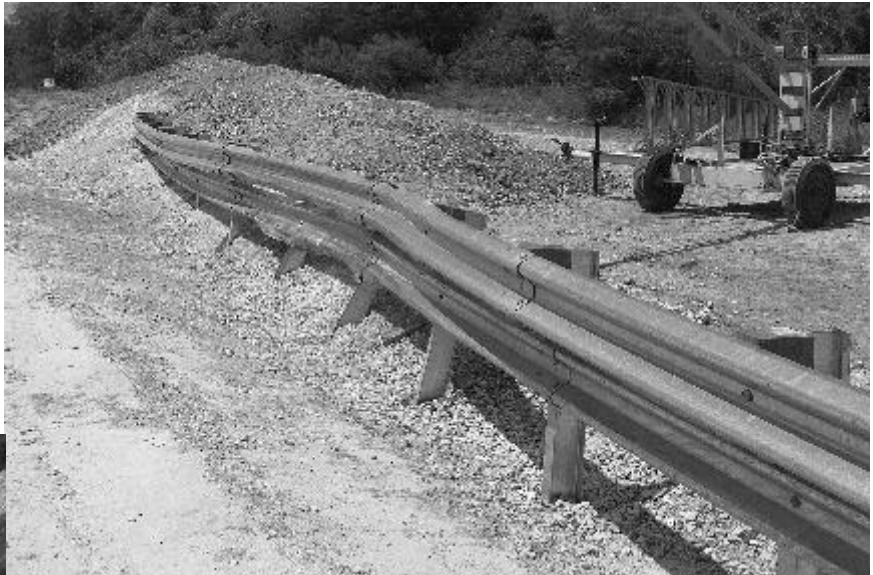
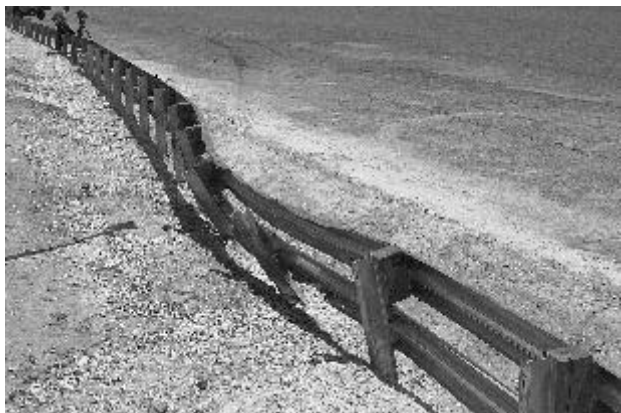
Figure 10. Installation after test 404211-13.

The buried-in-backslope terminal sustained minimal damage as shown in figure 10. Two sections of W-beam rail element and rub rail were deformed and tire marks were on the front face of posts 9 and 10. The blockout at post 9 was detached and resting behind the installation. The tops of the blockouts at posts 10 and 11 were scarred. Length of contact of the vehicle with the installation was 6.7 m. Maximum dynamic deflection during the test was 861 mm and maximum permanent deformation was 445 mm on the rub rail and 695 mm on the upper W-beam rail element.

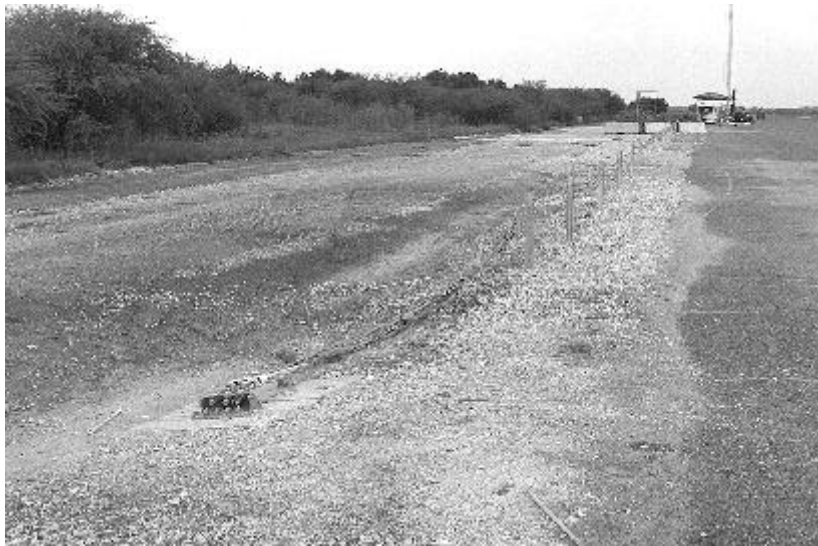
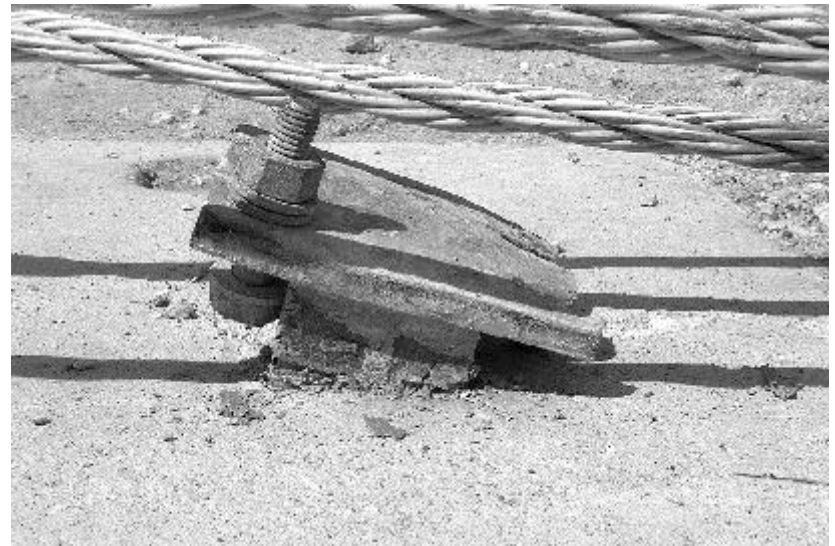
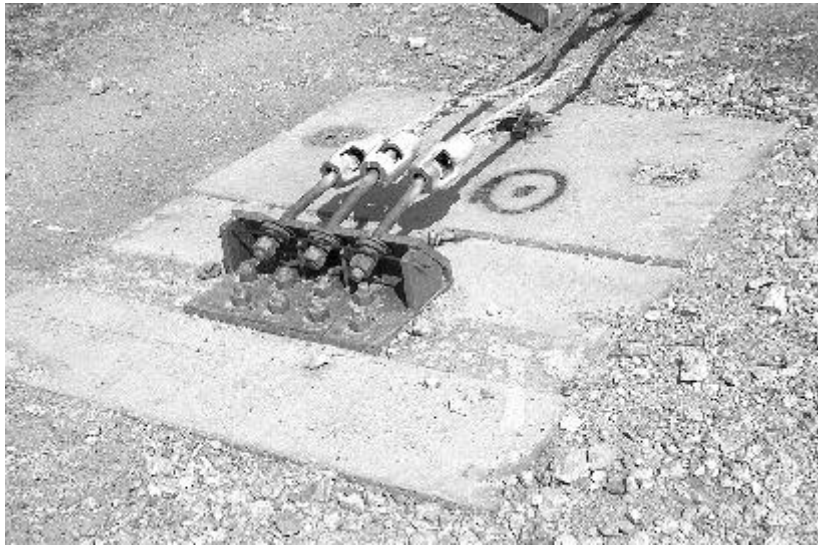
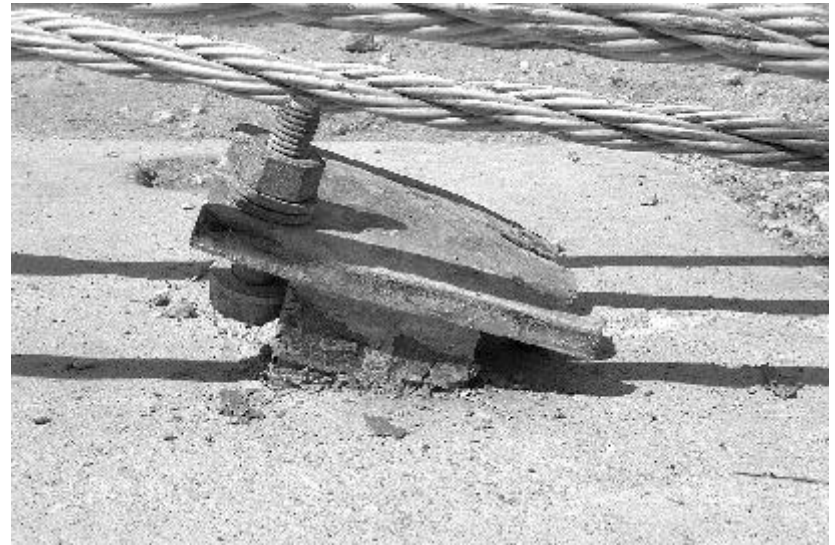
Figure 16. New York cable rail terminal after test 404211-6.

Damage to the 3-cable New York cable rail terminal was minimal as shown in figure 16. The end post broke away at the slip base and was found 480 mm from the base. The rear bolt on the right side remained on the base and the rear bolt from the left side was lying near the base. The two bolts on the front remained with the end post. The turnbuckles near the anchor plate and the cables received scuff marks from the vehicle tires. The cables were slack throughout the length of the installation, but neither anchor moved.

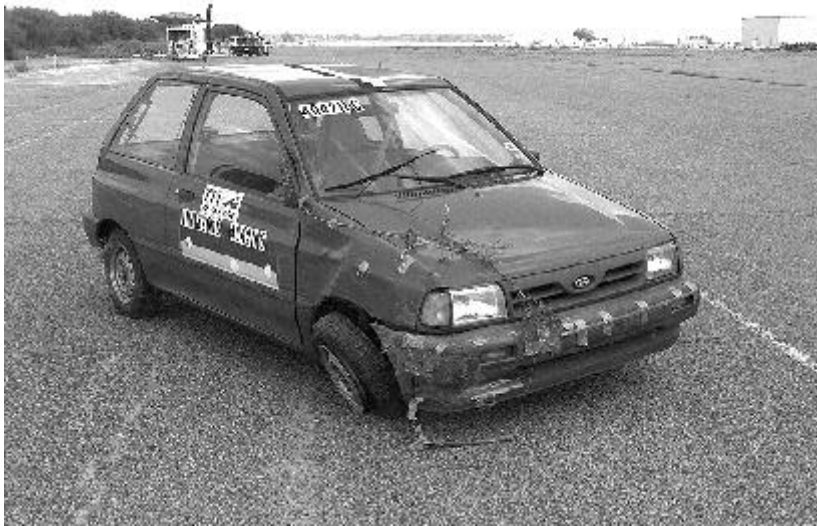
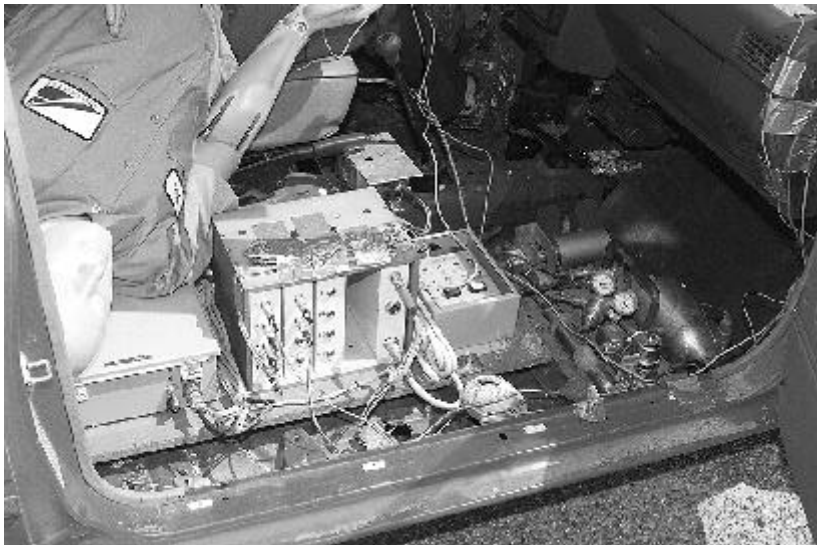
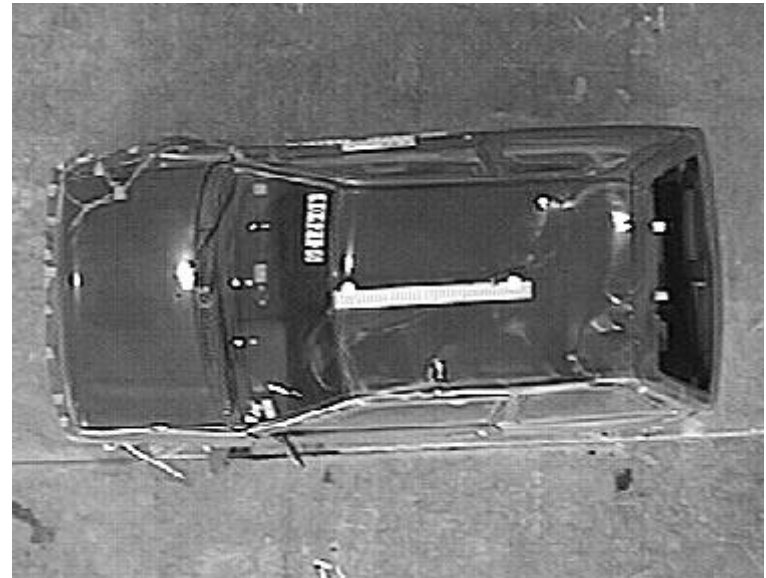
Figure 17. Vehicle after test 404211-6.

The vehicle sustained little damage from impact with the terminal. Structural damage included a deformed lower control arm and strut tower and a torn upper right strut mount. Minor damage occurred to the front bumper. The front right rim was bent and the tire deflated. After the vehicle exited the test site (traversed the sloped ditch and traveled beyond the right of way) the vehicle yawed clockwise and rolled onto its left side. Photographs of the vehicle after the test are shown in figure 17; however, most of the damage occurred during the rollover. No measurable deformation occurred to the front of the vehicle from impact with the terminal. No deformation or intrusion of the occupant compartment occurred prior to the rollover. Exterior crush and occupant compartment measurements are shown in appendix B, tables 29 and 30.

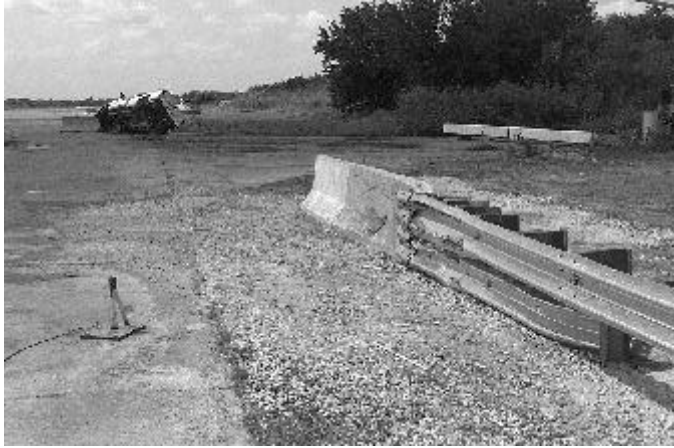
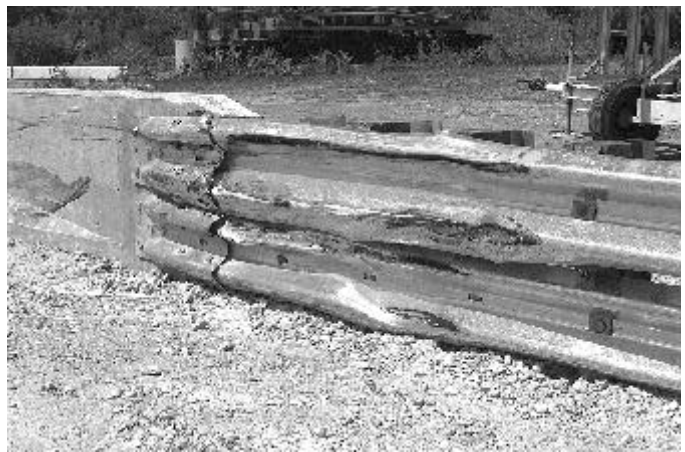
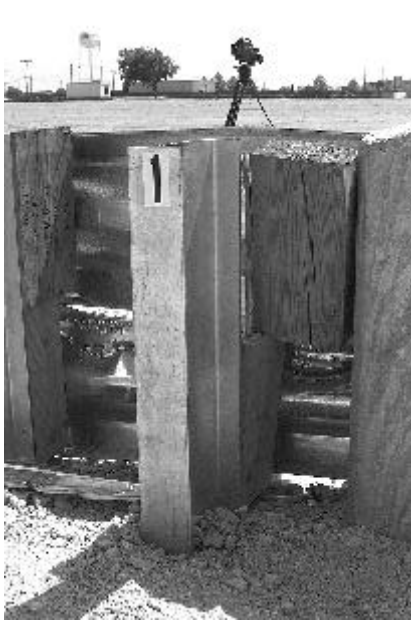
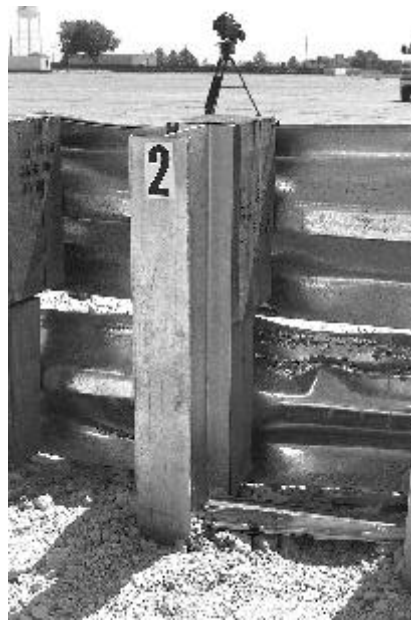
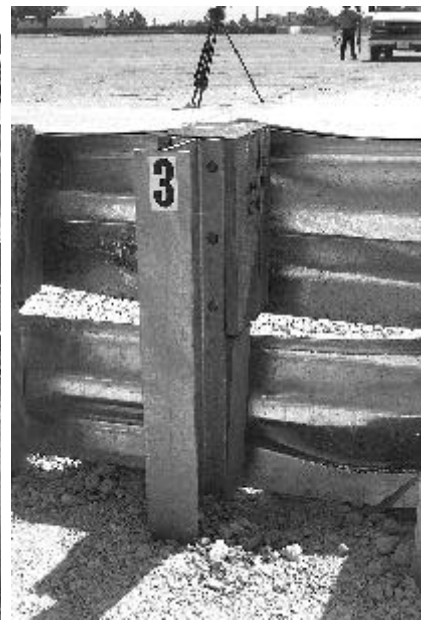
Figure 22. Installation after test 404211-2.

The vertical wall transition received moderate damage as shown in figure 22. The rail was deformed from post 5 through post 1. The blockout on the upper rail element at post 1 was split and separated from the post. The blockout on the rub rail at post 1 was split but remained attached. The blockout on the upper rail element at post 2 was gouged. A piece of metal from the vehicle was caught on the edge of the connection at the end shoe. The top of the CMB was scraped from contact with the vehicle. Total length of contact of the vehicle with the transition and CMB was 4.24 m. Maximum permanent deformation of the rail was 90 mm at post 2.

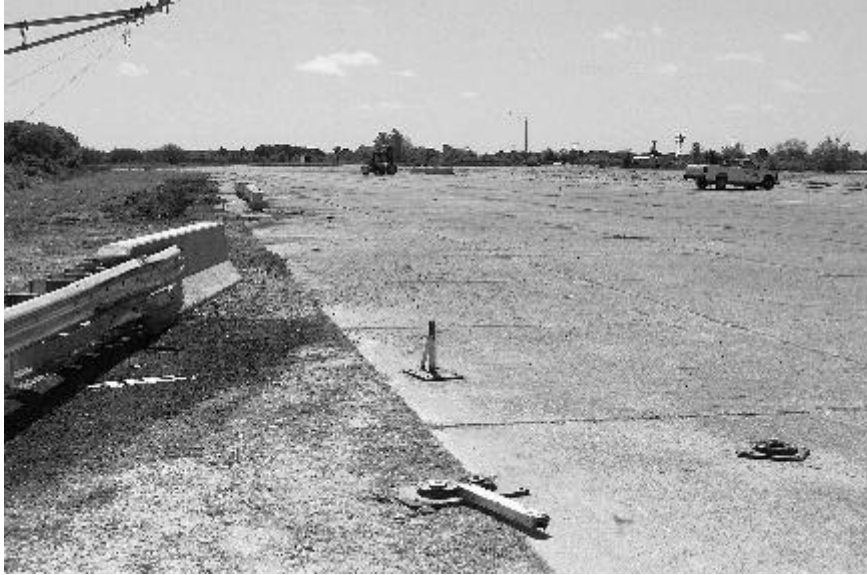
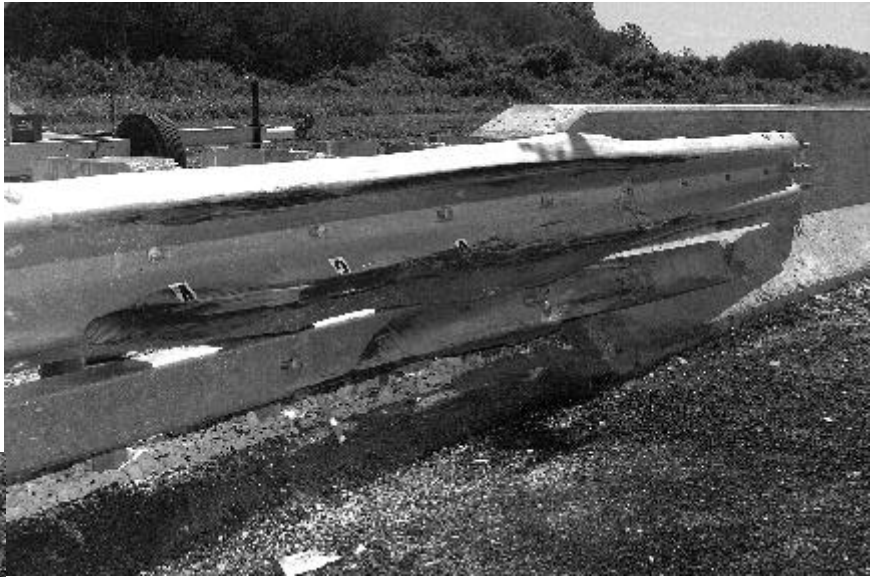
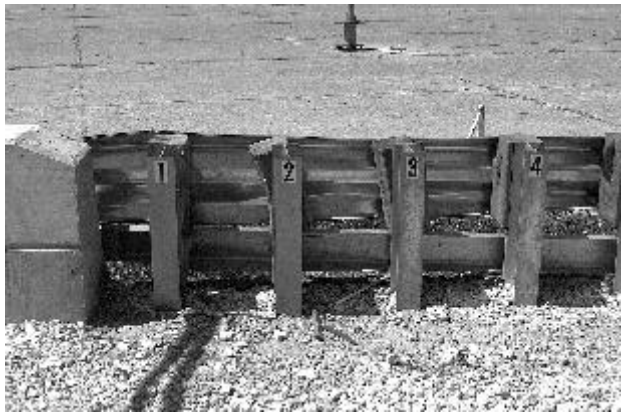
Figure 51. Installation after test 404211-9.

Moderate damage was imparted to the transition as shown in figure 51. Tire marks were on the face of the W-beam rail element and rub rail and both were deformed. The blockouts at posts 2 and 3 were rotated and the blockout at post 4 was fractured on one corner. The pipe insert was crushed 10 mm. The lower bolt on the connection to the parapet was partially pulled out. No movement was noted in the end terminal. Maximum dynamic deflection of the W-beam rail element was 77 mm. Maximum permanent rail deformation of the W-beam rail element was 68 mm at post 2 and the rubrail was deformed 45 mm at post 2. The length of contact with the transition was 2.9 m.

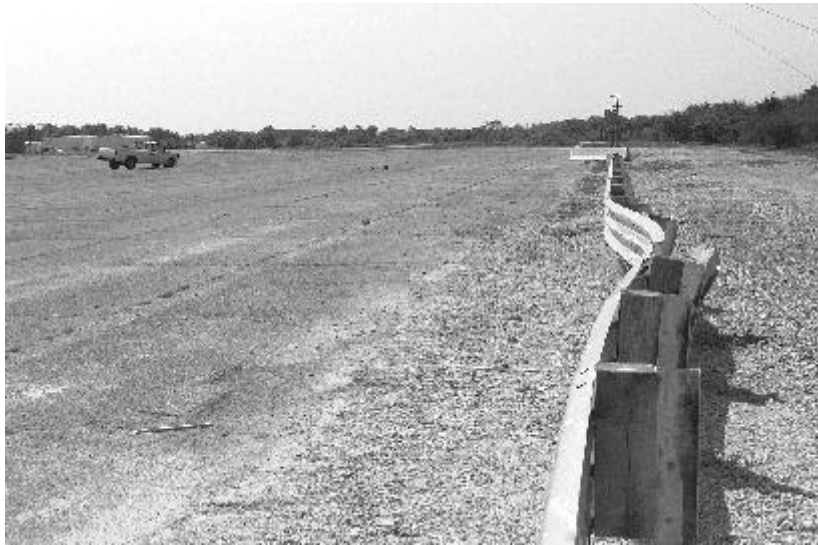
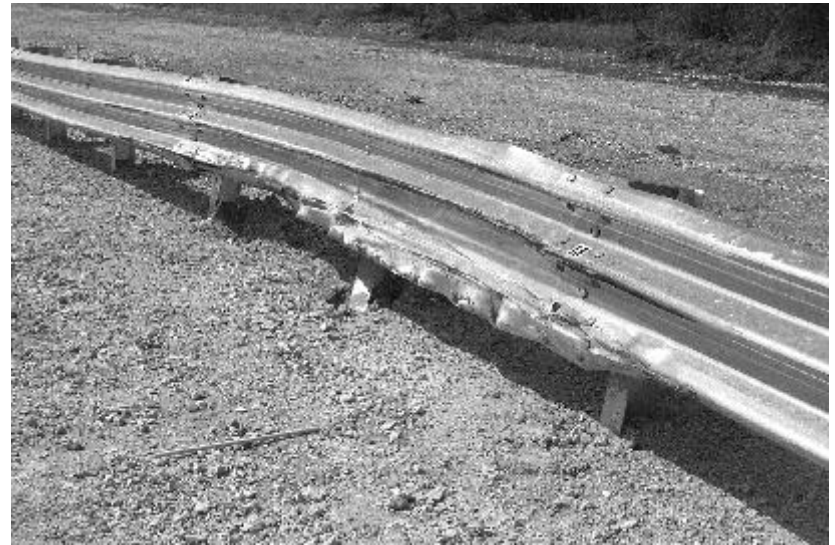
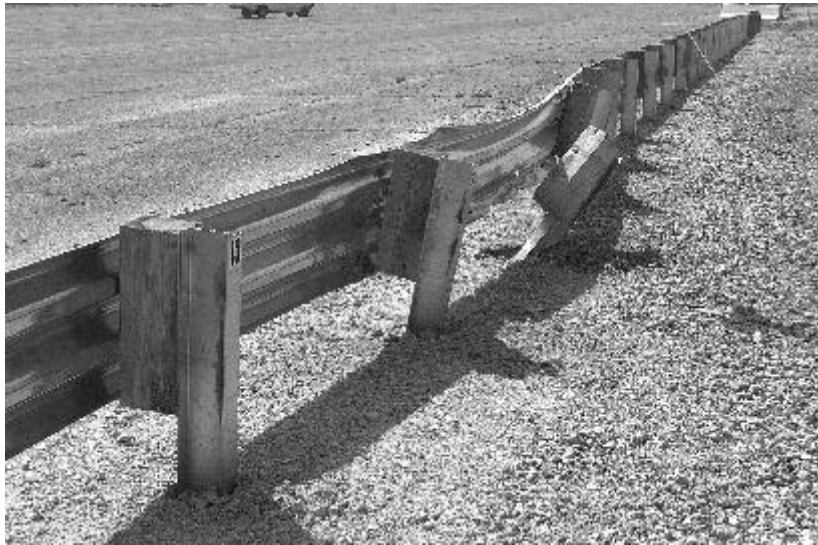
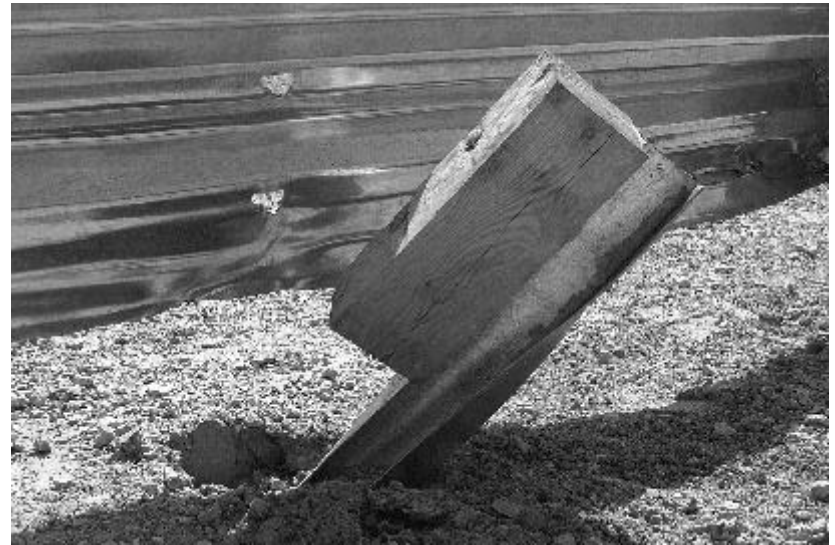
Figure 64. Installation after test 404211-10.

Result: The rail element separated from post 15. No other detached elements, fragments, or other debris were present. Neither the separated rail element nor the post penetrated or showed potential for penetrating the occupant compartment or presented undue hazard to others in the area. Maximum occupant compartment deformation was 75 mm in the center floor pan area. Due to the location, this deformation was judged to not cause serious injury.
