Solutions to Mitigate Dowel/ Tie-Bar Propagated Cracking - Phase 1

Shreenath Rao, Principal Investigator
Applied Research Associates, Inc.

April 2024

Final Report NRRRA202402

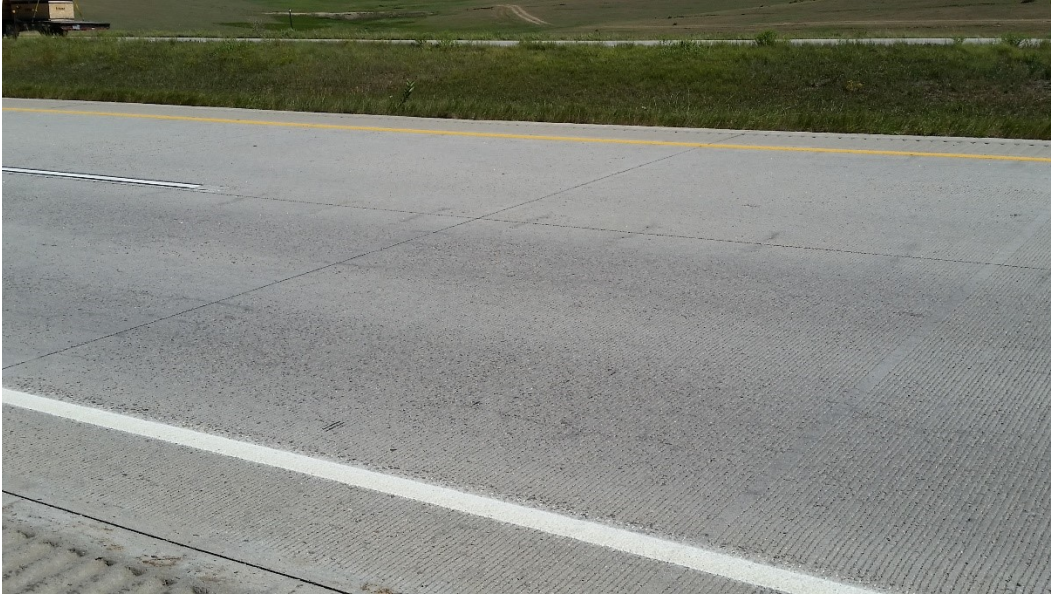
Figure 1.1 Photo. Cracking propagating from both tie bars and dowel bars on I-70 in Colorado.

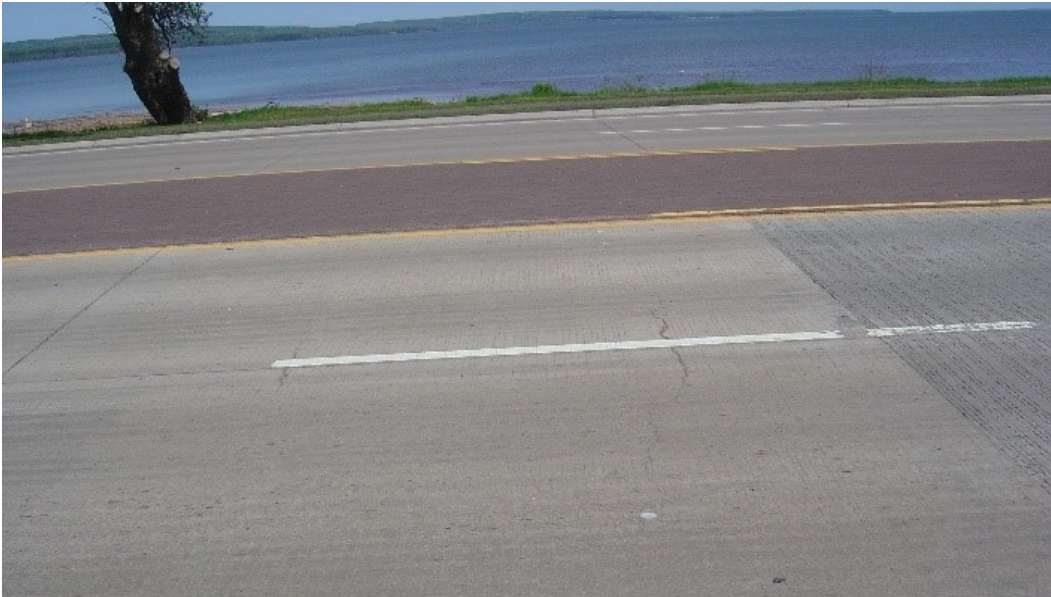
Figure 1.2 Photo. Cracking propagating from tie bars on US 2 in Wisconsin.

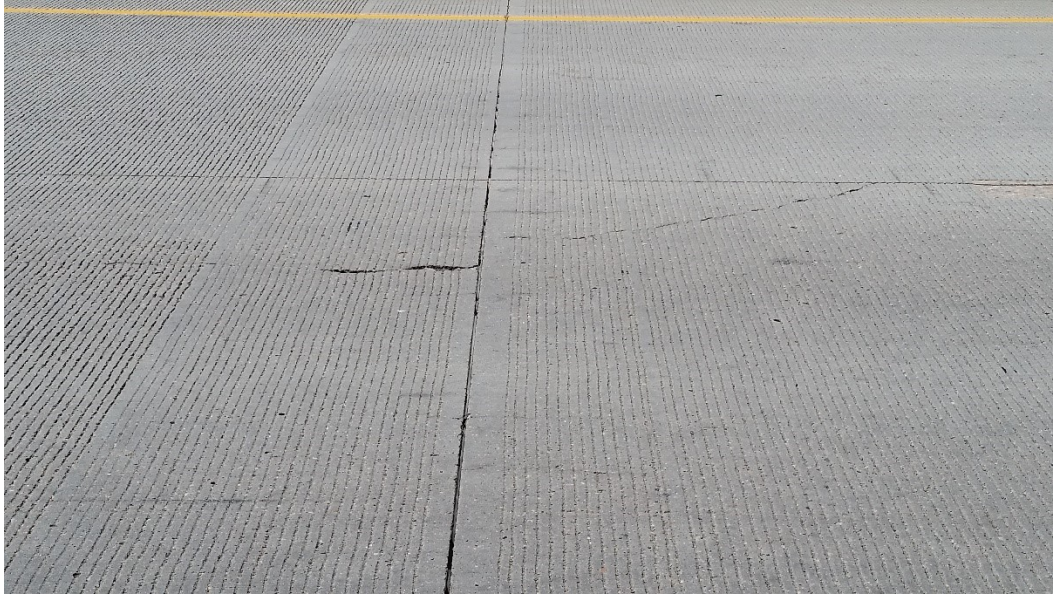
Figure 1.3 Photo. Fully formed longitudinal crack and corner break that initiated as a dowel bar crack on I-70 in Colorado.

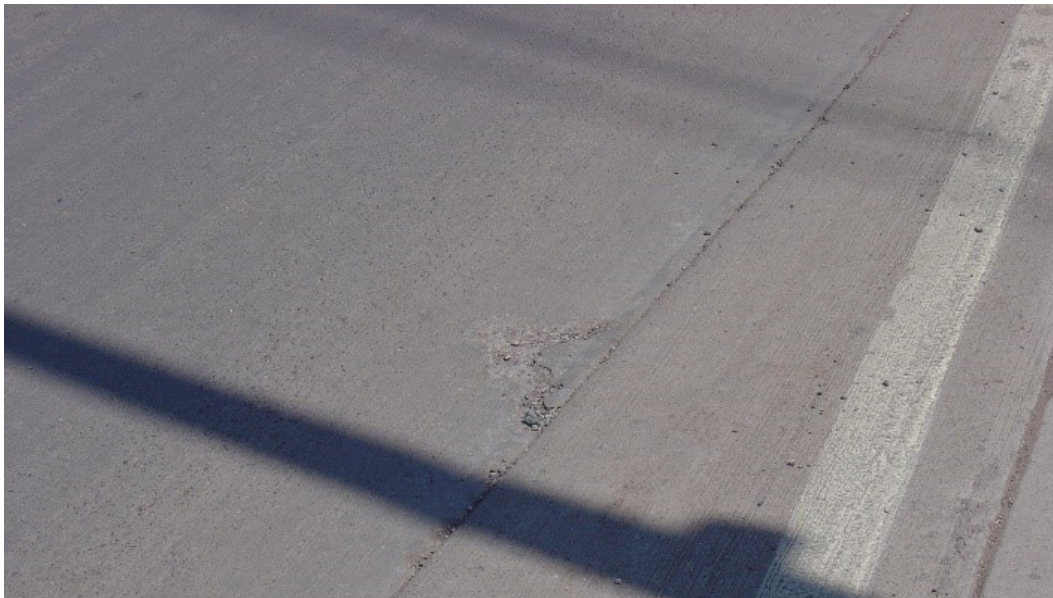
Figure 1.4 Photo. Delamination cracking on US 2 in Wisconsin.

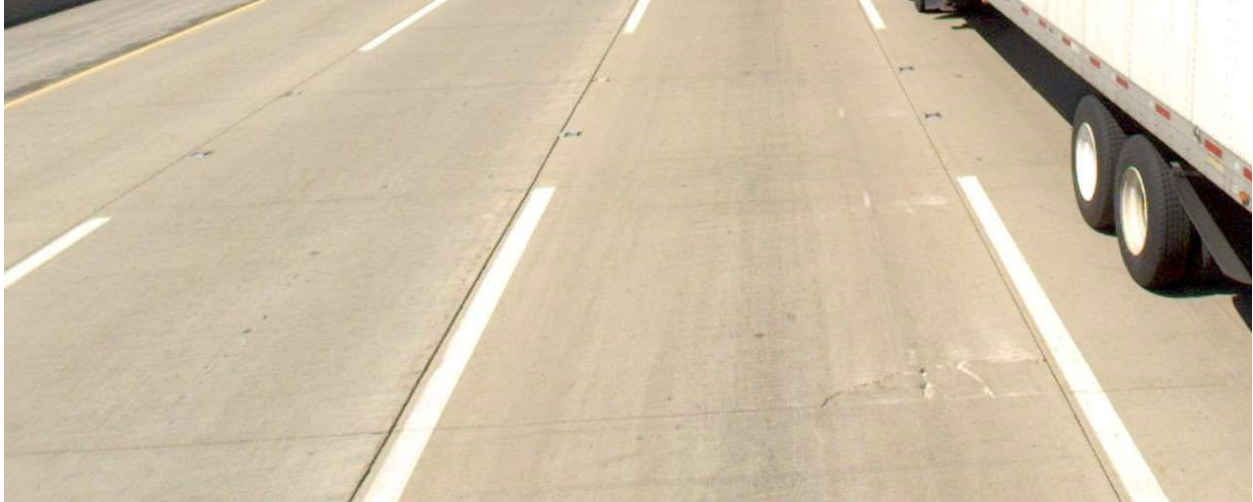
Figure 7.14 Photo. Early stage joint deterioration on I-94 at the Illinois Tollway.

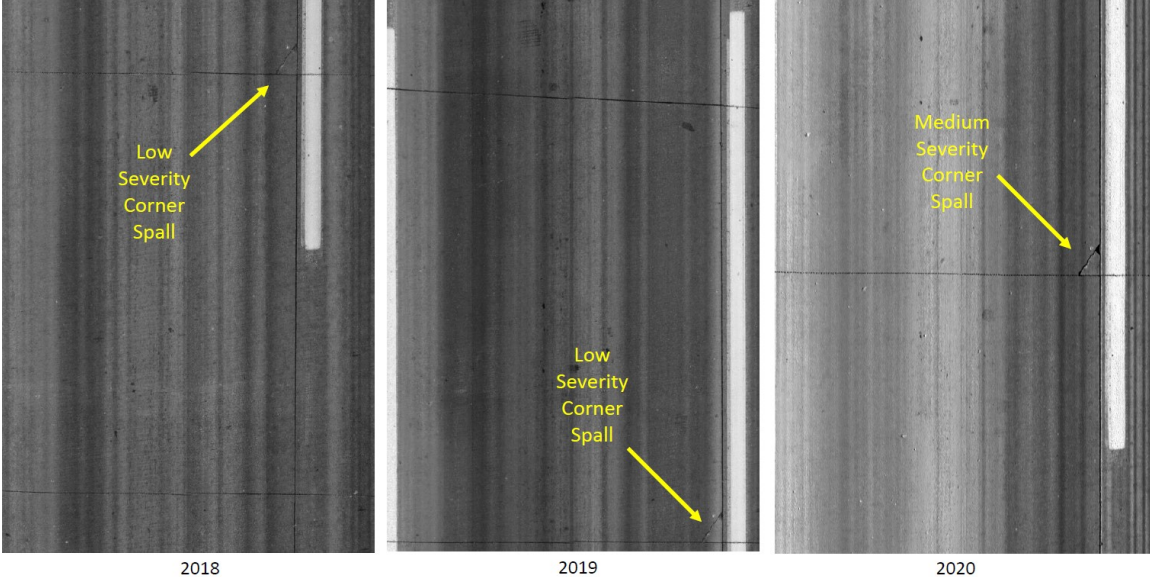
Figure 8.1 Photo. Spall progression from 2018 through 2020 taken using a downward facing camera on I-94 EB, Lane 3, MP 18.25 at the Illinois Tollway.

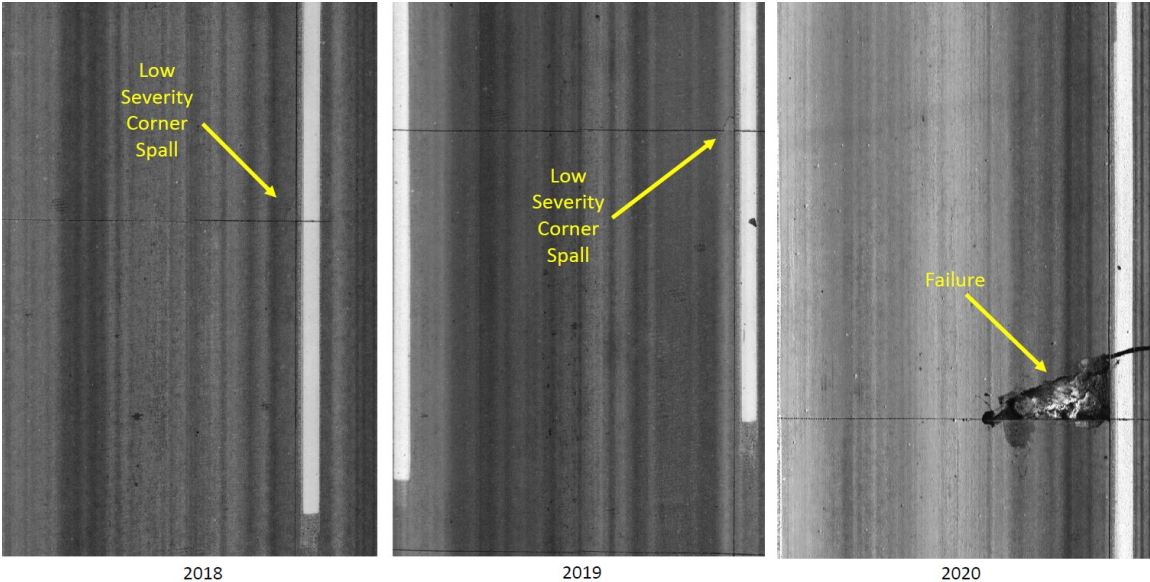
Figure 8.2 Photo. Spall progression from 2018 through 2020 taken using a downward facing camera on I-94 EB, Lane 3, MP 18.24 at the Illinois Tollway.

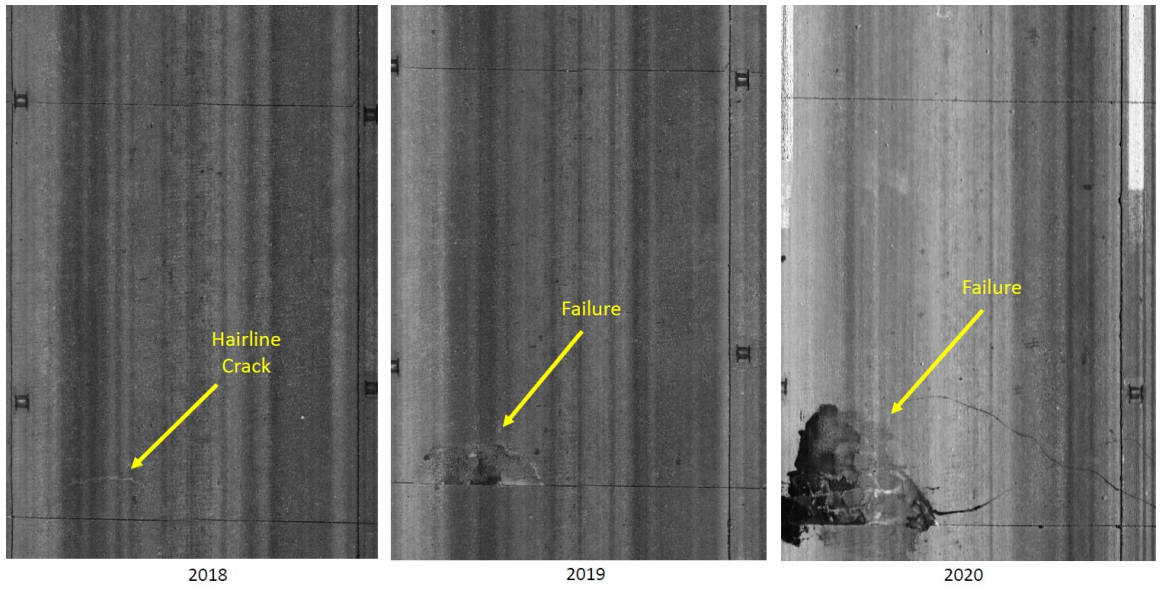
Figure 8.3 Photo. Spall progression from 2018 through 2020 taken using a downward facing camera on I-94 EB, Lane 3, MP 18.60 at the Illinois Tollway.

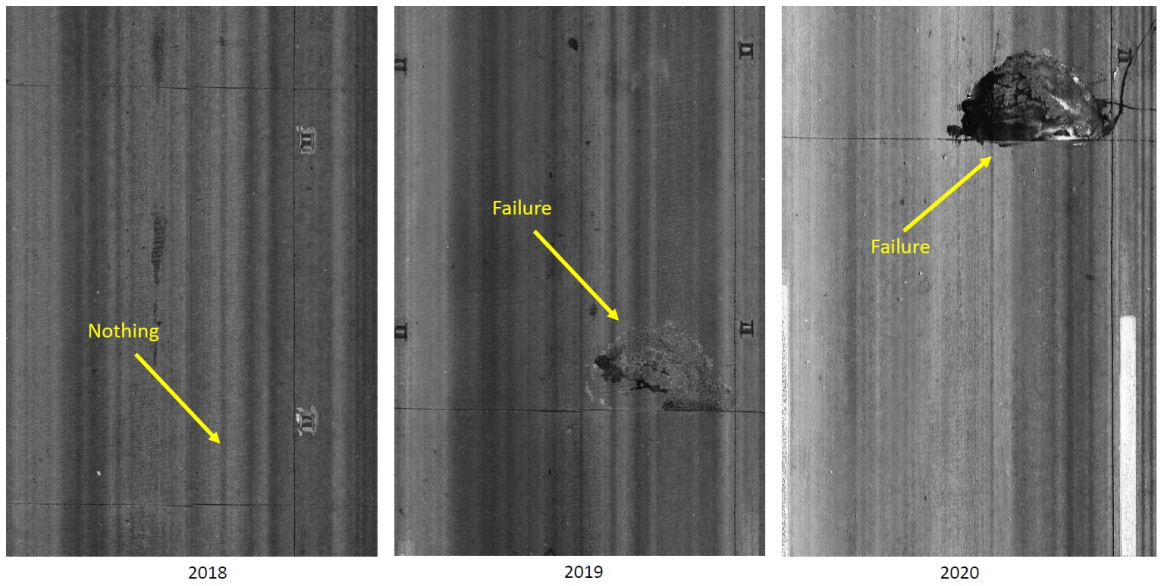
Figure 8.4 Photo. Spall progression from 2018 through 2020 taken using a downward facing camera on I-94 EB, Lane 3, MP 18.23 at the Illinois Tollway.

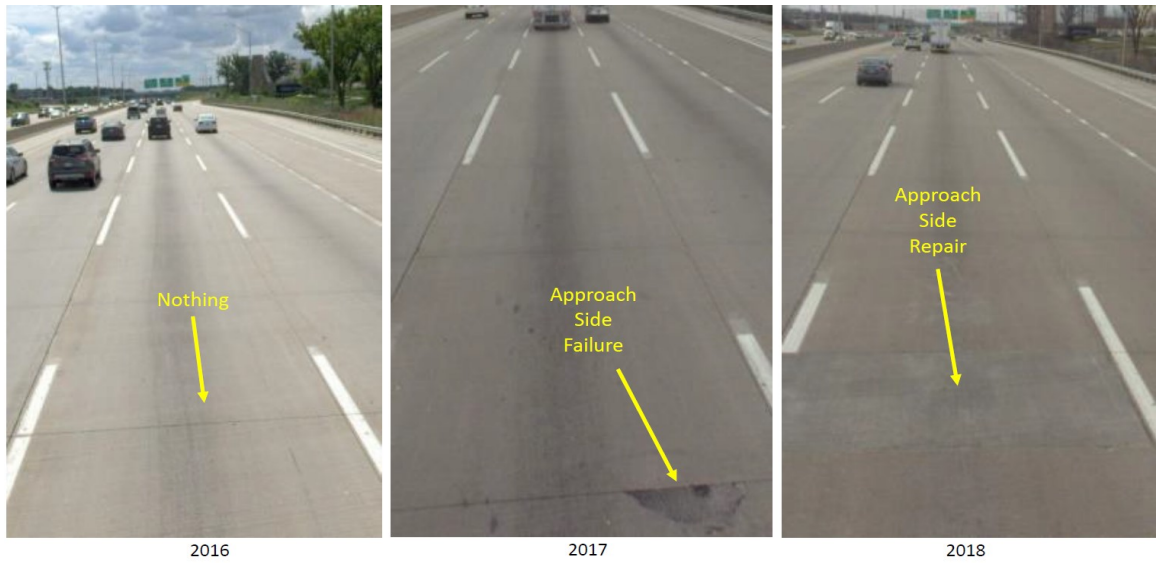
Figure 8.5 Photo. Spall progression from 2016 through 2018 taken using a front facing camera on I-94 EB, Lane 3, MP 18.55 at the Illinois Tollway.

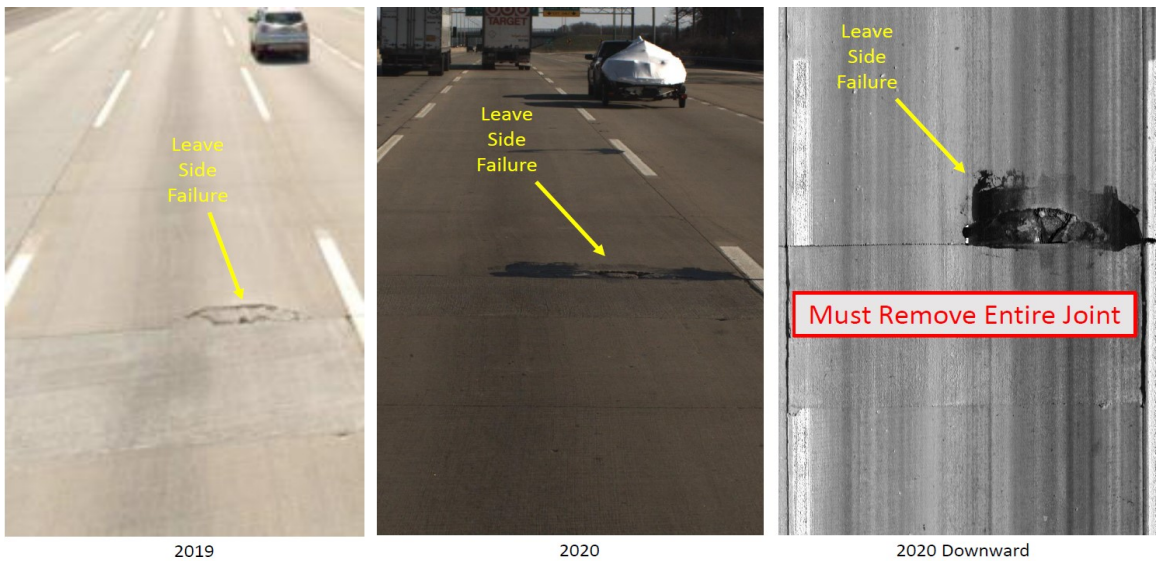
Figure 8.6 Photo. Spall progression from 2019 through 2020 taken using a front facing and downward facing camera on I-94 EB, Lane 3, MP 18.55 at the Illinois Tollway (continuation from Figure 8.5).

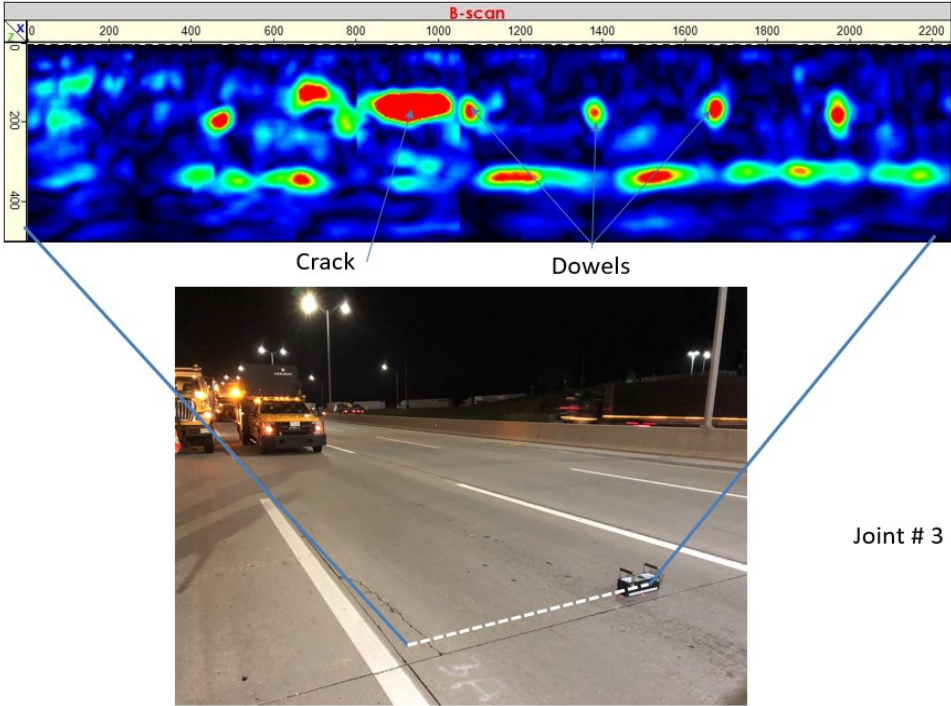
Figure 9.1 Photo and Contour Plot. 2D MIRA scan showing crack initiating at dowel bar level for Joint #3 on I-94 at the Illinois Tollway.

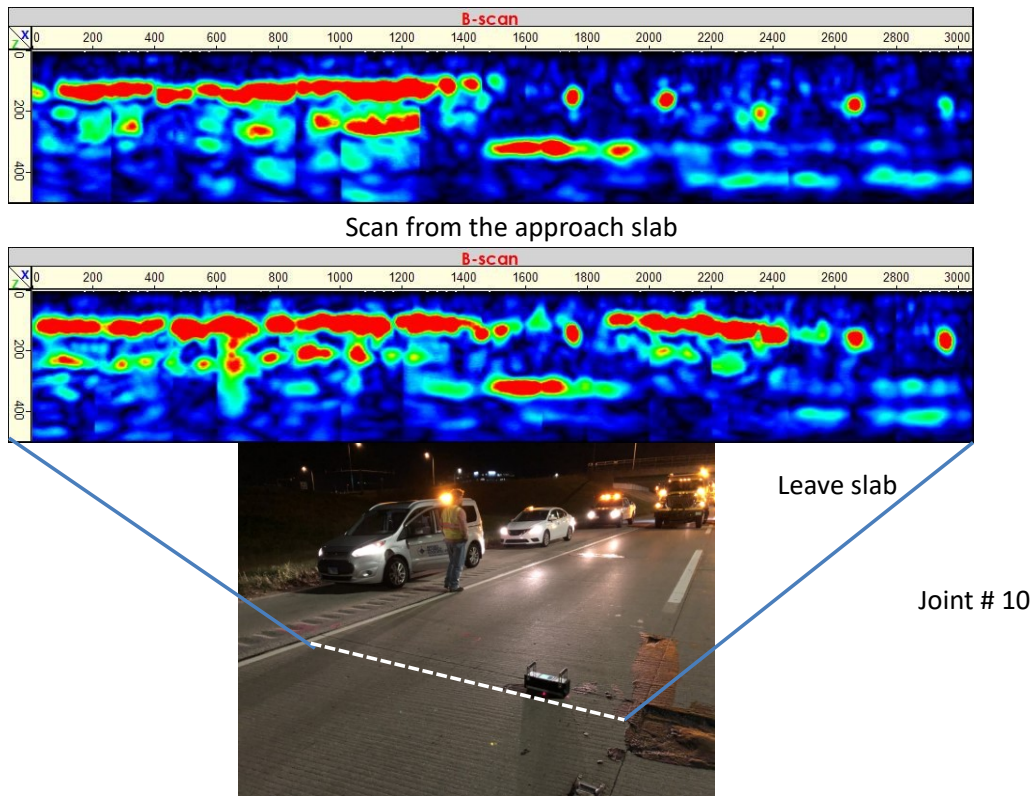
Figure 9.4 Photo and Contour Plot. 2D MIRA scan showing delamination cracks at dowel bar level at both the approach end and leave end for Joint #10 on I-94 at the Illinois Tollway.

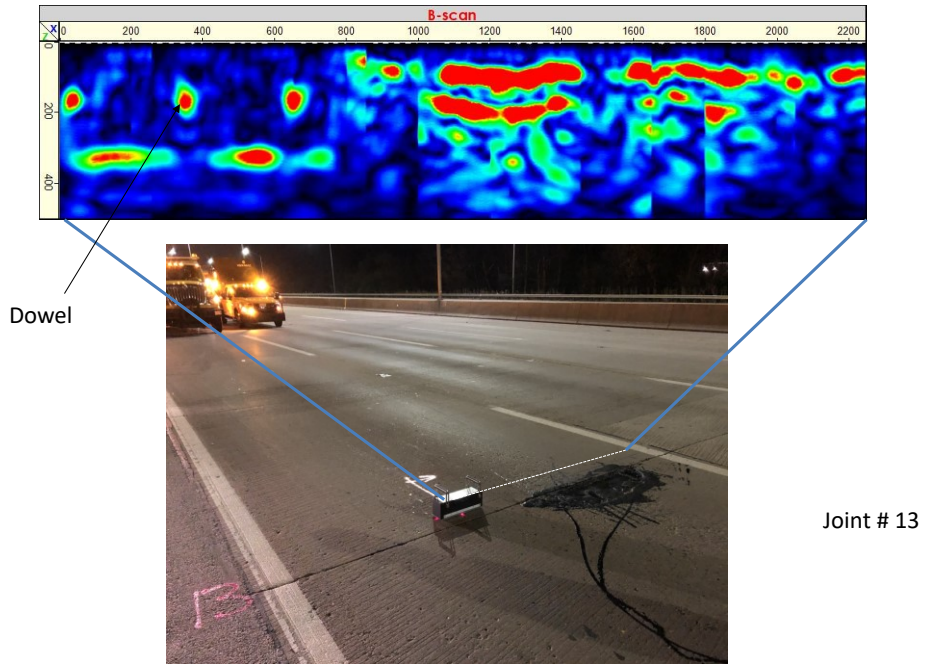
Figure 9.5 Photo and Contour Plot. 2D MIRA scan showing delamination crack initiating at dowel bar level for Joint #13 on I-94 at the Illinois Tollway.

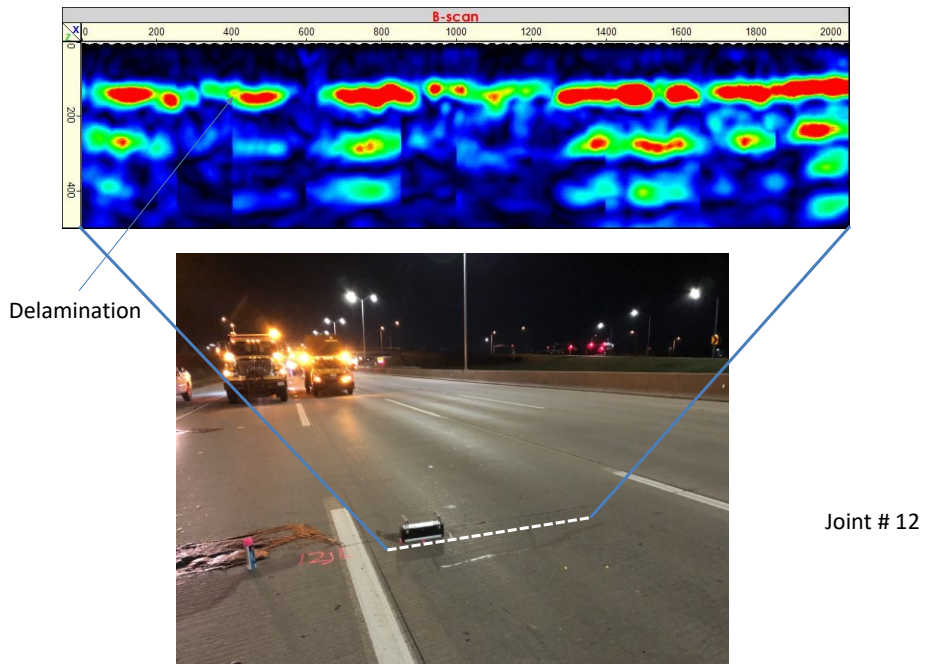
Figure 9.6 Photo and Contour Plot. 2D MIRA scan showing delamination crack initiating at dowel bar level for Joint #12 on I-94 at the Illinois Tollway.

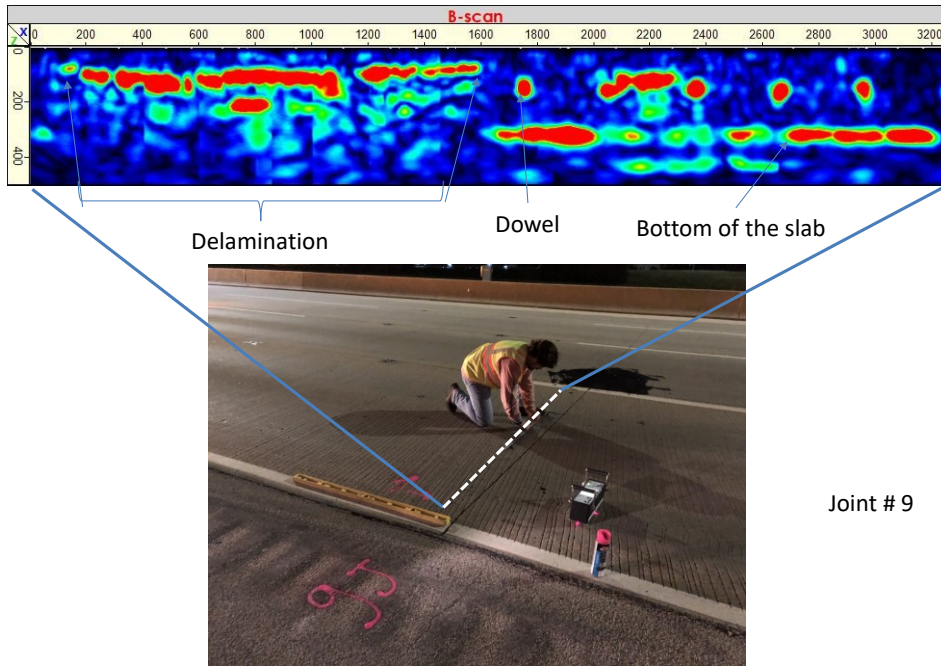
Figure 9.7 Photo and Contour Plot. 2D MIRA scan showing delamination crack initiating at dowel bar level for Joint #9 on I-94 at the Illinois Tollway.

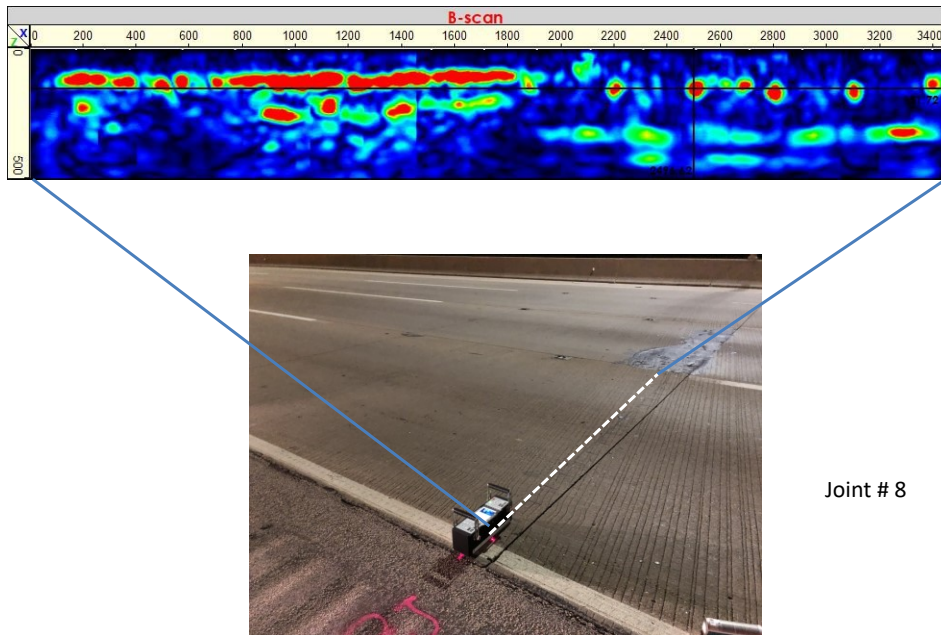
Figure 9.8 Photo and Contour Plot. 2D MIRA scan showing delamination crack initiating at dowel bar level for Joint #8 on I-94 at the Illinois Tollway.

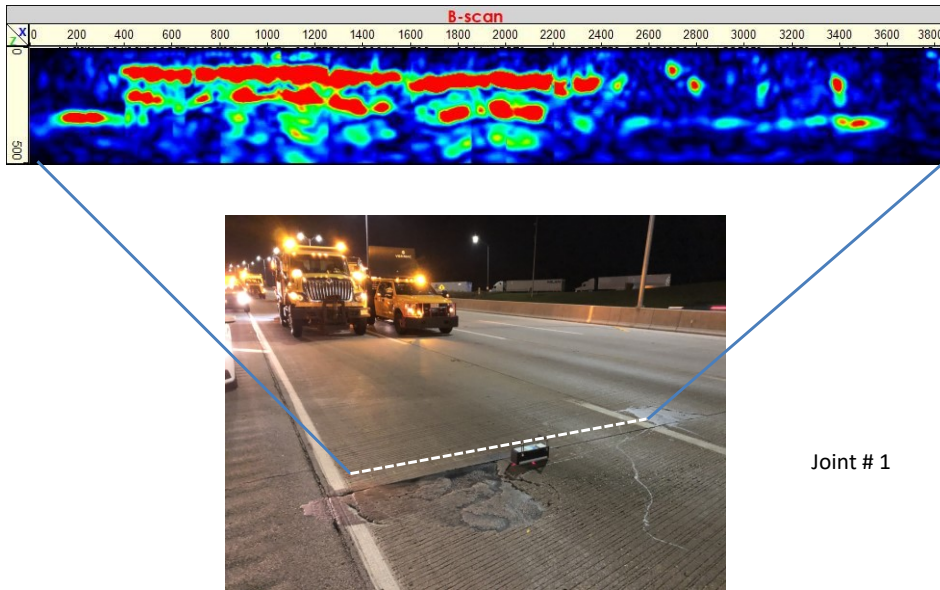
Figure 9.11 Photo and Contour Plot. 2D MIRA scan showing delamination crack initiating at dowel bar level for approach side of Joint #1 on I-94 at the Illinois Tollway.

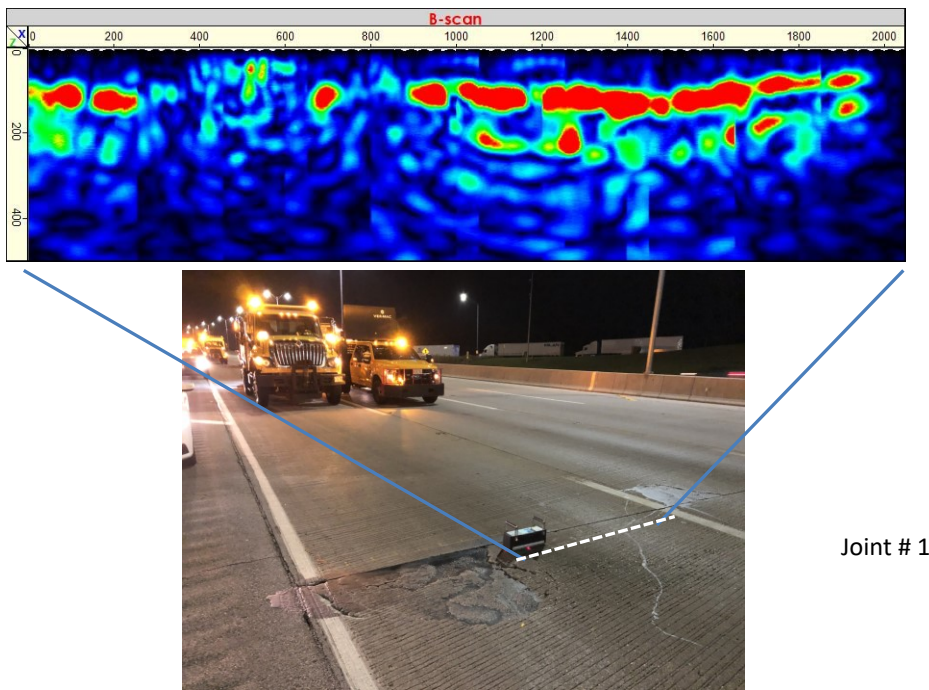
Figure 9.12 Photo and Contour Plot. 2D MIRA scan showing delamination crack initiating at dowel bar level for leave side of Joint #1 on I-94 at the Illinois Tollway.

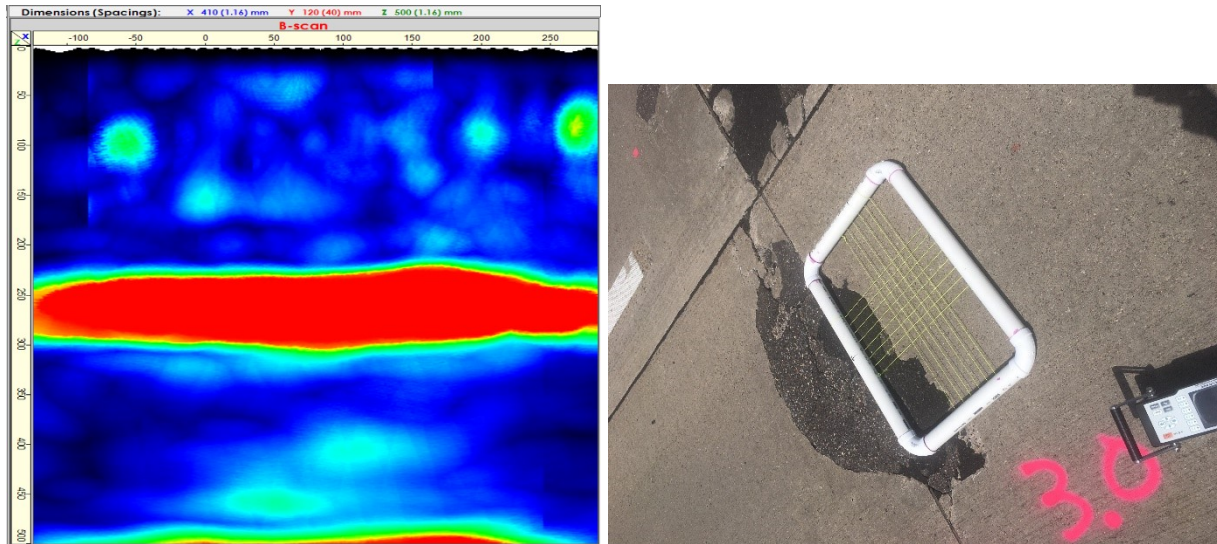
Figure 9.17 Photo and Contour Plot. MIRA scan showing no delamination cracking signal further away from the joint spall on TH 610 in Hennepin County, MN.

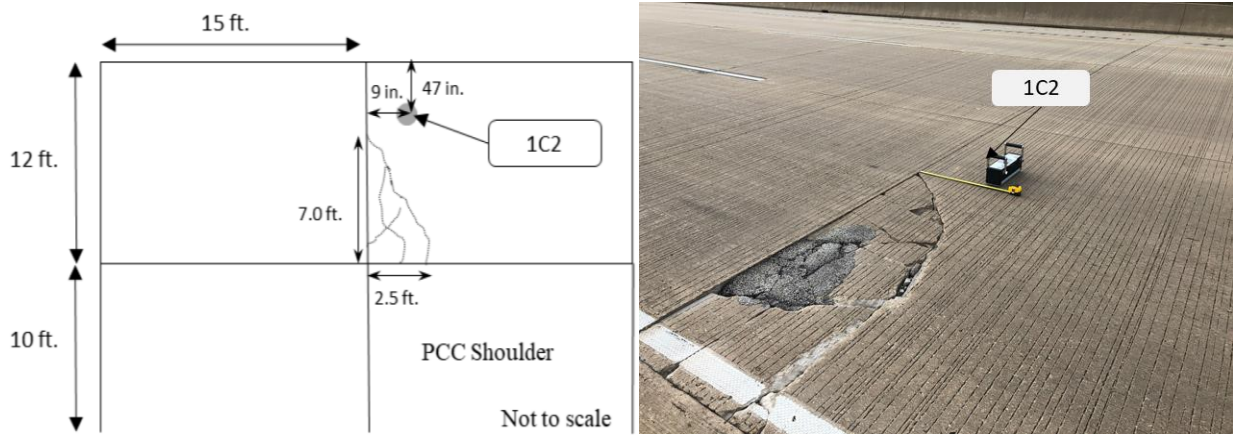
Figure 10.4 Photo and Illustration. Location of core on I-39 NB in Dane County, Wisconsin, with significantly large spall observed at the surface.

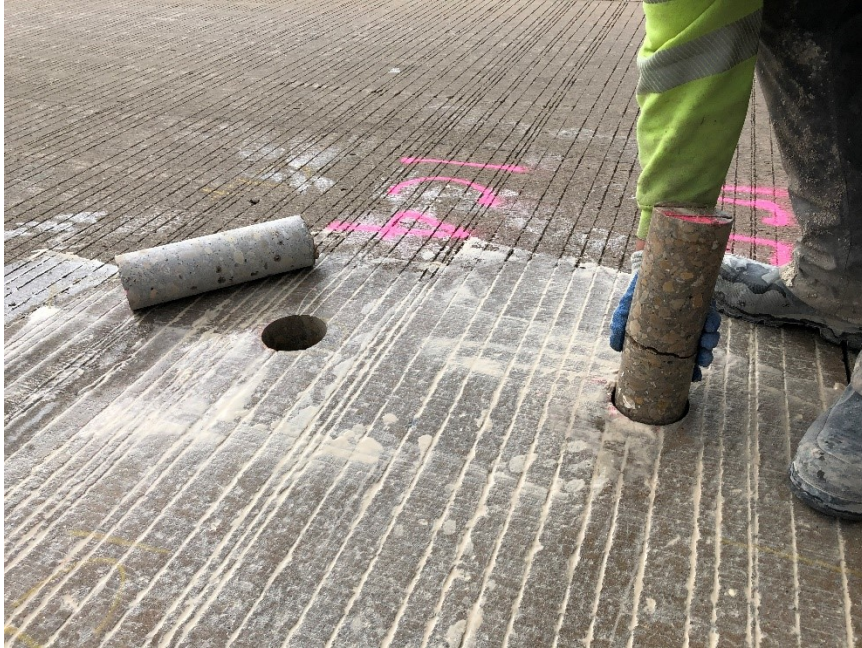
Figure 10.12 Photo. Two cores on I-39 NB in Dane County, Wisconsin, with no distresses observed at the surface. One core away from the joint is intact whereas the core closer to the joint had delamination cracking.

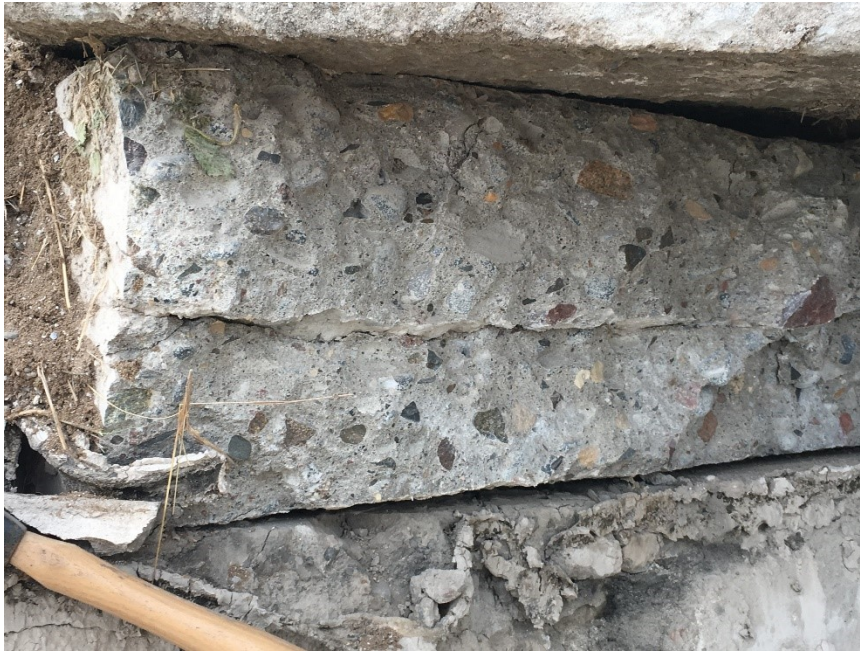
Figure 13.1 Photo. Stacked slabs of trenched concrete at the disposal/recycle yard from TH 610 in Hennepin County, Minnesota showing horizontal crack at about mid slab depth.

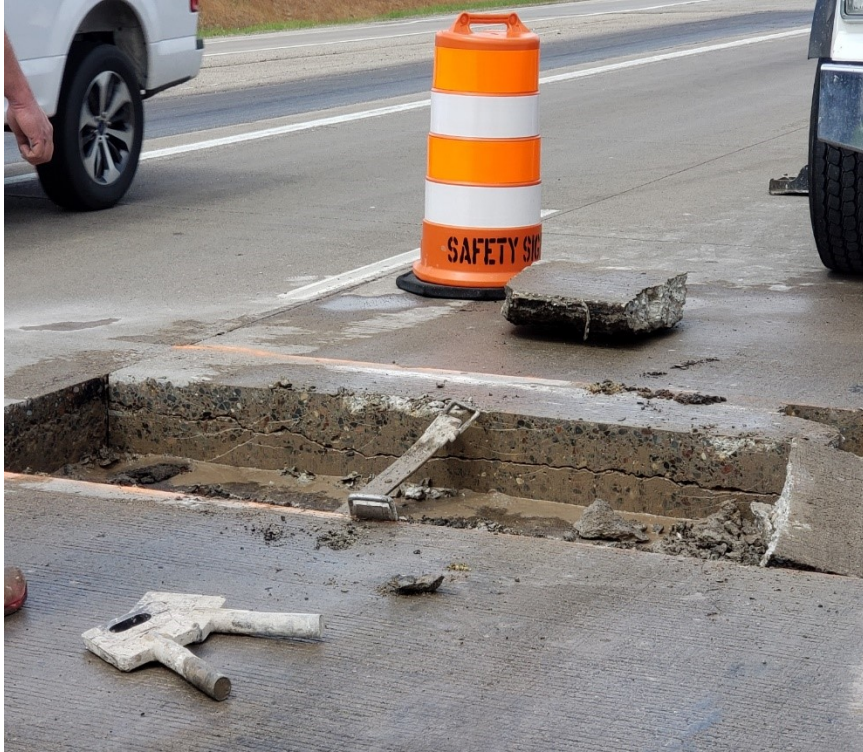
Figure 13.2 Photo. Trench showing delamination cracked concrete from TH 610 in Hennepin County, Minnesota.

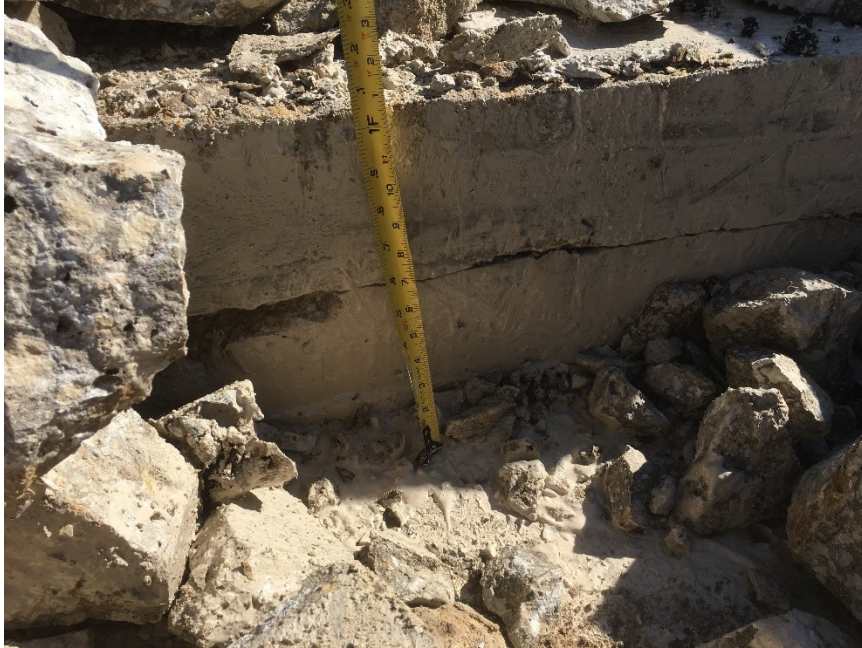
Figure 13.4 Photo. Trench showing delamination cracked concrete from I-39 NB in Dane County, Wisconsin.

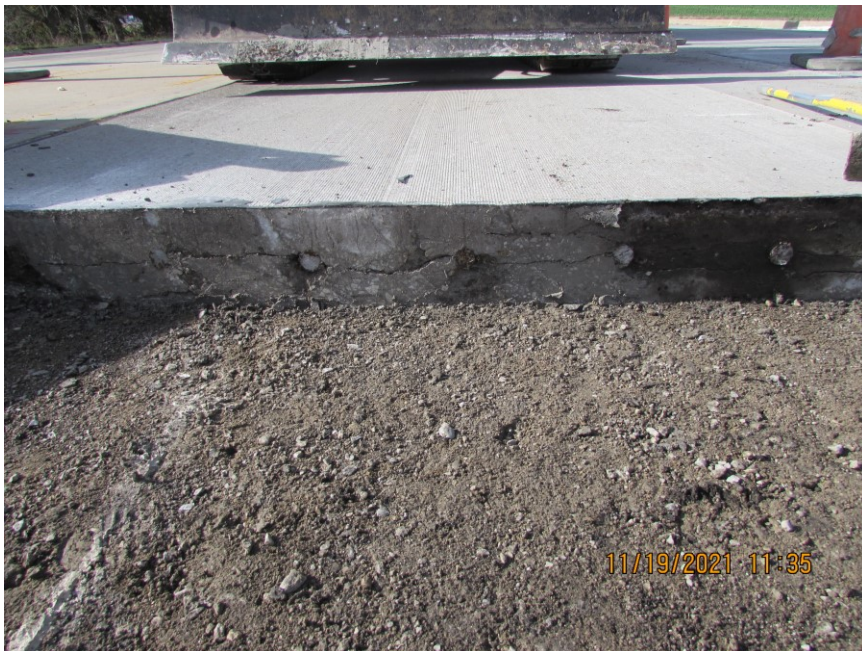
Figure 13.5 Photo. Trench showing delamination cracked concrete from a city street in Central Illinois on a relatively new (less than 3 years) concrete pavement.

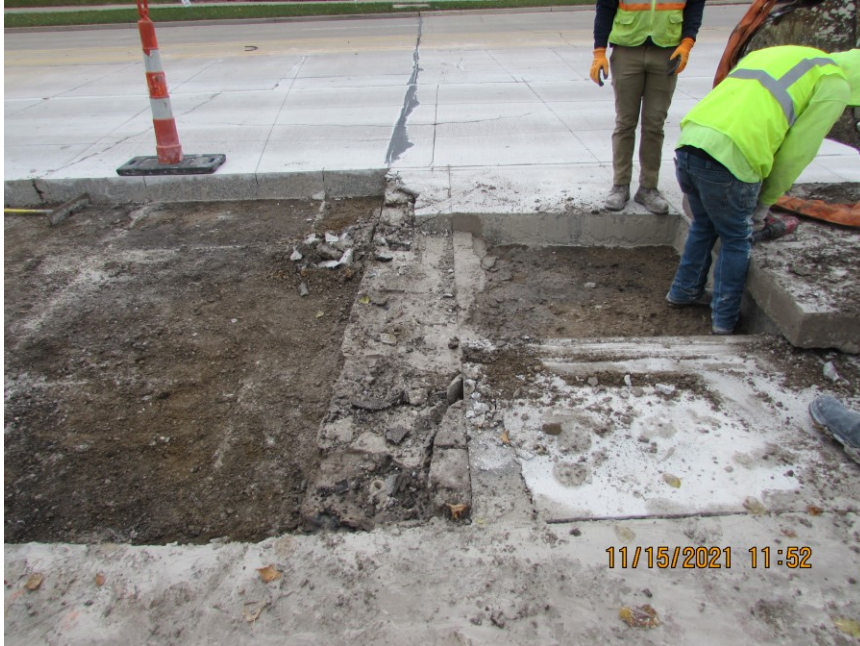
Figure 13.6 Photo. Trench showing concrete split at around mid-depth during trenching from a city street in Central Illinois on a relatively new (less than 3 years) concrete pavement.
