Federal Railroad Administration

Automated Weld Repair of Manganese Frogs for Extended Service Life

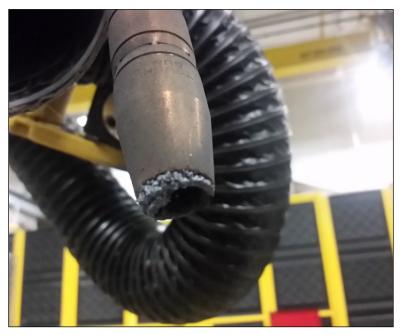
There was excessive spatter within the nozzle observed during the point welding process (Figure 20). EWI had some concerns about the weld spatter negatively impacting the weld characteristics and quality, especially considering that the wing repairs would be significantly longer passes. To evaluate the effect of spatter on weld quality, EWI executed a test weld on a carbon steel base plate, welding three beads across and three layers high over a 47-inch length (Figure 21). The entire length was subjected to radiographic testing that revealed zero pores and no lack of fusion. The spatter was not affecting the weld quality.

Figure 20. Spatter collection on nozzle

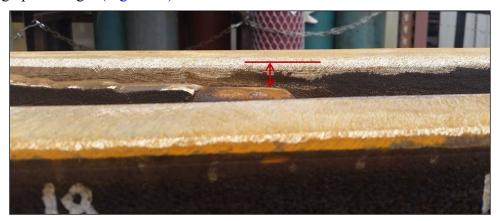
Both wings were ground to final dimensions and part of the point was finished. However, during final grinding, the point appeared to be slightly lower than the 0.1875-inch requirement (Figure 29). During initial layout of the repair, the point exhibited the correct height, but the additional thickness of repair on the wings was not taken into consideration. To bring the point back to the correct height, CSX recommended that EWI add additional weld material in the area shown in Figure 30, which extended 14 inches back from the point. EWI deposited eight layers of weld material in this area to bring up the height (Figure 31).

Figure 29. Point-to-wing height difference

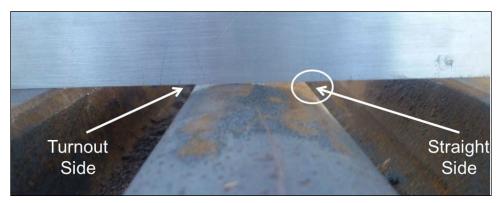
Figure 32. Area on point with uneven deformation

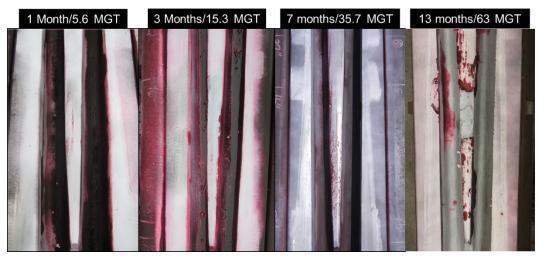
The wings of the frog had no crack indications, aside from isolated pores and one surface crack that formed after the point breakout occurred.

Figure 39. Penetrant inspection on repair area

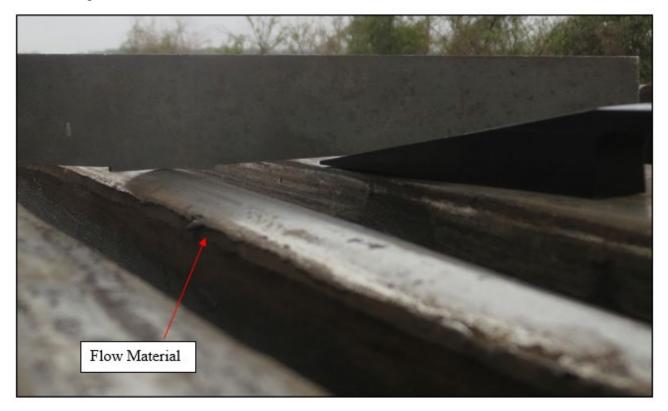
Material flow is common during running surface hardening (Figure 42). CSX reported some rollover material during its inspections and performed grinding to remove the plastic meAtal flow four times during the service test.

Figure 42. Point with unground flow material during a profile measurement

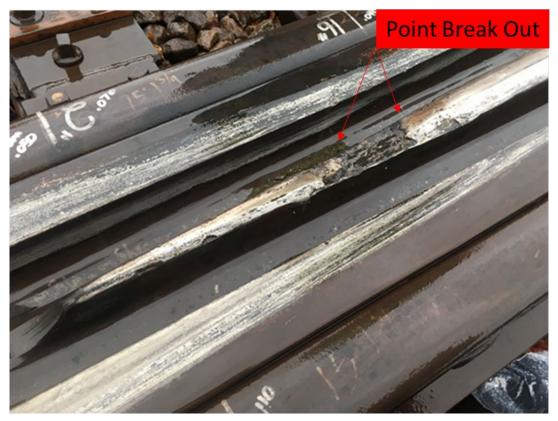
EWI observed a roughly 4-inch-long section of the point broken out 10 inches from the tip during the final visit on December 5, 2017 (Figure 43). In general, small areas of material loss are tolerable. However, due to the size and depth of this breakout, a weld repair would be required to keep the frog in service. The team decided to end the revenue service test at this service level (63 MGT).

Figure 43. Frog with break-out on point during final in track inspection

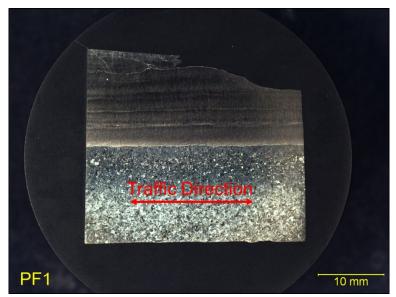
Cross-section PF1 cut into the side of the point. The section in Figure 53 is parallel to the point centerline. This section displays the edge of the breakout and part of the remaining point surface. The cross-section shows the cracking which led to the breakout. The crack lines do not follow the layers of the repair welds. After a high-magnification examination of the weld repair in this area, EWI concluded that there was no clear indication of discontinuity in the microstructure that would lead to a weld repair failure.

Figure 53. Cross-section PF1

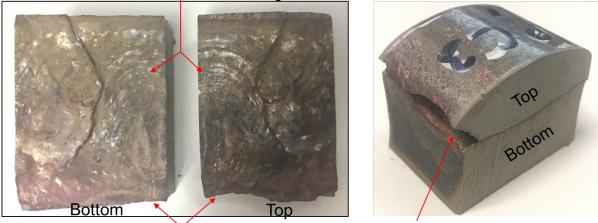
Fatigue Crack Growth Rings Emanating from the Picked Area

Broken out picked area which left notch

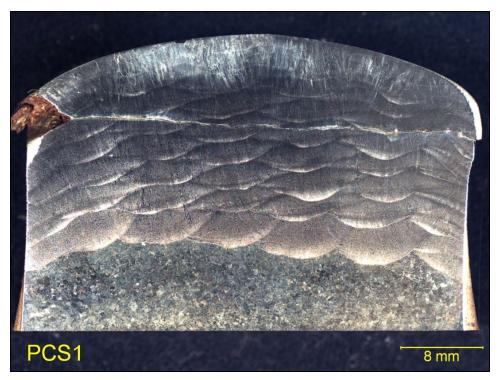
The waterjet-cut face of PCS1 was polished and etched for metallurgical examination (Figure 56). Overall, the weld cross-section looked good. There was no porosity or indication of issues at the bond line between the weld and casting. At the top, a roughly 0.1875-inch crack was visible and open to the running surface. This is likely due to shear stress caused by the passing train wheels. The crack running through the weld repair from one side of the point to the other did not appear to follow any metallurgical features.

Figure 56. Weld cross-section from the point, PCS1

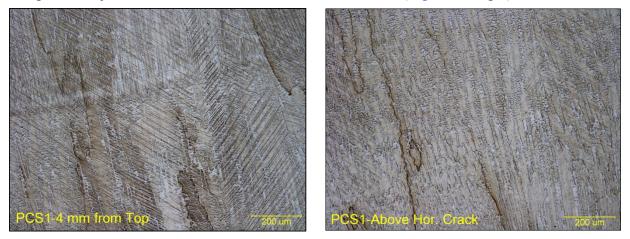
EWI performed a high-magnification examination of the PCS1 cross-section. Some strain bands are visible near the running surface of the point (Figure 57, left). These were straight, dark, parallel lines that cover the polished surface, occasionally changing orientation. Strain bands are caused by work-hardening as wheels roll over the point. An examination of the microstructure further from the running surface, just above the crack, shows fewer strain bands (Figure 57, right).

Figure 57. High-magnification images of the point microstructure

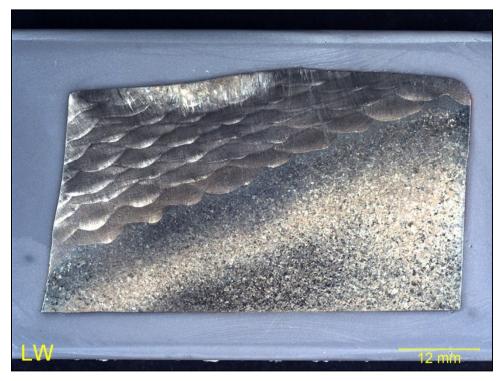
EWI also examined the cross-sections taken from the wings and found no indications of microstructural issues. Both wing cross-sections had clear areas of strain bands where the deformation was highest (Figure 58 and Figure 59). On the right wing a crack was visible on the running surface. This location corresponded with the breakout area on the point. When the wheel fell into the breakout, it landed on the wing, which is a likely cause for this crack.

Figure 58. Left wing cross-section

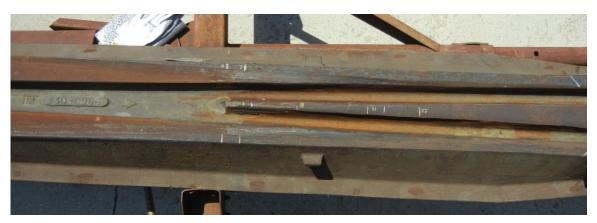
Figure 66. #20 WMB frog as delivered to EWI (with visible damage marked)

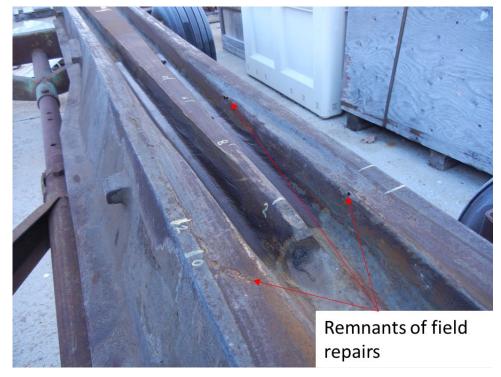
Figure 67. #20 WMB frog with evidence of field repairs indicated

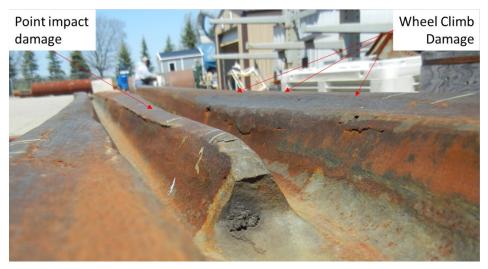
climbing or falling off the wing during the transition. This climbing and falling action caused severe wear on the wing and caused impact damage to the point where the wheel landed (Figure 68).

Figure 68. Wing damage due to wheel climb

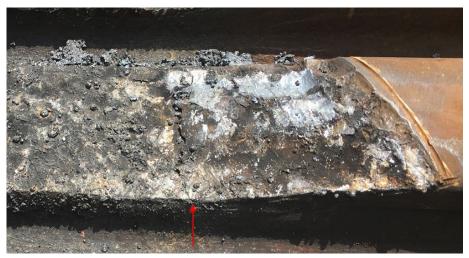
Figure 79. Crack in point found after gouging WBM frog, red arrow

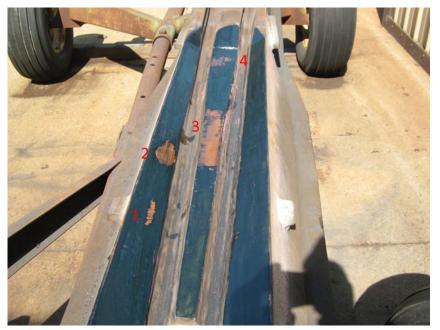
Figure 81. Acid etched repair area in NS frog with field repairs labeled

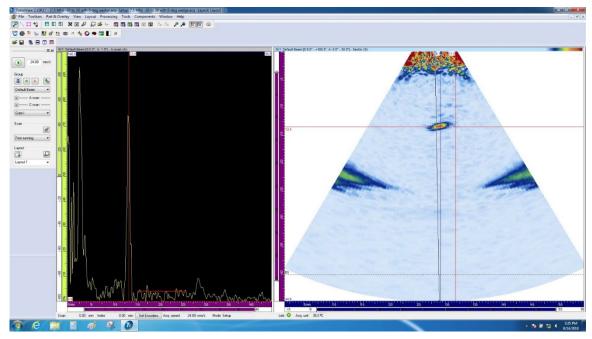
Figure 89. Example of a PAUT scan with discontinuity in sonogram

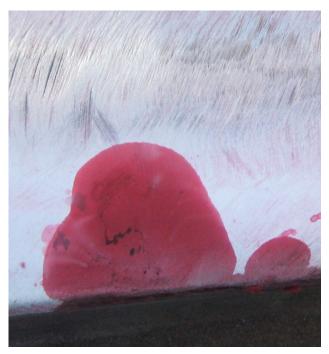
Figure 90. Surface crack found with PT outside the weld repair area

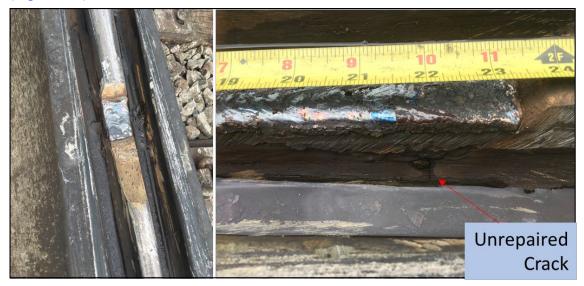
Figure 99. Crack repair area after cut out (left) and unrepaired crack on point and flangeway (right)
