TECHBRIEF

Corrosion-Induced Major Tendon Failures in Post-Tension (PT) Concrete Bridges

FHWA Publication No.: FHWA-HRT-24-148

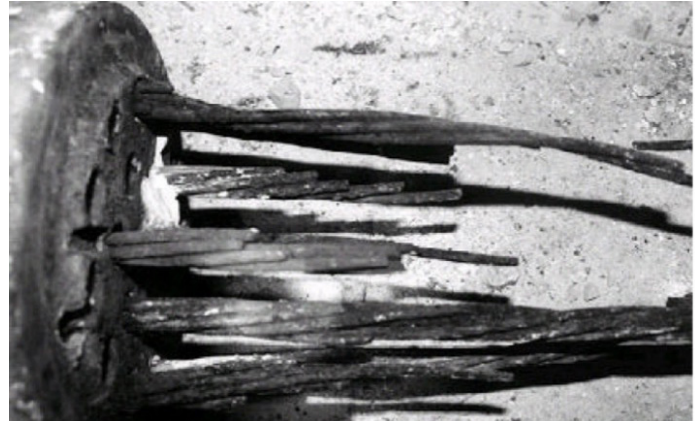
In 1999, bridge inspectors discovered that one of 234 external tendons had failed after 16 yr in service due to intensive corrosion in a grout void formed by bleed water. Figure 2 shows some of the damaged strands still attached to the anchor head associated with the failed tendon.^(4,5)

This incident was regarded the first PT tendon failure caused by corrosion in the United States. The void location was behind an anchor head at an expansion joint diaphragm. Recharging water contaminated with airborne chloride in the void was responsible for the corrosion. Inspectors speculated that the water leaked through the expansion joints and ran down the inner faces of the segment diaphragms onto the anchorage in question.

Figure 2. Photo. Failed tendon in the Niles Channel Bridge (main cause: chloride).^(4,5)

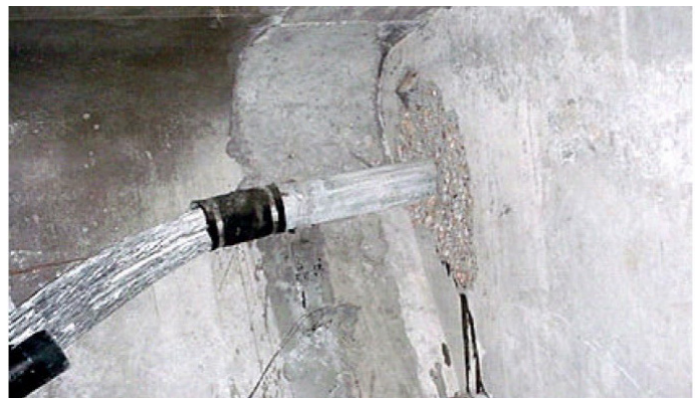
In August 2000, a routine inspection revealed that a failed tendon had separated from an expansion joint diaphragm due to severe corrosion in the anchorage zone. The strong bond between the grouted steel pipe and the failed tendon section pulled the steel pipe from the expansion joint diaphragm during the tendon rupture (figure 3).

The failure pattern resembled the failed tendon observed in the Niles Channel Bridge. This incident was regarded as the second PT tendon failure by corrosion in the United States.

Figure 3. Photo. Failed tendon in the Mid-Bay Bridge (main cause: chloride).⁽⁴⁾

These corrosion problems prompted the Florida Department of Transportation (FDOT) to launch emergency inspections, including visual crack inspections, vibration testing, the sounding of all ducts, and borescope inspections of all 1,728 anchorages. Inspectors subjected each PT tendon to magnetic flux leakage (MFL) testing to locate significant section losses nondestructively. The MFL testing located potential corrosion problems and wire fractures in two tendons. At the end of the inspections, inspectors replaced 11 severely corroded tendons of 846 tendons, and regouted anchor voids using the vacuum grouting (VG) method.

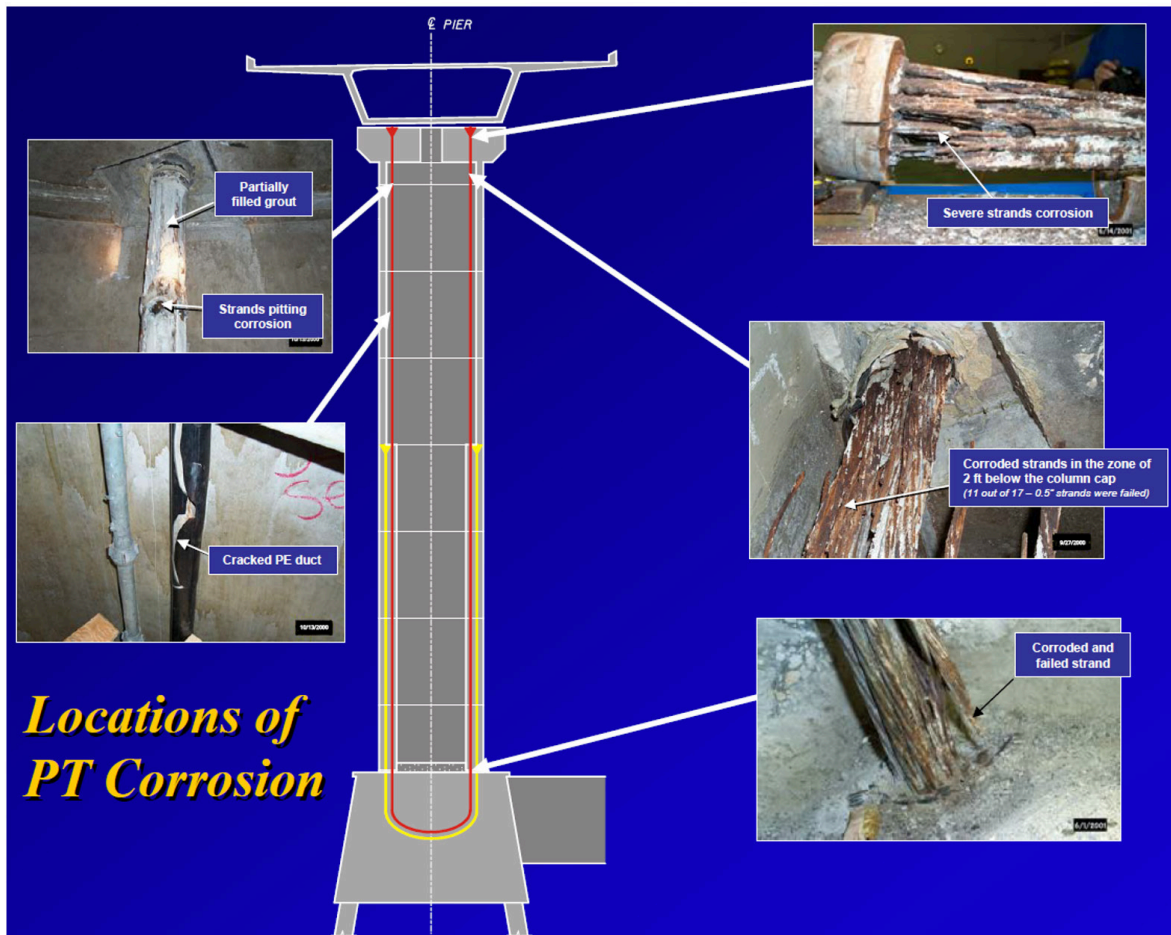
During a special inspection of the bridge in September 2000, inspectors discovered severe corrosion in a tendon housed in a northbound column: 11 of 17 0.5-inch (12.7-mm) strands were fractured at 2 ft (0.6 m) below a column cap. As a result, inspectors performed further inspections on all the other high-level approach columns (including comprehensive destructive testing on about 10 percent of the columns), the superstructure, and the cable anchorage of the main span. Figure 4 shows the locations of corrosion problems and illustrates construction of the precast segmental columns.

Figure 4. Schematic and photos. Column structure and locations of tendon corrosion (main cause: chloride).

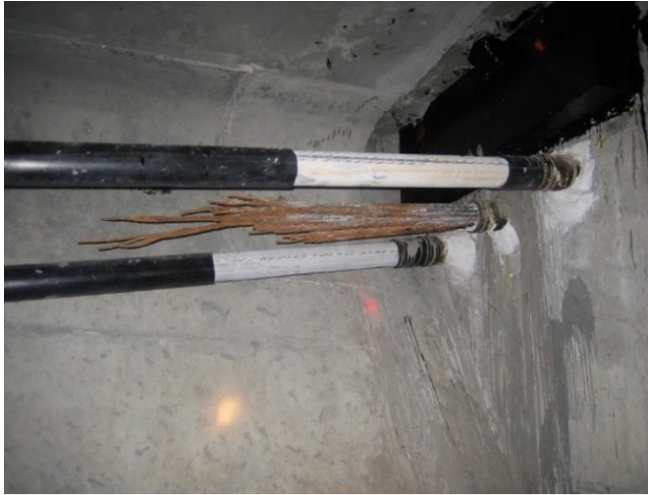
In May 2007, a routine inspection discovered one failed tendon in the southbound bridge. Even though the tendon was regouted in 2004, it still failed due to corrosion at the bridge age of 17 yr. Figure 5 shows the failed tendon: a short section attached to the diaphragm (figure 5-A) and the opposite section to the ruptured section fell onto a deviation block (figure 5-B).

Figure 5. Photos. Failed tendon in Varina-Enon Bridge (main cause: defective grout).

A. Section attached to the diaphragm.

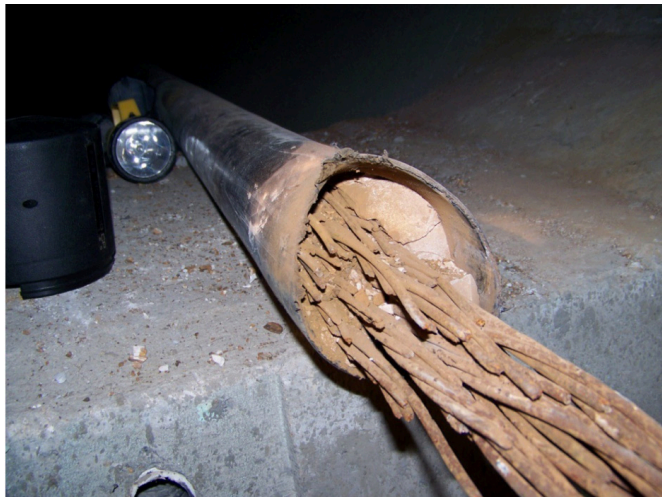
B. Opposite section on a deviation block.

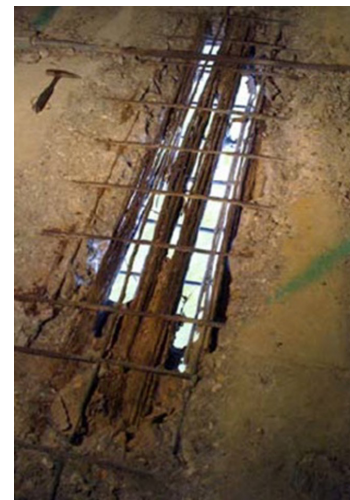
During an annual inspection in 2010, inspectors observed slab cracking and rust stains in the box girders. A follow-up inspection revealed significant cracking, rust stains, and corrosion of internal continuity tendons buried in the bottom slab under the delaminated concrete. Figure 6 shows the damaged bottom slab.

Figure 6. Photos. Plymouth Avenue Bridge's severely damaged bottom slab (main cause: chloride).⁽⁵⁾

A. Interior condition.

The 2010 investigation also determined that the chloride-bearing water from the deck that leaked through the misaligned drainage pipe sections inside the box girders and deicing salts accumulated in the bottom slab triggered corrosion of the internal tendons and adjacent reinforcing steel.

The bridge was closed for nearly 1 yr to carry out detailed inspections, subsequent repairs, and the installation of five additional external tendons in each box girder to strengthen the bridge. Each new tendon contains 12 0.6-inch (15.2-mm) strands. The new tendons were installed through new concrete deviation blocks attached to the bottom slab and anchored in the concrete blisters (anchor blocks) newly formed at the girder ends.

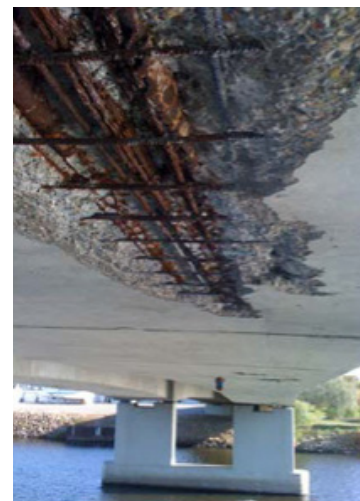
B. Exterior condition.

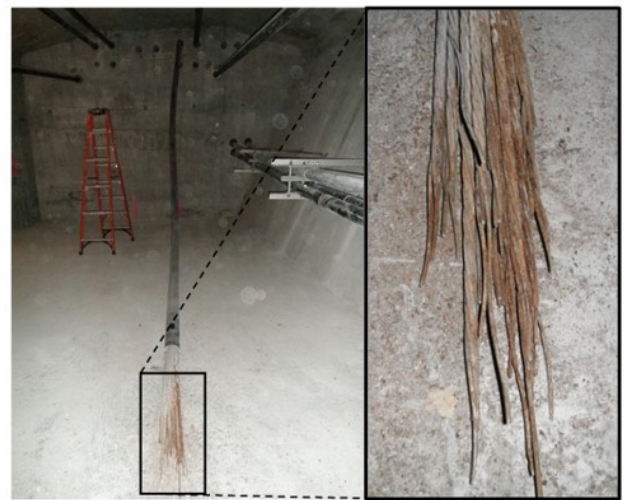
Figure 7 shows corrosion failure of an external tendon was discovered in January 2011, and another external tendon failed in July 2011 after less than 8 yr of service. The figure shows the as-discovered condition when the failed tendon fell to the girder floor. The inset image shows the complete separation of entire strands due to severe corrosion.

Figure 7. Photos. Ringling Causeway Bridge's first failed tendon (main cause: defective grout).⁽²¹⁾

The first tendon failure occurred in the upper horizontal portion of a sloped tendon section adjacent to an upper deviator. This tendon exhibited severe corrosion mostly concentrated on the strands in the upper portion of the failed tendon. Except for the heavily corroded strands, the failure mode of the remaining strands appeared ductile, as evidenced by necking signs at the ruptured ends of the wires. The corroded-in-two wire tips suggested that the failed tendon must have been exposed to a very corrosive environment for some time. Also observed was corrosion in the upper portion of the galvanized steel pipe in the upper deviator. Although there is no initial photograph of the pipe's condition, two distinctive rust lines on the interior wall indicated that there likely was water or watery grout up to the rusty watermarks for an unknown duration after grouting.
