Mitigation of Corrosion in Continuously Reinforced Concrete Pavement

Study SD2009-05

Final Report

Prepared by
Allen L. Jones and Nadim I. Wehbe
South Dakota State University
Department of Civil and Environmental Engineering

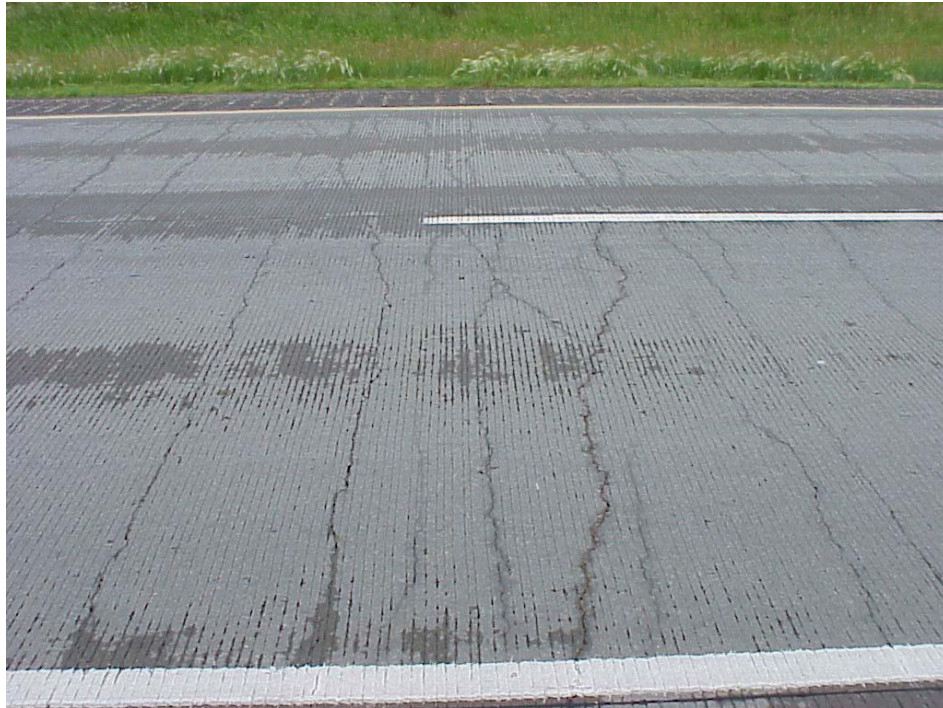
Figure 4-1: Network and Y-cracking (Johnston 2009)

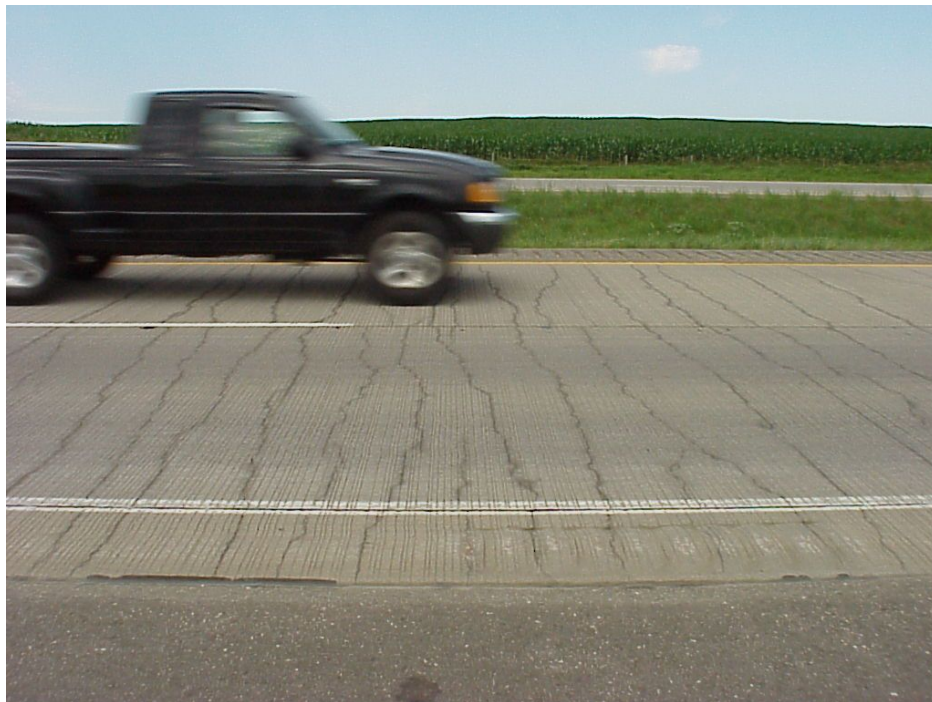
Figure 4-2: Cluster cracking (Johnston 2009)

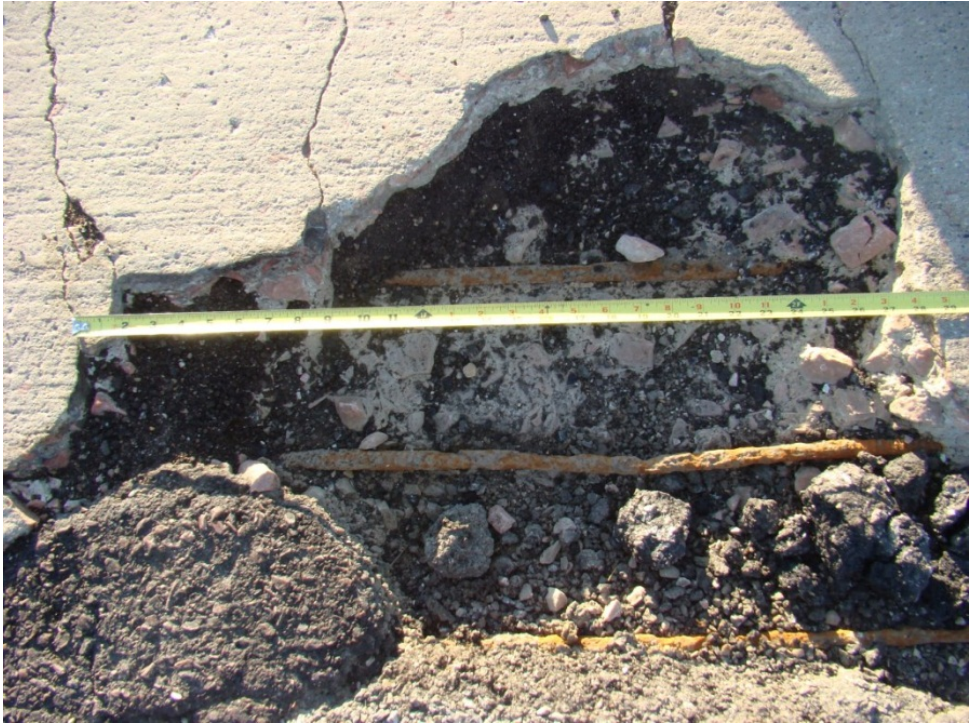
some CRCP sections in South Dakota are shown in Figure 4-3 and Figure 4-4. The reinforcement shown in these photographs are from CRCP which was constructed in 1968.

Figure 4-3: Corroded reinforcement exposed during CRCP removal

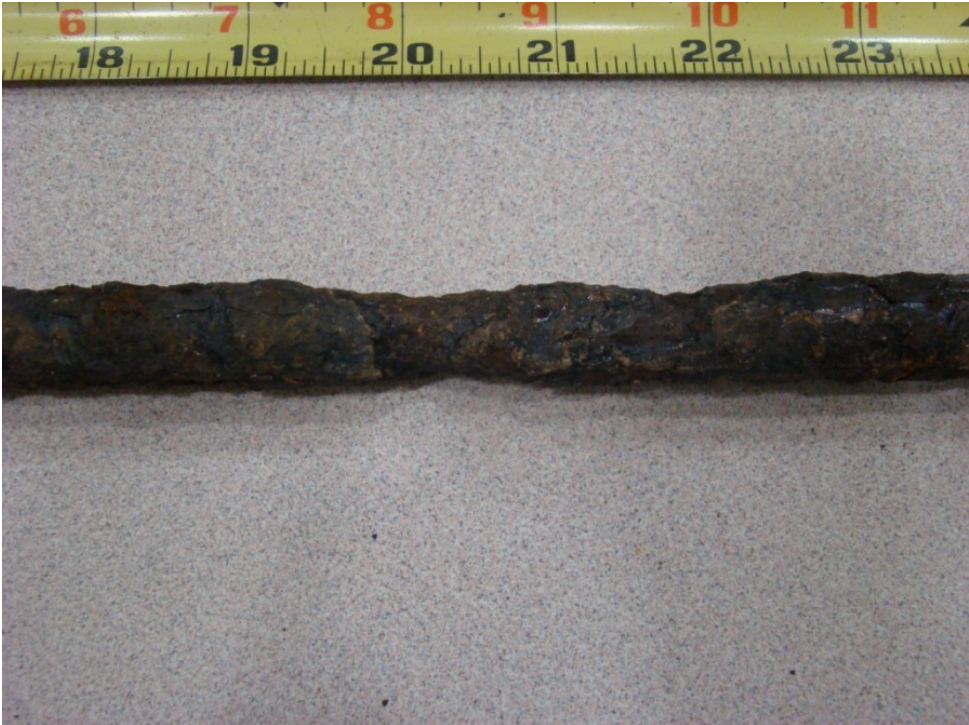
Figure 4-4: Corroded reinforcement removed from degraded CRCP

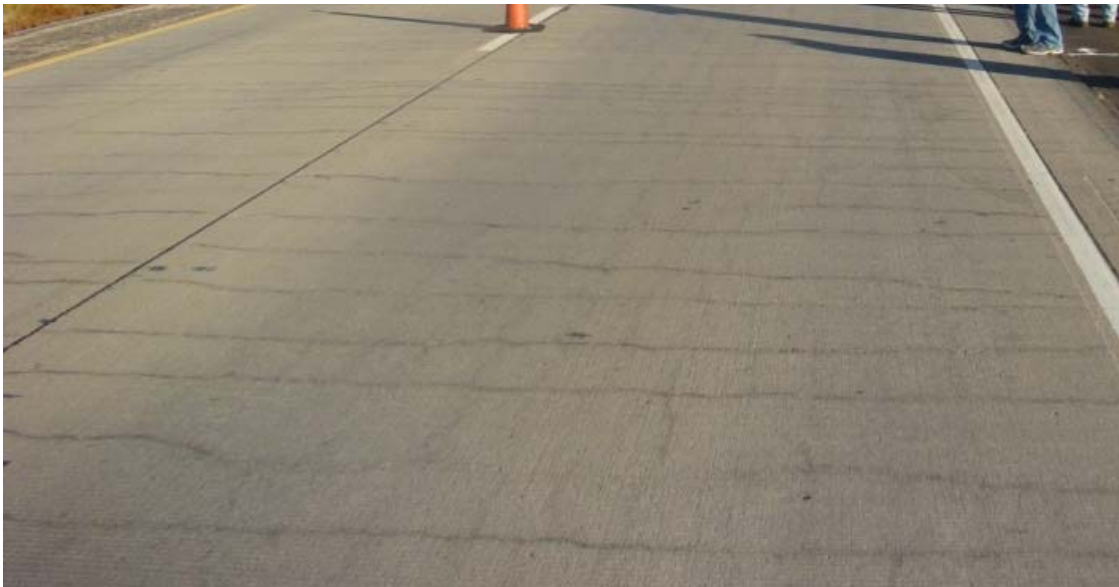
Figure 6-1: Cracking on Interstate 29 at MRM 87

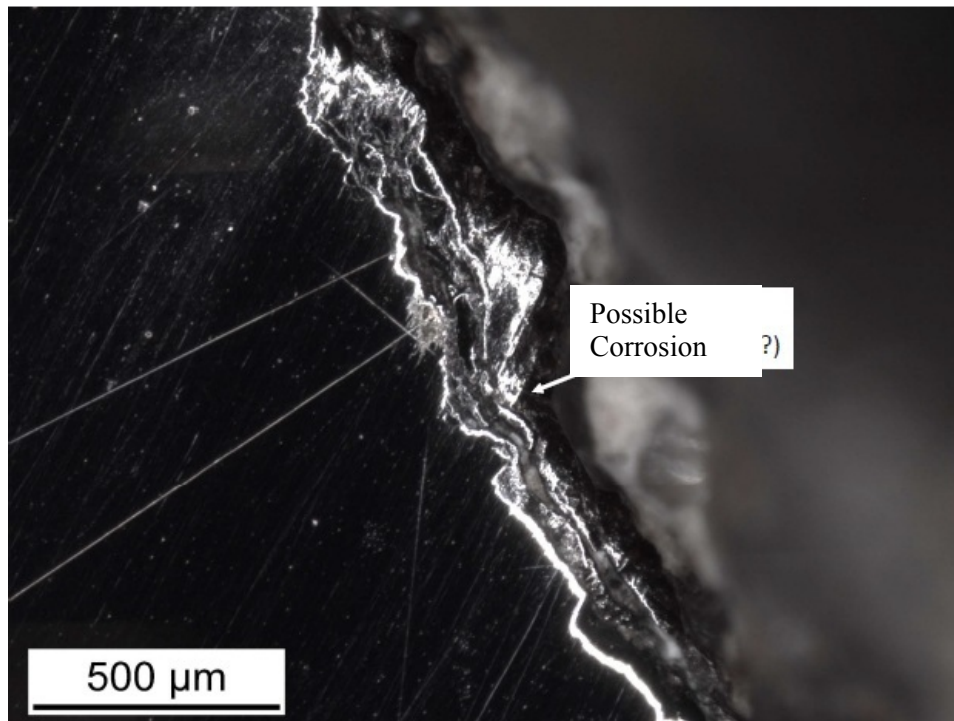
using the optical microscope. This is shown in Figure 6-10. Figure 6-11 shows a secondary electron image of the possible corrosion zone.

Figure 6-10: Thin layer of rust or possible corrosion

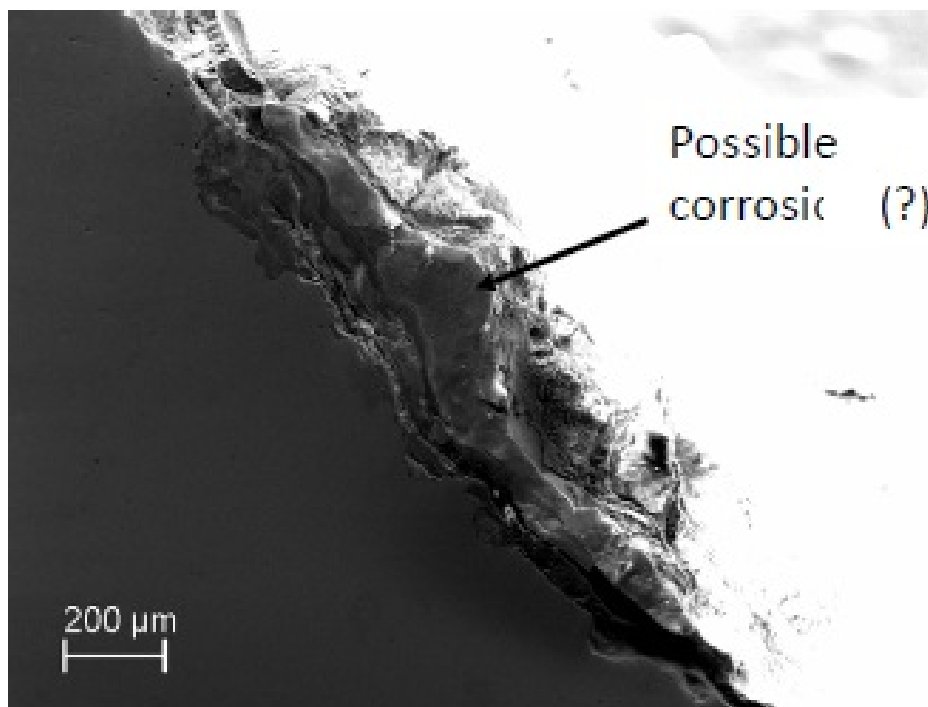
Figure 6-11: Secondary electron image of possible corrosion zone

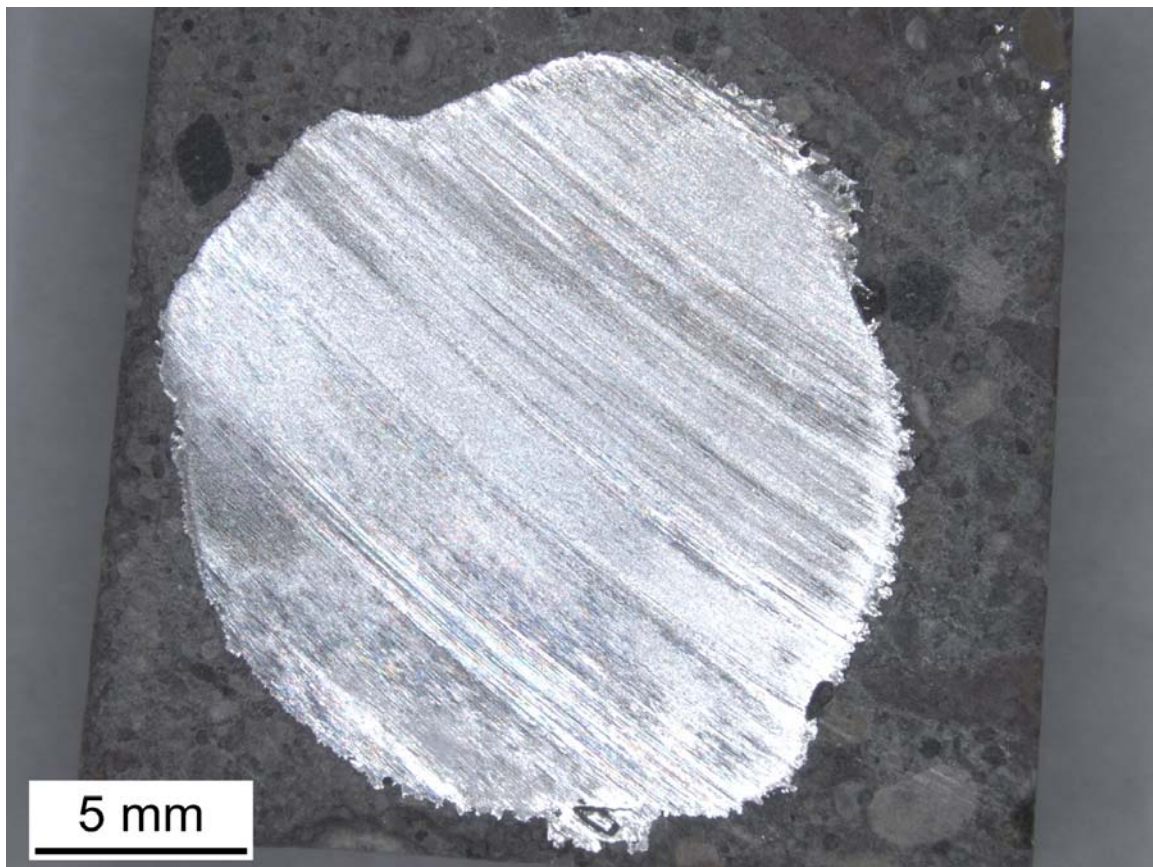
The reinforcement in an uncracked concrete core from site MRM 87 was also analyzed to determine if corrosion was present in the reinforcement away from pavement cracks. The core was labeled MRM 87-4. A photograph of the polished section of reinforcement from this core is shown in Figure 6-12. The photograph shows that there are no signs of corrosion in the reinforcement. As with cracked core MRM 87-3, the intact core exhibited a thin oxidized layer around the entire perimeter of the steel bar. This layer was analyzed using SEM, and the results showed no signs of chlorine or corrosion. Figure 6-13 shows the energy dispersive spectrum of the sample. Only iron peaks are present.

Figure 6-12: Steel bar section from core MRM 87-4 (uncracked concrete core)

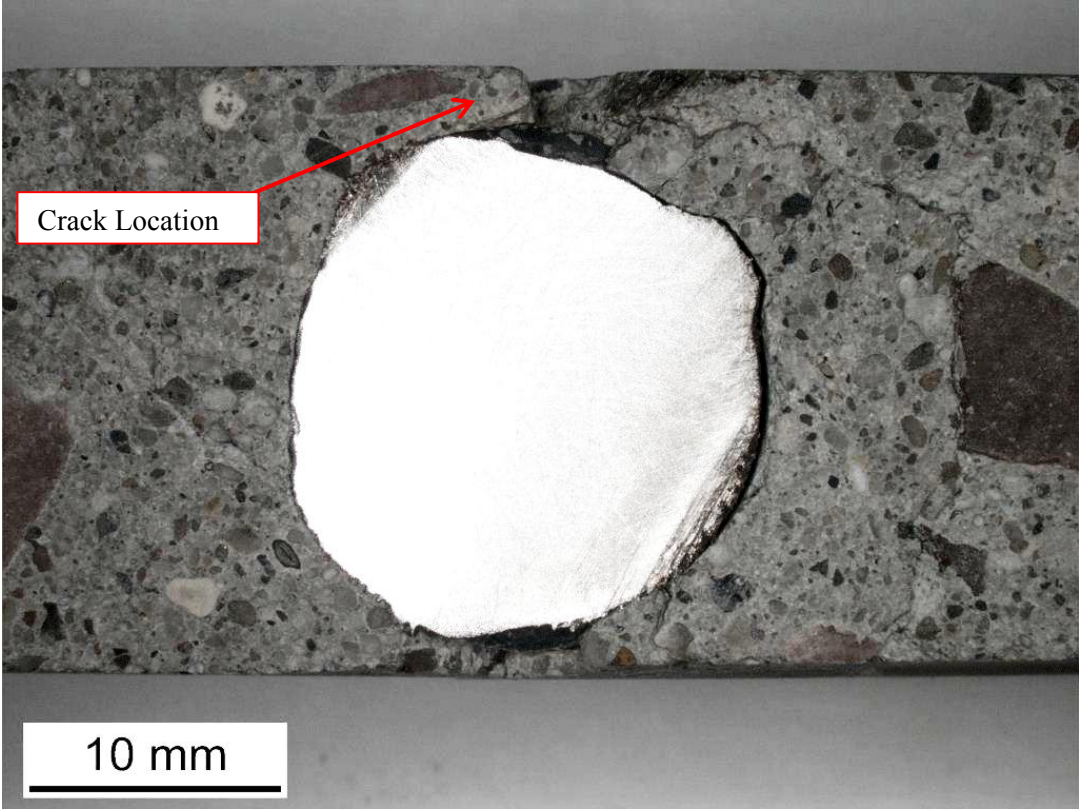
SEM, a thin oxidized layer (30-50 μm) was detected, consistent with that which was observed in core MRM 87-3. A backscattered electron image of a portion of the reinforcement is shown in Figure 6-16. There did not appear to be corrosion, even though there was local delamination evident along the reinforcement which could potentially allow the intrusion of chlorides.

Figure 6-15: Main crack intersecting reinforcement

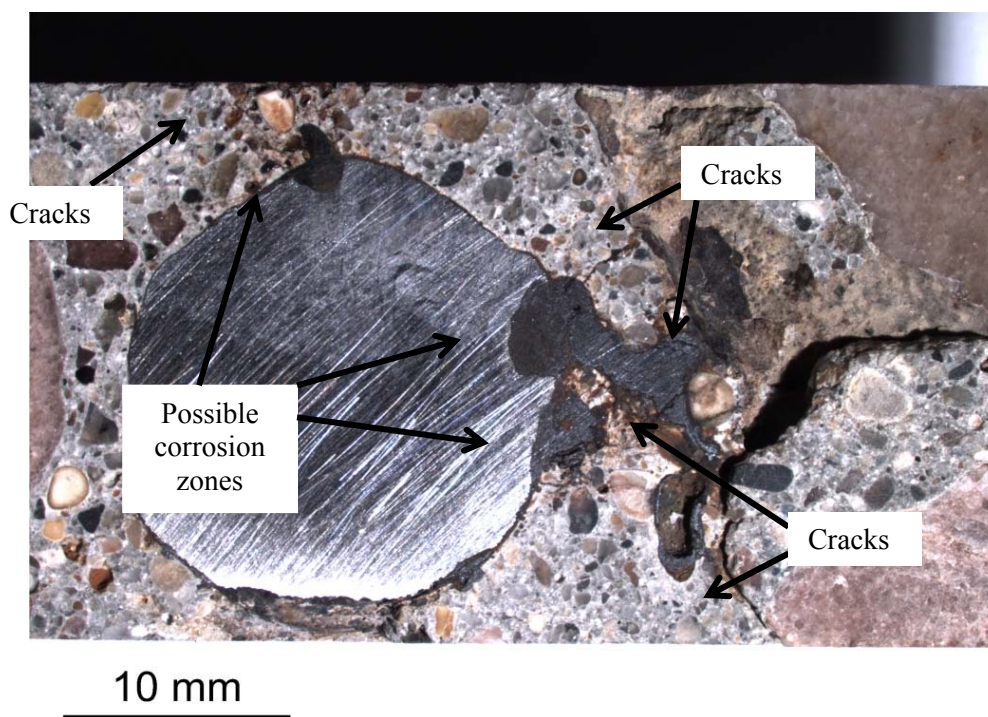
The steel reinforcement of one of the concrete core samples from site MRM 411 was analyzed using SEM. The core selected was MRM 411-1. The concrete cover placed above the reinforcement was 3.5 inches, and a crack of width 0.012 inches was observed on the core. Figure 6-19 shows a core slice through the steel bar. It was observed that the steel bar intercepted several concrete cracks. Corrosion was detected at three locations around the bar perimeter. The corroded spots coincided with the locations of the cracks. The loss of cross-sectional area of the polished section of reinforcement due to corrosion was determined to be approximately 0.026in², or 6.0%.

Figure 6-19: Corrosion at crack locations

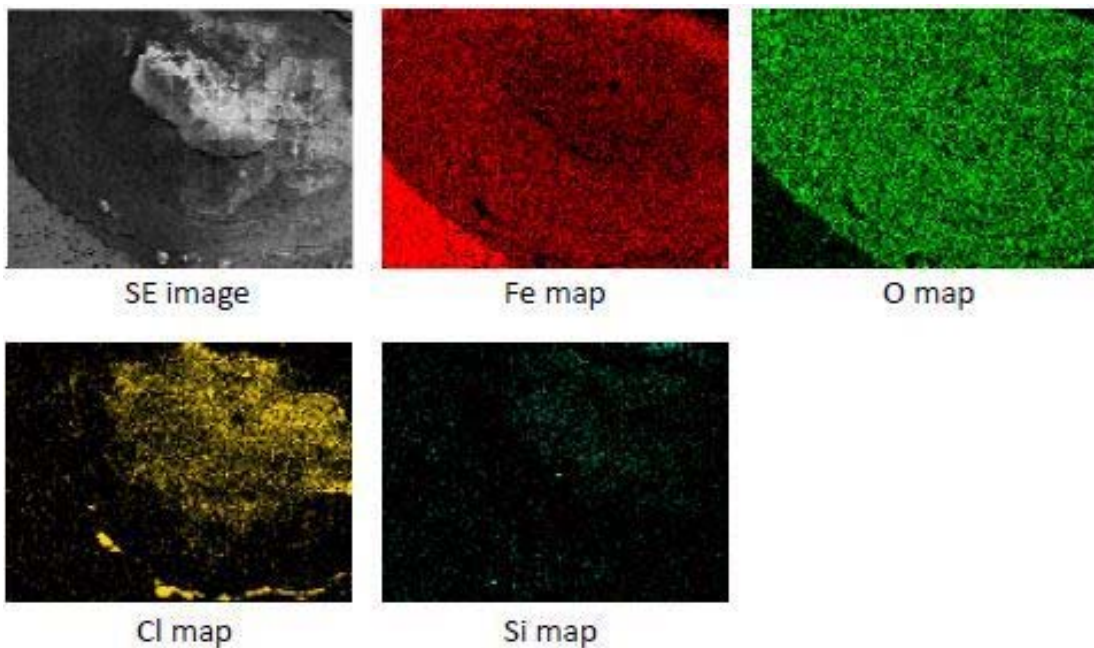
Figure 6-21: Elemental maps of corroded area (scanning electron microscope image, iron map, oxygen map, chlorine map, and silicon map)

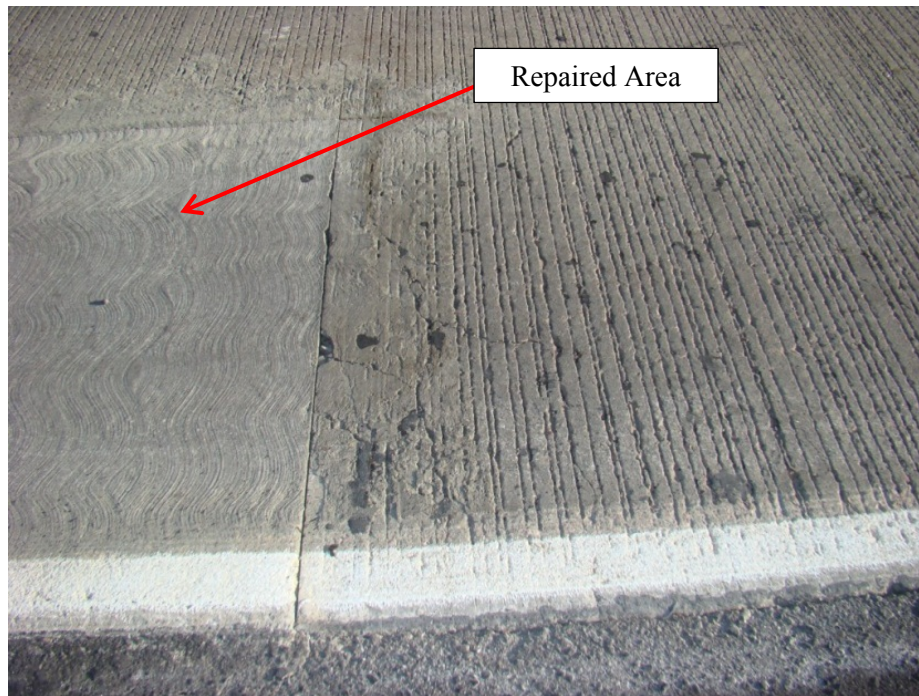
showed several signs of distress, including longitudinal cracking, transverse cracking, and spalling. Figure 6-26 shows transverse cracking and spalling close to a newly repaired section of CRCP. Figure 6-27 shows a wide longitudinal crack next to the longitudinal joint in the pavement.

Figure 6-26: Spalling and transverse cracking close to a repaired section

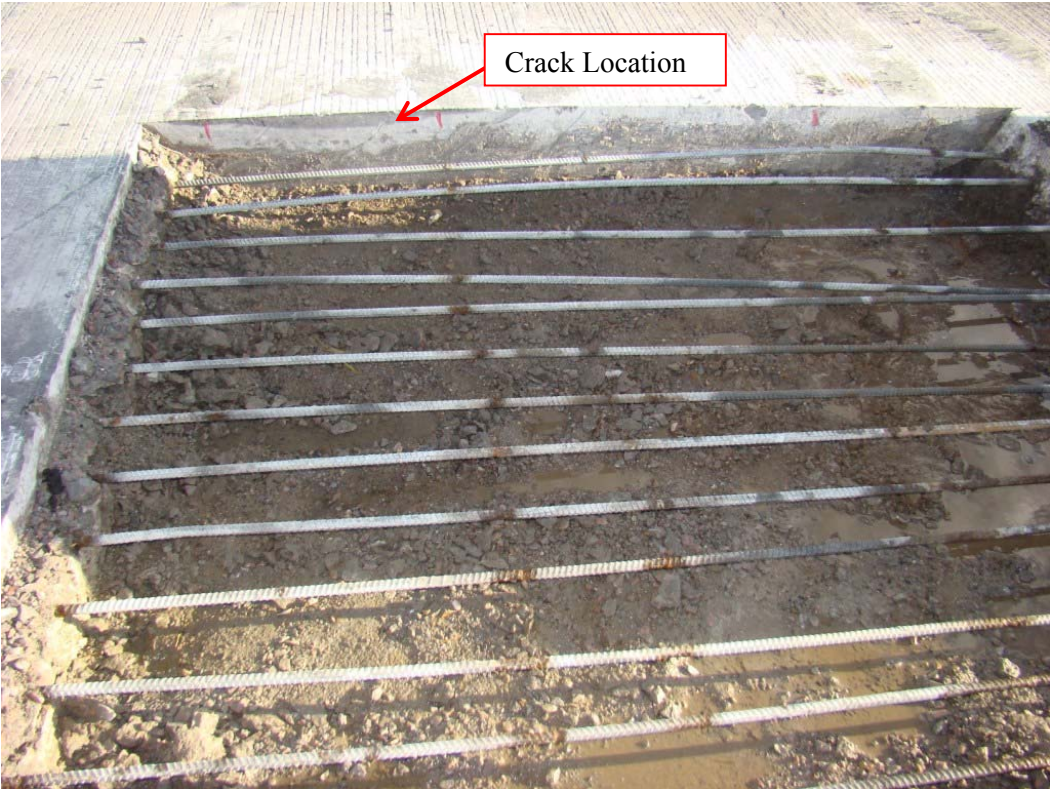
Figure 6-29: Corrosion at transverse crack location

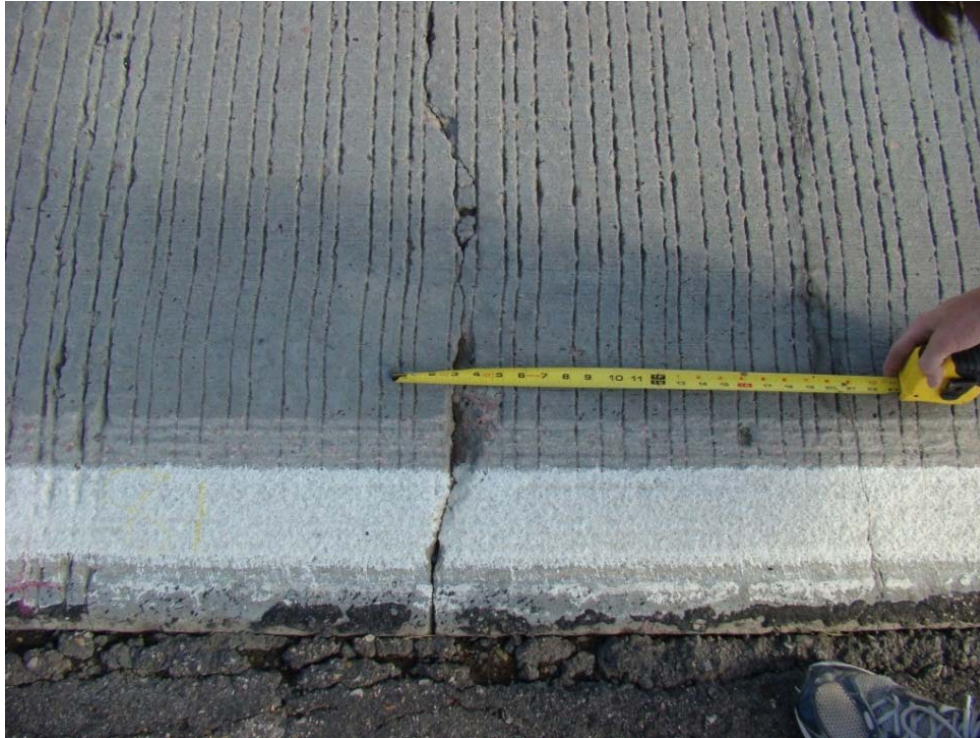
Evaluation of site MRM 222 occurred on July 27th, 2011. The crack density of the surveyed section was 0.334 foot/square foot. Transverse and Y-cracking was observed. The transverse cracks were spaced approximately every two to four feet. Several cracks were wide and exhibited spalling (Figure 6-37). No longitudinal cracking was identified within the 100 foot section. The depth to the reinforcement was measured as 5 inches with a hand-held tape measure.

Figure 6-37: Wide crack exhibiting spalling at MRM 222

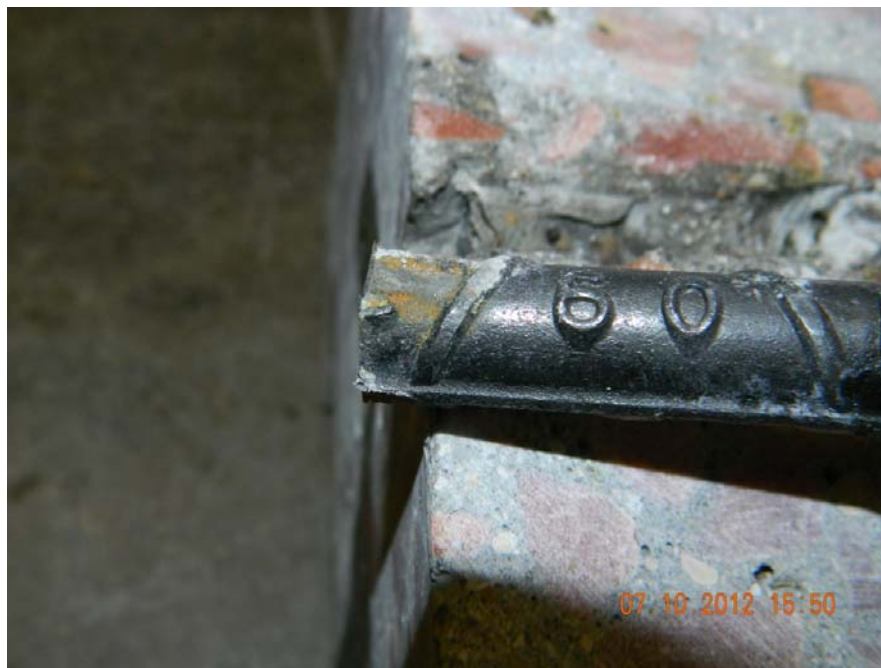
Figure 6-87: Close-up of corrosion of dry, cracked control specimen
