SD2004-02-F

Corrosion Monitoring of Hot Springs VSL Mechanically Stabilized Earth Wall

**Study SD2004-02
Final Report**

November 2005

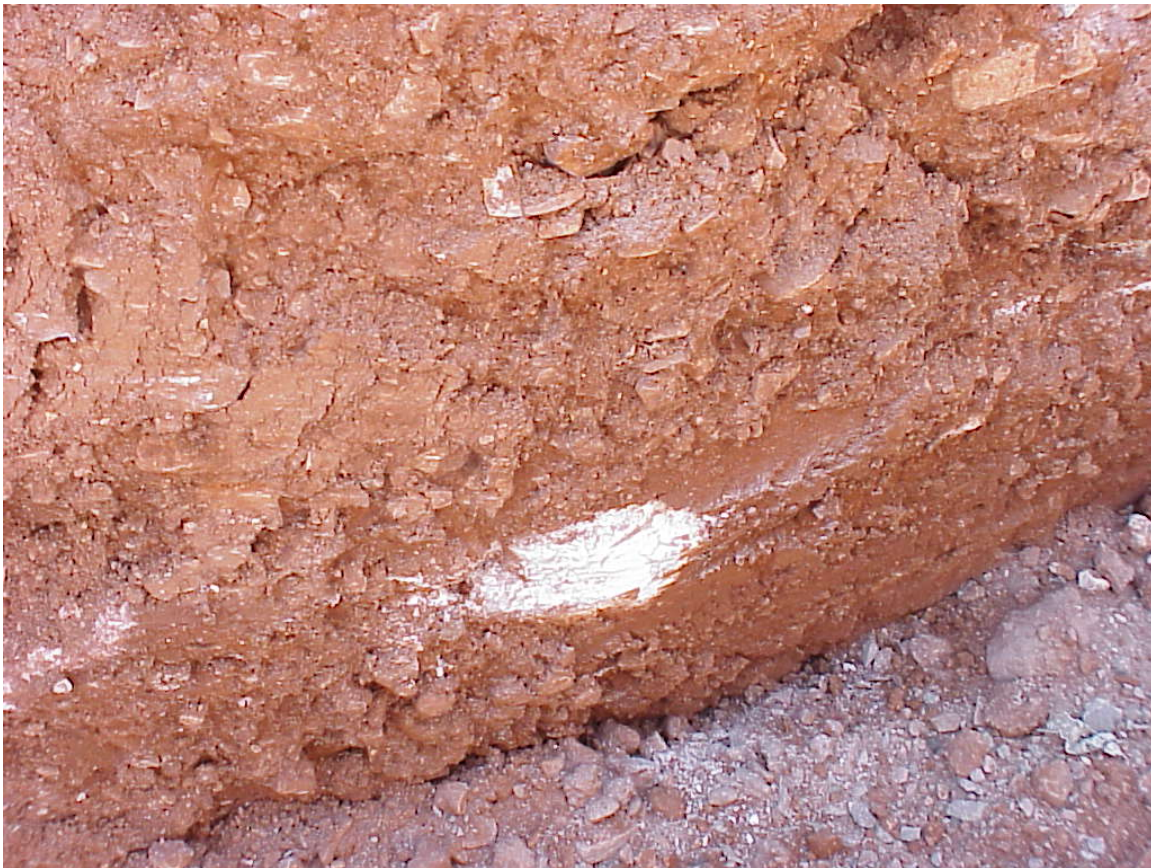
Although the granular backfill met specification requirements, the source of the material raised concerns as the pit lies in the Spearfish formation, a red shale noted for the presence of frequent gypsum lenses and notorious for sinkholes. Since the formula for gypsum is CaSO₄·2H₂O it was feared that the backfill might contain a significant amount of sulfate which could become soluble and contribute to corrosion under the wrong conditions. Figure 1 below provides an illustration of this potential corrosion issue with a prominent gypsum lens visible in the bottom center.

Figure 1 Excavated granular backfill at station 25+44, WBL. Note large gypsum lens.

The occurrence of such large pieces of gypsum throughout the granular backfill is somewhat ironic considering that the gradation requirements for the backfill called for 100% of the material passing a 6” sieve and no more than 25% retained on a 3” sieve. Acceptance samples tested over the course of construction all had 100% of the material passing the 4” sieve so the presence of oversize material was never indicated during construction.

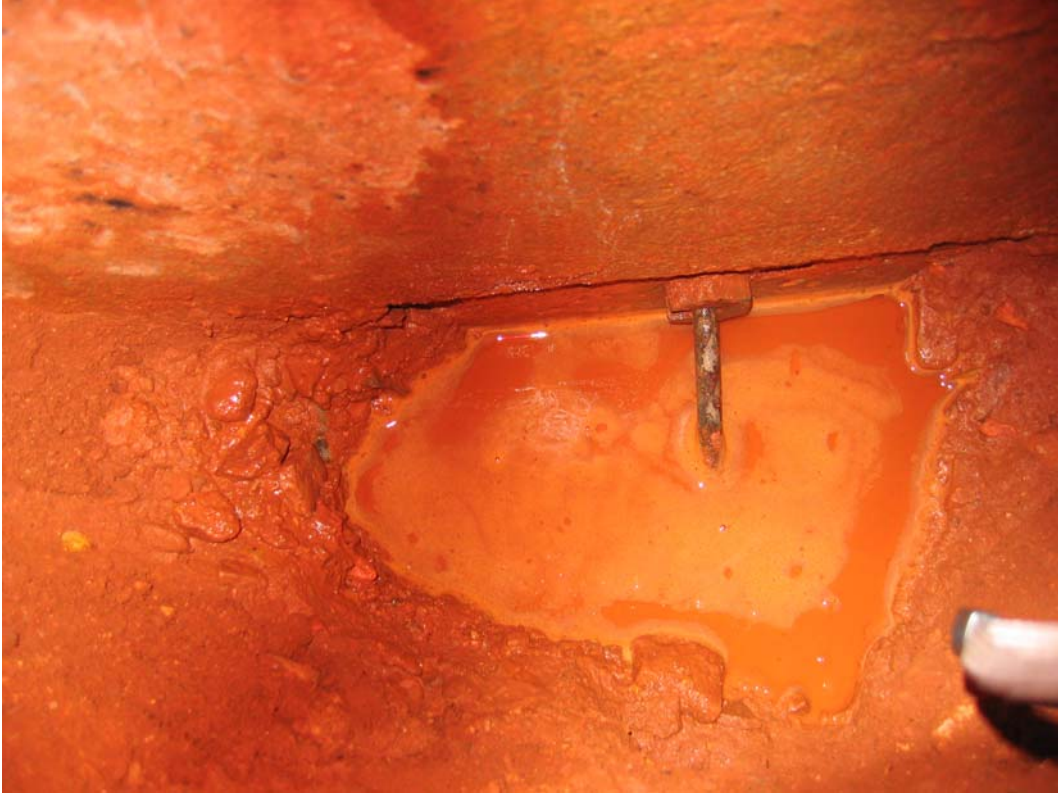
On May 3, 2004 Mr. Barrows and personnel from the SDDOT Office of Research, Geotechnical Section and Custer Area Office conducted a site inspection of the VSL wall at Hot Springs. The goal of the trip was to develop a testing plan for monitoring the reinforcement mesh corrosion using a linear polarization resistance approach. At that time a decision was made to coordinate coring locations for corrosion probe and instrumentation installation with the existing stationing for excavation and evaluation of mesh as per the project plans. An attempt was made to get some idea of the current mesh condition by climbing up on the east and west abutments of the Garden Street bridge to expose reinforcing mesh and determine the current condition. Surprisingly, every sample of mesh exposed on top of the wall at the abutments on both sides of the bridge were in excellent condition with no evident steel section loss though the galvanizing appeared to have interacted with the red shale material in an unusual manner to form a crust on the steel. Figure 3 shows a mesh connector on the east abutment which appears to be in excellent condition.

Figure 3 Mesh connector at east abutment of bridge

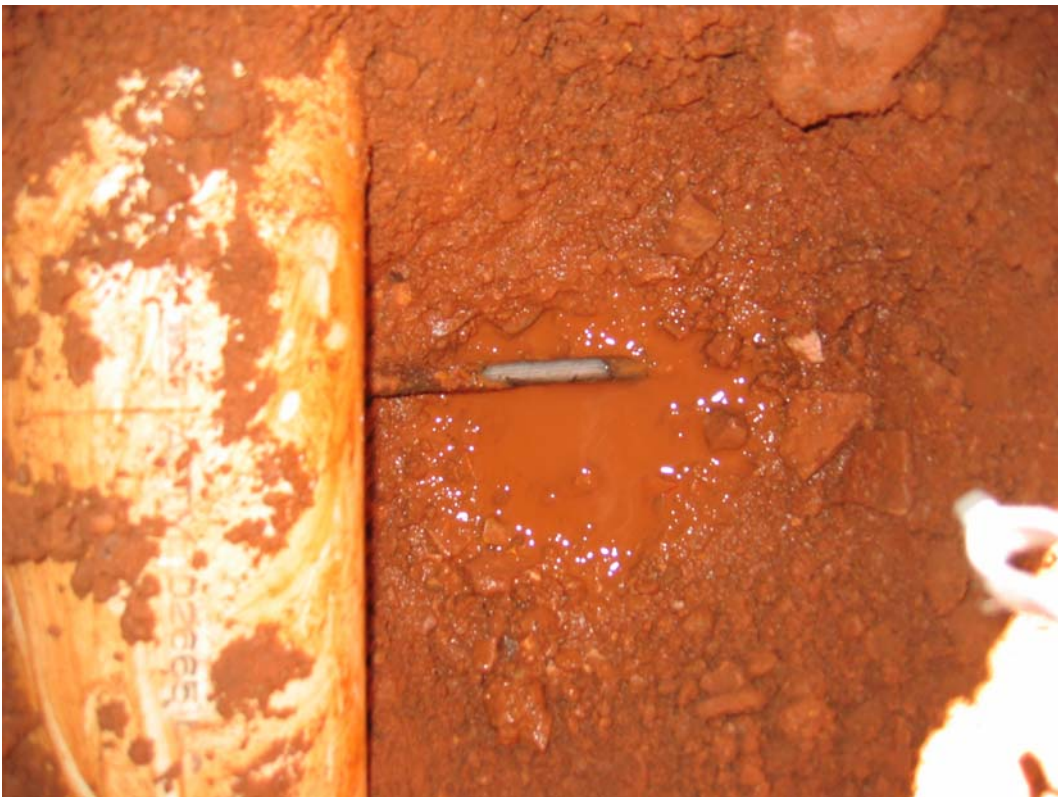
Mesh steel was also exposed at the south end of the west bridge abutment as this represented an area where deicer runoff was draining into the backfill material at the top of the abutment. Figure 4 illustrates its condition and, again, there was little evidence of corrosion problems beyond the expected loss of galvanizing even though this site represented worst conditions. Based on these tentatively positive results, a decision was made to defer further planning for corrosion monitoring equipment installation until after excavation of the backfill had given a clearer picture of the need for such an extended effort. This dovetailed nicely with the fact that the equipment to conduct the monitoring would not be available for some time.

Figure 4 Mesh at southwest corner of west abutment

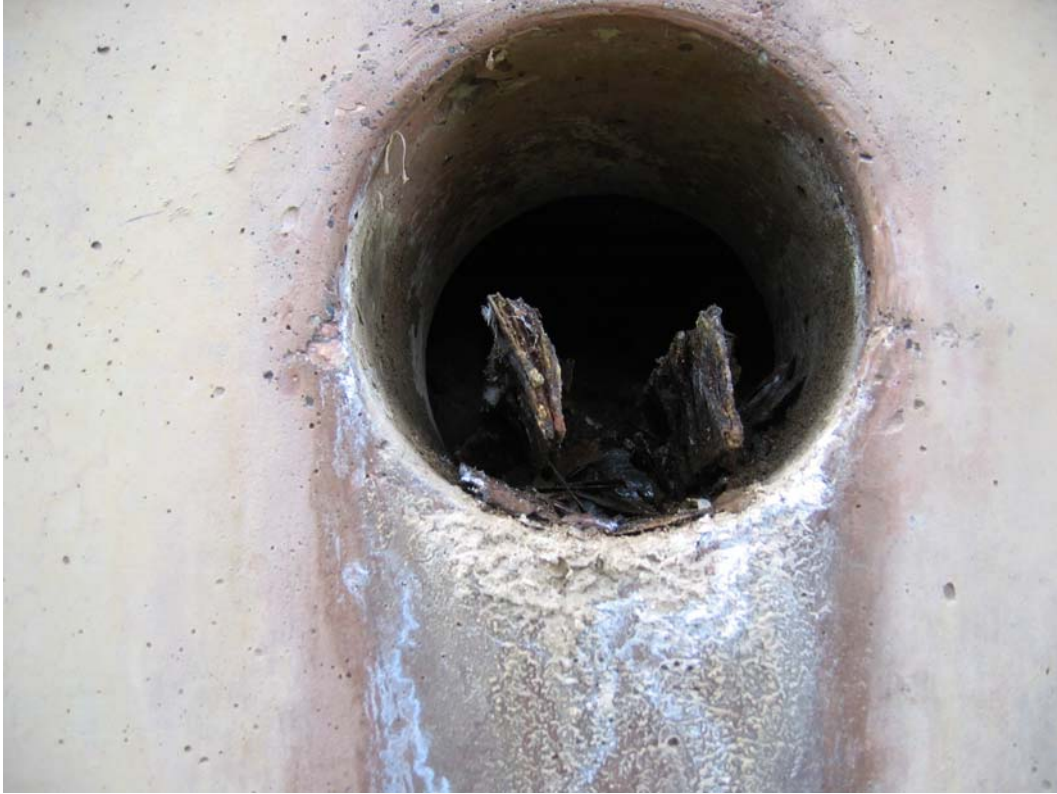
Figure 5 Severe corrosion of steel reinforcement straps in test location on Deadwood wall

As part of the initial effort to set up a corrosion monitoring program on the Hot Springs wall, the same group visited the wall at Deadwood to inspect the remaining test straps and compare their condition with the mesh reinforcement exposed at Hot Springs. The severe corrosion evident in the black steel straps (Figure 5), due to an acidic sulfate environment, confirmed the wisdom of using the epoxy coating. Steel loss was so advanced in these test specimens that the straps could not be pulled out from the wall interior as every attempt resulted in the steel breaking off under the stress. The galvanized steel samples (Figure 6), on the other hand, looked relatively good with no apparent steel section loss. Unfortunately, the galvanizing protection appeared to be mostly exhausted with surface rusting occurring in addition to the formation of zinc reaction products. There is a strong likelihood that these specimens will resemble the black steel samples in a decade or less. The epoxy steel straps were in excellent condition (Figure 7) with no evidence of active steel corrosion occurring. The rust colored material coating the straps in the picture is merely backfill that has undergone extensive degradation.

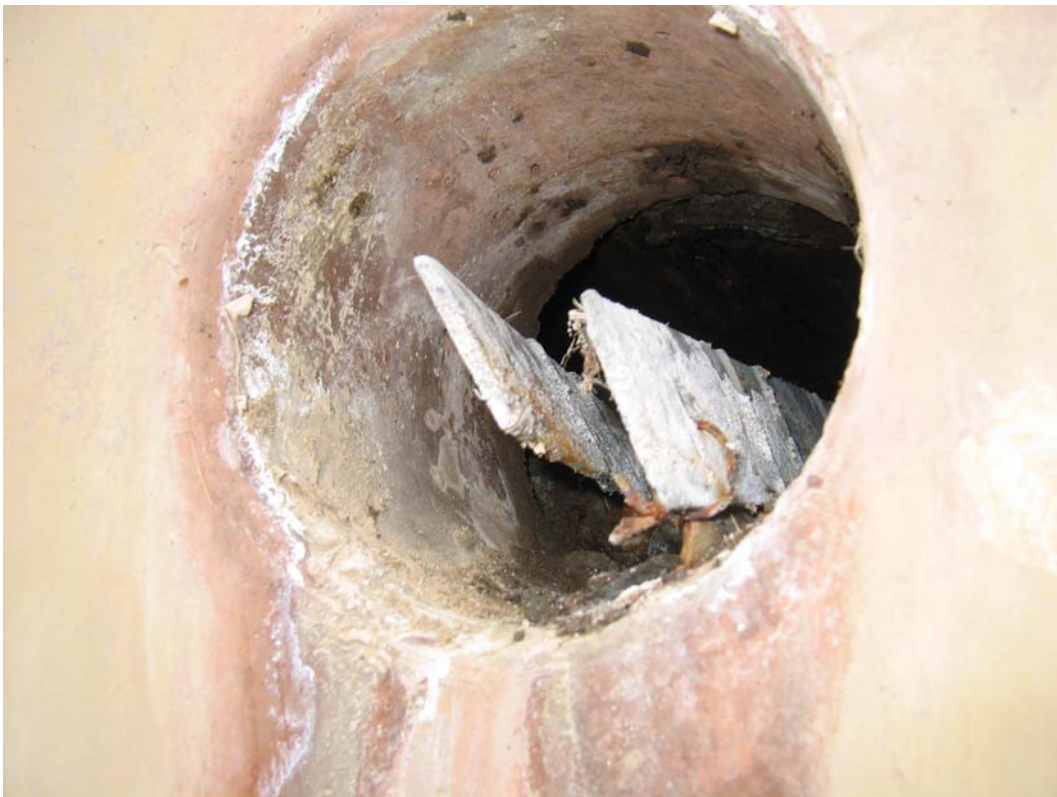
Figure 6 Galvanized reinforcement straps showing zinc reaction product

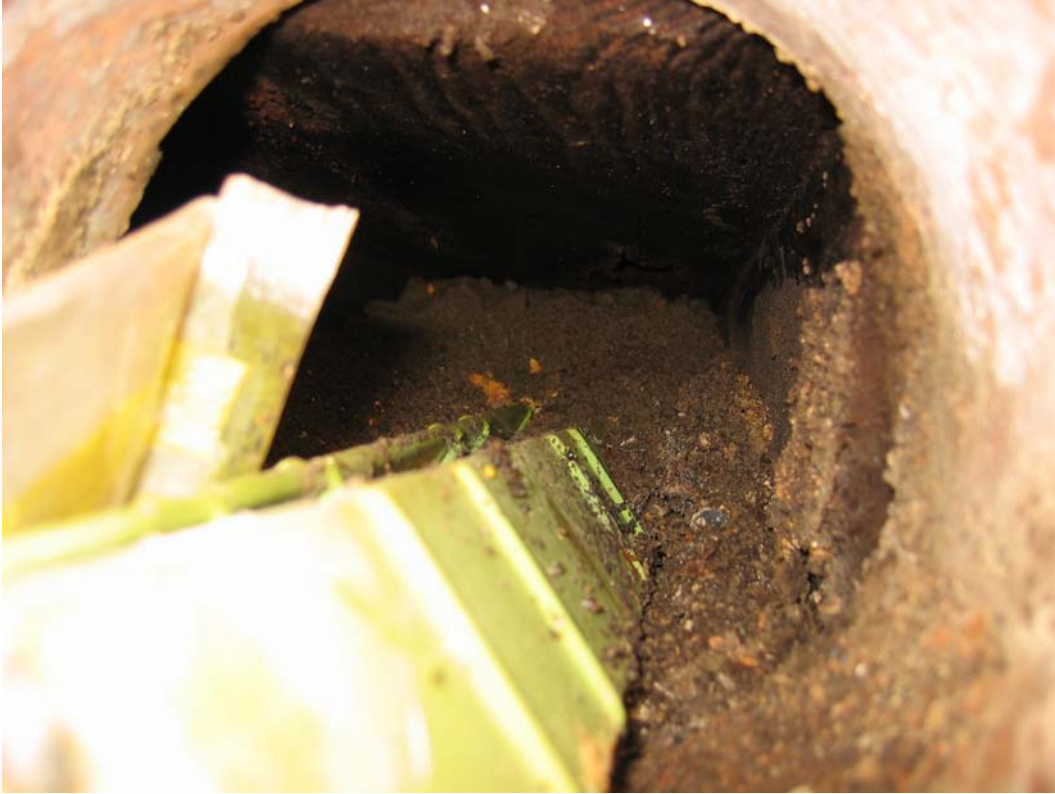
Figure 7 Epoxy-coated reinforcement straps at Deadwood wall

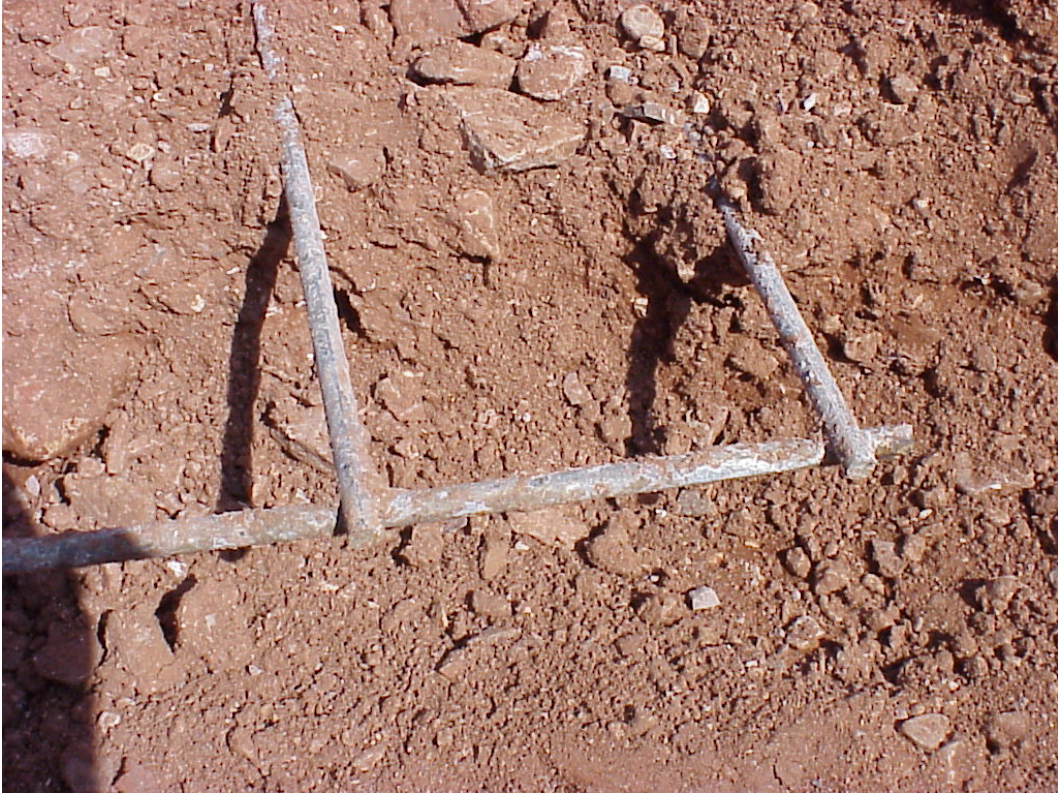
Figure 8 Reinforcement mesh at station 25+89 WB lane

In August of 2004, construction had proceeded to the point where excavation had exposed reinforcing mesh in the westbound lane of the structure. The first mesh examined, at station 25+89, was in excellent condition with no indication of steel loss or rust formation, as revealed in Figure 8. Figure 9 shows the mesh at station 25+44 in the same lane. Virtually every location where mesh was exposed exhibited the same reassuring lack of steel corrosion, including those areas where chloride levels in the gravel cushion above the backfill had been elevated. There was no evidence of any electrochemical activity beyond the strange interaction between the galvanizing and the red shale. Figure 10 is a close-up of the mesh at station 25+44 in the eastbound lane. Note the marked visual difference between this mesh and the galvanized strap in Figure 6 which shows typical galvanic protection with an abundance of white reaction products from the decomposition of the zinc. The only problem encountered in the process of evaluating mesh condition was the evidence of severe deformation of the mesh in several locations as shown in Figure 11. This was undoubtedly due to the settlement of the wall which occurred after the falsework was removed during construction.

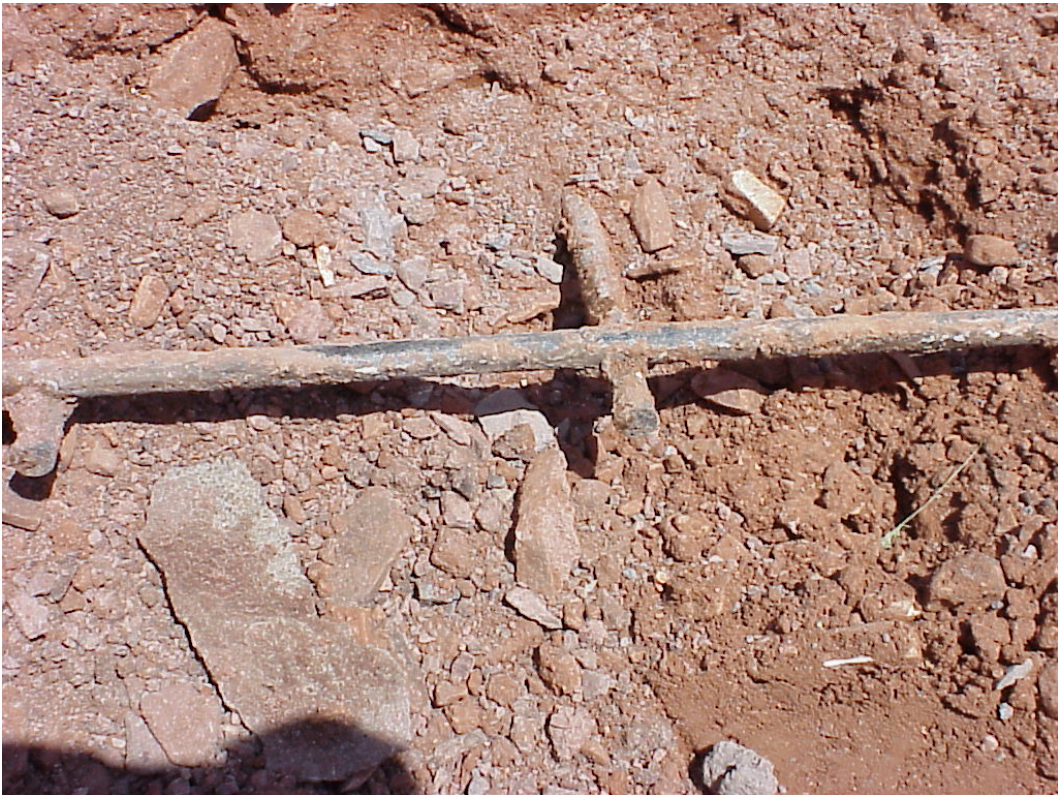
Figure 9 Reinforcement mesh at station 25+44 WB lane

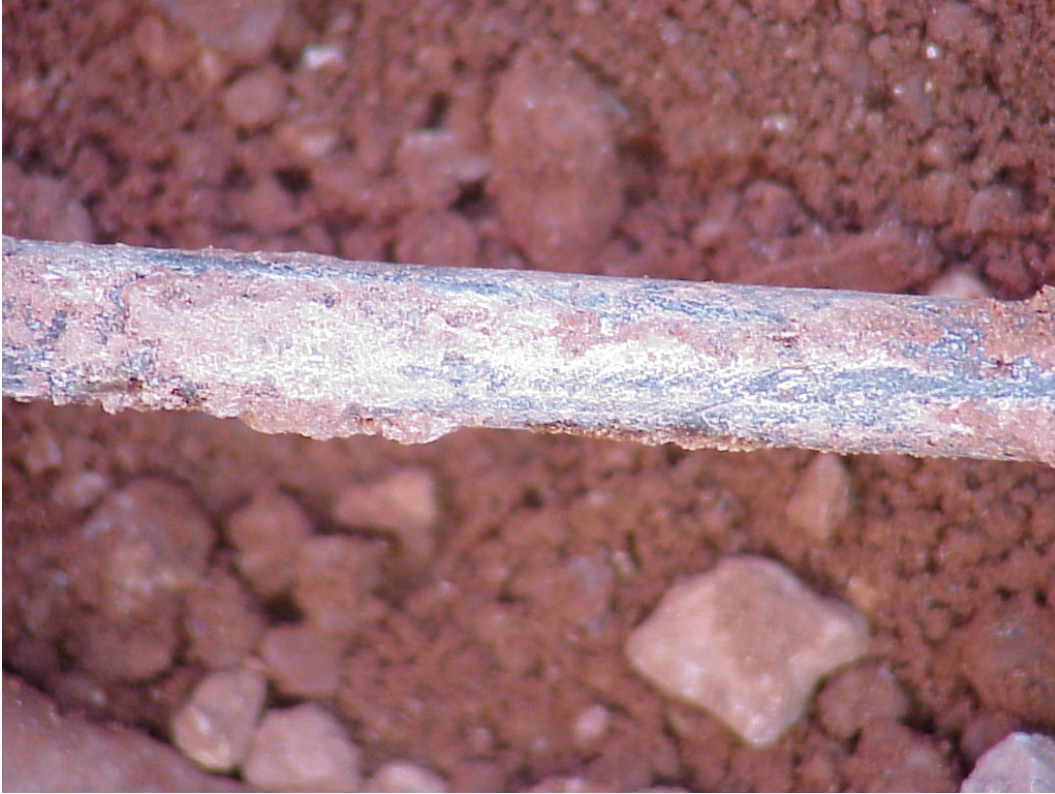
Figure 10 Closeup of reinforcement mesh showing coating of shale/galvanizing

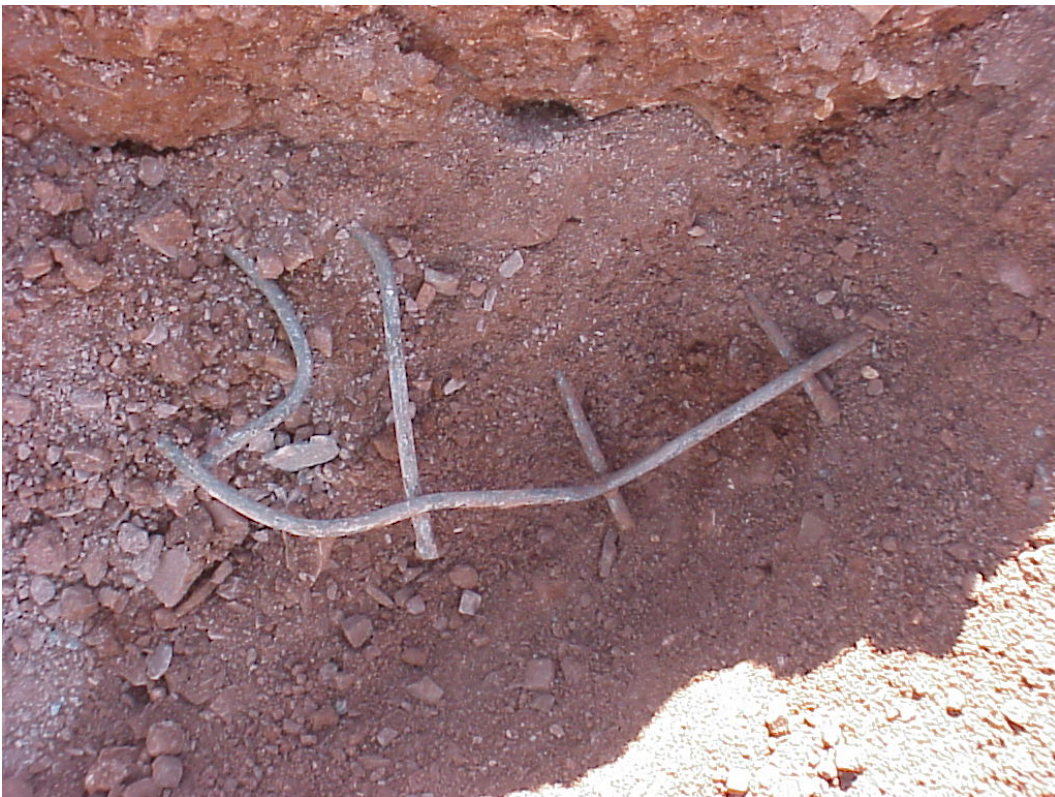
Figure 11 Mesh at station 25+89 EB lane showing severe deformation

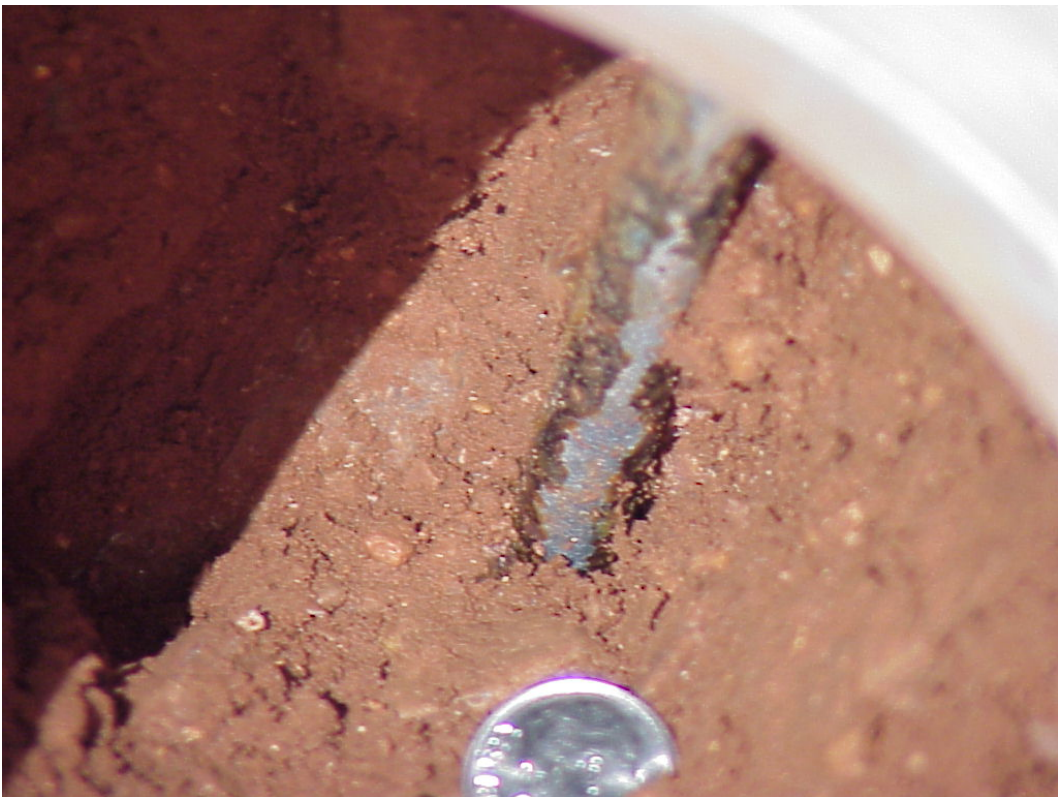
Six inch cores were cut from the wall (Figure 12) at accessible locations corresponding to the areas where mesh had been exposed above. The primary purpose of the cores was to inspect the condition of the mesh in the critical zone where it connected to the concrete panels and to determine how badly the poor consolidation and settlement had affected its integrity. The inspection of the first layer of reinforcement mesh indicated that there was little need to instrument the wall and monitor corrosion. In every case where a core was drilled, the area behind the concrete was generally part of a network of voids with relatively large chunks of granular backfill (many in excess of 6") providing the framework for the voids. The mesh was also uniformly bent downward, in many cases at angles approaching 45°. No evidence of any significant corrosion was forthcoming at any of the six core locations as illustrated in Figure 13. The beginning of a typical bend in the mesh just off the wall face is shown in Figure 14.

Figure 13 Mesh reinforcement in core hole at station 23+87 left

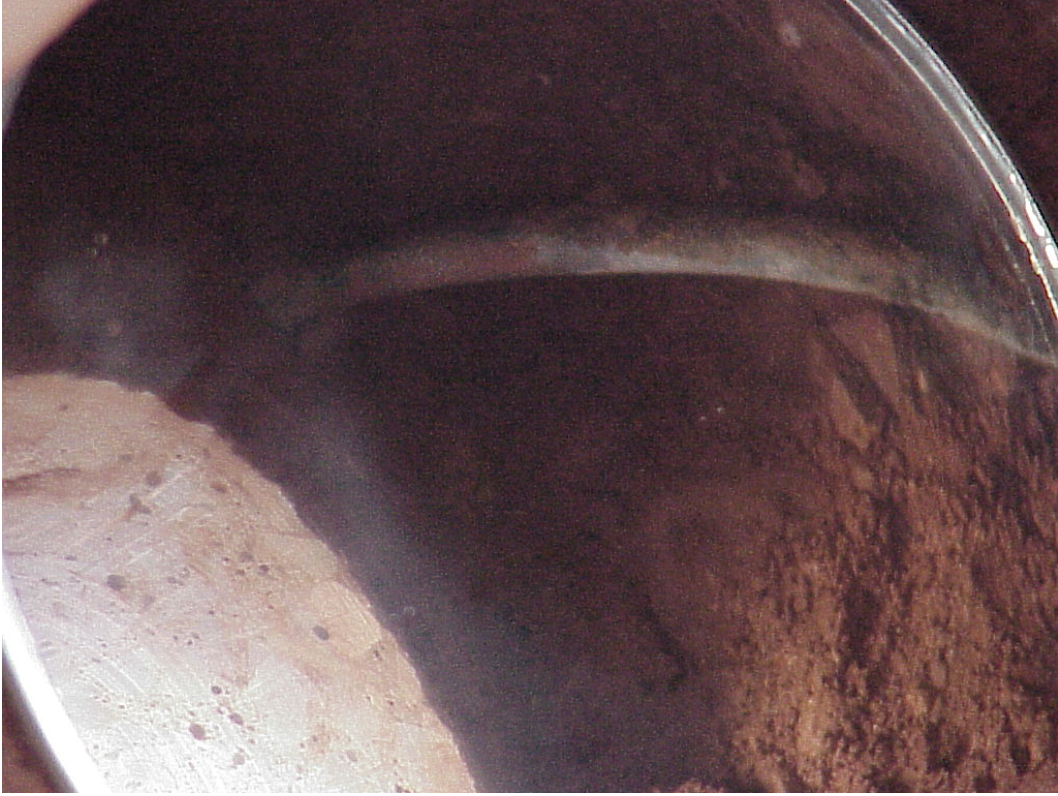
Figure 14 Beginning of bend in mesh at interior wall face station 23+87 left

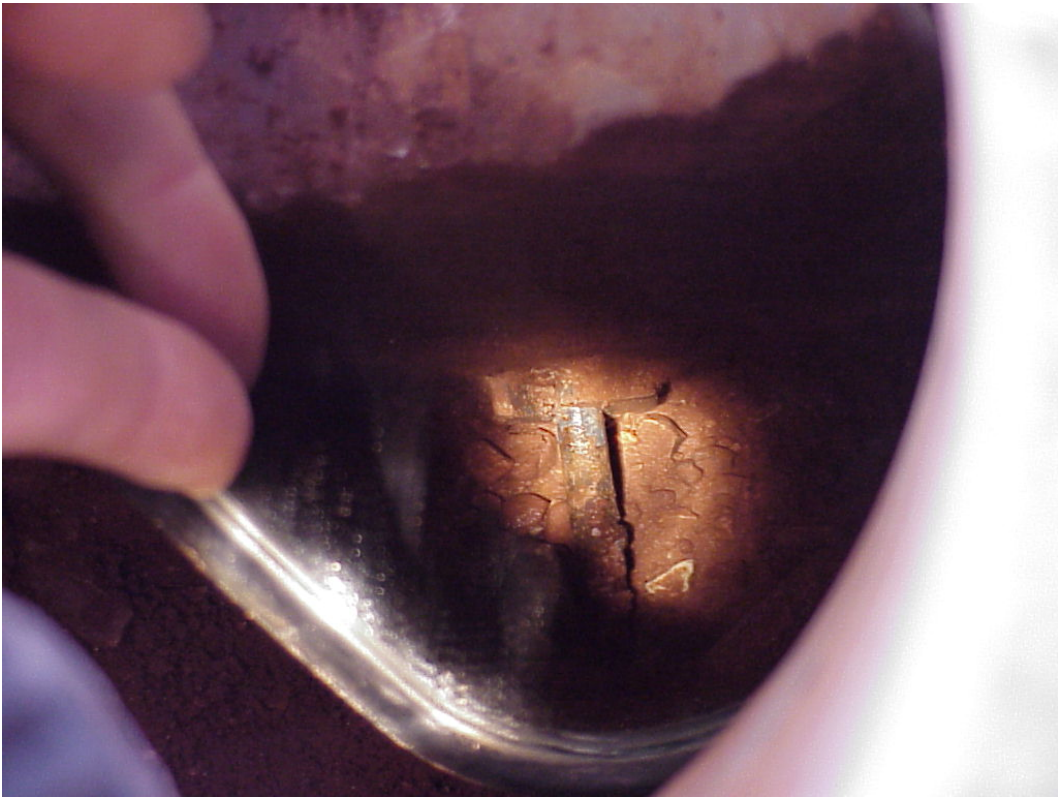
Figure 15 Panel connector near base of wall station 25+89 right

Another concern was the condition of the connectors between the concrete panels and the mesh. The position of the core holes was adjusted to cut through the panels either just above or just below the nominal position of a connector at each panel drilled with the terrain determining which approach was most feasible. After coring, every effort was made to excavate sufficient backfill material to expose and photograph the connectors if lighting permitted. Mirrors were used to illuminate the hole interiors with sunlight and an additional mirror used where possible. Every connector was found to be in pristine condition which was not a real surprise considering there was insufficient electrolyte (soil) adjacent to them to support corrosion. Retention of water in the same area was problematical considering the backfill along the wall face was obviously free draining. Fortunately, the point where the steel had yielded and bent when the wall settled was in the same environment so that stress corrosion at these bends is not an issue. A typical connector inside the lower wall is shown in Figure 15.

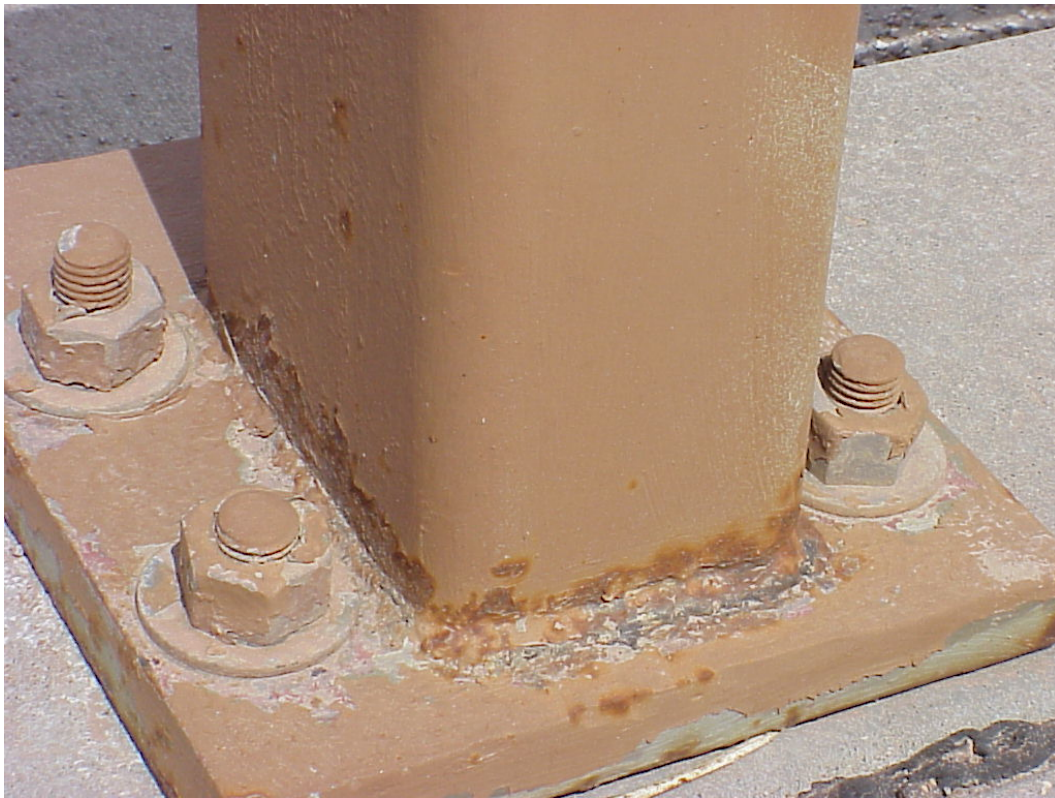
Figure 16 Steel railing post showing severe corrosion around base
