# **SD2005-11: Evaluation of Crack-Free Bridge Decks**

## **FINAL REPORT**

June 2011

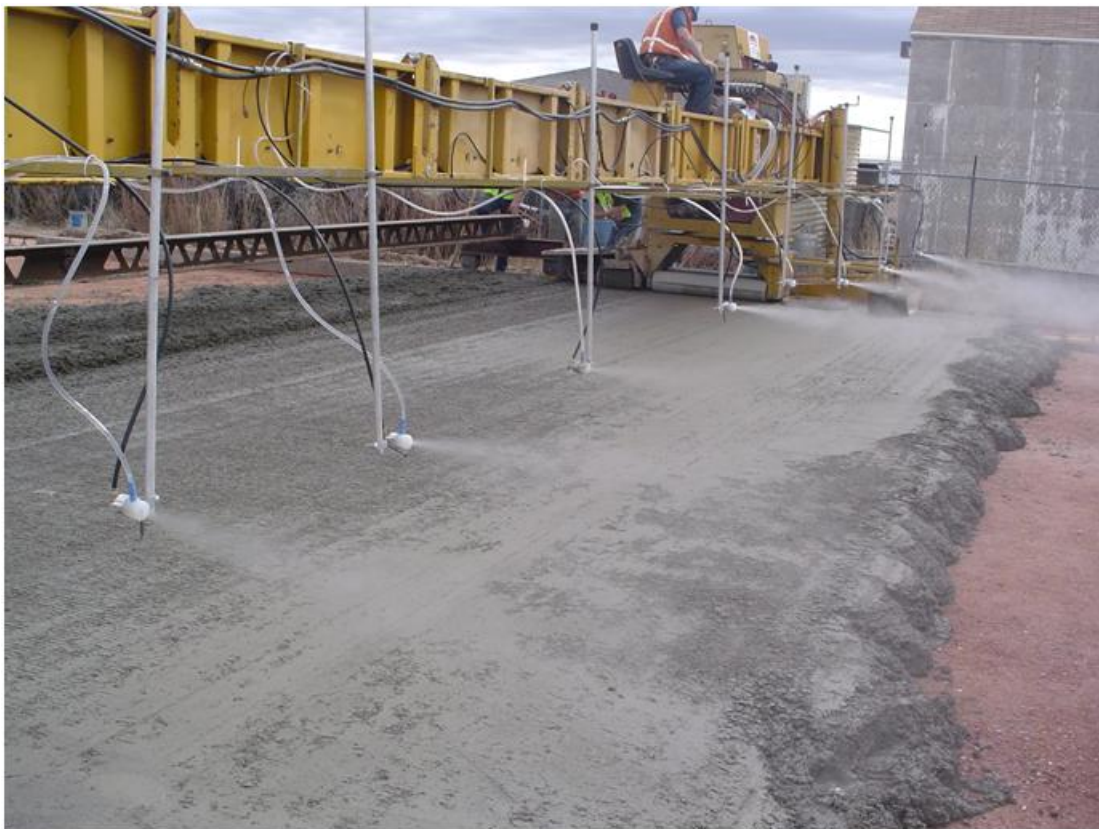
**Fig. 8.4** Excessive Fogging Caused Puddles of Water over Wet Concrete

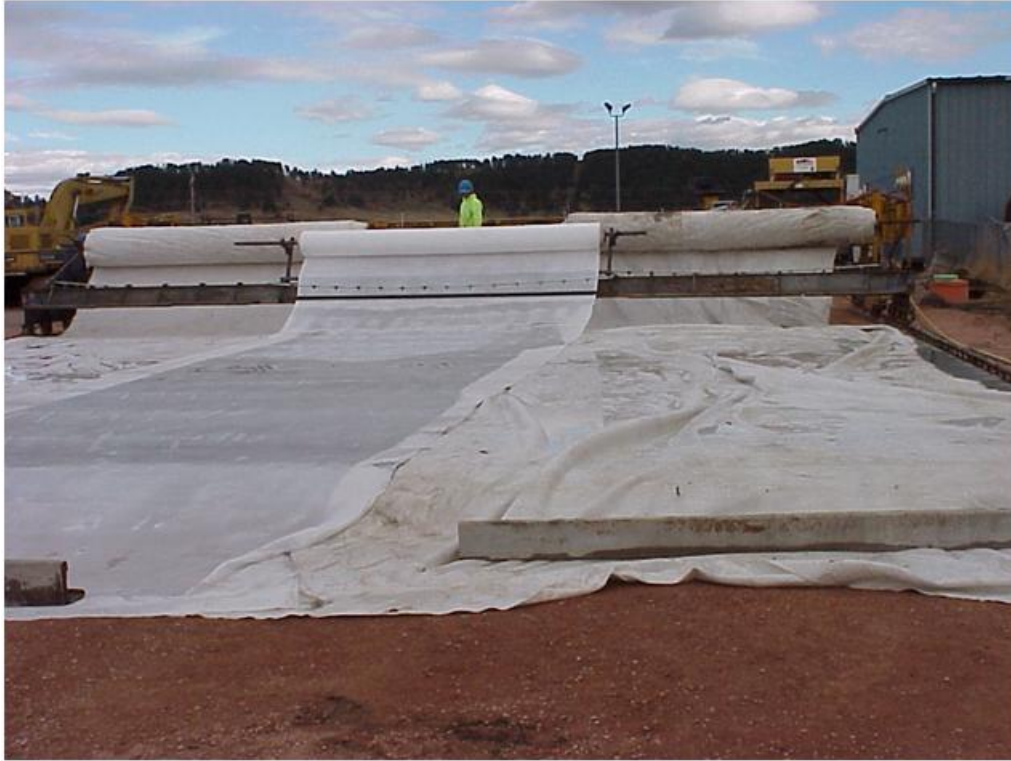
**Fig. 8.5** Water Soaked Curing Blankets in Place

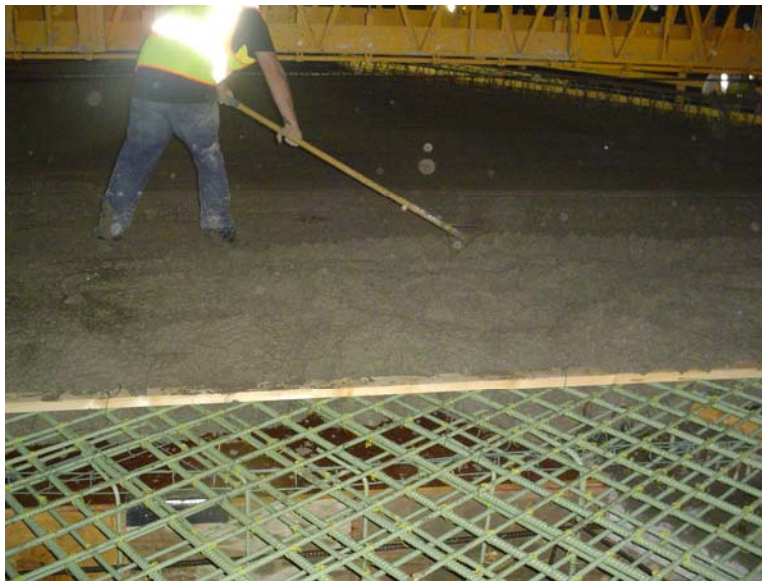
As a result of those deficiencies, the SDDOT engineer requested that the concrete placement be stopped and be resumed at a later date when the deficiencies were addressed and corrected. The pour was terminated at the face of the first diaphragm location. This location corresponded to approximately 50' of deck length. The finished segment of the deck was then covered with a wet curing blanket. The cold joint is shown in Figure 8.19.

**Fig. 8.19** Cold Joint in the A45 Concrete Deck in Brule County

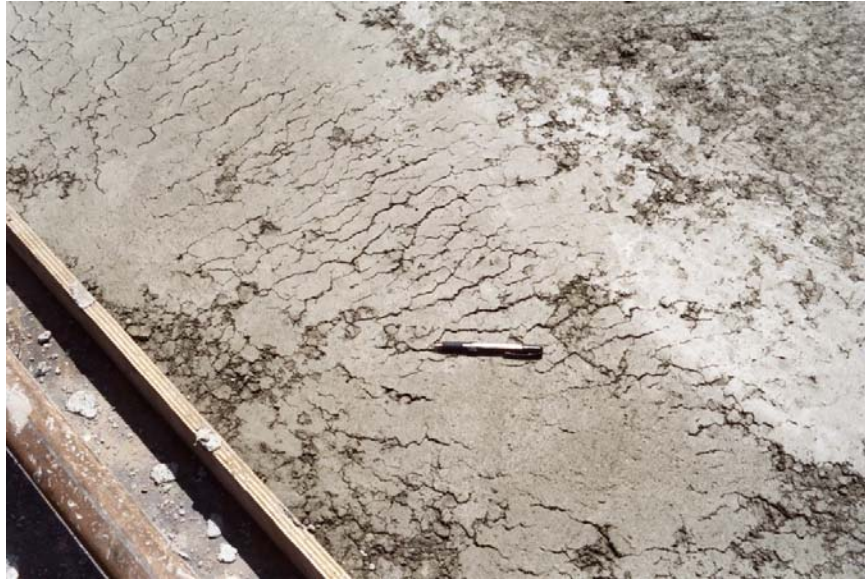
finish surface had many areas of exposed aggregates, either due to lack of paste, improper drum speed, or excessively dry mix. The finish obtained on the test slab can be seen in Figure 8.22.

**Fig. 8.22** Test Slab I Finished Surface

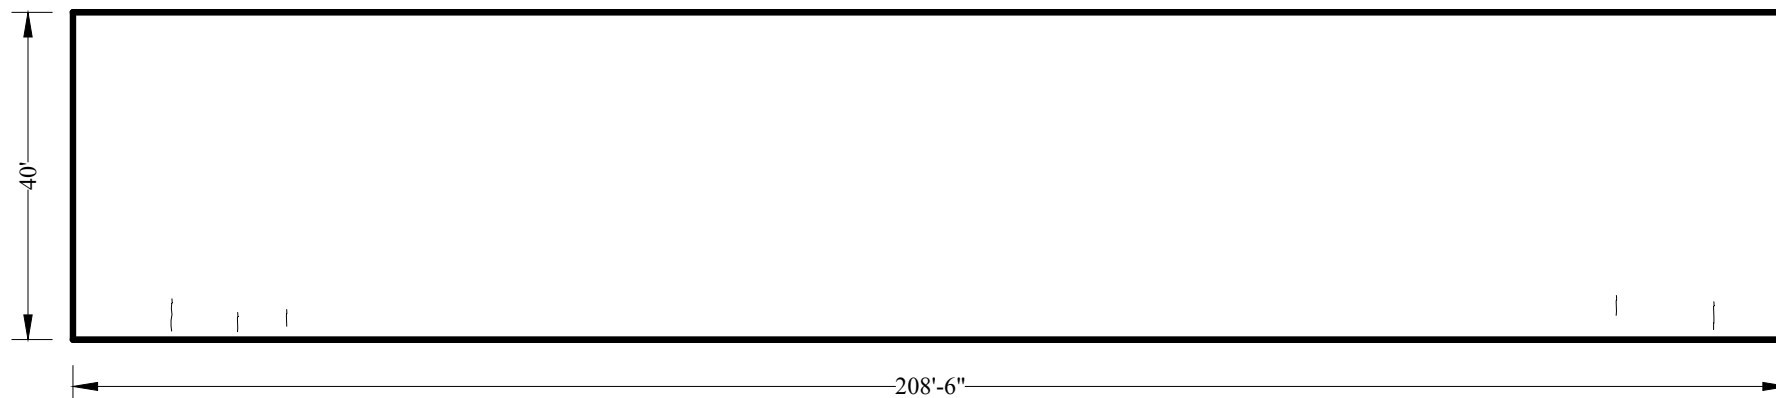
**Fig. 9.7** Crack Map CS1 (A45)

Crack Survey # CS1: A45 Concrete Deck  
(Prior to Opening to Traffic)

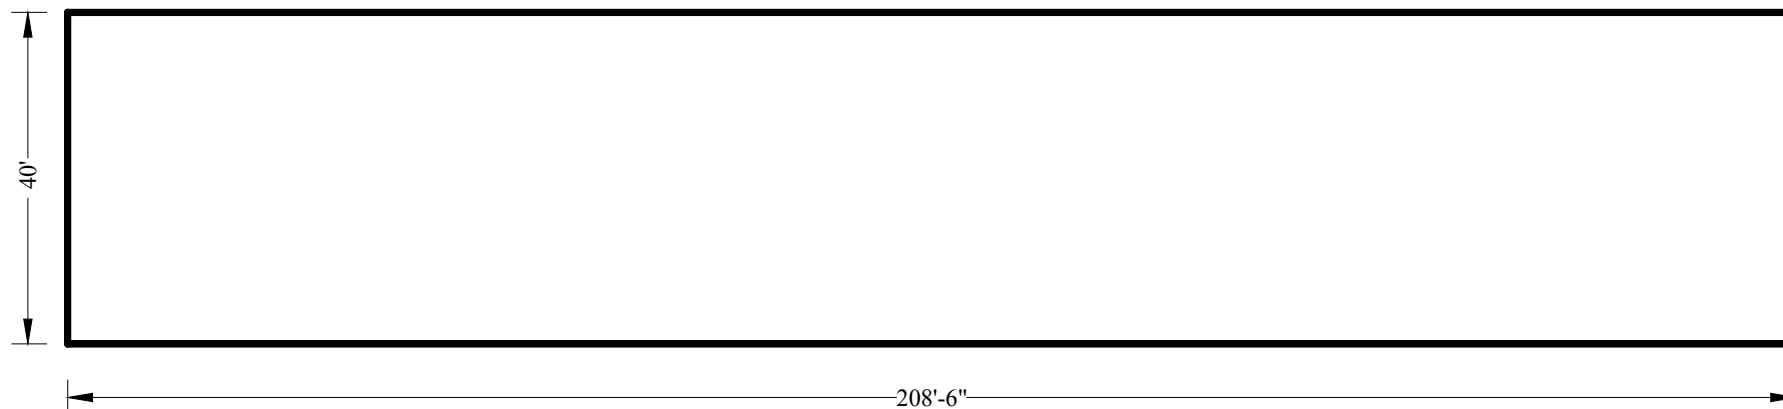
Crack Survey # CS2: LC-HPC Concrete Deck  
(Prior to Opening to Traffic)

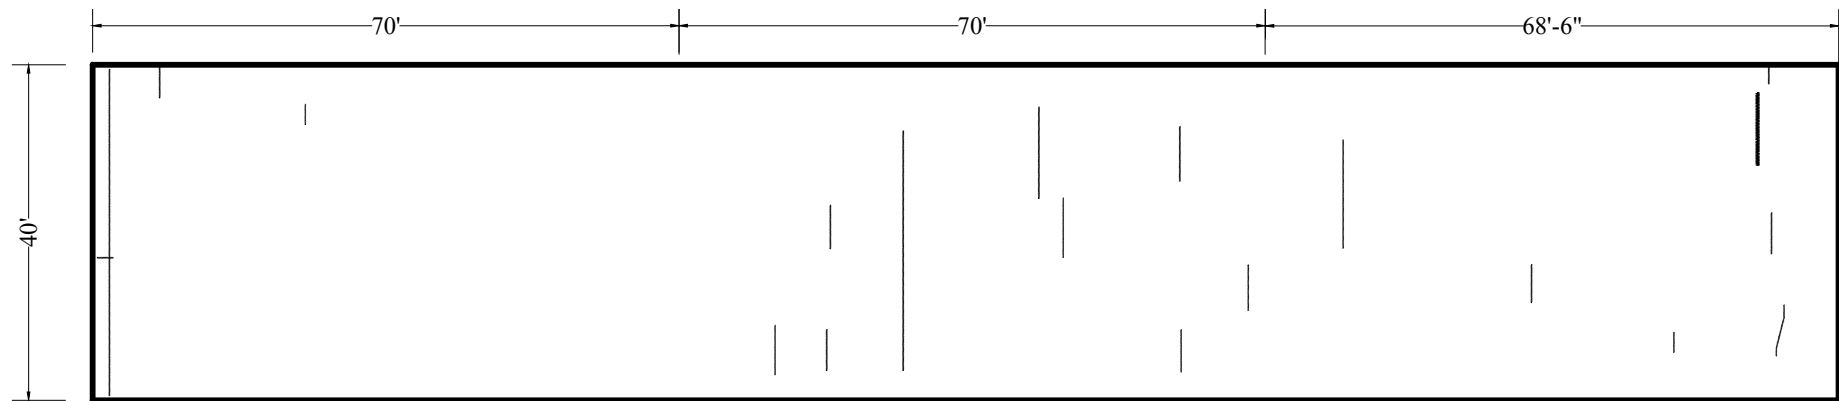
Crack Survey # CS22: LC-HPC Concrete Deck  
(Prior to Opening to Traffic)

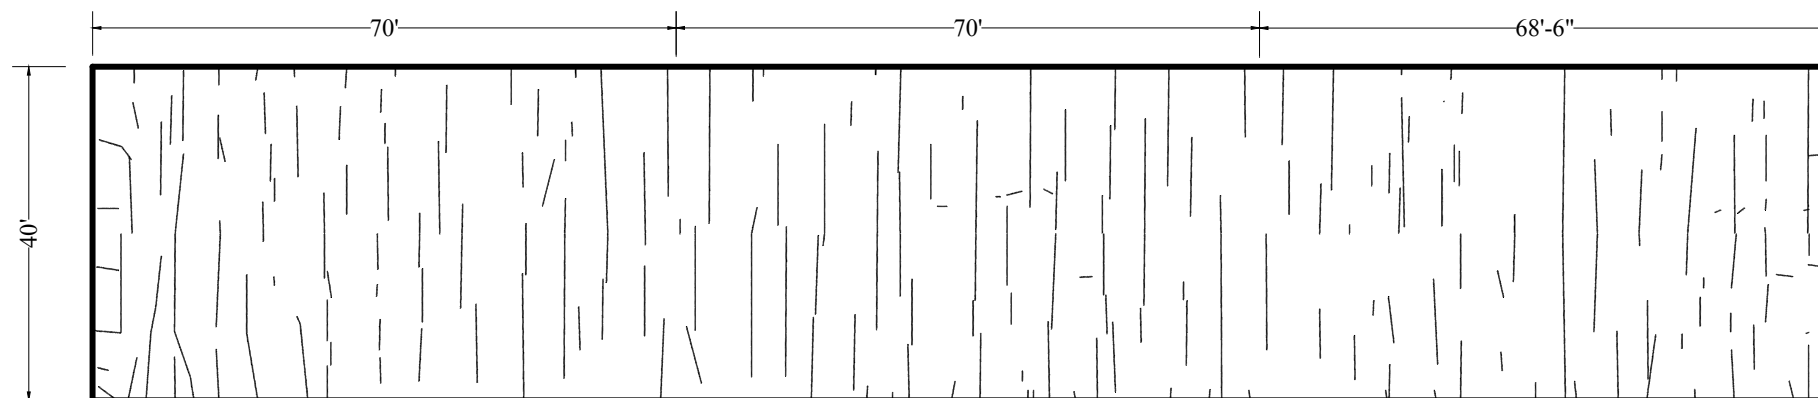
Crack Survey # CS3: A45 Concrete Deck

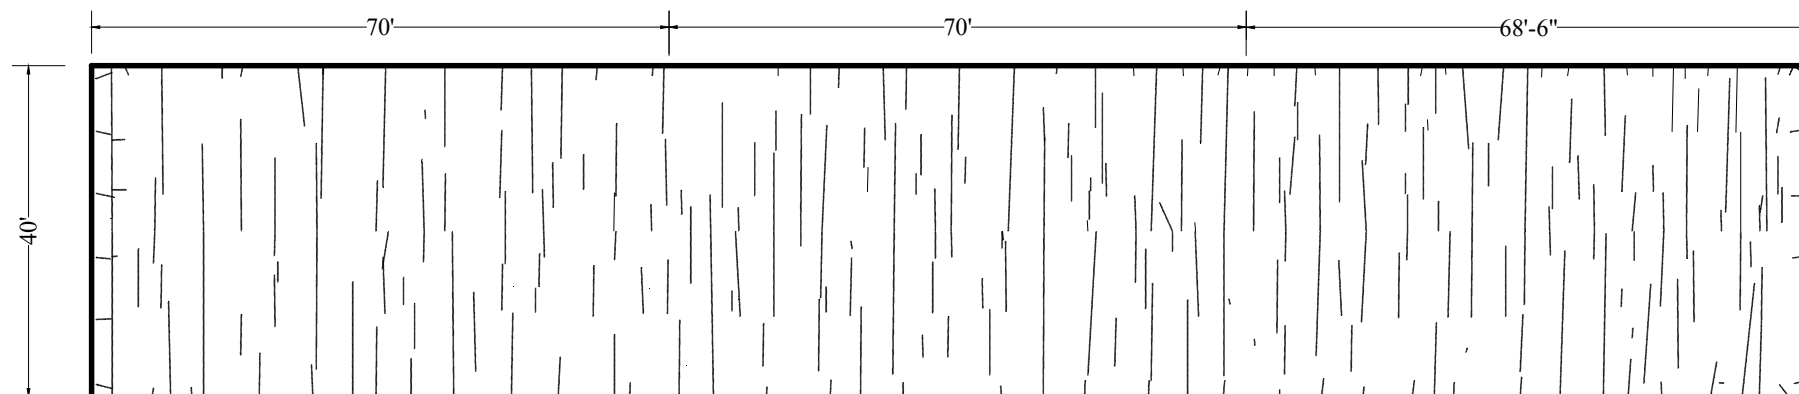
Crack Survey # CS4: LC-HPC Concrete Deck

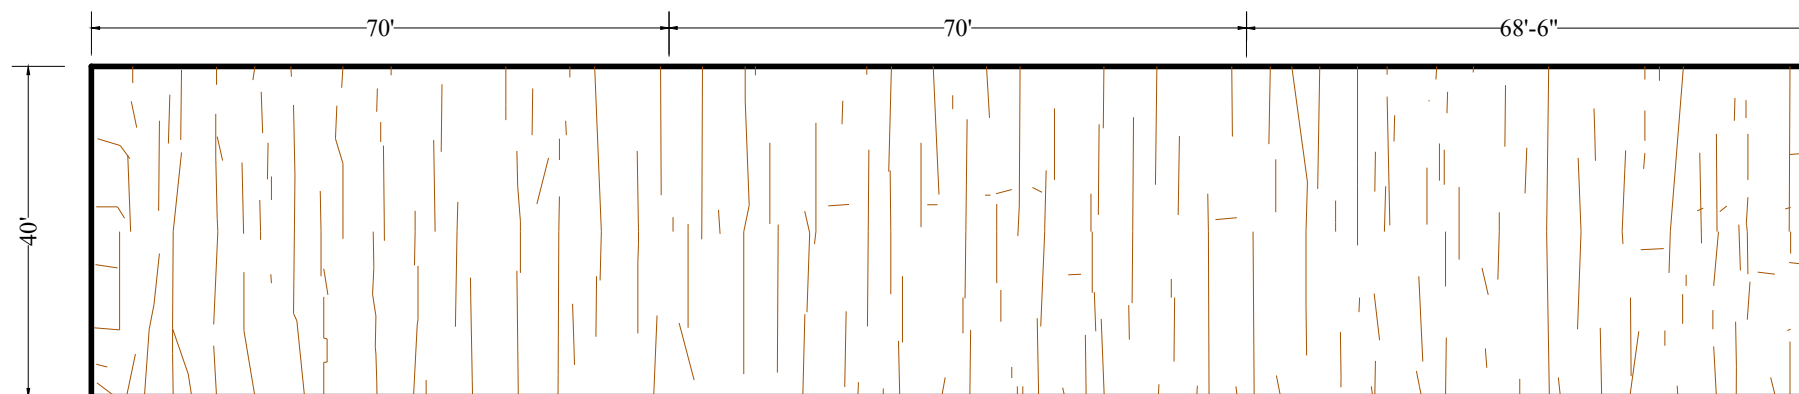
Crack Survey # CS5: A45 Concrete Deck

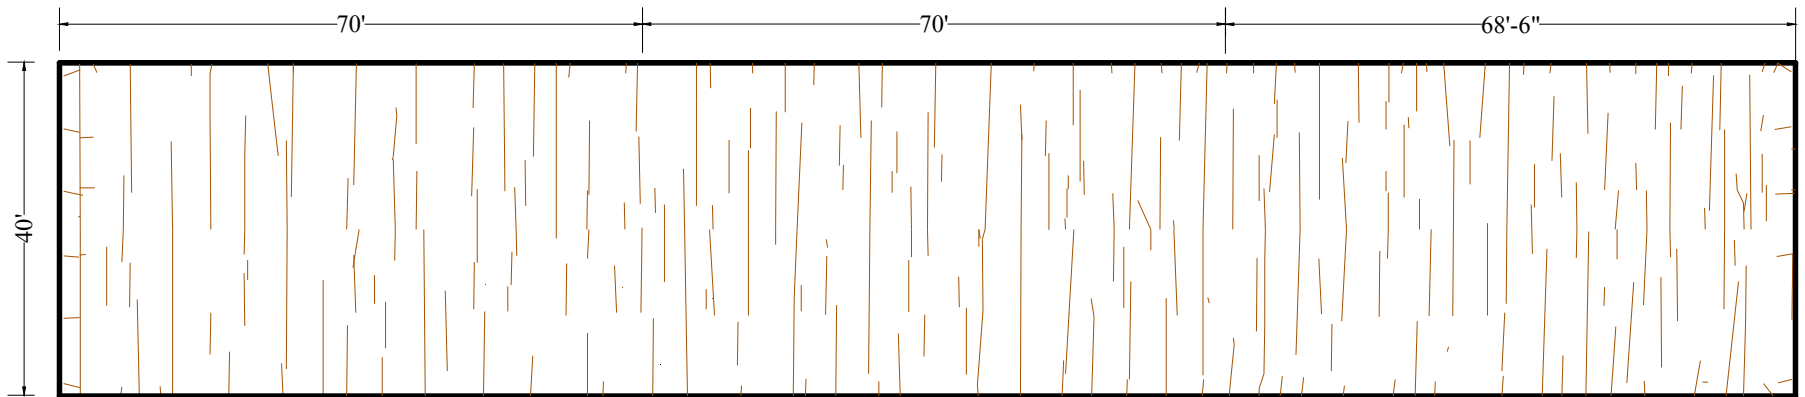
Crack Survey # CS6: LC-HPC Concrete Deck

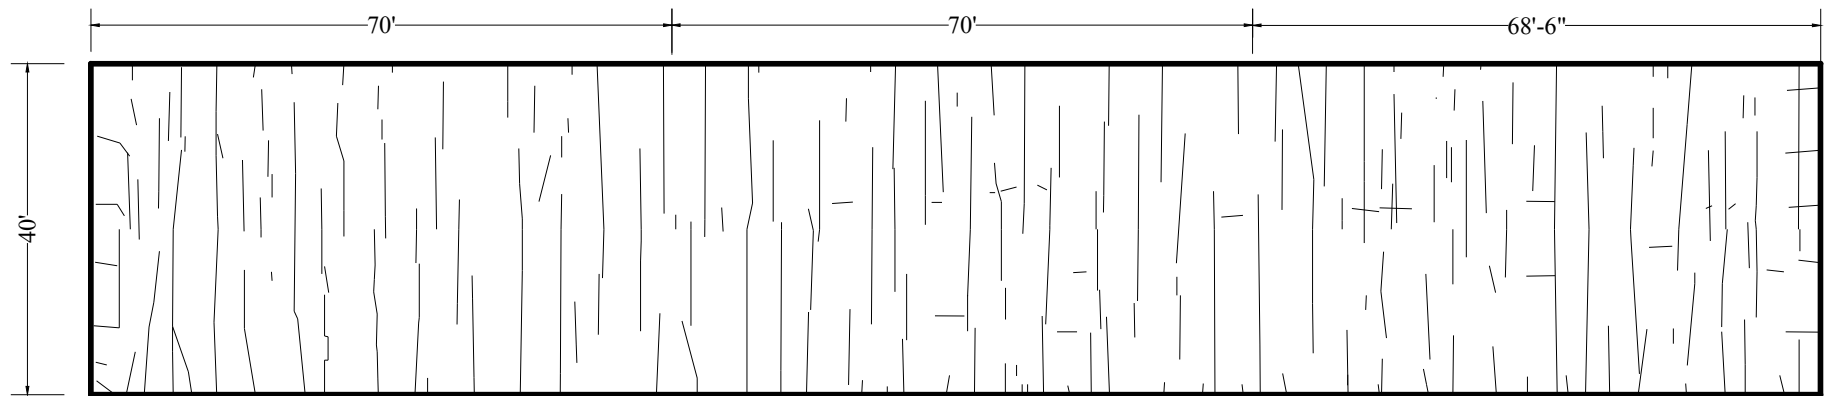
Crack Survey # CS7: A45 Concrete Deck

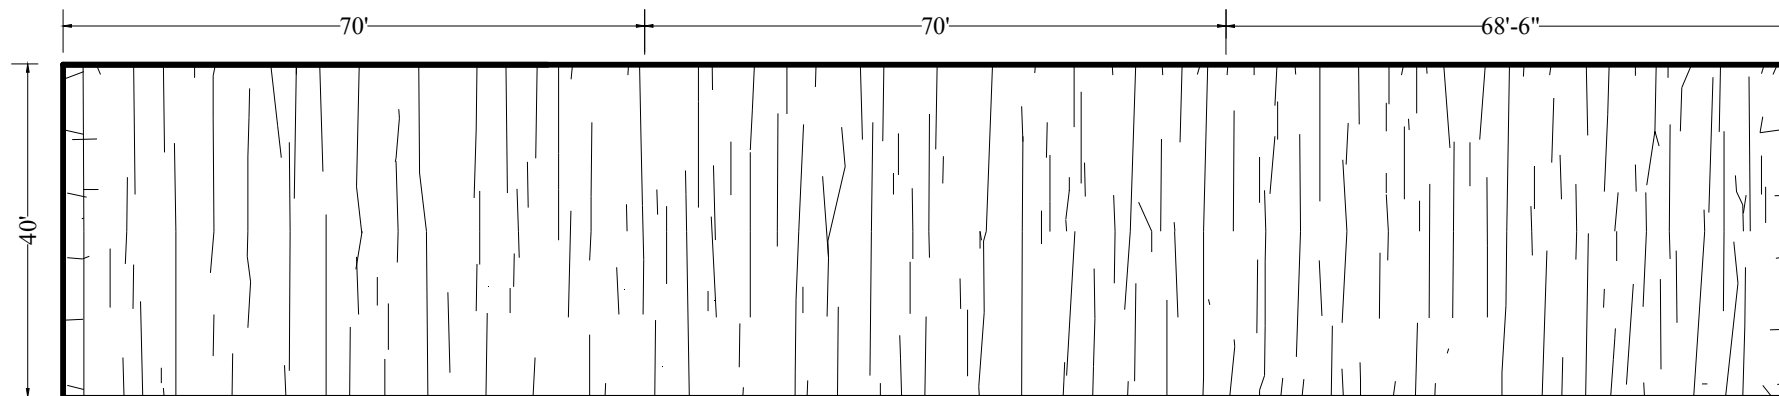
Crack Survey # CS8: LC-HPC Concrete Deck

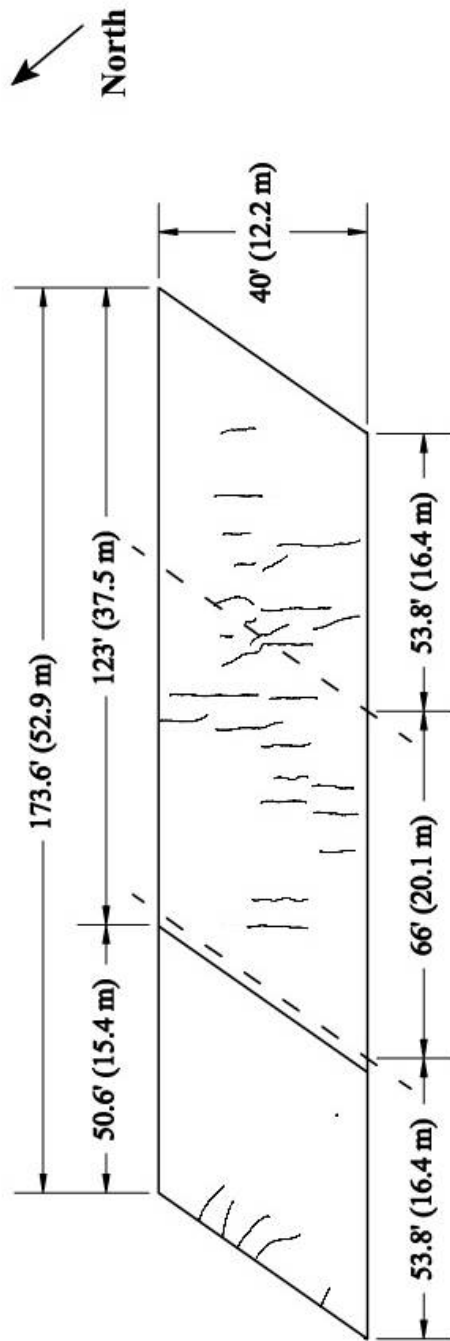
<b>Bridge Number:</b> 08-230-130	<b>Bridge Length:</b> 173.6 ft (52.9 m)	<b>Bridge Age:</b>
<b>Bridge Location:</b> WB Interstate 90 over XR20, Kimball, SD	<b>Bridge Width:</b> 40.0 ft (12.2 m)	<b>Placement 1:</b> 1.3 months
<b>Construction Date:</b>	<b>Skew:</b> 35°	<b>Placement 2:</b> 0.7 months
<b>Placement 1 (NW):</b> 7/26/2006	<b>Number of Spans:</b> 3	<b>Crack density:</b> 0.12 m/m <sup>2</sup>
<b>Placement 2 (SE):</b> 8/15/2006	<b>Span 1:</b> 53.8 ft (16.4 m)	<b>Span 1:</b> 0.06 m/m <sup>2</sup>
<b>Crack survey Date:</b> 9/5/2006	<b>Span 2:</b> 66.0 ft (20.1 m)	<b>Span 2:</b> 0.17 m/m <sup>2</sup>
	<b>Span 3:</b> 53.8 ft (16.4 m)	<b>Span 3:</b> 0.14 m/m <sup>2</sup>
	<b>Number of Placements:</b> 2	<b>Placement 1:</b> 0.06 m/m <sup>2</sup>
	<b>Placement 1:</b> 50.6 ft (15.4 m)	<b>Placement 2:</b> 0.15 m/m <sup>2</sup>
	<b>Placement 2:</b> 123.0 ft (37.5 m)

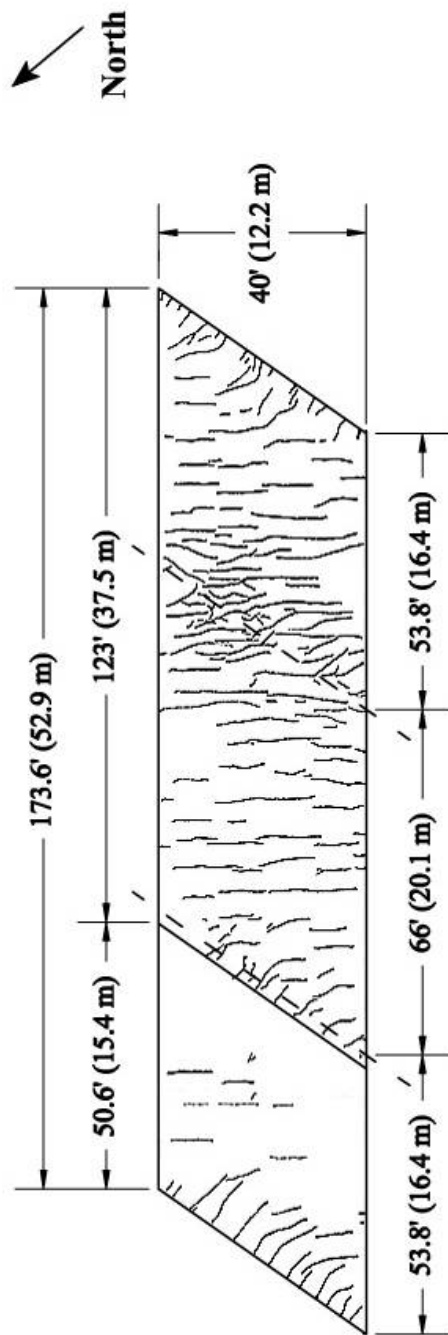
**Bridge Number:** 08-230-130  
**Bridge Location:** WB Interstate 90  
 over XR20, Kimball, SD  
**Construction Date:**  
**Placement 1 (NW):** 7/26/2006  
**Placement 2 (SE):** 8/15/2006  
**Crack survey Date:** 9/27/2007

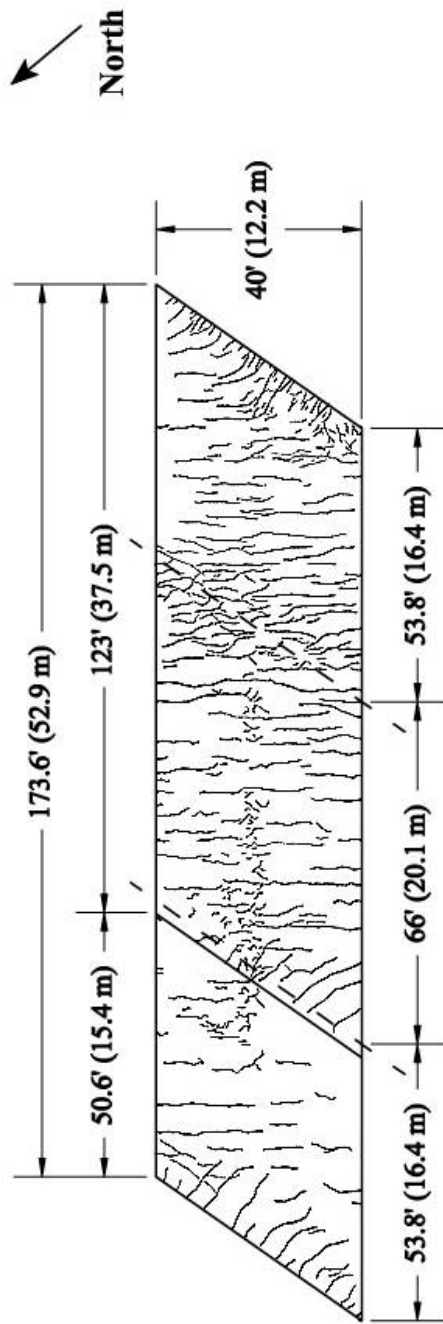
**Bridge Number:** 08-230-130  
**Bridge Location:** WB Interstate 90  
 over XR20, Kimball, SD  
**Construction Date:**  
 Placement 1 (NW): 7/26/2006  
 Placement 2 (SE): 8/15/2006  
**Crack survey Date:** 8/20/2008

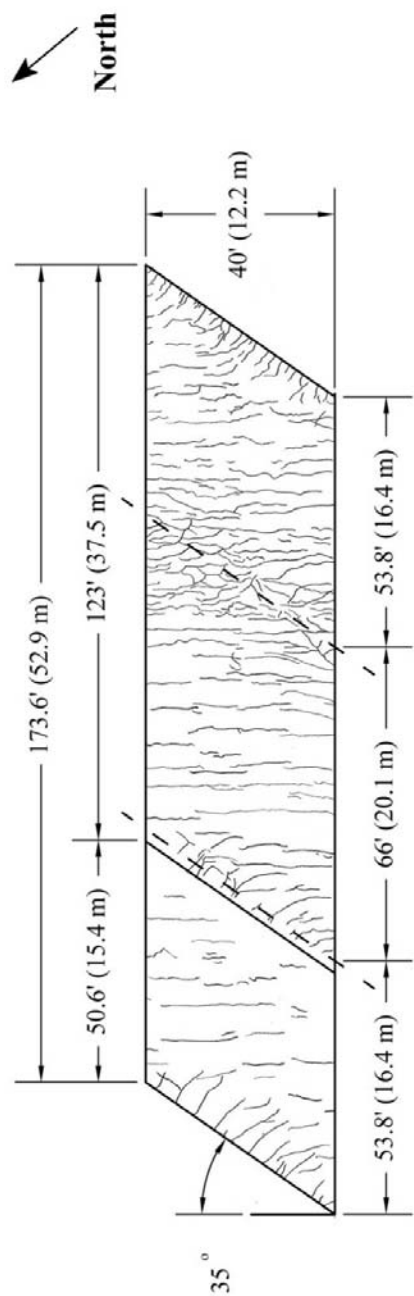
<b>Bridge Number:</b> 08-230-130	<b>Bridge Length:</b> 173.6 ft (52.9 m)	<b>Bridge Age:</b>
<b>Bridge Location:</b> WB Interstate 90 over XR20, Kimball, SD	<b>Bridge Width:</b> 40.0 ft (12.2 m)	<b>Placement 1:</b> 35.6 months
<b>Construction Date:</b>	<b>Skew:</b> 35°	<b>Placement 2:</b> 35.0 months
<b>Placement 1 (NW):</b> 7/26/2006	<b>Number of Spans:</b> 3	<b>Crack density:</b> 0.898 m/m <sup>2</sup>
<b>Placement 2 (SE):</b> 8/15/2006	<b>Span 1:</b> 53.8 ft (16.4 m)	<b>Span 1:</b> 0.497 m/m <sup>2</sup>
<b>Crack survey Date:</b> 7/14/2009	<b>Span 2:</b> 66.0 ft (20.1 m)	<b>Span 2:</b> 1.005 m/m <sup>2</sup>
	<b>Span 3:</b> 53.8 ft (16.4 m)	<b>Span 3:</b> 1.175 m/m <sup>2</sup>
	<b>Number of Placements:</b> 2	<b>Placement 1:</b> 0.513 m/m <sup>2</sup>
	<b>Placement 1:</b> 50.6 ft (15.4 m)	<b>Placement 2:</b> 1.056 m/m <sup>2</sup>
	<b>Placement 2:</b> 123.0 ft (37.5 m)

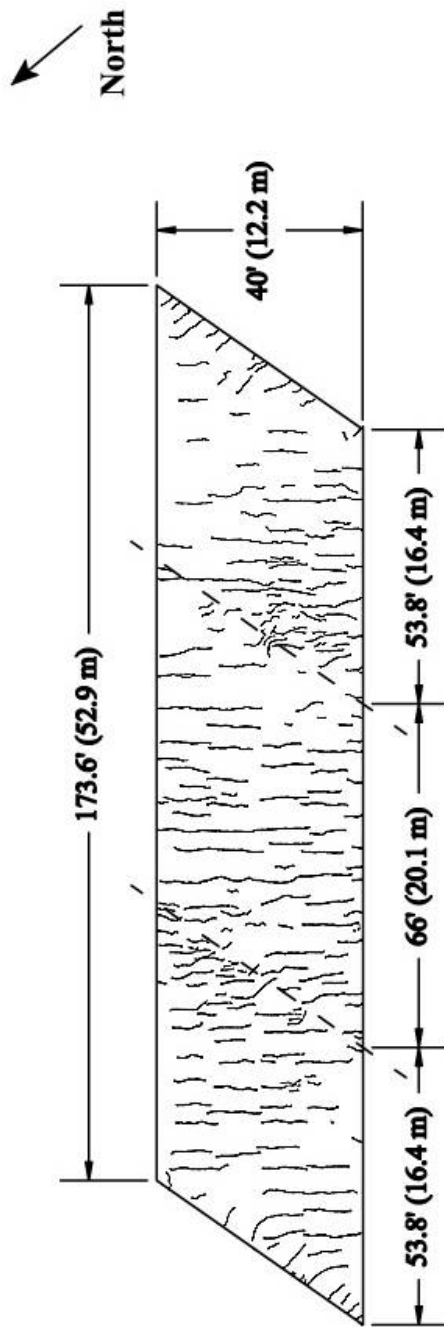
<b>Bridge Number:</b> 08-230-131	<b>Bridge Length:</b> 173.6 ft (52.9 m)	<b>Bridge Age:</b> 13.8 months
<b>Bridge Location:</b> EB Interstate 90 over XR20, Kimball, SD	<b>Bridge Width:</b> 40.0 ft (12.2 m)	<b>Crack density:</b> 0.641 m/m <sup>2</sup>
<b>Construction Date:</b> 6/27/2007	<b>Skew:</b> 35°	<b>Span 1:</b> 0.666 m/m <sup>2</sup>
<b>Crack survey Date:</b> 8/20/2008	<b>Number of Spans:</b> 3	<b>Span 2:</b> 0.642 m/m <sup>2</sup>
	<b>Span 1:</b> 53.8 ft (16.4 m)	<b>Span 3:</b> 0.620 m/m <sup>2</sup>
	<b>Span 2:</b> 66.0 ft (20.1 m)	
	<b>Span 3:</b> 53.8 ft (16.4 m)	
	<b>Number of Placements:</b> 1

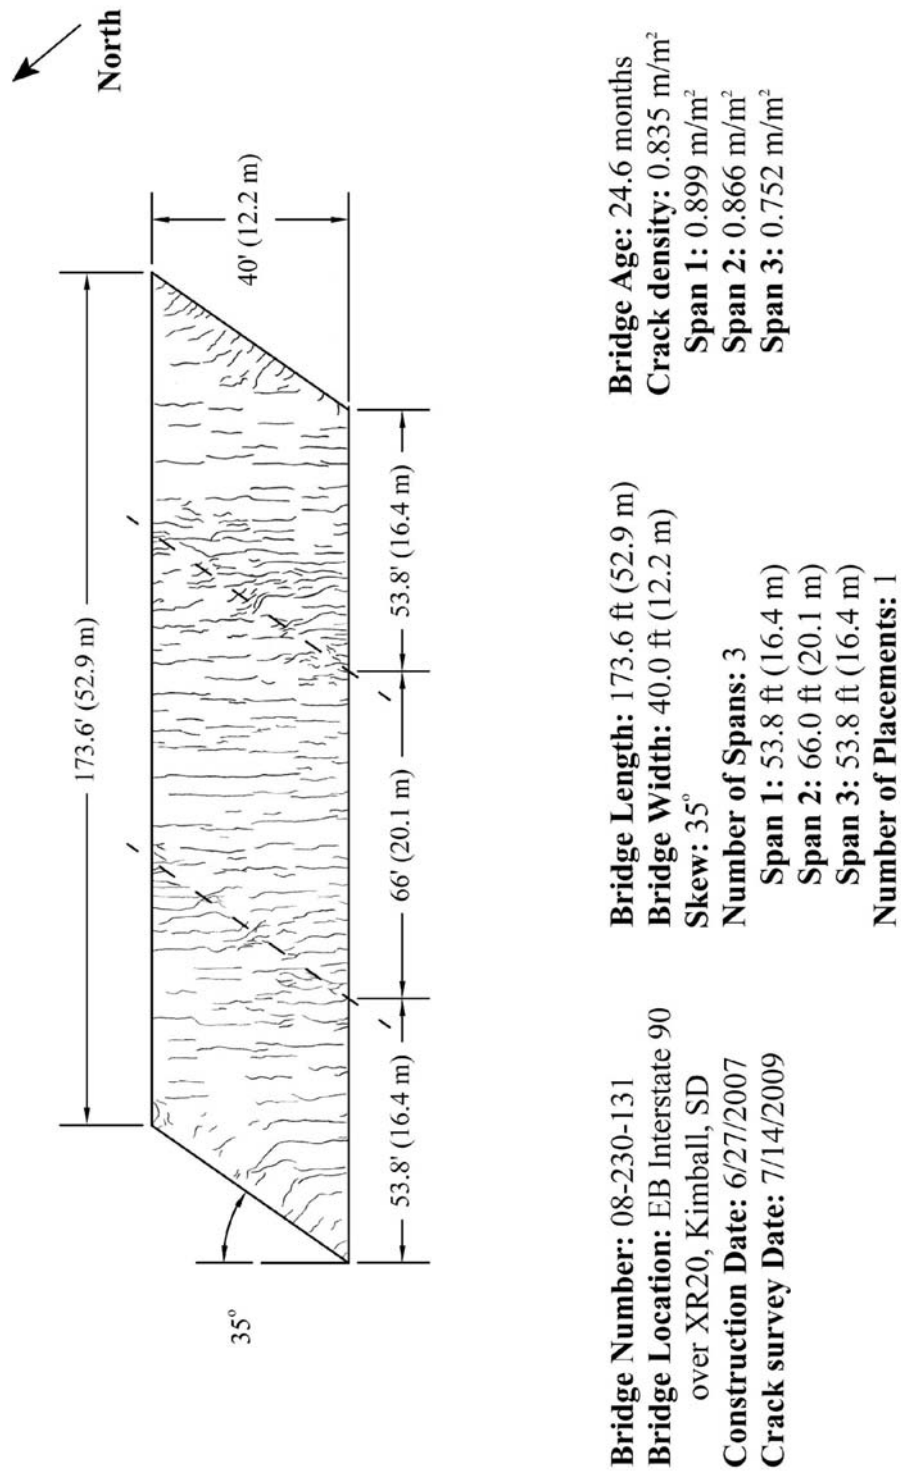
**Fig. 9.22** LC-HPC Deck-2 Year Crack Survey

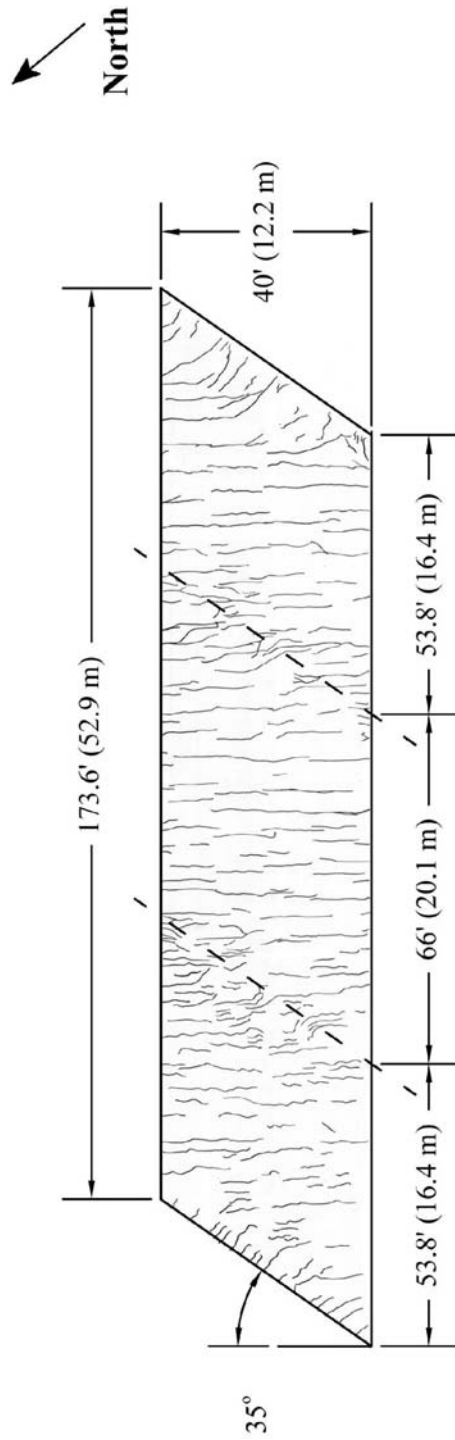
**Bridge Number:** 08-230-131  
**Bridge Location:** EB Interstate 90  
 over XR20, Kimball, SD  
**Construction Date:** 6/27/2007  
**Crack survey Date:** 5/5/2010

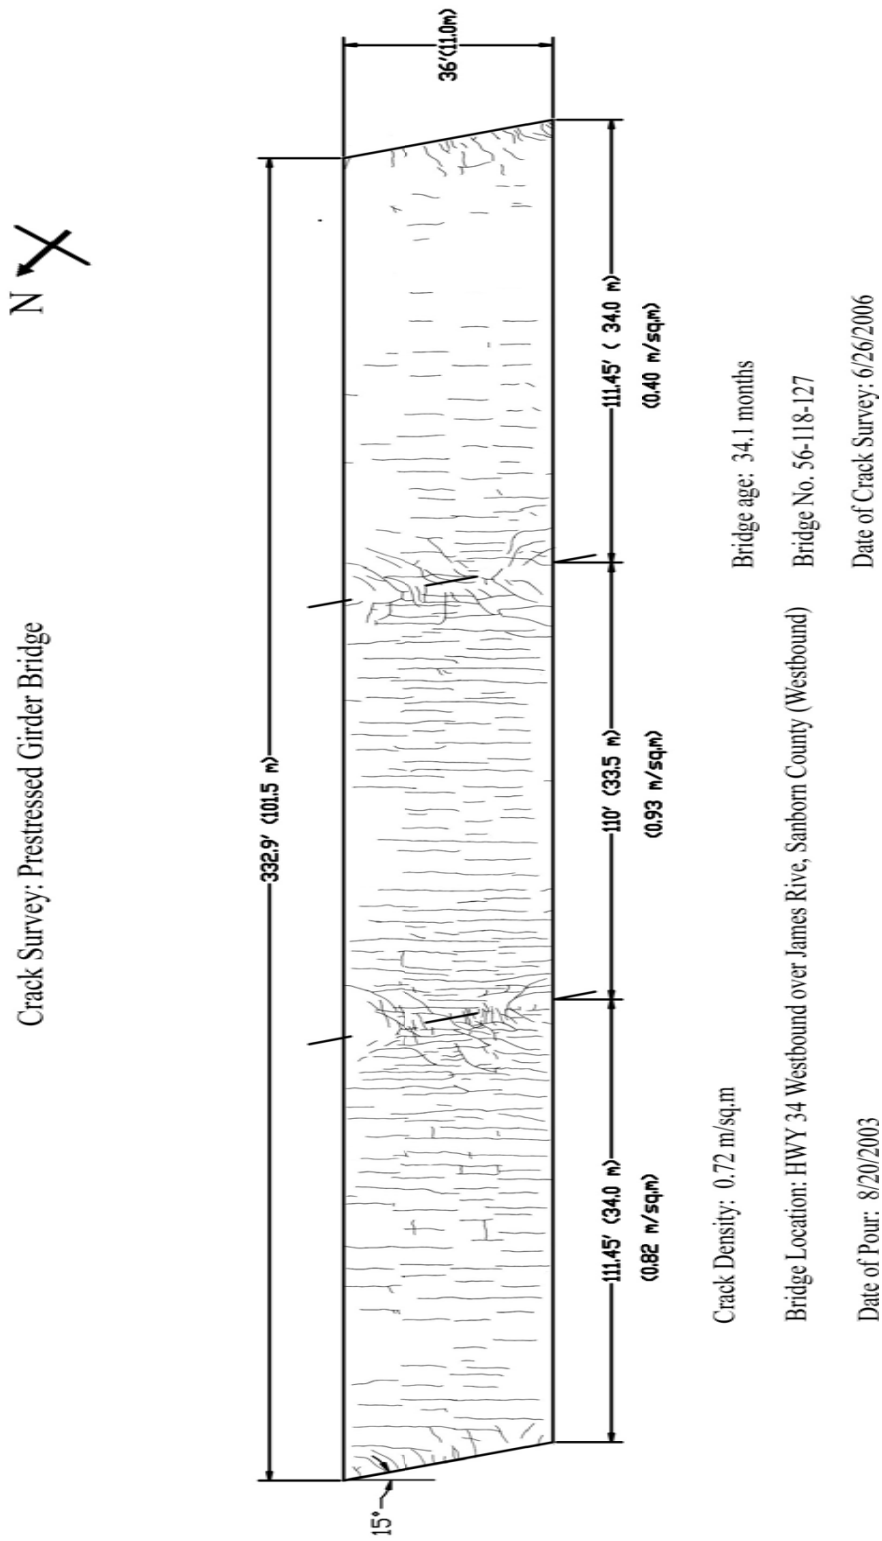
**Fig. 10.3** Prestressed Girder Bridge #56-118-127 Crack Survey

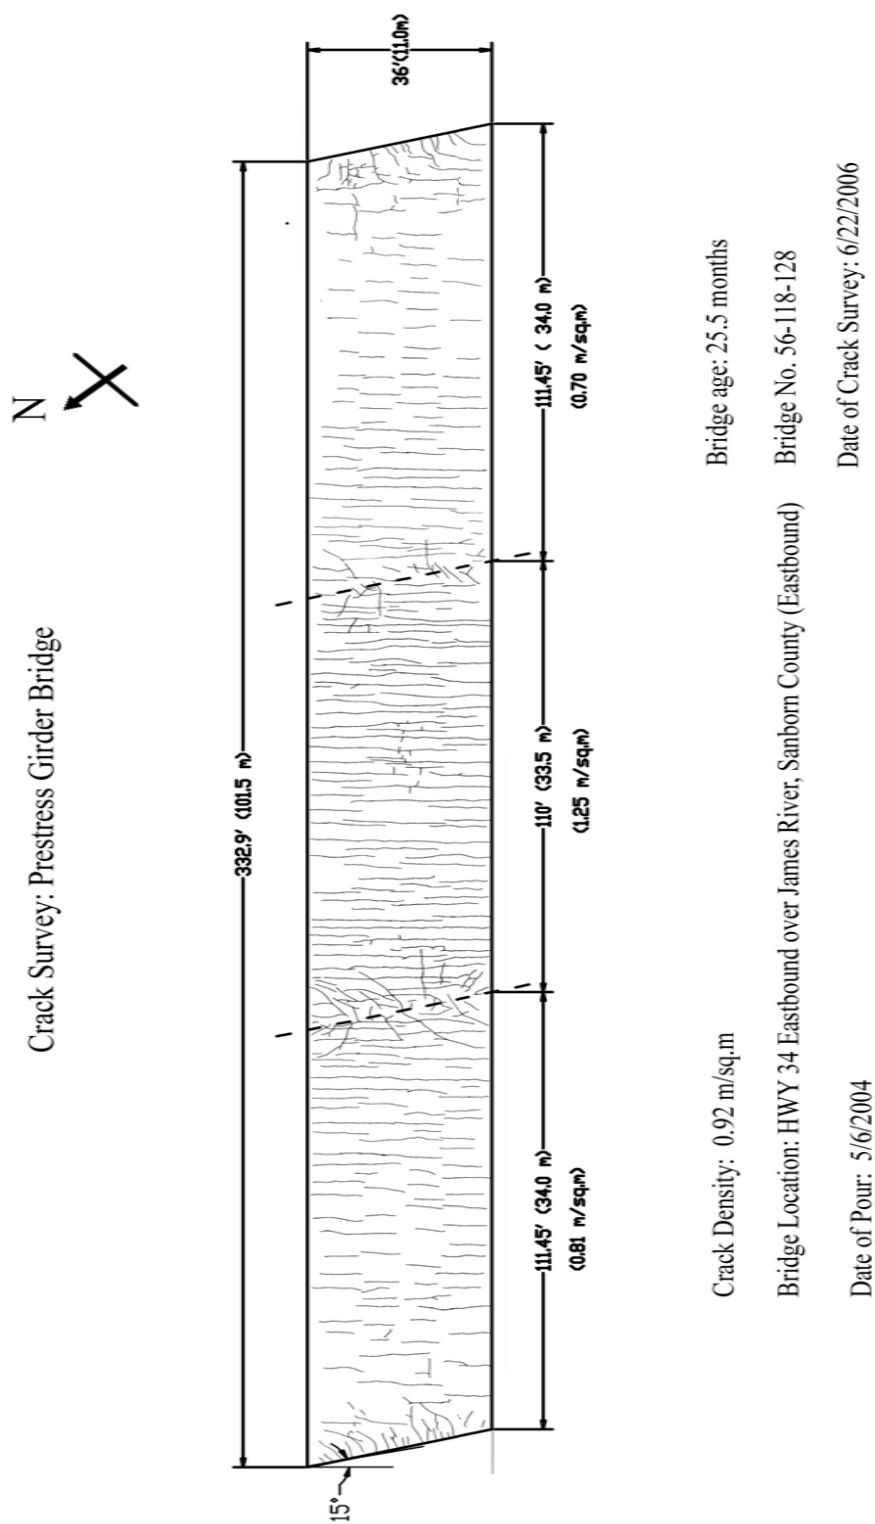
Fig. 10.4 Prestressed Girder Bridge #56-118-128 Crack Survey

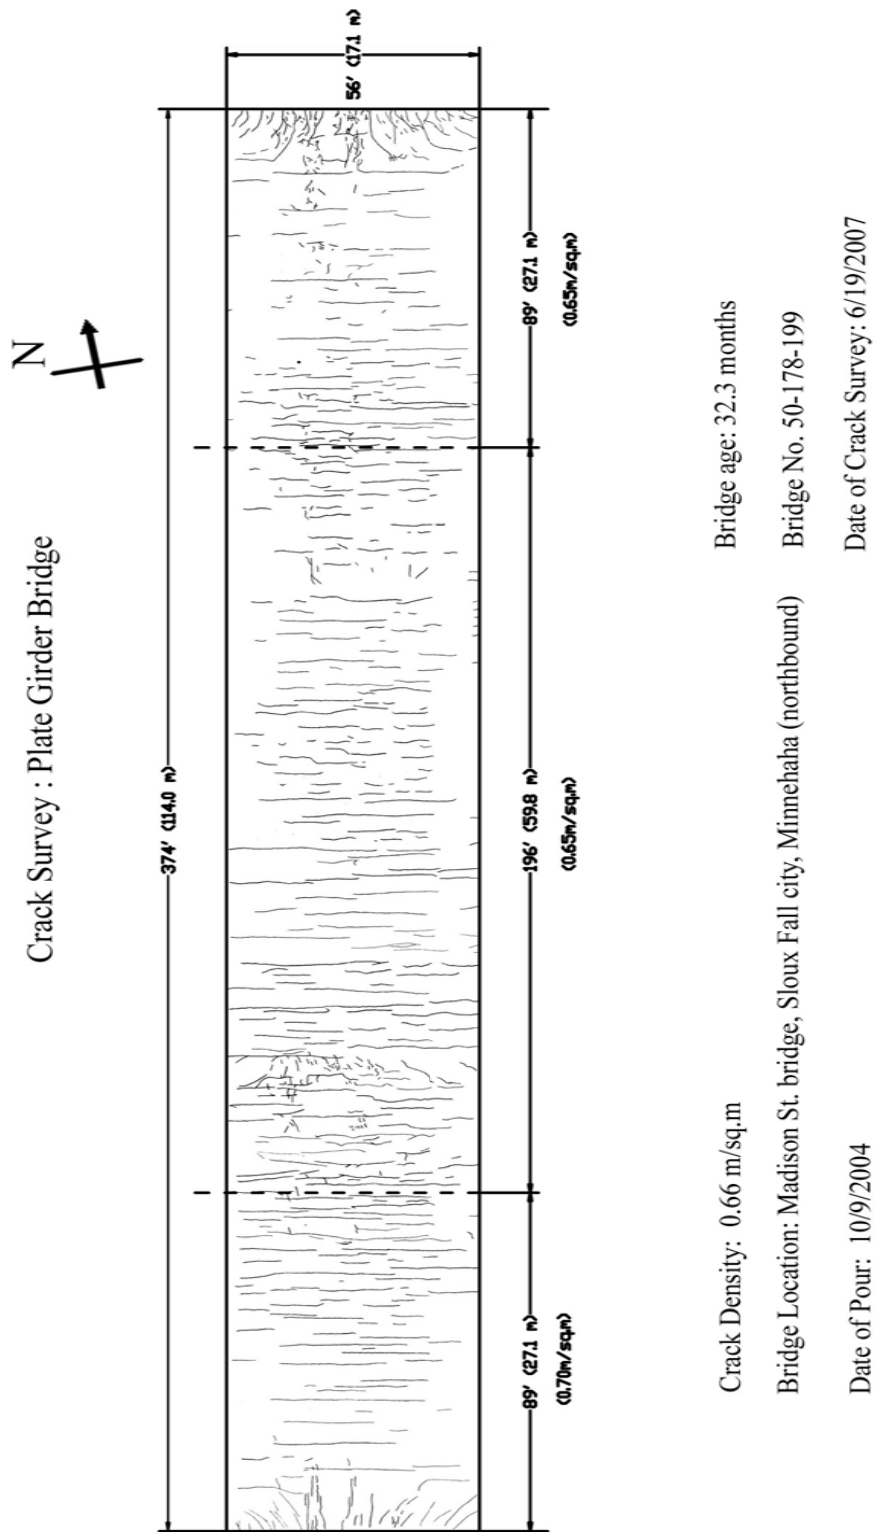
Fig. 10.5 Steel Girder Bridge #50-178-199 Crack Survey

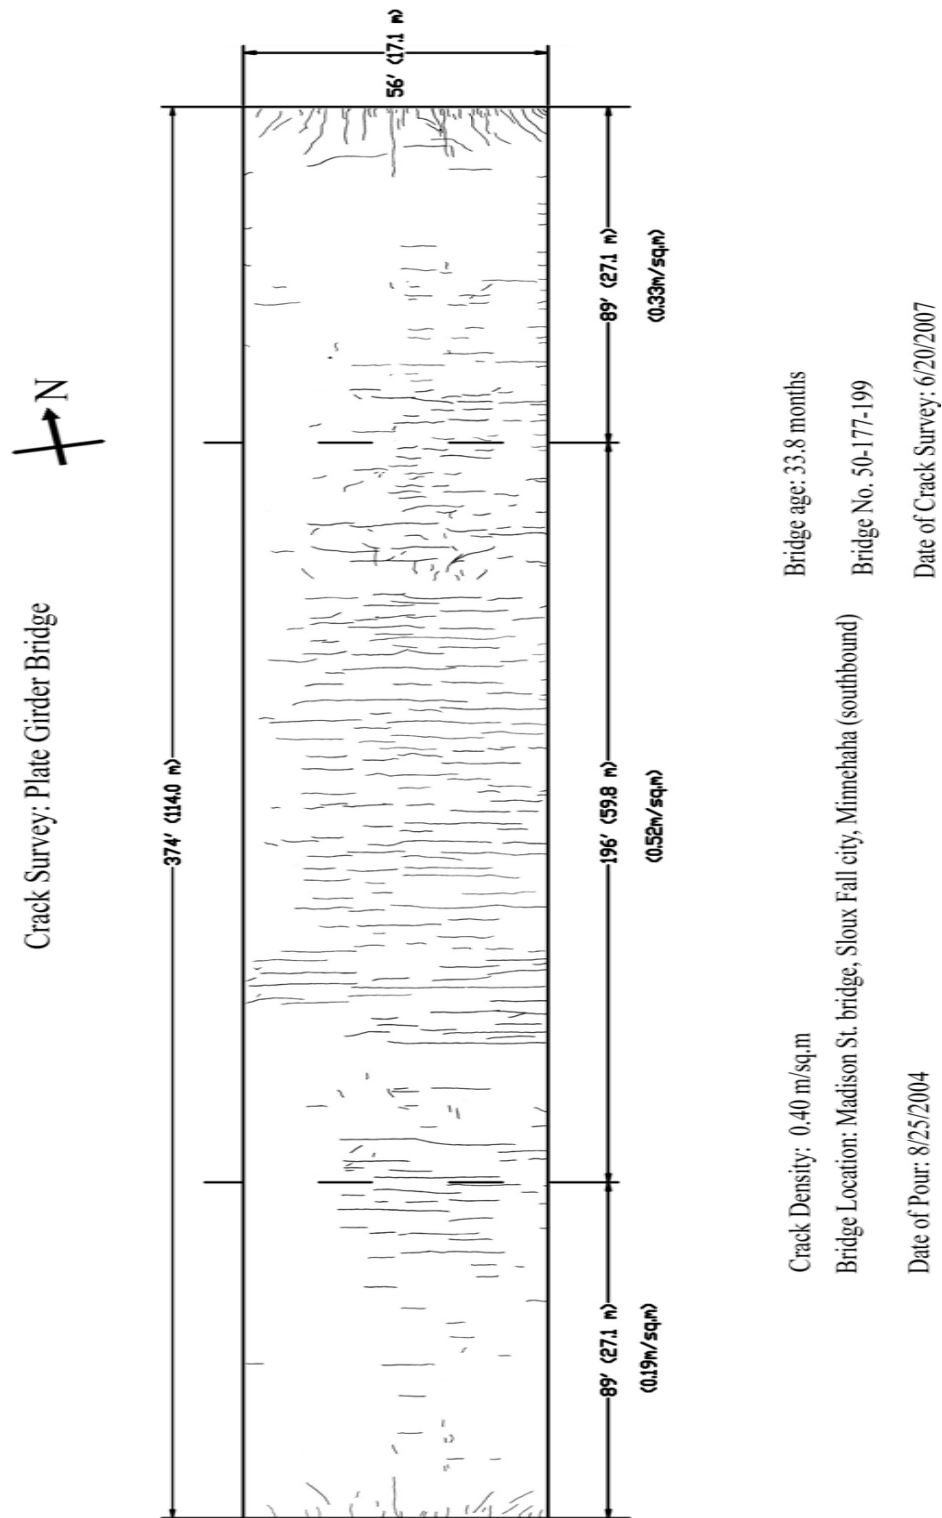
**Fig. 10.6** Steel Girder Bridge #50-177-199 Crack Survey

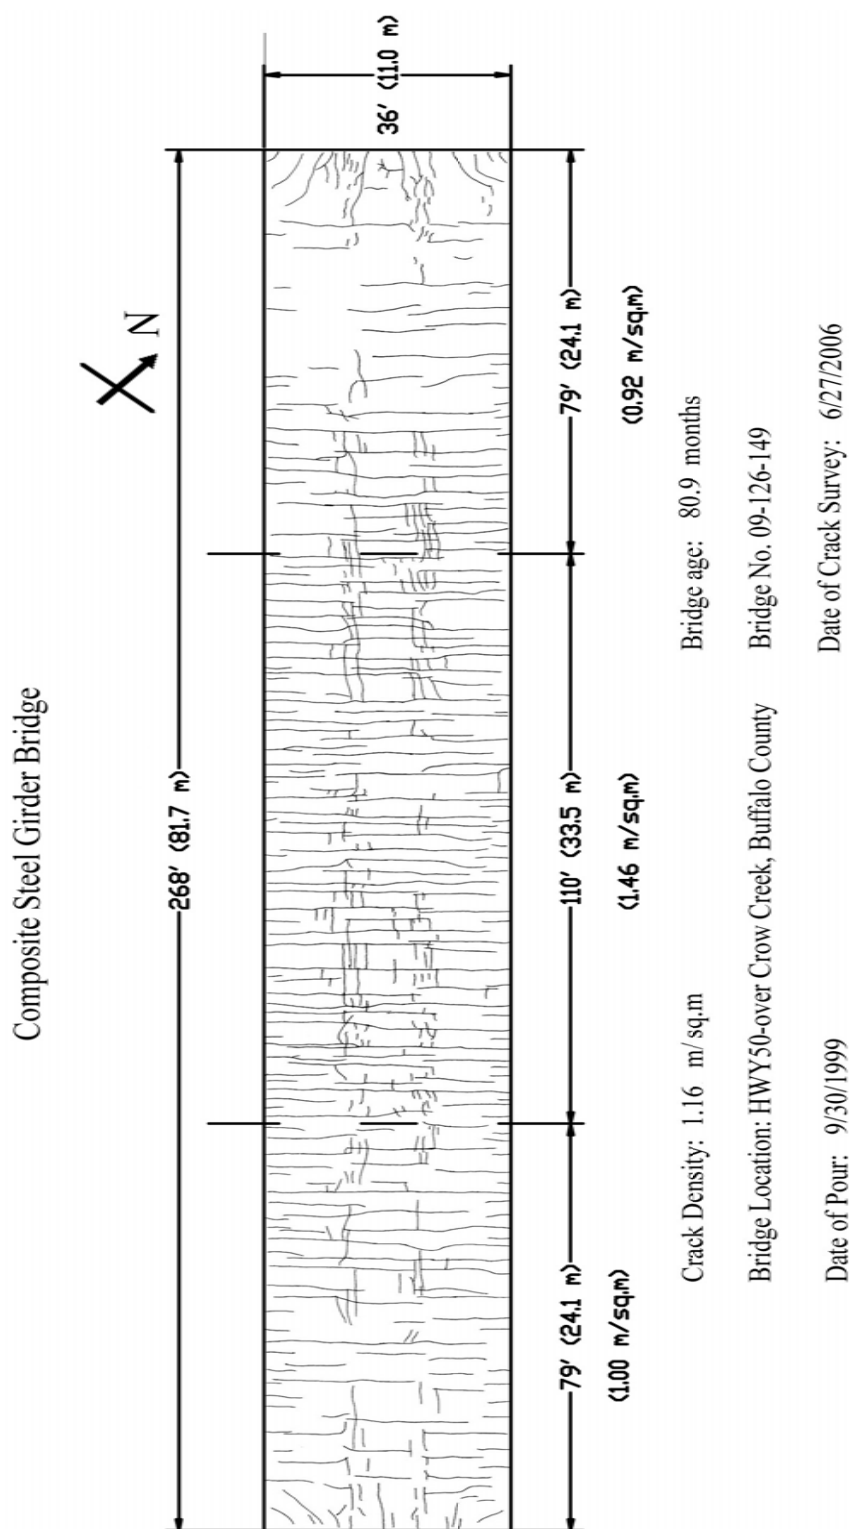
**Fig. 10.7** Steel Girder Bridge #09-126-149 Crack Survey

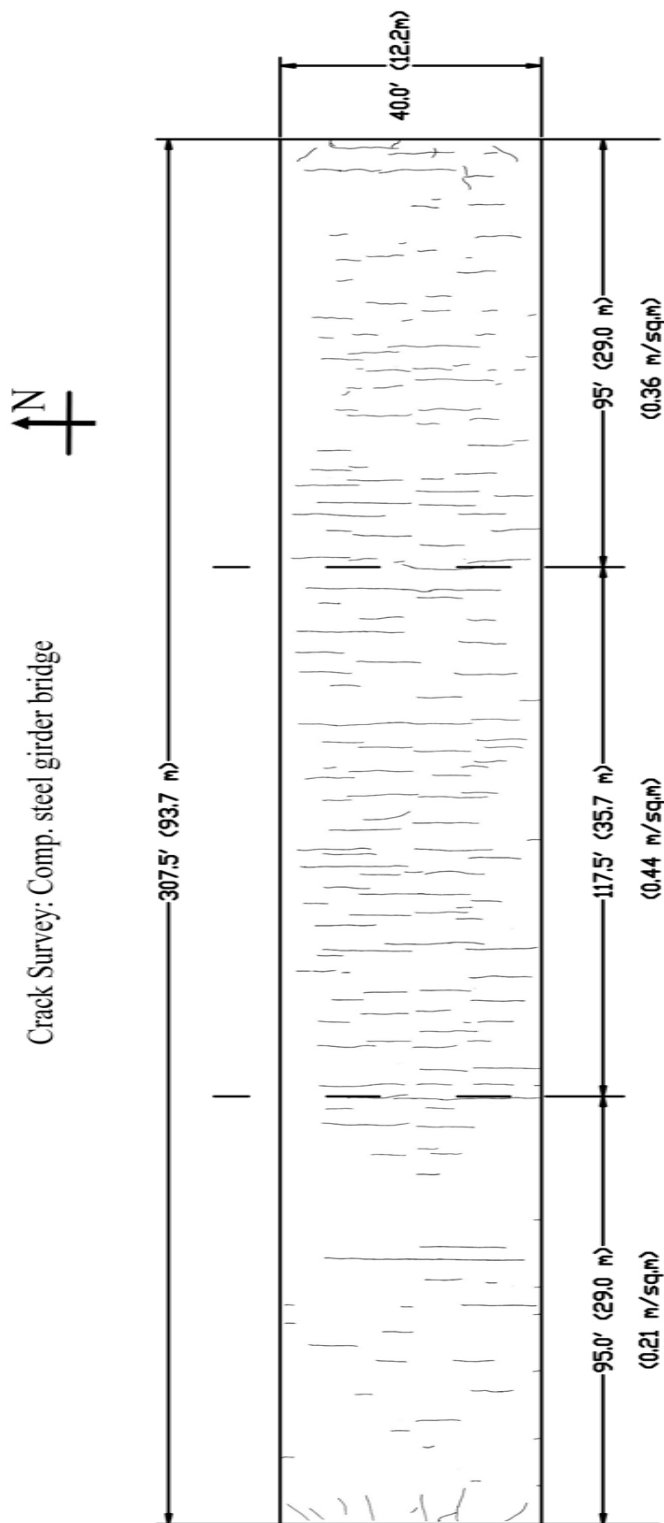
Crack Density: 0.34 m/sq.m	Bridge age: 213 months
Bridge Location: HWY 38-over James River, Davison County	Bridge No. 018-180-100
Date of Pour: 9/1988	Date of Crack Survey: 6/27/2006
