# **SD2005-11: Evaluation of Crack-Free Bridge Decks**

## **FINAL REPORT**

June 2011

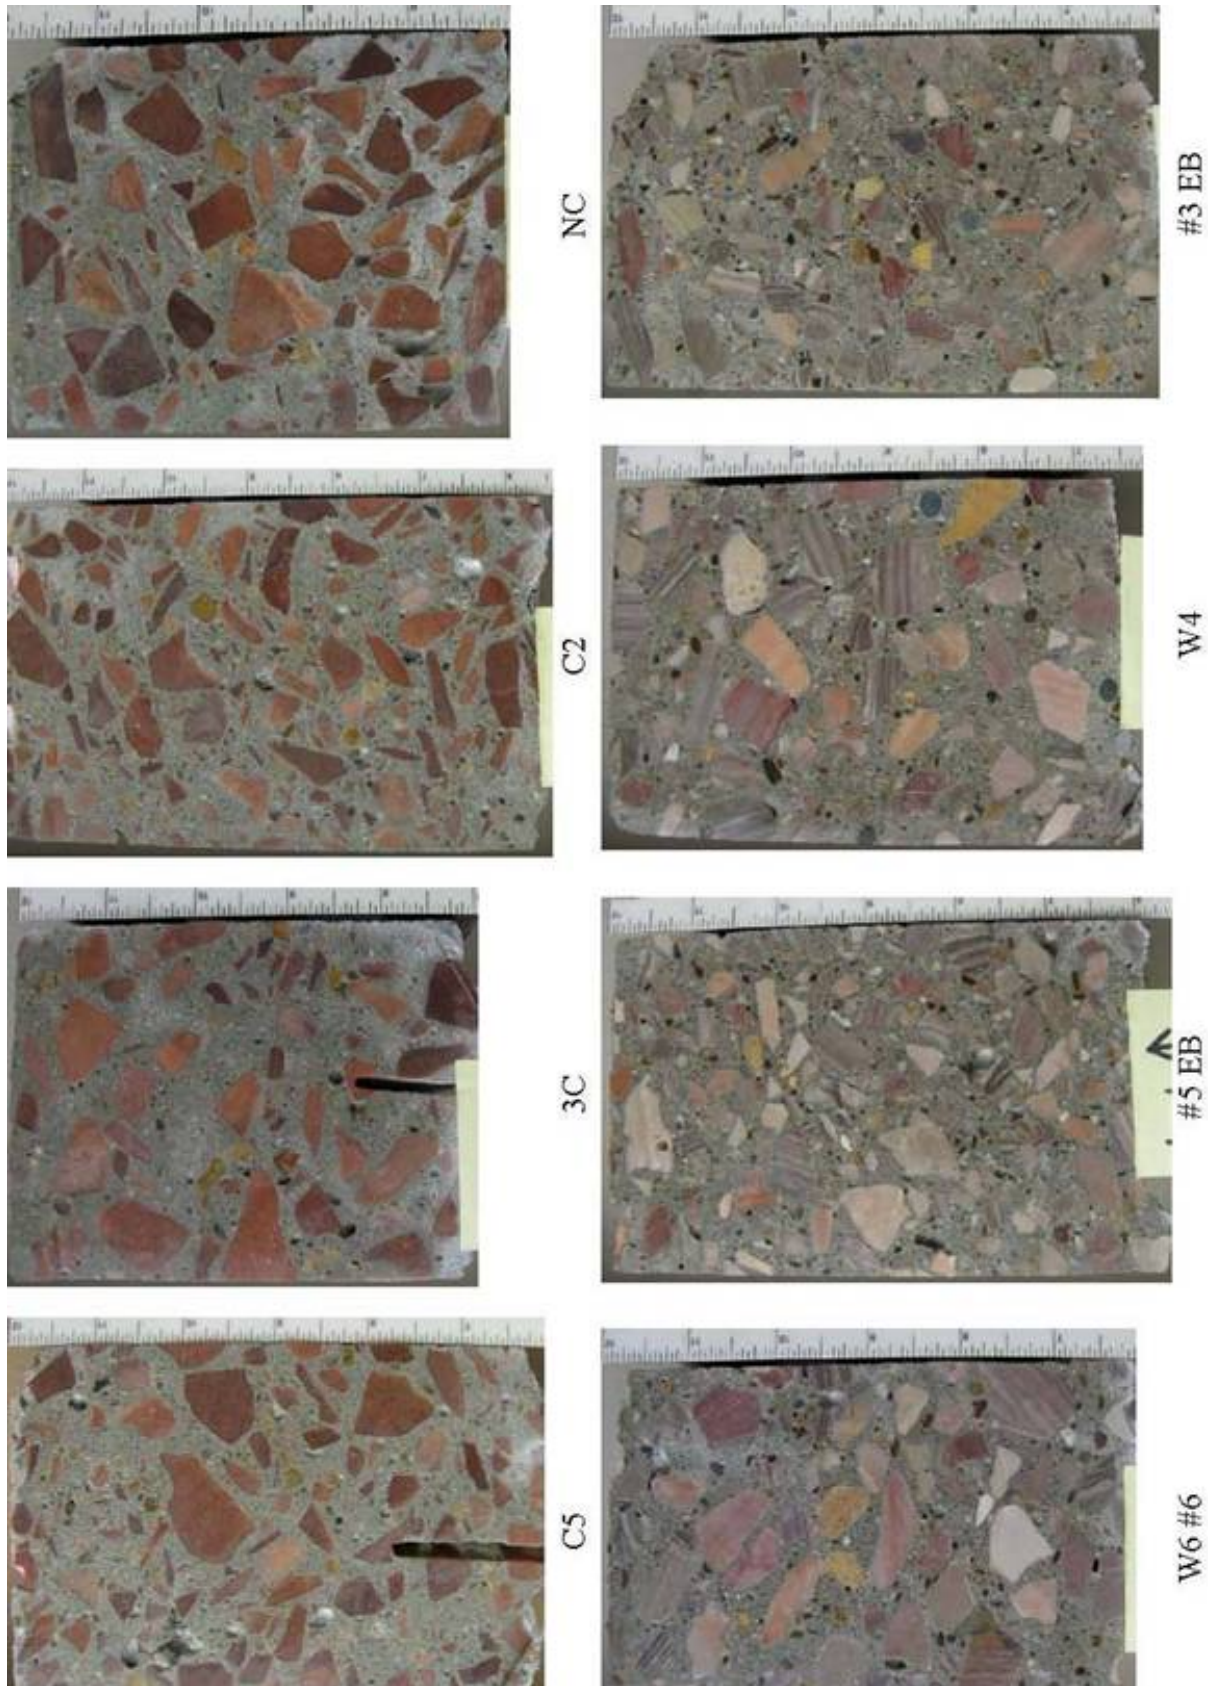
Figure 1. Photographs of cut surface of half-cores (wear surface is at top in all photos). Scale in inches at right of each core.  
12/30/2009

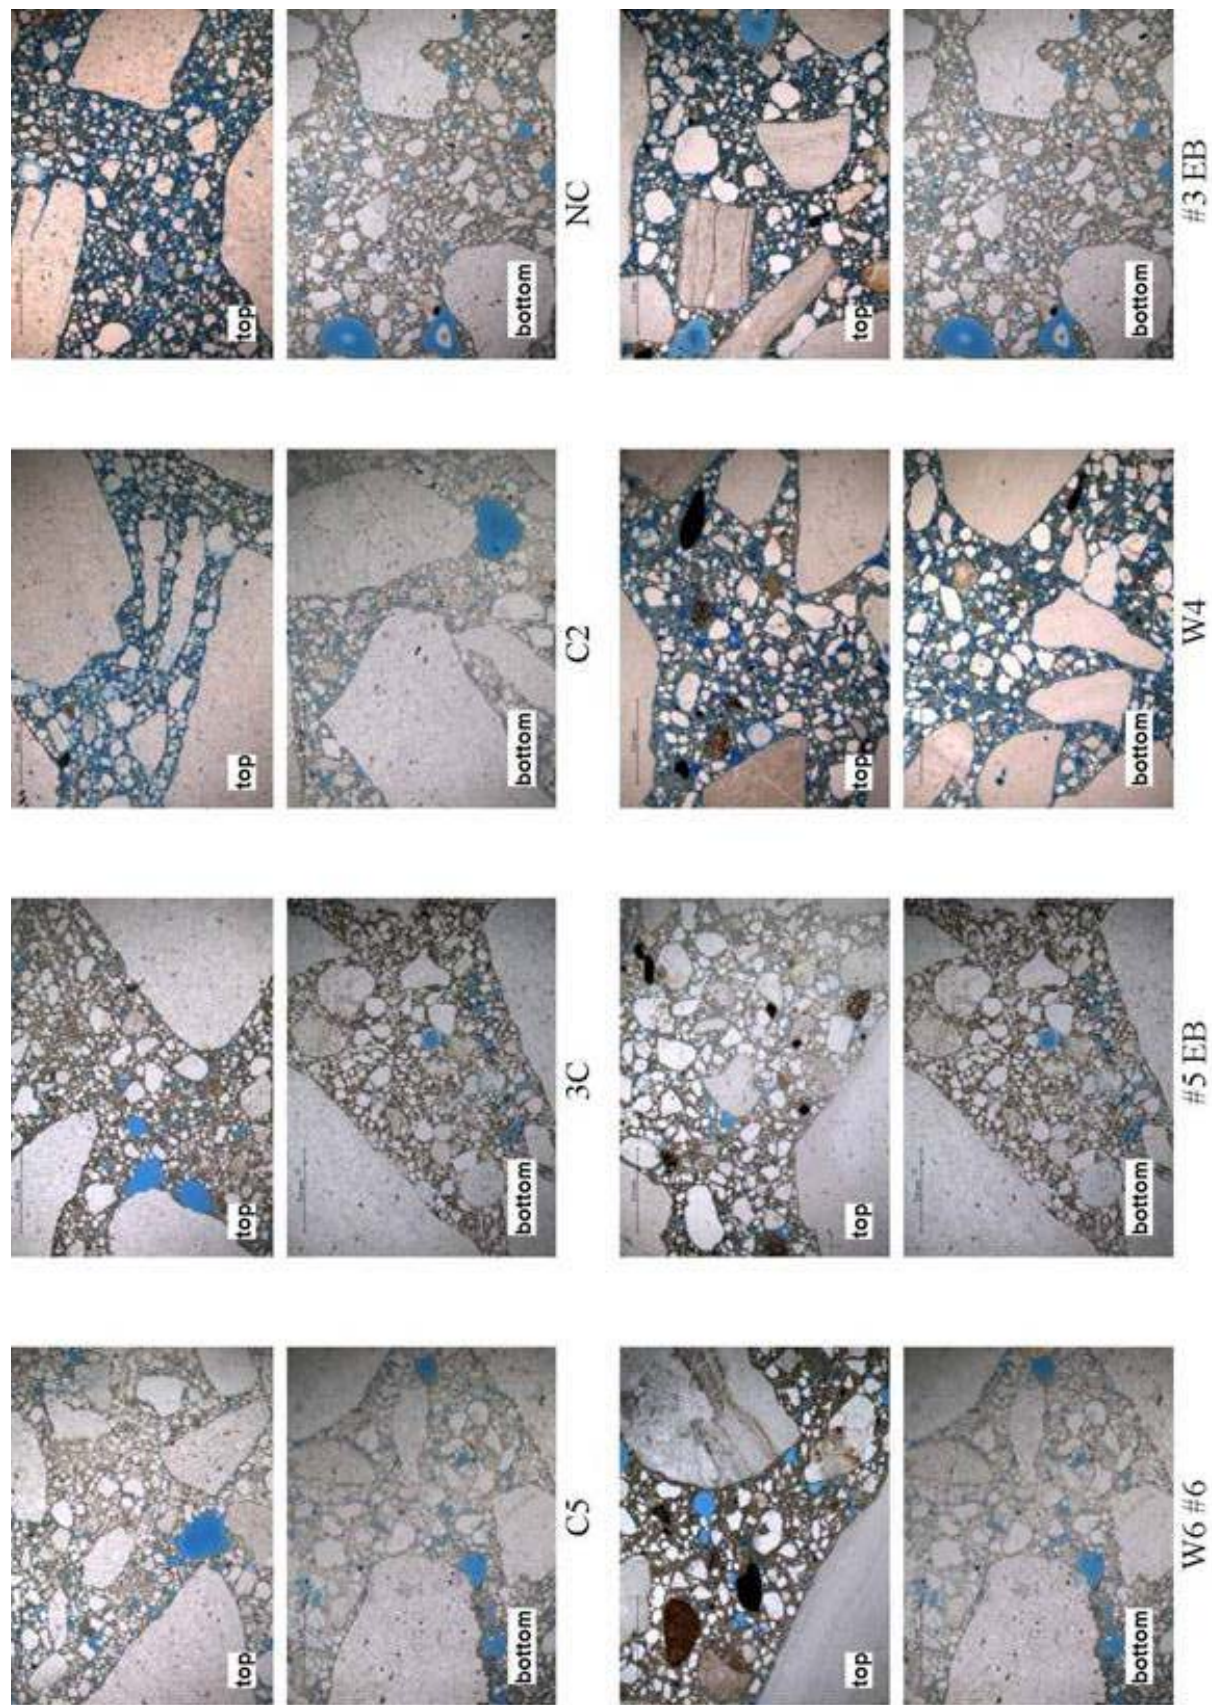
Figure 2. Photomicrographs of concrete thin sections. Blue epoxy shows air voids. Scale bar is 5 mm.  
Wear surface is at top in all photos.
