Final Report
Project Number 930-866R

EVALUATION OF REMEDIATION STRATEGIES FOR SHRINK-SWELL CLAYS IN WESTERN ALABAMA

The Alabama Department of Transportation

JUNE 2024

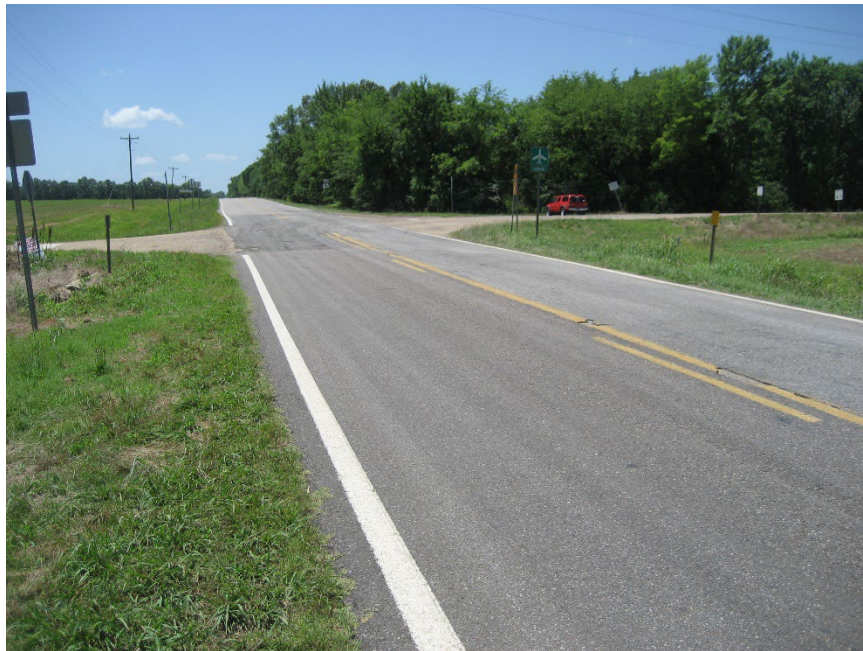
Figure 54: AL 5 Facing South of Boring B3.0 MP 51.85 (Photo Taken 06/15/15)

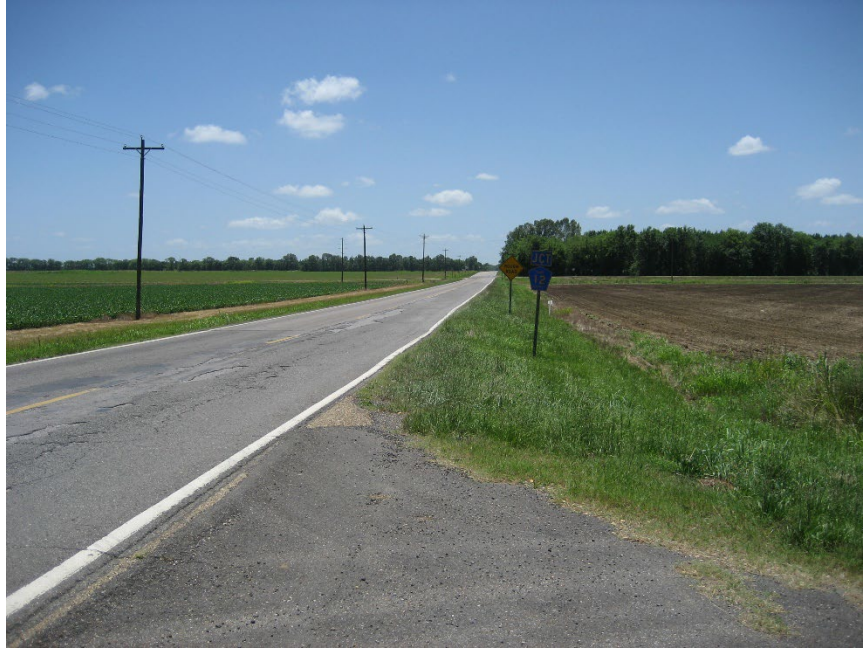
Figure 55: AL 5 Facing North of CR 12 Intersection MP 51.82 (Photo Taken 06/15/15)

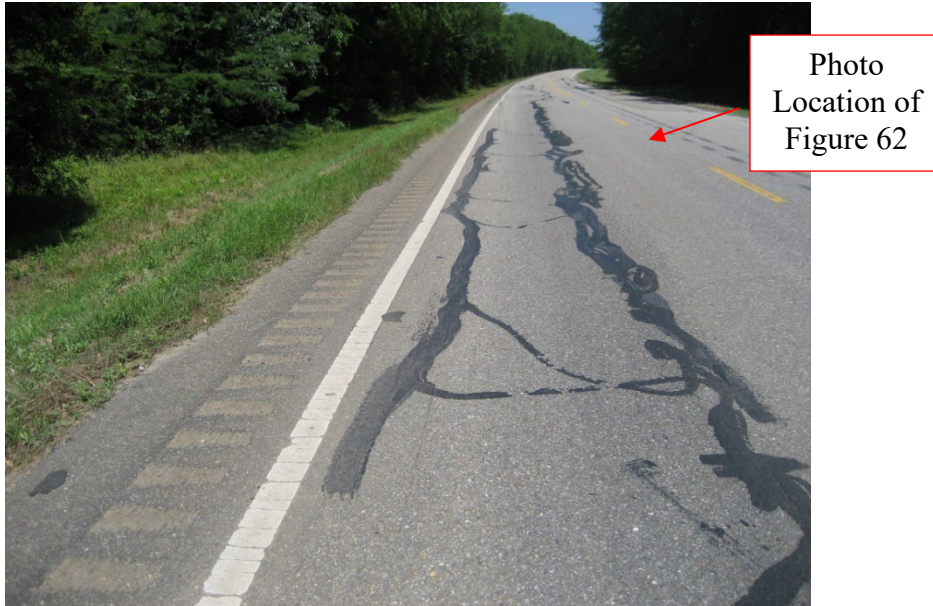
Figure 63: Observed Rutting and Longitudinal Cracking (Photo Taken 09/14/16)

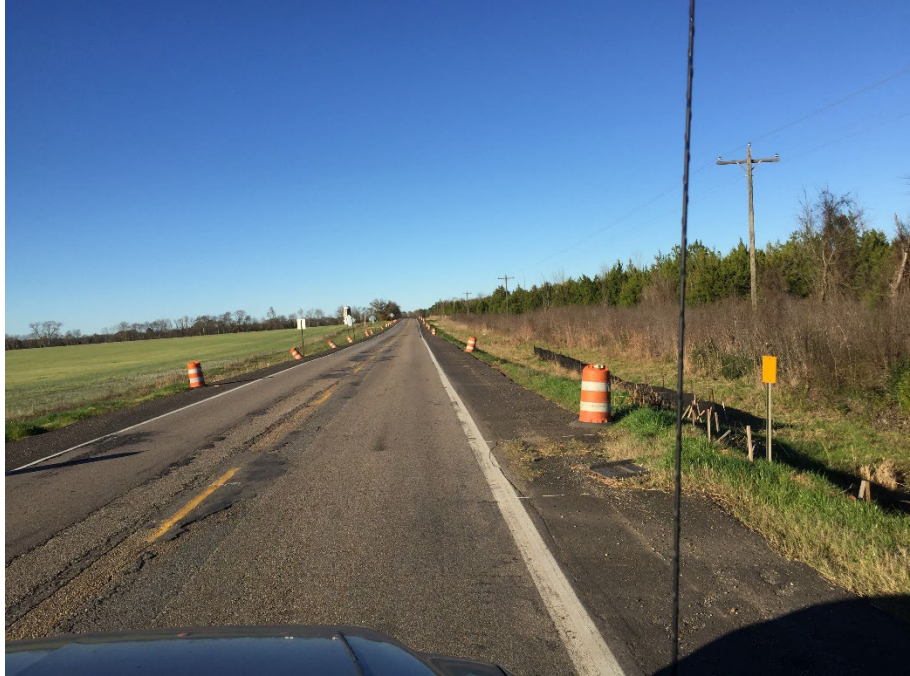
Longitudinal cracks observed in the paved shoulder section are shown in Figure 131. A pair of photos taken after the buildup of the paved shoulders is included as Figure 132

Figure 131: Longitudinal Cracks in Travel Lane at AL 5 Visible During Construction

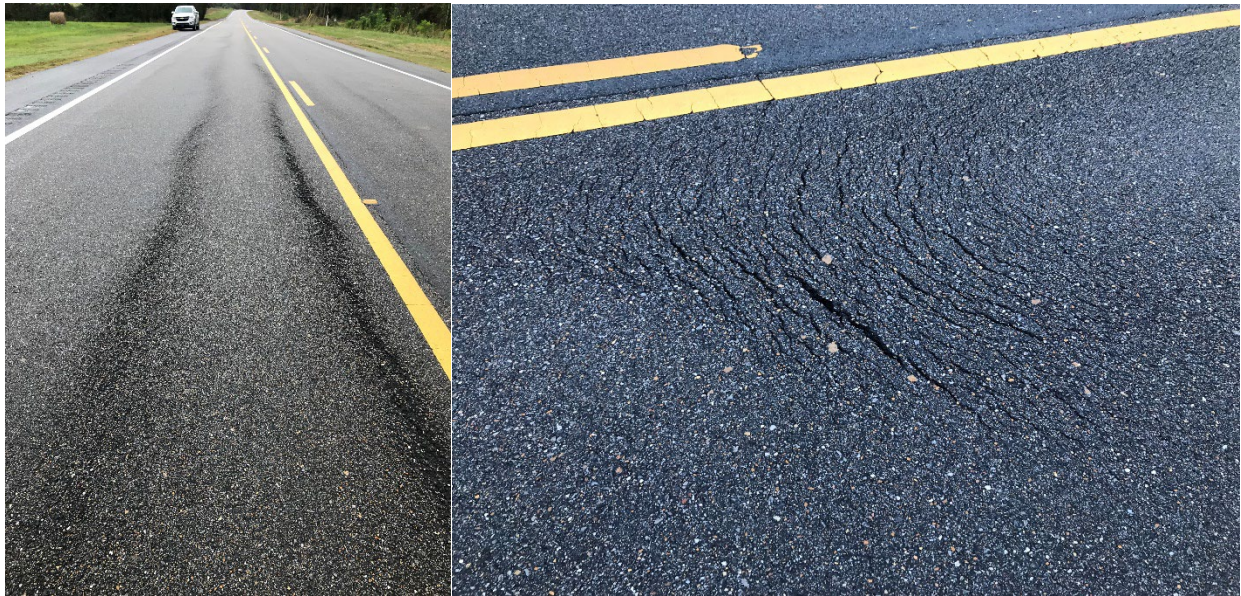
Figure 204: Visible Distress in paved shoulders section

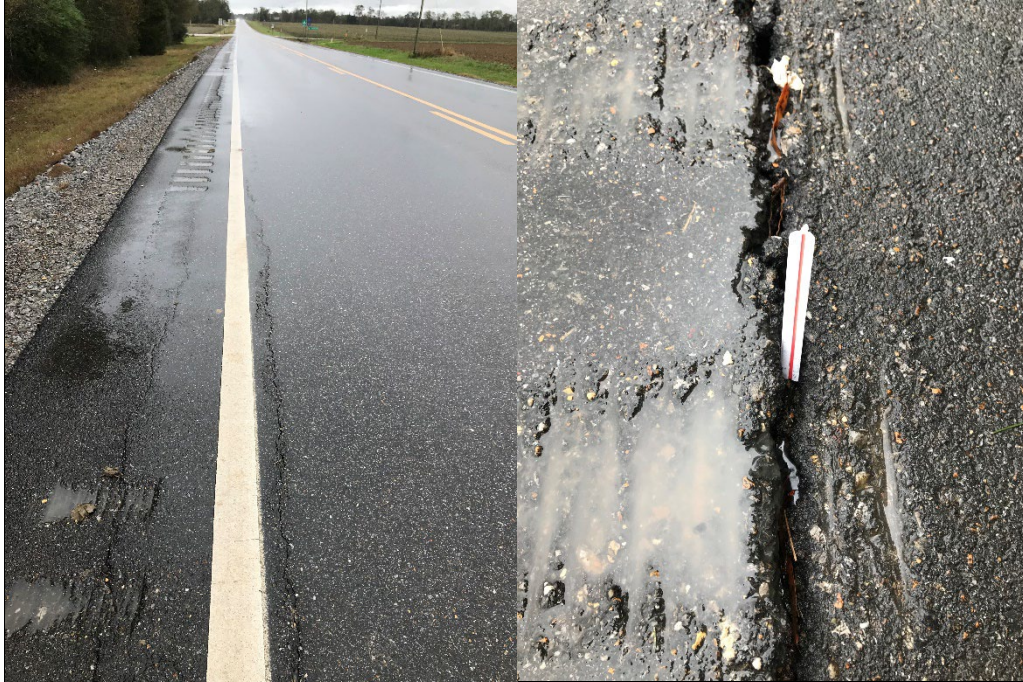
Figure 205: Vertical barrier section crack propagation

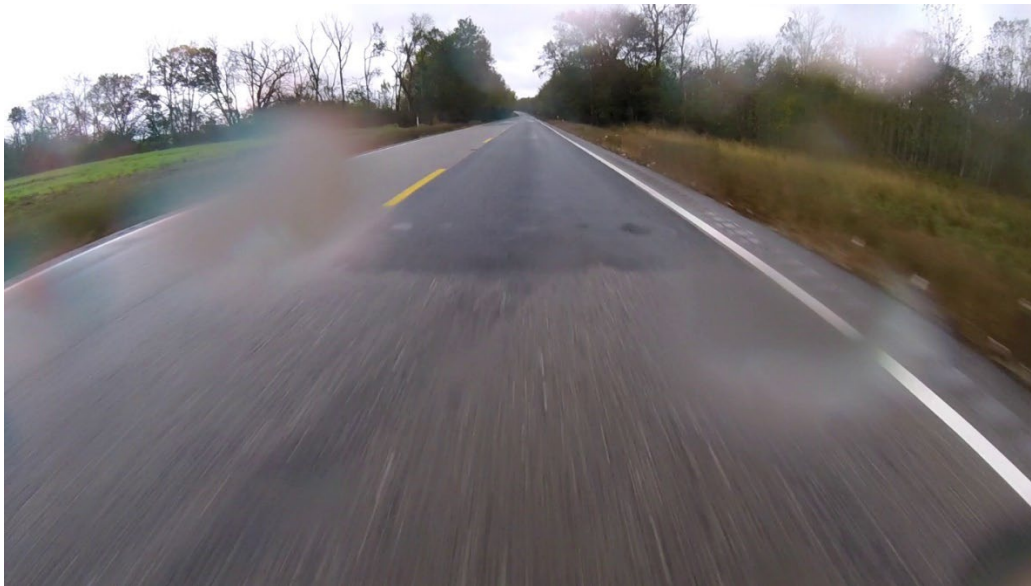
Figure 206: Severe pavement distress south of the Dallas County line

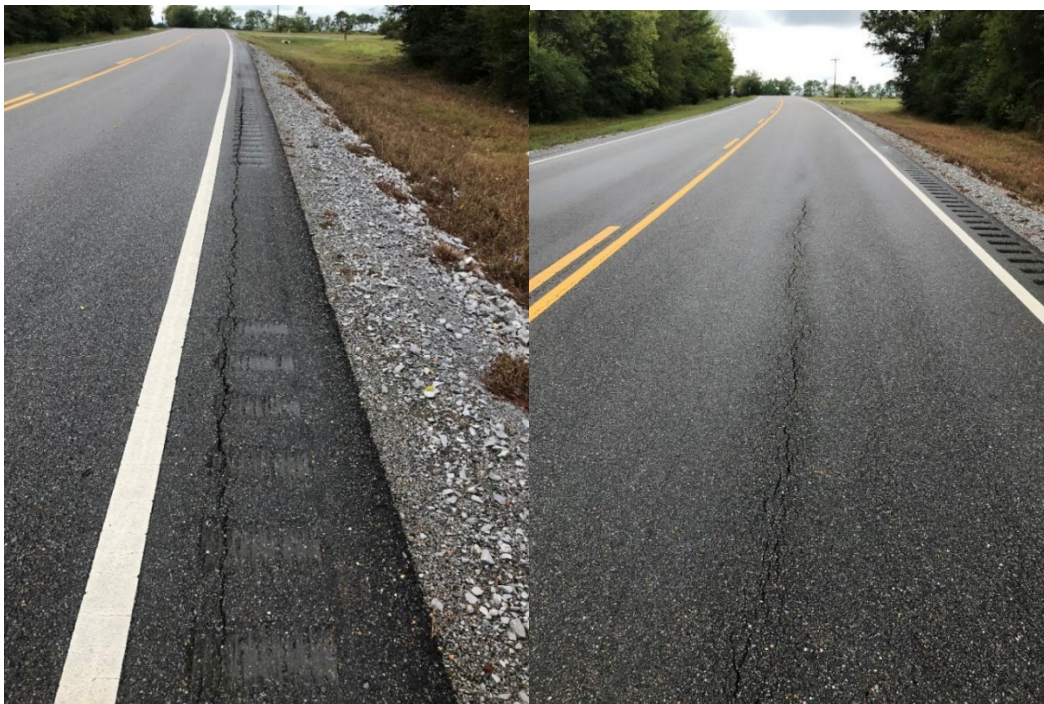
Figure 208: Shoulder and Lane Cracking in the Edge Drains

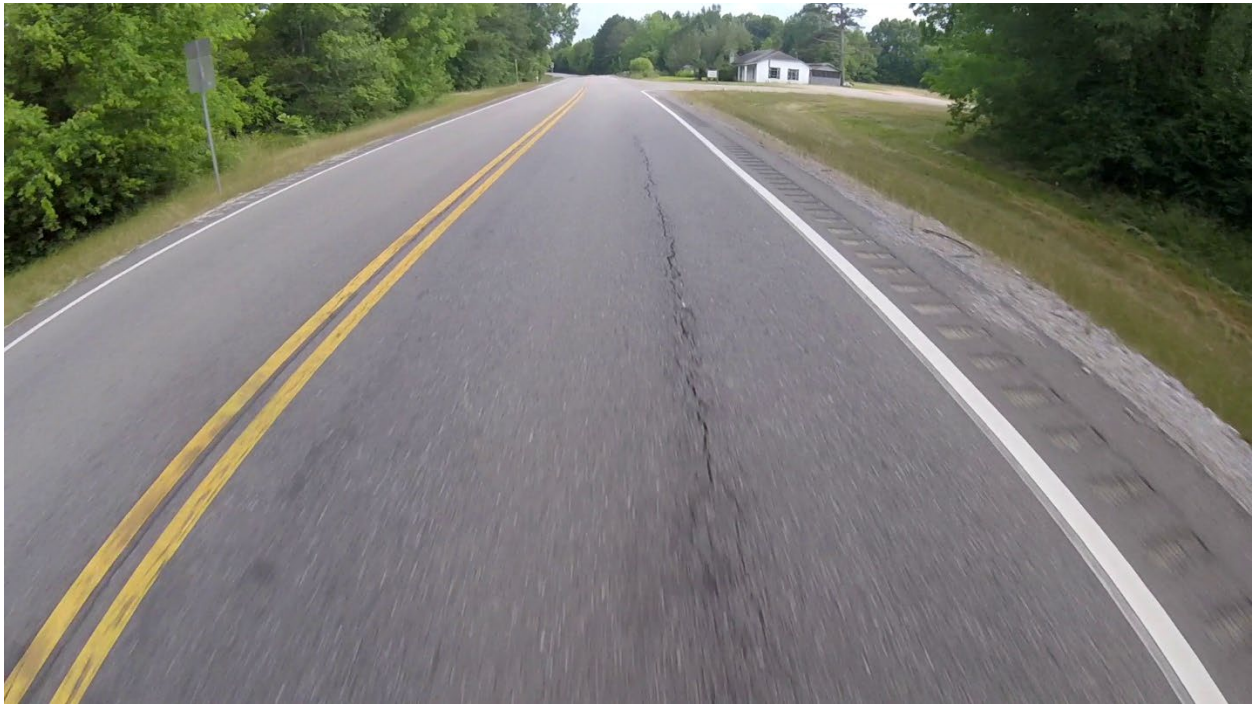
Figure 216: Cracking in Control Near Tree

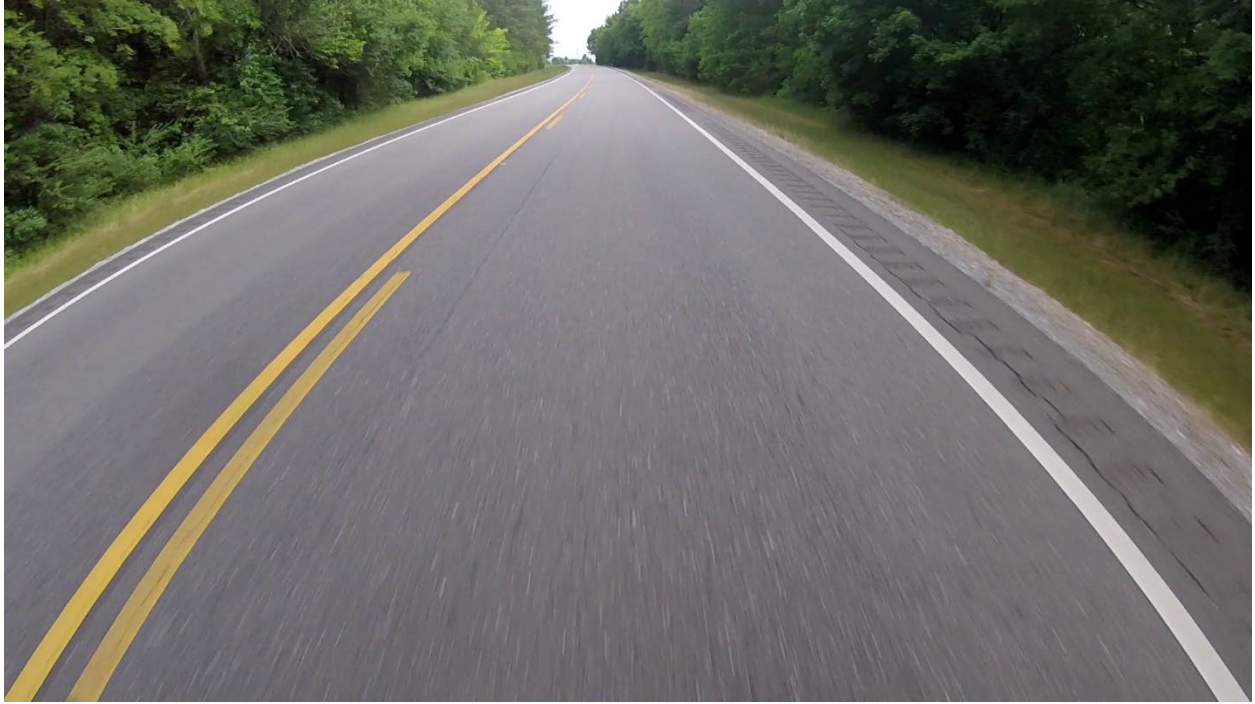
Figure 217: Cracking along Safety Widening in Edge Drains Section

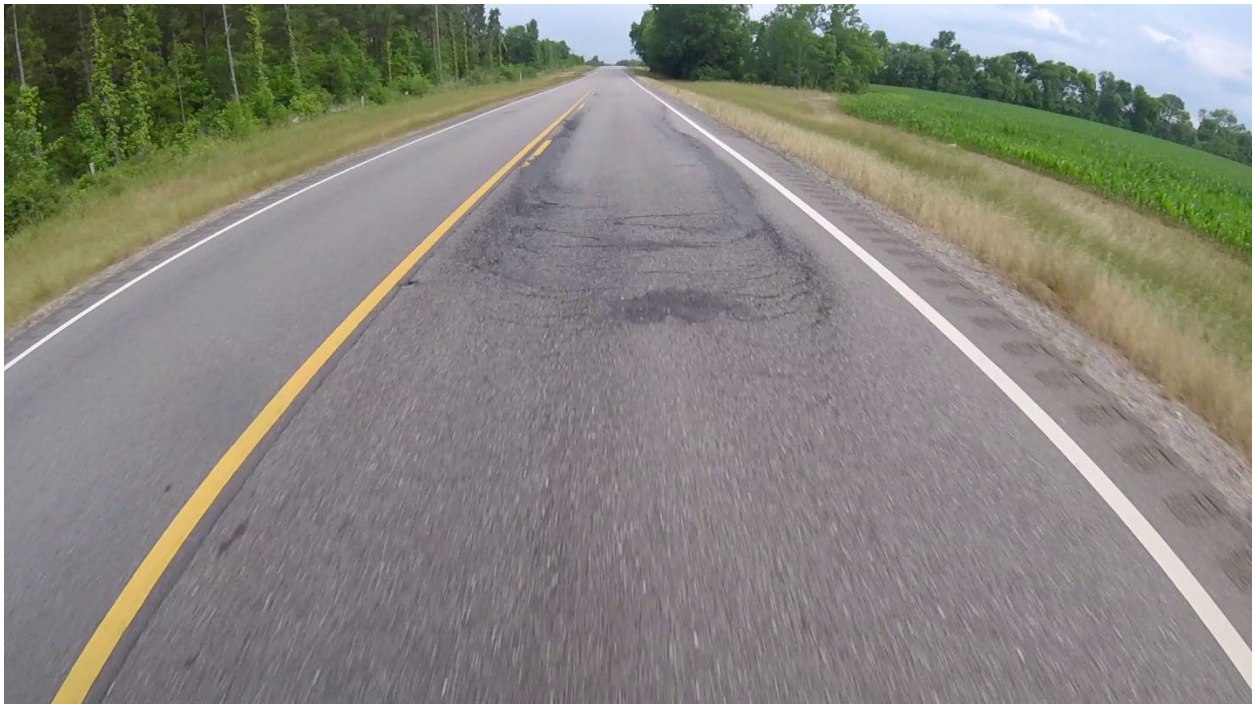
Figure 218: Shoving in Edge Drain Section

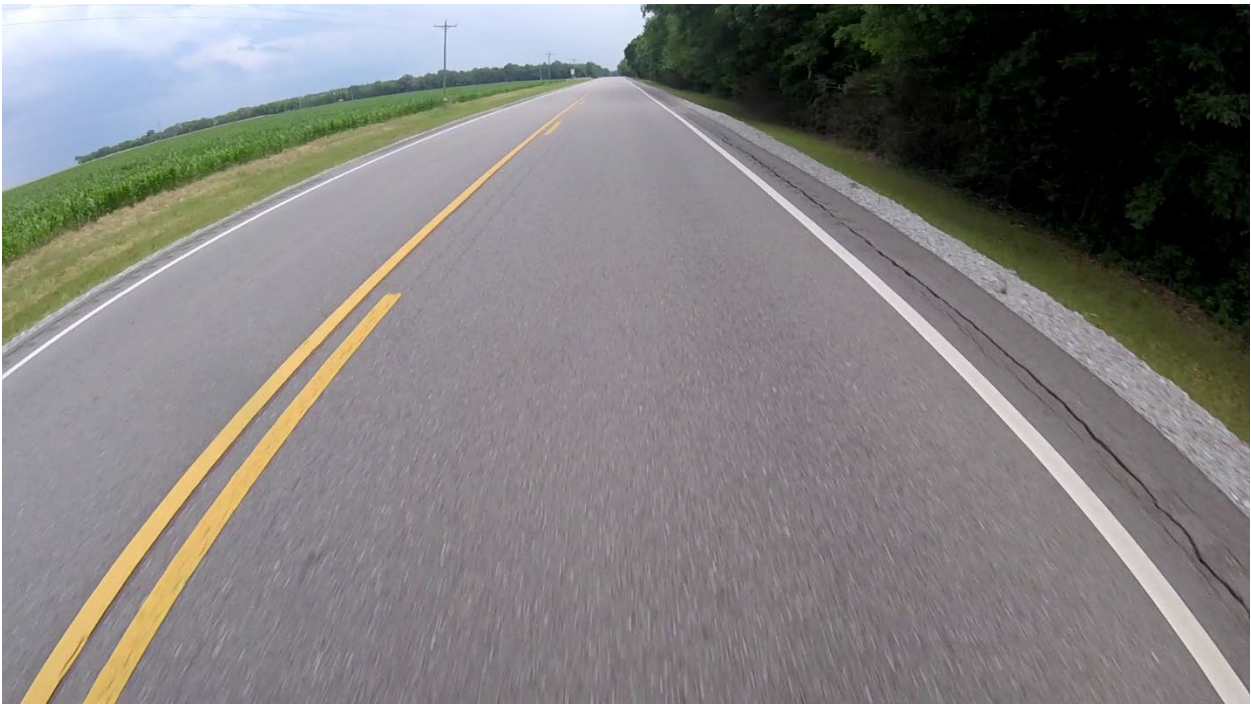
Figure 220: Opening Crack with Settlement in Safety Widening of Paved Shoulders

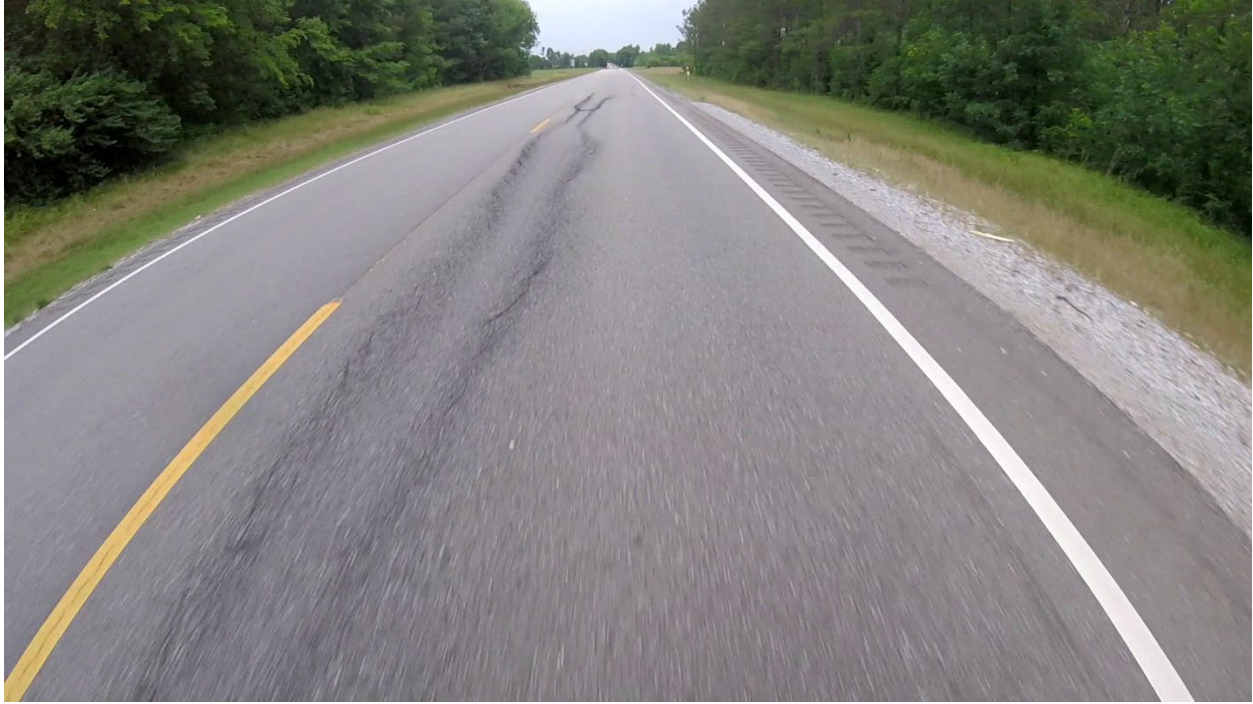
Figure 221: Pavement Surface Raveling in Control Section
