Effect of Long-Term Inactivity on Railcar Bearings – Year 1

A Report on Research Sponsored by

University Transportation Center for Railway Safety (UTCRS)

September 2024

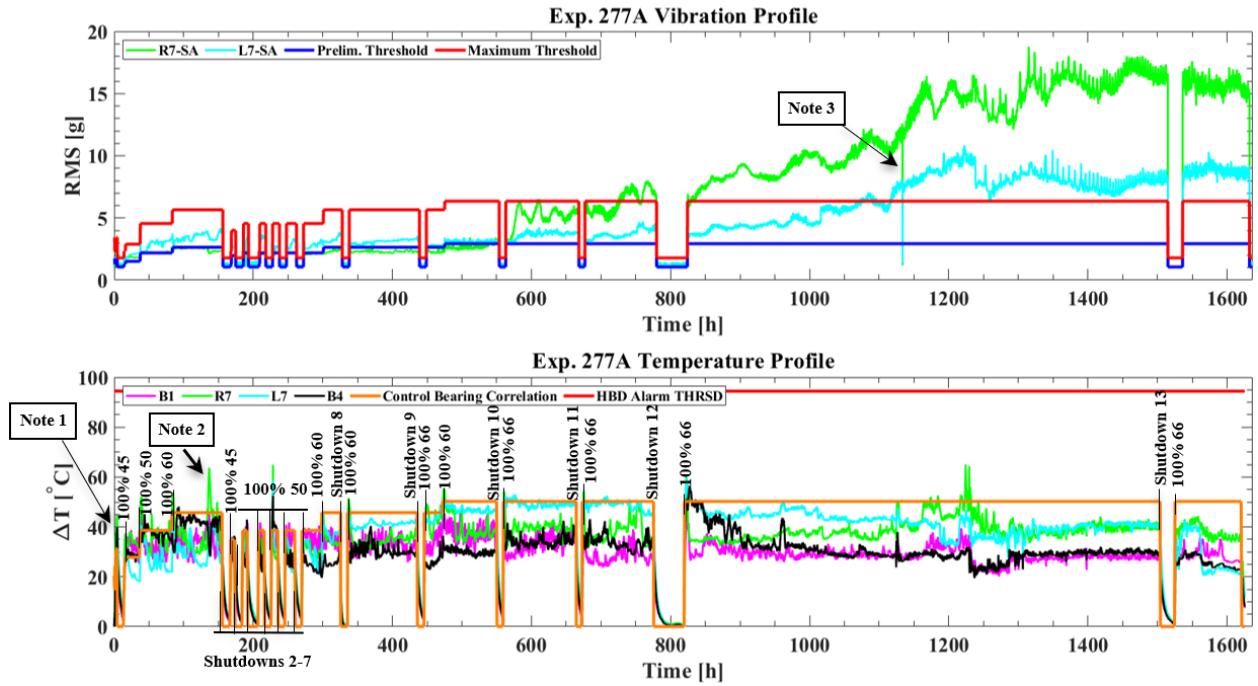
Examining the vibration profiles of Figure 5, it is apparent that the R7 bearing developed a defect around 724 hours into the test, as exhibited by the vibration levels exceeding the maximum threshold represented by the solid red line (i.e., level 1 vibration analysis described in reference [1]). In fact, the vibration profile of the R7 bearing suggests that the defect developed earlier, a little after 570 hours into the test, but the vibration levels did not exceed the maximum threshold until 724 hours into the test. As explained earlier, vibration levels that lie between the solid blue and red lines suggest that the bearing is possibly defective [1]. Interestingly, while the vibration levels clearly suggest that the R7 bearing developed a significant defect, the temperature profile was below the average operating temperature for healthy bearings running at the same speed and load conditions, and well below the HBD alarm threshold. Considering the significant damage observed on the R7 bearing components depicted in Figure 11-21 and summarized in Table 6, it is concerning that the bearing operating temperature did not exhibit any signs of distress.

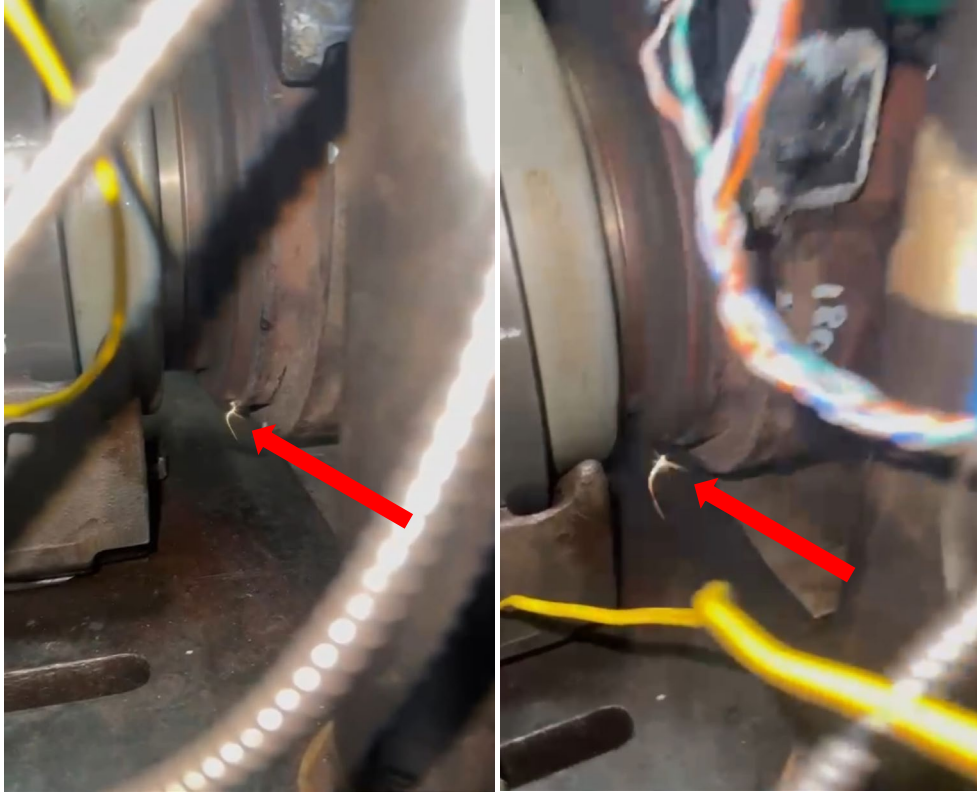
Figure 8: Pictures showing sparks emitting from the inboard seal location of R7 bearing

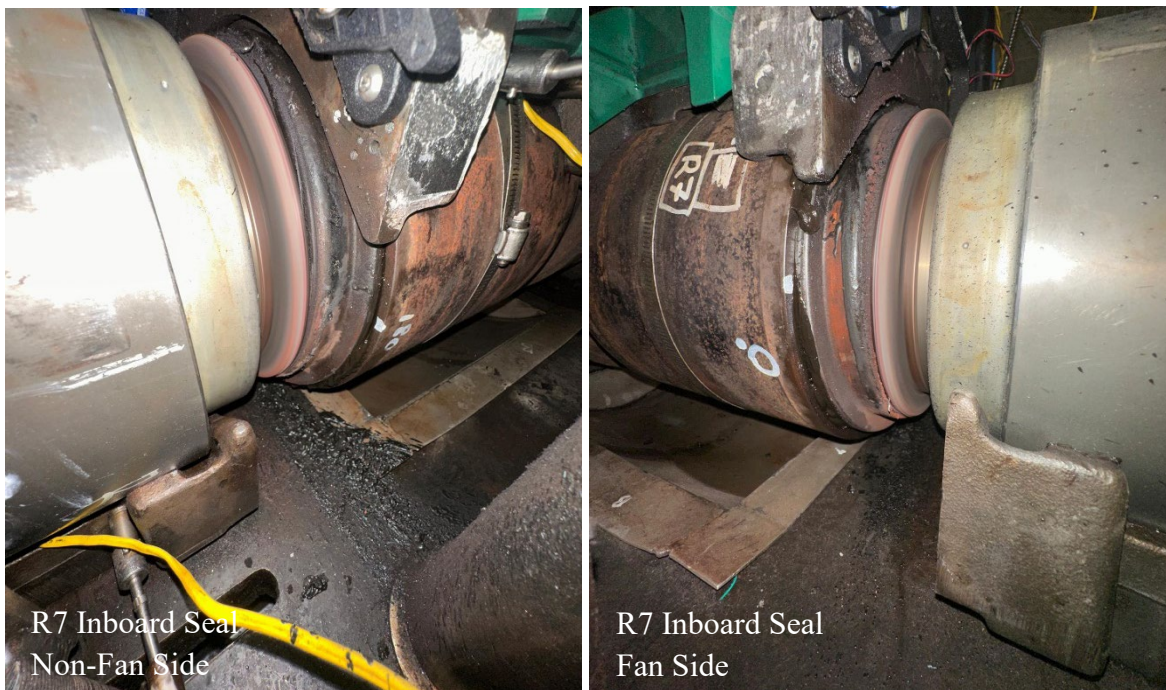
Figure 9: Picture of the inboard seal of bearing R7 that dislodged during testing. The face of the seal is no longer flush with the base of the seal that sits in the bearing cup

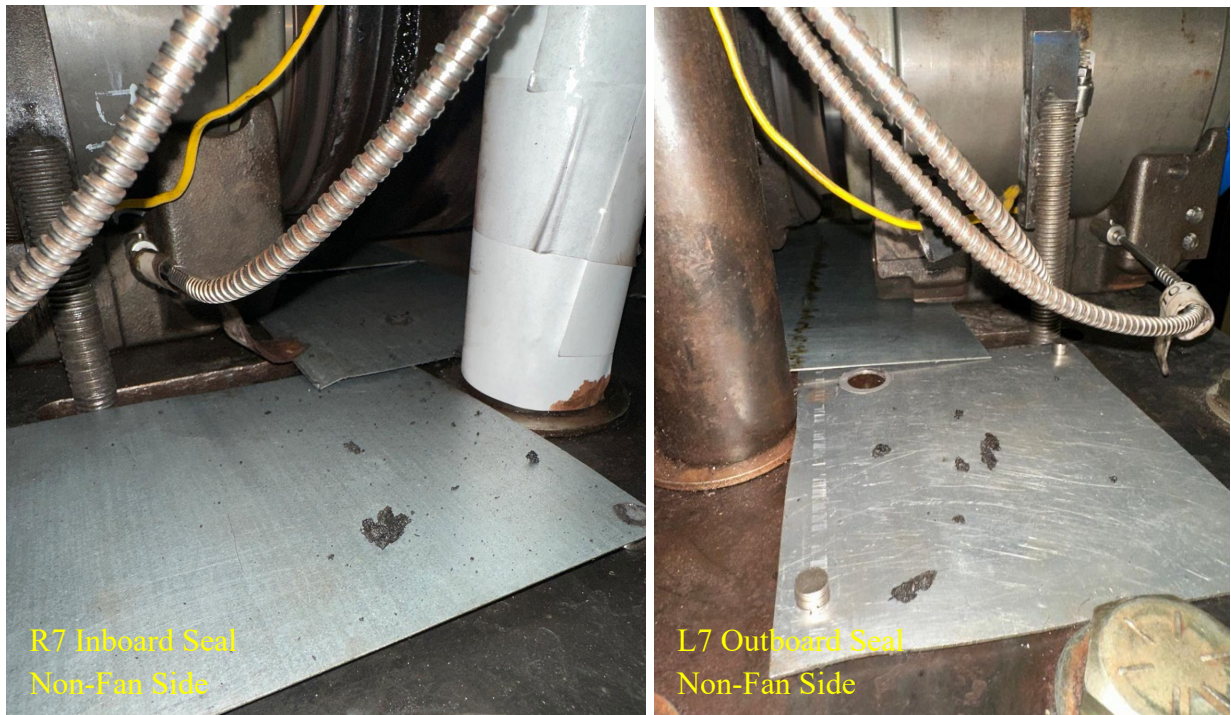
Figure 10: Pictures of the grease that was released from the R7 and L7 bearings around 19,000 miles from the start of the test

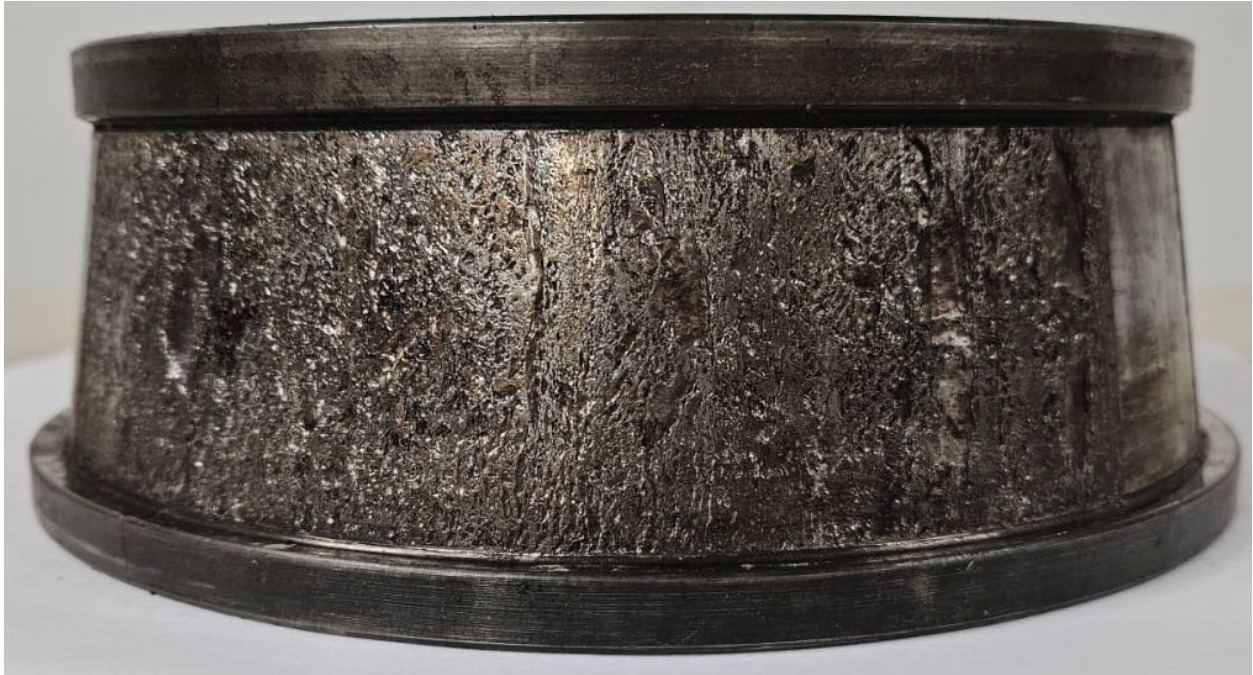
Figure 11: R7 inboard cone (inner ring) raceway – Picture 1

Figure 30: One of three parts of the R7 inboard cone spall which had a total area of 13.6 in² (refer to Figure 11)

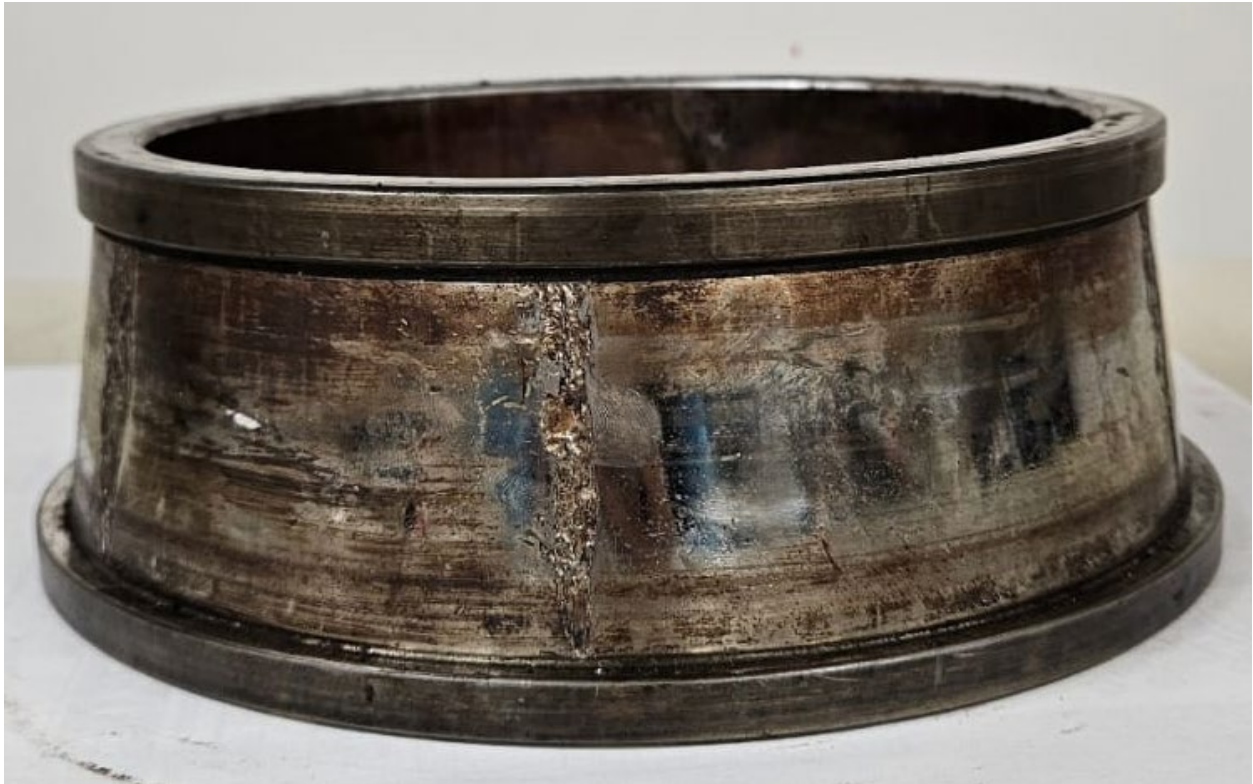
Figure 32: R7 inboard cone spall of Figure 12 with an area of 0.45 in² (left) and R7 inboard cone spall of Figure 14 with an area of 0.61 in² (right)

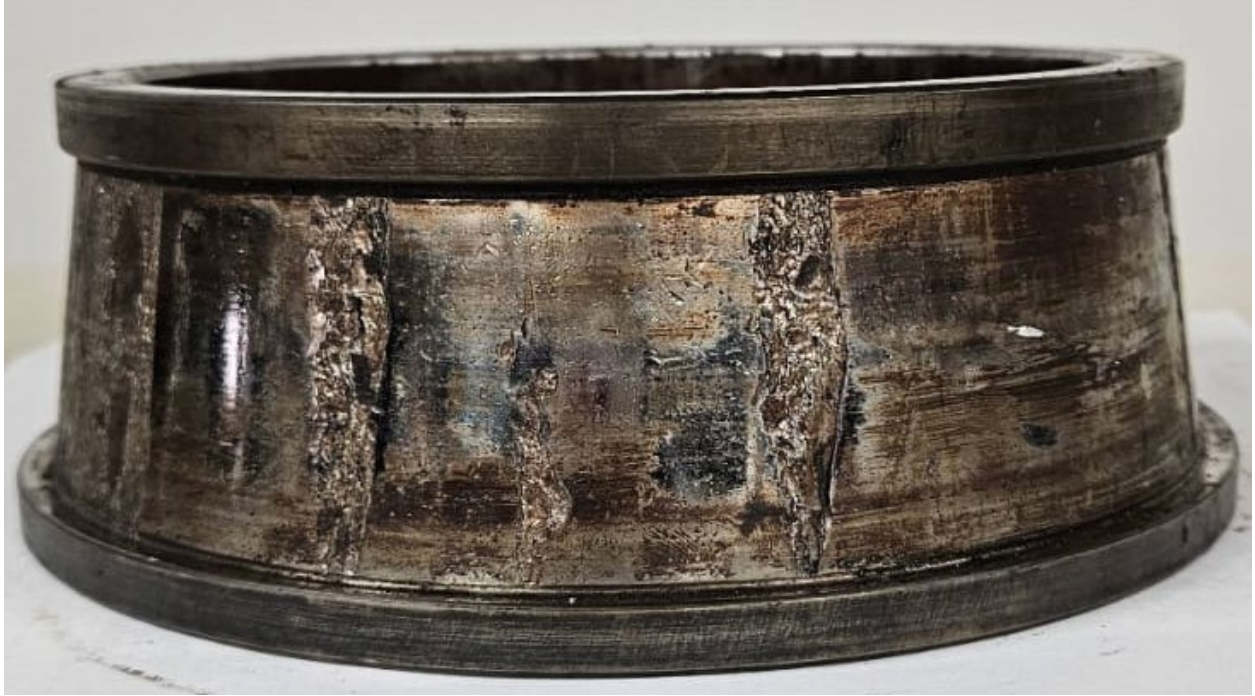
Figure 13: R7 inboard cone (inner ring) raceway – Picture 3

Figure 31: R7 inboard cone spall of Figure 13 with a measured area of 1.82 in²

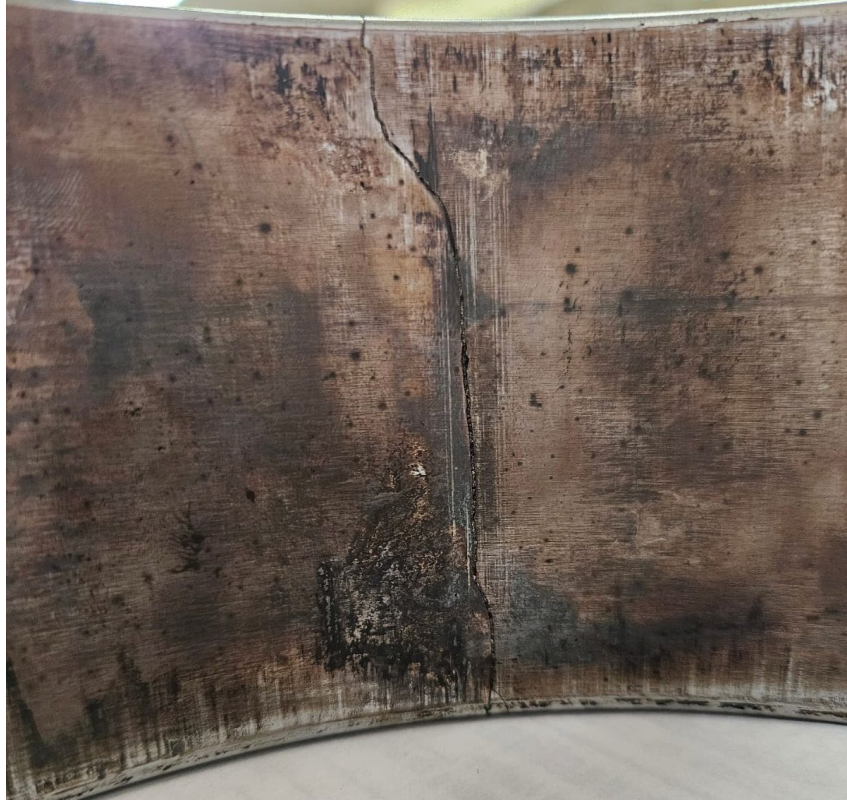
Figure 15: R7 inboard cone (inner ring) raceway with crack spanning its entire width

The visual inspection revealed that only components in the R7 bearing had critical damage on both cone raceways and the cup outboard raceway, with the inboard cone showing a deep crack along the entire width circumference. Careful documentation of the damage observed on the different components of the R7 bearing was done by performing detailed spall area measurements. The latter was accomplished by creating an imprint of each spall using molten bismuth, and then utilizing image processing software to accurately quantify the spall area. More information about this process can be found elsewhere [2]. The following pictures present the different bismuth imprints created to quantify the spall (damage) area. In the case of the large spall that developed on the inboard cone (inner ring) of R7 bearing, three imprints were created for better accuracy. Table 6 summarizes the spall area measurements taken and their percentage of the total raceway surface area for an AAR Class F bearing.

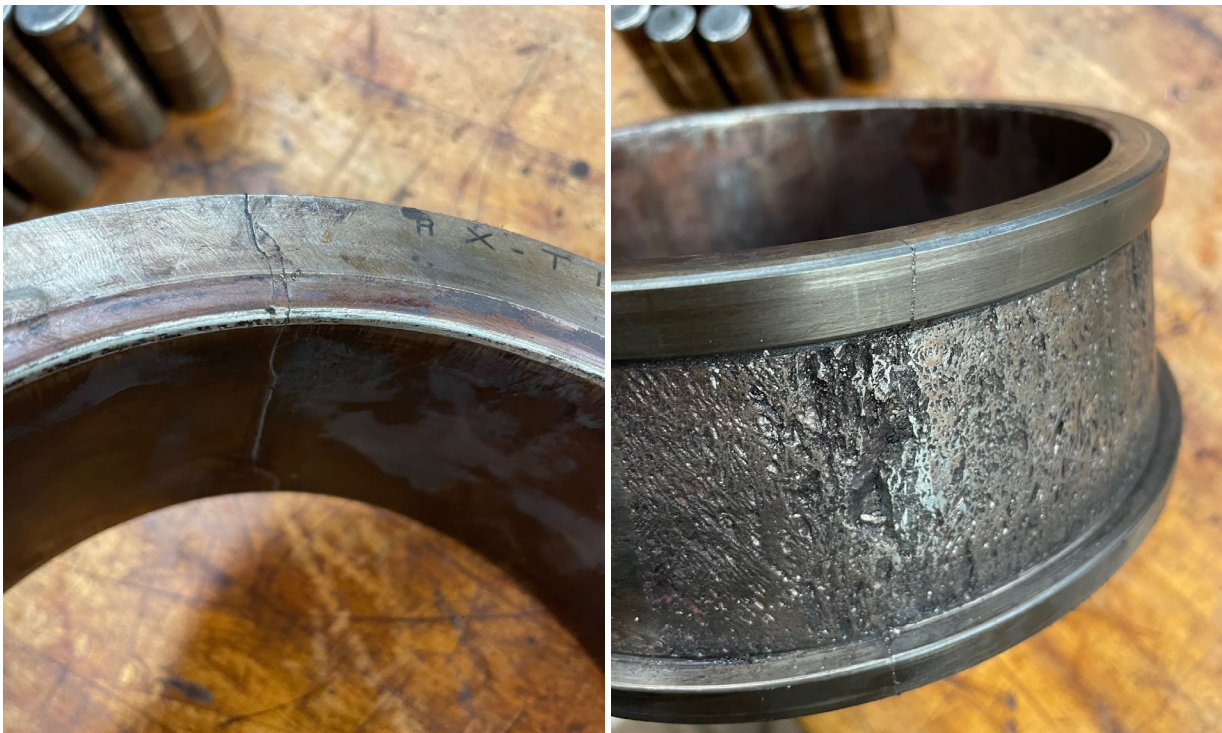
Figure 16: R7 inboard cone (inner ring) raceway showing crack along the width

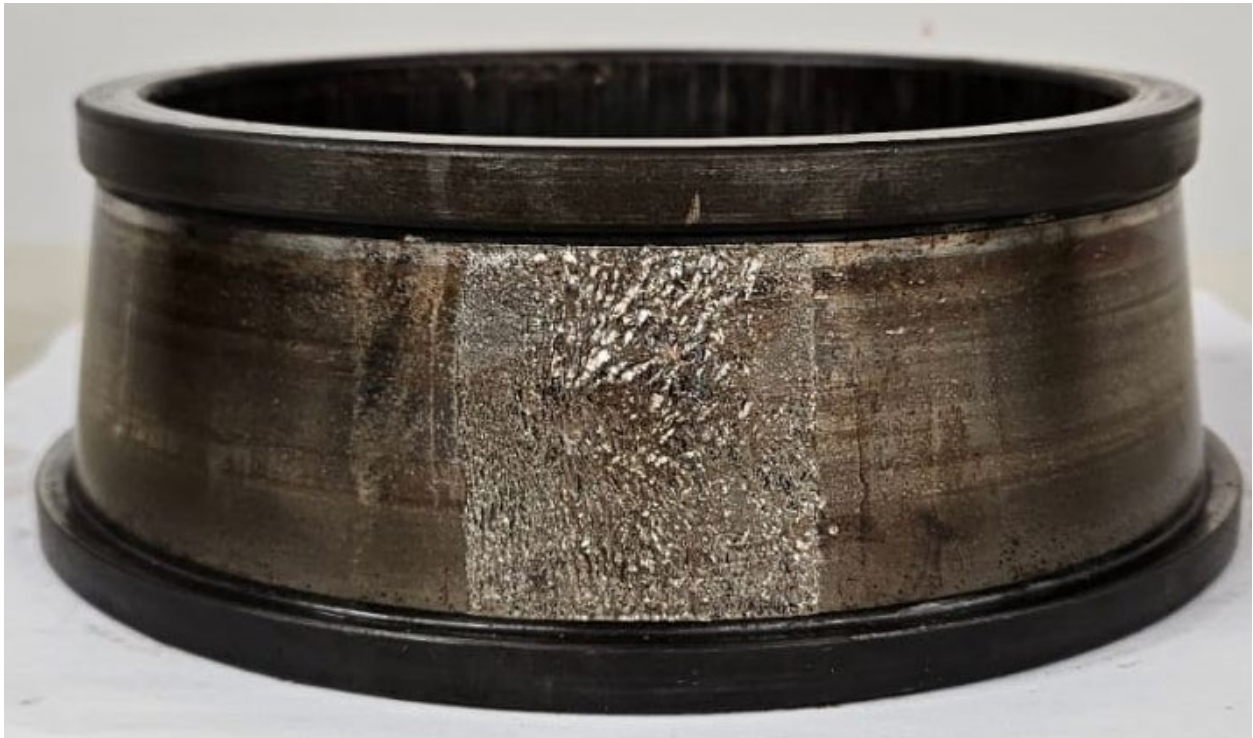
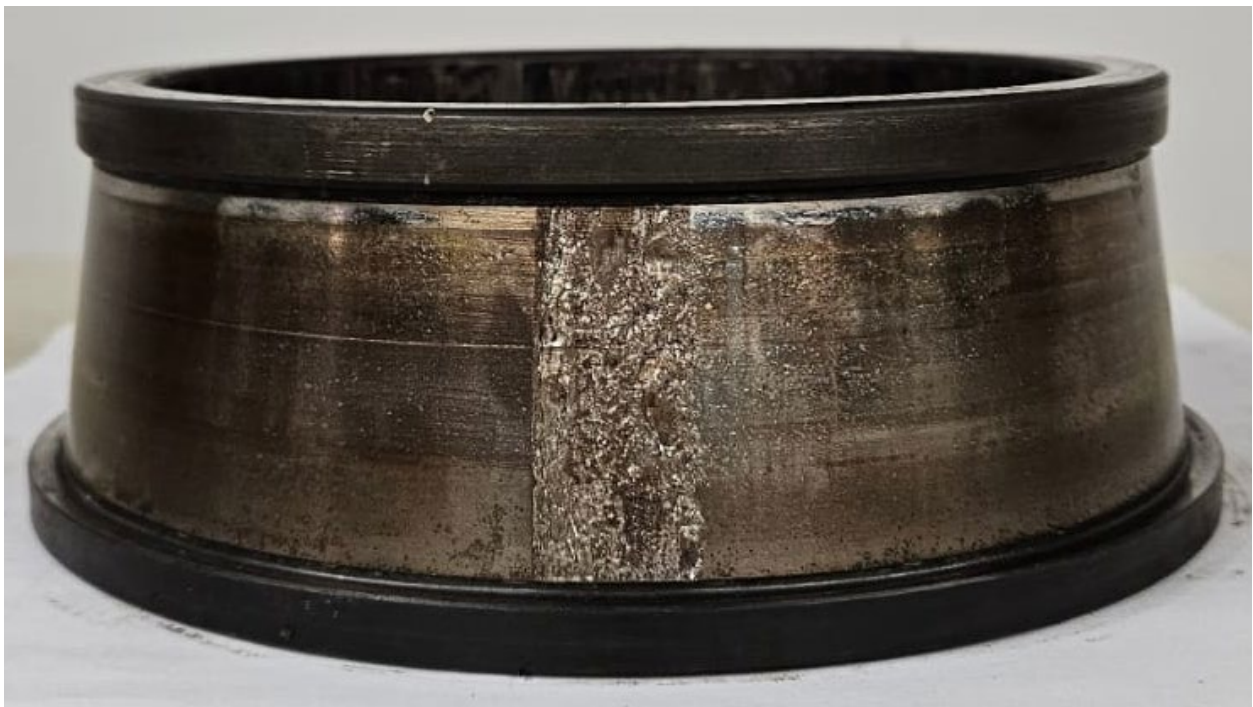
Figure 33: R7 outboard cone spall of Figure 17 with a measured area of 2.47 in² (left) and R7 outboard cone spall of Figure 18 with a measured area of 1.43 in² (right)

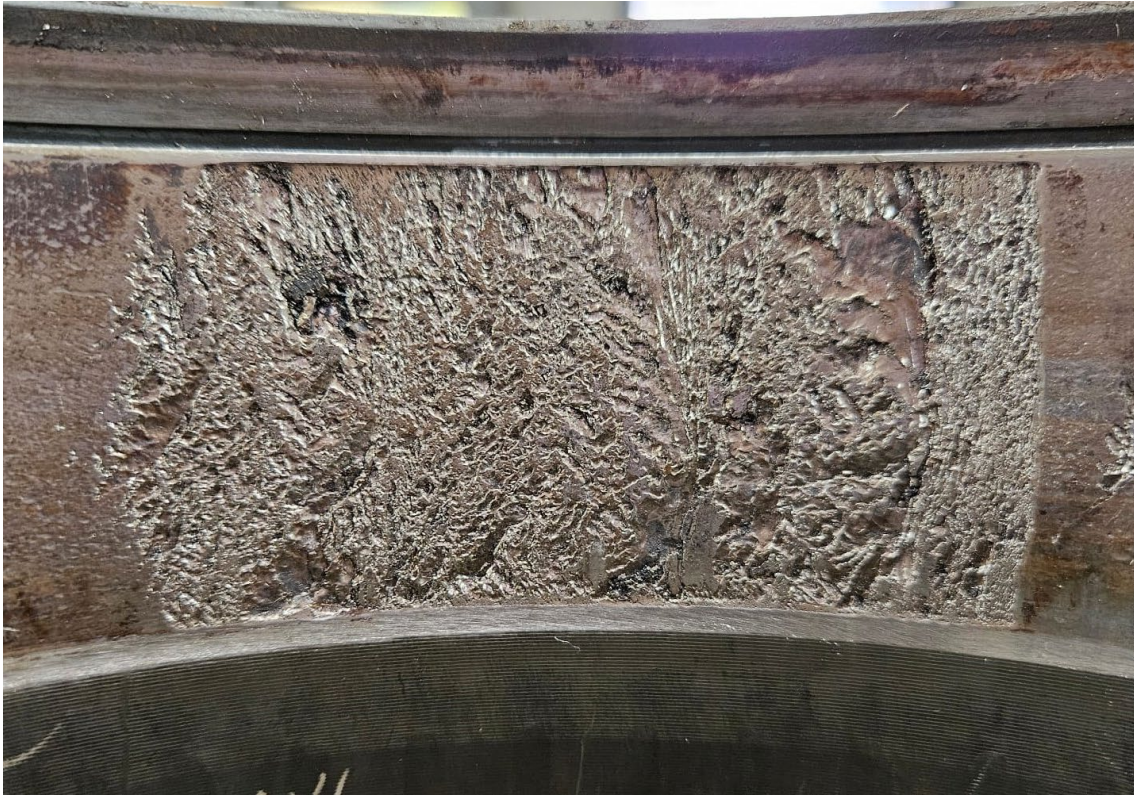
Figure 19: R7 cup (outer ring) outboard raceway damage on loaded side

Figure 34: R7 cup outboard raceway spall of Figure 19 with a measured area of 7.88 in²

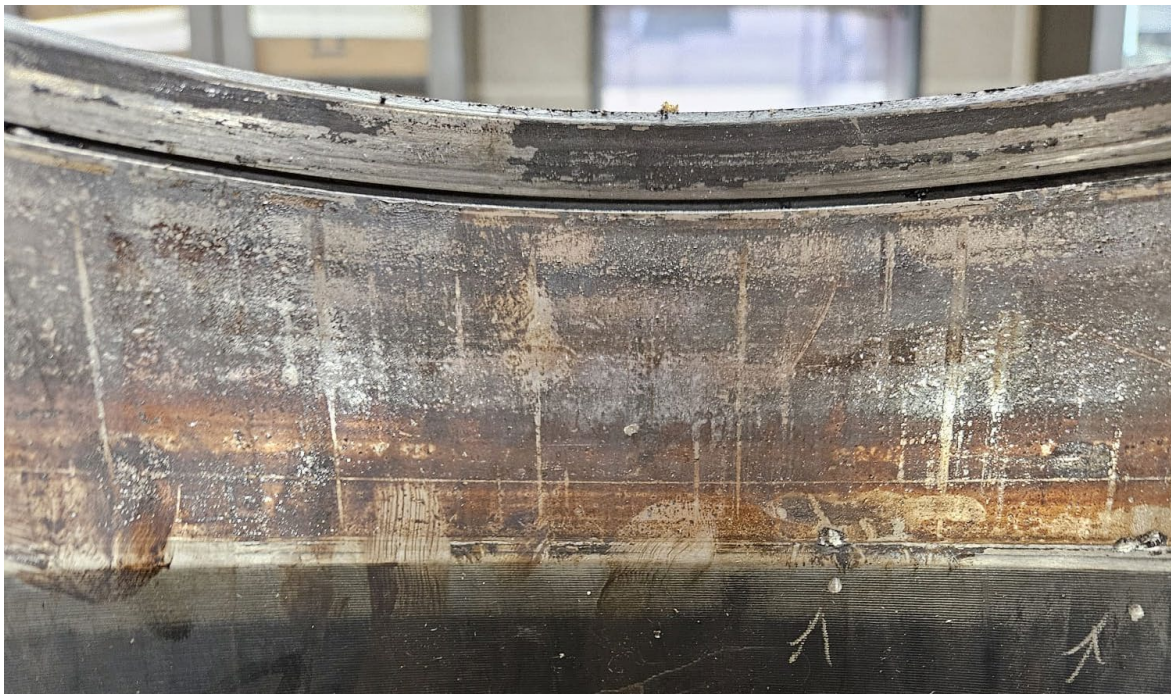
Figure 20: R7 cup (outer ring) inboard raceway on loaded side showing repaired spalls

Not surprisingly, the inboard side of R7 bearing, which is the side with the dislodged seal, exhibited the most damage, with 38.1% of the total cone raceway area being damaged. Interestingly, the cup inboard raceway showed no signs of notable damage other than some small pits and accelerated surface wear. However, the outboard raceway of the cup sustained damage on the loaded portion covering 13.8% of the total cup outboard raceway. In total, the damaged area within the R7 bearing was 28.26 in², which represents 14.1% of the 200.38 in² of total surface area for all four raceways in an AAR Class F bearing (two cone raceways and two cup raceways).

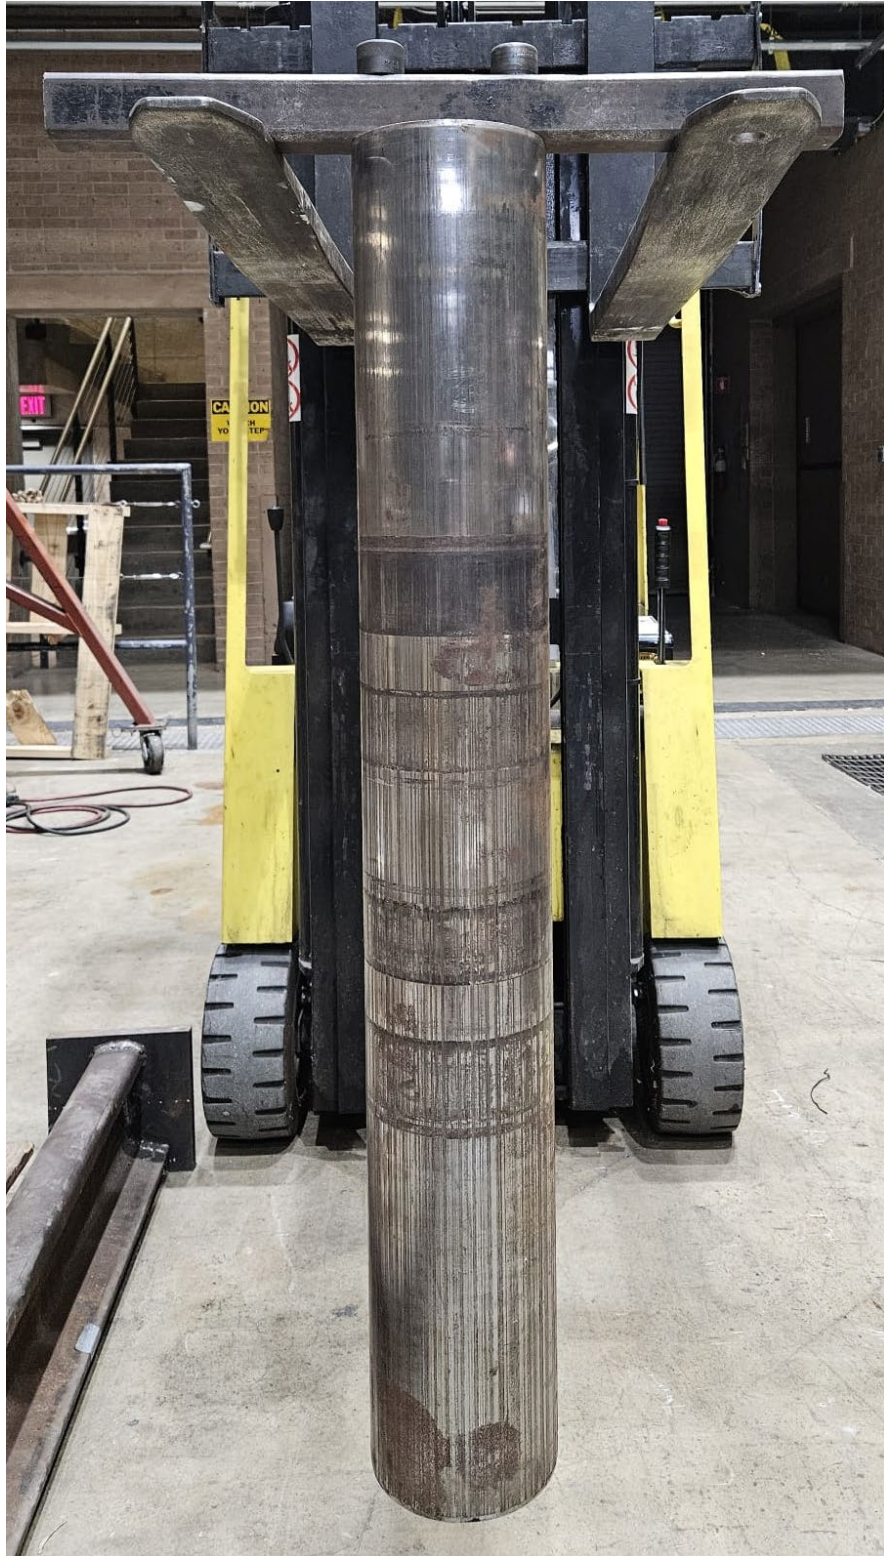
Figure 29: Test axle post press-off showing significant heat tinting in the location where the R7 inboard cone assembly was positioned
