U.S. Department  
of Transportation

**National Highway  
Traffic Safety  
Administration**

DOT HS 813 644

# **A Teardown Study of Flood-Damaged Electric Vehicles**

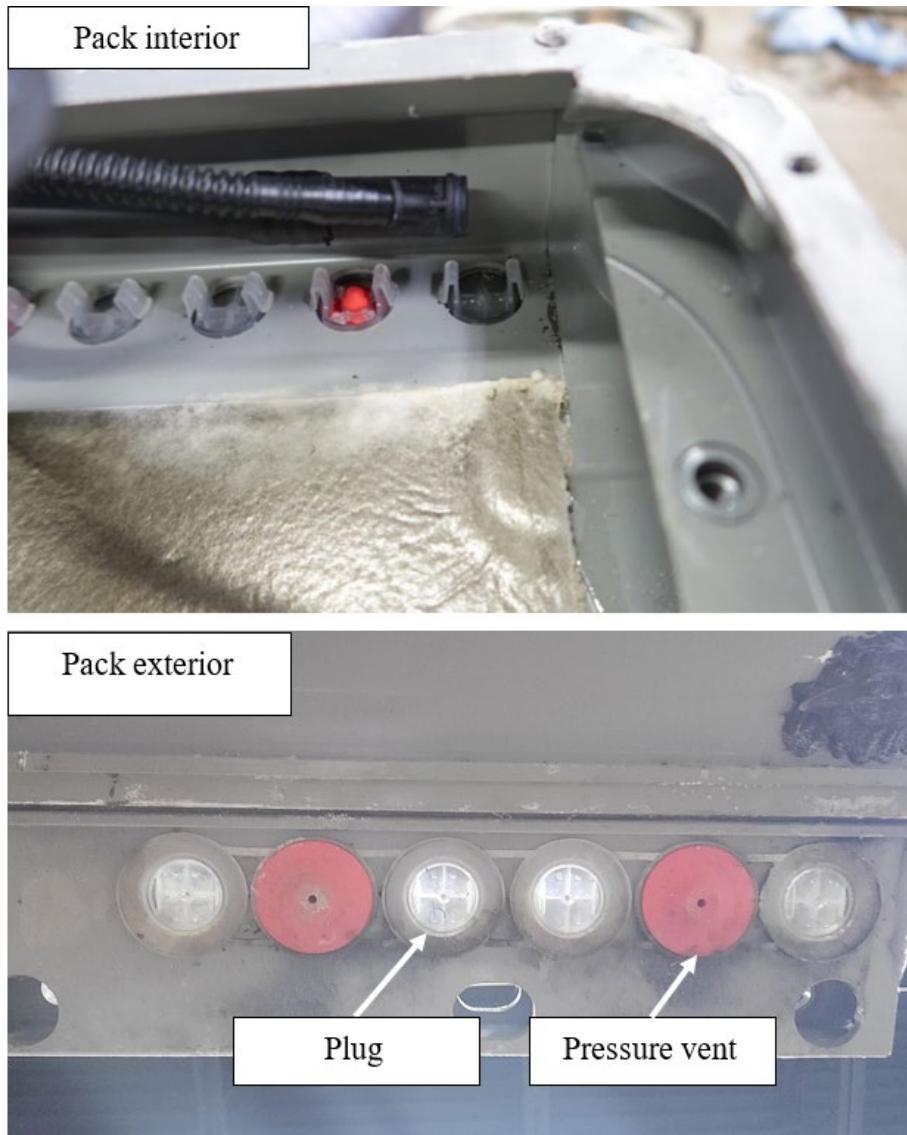
Several pressure vents lay along both side sills of the pack. The compartments for each battery module, except for the two closest to the penthouse, had a pressure vent assembly, as shown in Figure 12. Each module compartment vent assembly had two actual vents and four dummy vents (plugs) for a total of six holes in the side sill per compartment. The plugs could easily be converted into vents, if needed, for additional vent capacity, but this feature was apparently not needed. However, this left four additional holes to be sealed per applicable module compartment, creating several unnecessary potential leak paths that could have been avoided.

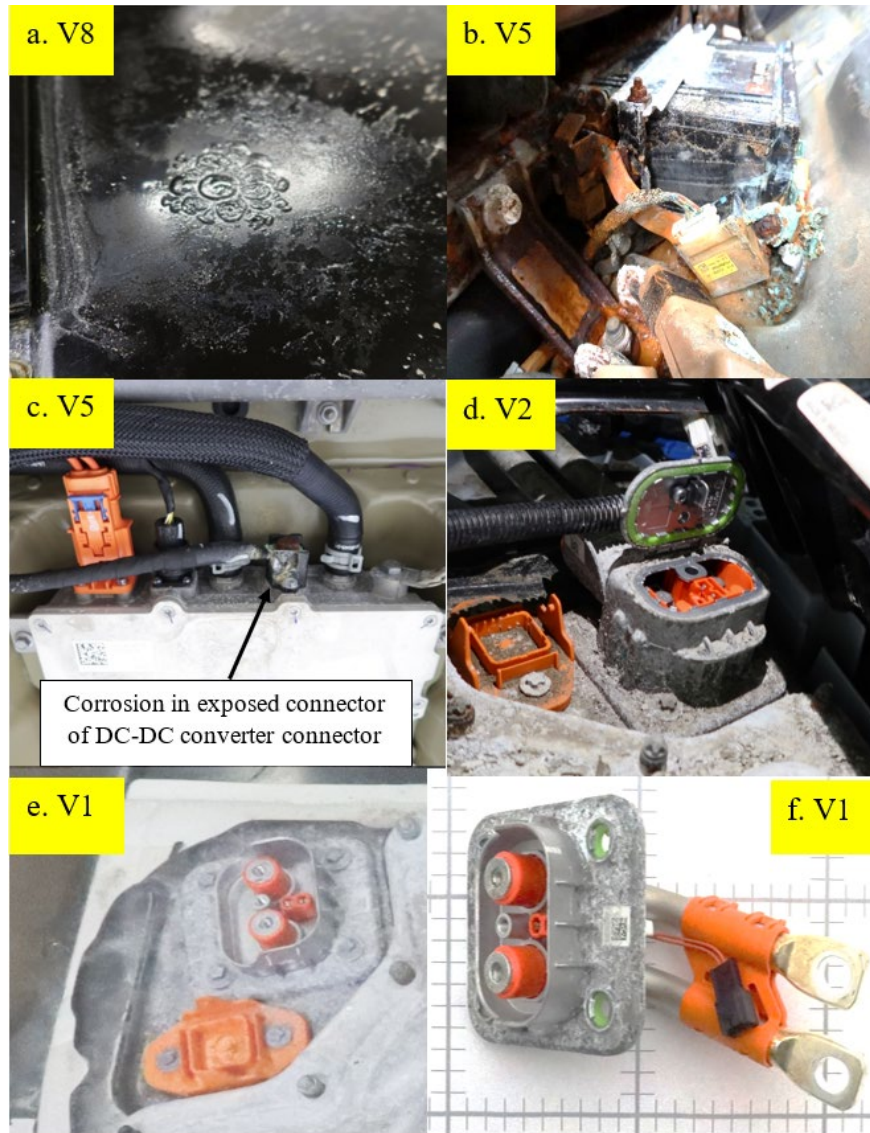
Figure 20. (a) Areas of corrosion were observed on the battery lid surface of V8. (b, c) The primary 12-volt battery and surrounding components located under the second-row passenger seat cushion exhibited excessive amounts of corrosion in V5. (d) The corrosion on the exterior of the same connector of V2 was so severe the two halves could not be separated without causing damage to the connector and surrounding components. (e, f) The on-board penthouse charging connector showing distinct corrosion outside for V1; the interior showed no corrosion.

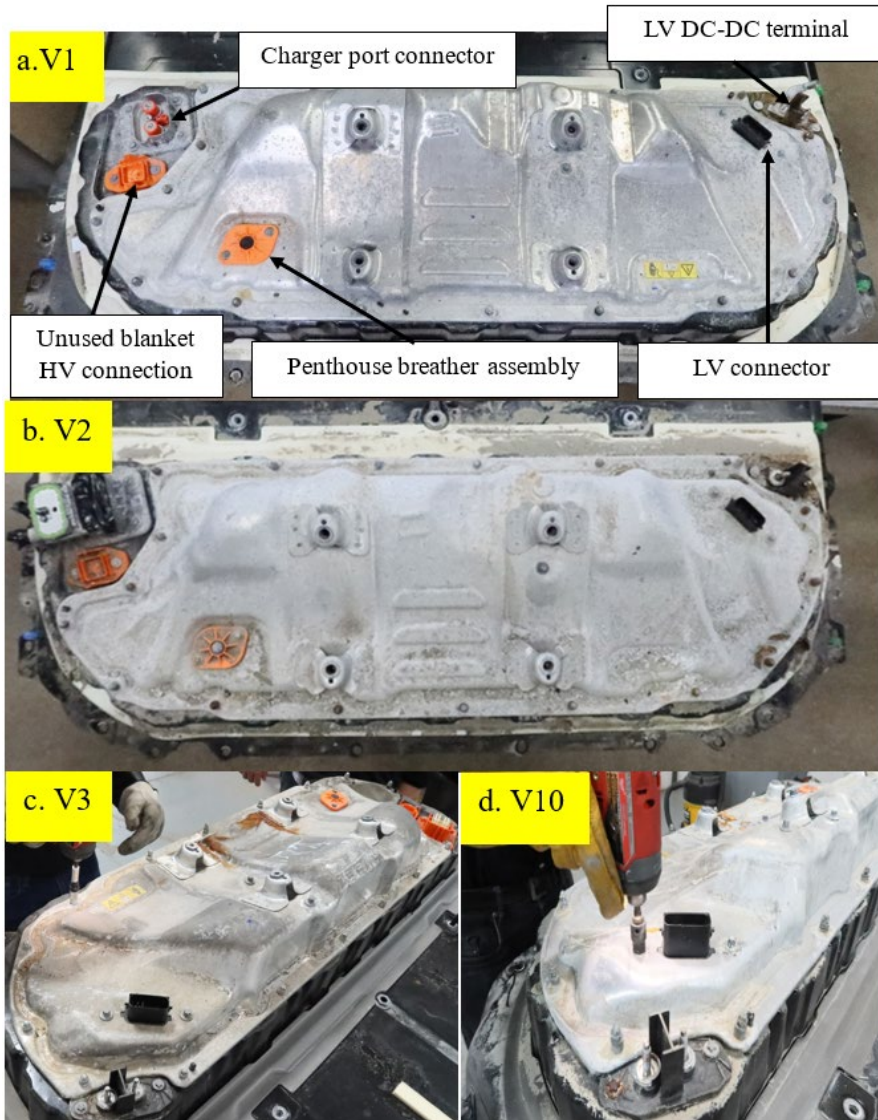
Figure 21. Penthouse exterior cover showing distinct saltwater-induced corrosion

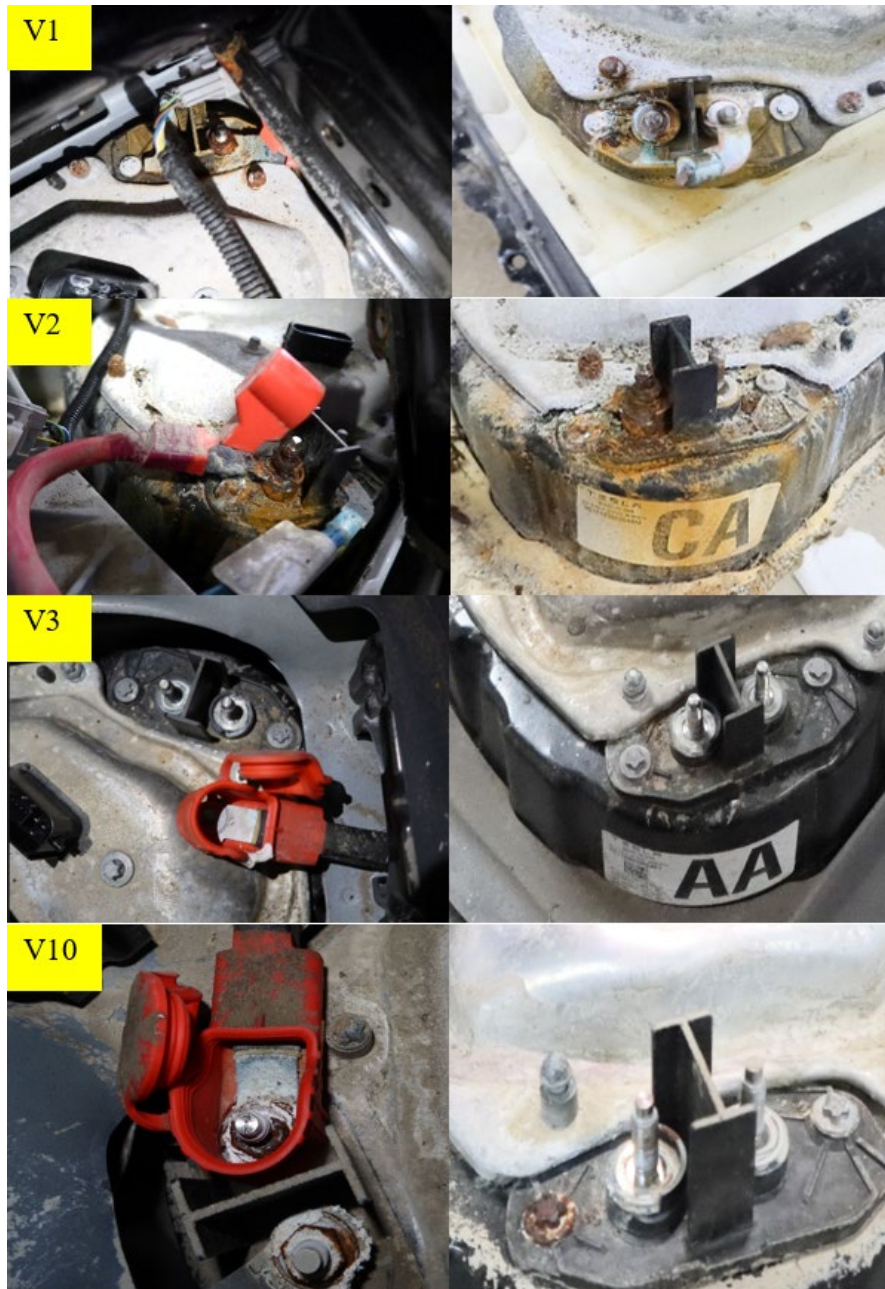
*Figure 22. The front-right corner of the penthouse compartment shows two exposed terminals linking the DC-DC converter output to the LV system EDS.*

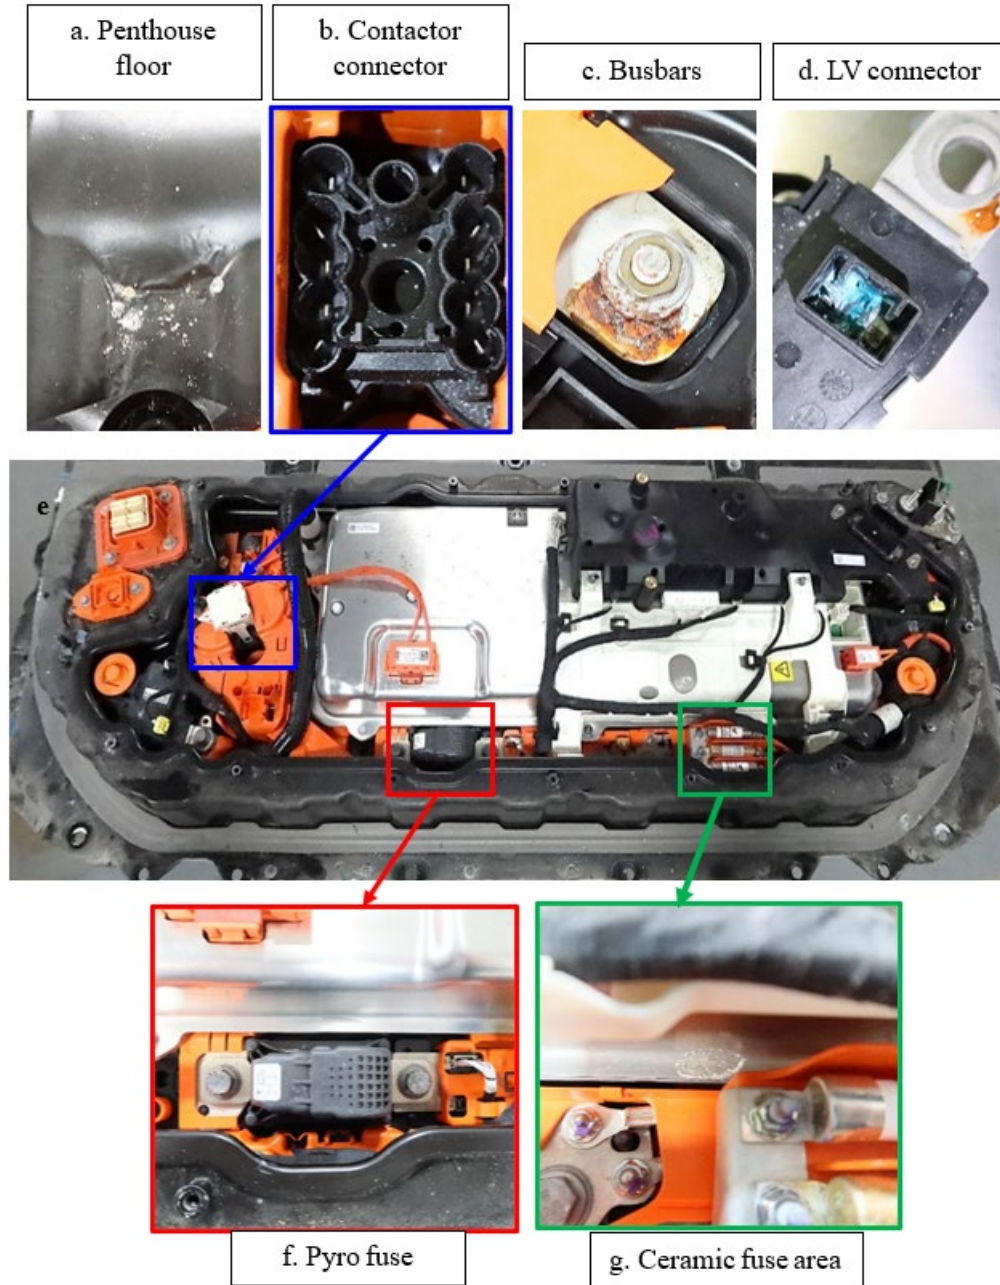
Figure 25. The internals of the penthouse of V3. The presence of water, water marks and residues, contaminations, and corrosion are highlighted in the figure insets.

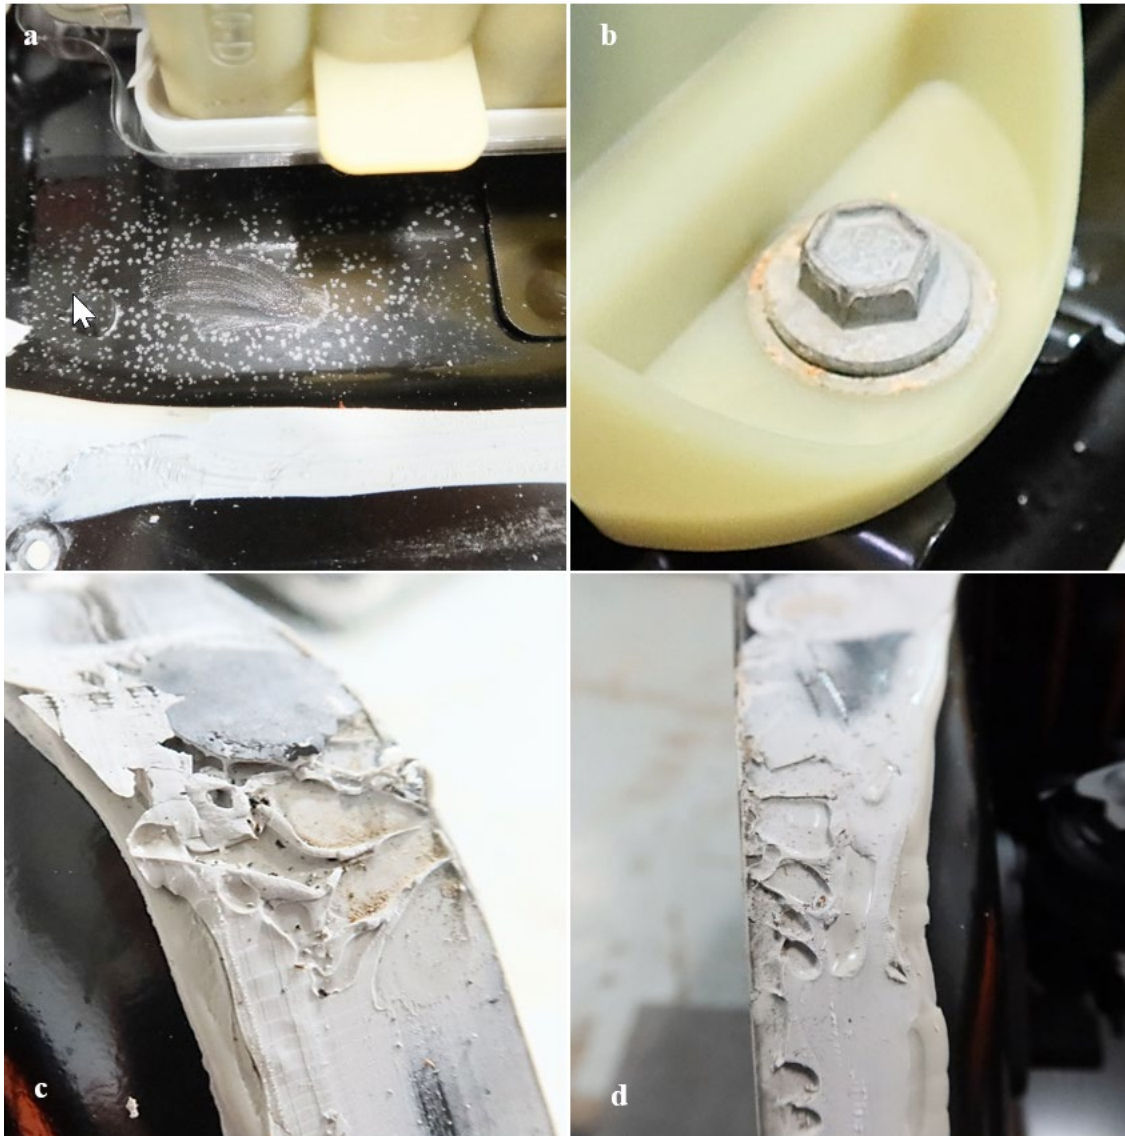
perimeter seal at a complex curve near the front-right corner, as shown in Figure 30(c–d), possibly due to trapped air and/or inadequate clamping load prior to curing of the seal.

*Figure 30. Observation inside the V10 battery pack: (a) water residue (note smear) underneath battery module, (b) corroded module fastener, (c) defective appearance of the lid seal, and (d) air pockets in another area of the seal, which did not result in ingress (bottom right)*

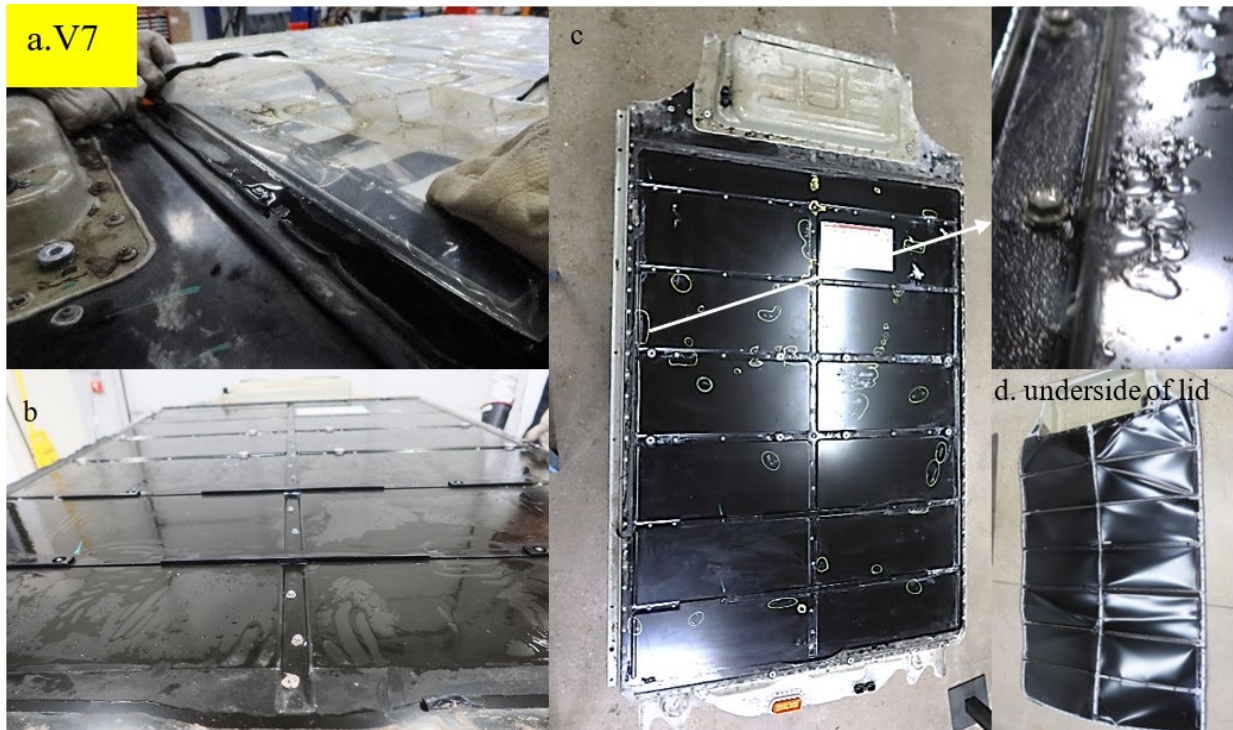
*Figure 36. V7 battery pack after removal from the vehicle: (a) V7 battery pack exterior showing failed plastic cover, (b) water underneath plastic cover, (c) marked corroded areas, and (d) corrosion free lid underside*

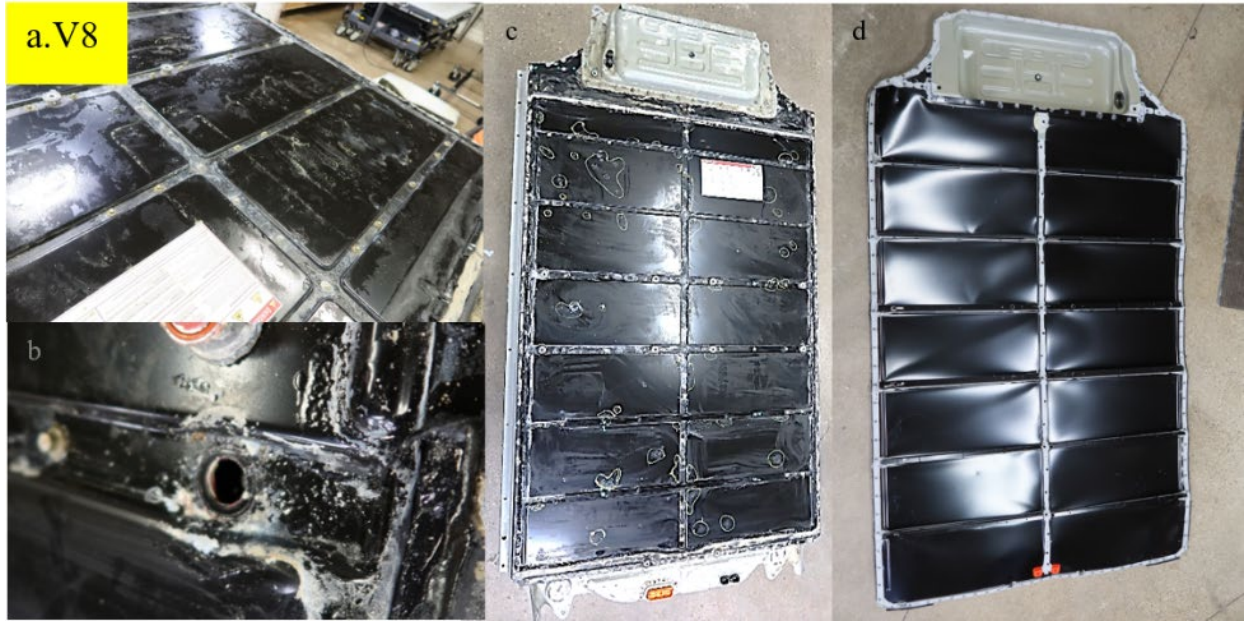
*Figure 37. V8 battery pack after removal from the vehicle:  
(a) water underneath plastic cover, (b) salt residue near a fastener, (c) marked corroded areas,  
and (d) corrosion free lid underside*

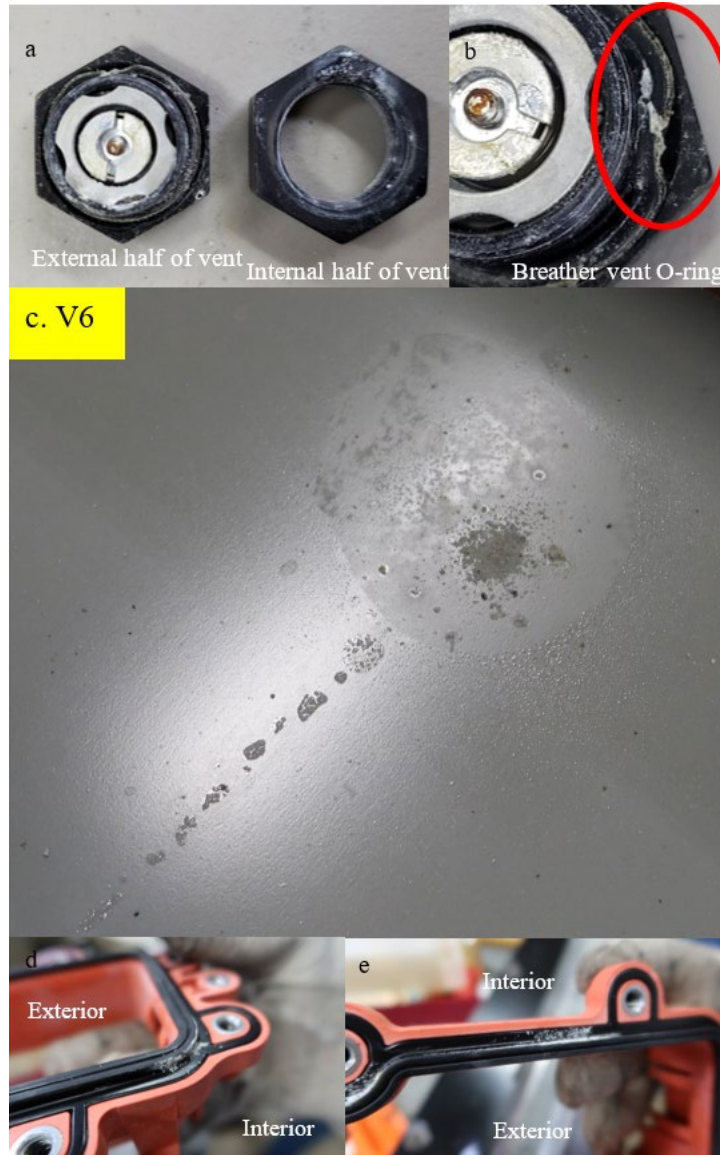
*Figure 40. Vehicle V6 penthouse components: (a) exterior and interior of the penthouse breather vent, (b) compromised breather vent O-ring, (c) water marks and contaminants on the battery penthouse floor, directly underneath the breather vent, and (d, e) sediments on the pyrotechnic fuse*

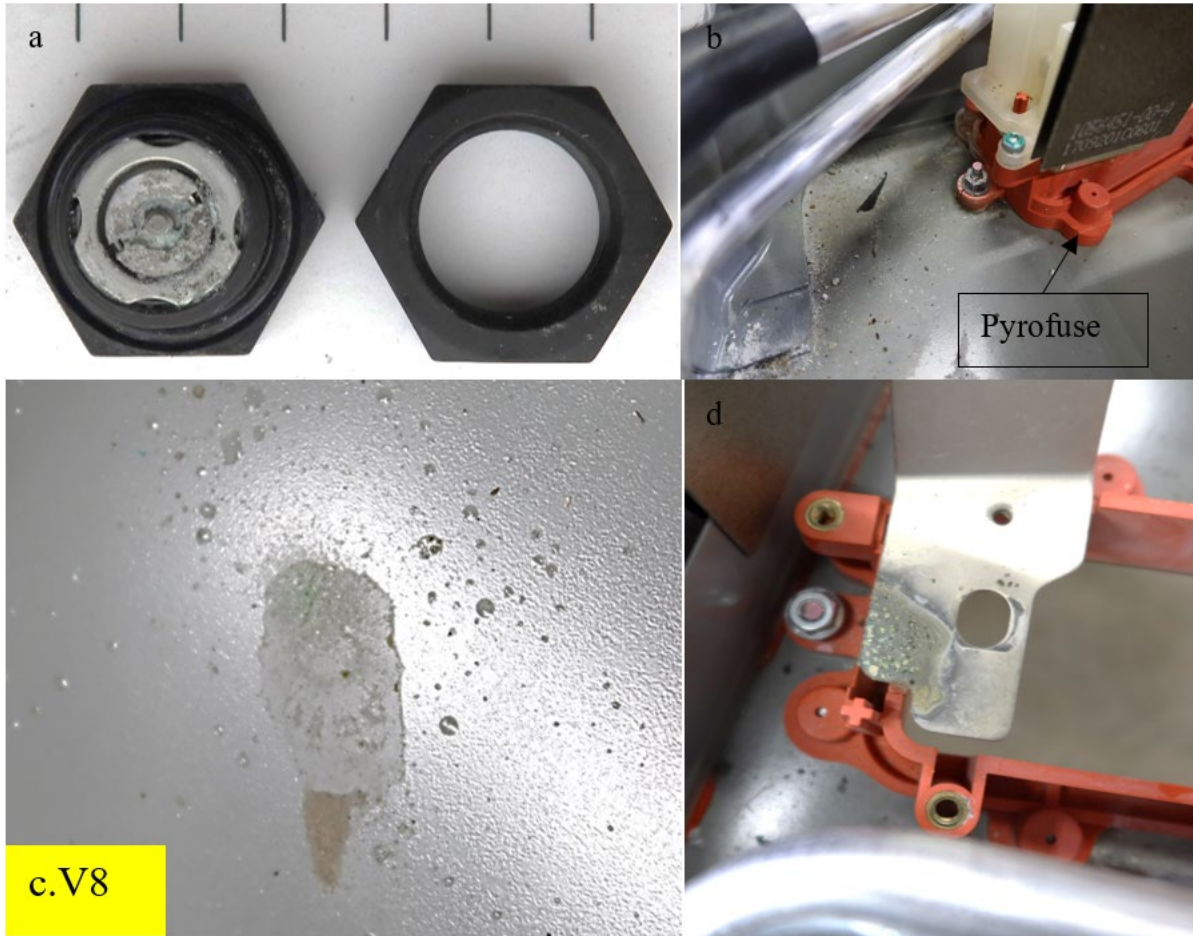
*Figure 41. Vehicle V8 penthouse components: (a) penthouse breather vent, (b) water marks and contaminant surrounding pyro-fuse housing, (c) water marks and contaminants on the battery penthouse floor, directly underneath the breather vent, and (d) corrosion on the pyro-fuse busbar.*

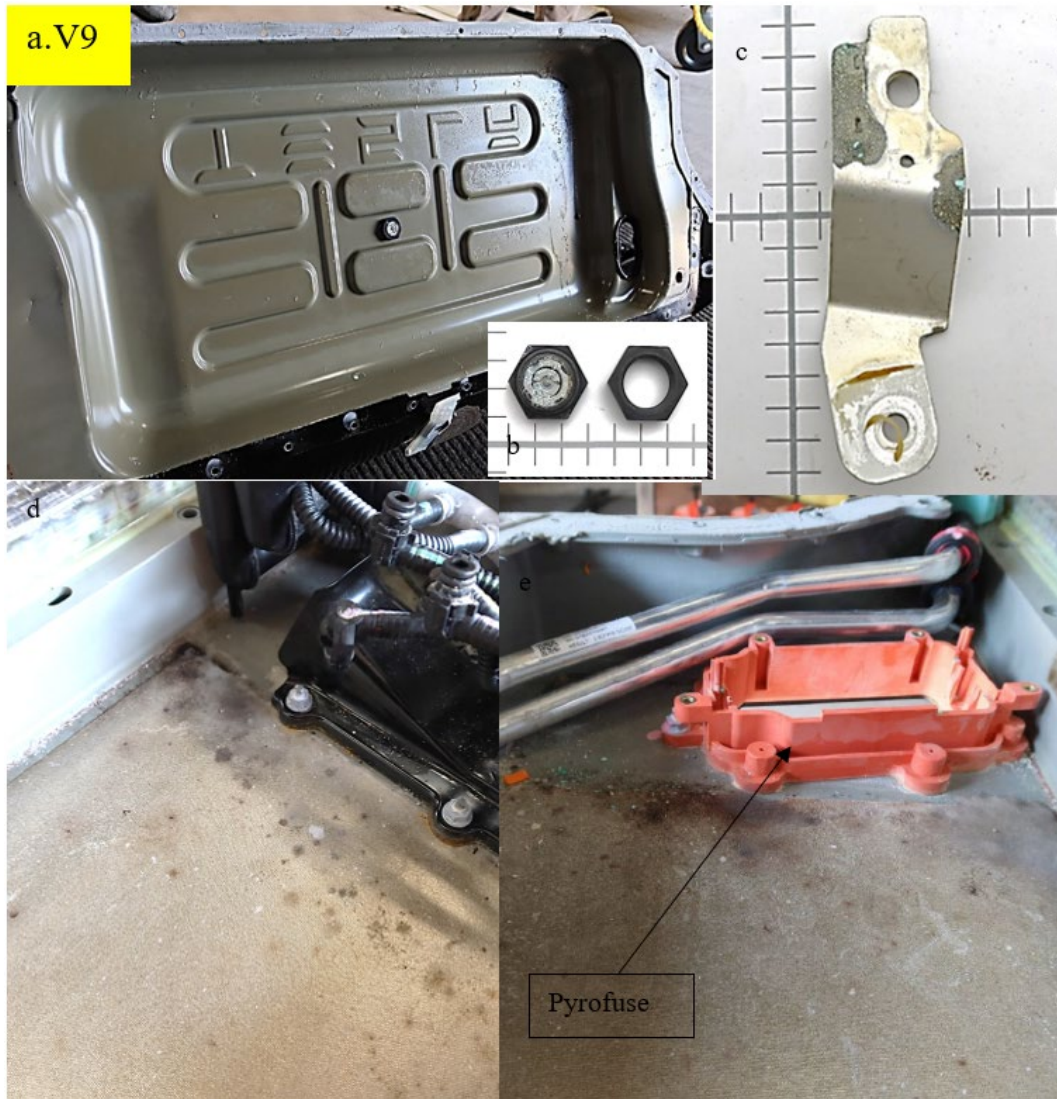
*Figure 42. Vehicle V9 penthouse area: (a) interior face of penthouse lid, covered in condensation, (b) heavily corroded vent, (c) corrosion on the pyro-fuse bus bar, and (d, e) water marks, contaminants, and mold on battery penthouse floor*

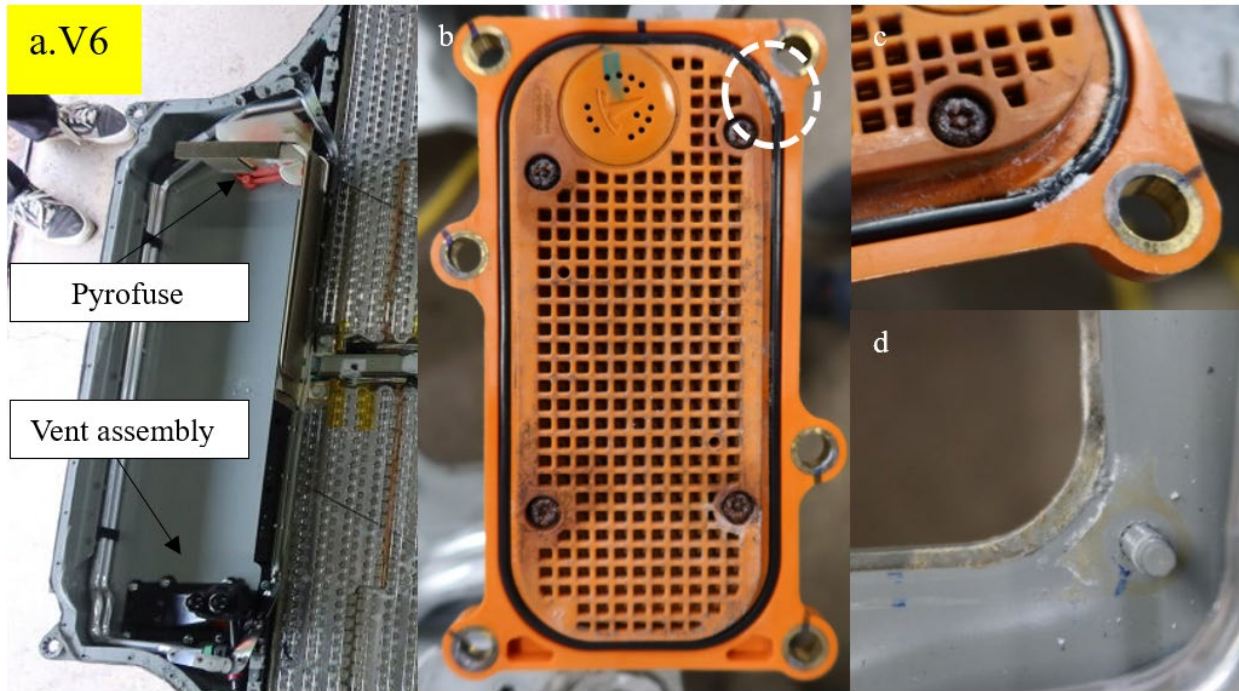
*Figure 43. A representative (V6) vent assembly of Pack Design 2: (a) location of vent assembly, (b) interior side of the vent assembly with identified location of sediment, (c) sediment on vent seal, and (d) witness marks inside pack.*

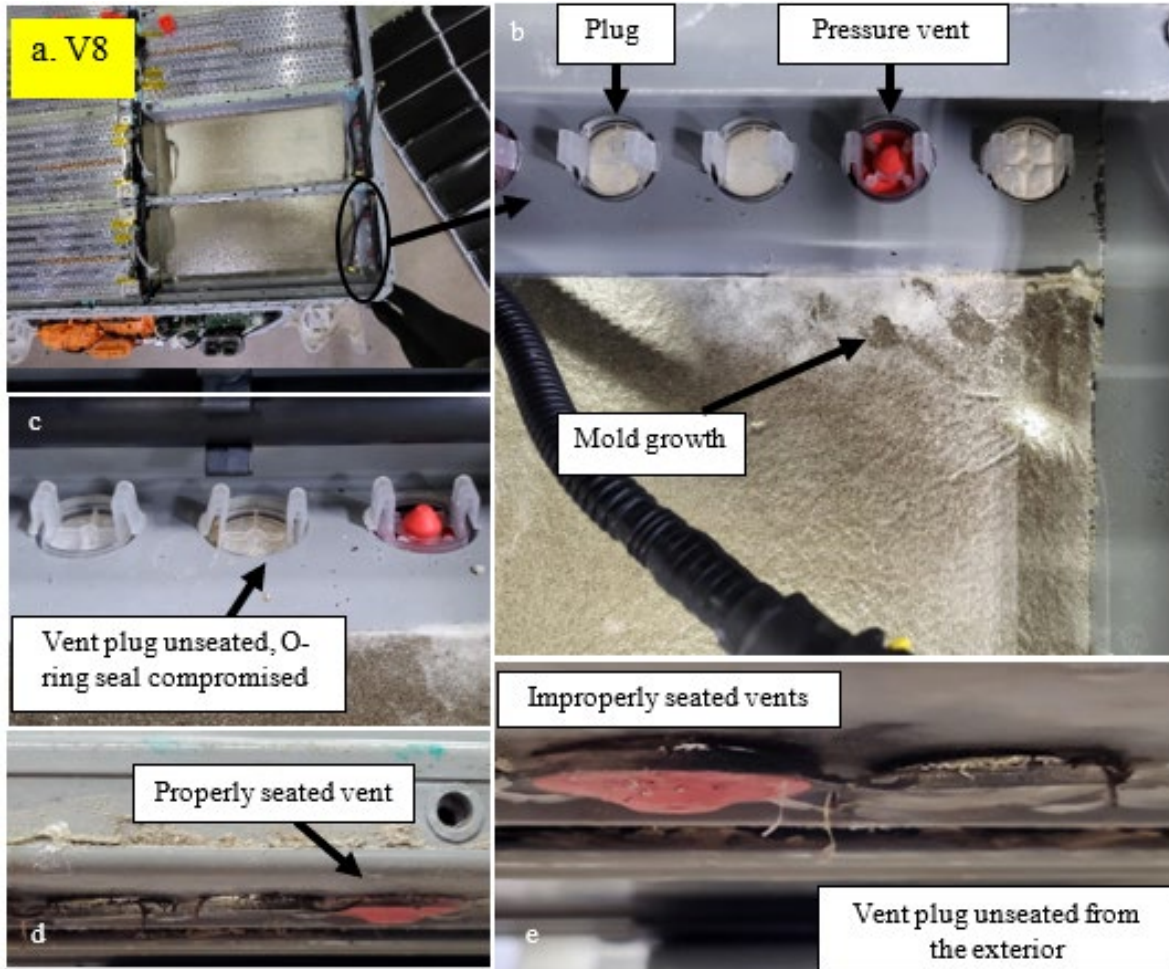
Figure 44. Evidence of water ingress in main battery pack of V8 through the side sill pressure plug:

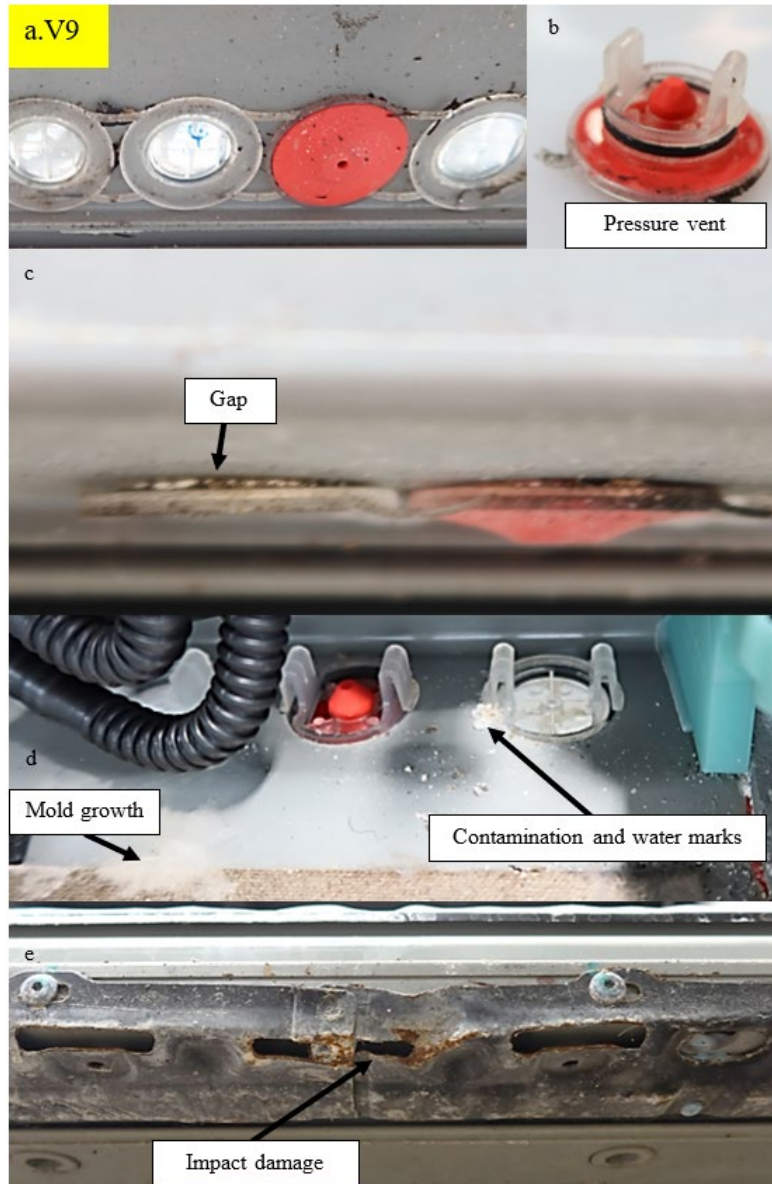
*Figure 45. Evidence of water ingress in the main battery pack of V9 through the side sill pressure plug:*

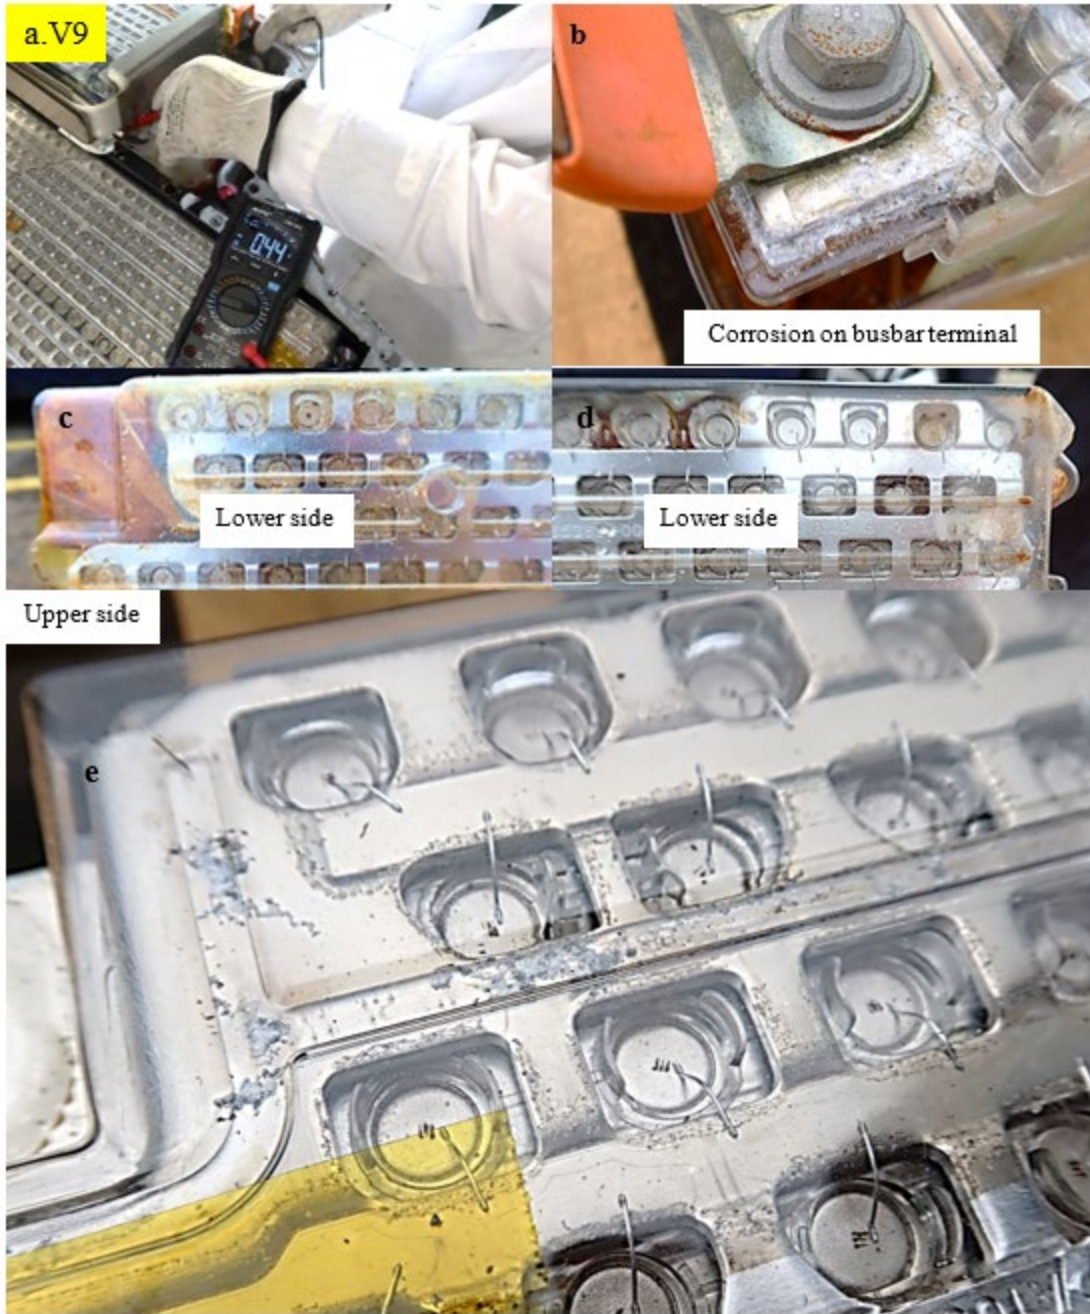
*Figure 46. Vehicle V9, module M8 (the lower module in the penthouse): (a) module voltage measurement; (b) corroded busbar terminal; (c), (d) corrosion, contamination, and residue on lower side of module M8; and (e) corrosion on upper side of module M8*

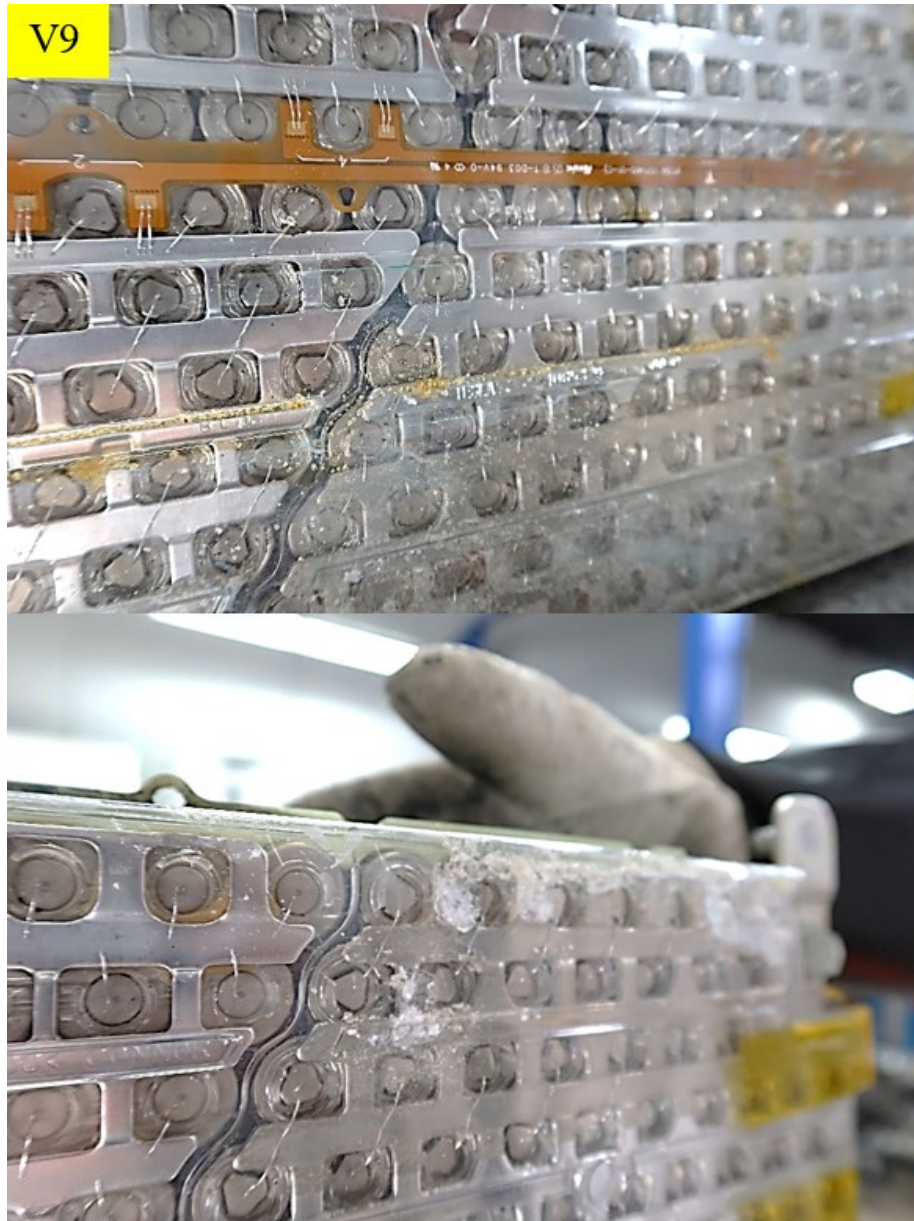
*Figure 47. Vehicle V9, module M9 (i.e., the upper module in the penthouse), showing watermarks, contamination, and corrosion*

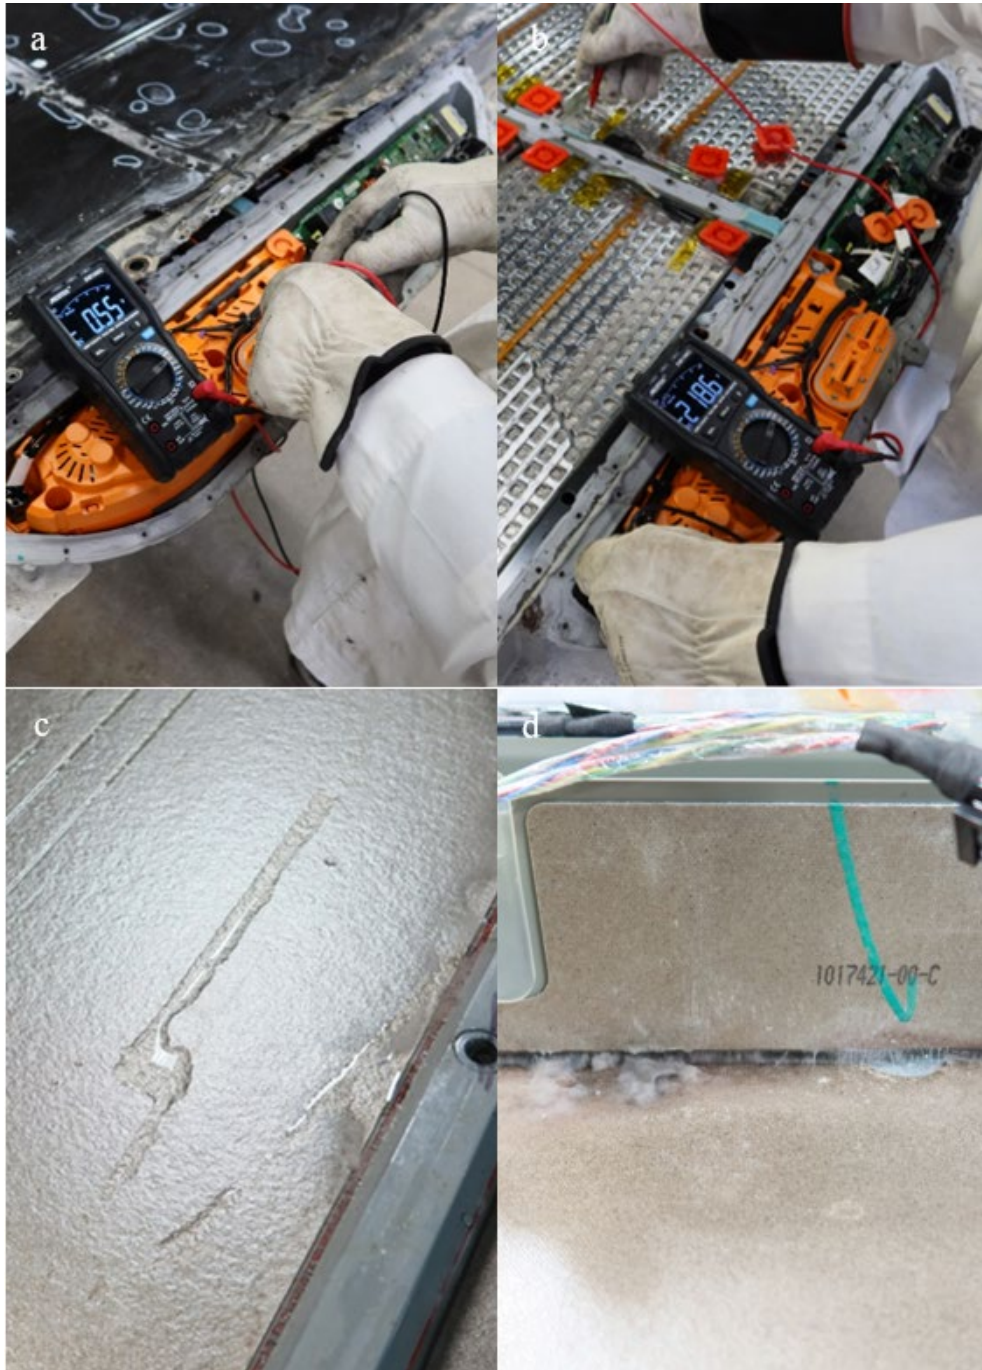
*Figure 48. V9 battery pack:  
(a) measuring the external HV terminals with the contactor open; (b) measuring the voltage between battery module M1 and the battery chassis; (c) water on the floor of the module cavity; and (d) mold along the center spine of the tray*

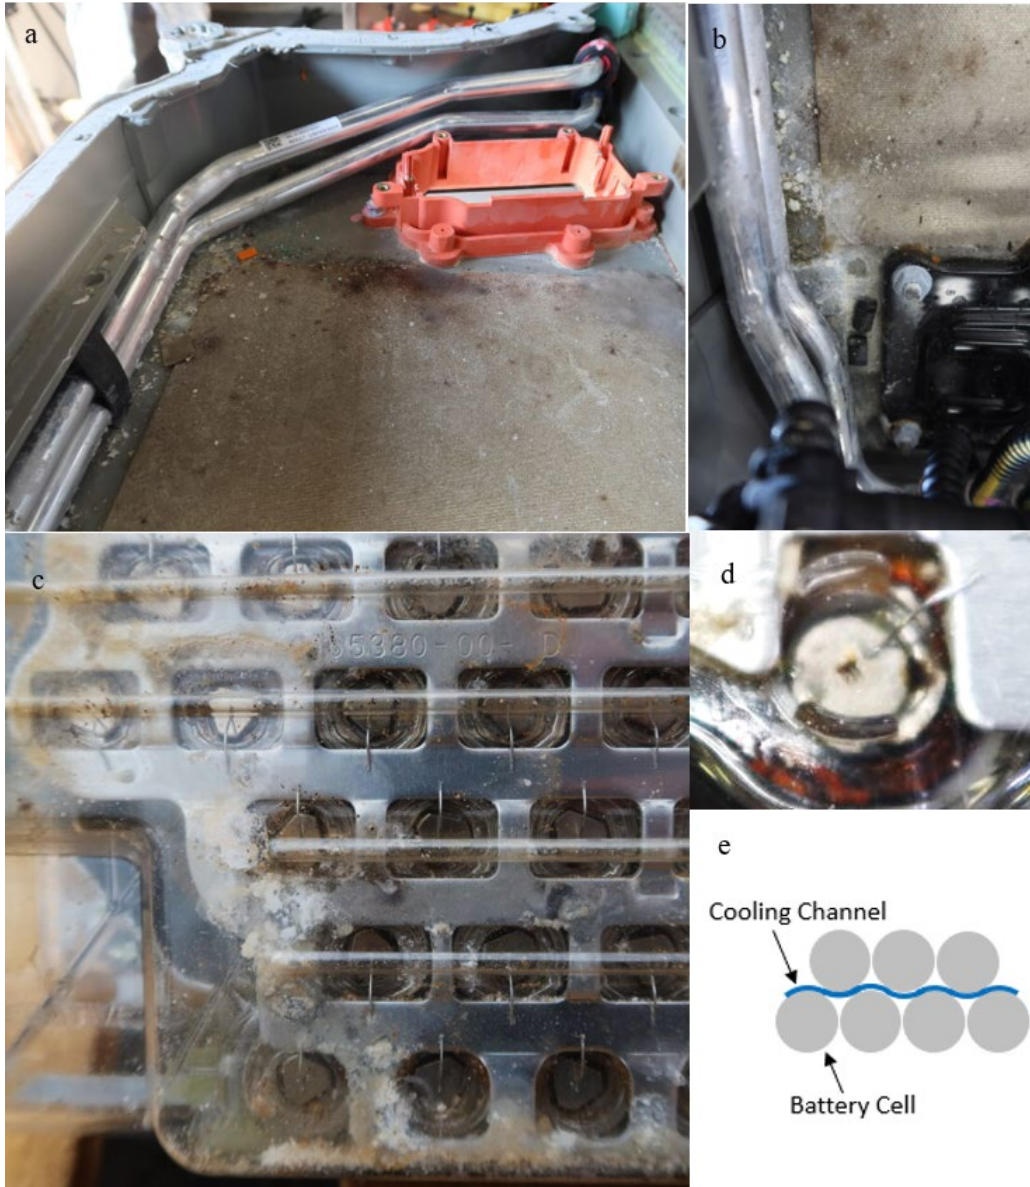
*Figure 49. Image showing the impact of water damage that may have contributed to an isolation fault in Vehicle 9:  
 (a) aluminum coolant tube at front of pack, (b) corrosion build up between aluminum coolant tubes and pack chassis, (c) corrosion on current collectors because of ingress, (d) corrosion on battery cell, and (e) cell-cooling arrangement*

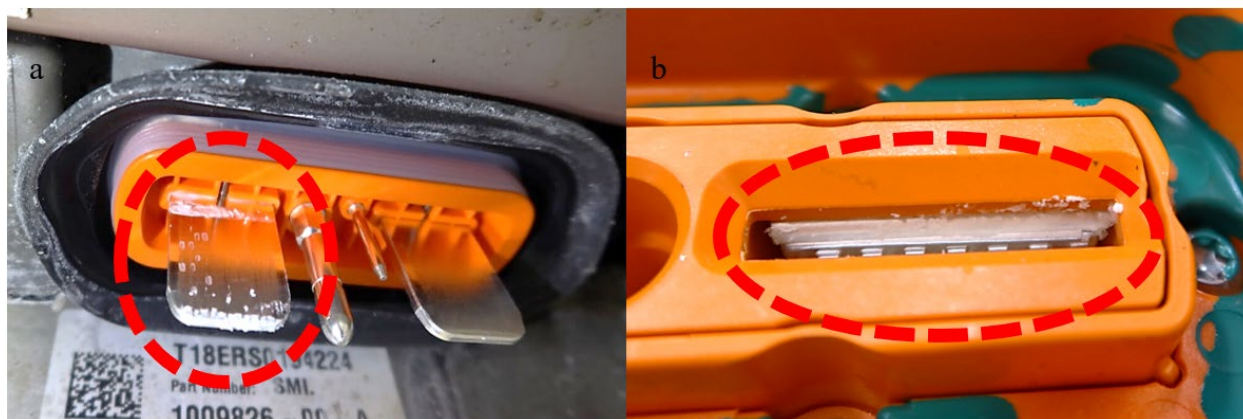
*Figure 51. Ingress in HV terminal of vehicle V9*

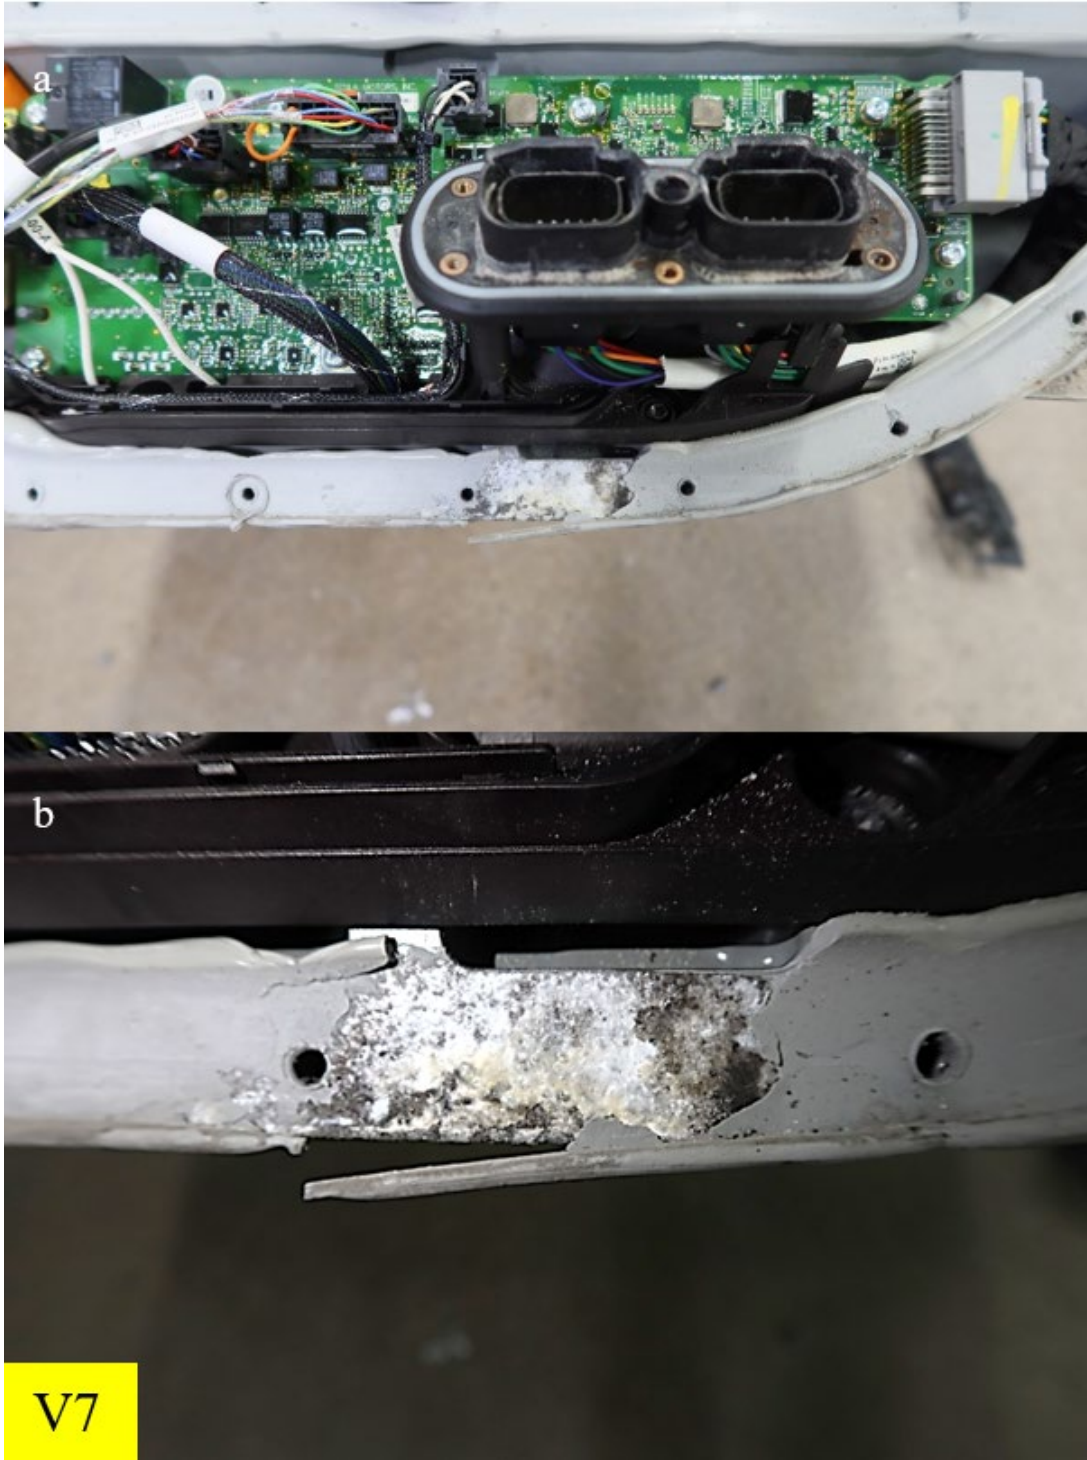
*Figure 52. Corrosion on PDU-lid sealant-mating surface*
