U.S. Department  
of Transportation

**National Highway  
Traffic Safety  
Administration**

DOT HS 813 644

# **A Teardown Study of Flood-Damaged Electric Vehicles**

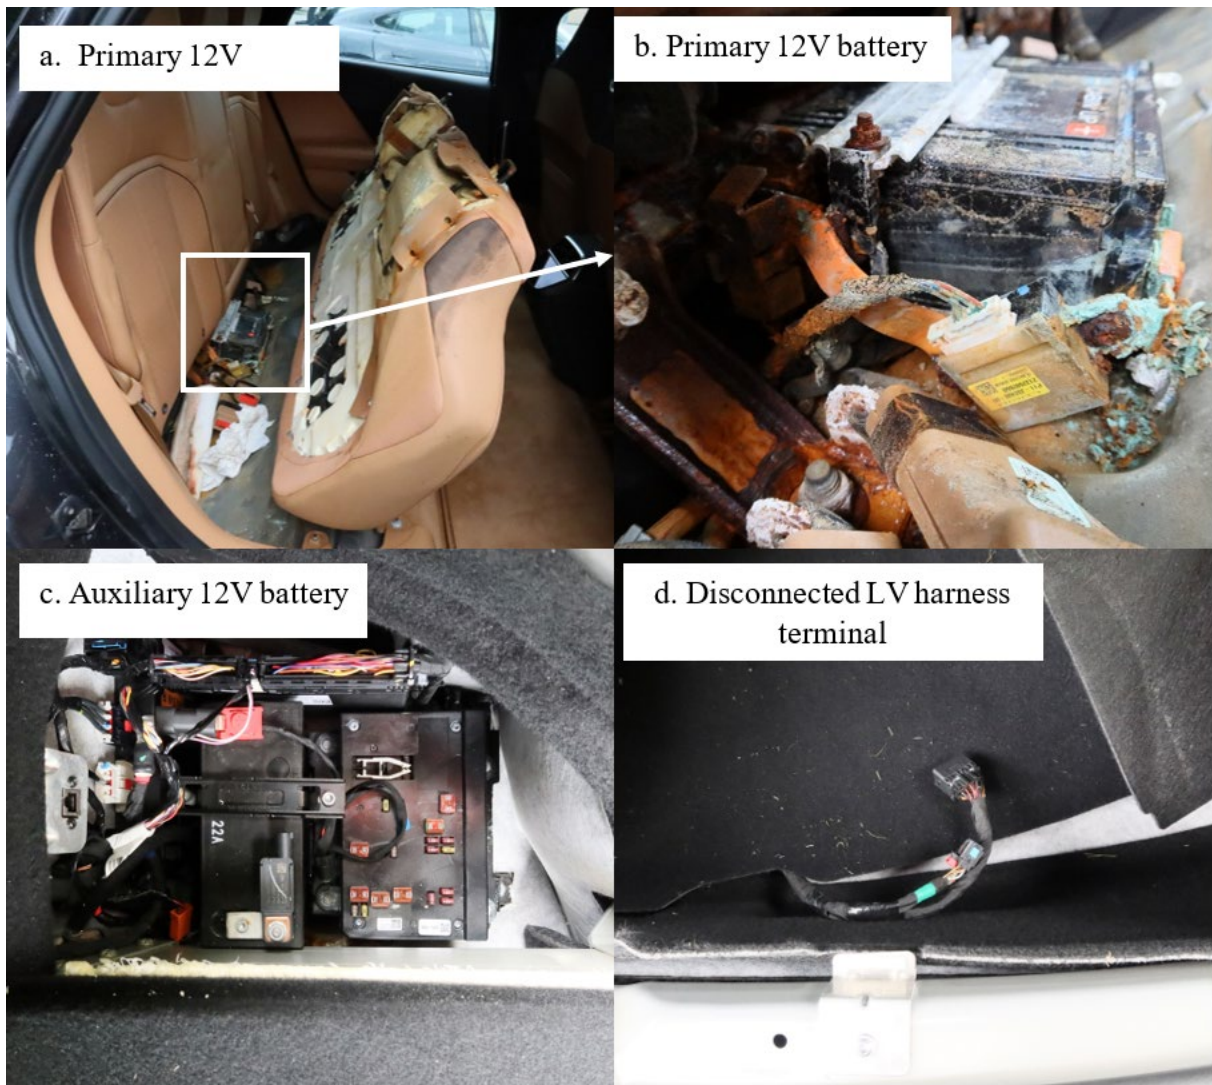
*Figure 53. (a, b) 12-volt primary lead-acid battery underneath the second-row seat cushion, showing the disconnected negative terminal. (c, d) Auxiliary 12-volt lead-acid battery in trunk space, showing the disconnected negative terminal and LV harness.*

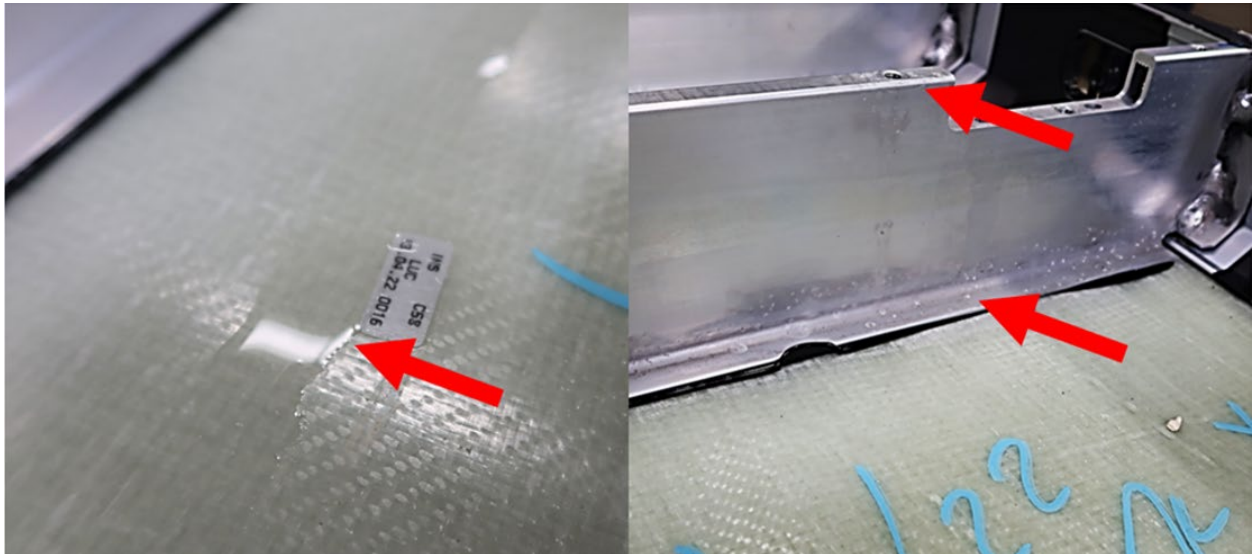
*Figure 56. Inspection of the battery tray revealed locations with water collected on the floor plate below the modules and corrosion/water marks on a crossbeam.*

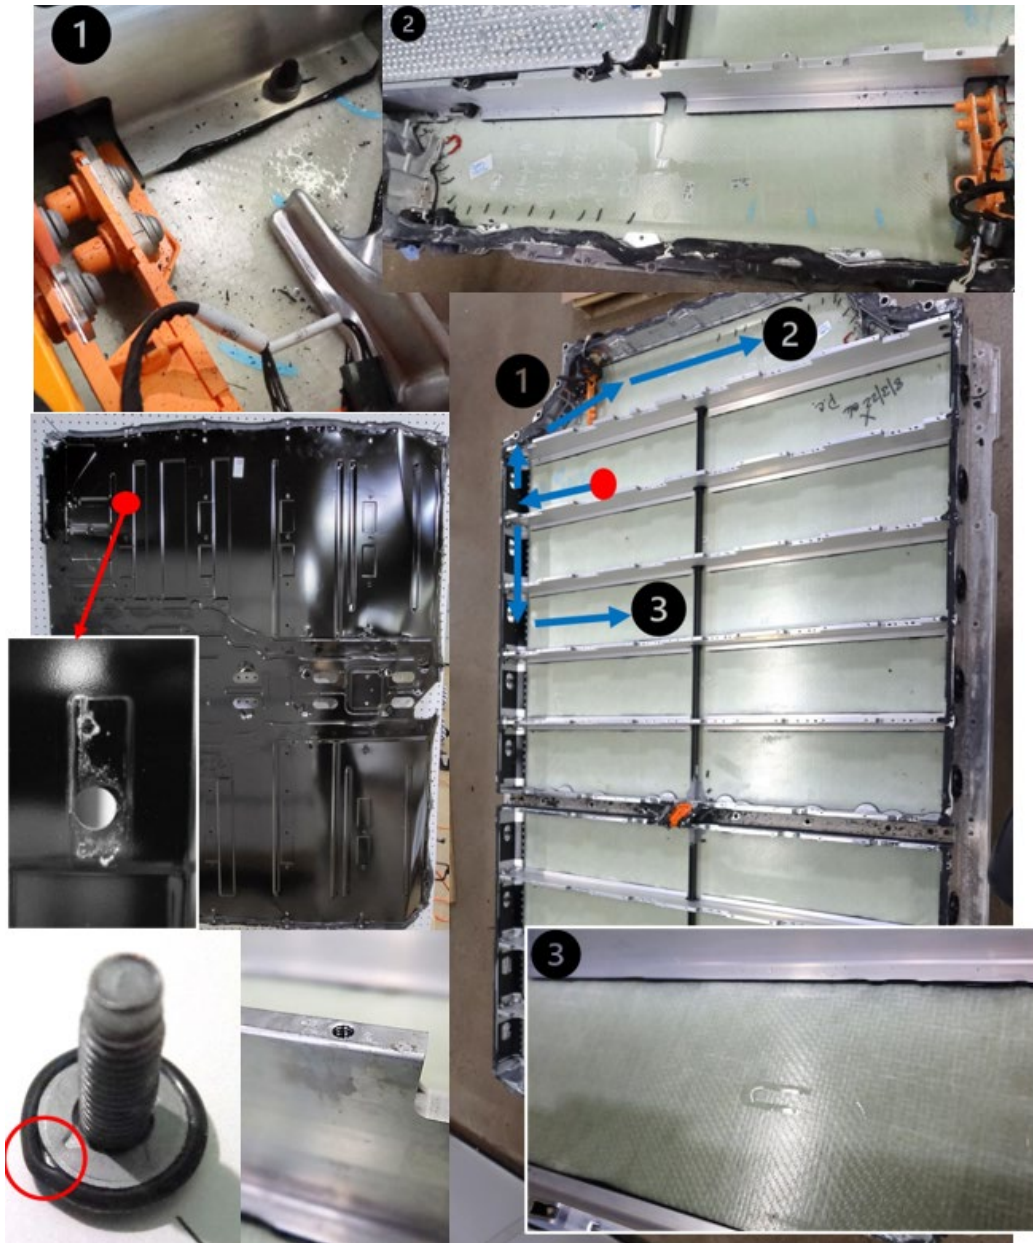
Figure 57. Locations of water contamination within the pack interior. The water ingress source is marked with red on both the lid and the tray, and the probable path of water ingress inside the pack is marked with blue arrows.

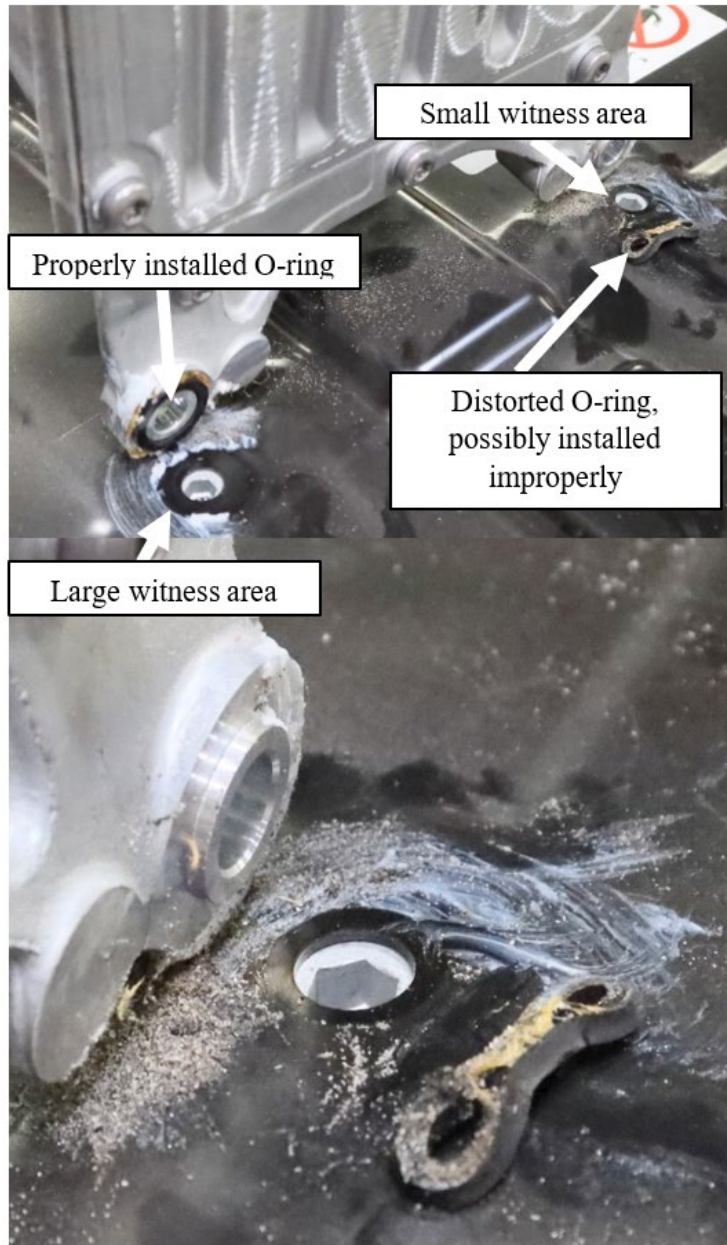
*Figure 60. Possible assembly flaw found on the fastener seal of the electronics penthouse*
