Final Report: Submitted to
State of Florida
Department of Transportation

Submitted by the
Texas A&M Transportation Institute

Green Bike Lane Evaluation for Florida Pavements

Final Report

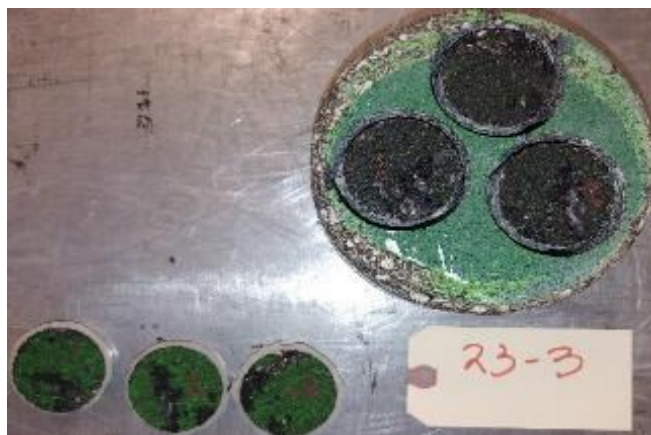
Figure 3-10. Clean Delamination under Pull-Off Test.

- a) **Clean Delamination:** The specimen fails at the GCPM/substrate interface (Figure 3-10). The substrate and treatment are stronger than the bond.

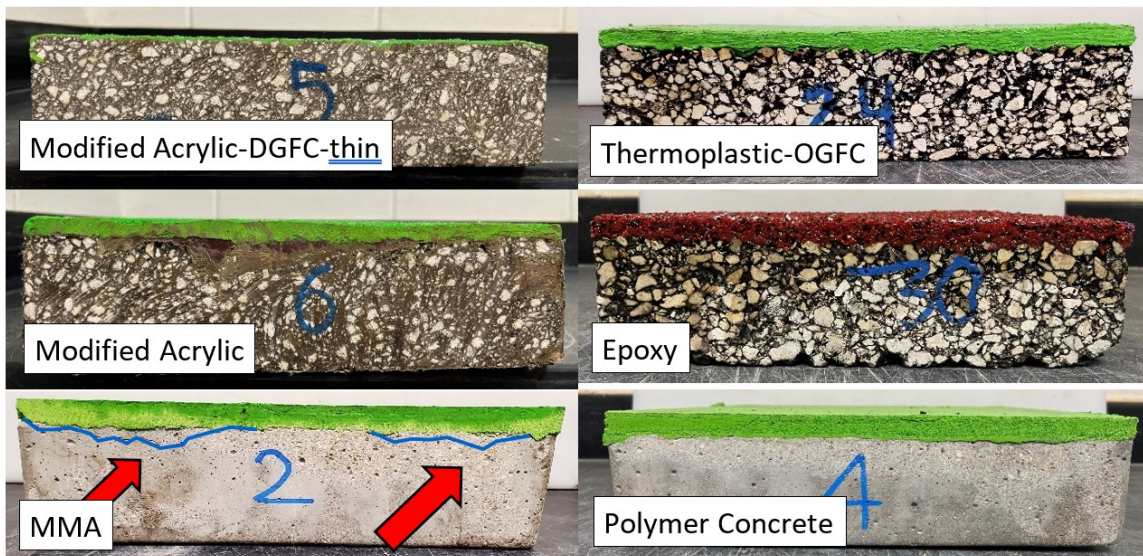
Figure 4-18. Samples after Freeze-Thaw.

Figure 4-18 shows examples of the slabs after freeze and thaw conditioning. The full cracking results are in Table 4-13. The research team observed that one concrete slab treated with 0.5-inch MMA had thermal-induced cracking. The only other signs of distress were from the sample preparation. The polymer-cement slab on concrete had shrinkage cracking on the surface. This treatment on this sample, notably, had a higher water content because of mixture segregation. The thick modified-acrylic samples also had shrinkage cracks on the surface (Figure 4-19). The cracks were induced by curing the water-based treatment quickly with a heat gun.

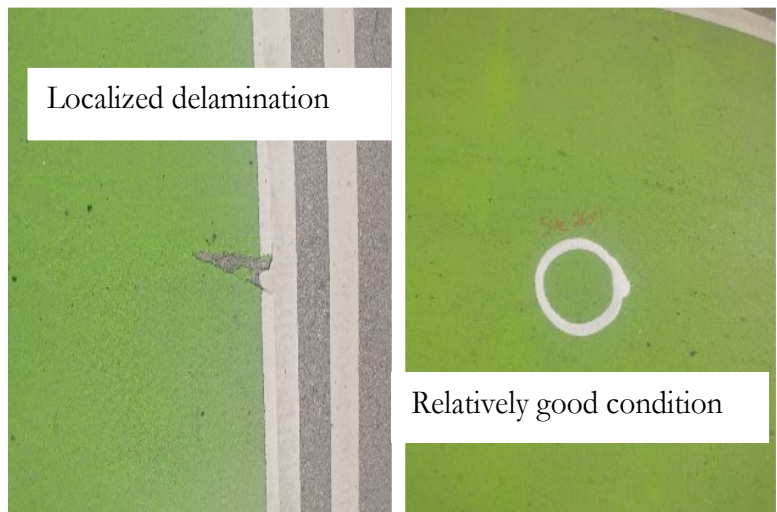
Figure A-4. Site 26-Location and Distresses.

- Observation
 - Overall good condition.
 - Small delamination. It looks like a dent from a sharp object.

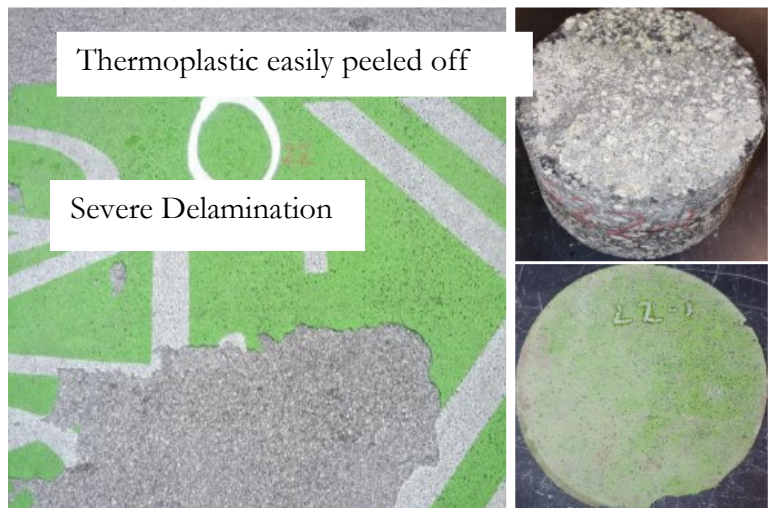
Figure A-5. Site 22-Location and Distresses.

- Observation
 - Overall poor condition.
 - Severe Delamination.
 - Delamination reduced the green bike lane treatment to less than 60 percent.
 - Thermoplastic could easily peel off.

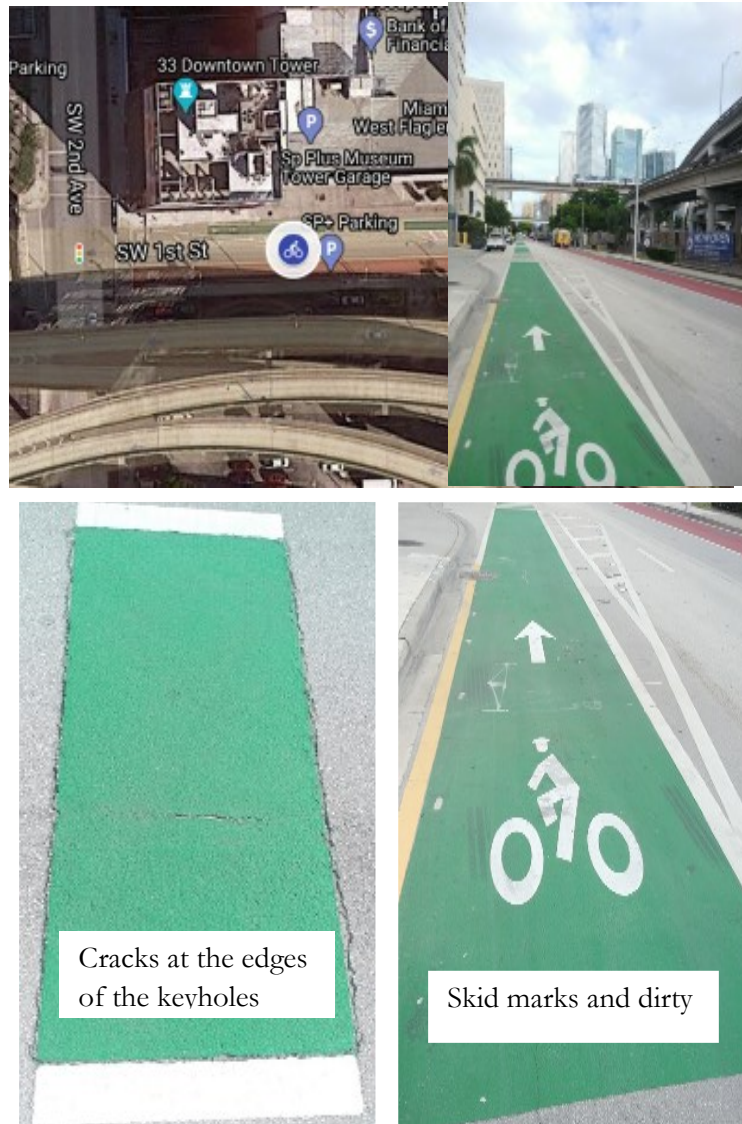
Figure A-23. Site 59-Location and Distresses.

- Cracks at edges of some keyhole.
- Delamination and cracking at sections corresponding to heavy traffic conflicts.
