Test Report No. 440863-03-1

**MASH TEST 4-12 EVALUATION OF A LUMINAIRE POLE BEHIND
SINGLE SLOPE TRAFFIC RAIL**

Texas Department of Transportation

TEXAS A&M TRANSPORTATION INSTITUTE PROVING GROUND

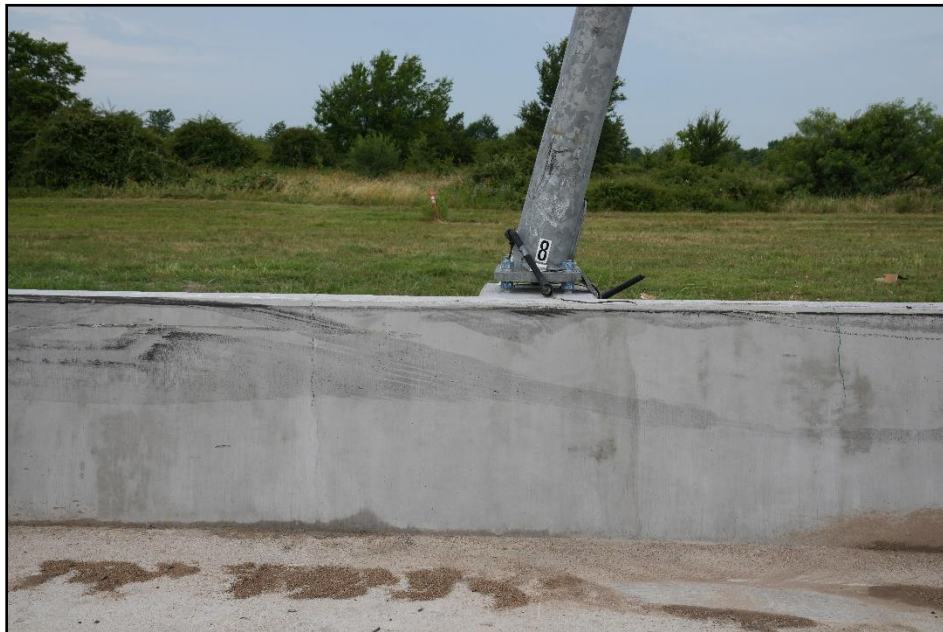
Figure 5.6. Traffic Side View of the Damage to the Base of the Luminaire Pole after Test 440863-03-1.

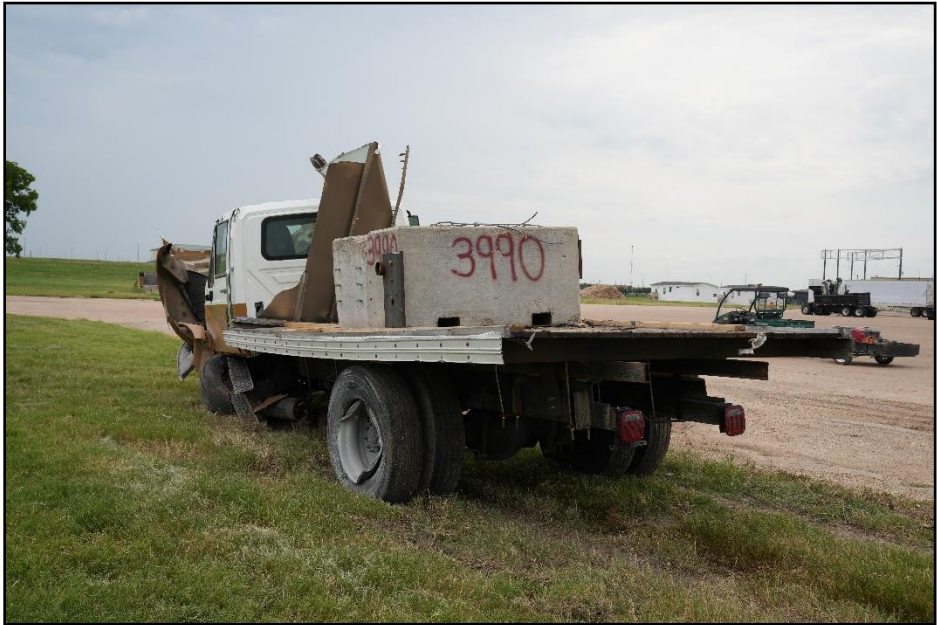
Figure 5.8. Rear Impact Side of Test Vehicle after Test 440863-03-1.

Side Windows	Side windows remained intact.
Maximum Exterior Deformation	14 inches in the left fender.
VDS	11LFQ7.
CDC	01FLWH3.
Fuel Tank Damage	None.
Description of Damage to Vehicle:	The left front bumper, grill, left front headlight, left fender, left front wheel, left front tire, left side mirror, left door, top left side, top of box, steps, air tanks, and the left rear outer tire and wheel were damaged. There was a 3-inch-wide × 4-inch-long × 1-inch-deep dent on the top of the door frame on impact side. The top and sides of the box were pulled off. The floorpan had a 2-ft-long and 7-inch-high separation at a seam. The seam separation in the floor pan of the vehicle was not caused by intrusion of the test article, but due to the flexing of the vehicle during the crash.

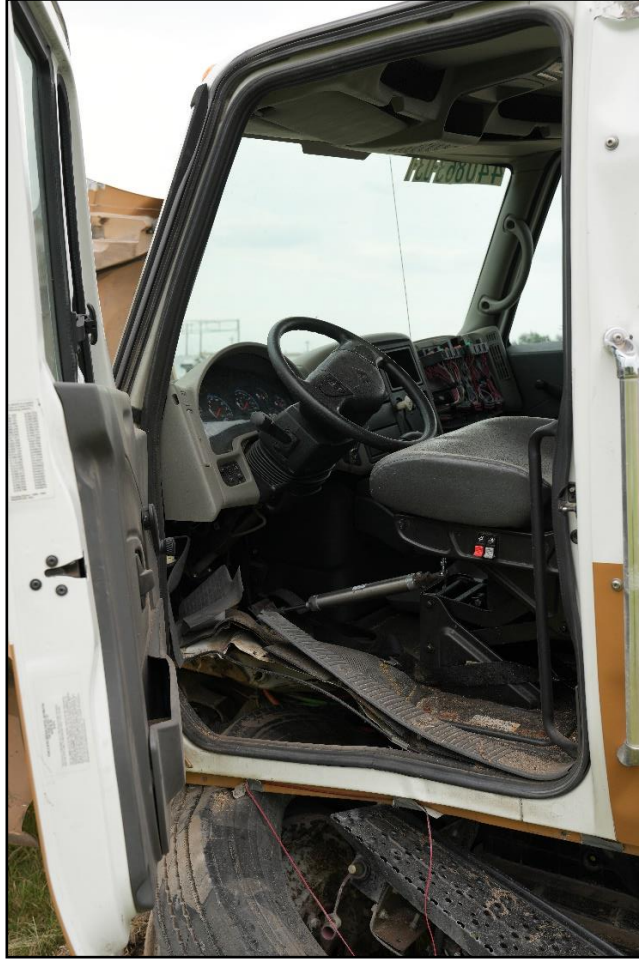
Figure 5.9. Overall Interior of Test Vehicle after Test 440863-03-1.
