FISH PASSAGE ENGINEERING PROJECT

Site Analysis Final Report

SITE ANALYSIS FINAL REPORT

Humboldt State University
Michael Love & Associates, Inc.

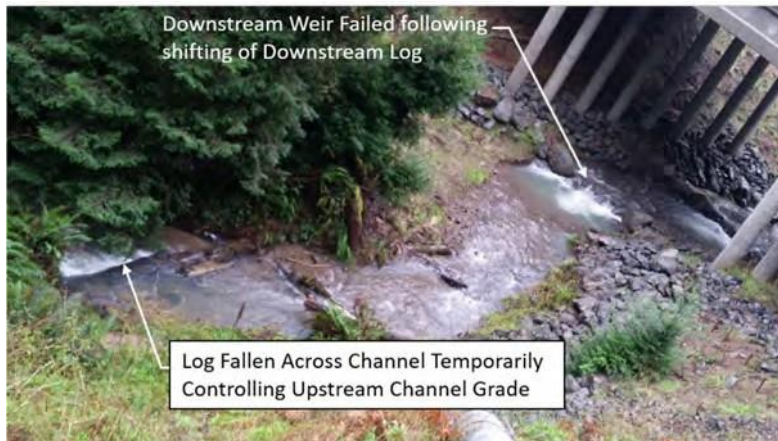
At Dunn Creek, the design relied on a tree that had recently fallen across the channel downstream of the project reach to control the stream grade at the downstream-most rock weir. This in-channel wood should have been noted as a transitory control of the streambed elevation and not relied on for the long-term stability of the rock weirs. After construction this wood shifted, causing the streambed to incise through deposited sediments. The resulting downcutting of the streambed caused an excessive drop over the downstream rock weir. The excessive drop likely increased the exposure and instability of the footer rocks eventually leading to the rock weir's failure. Loss of the most downstream weir has created a larger drop over the next upstream weir, placing additional upstream weirs in jeopardy.

FIGURE 5-2. THE DESIGN ELEVATION AND DROP OVER THE DOWNSTREAM WEIR WAS BASED ON THE DOWNSTREAM CHANNEL BED ELEVATION CONTROLLED BY RECENTLY FALLEN LOG WITHIN THE CHANNEL BED, WHICH SUBSEQUENTLY SHIFTED, CAUSING THE BED TO DROP AND THE BOULDER WEIR TO FAIL.

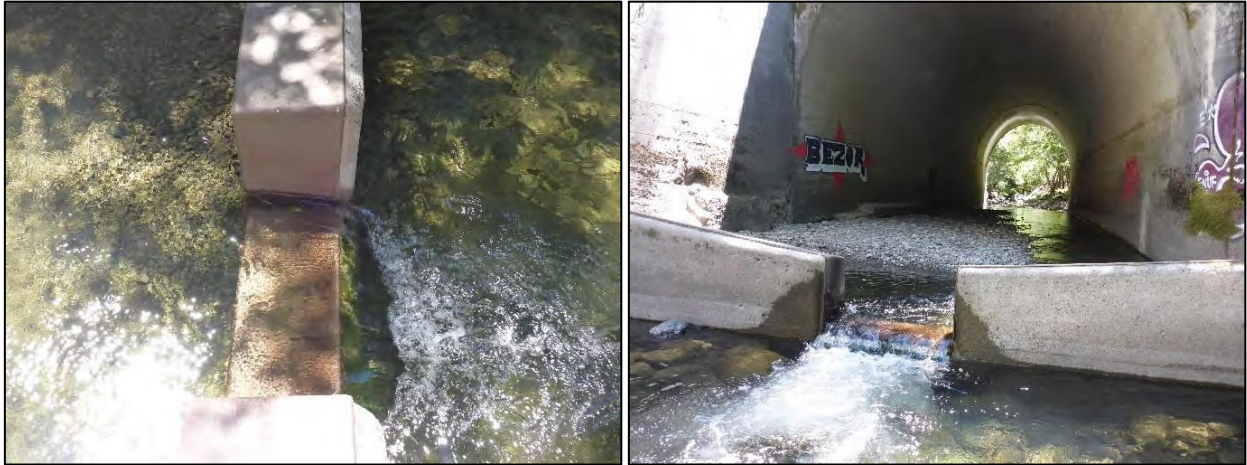
FIGURE 9-3. THE WEIR NOTCHES ON THE OUTLET FISH LADDER ARE BROAD, CREATING LOCALIZED SHALLOW, FAST FLOW. WEIR 1 SHOWN HERE HAD THE SHALLOWEST DEPTHS (0.45 FT ON THE US SIDE, 0.25 FT ON THE DS SIDE). AT SOME FLOWS THE NOTCH CONDITIONS MIGHT EXCEED FISH PASSAGE SWIMMING CRITERIA, ESPECIALLY FOR JUVENILE SALMONIDS. PHOTOS TAKEN JULY 17, 2019.

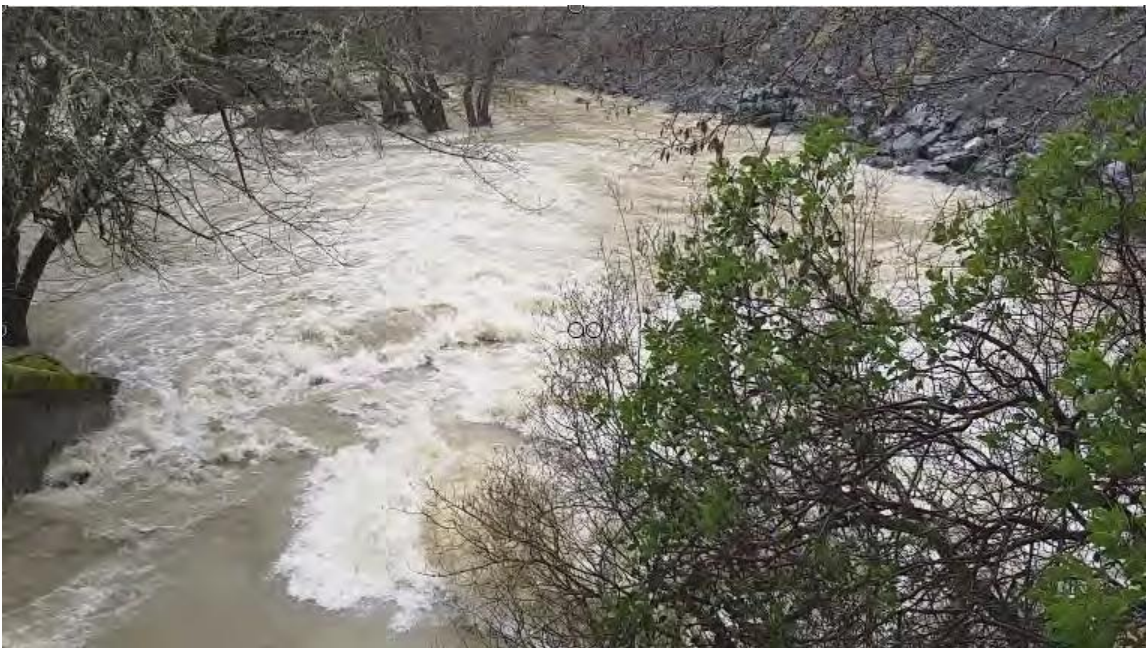
FIGURE 9-4. RATTLESNAKE CREEK OUTLET DURING HIGH FLOW. THE PRIMARY FLOW EXITING THE FISHWAY FOLLOWS THE NEW FISHWAY ORIENTATION AWAY FROM THE RIGHT BANK. AN EDDY FORMS ON THE RIGHT CREATING SOME SCOUR ALONG THE SIDE OF THE FISHWAY. PHOTO TAKEN FEBRUARY 27, 2019 BY M. LANG.

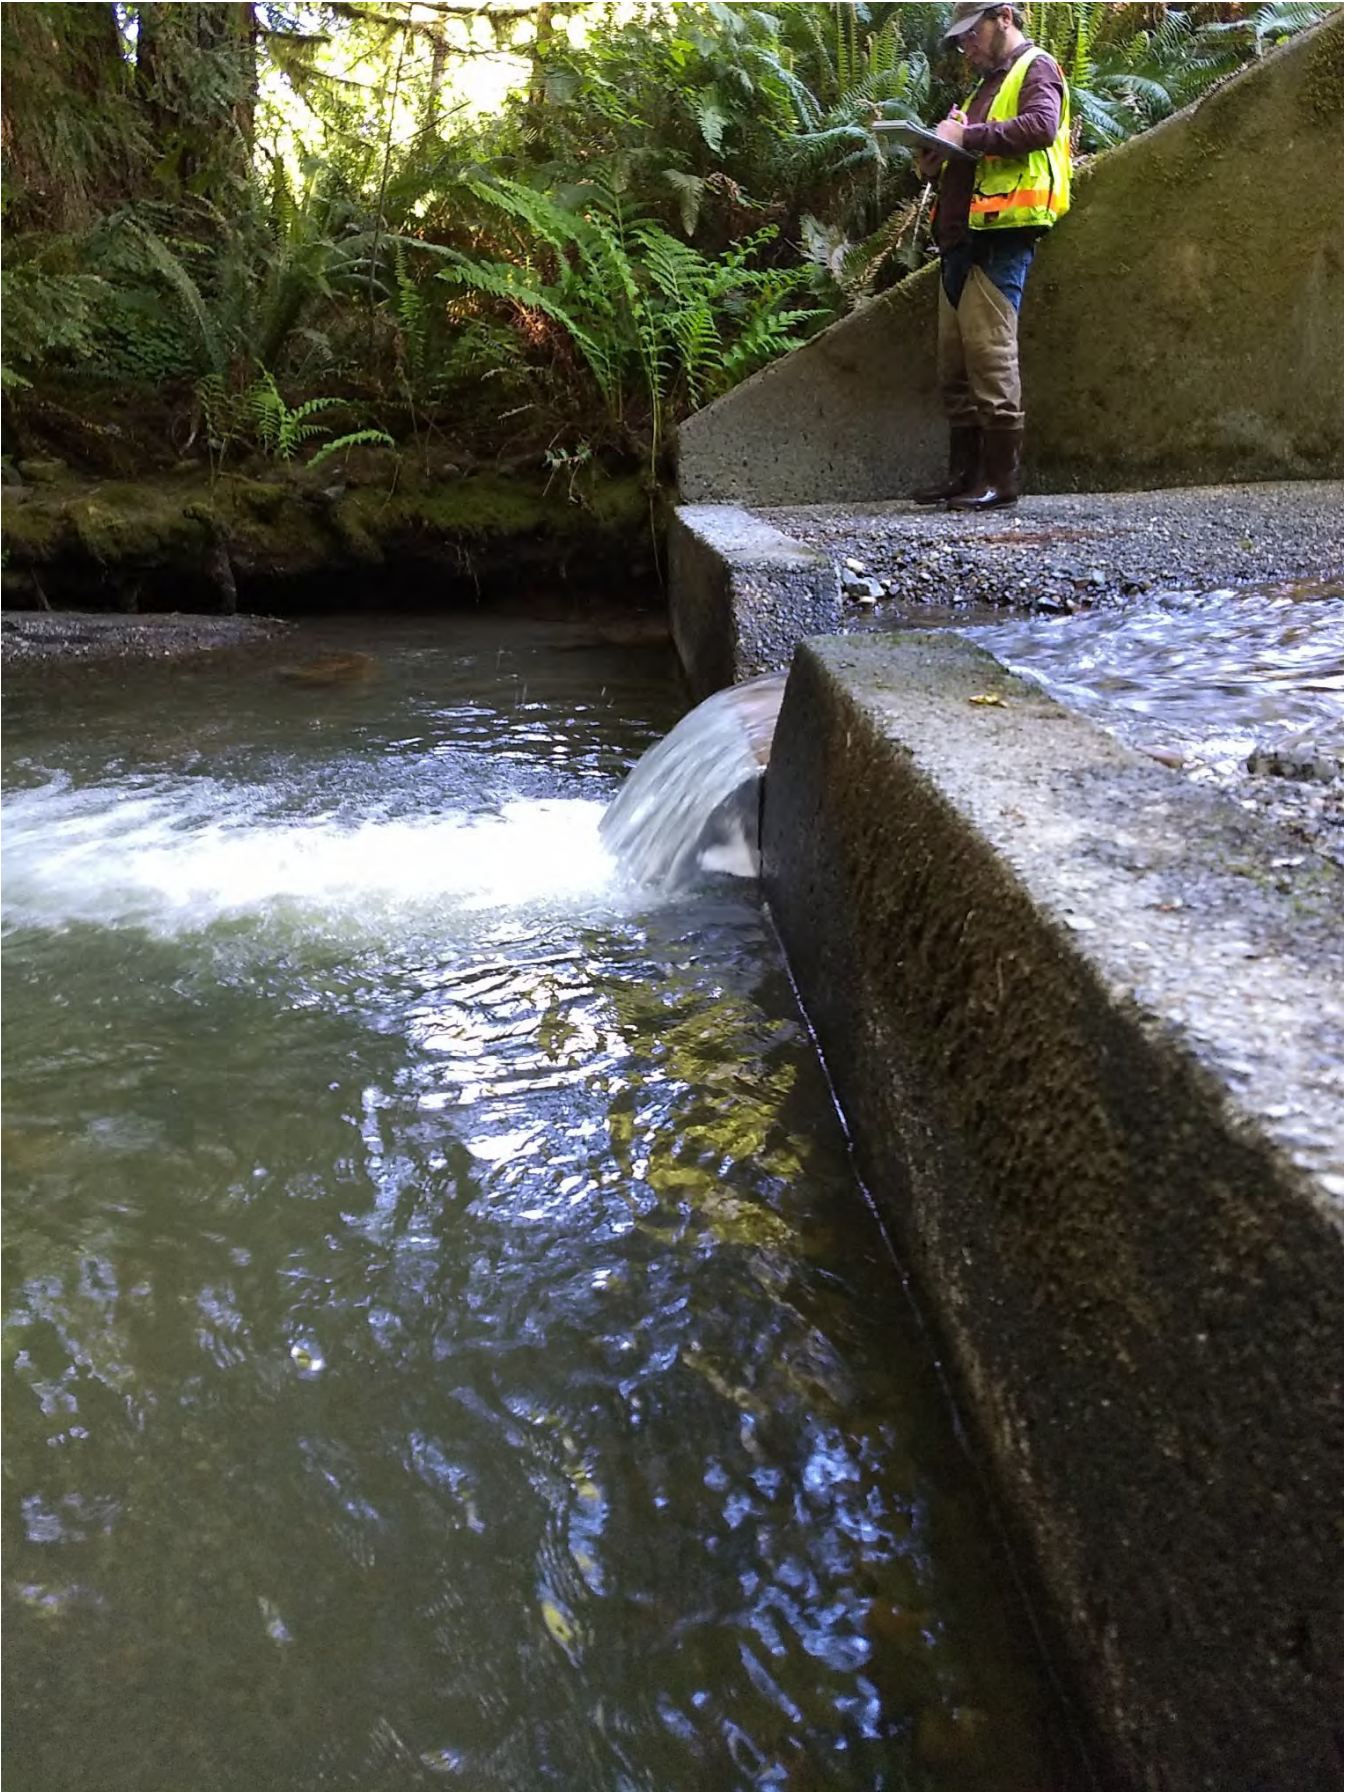
Figure 5. Concrete square-notched weir at outlet. Drop elevation is ~1 foot at low flow.

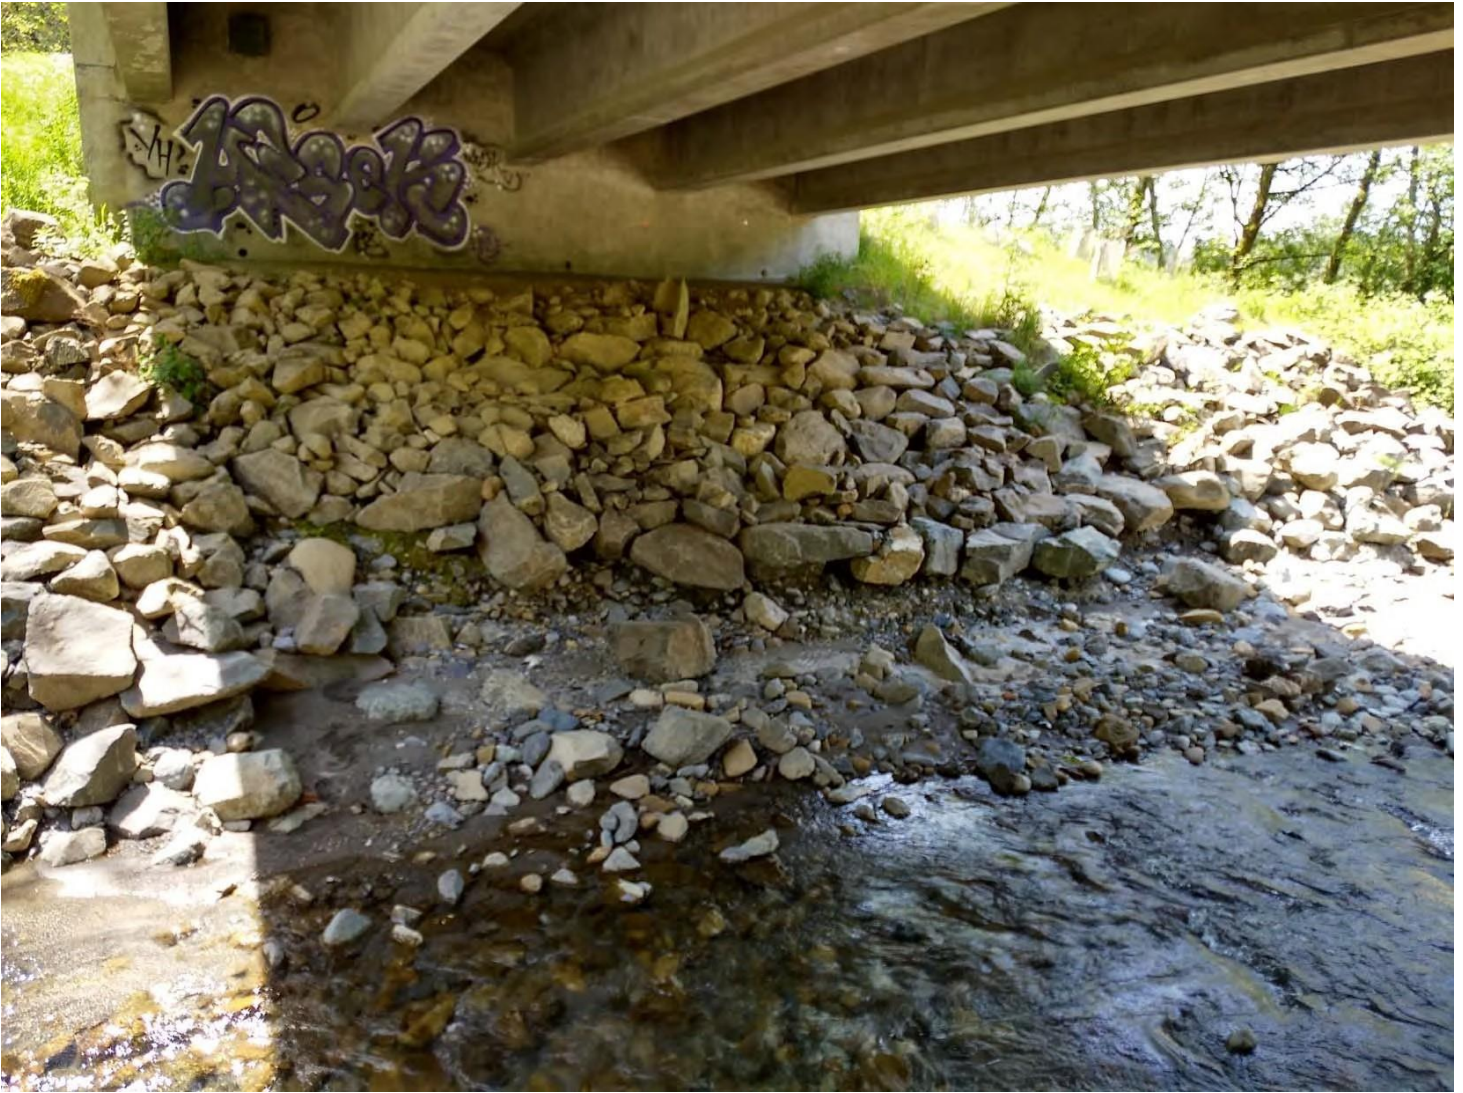
Figure 5. Left bank erosion of rip rap toe. Lowest rock appears to be missing.

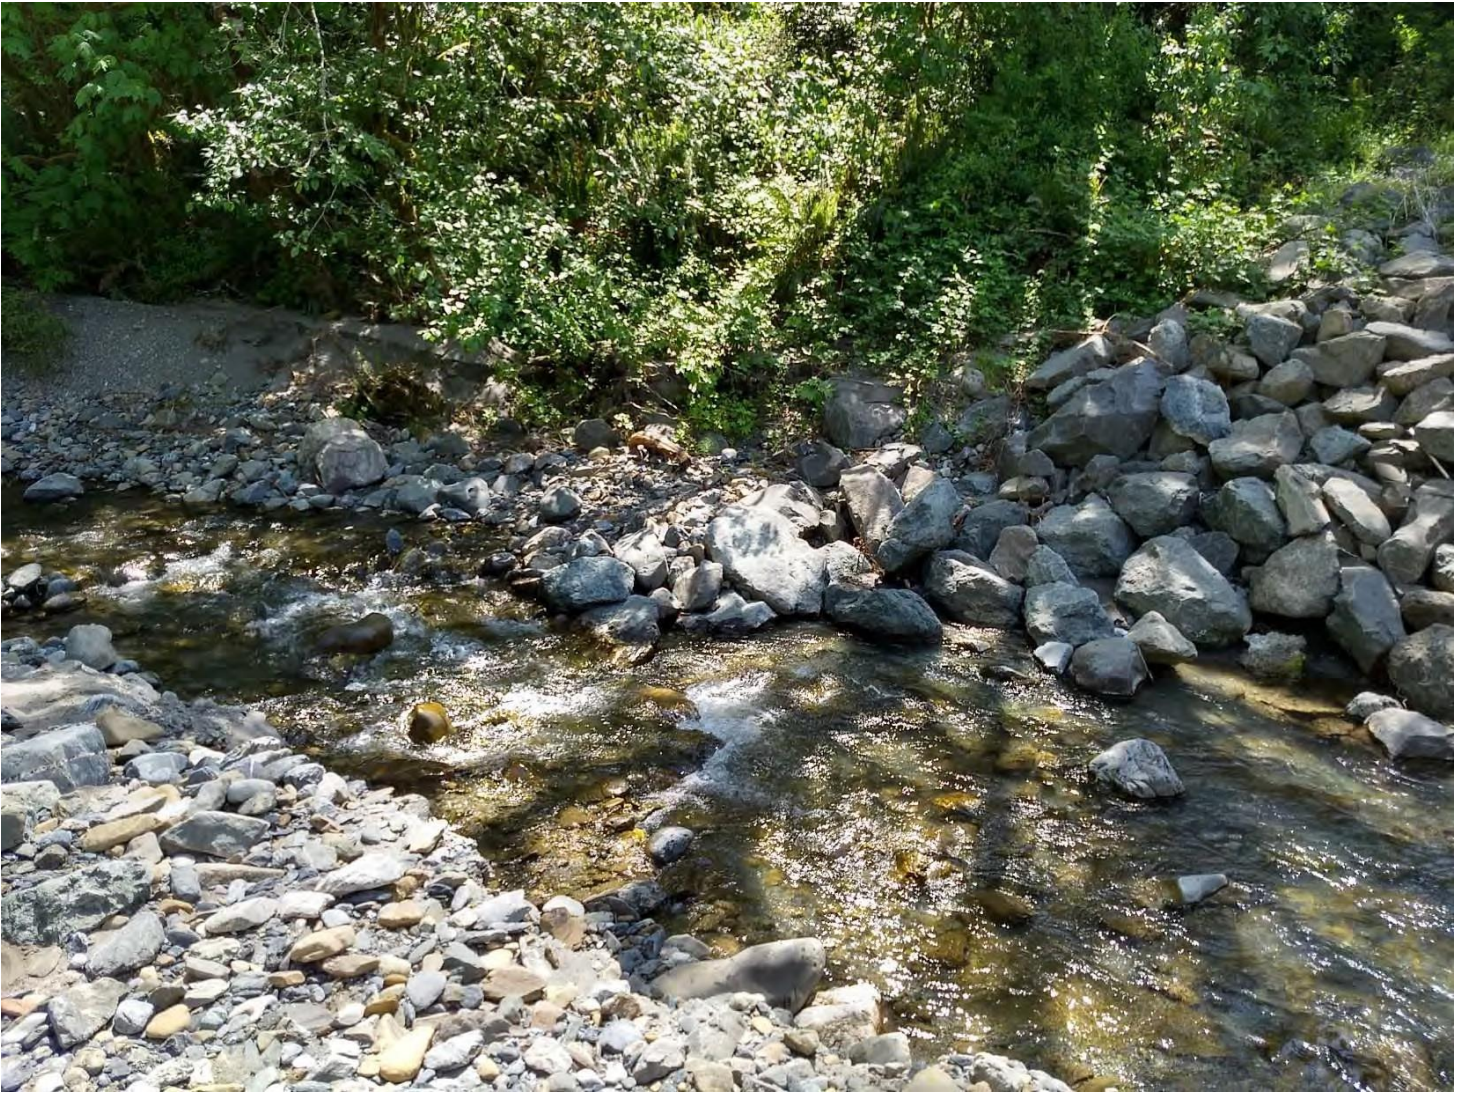
Figure 6. Missing/eroded rock weir grade control at upstream end of project site. Fish passage conditions are not compromised by the missing rock weirs.

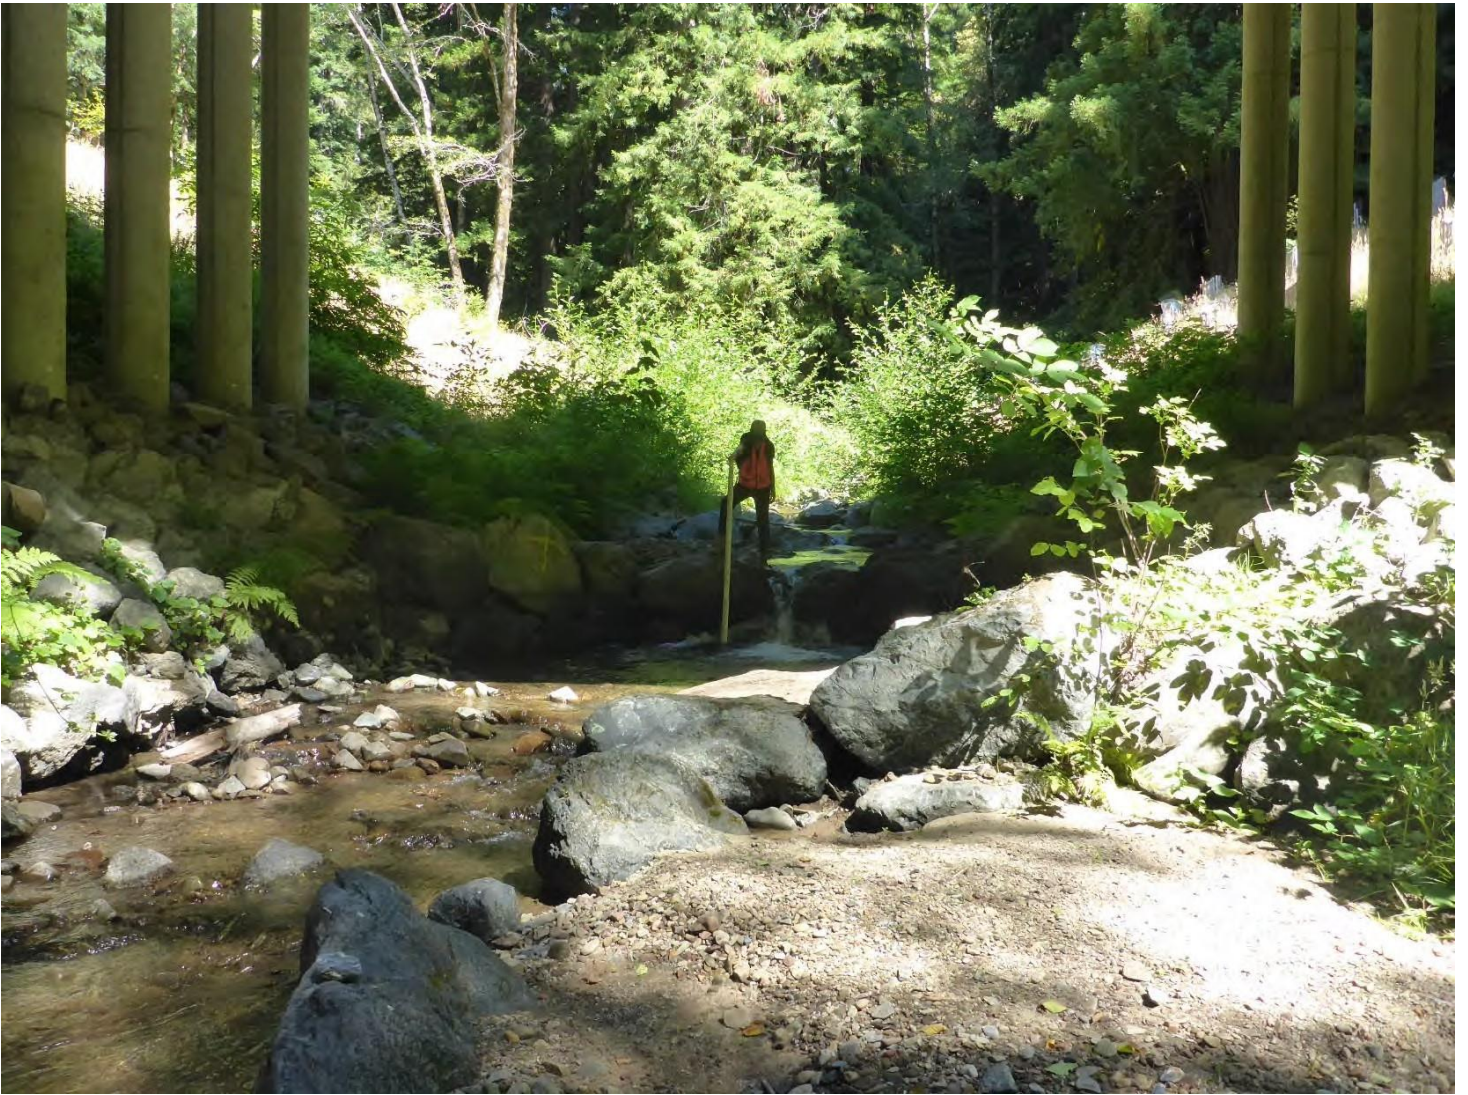
Figure 1. Most downstream rock weir that has failed is in foreground. The next weir is currently in place but now has a 1.8 ft elevation drop at low flow. Photo by Michael Love on 7/17/2019.

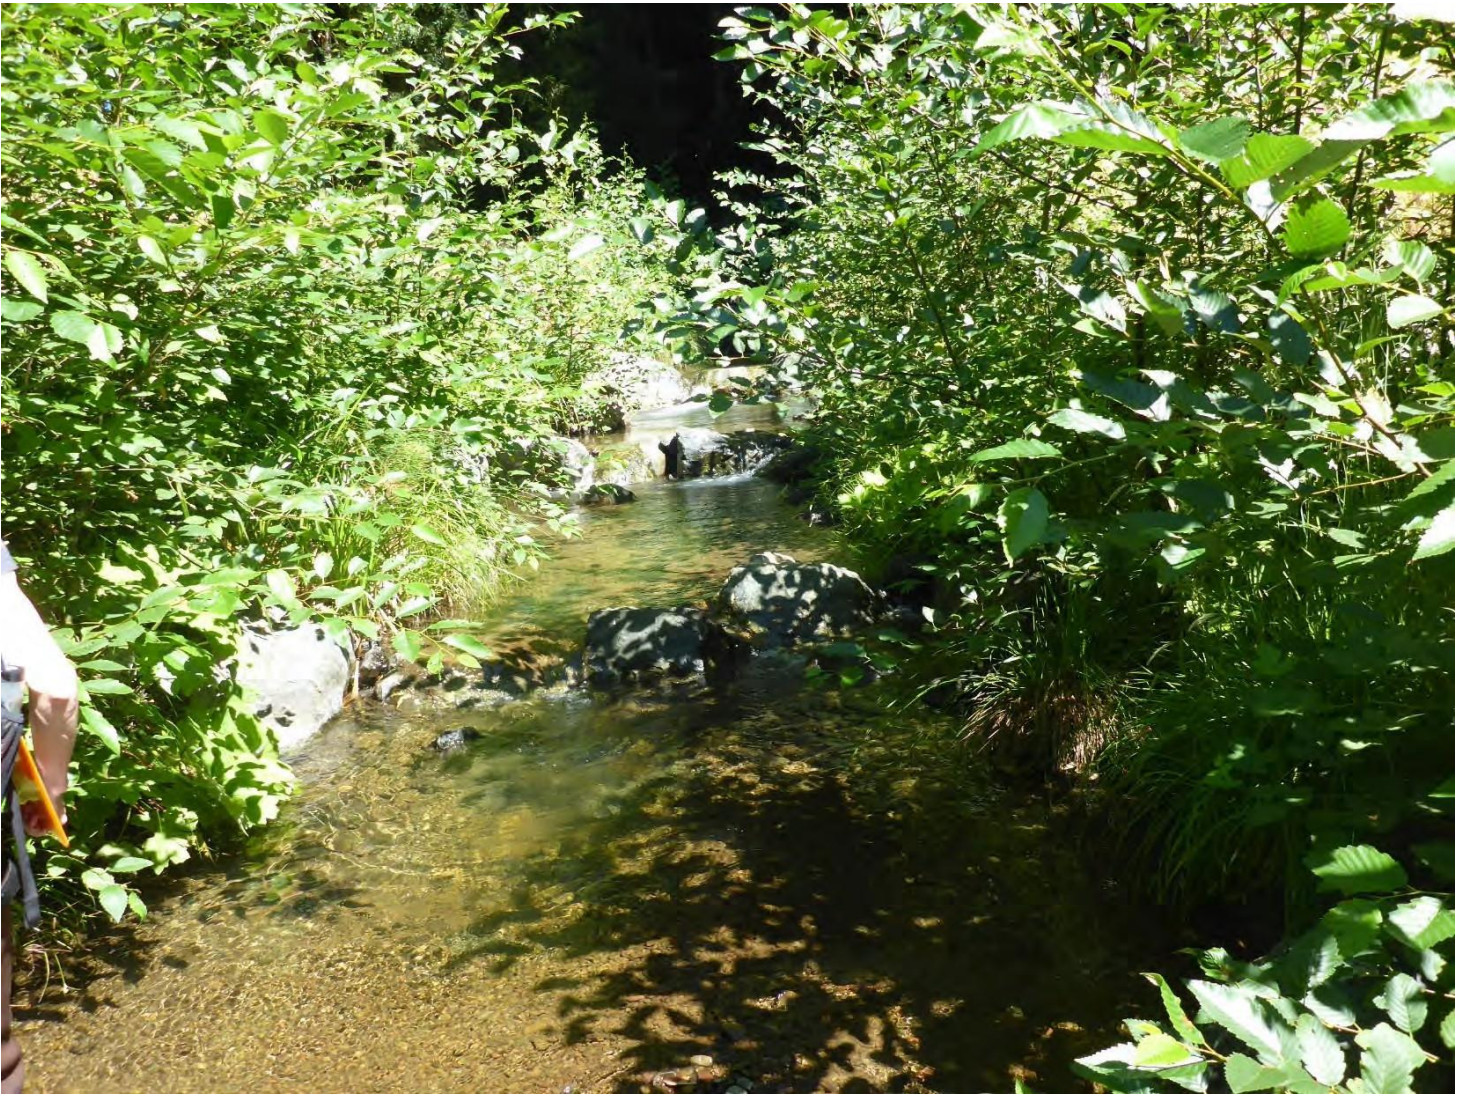
Figure 2. Upstream rock weirs with deep plunge pools. Photo by Michael Love on 7/17/2019.

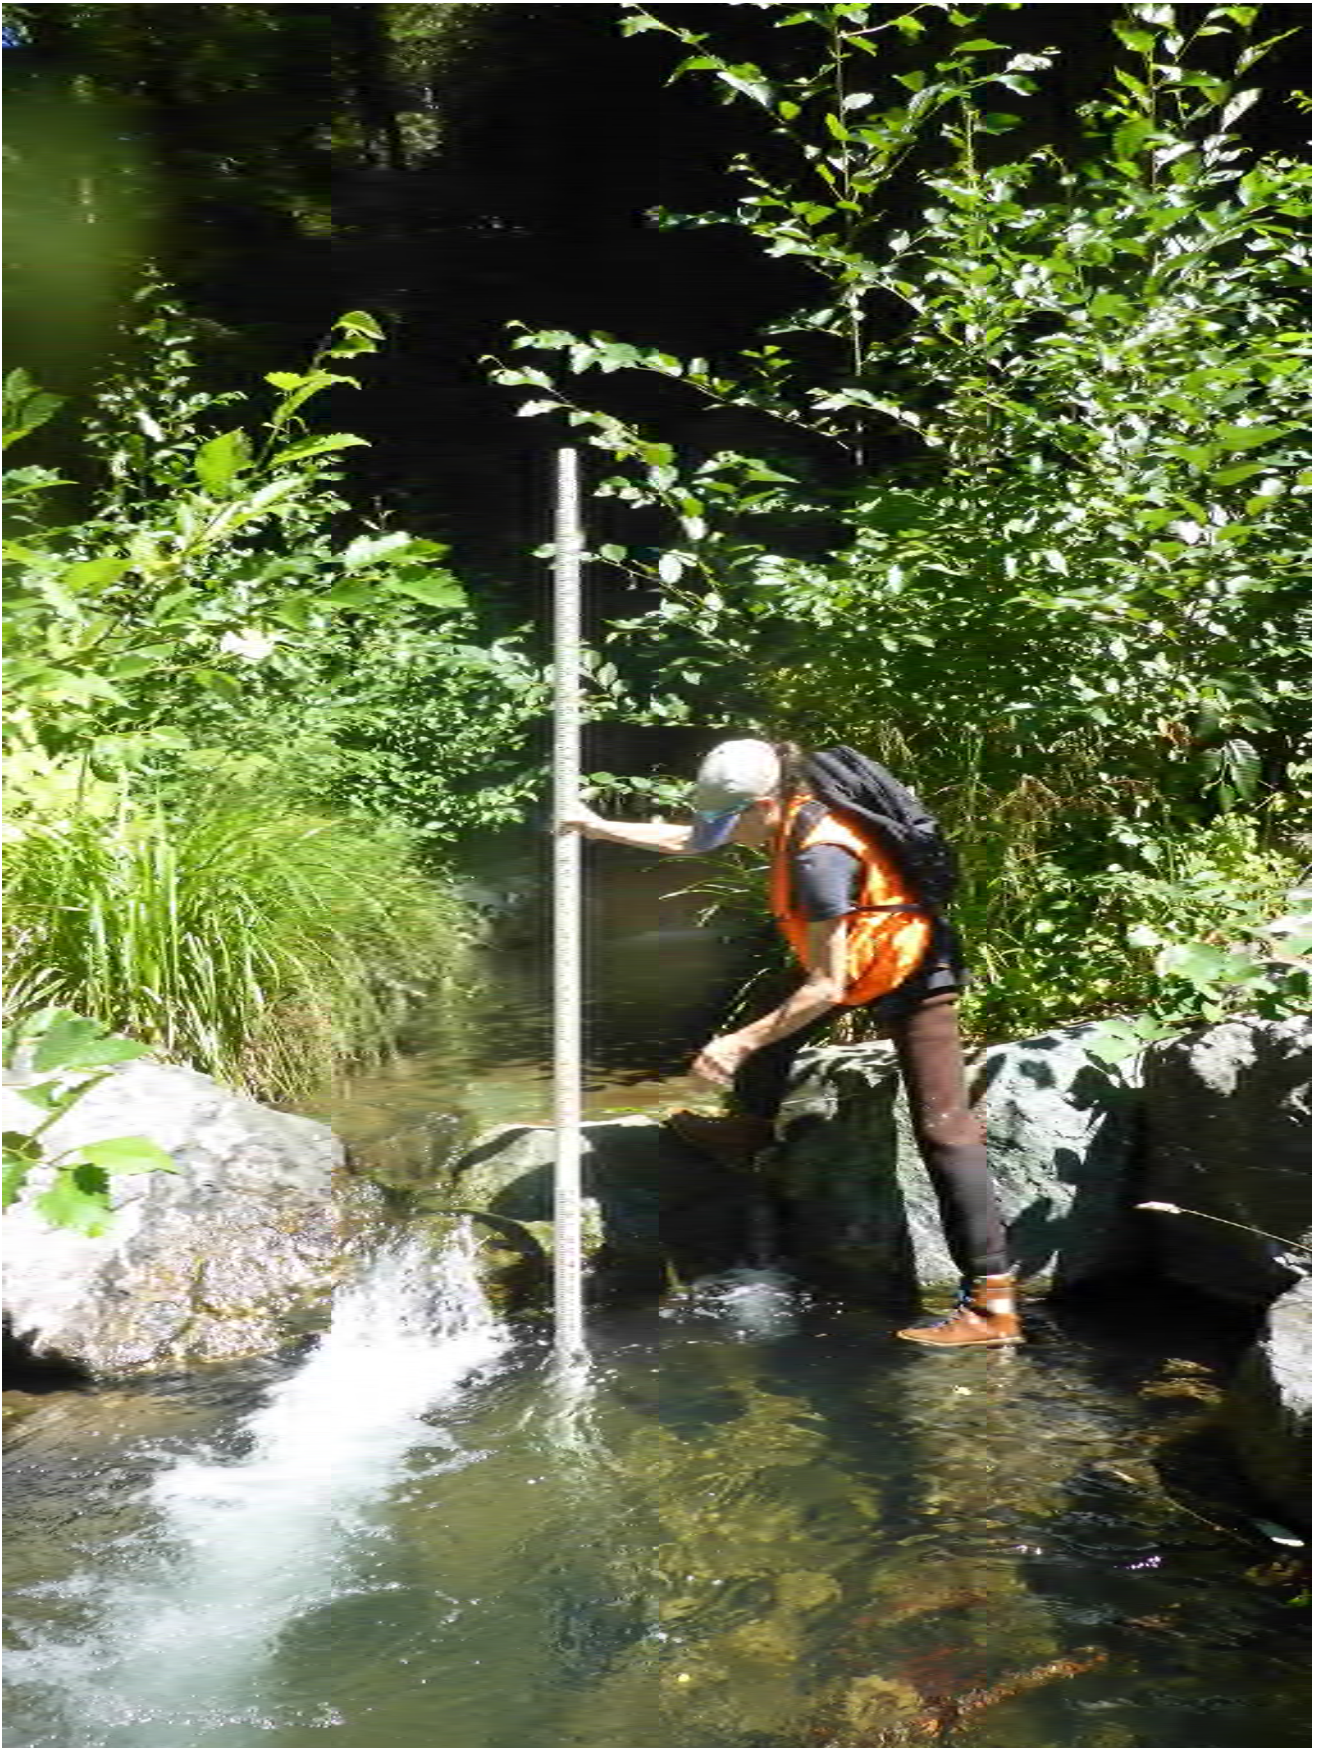
Figure 3. Upstream rock weir with deep plunge pool exposing foundation rock. Photo by Michael Love on 7/17/2019.

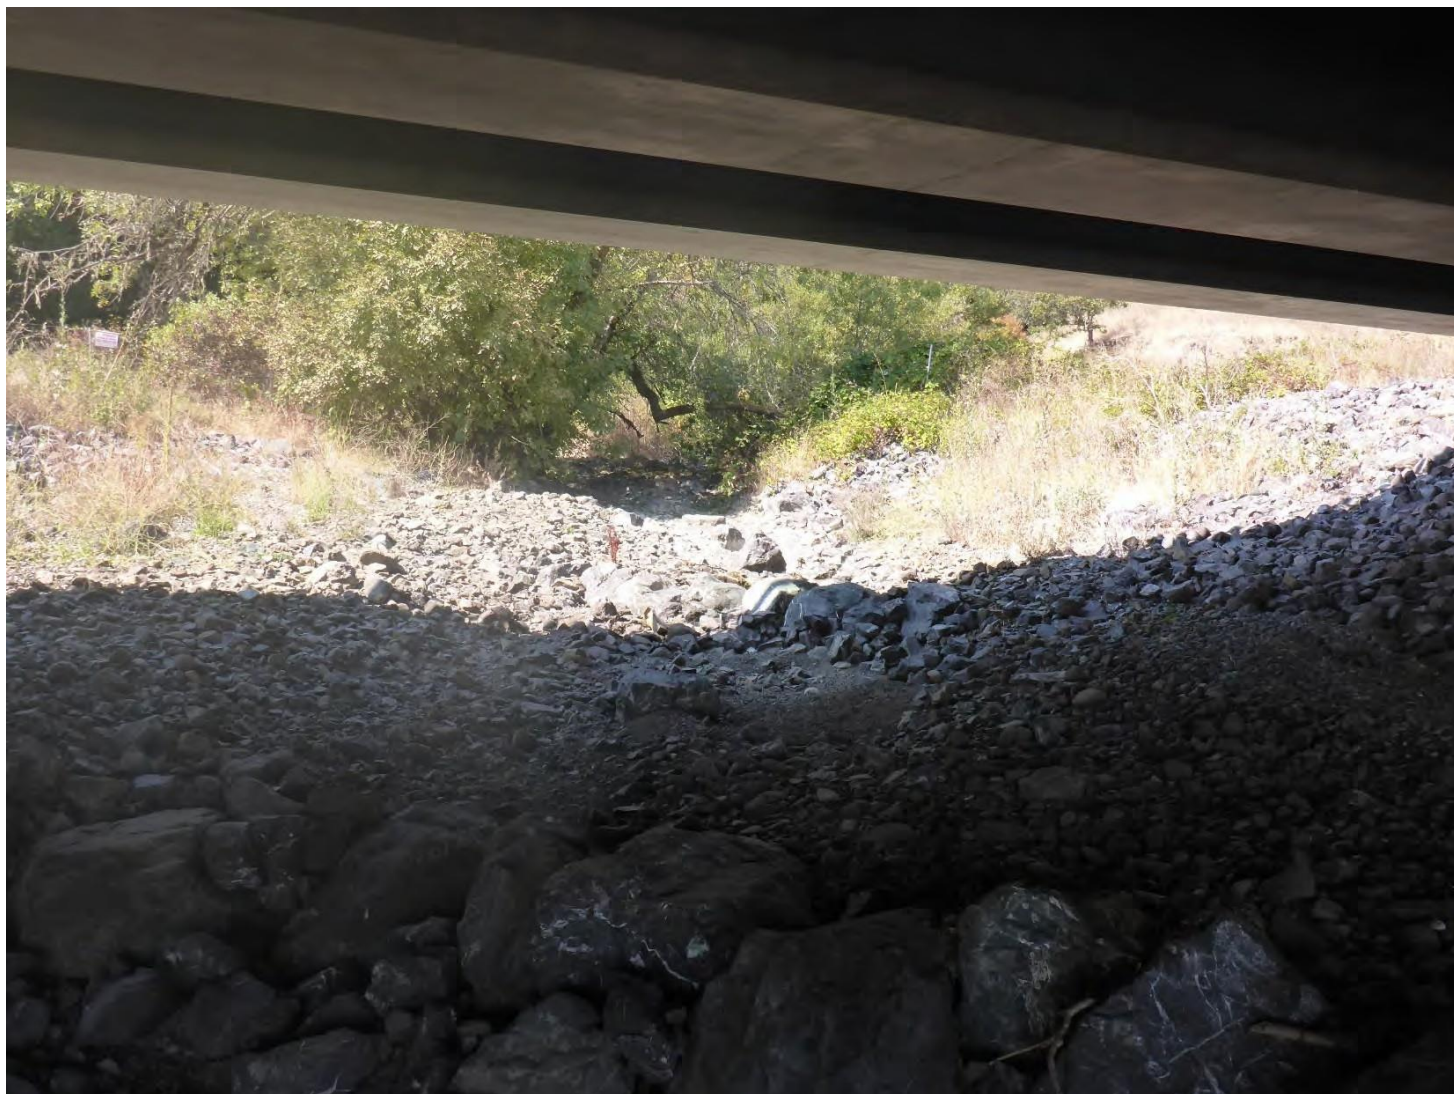
Figure 1. View looking upstream from beneath the new bridge. The most upstream V-shaped rock weir is in the foreground and the straight rock weir upstream of this weir is missing. Photo by Michael Love on 9/12/2019.

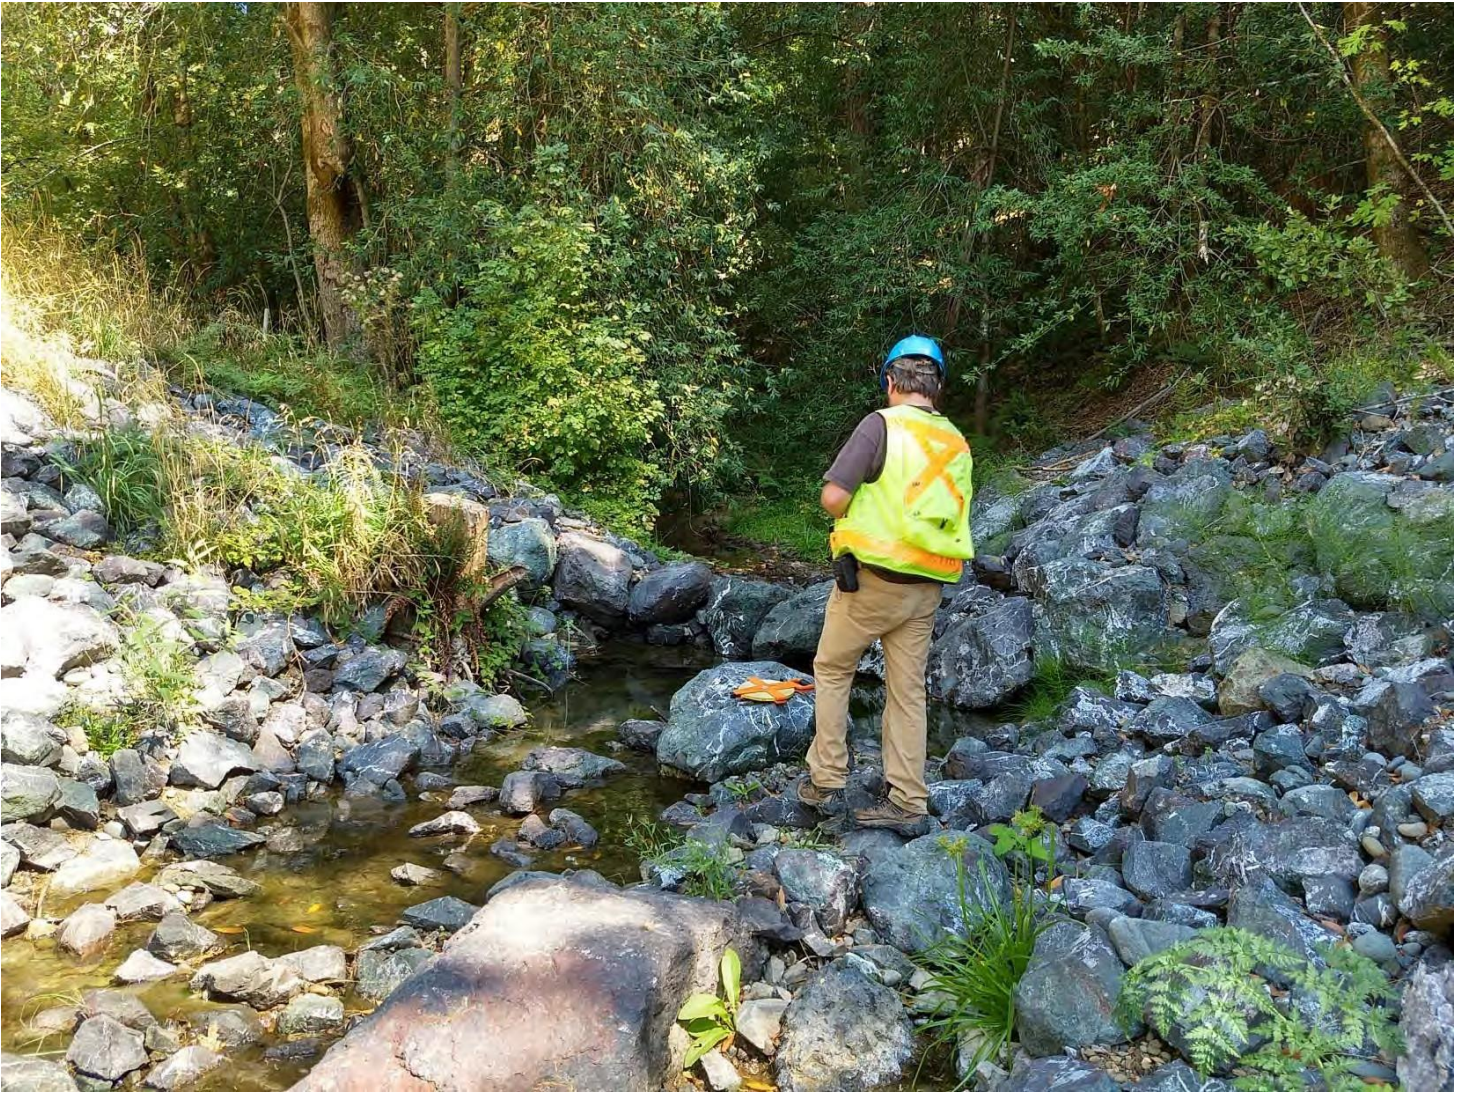
Figure 2. Close-up view of the upstream rock weir. The footing rocks are exposed in the pool increasing the potential for weir failure. Note that the low flow is going through the rocks in the weir rather than over the crest. Photo by Margaret Lang on 9/12/2019.

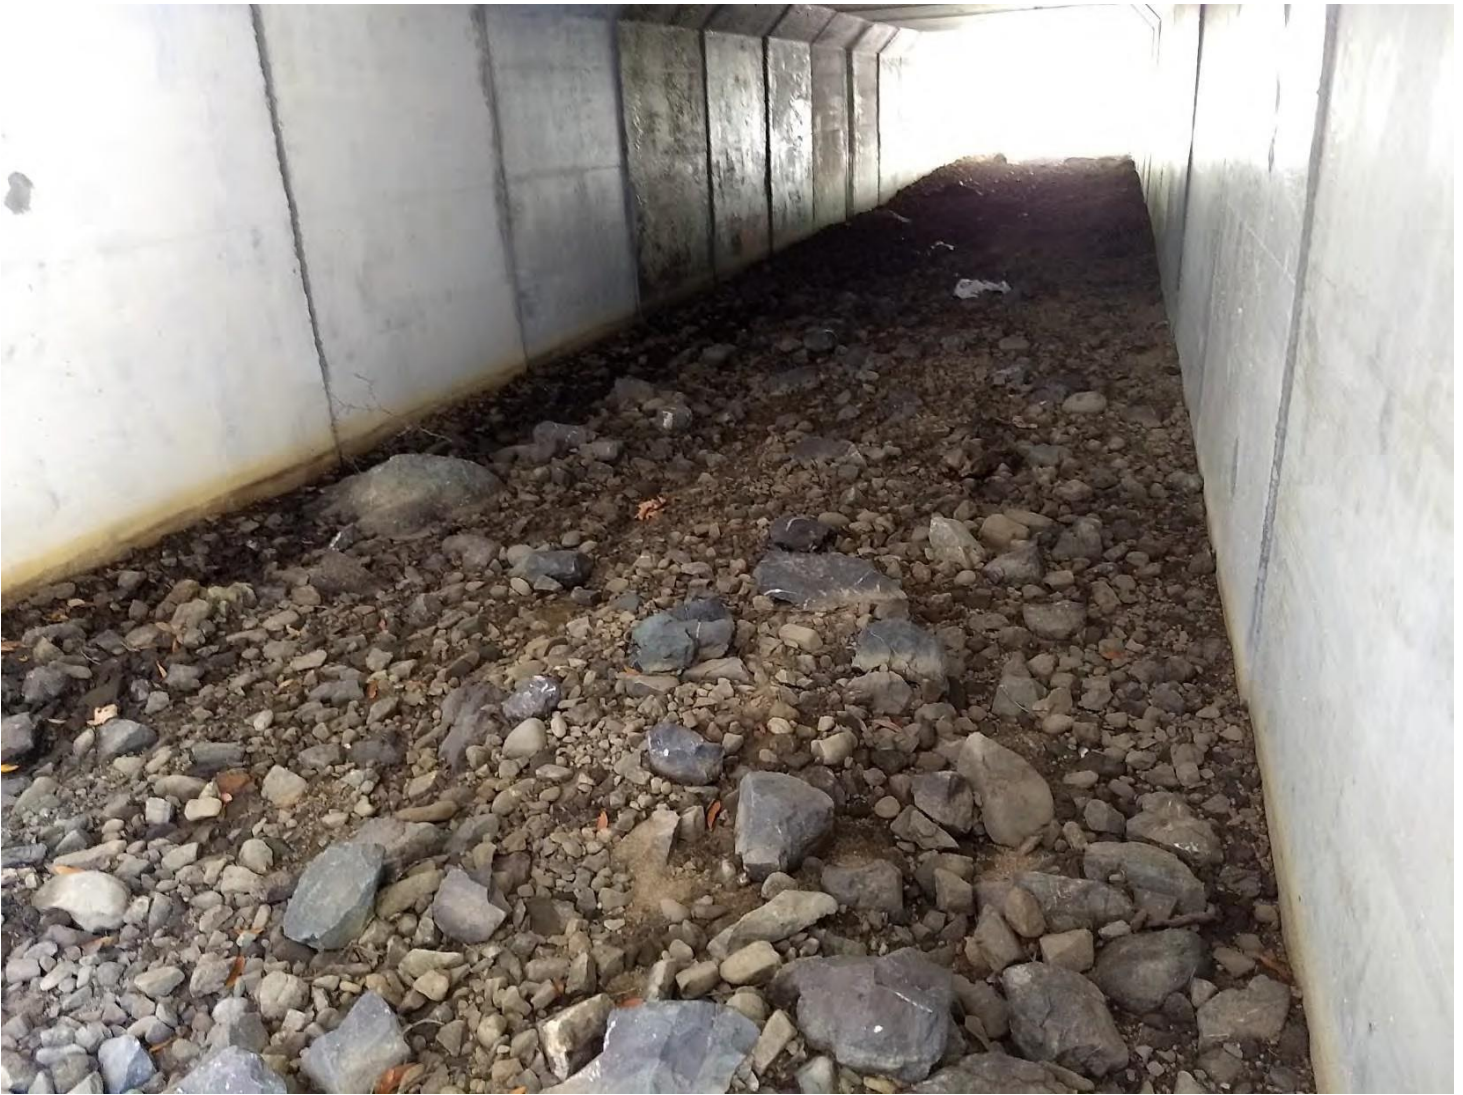
Figure 4. The culvert's invert and natural substrate bottom. The culvert substrate is almost a plain bed with the larger disruptor rocks mostly buried. At this low flow, there was no flow in the culvert, but it was very moist along the left side. Photo by Margaret Lang on 9/12/2019.

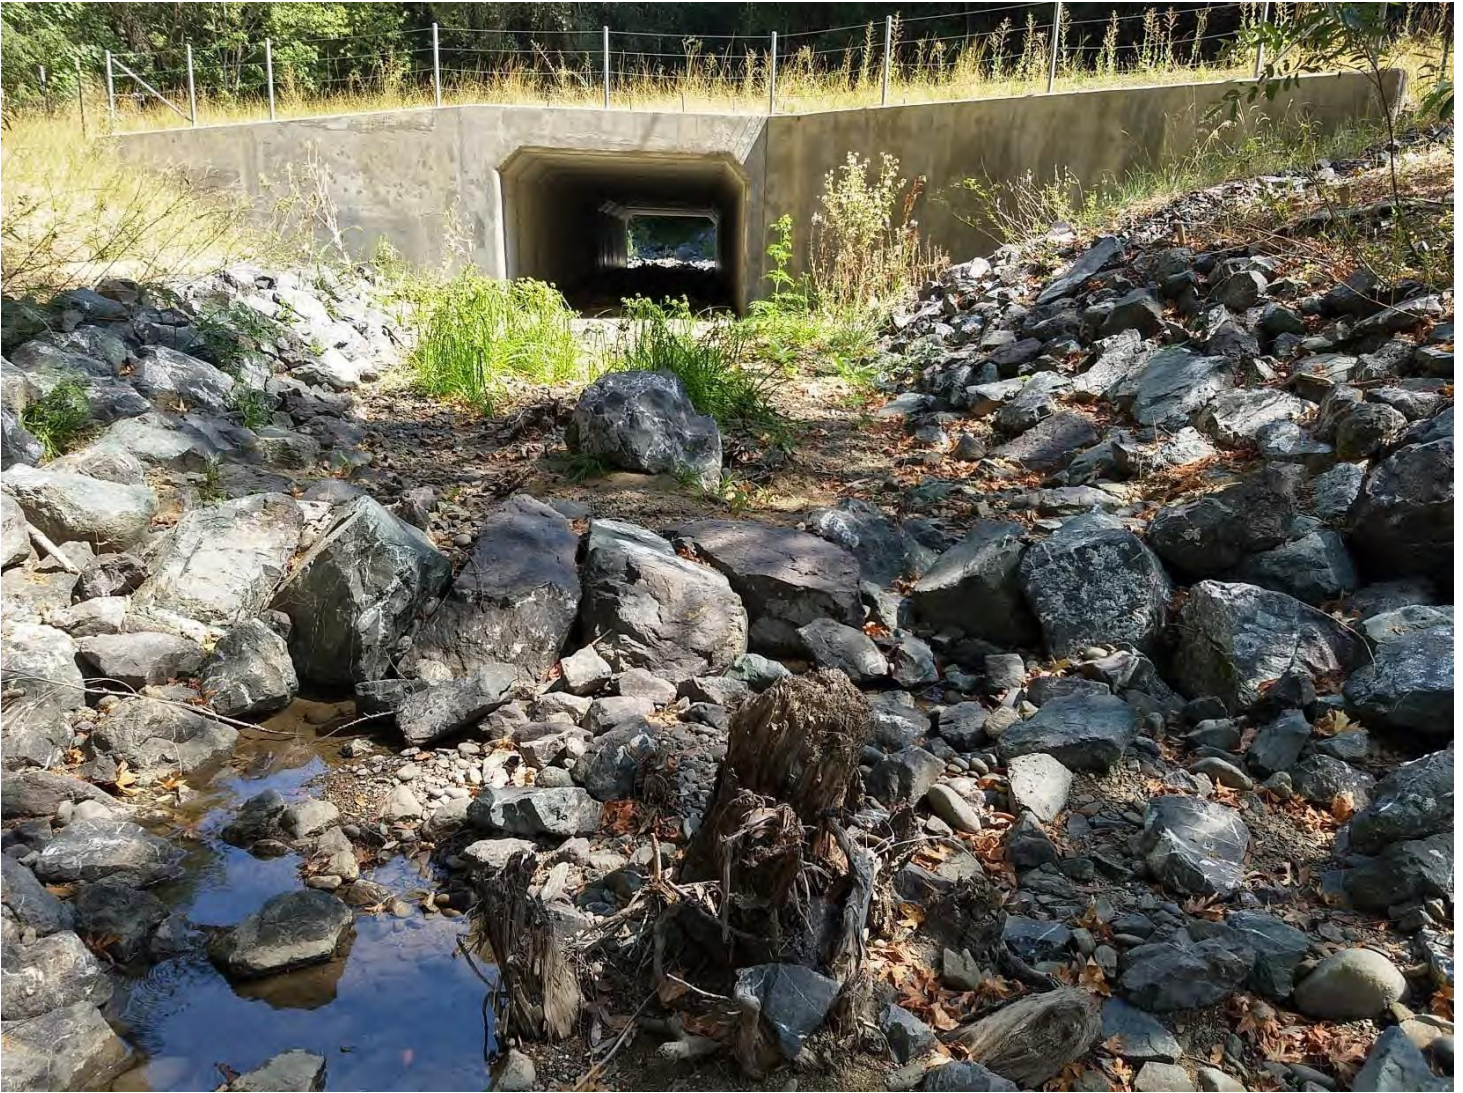
Figure 5. The culvert outlet looking upstream. The flow becomes discontinuous starting at the culvert inlet and remains discontinuous through the culvert and within the downstream project reach. Photo by Margaret Lang on 9/12/2019.

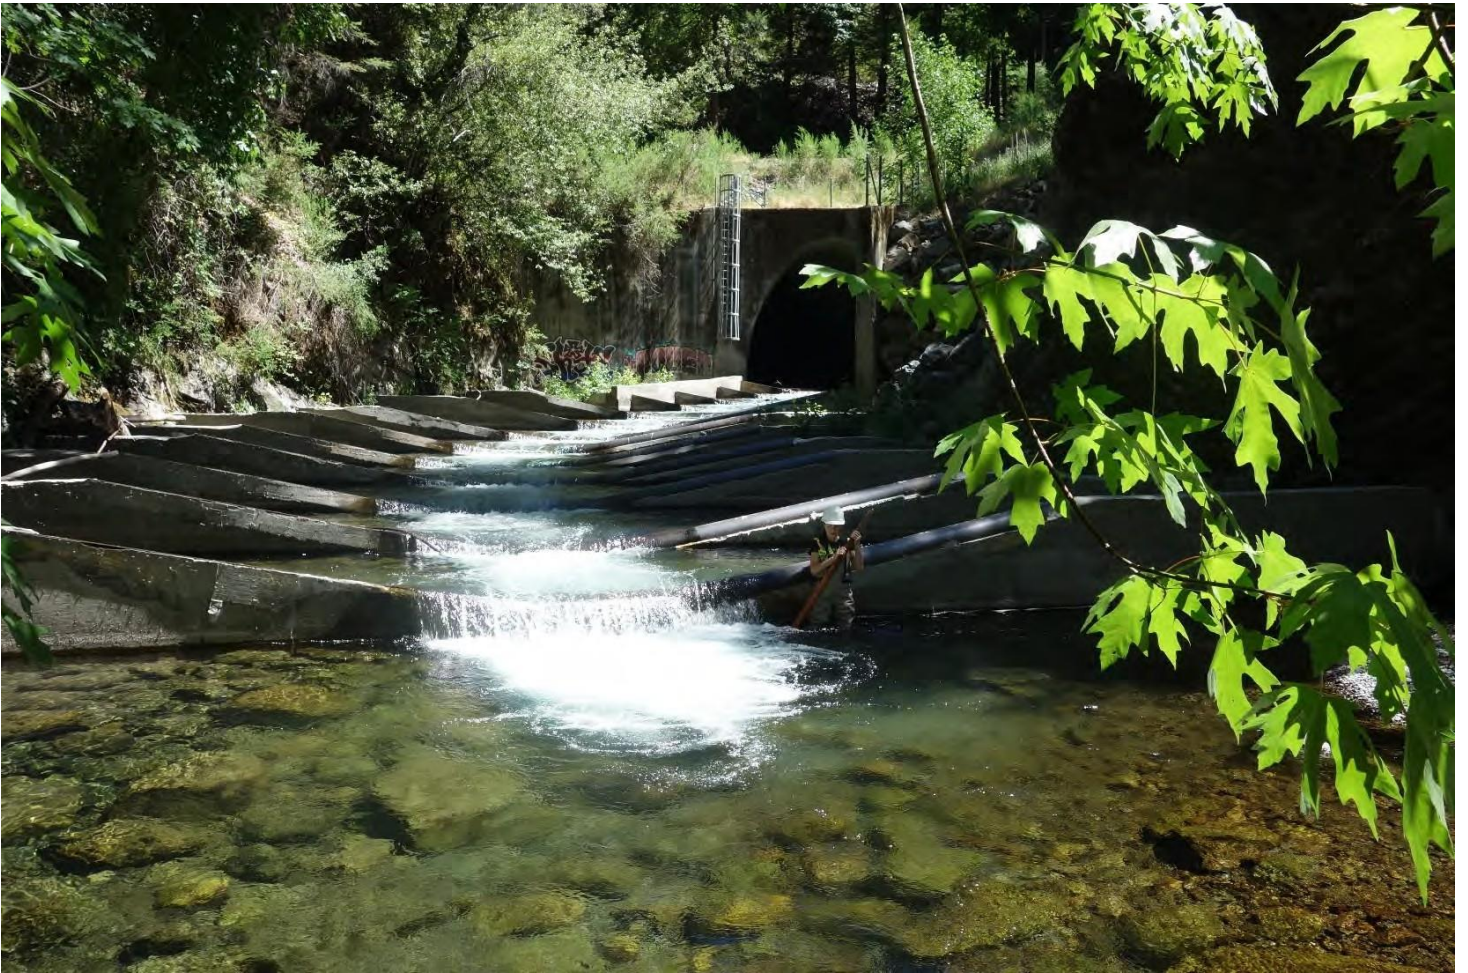
Figure 5. Cedar Creek outlet fishway looking upstream. The drop heights over the weirs under these conditions ranged from 1.25 ft (drop height at most downstream weir) to 0.4 ft; all but two drop heights were less than 0.75 ft. Photo taken June 3, 2021.
