FISH PASSAGE ENGINEERING PROJECT

Site Analysis Final Report

SITE ANALYSIS FINAL REPORT

Humboldt State University
Michael Love & Associates, Inc.

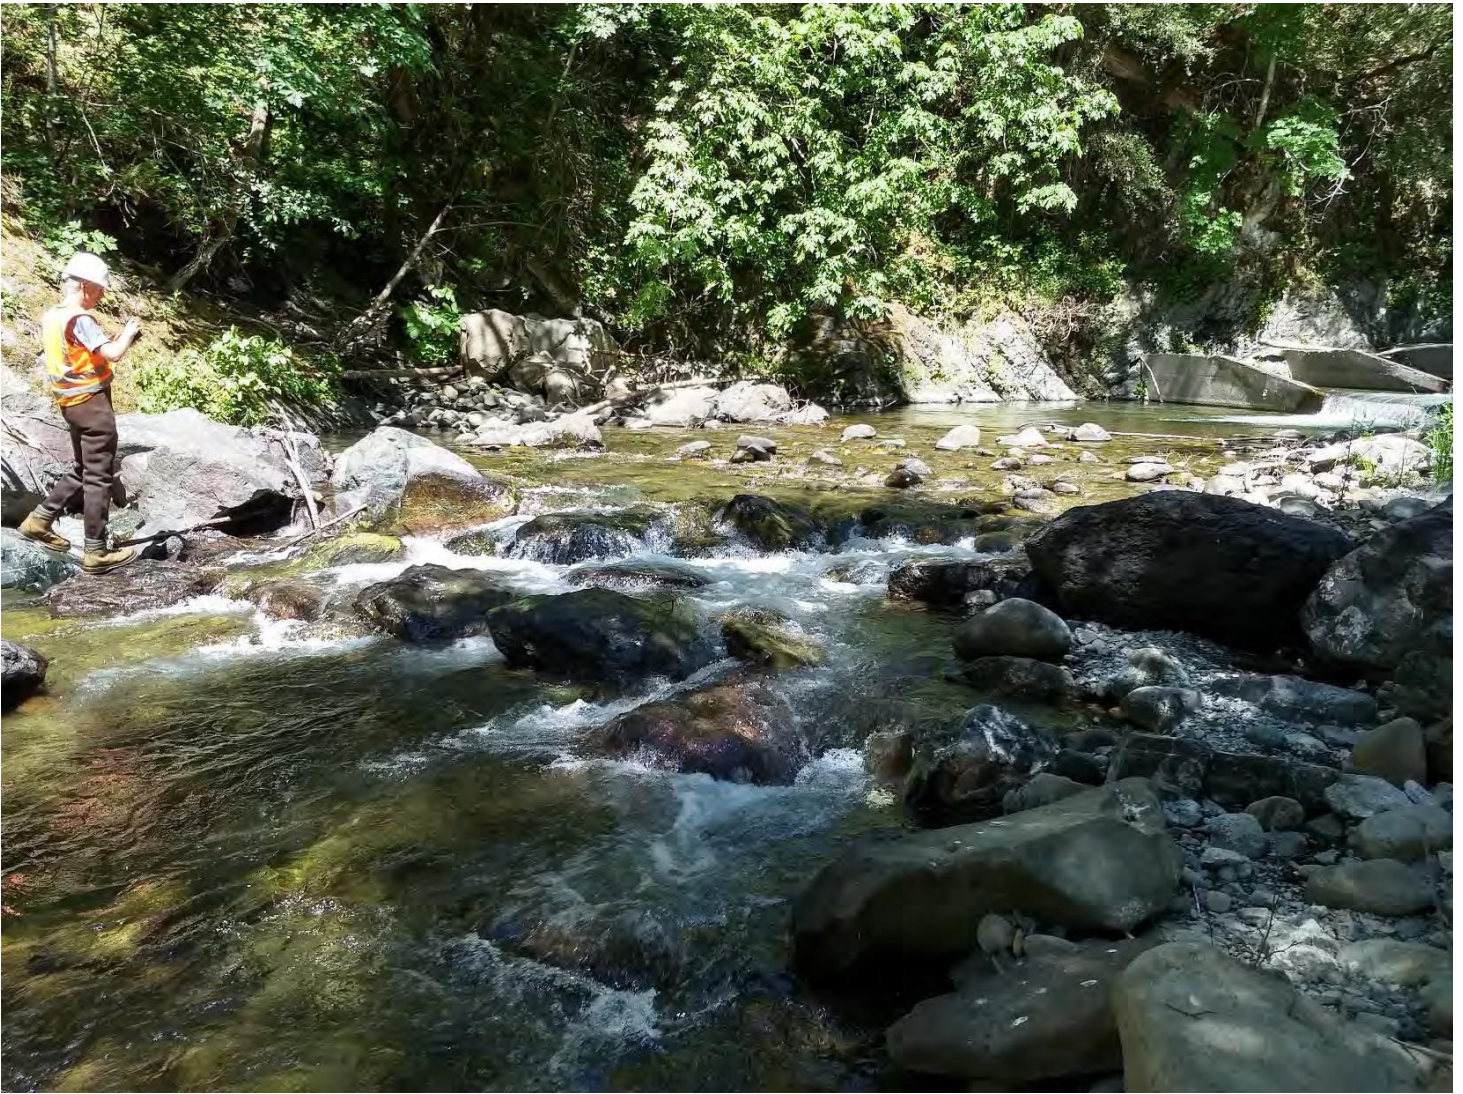
Figure 6. Looking upstream from the rock weir locations. In the foreground, the most downstream of the two rock weirs is somewhat intact. The most upstream rock weir is no longer present but its bank rocks are still present. The missing rock weir creates a larger drop height at the last fishway weir (~1.25 ft compared to 0.5 ft at most of the other weirs). Photo taken June 3, 2021.

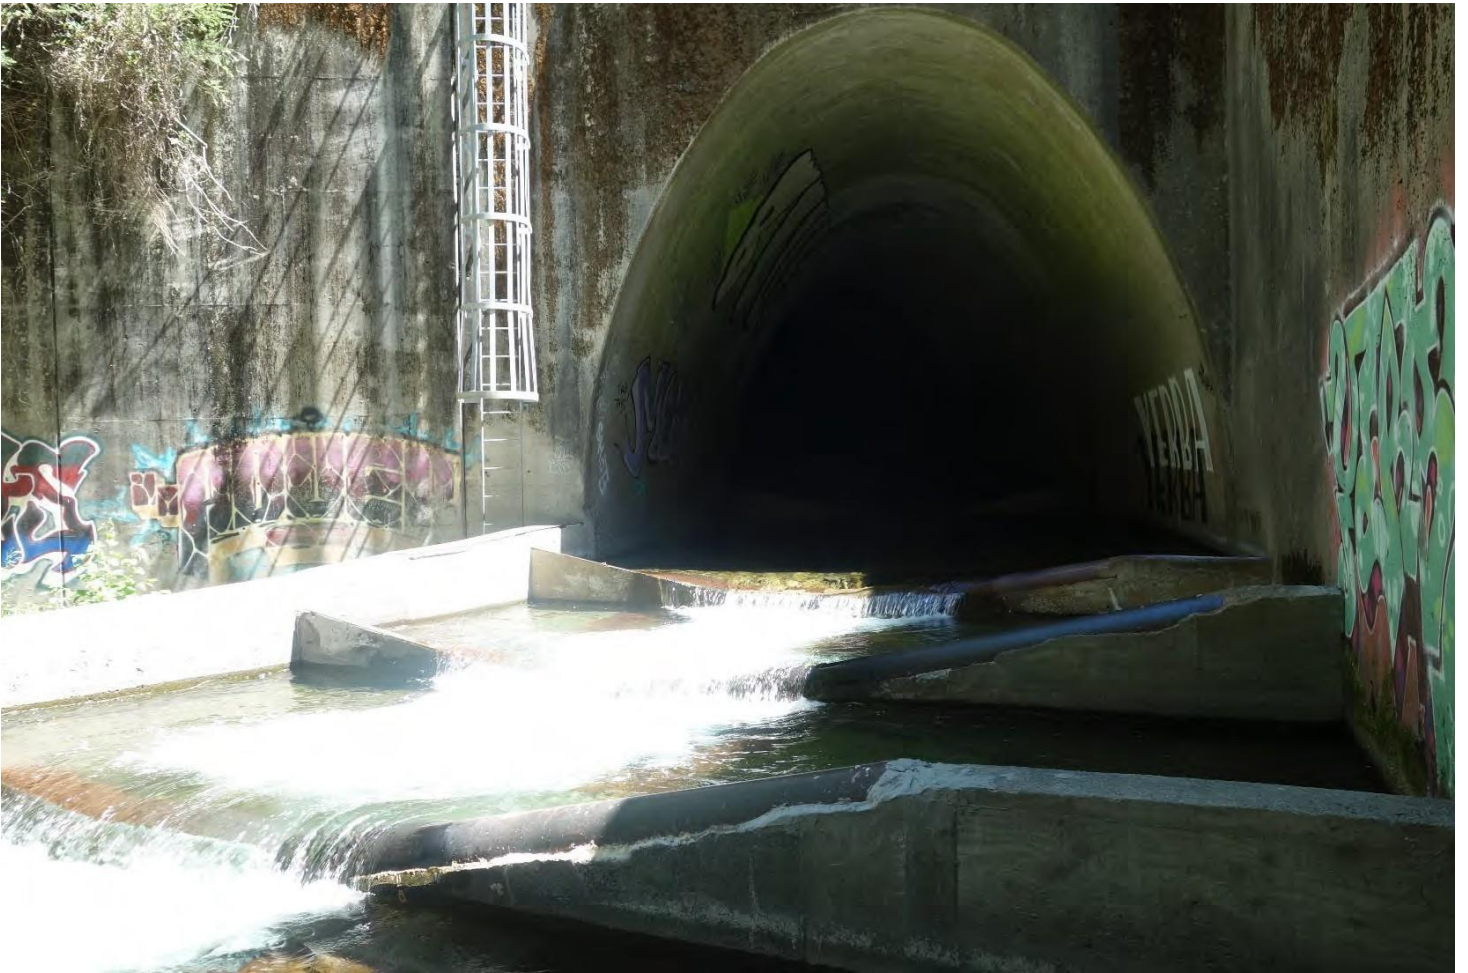
Figure 10. Cedar Creek culvert outlet weirs showing some of the crumbling concrete weir edges, especially around the installed steel plate coverings. Photo taken June 3, 2021.

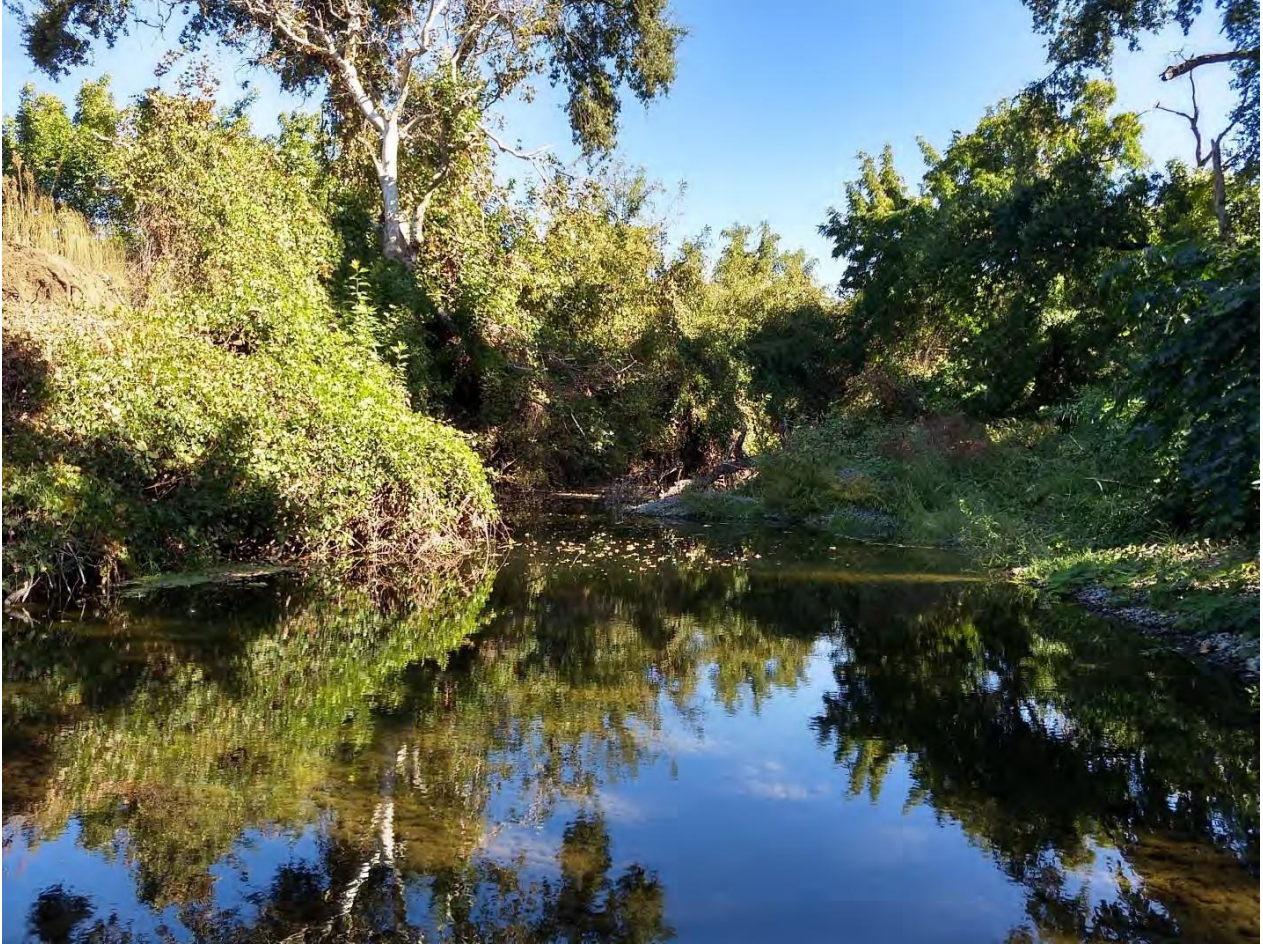
Figure 4. Craig Creek looking downstream. The downstream channel is highly incised due to regional conditions unrelated to the crossing. Photo taken October 4, 2019.

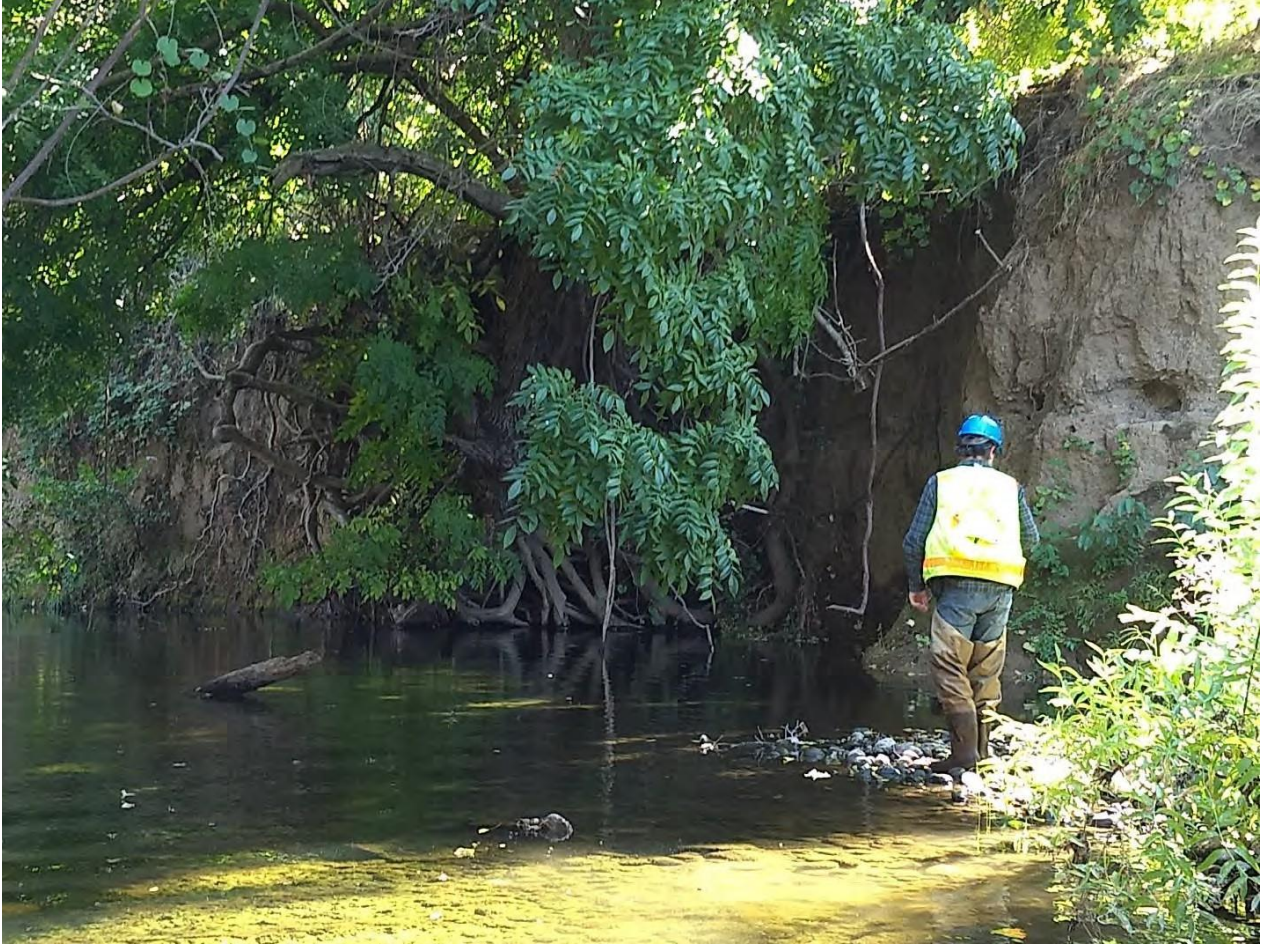
Figure 5. Craig Creek downstream channel showing extreme incision that is not related to the crossing but could influence conditions through the crossing. Photo taken October 4, 2019.

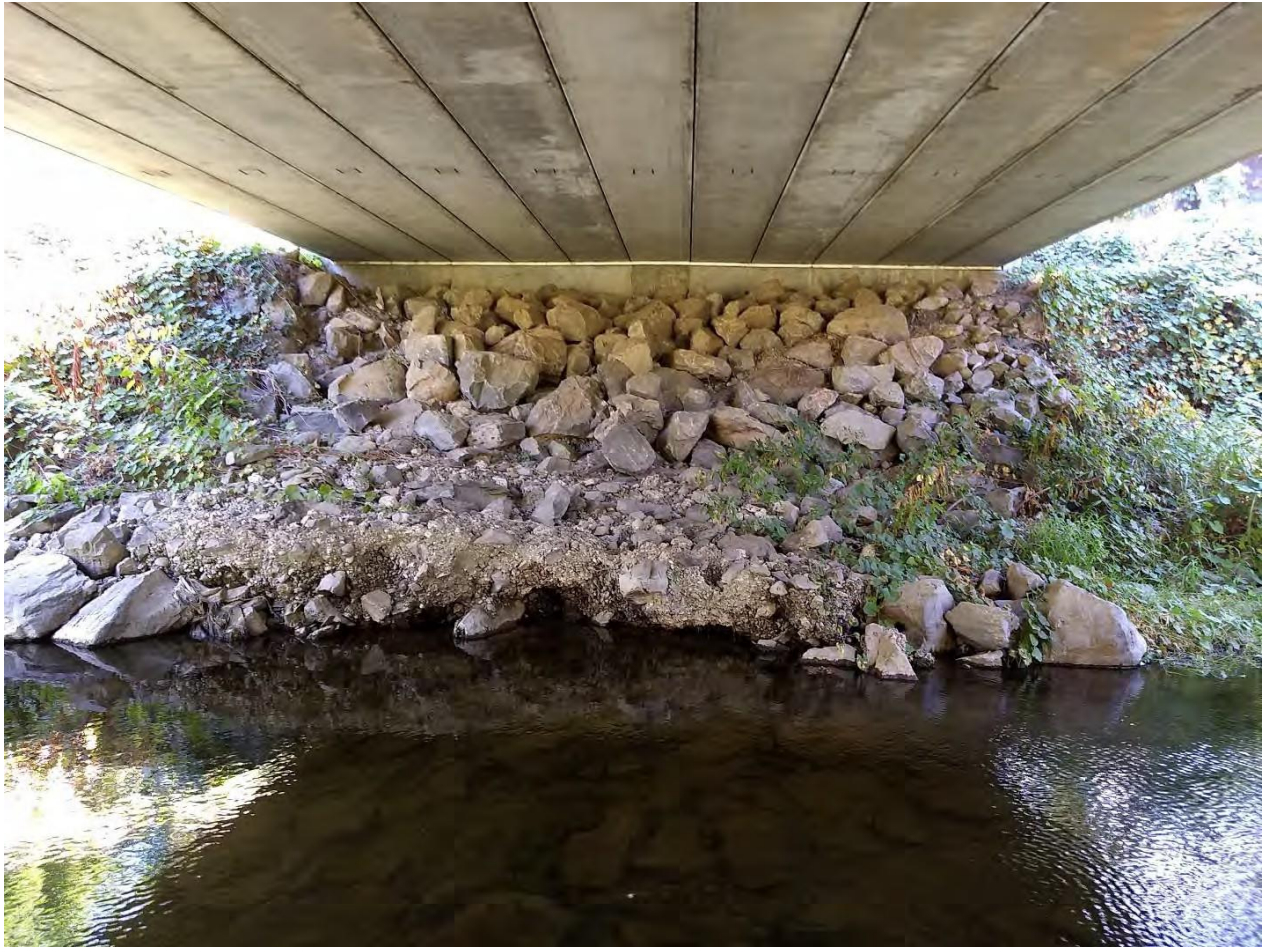
Figure 6. Craig Creek Right bank erosion and loss of bank protection by undercutting at the crossing. Photo taken October 4, 2019.
