# Implementation of Concrete Overlay Evaluation and Design

Research Project 5-6910-01  
Research Report 5-6910-01 R1  
<http://www.techmrt.ttu.edu/reports.php>

1. Report No. FHWA/TX-24/5-6910-01-1	2. Government Accession No.	3. Recipient's Catalog No.	
4. Title and Subtitle Implementation of CRCP Overlay on CPCD		5. Report Date July 2023

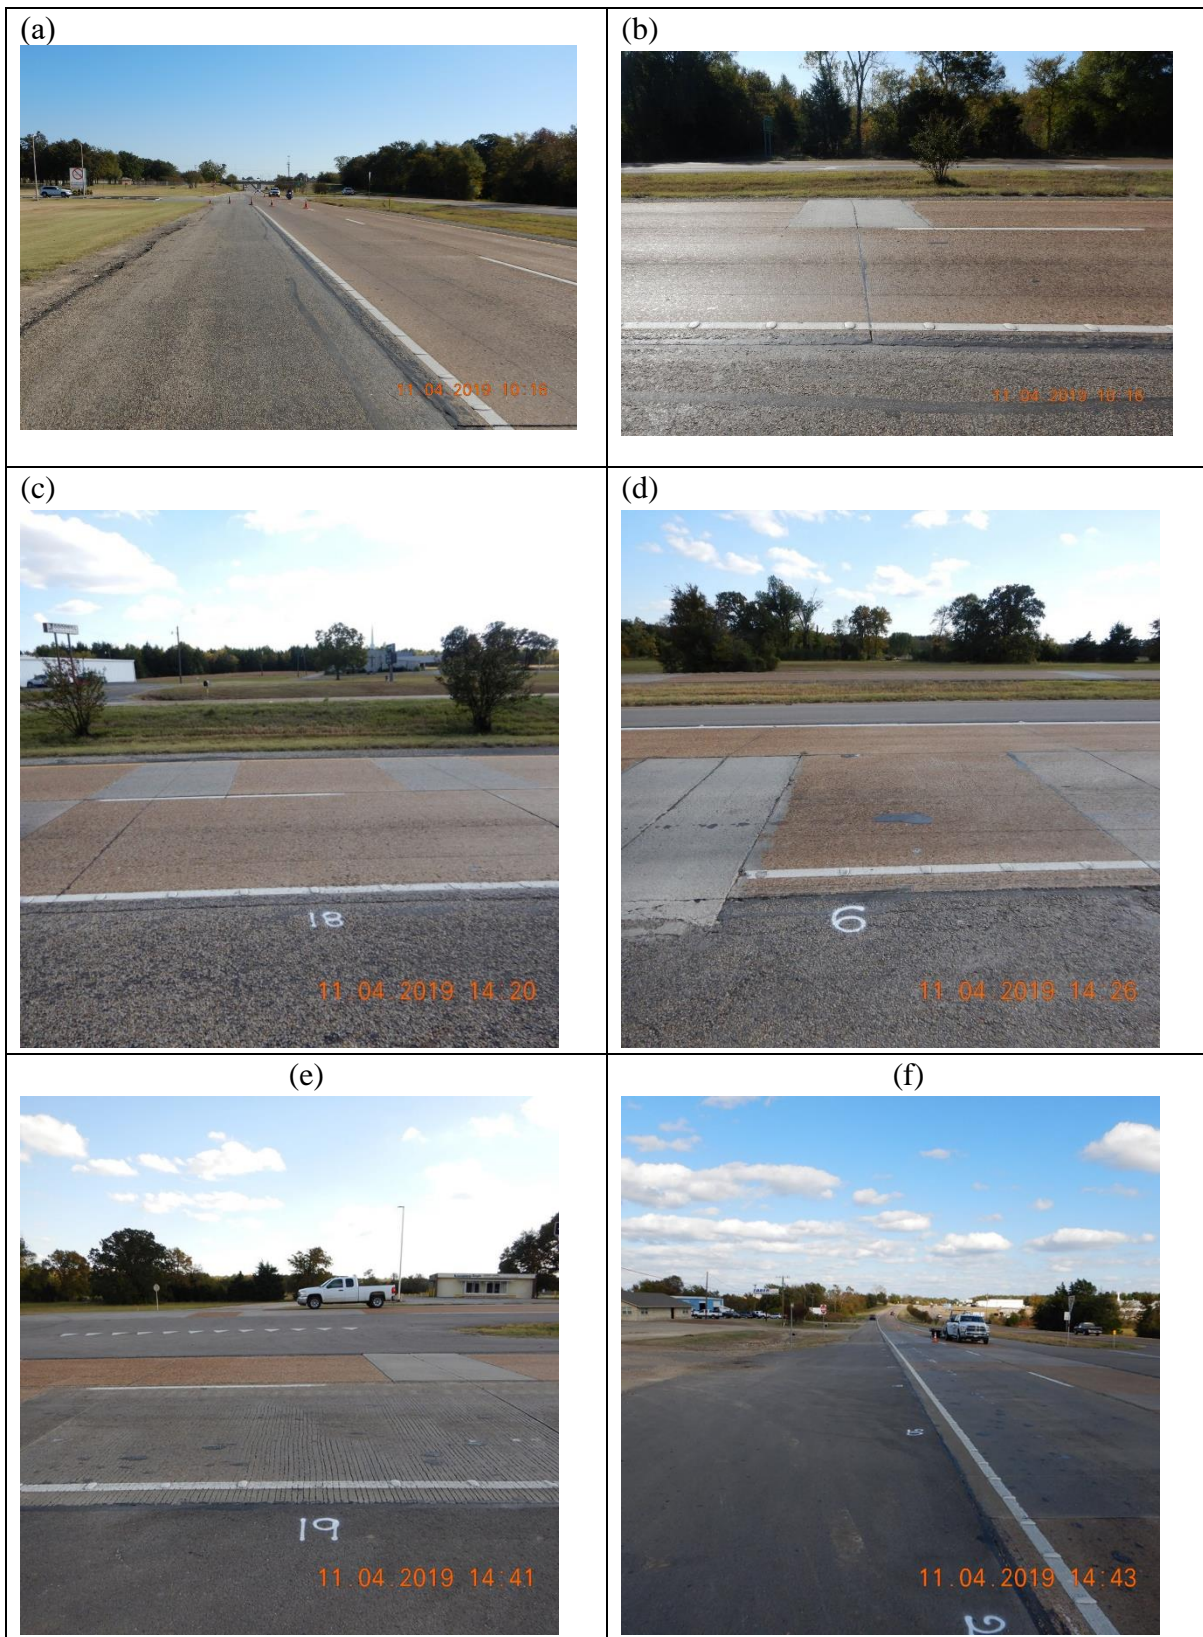
**Figure 6 Existing CPCD condition on Loop 286**

Figure 6 shows typical pavement condition. Figure 6-(a) shows the driveway to the Campbell Soup Company where the beginning of the test section is located. This is a two-lane highway where most of the trucks drive through the outside lane. It was observed that even though most of the truck traffic uses the outside lane, repair sections are also observed in the inside lane as shown in Figure 6-(b) and (c). This indicates that the distresses were not necessarily due to structural issues, but potentially due to a joint issue in the CPCD. Figure 6-(d) shows similar types of concrete patches in the outside lane as the inside lane, which supports the assumption that joint failures necessitated the repairs. Furthermore, it can also be observed that these are full depth repairs, mostly in the outside lane as shown in Figure 6-(e) and (f).

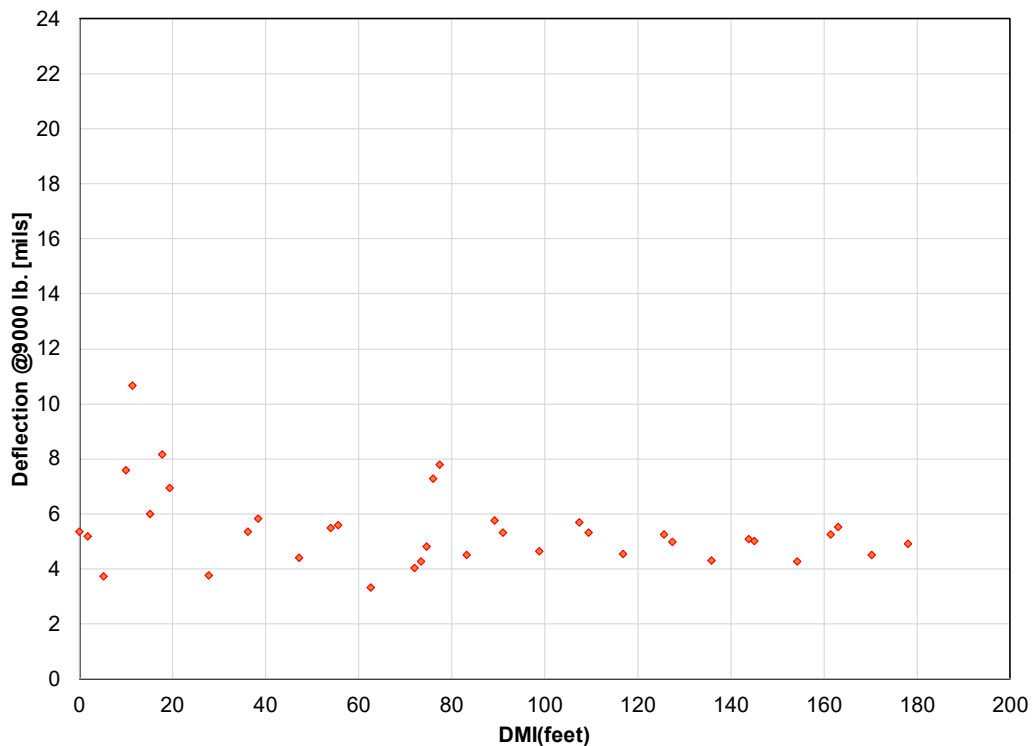
**Figure 11 Location 1 FWD deflections**

In Location 1 as shown in Figure 10, the deflection of 37 points were measured. Figure 11 shows the measured deflections in Location 1 segment. It is observed that 2 larger deflections are between 2 smaller deflections. The 2 larger deflections are those evaluated at a joint, and the other 2 smaller deflections are at mid-slabs. Most of the mid-slab deflections are about 4 mils, while the joint deflections vary from 4 to 8 mils. The variations at transverse contraction joints or repair joints may be attributed to various conditions of joints – some may be locked, and some may be fully separated. It can be recalled in the specifications that the dowels shall be coated or smooth. This is to prevent bonding of the dowel bar and concrete. However, when the dowel bars are bonded to the concrete at both sides of joints, joint movements are restrained, forcing slabs on both side of the joint behave like a continuous slab (“locked joints”). With this, some joints in Location 1 are potentially locked, resulting deflections comparable to those mid-slabs. Such

behavior suggests potential issues with dowel installation. It was also noticed that the LTE values obtained at those suspected locked joints were relatively high.

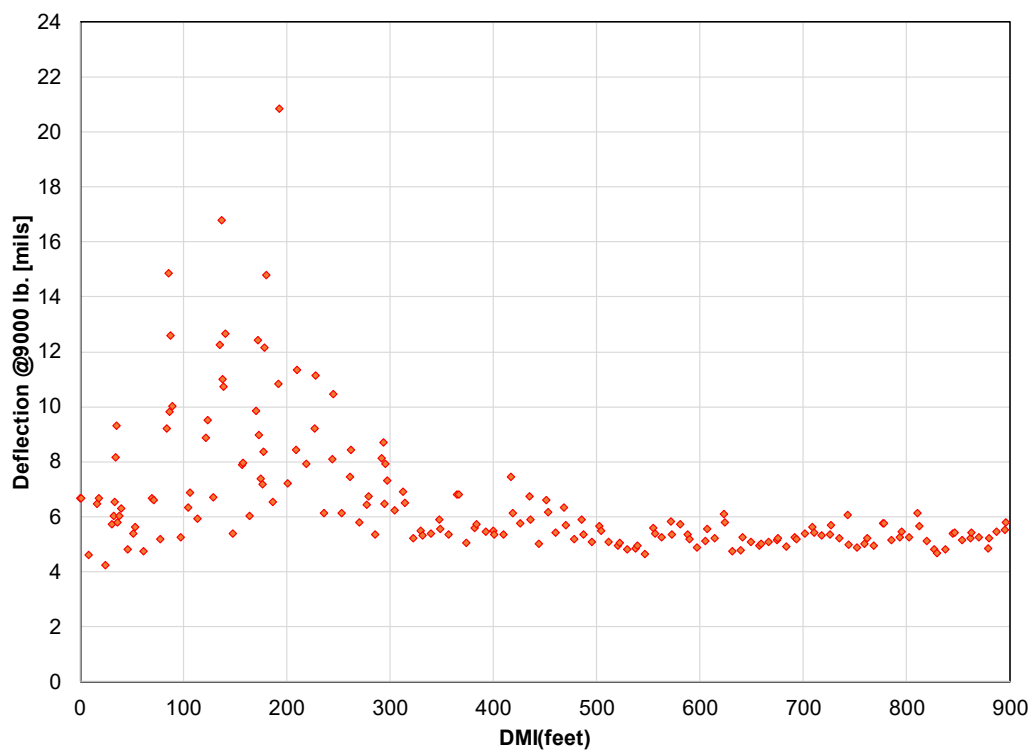
**Figure 13 Location 2 FWD deflections**

The Location 2 segment, shown in [Figure 12](#), had a total of 180 points covering 53 slabs. [Figure 13](#) shows the measured deflections across the entire segment. It can be observed that the first 300

feet of the segment have high deflections. The deflection recorded went up to 20 mils. Pavement condition information shows that these areas are repaired slabs, which indicates that the repairs were not done properly. Meanwhile, the deflections mid-slabs recorded after the first 300 feet of the segment were relatively consistent which ranges from 4 to 4.5 mils.

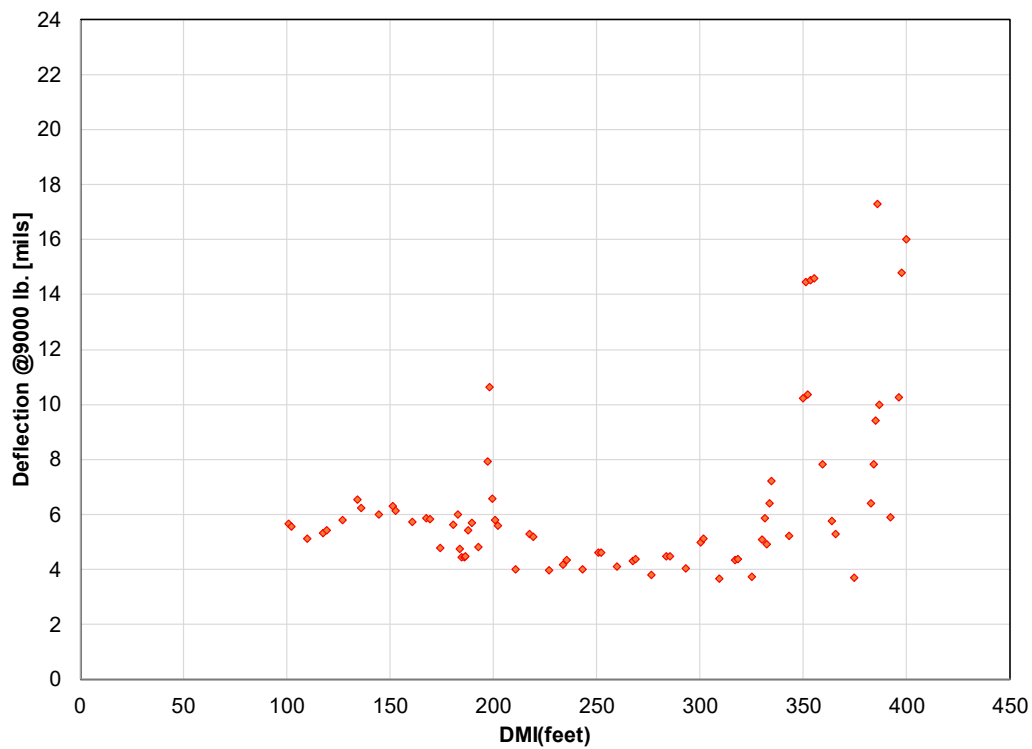
**Figure 15 Location 3 FWD Deflections**

The Location 3 segment, shown in [Figure 14](#), had a total of 74 points covering 25 slabs. [Figure 15](#) shows the measured deflections in the entire segment. It was also observed that the large deflections were measured on the repaired slabs. The highest deflection in the segment was recorded to be 17.3 mils whereas the lowest deflection was 3.9 mils.

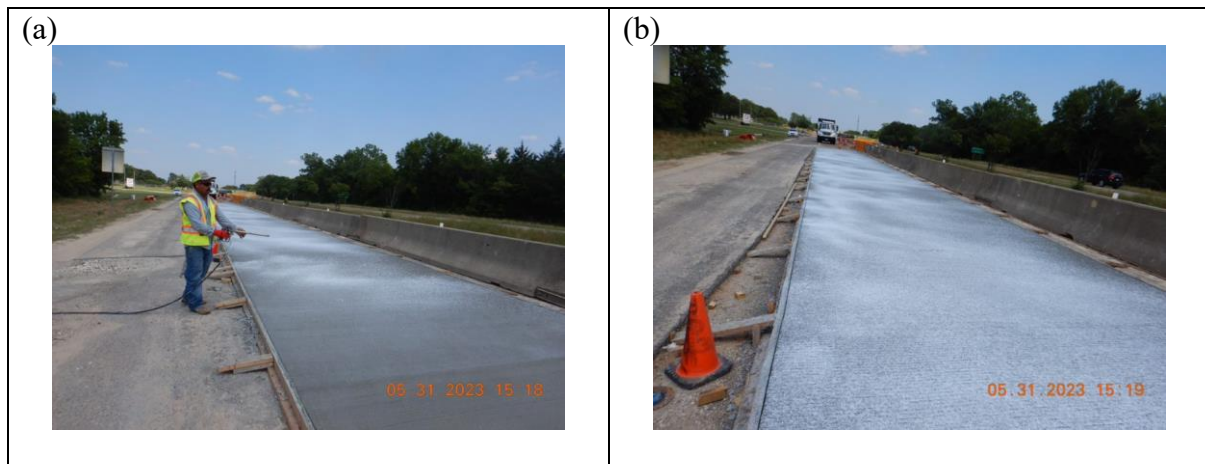
**Figure 45 Curing compound application after concrete placement.**

Figure 45 shows the curing operation. It is observed that there are areas with deficient curing. The grey areas were more dominant on the inside of the outside lane. The insufficient application of curing compound may not prevent moisture loss from the concrete surface, potentially increasing temperature loss and shrinkage of concrete.

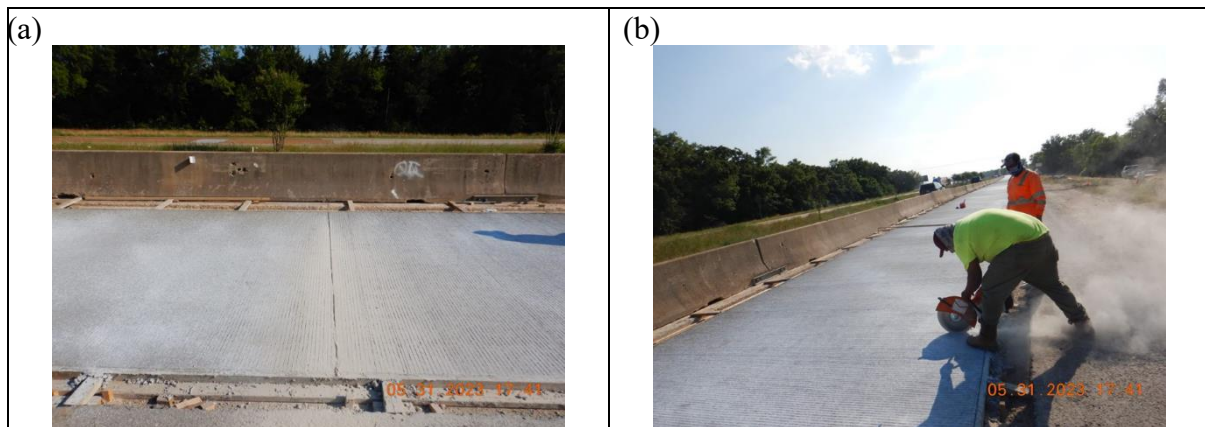
**Figure 46 Saw-cut on Segment 1A, Segment 2 and Segment 3**

The day after concrete placement, saw-cuts were made on the CRCP overlay as shown in Figure 46 even though saw-cuts are not needed in CRCP. As pointed out earlier, the saw-cut was made only on Segments 1A, 2 and 3. The effect of the saw-cut in crack propagation was monitored and will be discussed in the discussion of the results.

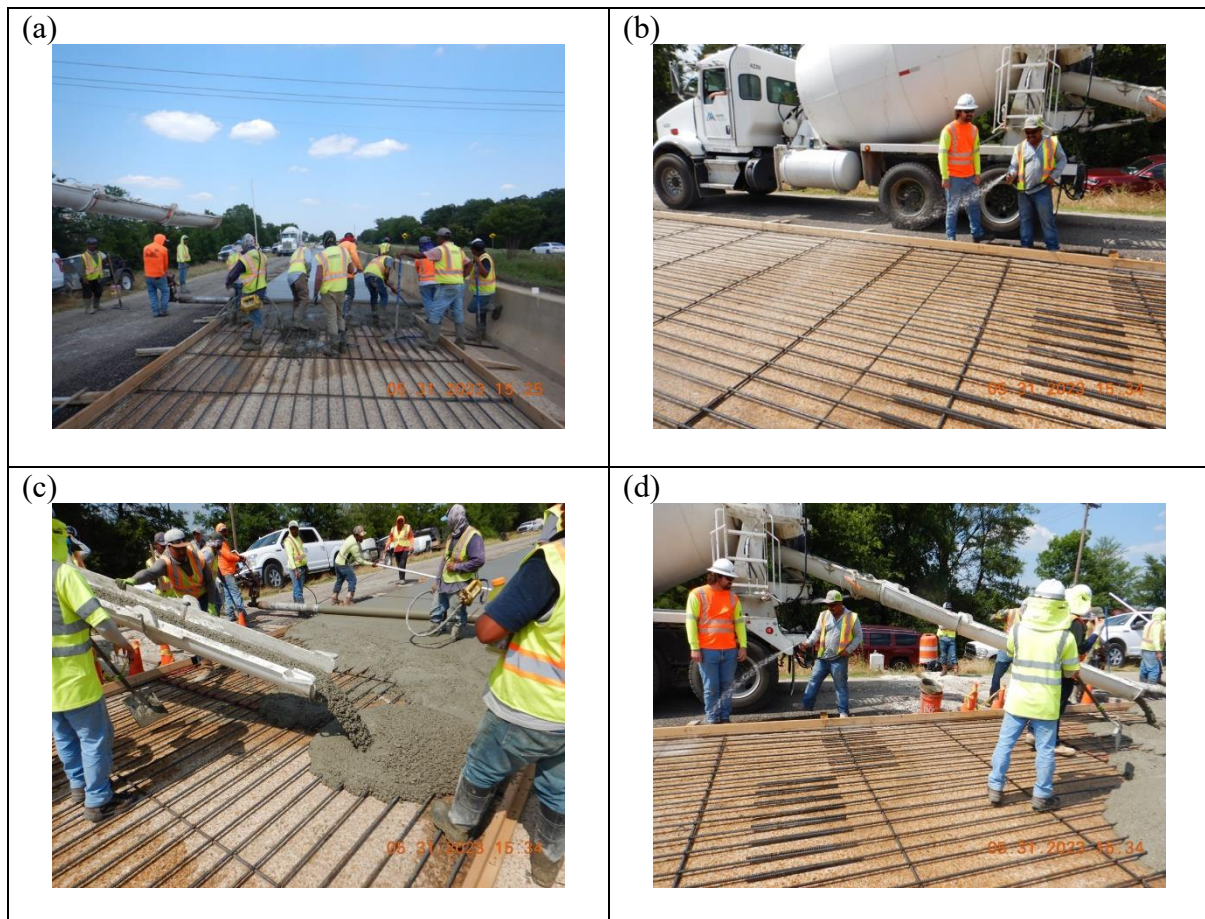
**Figure 47 Surface condition during concrete placement**

It was also observed that in some areas, the surface of the existing CPCD was not in SSD condition prior to the concrete placement. The need for SSD condition or damp condition on the existing surface is necessary to establish a good bonding at the CPCD and CRCP interface. However, as seen in [Figure 47 -\(a\)](#) to [Figure 47-\(d\)](#), there were areas where the surface of existing CPCD dried up before the concrete was placed. Those dry areas were mostly in the left half of the outside lane.

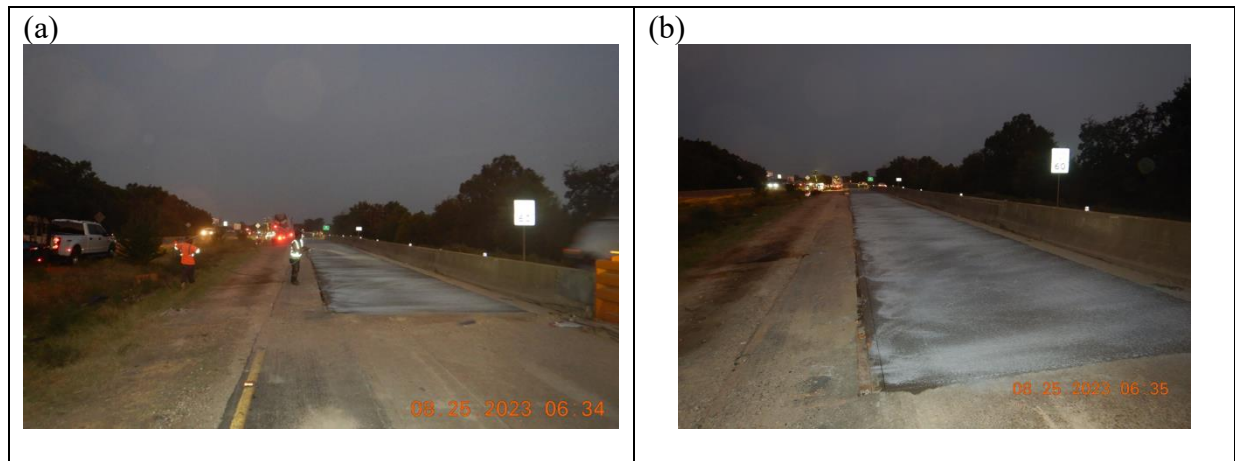
**Figure 50 Curing compound application after concrete placement**

Figure 50 shows the curing operation and the condition of curing membrane. It shows that the curing membrane was in a rather non-uniform condition.
