Pocket Lidar Culvert Assessments

FHWA Publication No.: FHWA-HRT-25-016

This document is a technical summary of a case study for the FHWA report *Leveraging Pocket Lidar for Construction Inspection and Digital As-Builts—Phase 1 (Forthcoming)*.

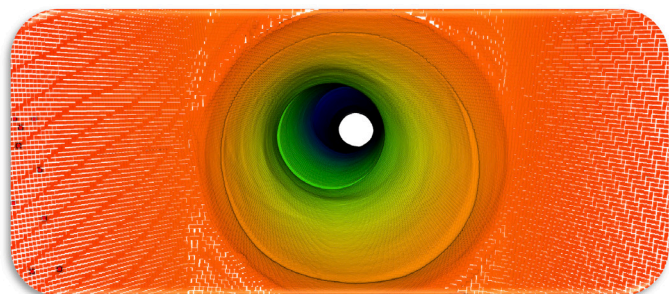
Figure 1. Screenshots. Example point cloud of a culvert showing deformation.

A. View looking into the culvert.

B. View looking at the culvert elevation profile.

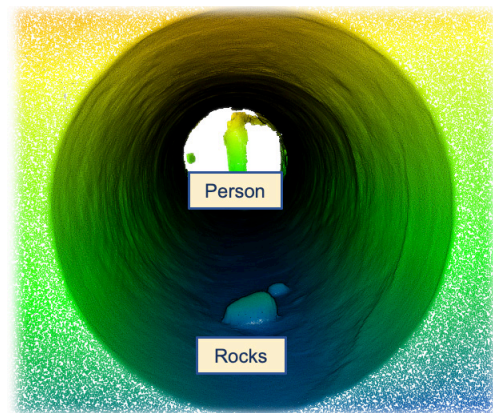
Figure 5. Illustration. Examples of rock debris near the outlet of the culvert.

Small rocks near the outlet of the culvert were clearly distinguishable in the PL data (figure 5). Small cracks and spalling were visible near a joint in the culvert; however, those cracks and spalling could not be distinguished in the point cloud data from PL. While these cracks and spalling were captured in the texture-mapped mesh (figure 6), they were somewhat difficult to distinguish in the mesh from photogrammetric stitching artifacts and prolific graffiti in the culvert. However, the joint and spalling could not be detected from mesh geometry itself.

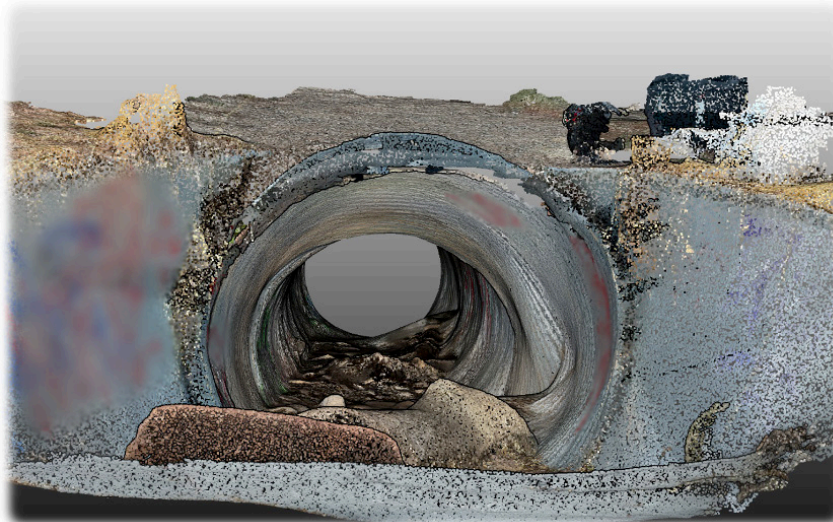
The Tanner Creek culvert is a 50-inch diameter, corrugated metal pipe with a constricted area due to debris. The culvert also has experienced substantial damage and distortion. Figure 9 shows an example of the data-collection process with one person operating the PL to scan the culvert and a second person following with a light source to help improve the data quality. The entire culvert length was scanned in a matter of minutes with PL (figure 10). Overall, the PL scans tended to be smoother than the RTC360 scans (figure 11).

A. View looking into pipe showing the substantial presence of debris and deviations from the circular shape.

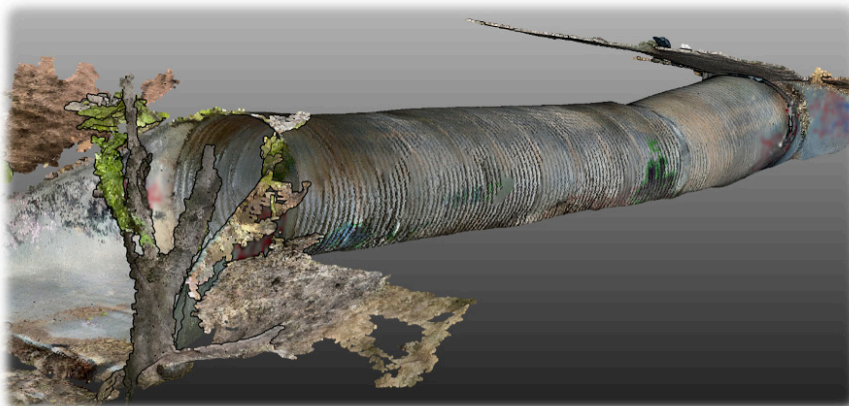
B. Side view of the pipe showing bending and other damages.

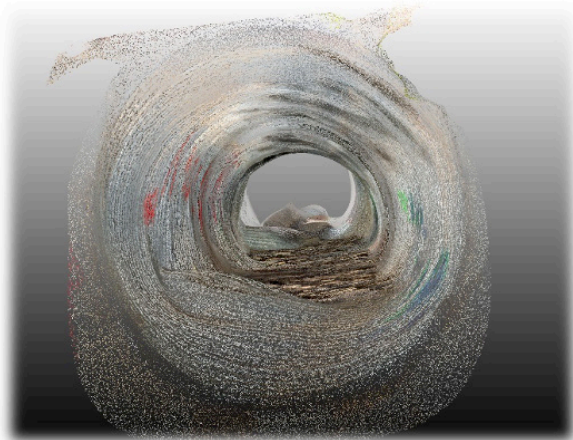
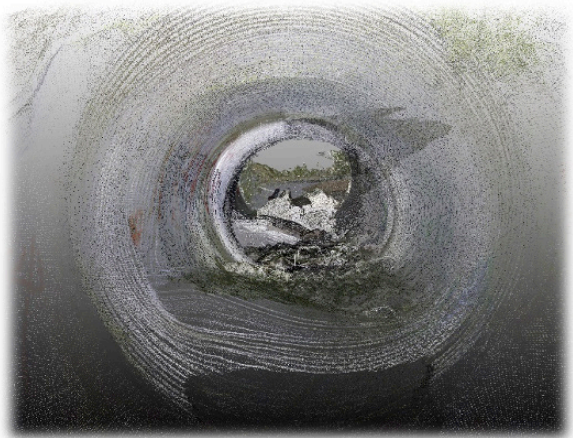
Figure 11. Screenshots. Example views of pipe showing the differences between PL and RTC360 reference scans.

PL was able to capture the major deviations and distortion in the pipe; however, finer details such as the roughness and angularity of the debris, were smoothed in the PL data (figure 11 and figure 12). Nevertheless, the cross-sectional area of the pipe was comparable to the RTC360 reference data, with an RMS difference of 0.092 m² or 7.8 percent. As evidenced by the average difference of -0.084 m², PL tended to underestimate the cross-sectional area, likely because of the smoothing of the data on the corrugated surface of the pipe.

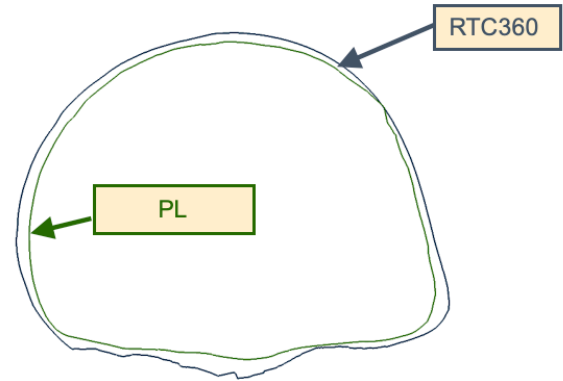
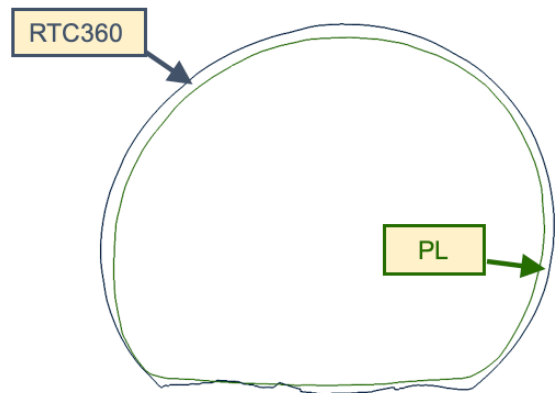
Figure 12. Illustration. Example cross sections showing the shape differences between PL (inside) and RTC360 reference scans (outside).

For each cross section, a polygon was fitted to the data (figure 12) using CloudCompare's fitting tool. The area of each polygon was then computed based on a 2D reference plane of the polygon (table 4).

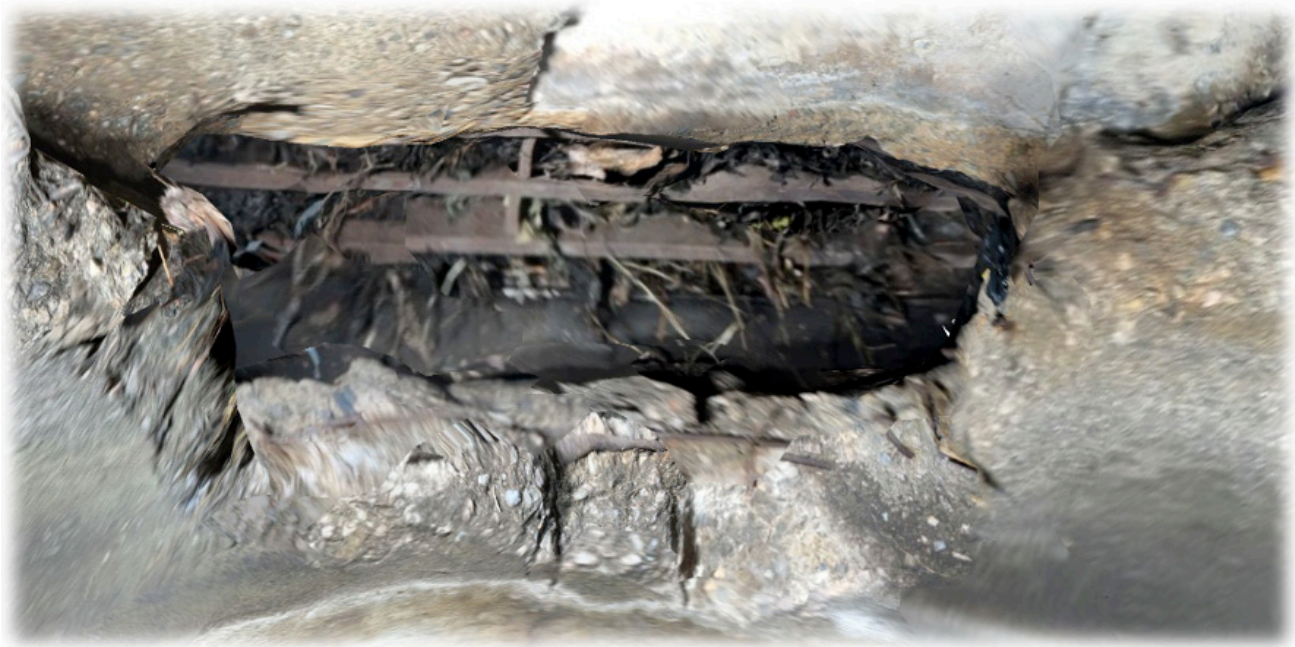
used PL to capture details on a clogged catch basin (figure 18). These details could not be distinguished in the point cloud data but were adequately captured in the texture map of the mesh. In comparison to an ordinary photograph, which provides excellent texture information, the point cloud data offer a more precise location of the feature with respect to the entire culvert. In addition, the 3D representation of the surrounding environment helps put those features in context.

A. Clogged catch basin near the inlet.

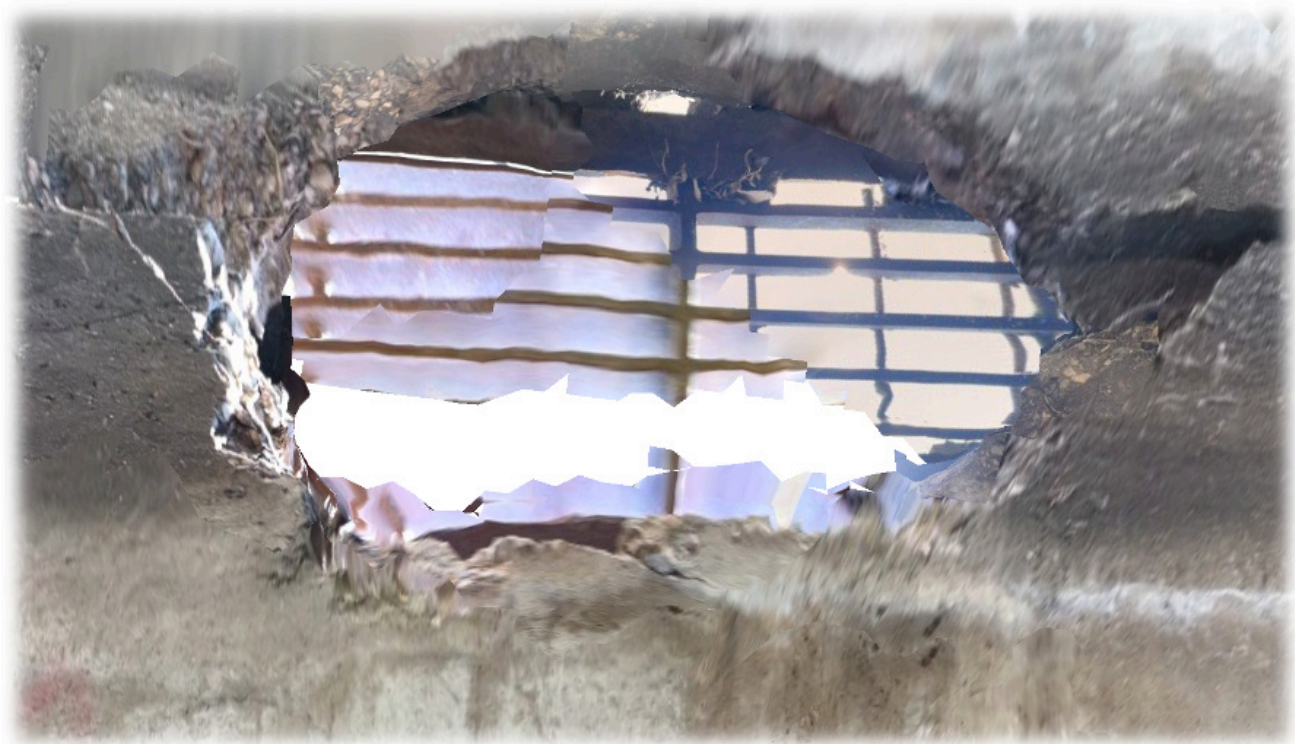
B. Unclogged catch basin near the outlet.
