SD1998-07

OPTIMIZATION OF AC SHOULDER DESIGN AND CONSTRUCTION FOR PCC PAVEMENTS

Study SD1998-07
Final Report

May 2003

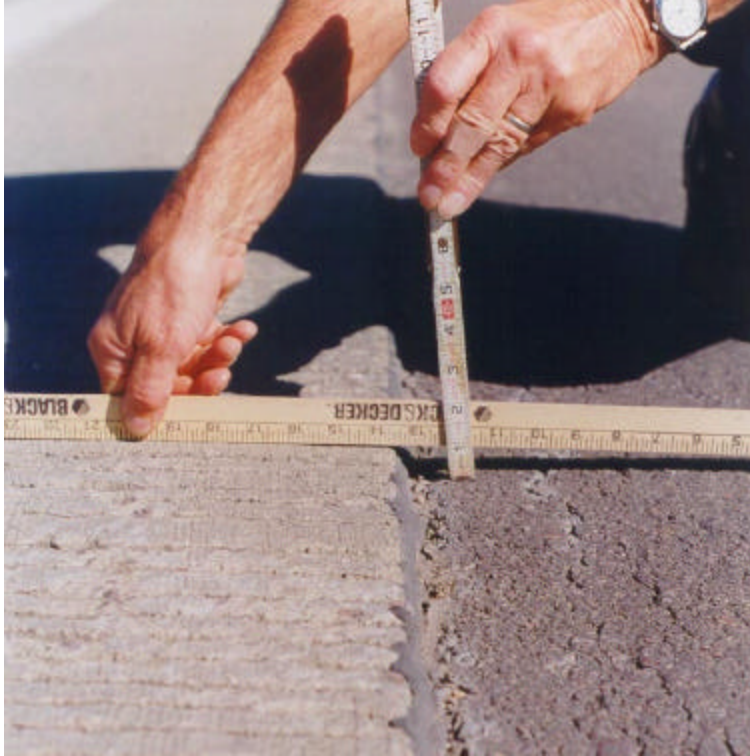
Figure 6. Approximate 1-in shoulder settlement on project 9a (US 12 EB, Bath).

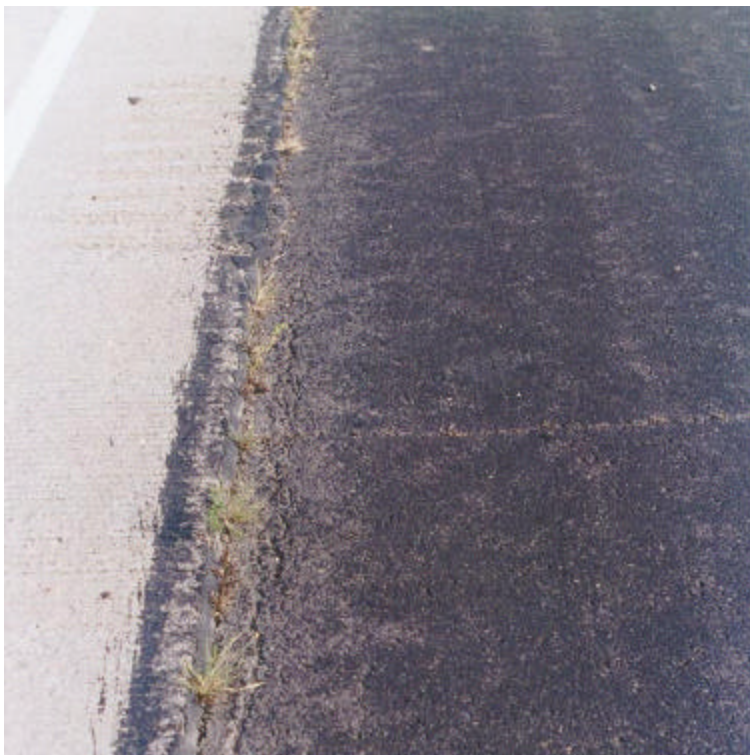
Figure 7. Joint seal failure and inside edge fatigue cracking on project 1 (US 81, Arlington).

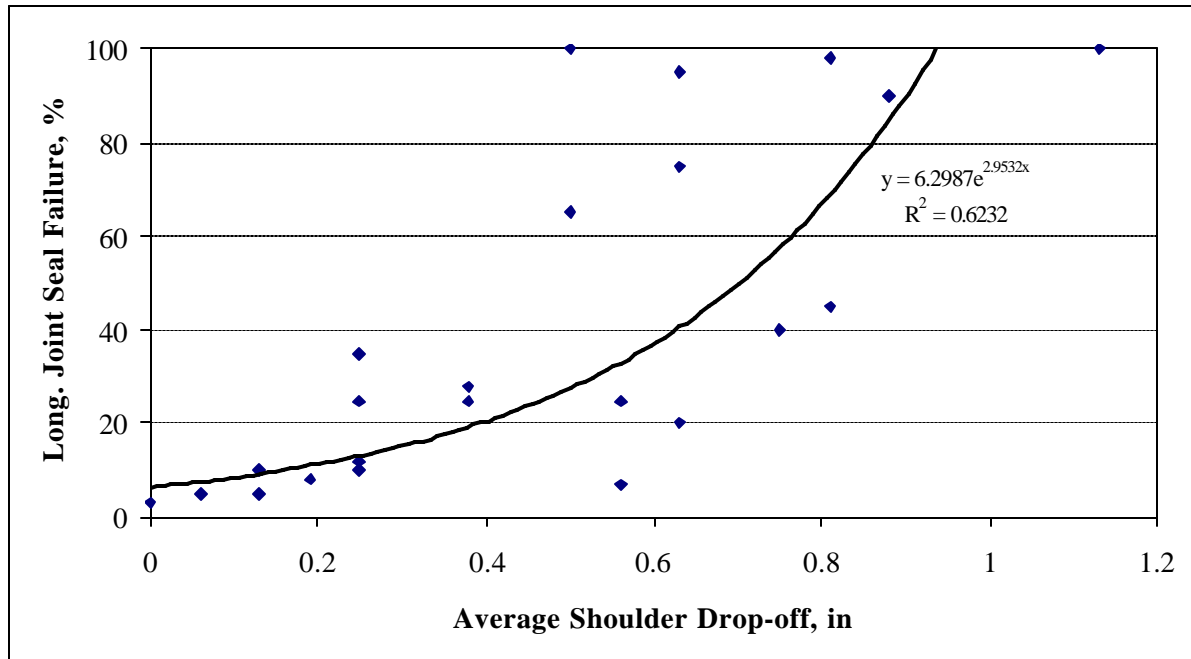
- Field evaluation of many different AC shoulders in South Dakota indicates a general relationship between shoulder drop-off and longitudinal joint seal failure. While it is not known for sure if one parameter is more dependent upon the other, it is believed that settlement of the shoulder occurs initially due to other factors (inadequate compaction of shoulder layers, presence of water in the shoulder structure) and that as the shoulder settles and/or widens, the joint seal becomes debonded. The failed joint seal allows more water to infiltrate the shoulder structure, which in turn facilitates shoulder drop-off and widening.

Figure 8. Shoulder drop-off versus joint seal failure, based on survey of 24 shoulder projects.

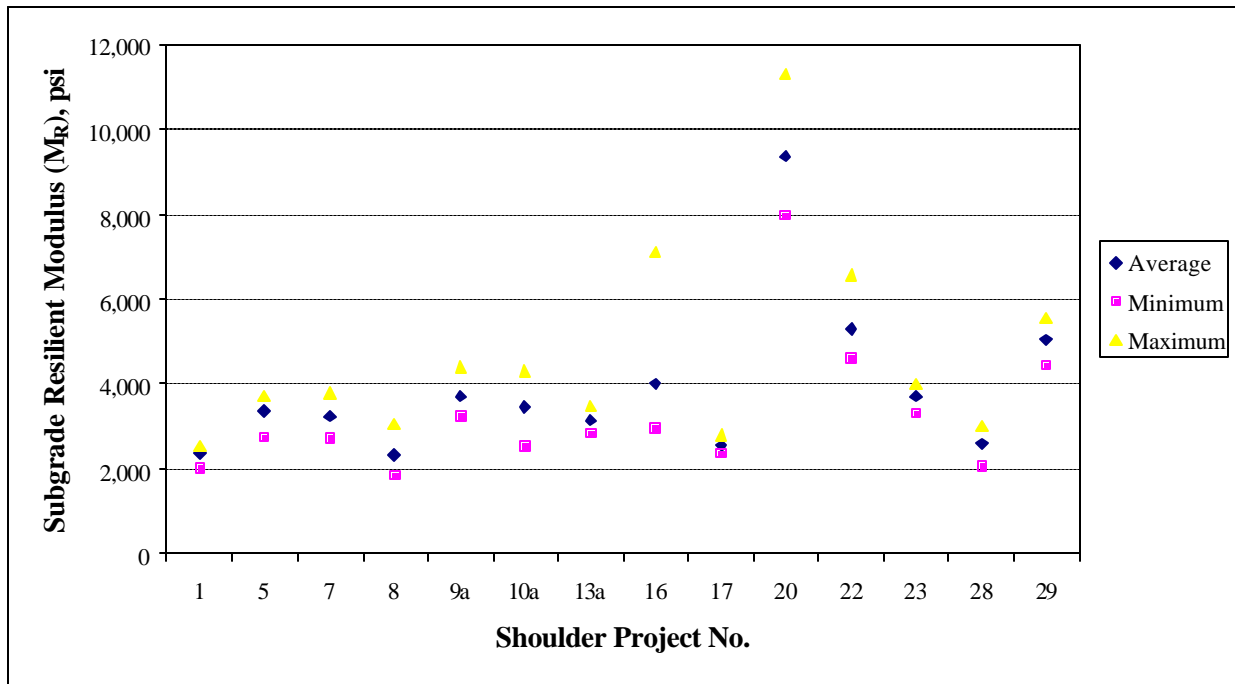
Figure 10. Back-calculated subgrade resilient moduli of tested shoulder projects.

As seen in figure 10, with the exception of Project 22 (US 81 NB, Salem), the back-calculated resilient moduli ranged from about 2,000 to 6,000 psi. These values are fairly typical of the silt-clay soils that comprise most of the shoulder projects surveyed and tested under Task 2 of the study.

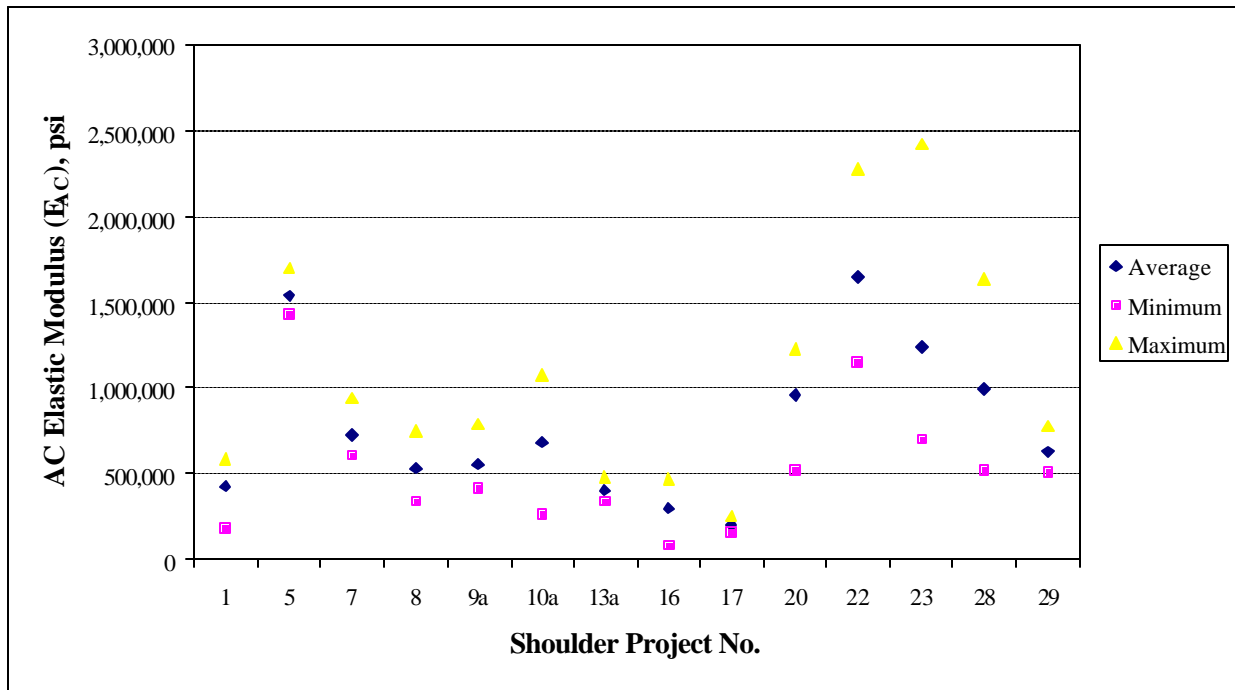
Figure 12. Back-calculated AC elastic moduli of tested shoulder projects.

The results of this back-calculation effort are presented in figures 12 and 13. With the exception of a few shoulder projects, the AC surface moduli seem fairly reasonable, given the temperatures encountered during testing (55 to 75°F). It is probable that the very high modulus values computed for projects 5 and 22 are the result of using AC thickness values that were less than the actual in-place thicknesses. In other words, the AC thickness of shoulder project 5 is likely to be greater than the 2 in documented in construction plans and used in the back-calculation. Also, the AC thickness of shoulder project 22 is likely to be greater than the 3 in that was assumed in the back-calculation.

Although it is possible that the very low modulus values seen in figure 12 (e.g., projects 1, 13a, 16, and 17) are the result of using higher than actual thicknesses, it is likely that the values are simply reflective of the fair to poor conditions observed for these projects in the distress survey (see table 4).

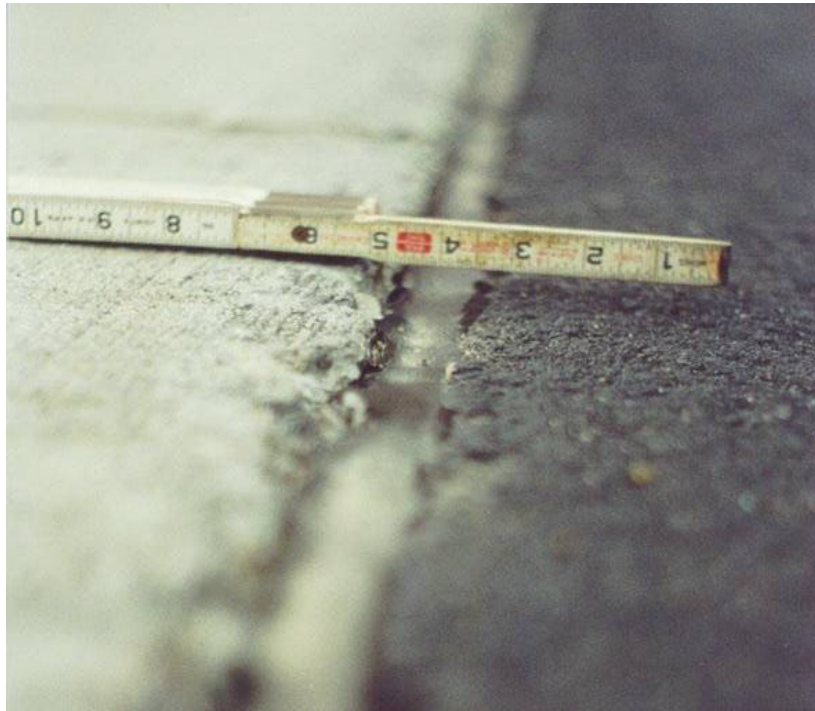
Figure 21. Approximate 0.2-in shoulder settlement in windrow-leveled salvage aggregate test section (strategy 6).

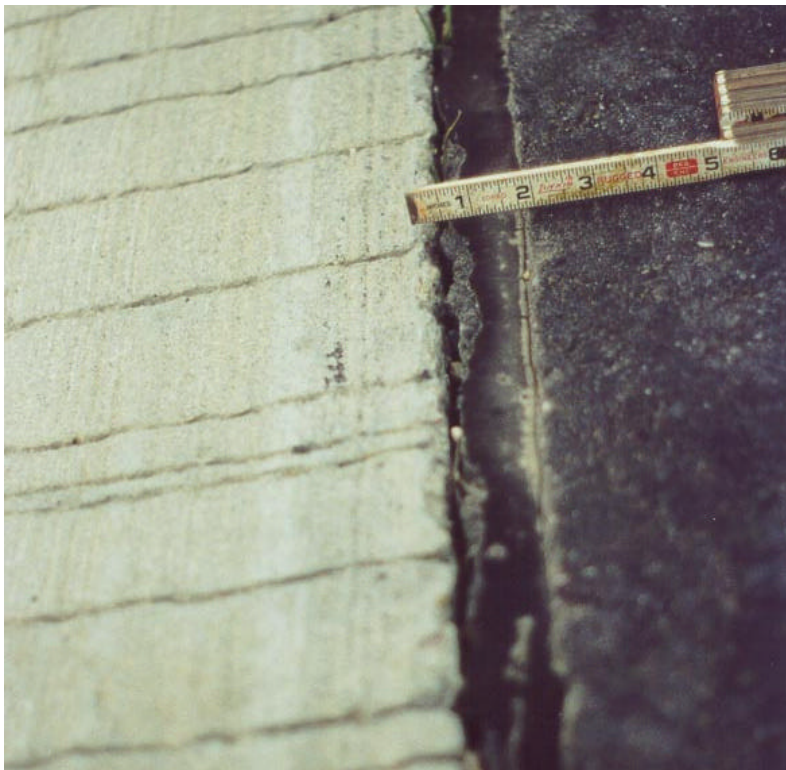
Figure 22. Longitudinal joint seal failure in one of the control sections.

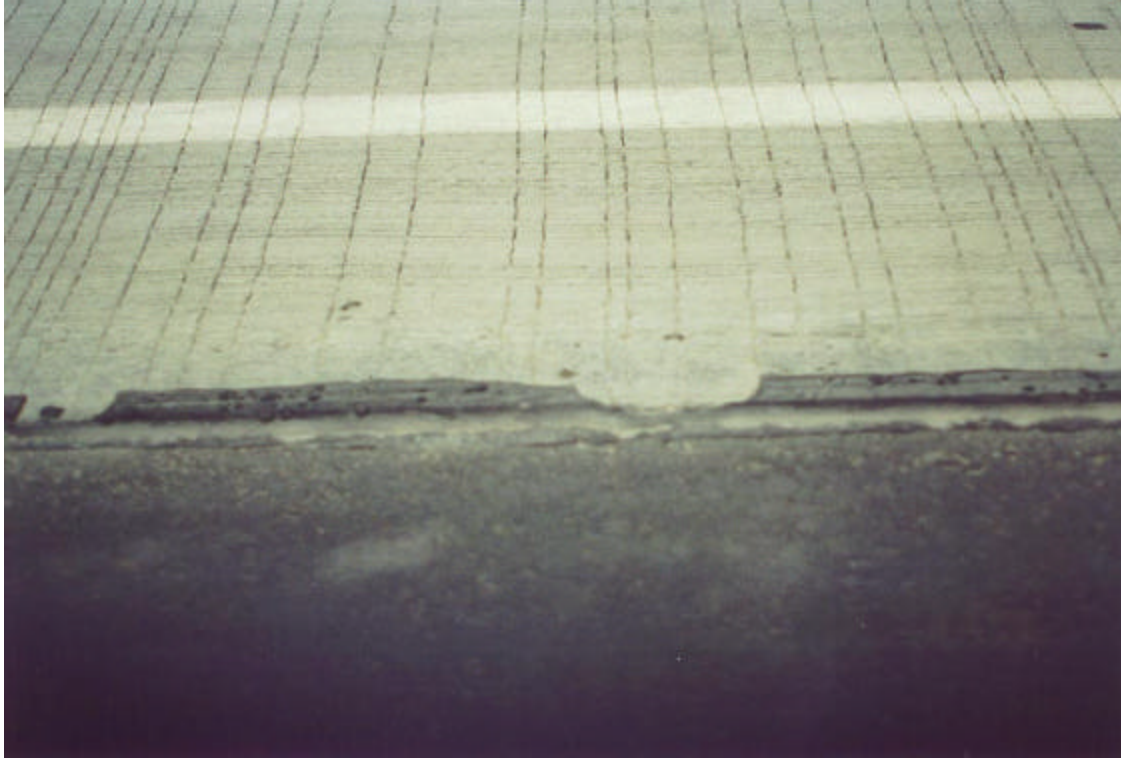
Figure 23. Snowplow damage to band-aid seal in daylighted ATPB test section (strategy 9).

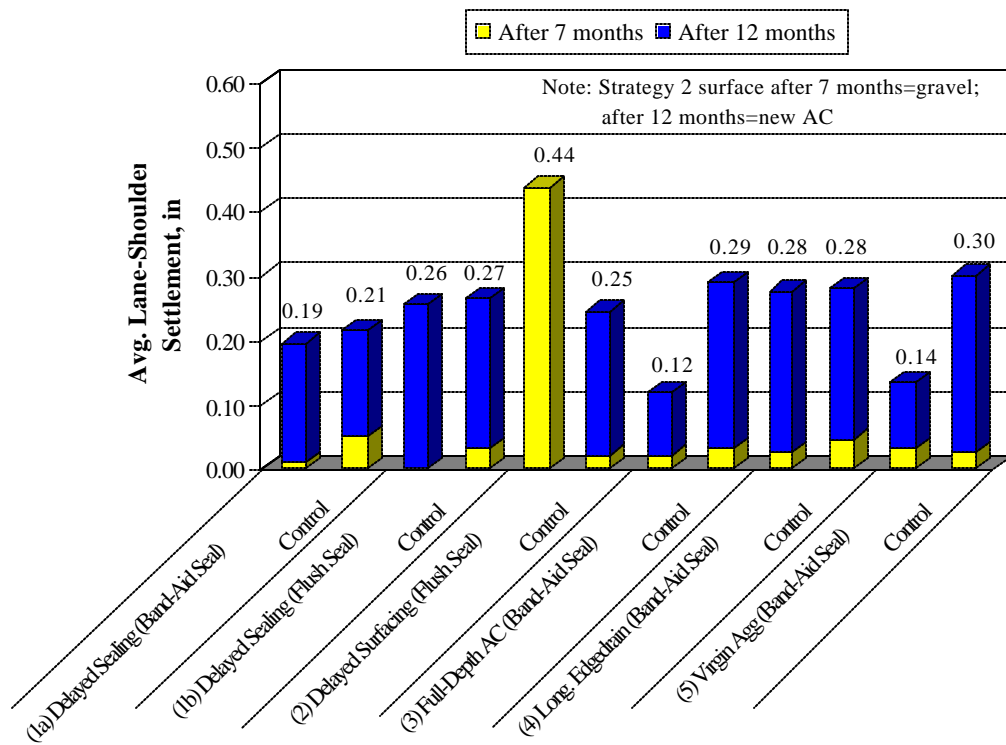
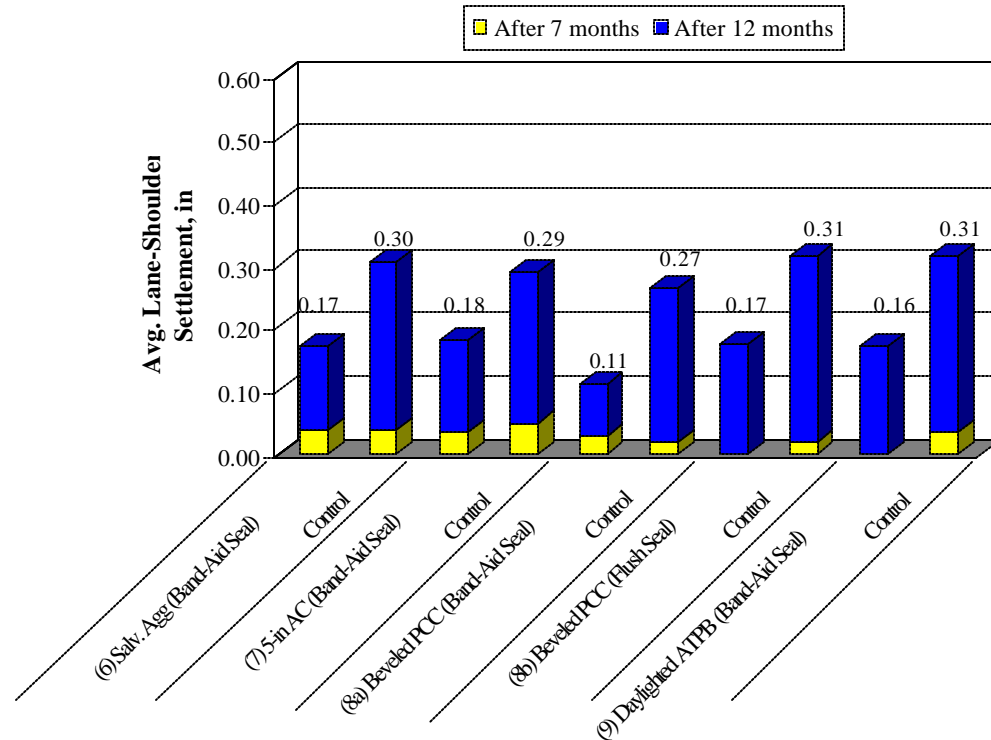
Figure 24. Shoulder settlements at 7 and 12 months after construction.

- Average settlements for the two delayed sealing strategies (strategies 1a and 1b) and the longitudinal edge drain strategy (strategy 4) after 12 months are the highest of all strategies tested and are similar to settlements in corresponding control sections. The high settlement for the edge drain strategy is largely attributed to inadequate compaction of the backfill material during construction.

As can be seen, with the exception of the delayed sealing and longitudinal edge drain strategies (strategies 1a, 1b, and 4), each test strategy has exhibited significantly less settlement, on average, than the control. The strategies with the lowest average settlement are the PCC beveled

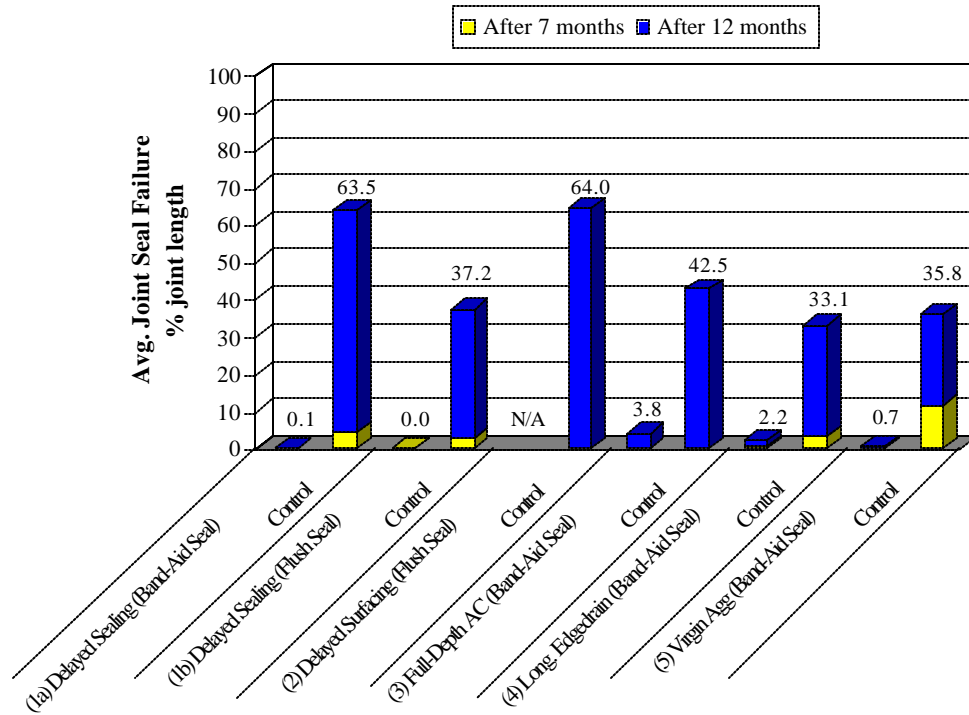
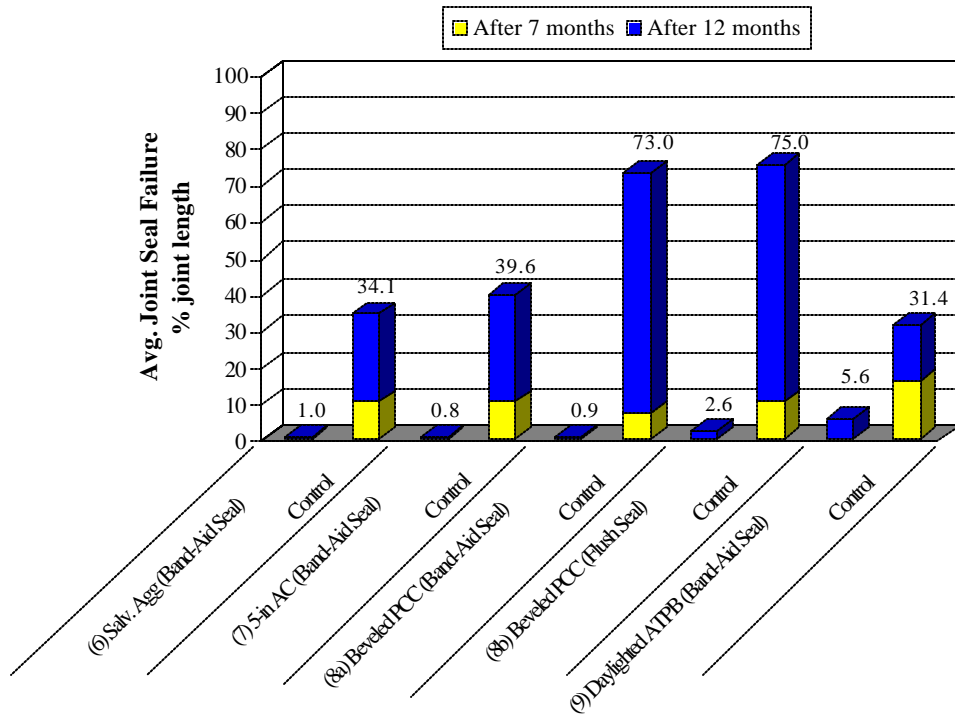
Figure 25. Lane-shoulder joint seal performance after 7 and 12 months of service.

- Longitudinal joint seal performance in shoulder test sections is excellent after 12 months of service. For the eight shoulder strategies in which joint seal has been in place for 1 year, none have more than 5 percent of the seal length in a failed state. In contrast, the percent failure observed in the corresponding control sections ranges from 30 to 75 percent. Although it is believed that the use of low-modulus rubberized asphalt (modified SDDOT Standard Specification 870.1 A) instead of standard rubberized asphalt (SDDOT 870.1 A) is the primary reason for this difference in performance, construction quality and shoulder settlement are likely to be contributing factors.

Figure 25 shows the condition/performance of the longitudinal lane-shoulder joint seals for each strategy, and their counterpart controls. This figure clearly shows that the seal system used in the control sections (standard-modulus rubberized asphalt placed in the reservoir-and-flush

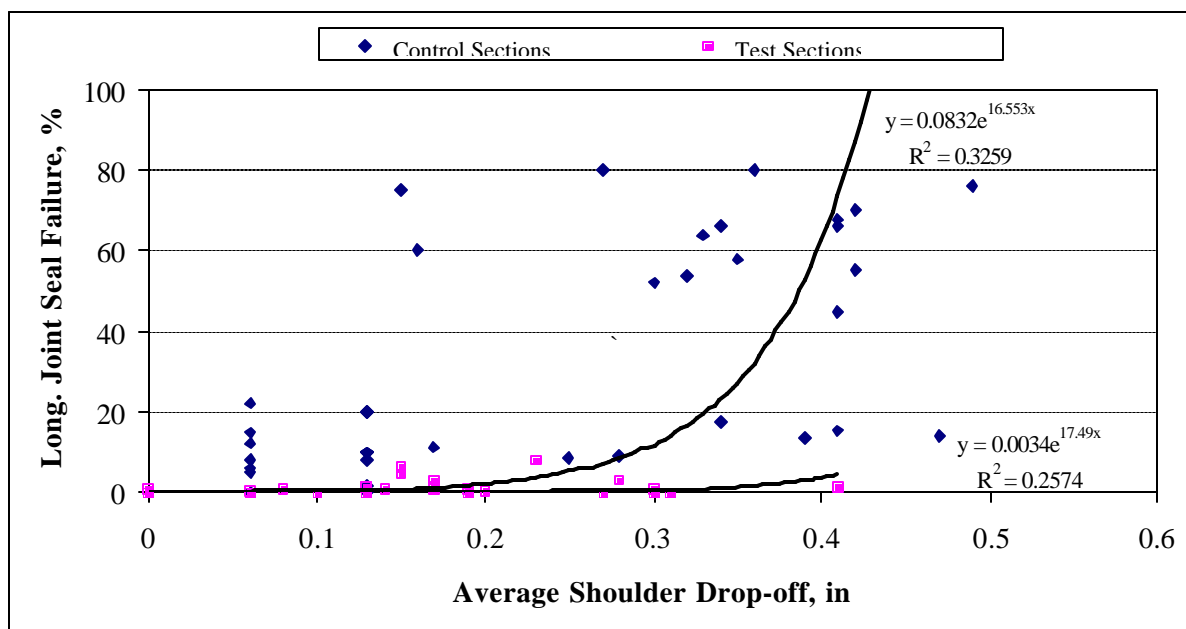
Figure 26. Shoulder drop-off versus joint seal failure at SD 37 shoulder test site.

Figure 26 shows the relationship between shoulder drop-off and longitudinal joint seal failure at the SD 37 test site. Although the trend is not nearly as strong as the one established in the Task 2 field surveys (chapter 3), it does generally indicate that the higher the drop-off, the more seal failure likely to be incurred. This figure also shows a considerable difference in the settlement–seal failure trend of the test shoulders versus the trend for the control sections. Although the control
