HEAVES AT TRANSVERSE CRACKS IN ASPHALT CONCRETE PAVEMENT

Study SD92-11
Final Report

Prepared by
Terje Preber and Darla J. Peters
South Dakota School of Mines and Technology
501 E St. Joseph St.
Rapid City, SD 57701

June, 1993

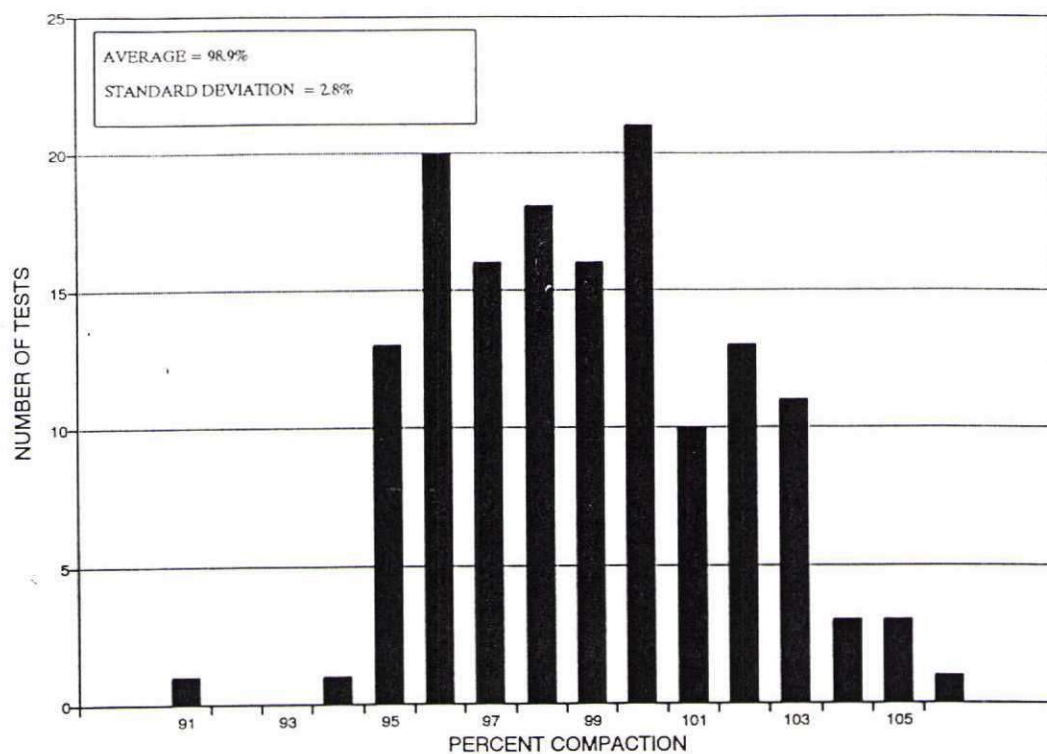
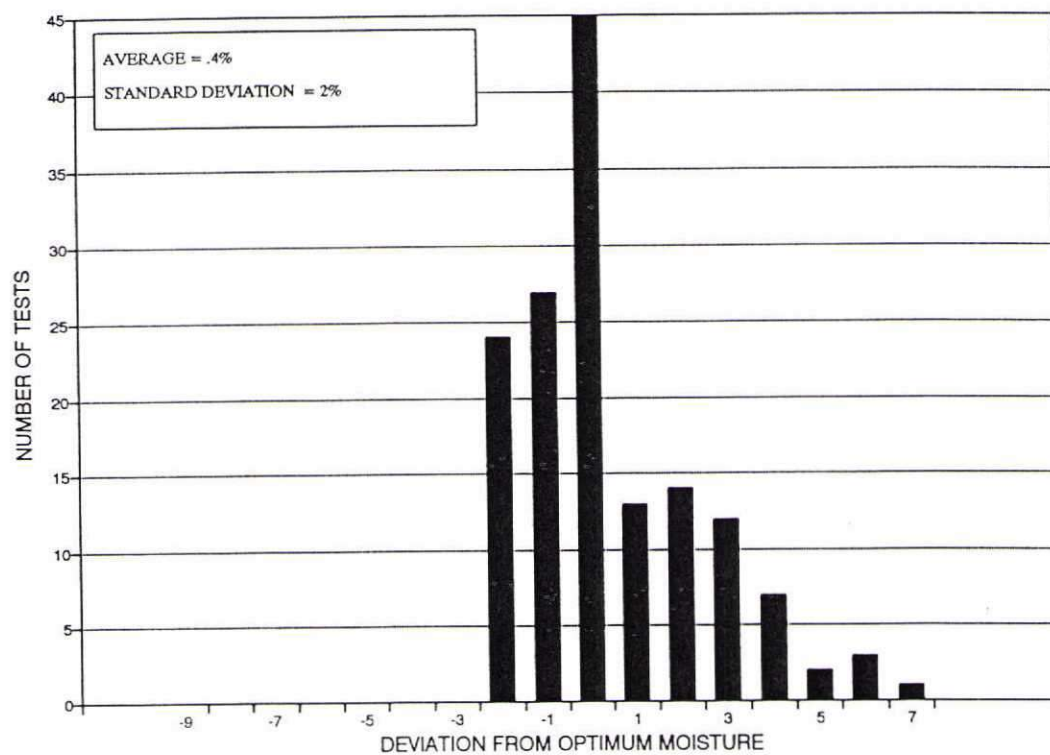
The results of the density and moisture tests performed during construction are presented in Figures IV-7 and IV-8. The average deviation in moisture content from optimum was .4 percent, which indicates that more than half the samples were placed wet of optimum. The standard deviation from optimum moisture content was 2.0 percent. No samples were more than two percent dry of optimum. The analysis of the

density tests gave an average degree of compaction of 98.9, with compaction for most samples ranging from 95 to 105 percent. As can be seen from Figure IV-7, the density test results are almost evenly distributed between 95 and 103 percent compaction.

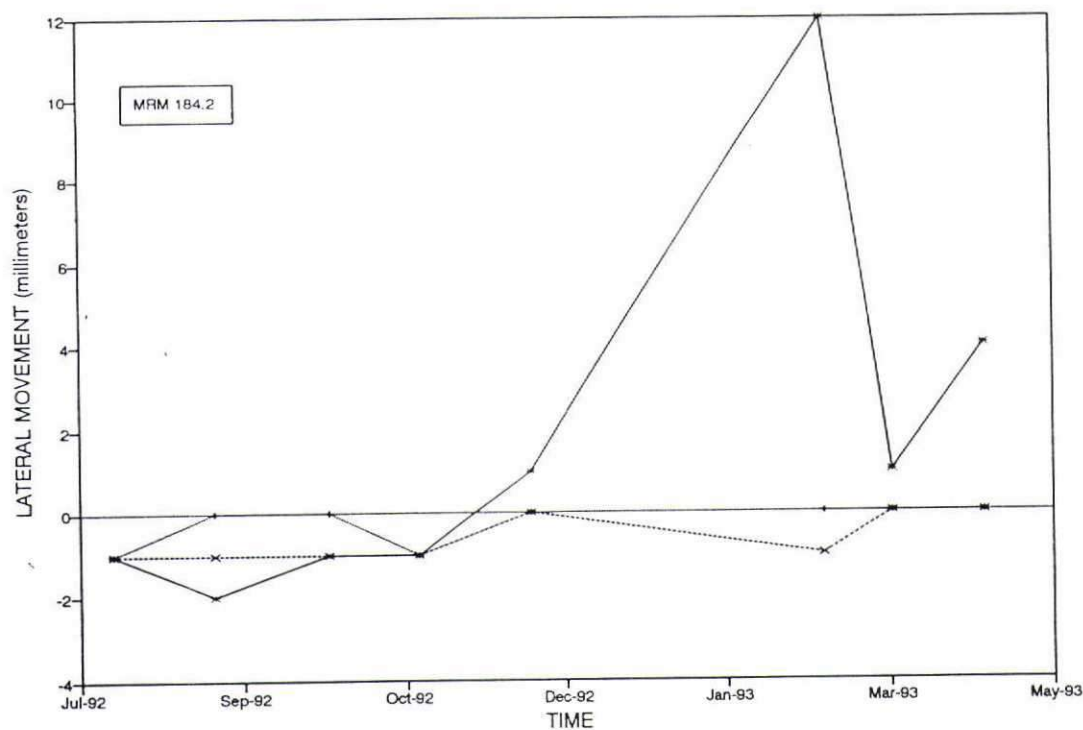
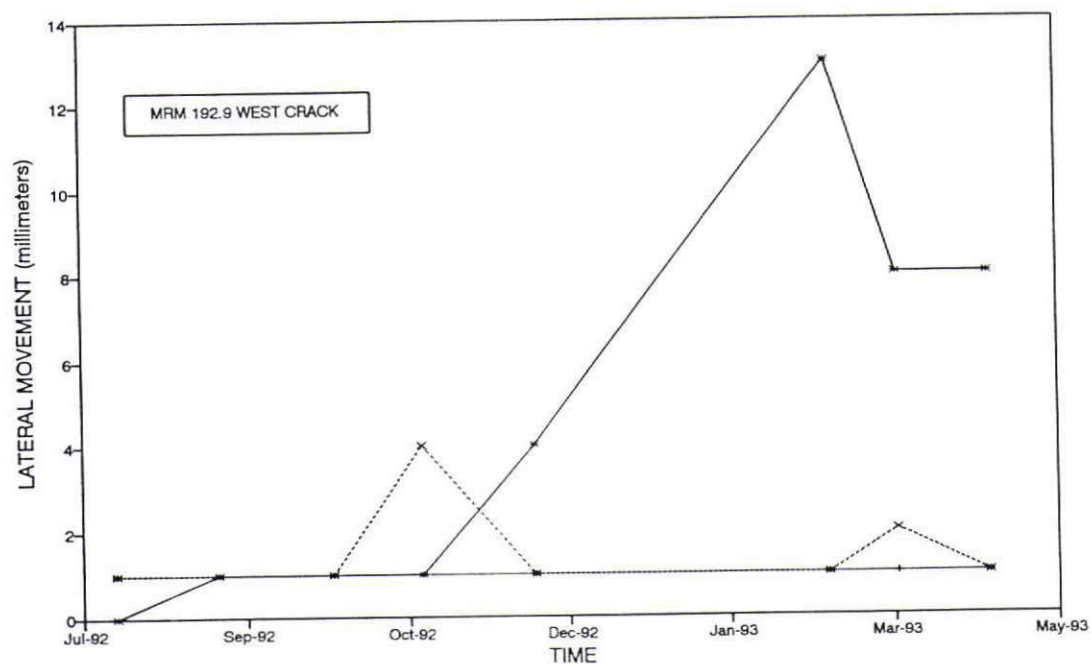
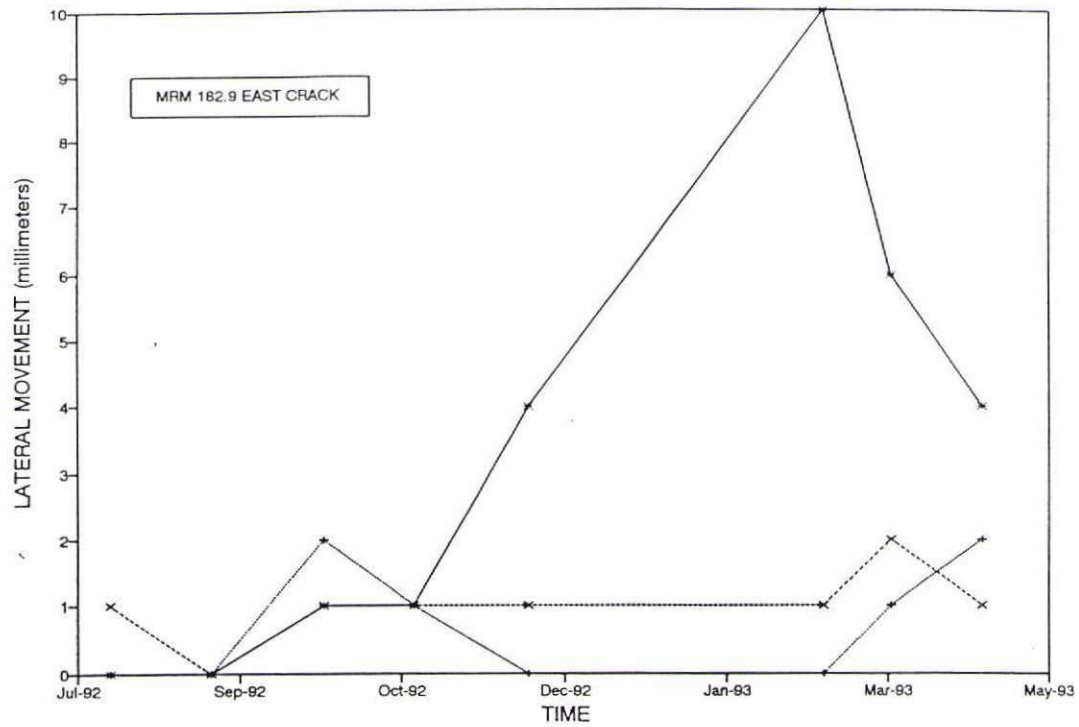
As shown on Figure V-13 through V-15, a maximum lateral movement of 12 millimeters across the crack was observed March 2, 1993, 285 days after the baseline measurements were taken. Over the period of the investigation, the lateral movements varied from a 2 millimeter shrinkage to a 13 millimeter expansion at MRM 182.9, with the largest movement occurring across the crack. The average maximum expansion was 12 millimeters.

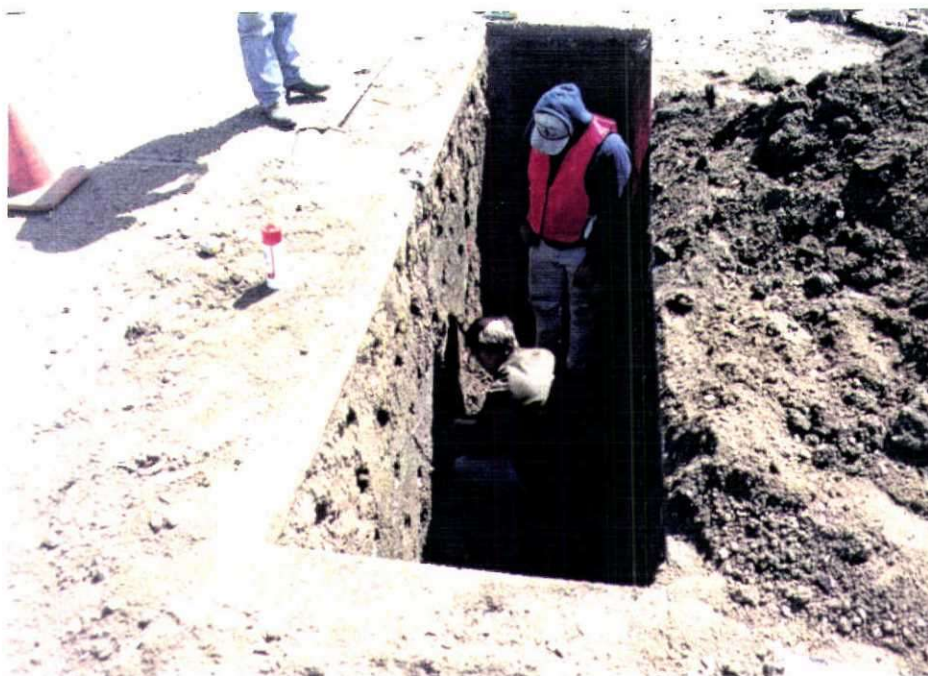
PHOTO V-1. US212 LAPLANT TO RIVER
TEST PIT

The maximum measured moisture content of 42.4% occurred at the crack location at a depth of one foot below the base/subgrade interface.
