Void Development Under Bridge Approaches

Study SD90-03

Final Report - Executive Summary

Prepared by
Department of Civil Engineering
South Dakota State University
Brookings, South Dakota 57007-0495

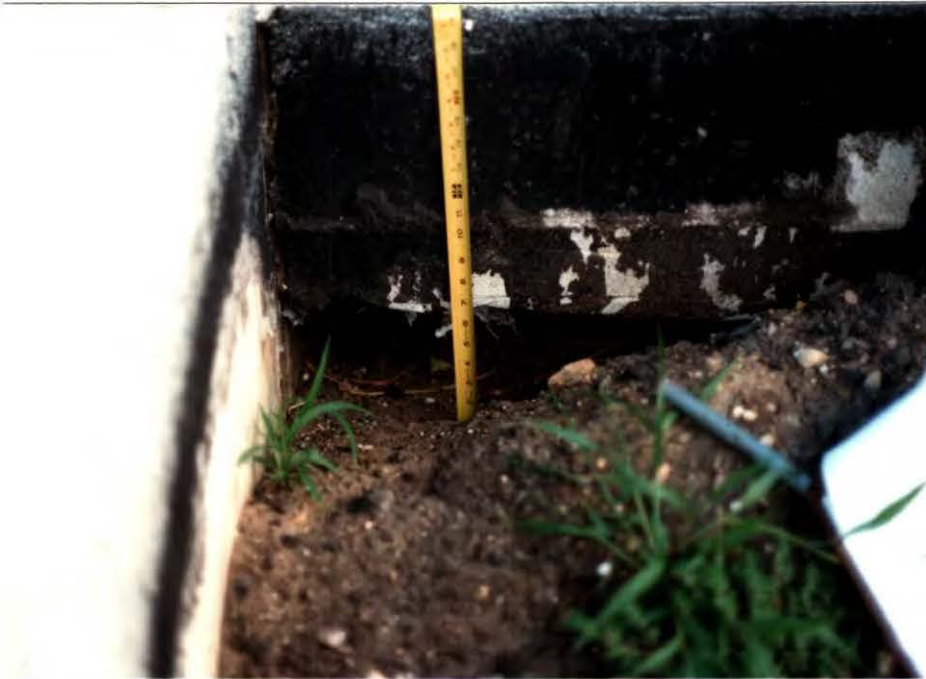
- a. Structure No. 64-006-090, crosses I-29 at mile marker 38.32 in Union Co. Seven-inch void developed under north corner of east approach.

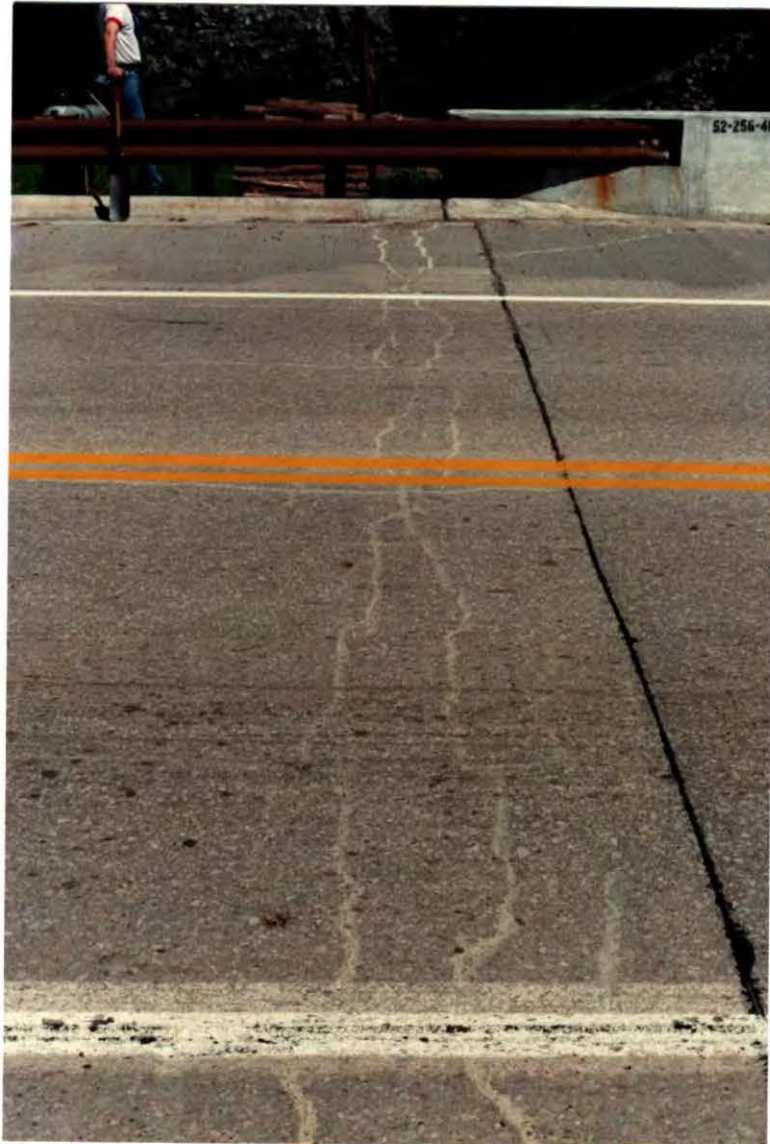
This cracking is easily explained. It occurs on approach slabs where voids have developed beneath the slab. The transverse cracks develop due to a loss of support under the approach slab adjacent to the structure. The location of the transverse cracks corresponds to the end of the dowel bars from the bridge abutment. The dowel bars provide more flexural support in the first two feet of the approach slab, preventing an even distribution of flexural stresses through out the approach slab. Consequently a stress concentration develops at the end of the dowel bars, causing a transverse crack to develop in the concrete at this location. The longitudinal cracking also develops on approaches with voids under the approach slab. This cracking is most often located

Figure 3-4. Photograph of typical crack development in approach slab. Cracks in this photograph have been filled and sealed. Structure No. 52-256-401 on US 16 at mile marker 42.64 in Pennington Co.

between the wheel paths, and occurs due to a loss of flexural support due to the presence of the void.

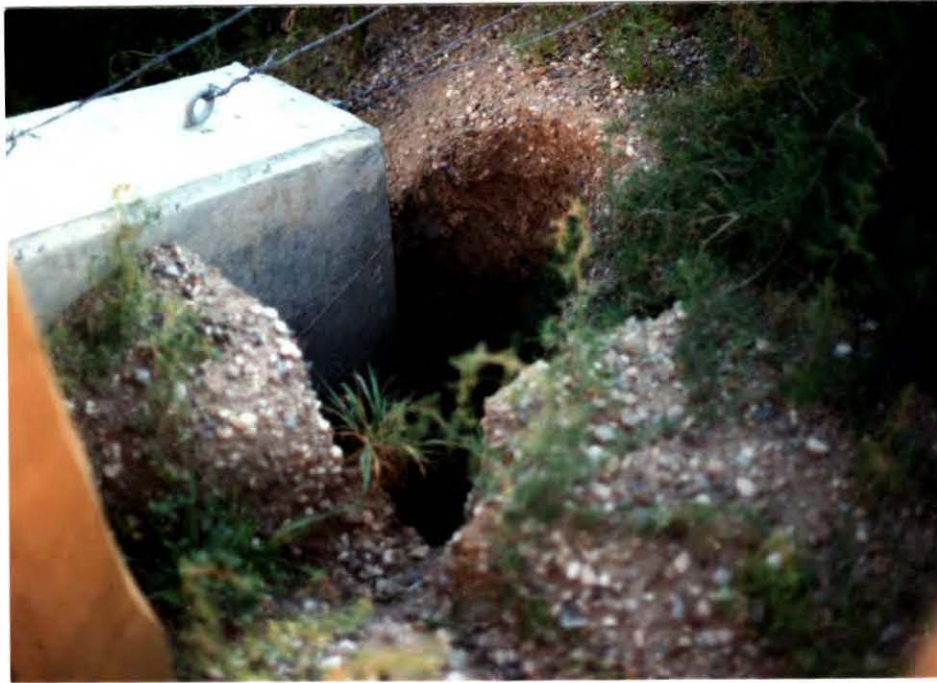
a. Erosion around wing wall. Structure No. 48-440-253 on SD 53 in Mellette Co.

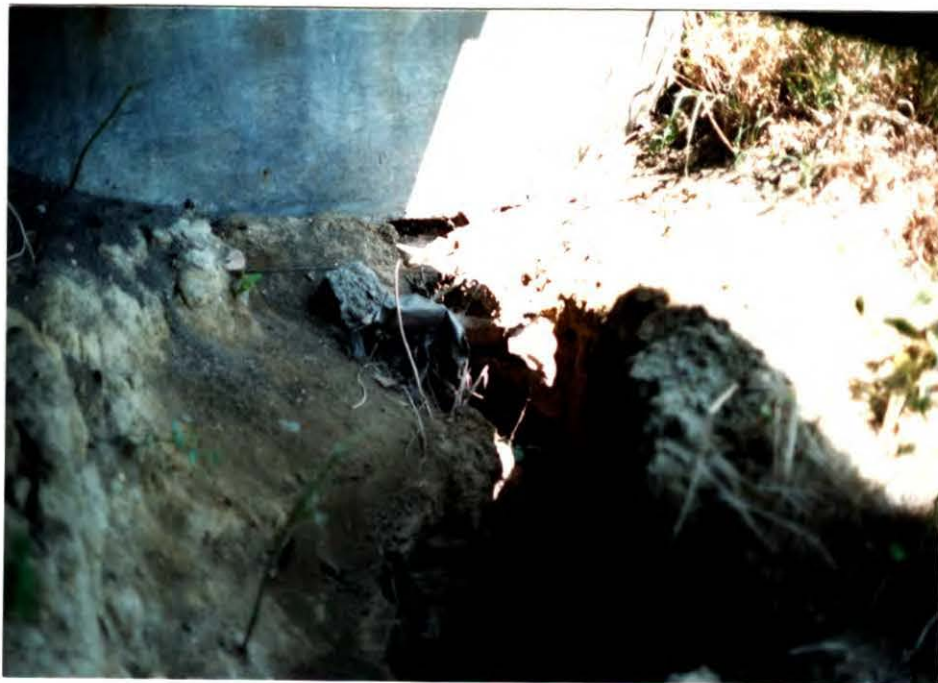
b. Erosion of berm in front of abutment. Structure No. 14-100-200 on SD 50 in Clay Co.

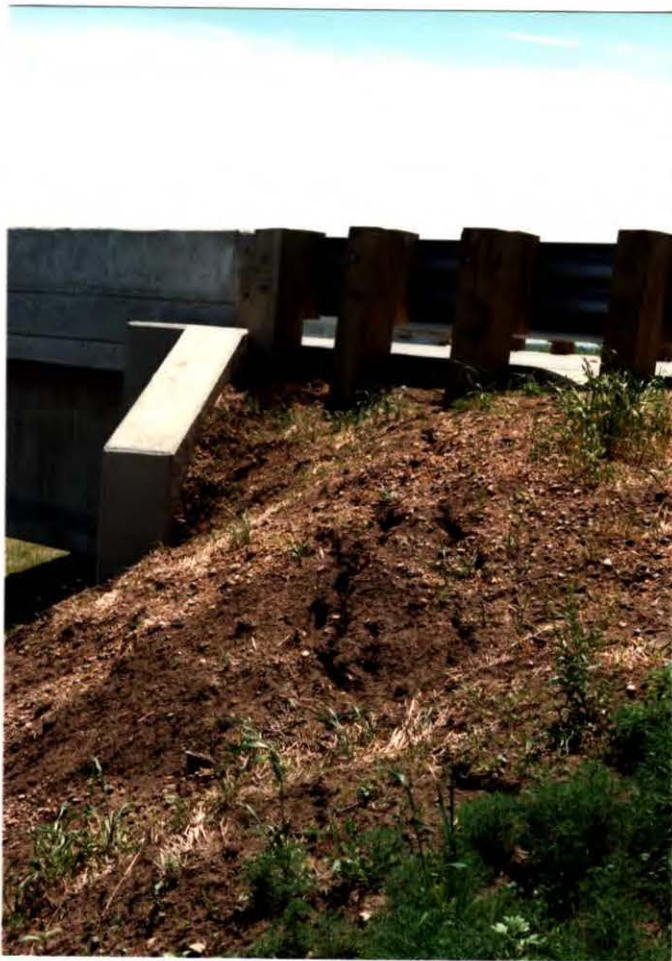
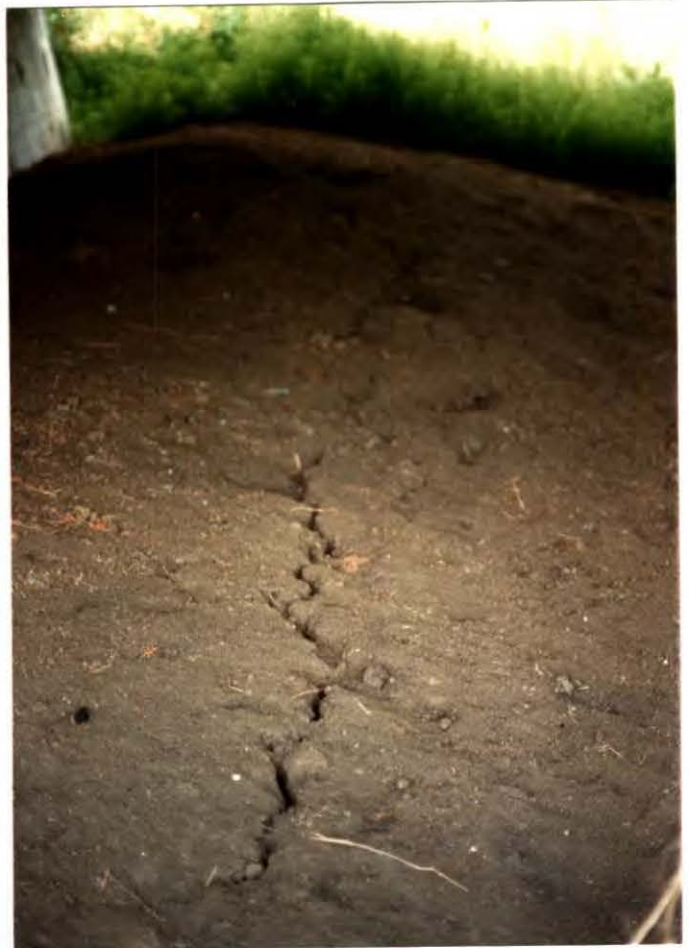
The data in Table 3-2 show that embankment cracking has occurred in eight of the integral abutment structures visited and the berm in front of the abutment has cracked in 27 of the integral abutment structures visited. Photographs of embankment and berm cracking are shown in Figure 3-6. These photos represent some of the most severe cracking observed, but are indicative of the pattern of cracking. Cracking of the approach embankment typically developed from the contact of the wing wall and the abutment and radiated out at about a 45 degree angle. The embankment cracking shown in Figure 3-6a is likely due to a slope instability problem rather than from abutment action. Cracking of the berm in front of the abutment was a rather common observation, with the cracks out about five to eight feet from the abutment face and running parallel to the abutment until turning either upward or downward near the outer edge of the berm (Figure 3-6b).

Figure 3-6. Photographs of cracking observed in the field.

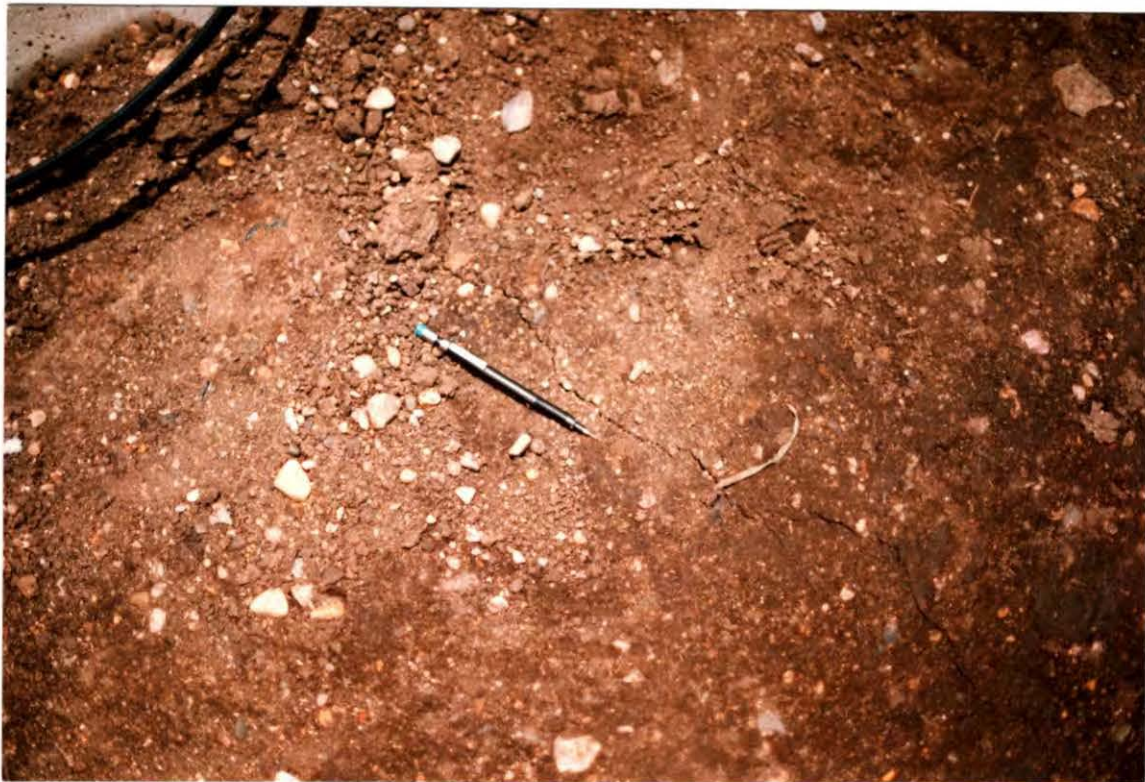
Figure 5-10. Diagonal cracks in south embankment near abutment at +0.60 inches of movement.

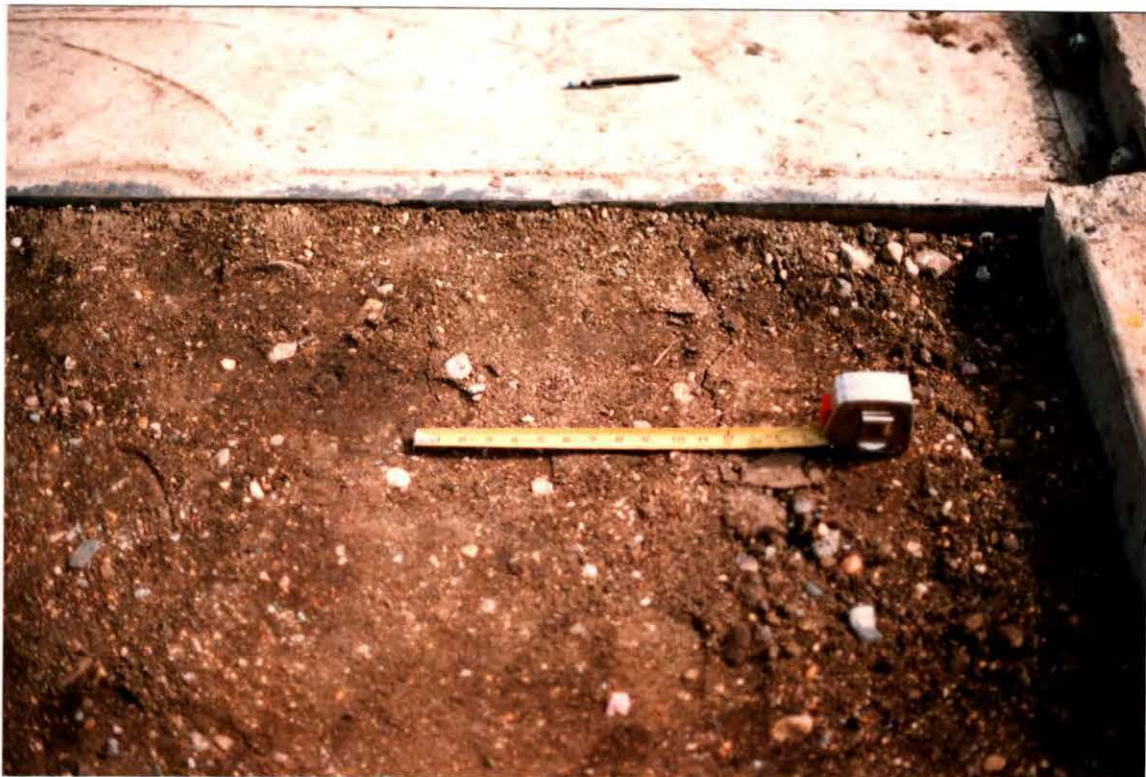
Figure 5-11. Cracking of north embankment during first contraction step, movement at +0.20 inches.

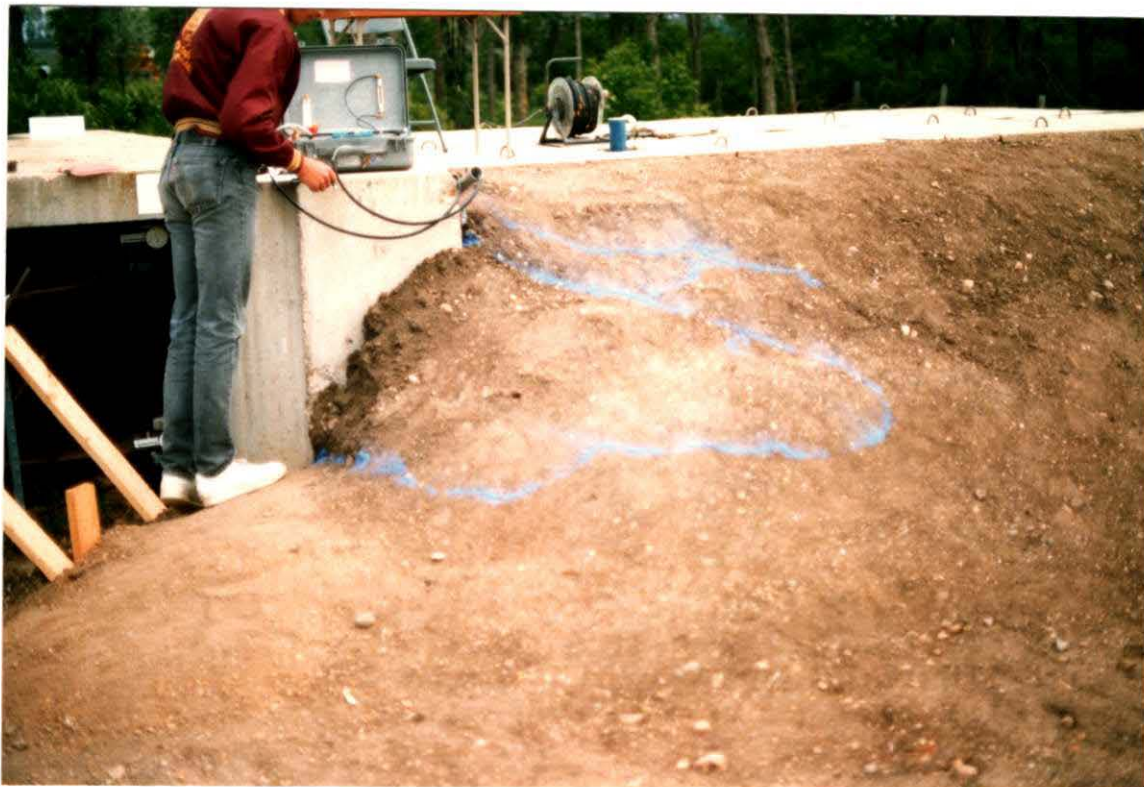
Figure 5-12. Outline of a wedge of failed embankment. Failure occurred during September expansion step.

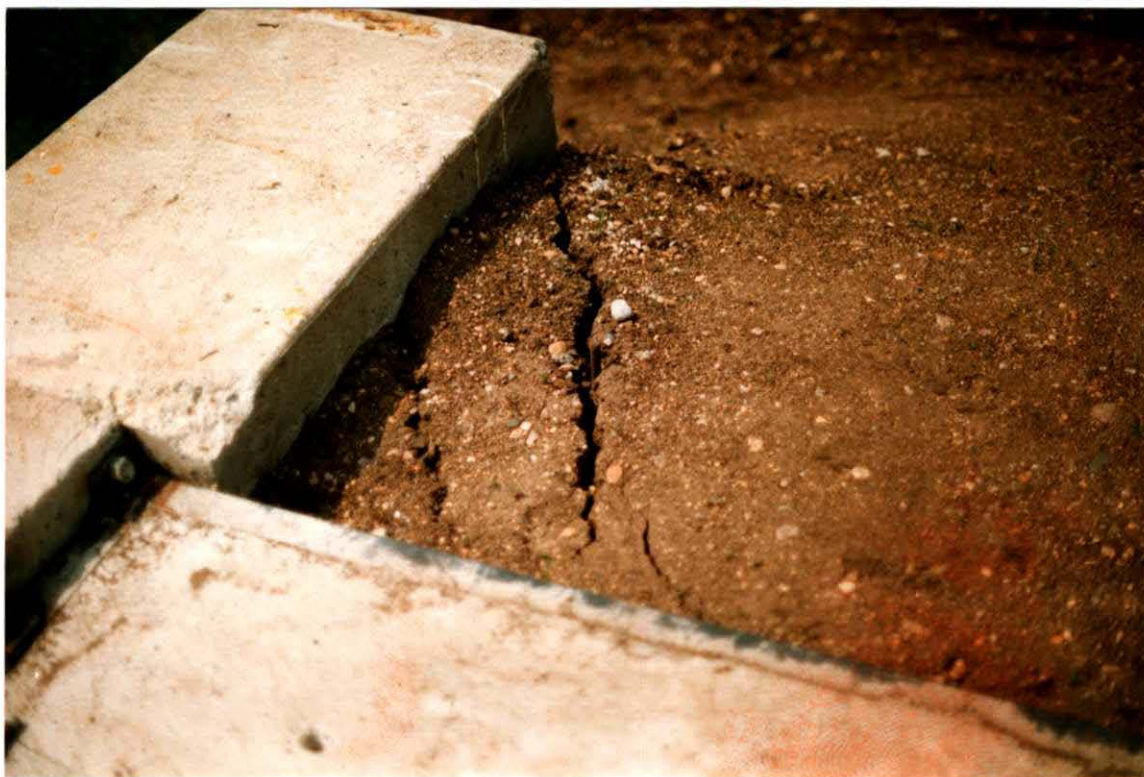
Figure 5-13. Crack development in front of north wing wall during winter month cycles.

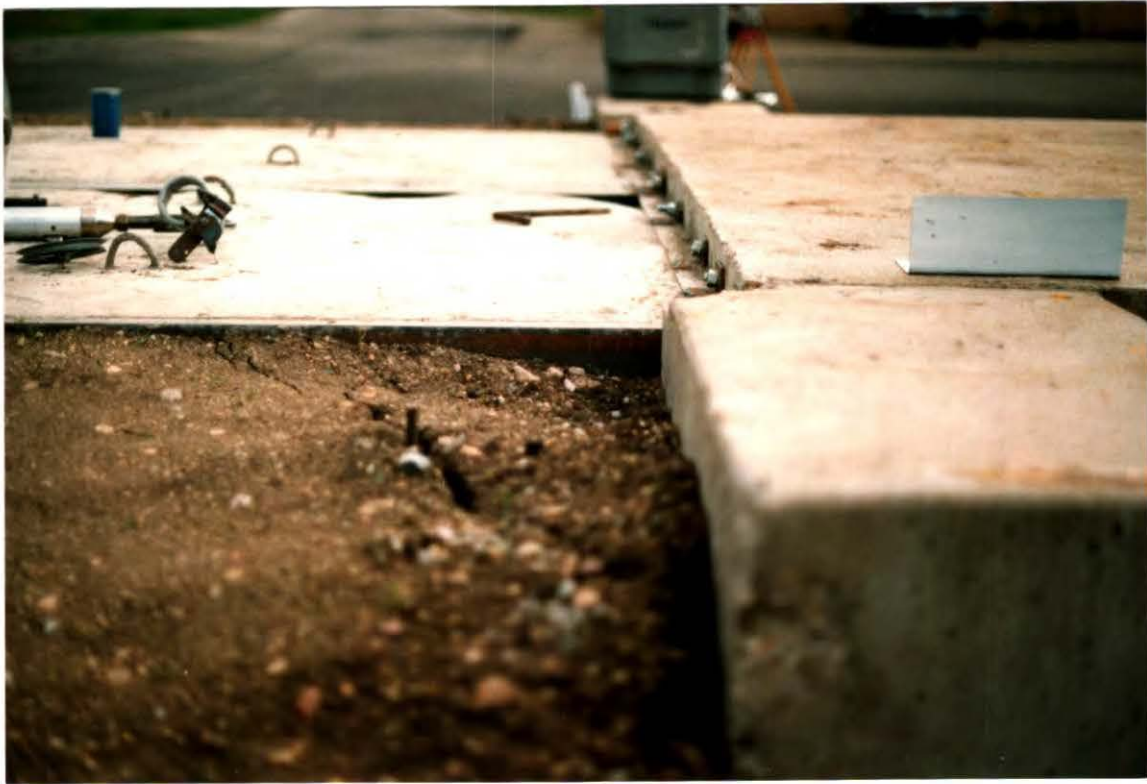
Figure 5-14. Settlement of north embankment next to approach slab and wing wall. February cycle.

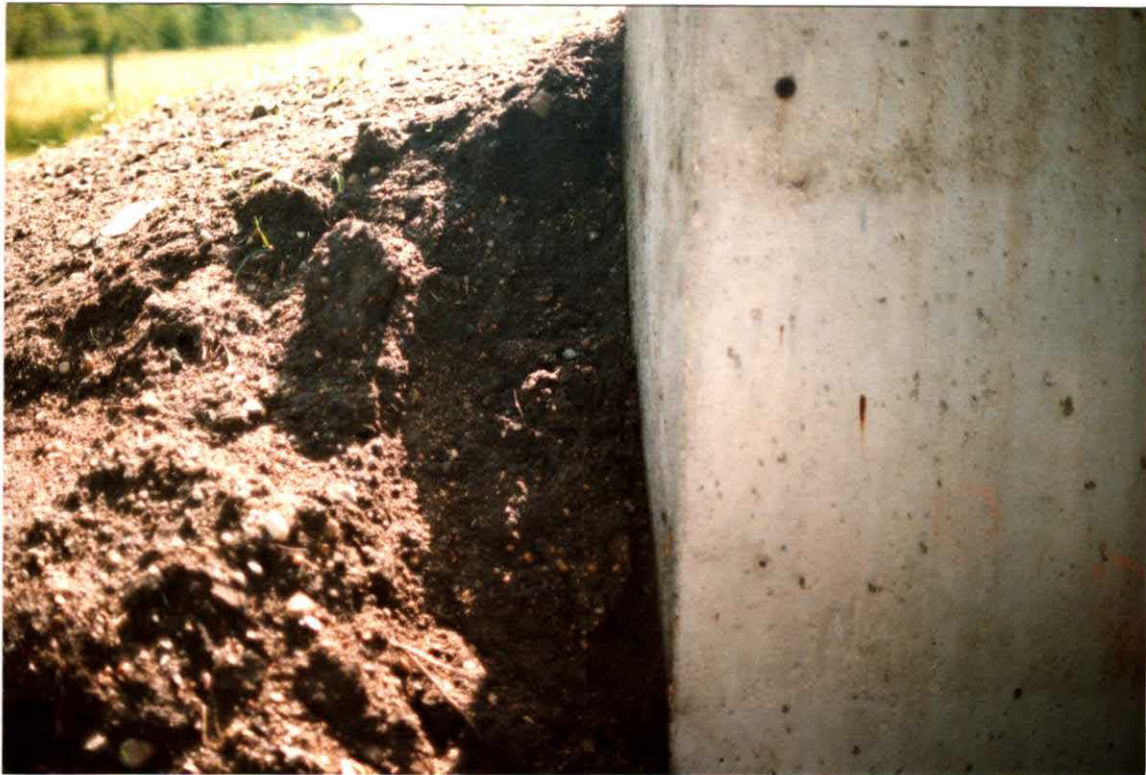
Figure 5-17. Erosion around wing wall following March rainstorm.
