# Railroad Crossing Study

Study SD90-14  
Volume I: Final Report

Prepared by  
Department of Civil Engineering  
SD School of Mines & Technology  
Rapid City, South Dakota

January, 1992

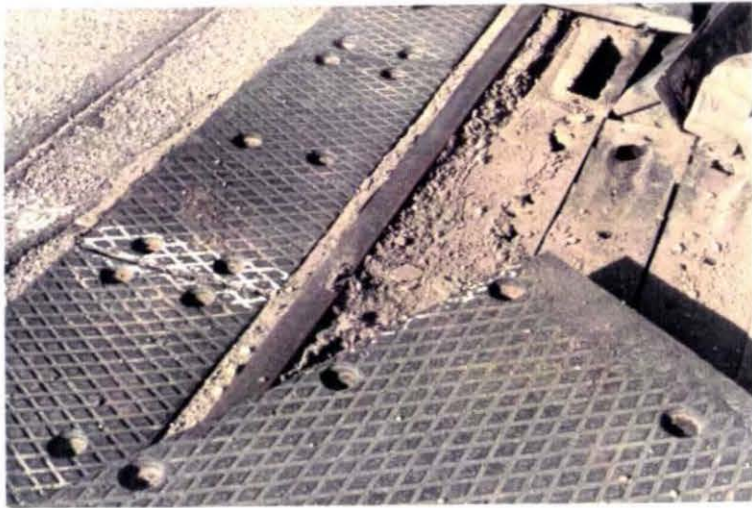
Photo V-1. Summit - Old True Temper Crossing. Panels Resting Rubber Spacers

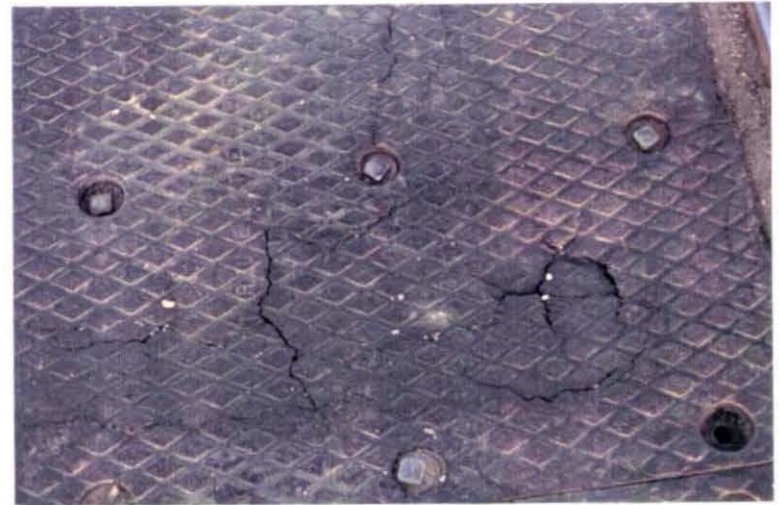
Photo V-2. Summit - Cracked and Failed Panels.

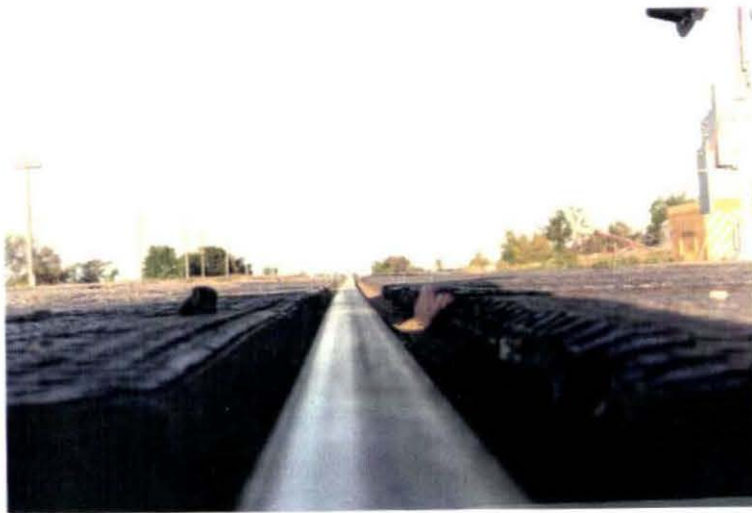
Photo V-3. Summit - Panels Raised Relative to Rail.

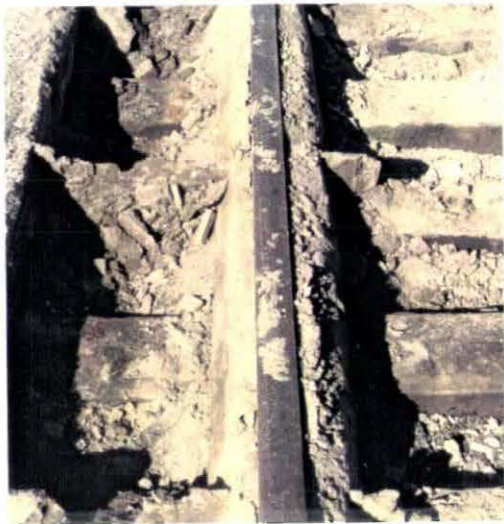
Photo V-5. Summit - Mud Packed Rail.

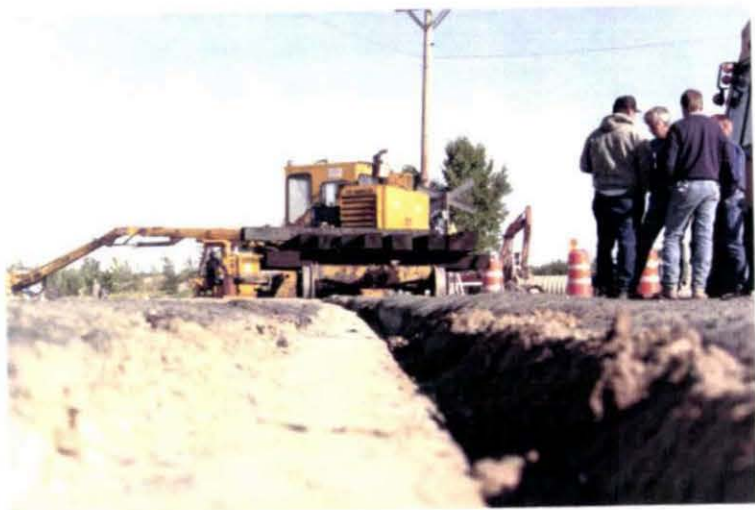
Photo V-9. Aberdeen, Fifth Street - Condition of Old Crossing.

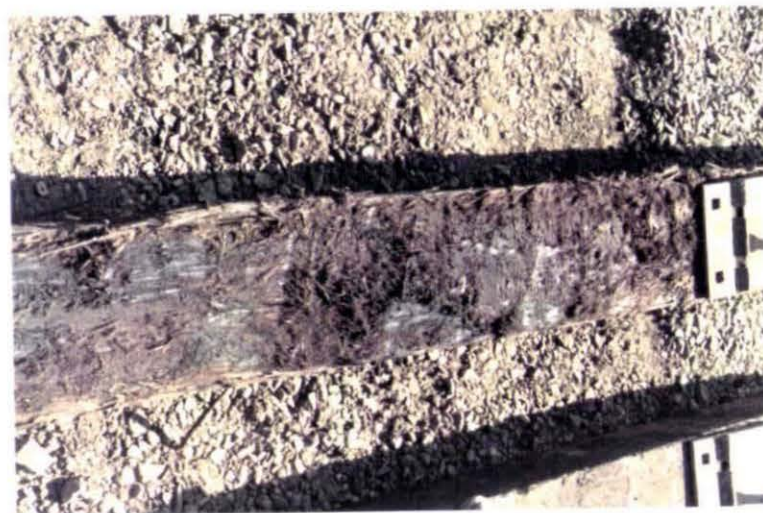
The ties in the crossing appeared to be in good condition, but the underside of the ties was considerably frayed from contact with the ballast (Photo V-10). Severe pumping had taken place at some locations (See Photo V-11) and the ballast was highly contaminated with fines and clay. Inspection of the exposed rail showed that the outside of the rail was completely filled with asphalt, while the space inside the rail was completely packed with asphalt and mud. The spikes holding the ties were partially

Photo V-10. Aberdeen, Fifth Street - Tie Damaged by Contact with Ballast.

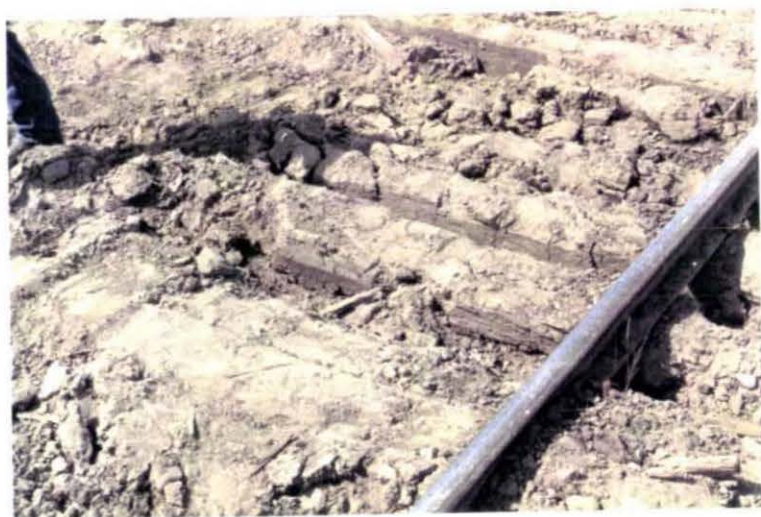
Photo V-11. Aberdeen, Fifth Street - Pumping.

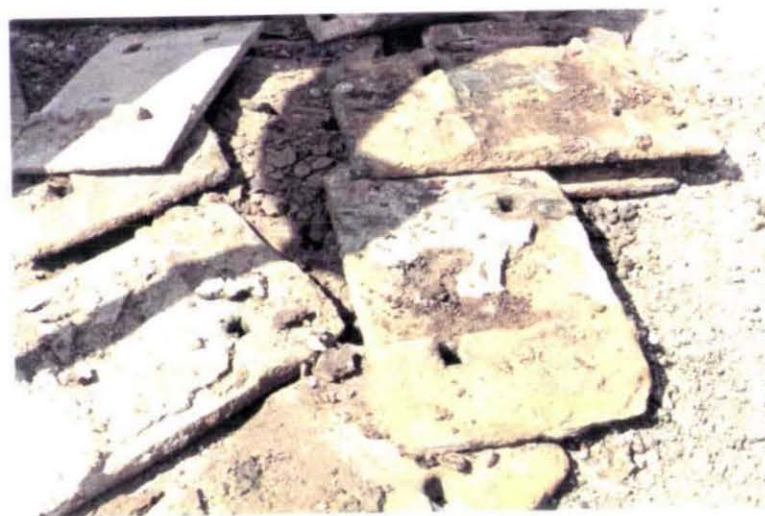
Photo V-12. Aberdeen, Fifth Street - Mud Squeezed in between the Rail and the Bearing Plates.

loose, hence up to one half of an inch of mud had been forced in between the rail and the bearing plate (See Photo V-12).

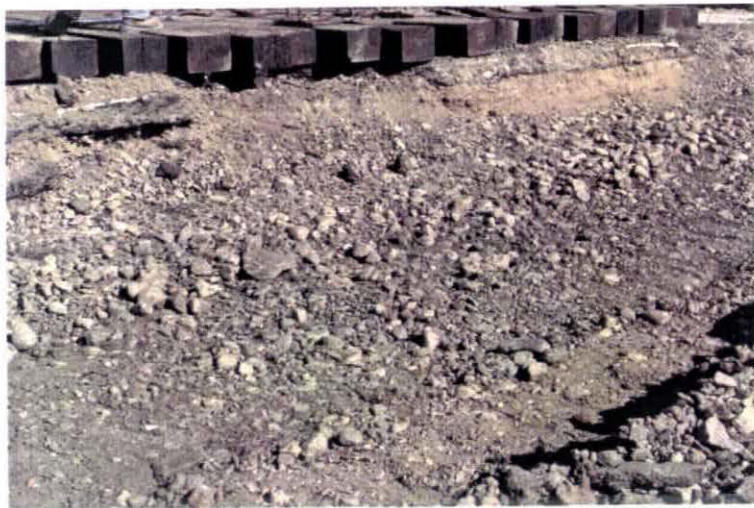
Photo V-13. Aberdeen, Fifth Street - Exposed Subgrade with Loose Cobbles.

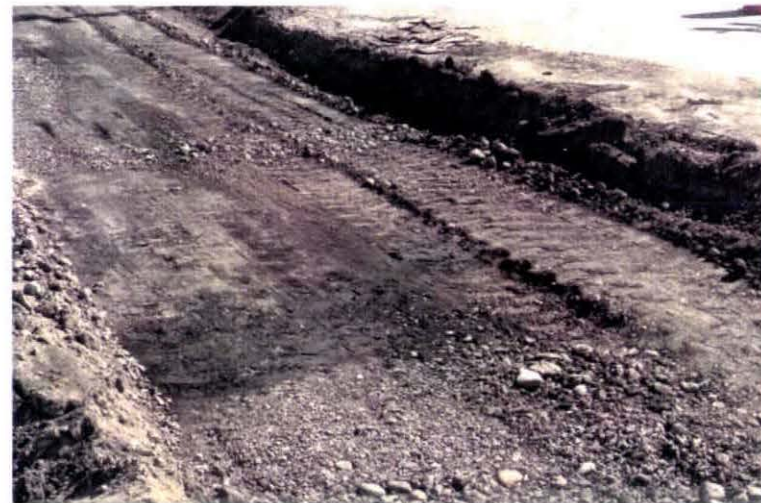
Photo V-14. Aberdeen, Fifth Street - Exposed Clay Subgrade.

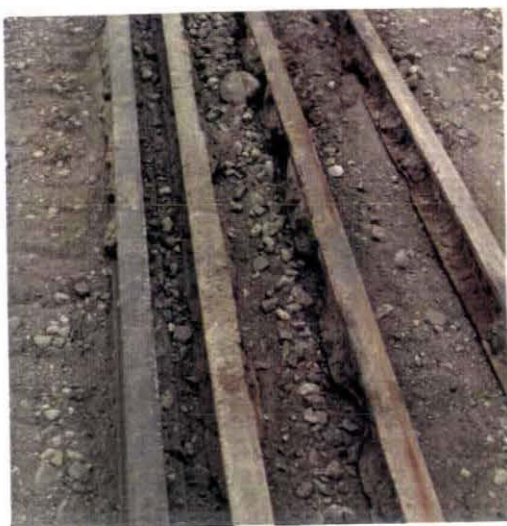
Photo V-19. Aberdeen, 12 Street - Corroded Rails.

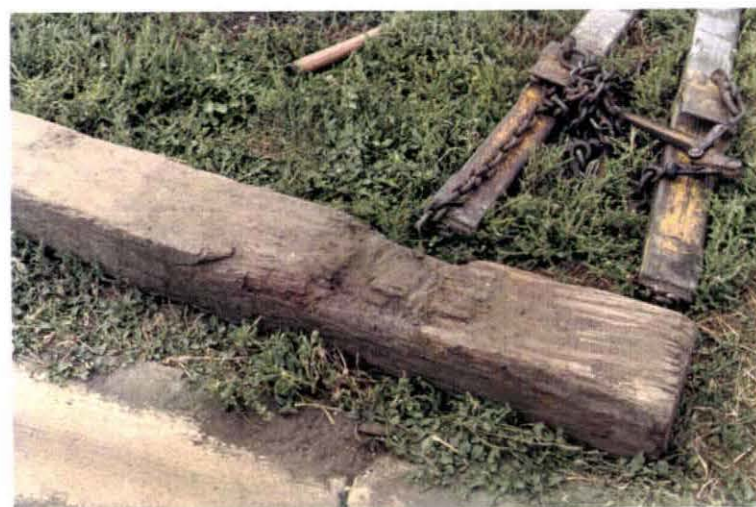
Photo V-20. Aberdeen, 12 Street - Deteriorated Tie.

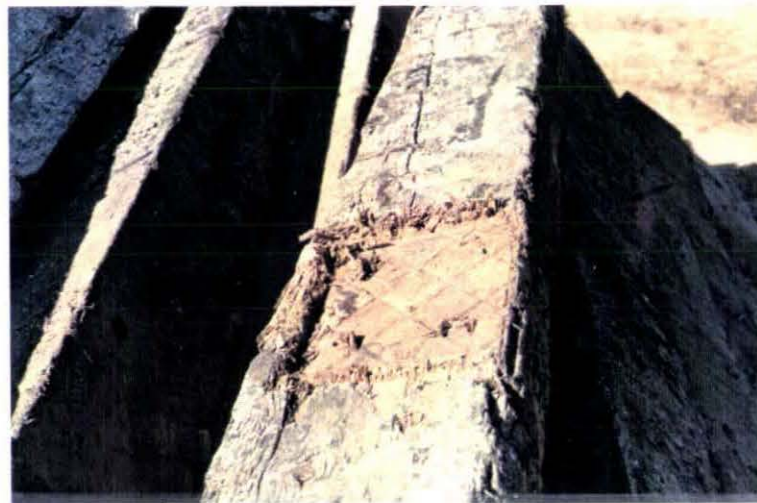
Photo V-26. Sturgis, Ball Park Road - Tie Damaged under Bearing Plate.

(Photo V-26). Such penetration would have contributed significantly to the settlement of the rails in the crossing.

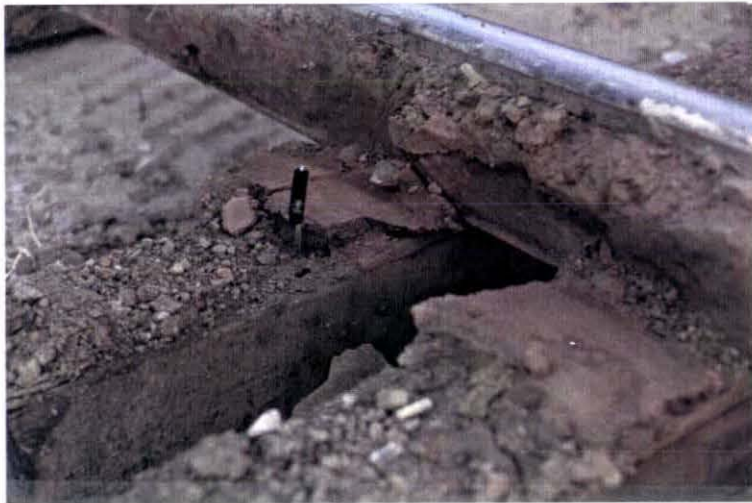
Photo V-33. Rapid City, Second Street - Mud Squeezed in between Bearing Plates and Mud Rail.

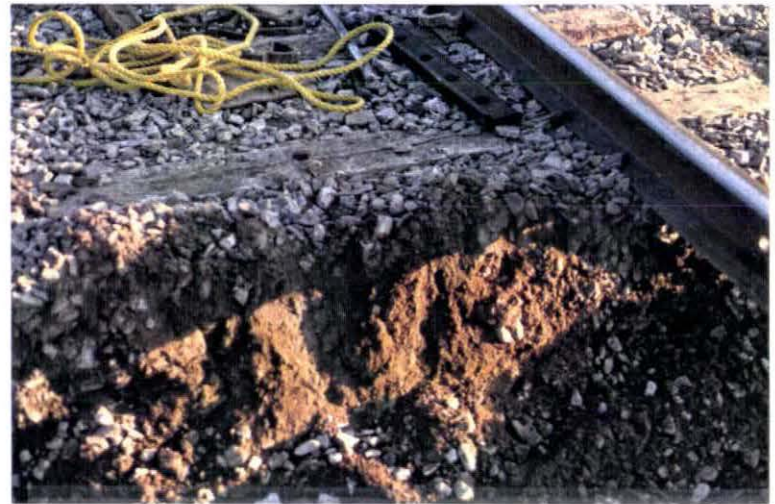
Photo V-34. Rapid City, Second Street - Deteriorated Ballast and Subgrade.

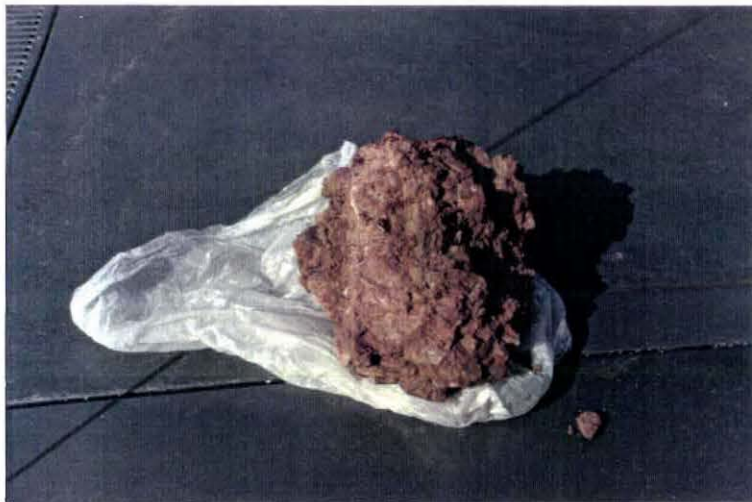
Photo V-35. Rapid City, Second Street - Degraded and Cemented Limestone Ballast.

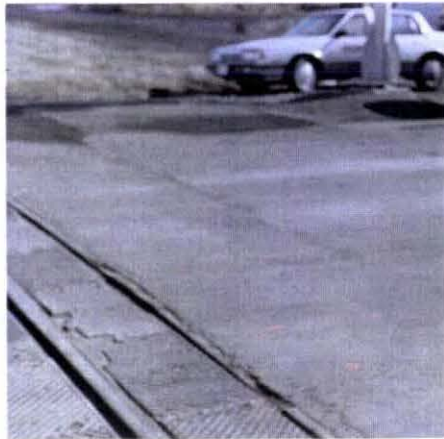
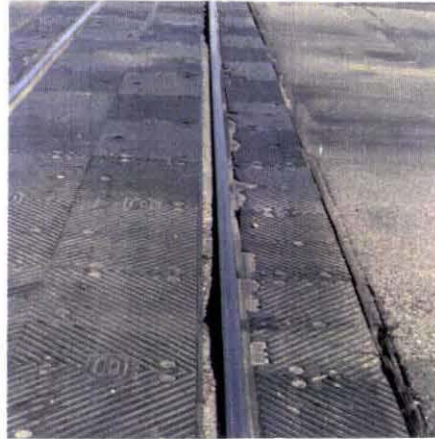
Photo VI-1 and VI-2. Aberdeen, Kline Avenue - Condition in February, 1991 (Left) and September 1991 (Right).

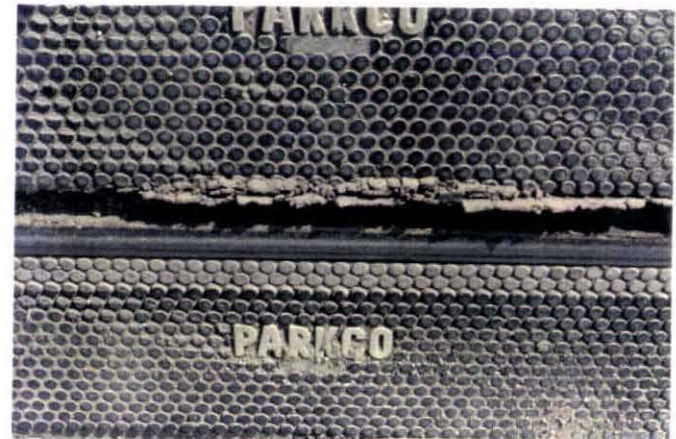
Photo VI-3. Effect of Freeze-Thaw - Mud Squeezing up between Rails and Panel.

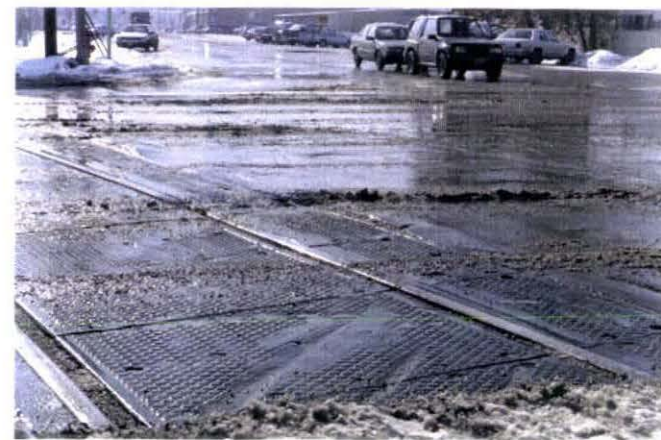
Photo VI-5. Effect of Freeze-Thaw - Frost Heave at Approach to Crossing.

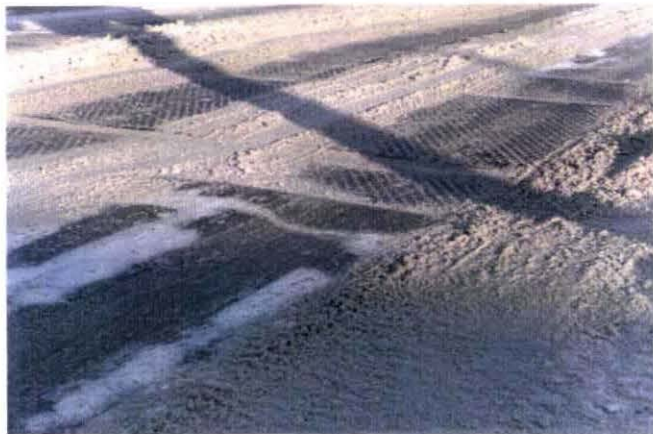
Photo VI-6. Effect of Freeze-Thaw - Frost Heave of Asphalt Approach.

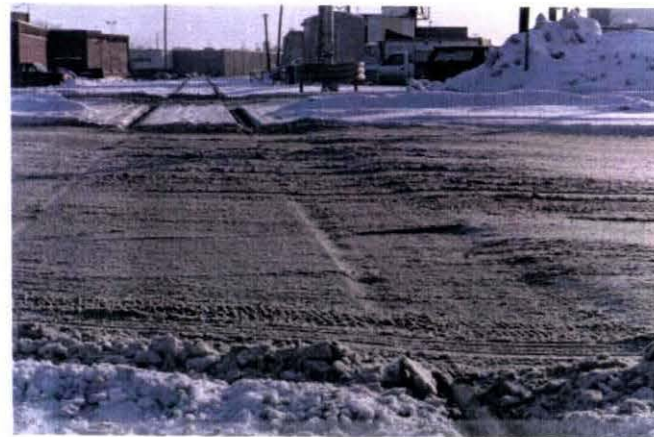
Photo VI-7. Snow Accumulation on Approaches.

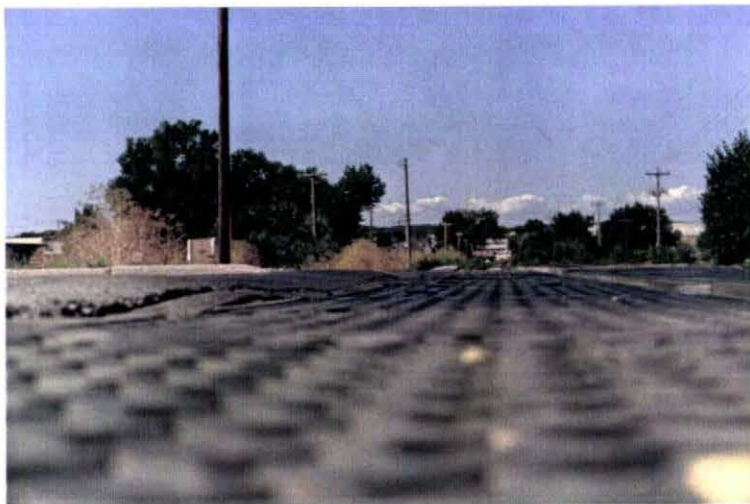
Photo VII-1. Overall Settlement of Track Relative to Approaches.

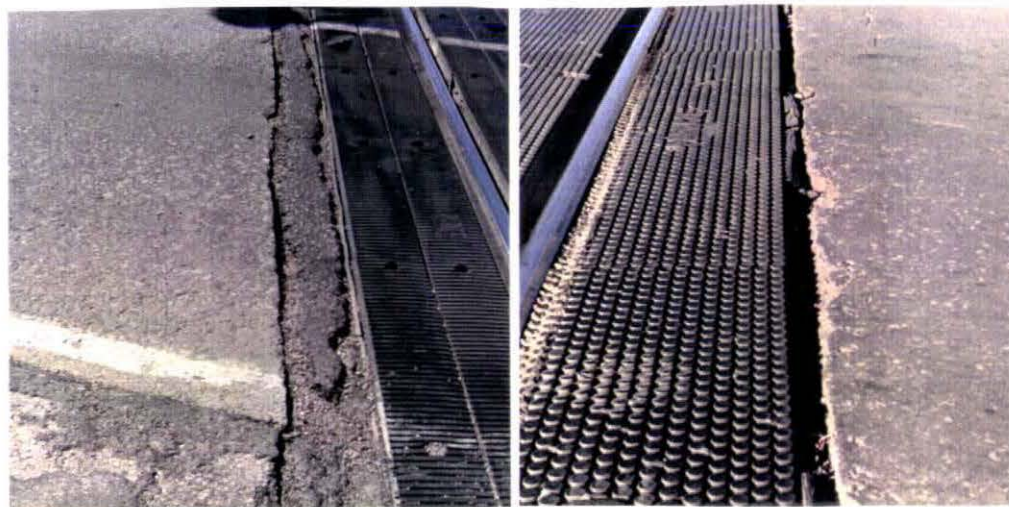
Photo VII-2 and 3. Failure of Asphalt and Wood Headers.

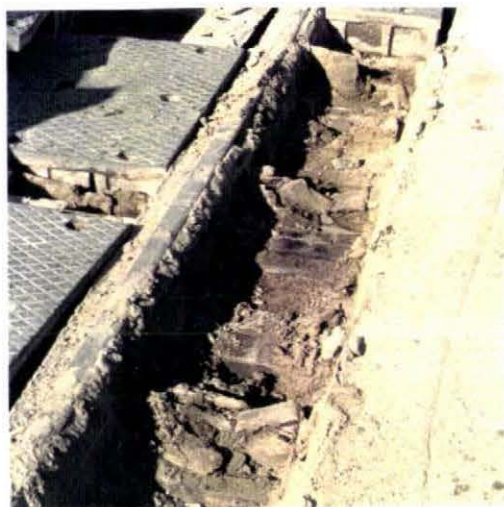
Photo VII-4. Debris Forced Under Panels.

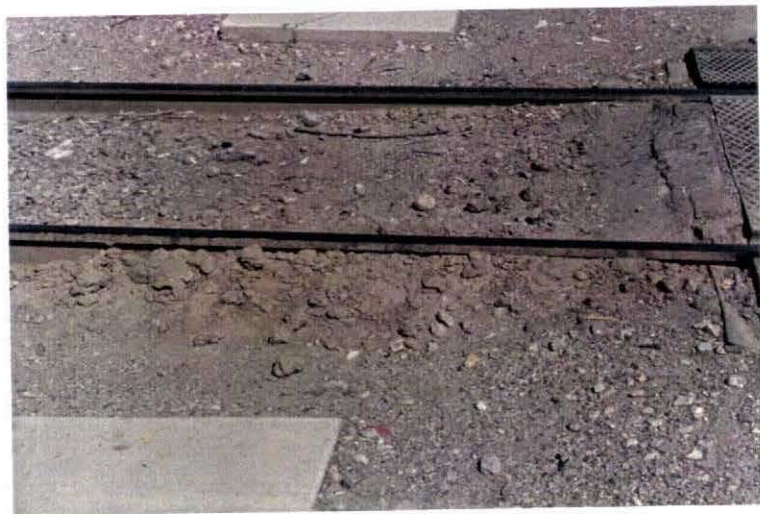
Photo VII-6. Pumping of Track Bed.

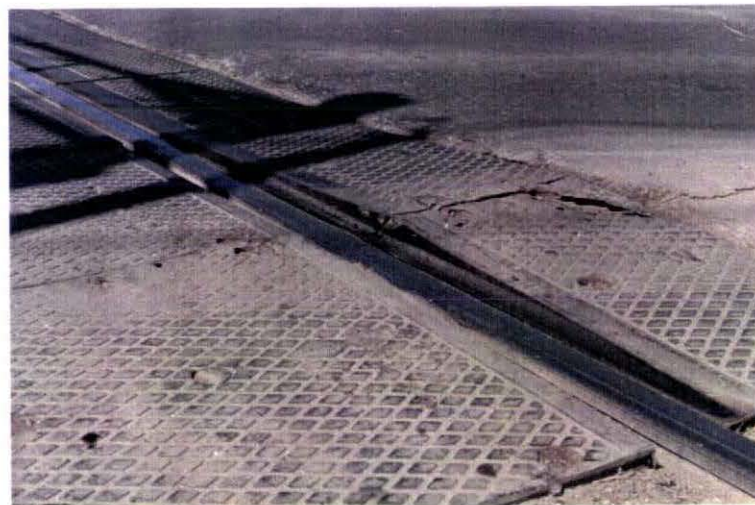
Photo VII-7. Loosening of Panels, Fastener Failure and Loss of Protective Caps.

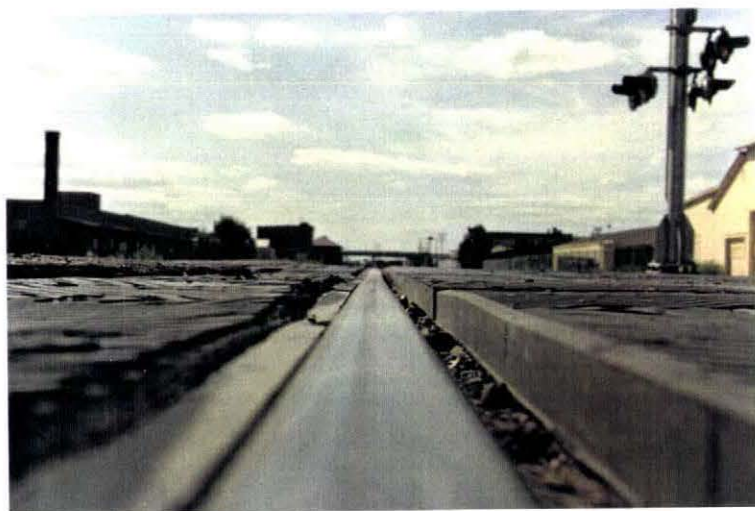
Photo VII-8. Warping of Panels.

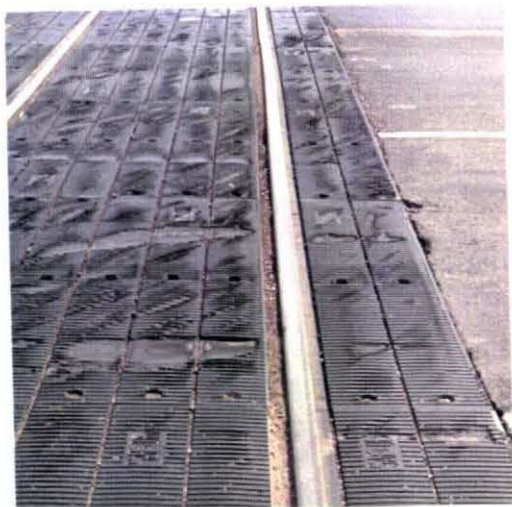
Photo VII-10. Panel Wear and Snowplow Damage.

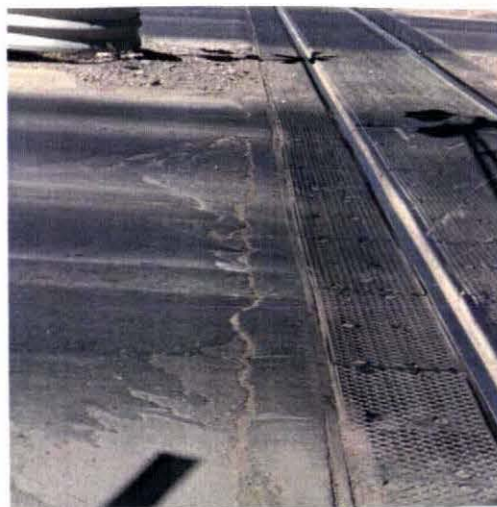
Photo VII-11. Rutting and Cracking of Approach Pavement and Frost Action.

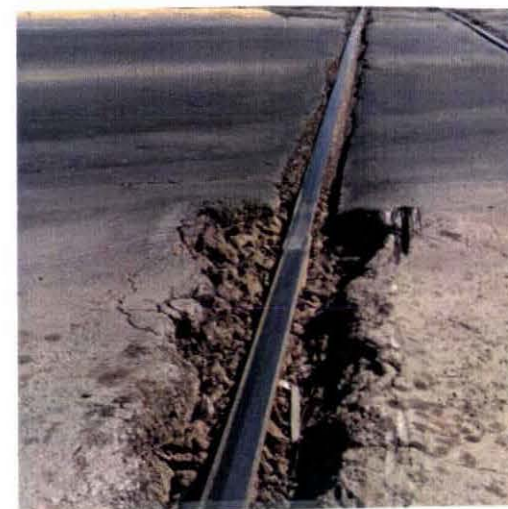
Photo VII-15. Pumping and Breakdown of Asphalt along Rail.

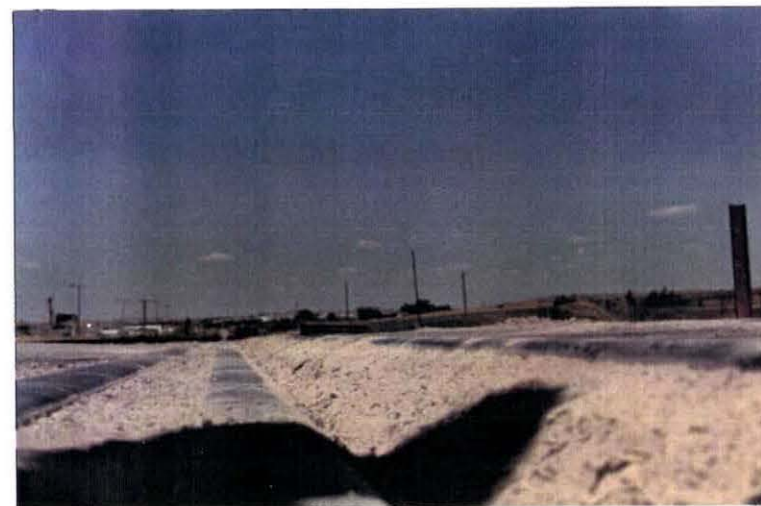
Photo VII-14. Differential Settlement between Main Rail and Mud Rail.

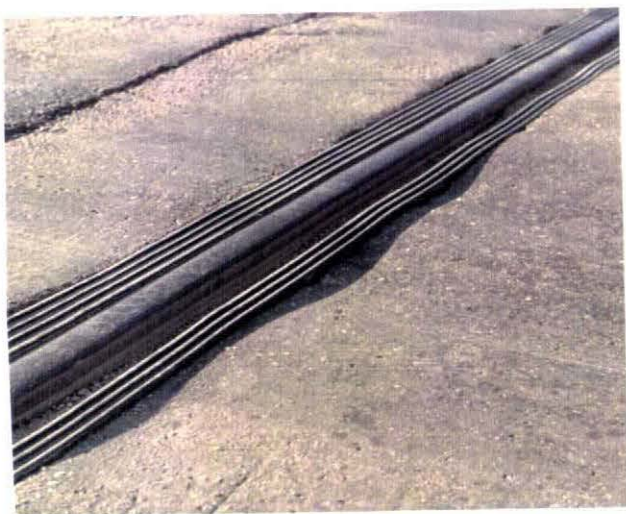
Photo VII-16. Rutting of Asphalt.

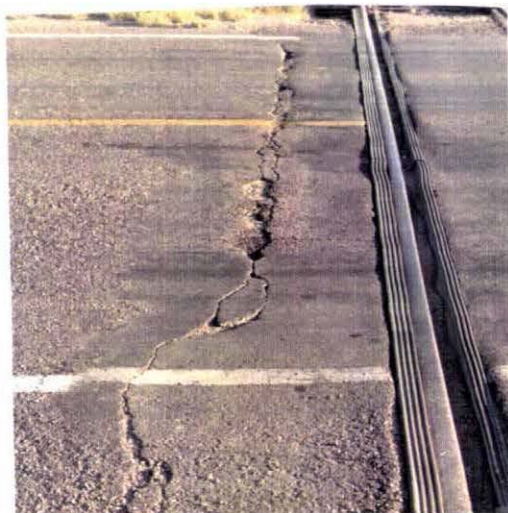
Photo VII-17. Frost Action.

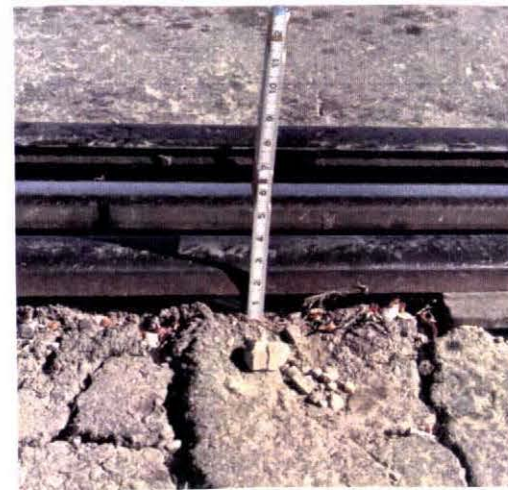
Photo VII-18. Asphalt Weathering and Settlement.

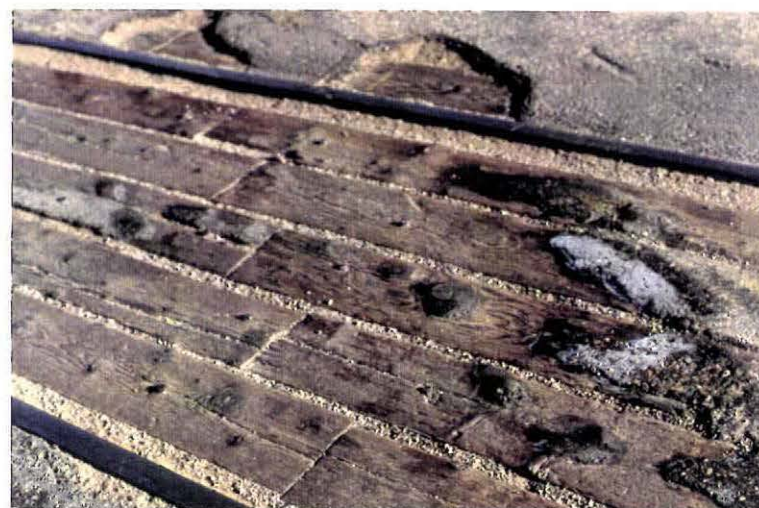
Photo VII-20. Wear by Traffic and Protruding Fasteners.

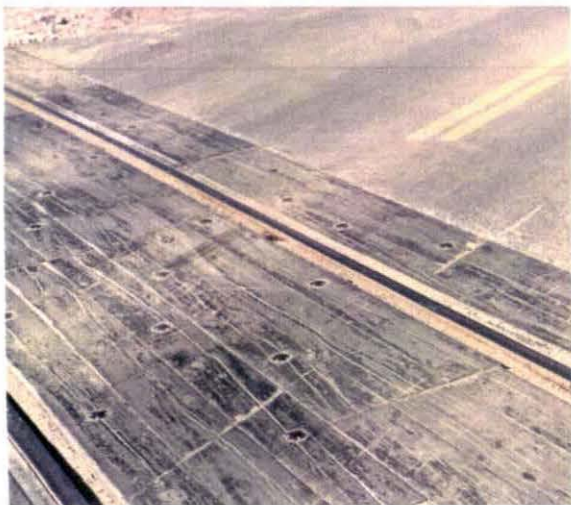
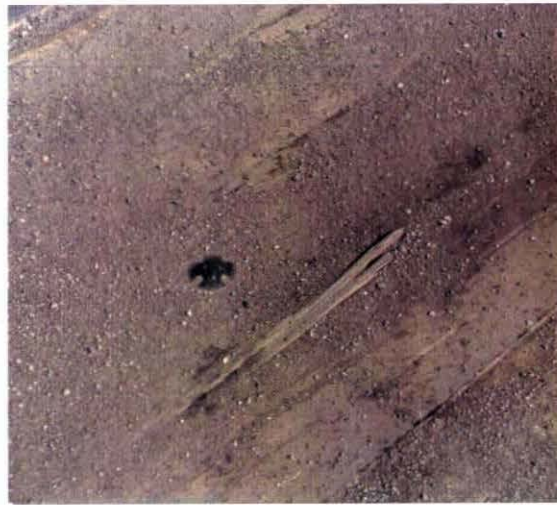
Photo VII-21 and 22. Snow Plow Damage.

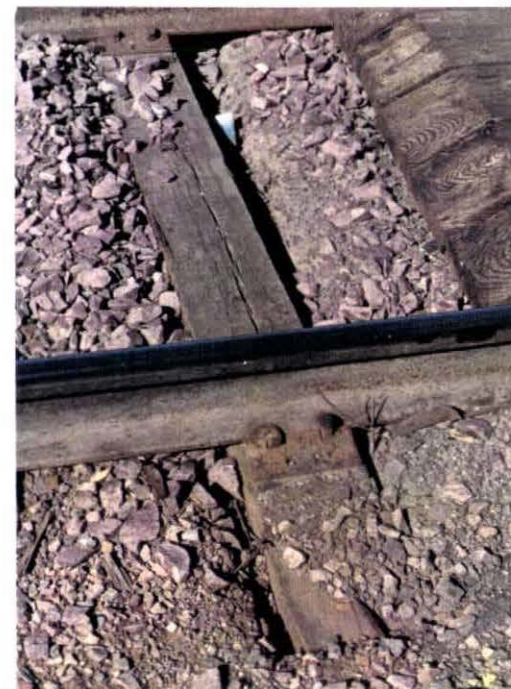
Photo VII-23. Pumping and Track Deflection.

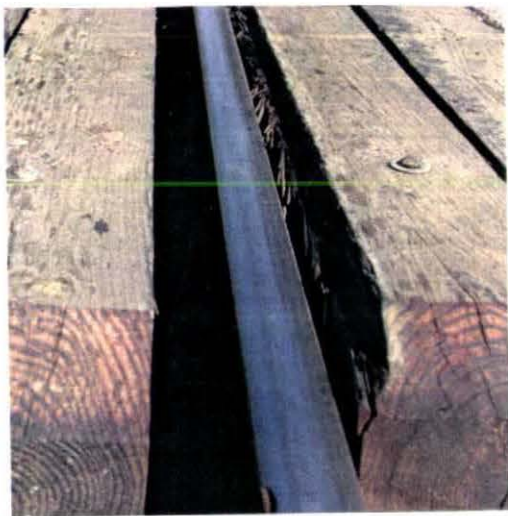
Photo VII-24. Timber Damage from Rail Traffic.

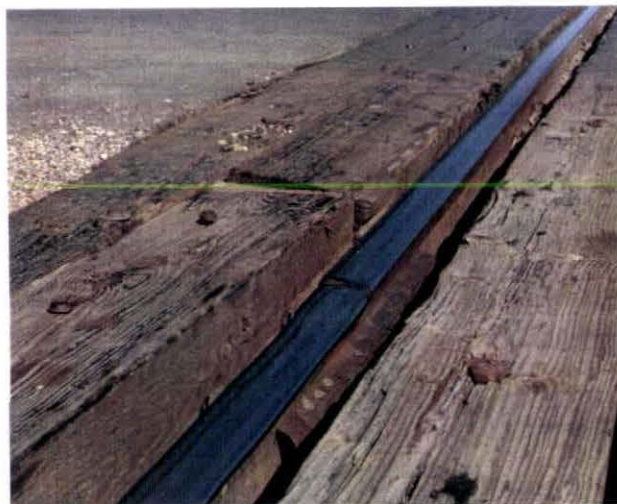
Photo VII-25. Warped Timbers.
