Crash Testing of Standard South Dakota Road Closure Gates

Study SD94-10 Final Report

Prepared by:
Midwest Roadside Safety Facility (MwRSF)
Center for Infrastructure Research
Civil Engineering Department
University of Nebraska-Lincoln
1901 Y Street, Building C
Lincoln, Nebraska 68588-0601
(402)472-6864

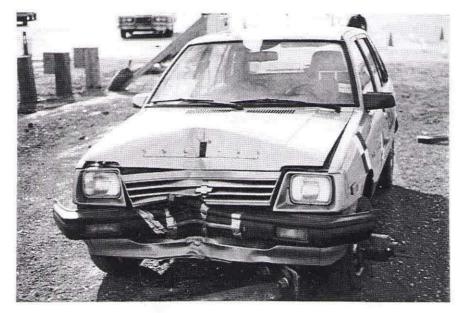
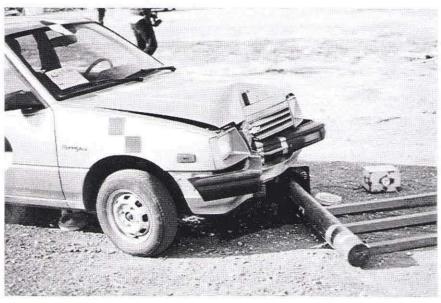
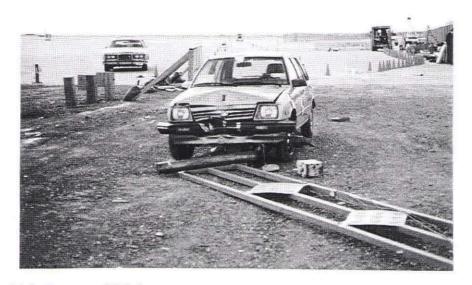
Figure 23. Vehicle Damage, SDG-1

Test vehicle damage consisted of only frontal crush to the bumper, hood, and grill. A maximum crush depth of 20.3 cm (8 in.) was measured on the front bumper of the test vehicle and approximately 27.9 cm (11 in.) of crush was measured on the hood of the test vehicle. There was no damage to the suspension or undercarriage of the test vehicle. The minimal damage to the test vehicle is shown in Figure 23.

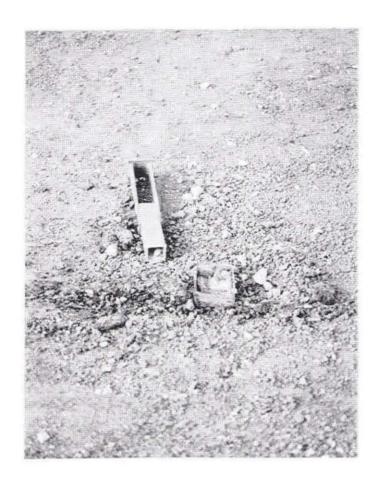
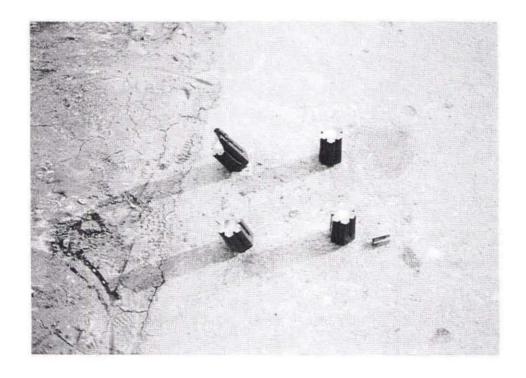
Figure 24. Component Damage, SDG-1

Damage to the road closure gate consisted only of fracture of the frangible couplers, hold back post, and gate stands, as shown in Figure 24. The frangible couplers were broken off flush with the top of the anchor rods, leaving a 7.6-cm (3-in.) stub height above the concrete surface. Two of the anchor bolts were bent forward. Damage to these components is shown in Figure 24. The gate post and gate were undamaged and remained connected. The final resting position of the gate was approximately 15.2-m (50-ft) downstream of impact, as shown in Figure 18.

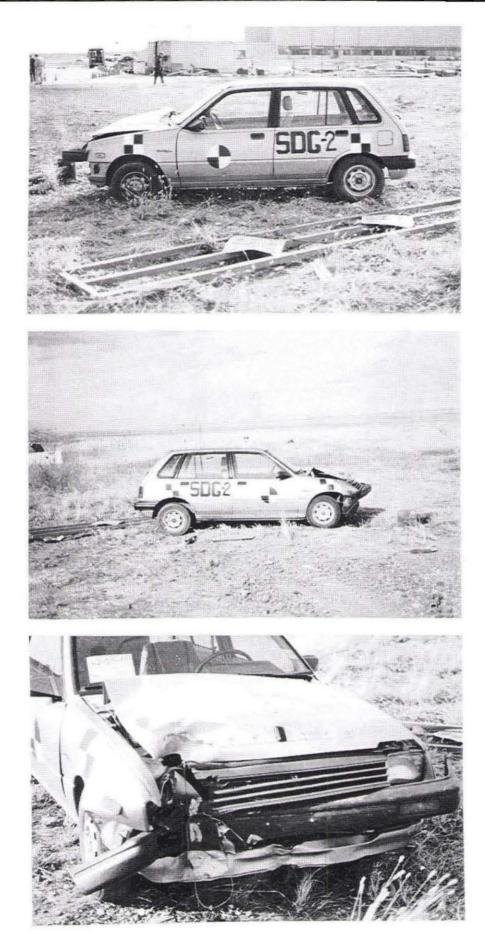
Figure 29. Vehicle Damage, SDG-2

Test vehicle damage consisted of frontal crush to the bumper, hood, and grill at the quarter point location. A maximum crush depth of approximately 30.5 cm (12 in.) was measured on the front bumper and hood. The right-front fender, wheel well, and hood were slightly buckled. There was no significant damage to the suspension or the undercarriage, since the vehicle did not run over any parts of the gate. There were no broken glass, flat tires, or occupant compartment damage. The damage to the test vehicle is shown in Figure 29.

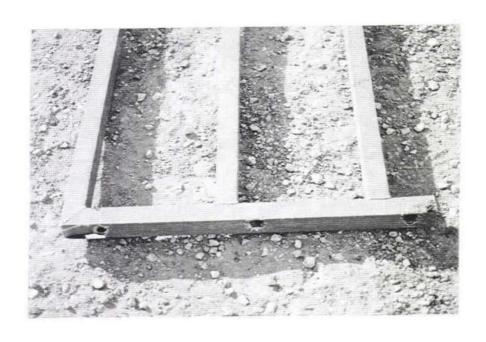
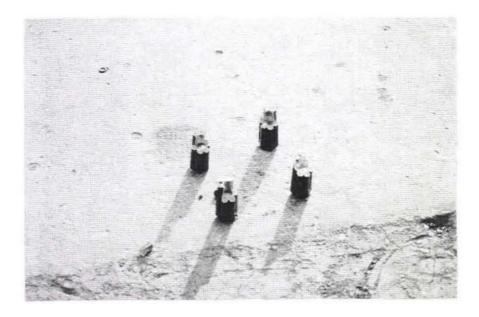
Figure 30. Component Damage, SDG-2

Damage to the road closure gate consisted of fracture of the couplers, hold back post, and gate stands, as shown in Figure 30. The frangible couplers were partially broken off with the top of the anchor rods on the upstream end of the couplers. The anchor rods were not bent, as shown in Figure 30. The gate post was undamaged, and the gate suffered minimal damage including the tear-out of the 1.9-cm (3/4-in.) bolts that connected the gate and gate post. The vertical aluminum tube on the upstream end of the gate was bent slightly. The final resting position of the gate was approximately 39.6 m (130 ft) downstream of impact, as shown in Figure 25.
