SD94-14-F

Crash Testing of Dual 4" x 6" Cedar Posts for Breakaway Applications

Study SD94-14
Final Report

1. Report No. SD94-14-F		2. Government Accession No.		3. Recipient's Catalog No.	
4. Title and Subtitle Testing of South Dakota Sign Support System, Foil Test Numbers: 95F005 and 95F006				5. Report Date July 1995

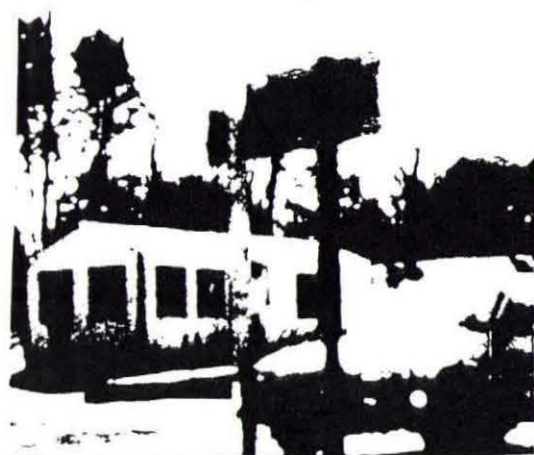
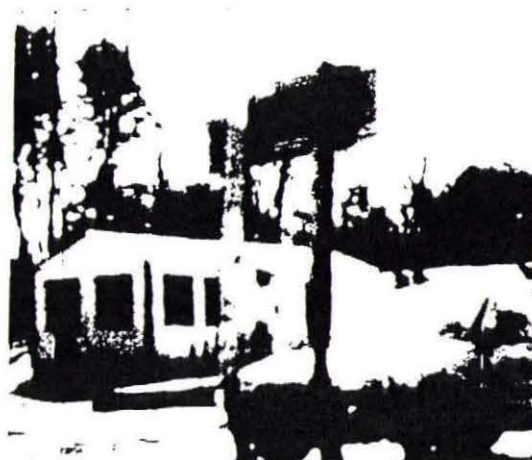
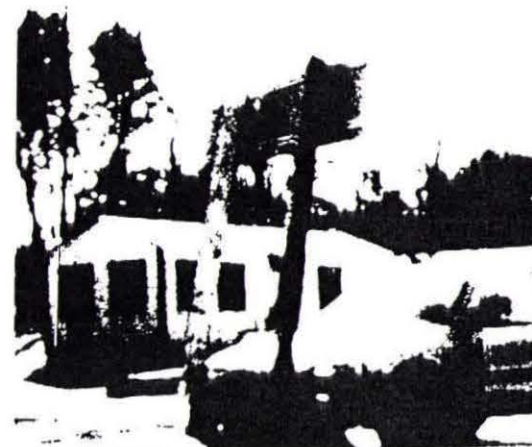
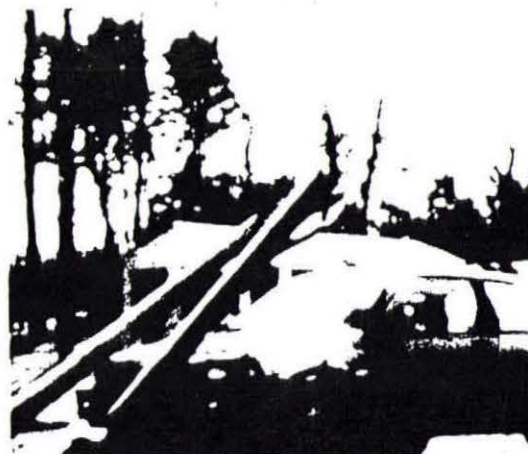
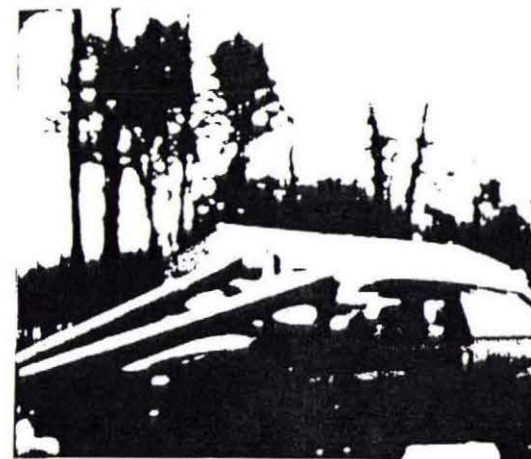
Figure 3. Test photographs during impact, test 95F005.

The vehicles' bumper made contact with the sign posts 457 mm above ground in both tests. The two wooden posts began to bow at the point of contact 0.018 s into the event during test 95F005 and 0.006 s into the event in test 95F006. The wood posts failed completely at 0.052 s after impact in test 95F005 and at 0.016 s after impact in test 95F006.

In test 95F005, the sign support structure initially stayed in contact with the vehicle causing the sign panel to hit the windshield on three occasions before falling to the left of the vehicle 13 m from the original sign position. The small pieces of wood created by the sign post fracturing at the point of contact and below ground were propelled forward while the vehicle passed over them. The right rear wheel of the vehicle rolled on one of the small wood fragments which caused the vehicle to yaw 28 degrees to the left of its original trajectory. Except for the windshield crack, there was no structural damage to the test vehicle.

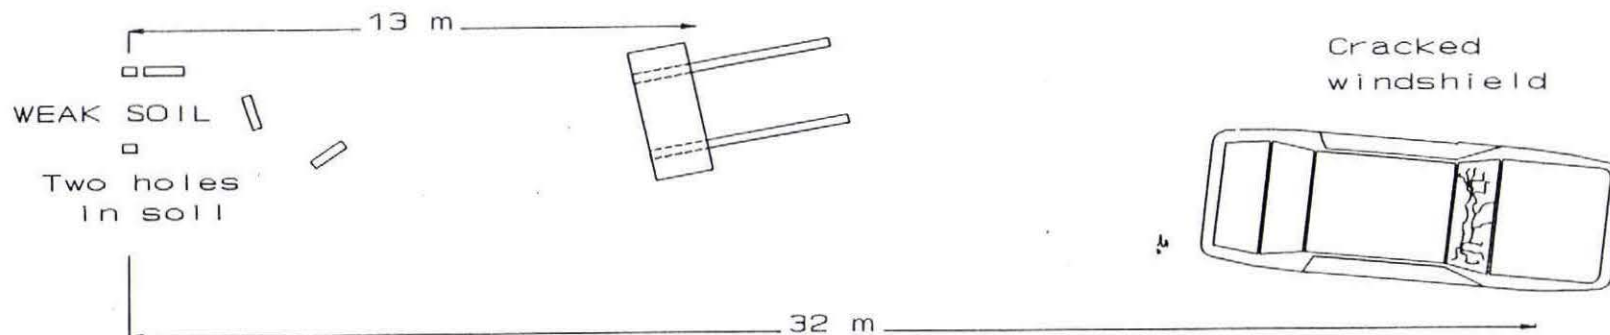
Figure 4. Summary of test 95F005.

Test number..... 95F005
 Date..... February 22, 1995
 Test vehicle..... 86' Honda Civic
 Vehicle weight..... 839 kg
 Test article..... double-leg small sign support
 Material..... 102 mm by 152 mm red cedar wood
 Embedment depth..... 1.2 m
 Panel type..... 0.6 m by 1.5 m aluminum sheet
 Height..... 2.7 m
 Foundation..... S-2 weak soil
 Impact speed..... 9.9 m/s
 Impact angle..... 0 degrees
 Impact location..... Head-on, centerline

Vehicle analysis:	<u>Observed</u>	<u>Design/Limit</u>
Longitudinal:		
Occupant Delta V at 0.61 m.....	2.3 m/s	≤ 5.0 m/s
Ridedown Acceleration.....	1.4 g's	15/20 g's
Lateral:		
Occupant Delta V at 0.305 m.....	no contact	no spec
Ridedown Acceleration.....	no contact	no spec
Peak 50 msec acceleration		
Longitudinal.....		3.5 g's
Lateral.....		NA
Vehicle Damage (TAD).....		12-FC-1
(VDI).....		12FCAU1
Crush.....	No residual deformation	
Vehicle velocity change.....	3.1 m/s	
Exit angle.....	0 degrees

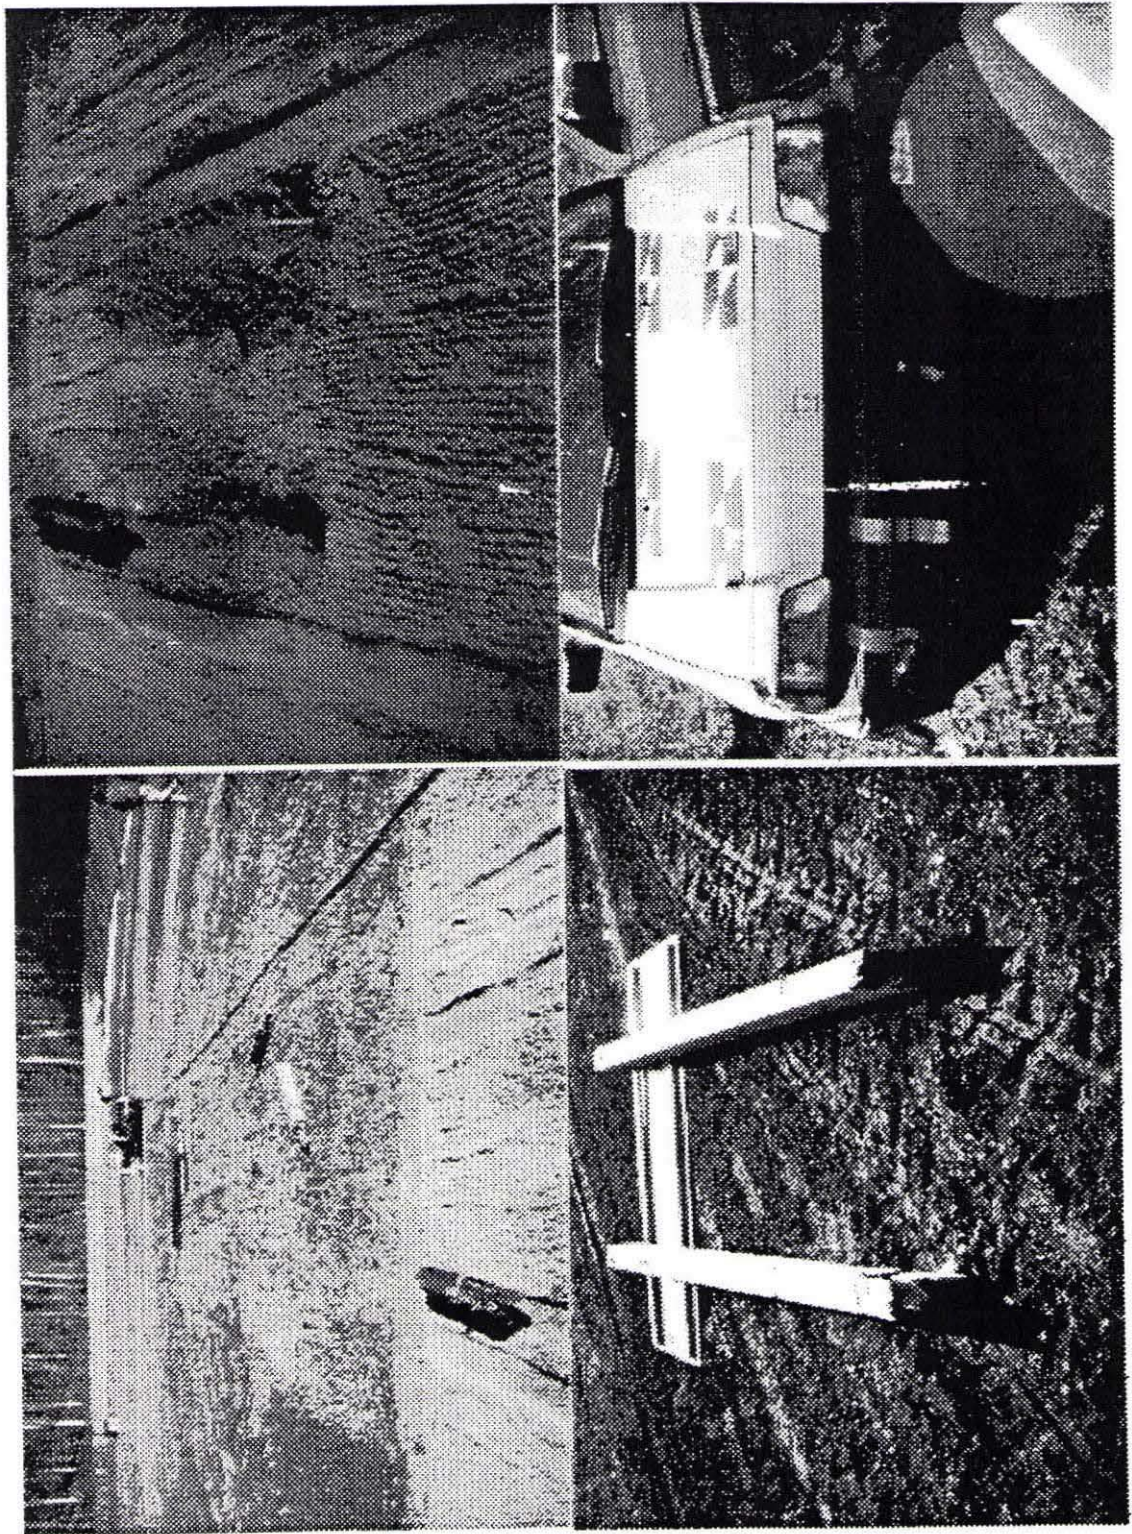
Figure 11. Post-test photographs of test 95F005.

The sign support fractured in a predictable manner during both crash tests. Damage to the sign support consisted of two fractured wood posts in both tests. Each post fractured at two locations. During test 95F005 the left post fractured once 457 mm above ground and once 127 mm below ground. The right post fractured once 452 mm above and once 118 mm below ground. During test 95F006 the left post fractured once 450 mm above ground and once 129 mm below ground. The right post fractured once 450 mm above ground and once 121 mm below ground. The lower wood fragments of the sign posts remained buried in the weak soil during both tests. The broken wood fragments of the sign support and the sign post would not have presented any danger to other traffic or pedestrians. The panel was in good condition after both tests.

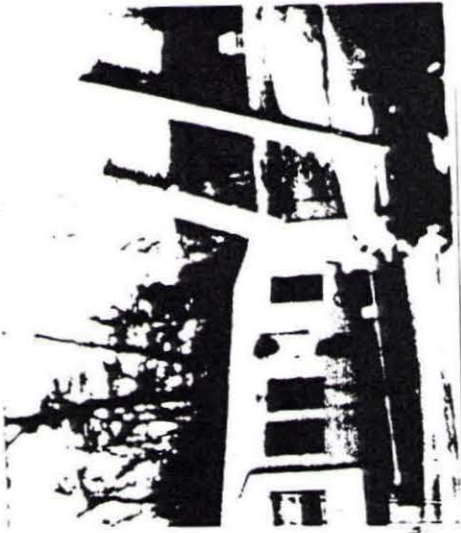
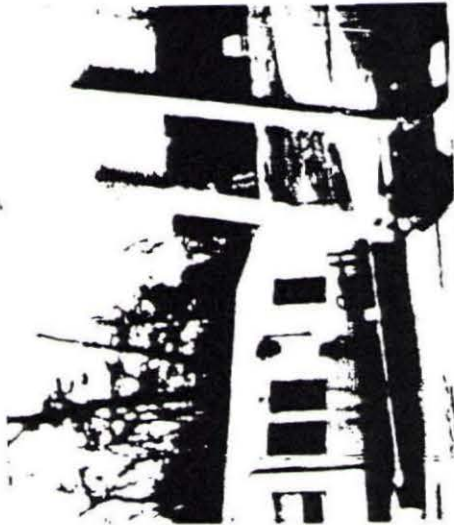
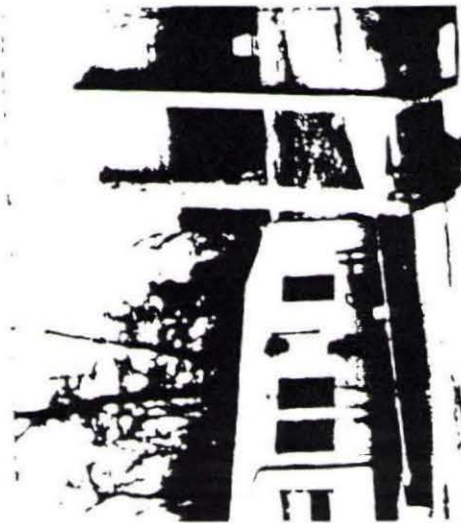
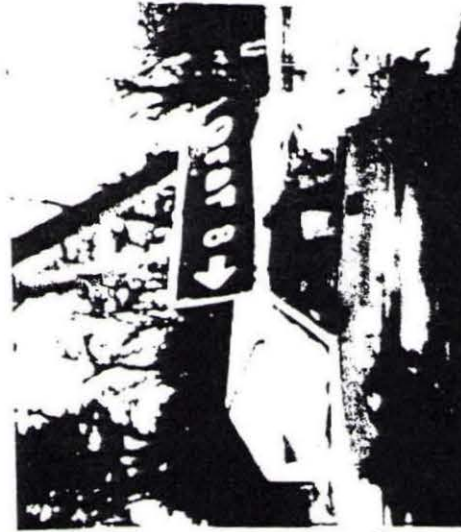
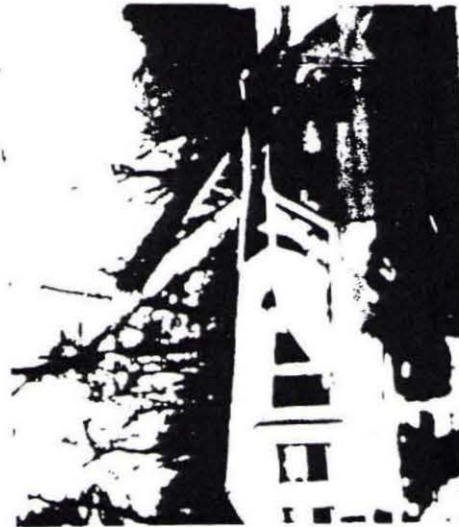
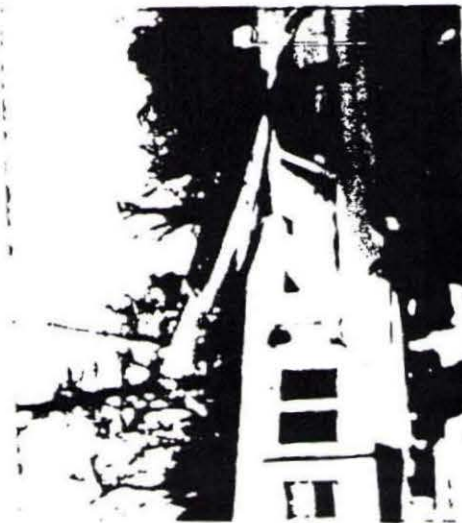
Figure 13. Test photographs during impact, test 95F006.

In test 95F006, the sign support was thrown upwards by the test vehicle and then fell upside down causing the sign panel to hit the rear part of the vehicles' roof and bounce off the test vehicle. The small wood fragments caused by the wood posts fracturing at the point of contact and below ground were propelled forward while the vehicle rolled over them. The left rear wheel of the test vehicle rolled over one of the small wood fragments and caused the car to yaw 6 degrees to the right of its original trajectory. The panel's contact with the roof caused a 75 mm dent in the roof and caused the left rear passenger window to shatter.

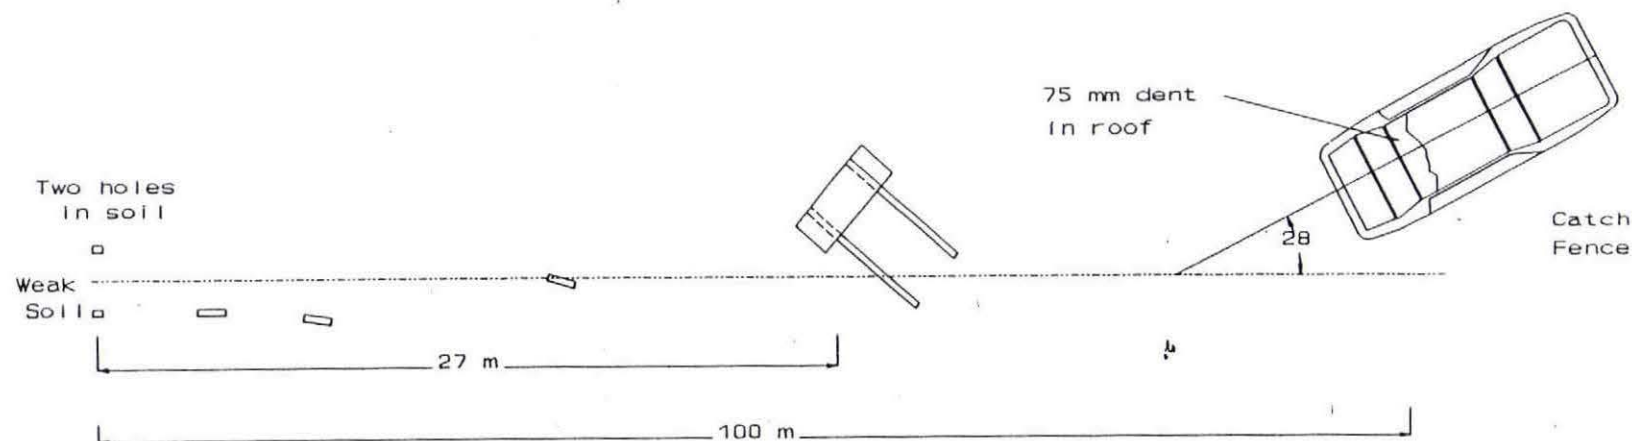
Figure 14. Summary of test 95F006.

Test number..... 95F006
 Date..... March 2, 1995
 Test vehicle..... '86 Honda Civic
 Vehicle weight..... 839 kg
 Test article..... double-leg small sign support
 Material..... 102 mm by 152 mm wood
 Embedment depth..... 1.2 m
 Panel type..... 0.6 m by 1.5 m aluminum sheet
 Height..... 2.7 m
 Foundation..... S-2 weak soil
 Impact speed..... 26.9 m/s
 Impact angle..... 0 degrees
 Impact location..... Head-on, centerline

Vehicle analysis:	<u>Observed</u>	<u>Design/Limit</u>
Longitudinal:		
Occupant Delta V at 0.61 m.....	1.9 m/s	≤ 5.0 m/s
Ridedown Acceleration.....	2.0 g's	15/20 g's
Lateral:		
Occupant Delta V at 0.305 m.....	no contact	no spec
Ridedown Acceleration.....	no contact	no spec
Peak 50 msec acceleration		
Longitudinal.....		2.6 g's
Lateral.....		NA
Vehicle Damage (TAD).....		12-FC-1
(VDI).....		32FTAN2
Crush.....		No residual deformation
Vehicle velocity change.....		2.6 m/s
Exit angle.....		0 degrees
Roof damage (crush).....		75 mm
