*Midwest State's Regional Pooled Fund Program
Research Project Number SPR-3(017)*

CRASH TESTING OF SOUTH DAKOTA'S CABLE GUARDRAIL TO W-BEAM TRANSITION

MwRSF Research Report No. TRP-03-80-98

December 4, 1998

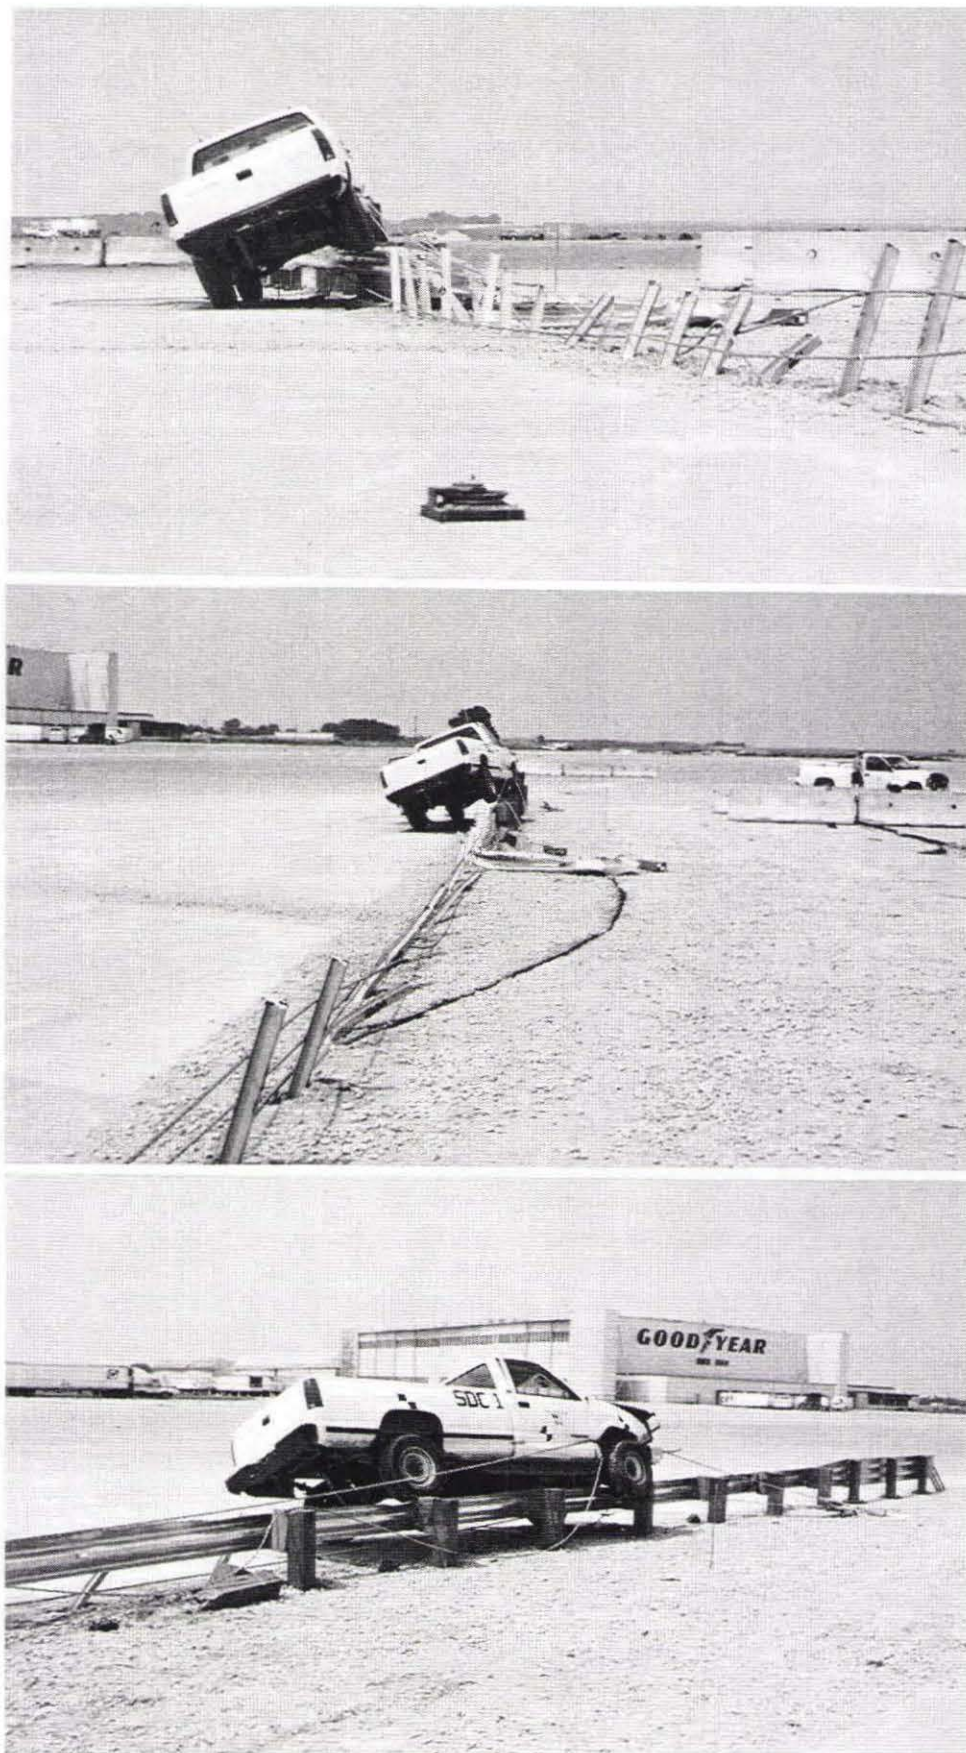
Figure 25. Cable Guardrail to W-Beam Transition Damage, Test SDC-1

Damage to the barrier was extensive, as shown in Figures 25 through 28. Barrier damage consisted mostly of deformed steel posts and W-beam, fractured wood posts, ruptured or stretched cables, and deformations to the steel anchorage hardware. Steel post nos. 1C through 14C were deformed above the ground line, while post nos. 15C through 17C were rotated in the soil. Wood post nos. 1W through 4W were fractured, while post nos. 5W through 11W were all displaced, as determined either visually or by measurements taken at the ground line. The BCT head was collapsed at the nose section, and the W-beam buckled and deformed at post nos. 2W and 3W, respectively. The upper and lower cables remained intact while the middle cable was no longer anchored at the upstream end due to the failure of the threads on the connecting rod. The steel transition brackets located at post nos. 7W and 9W were deformed and only contained the lower cable following the crash test. The maximum lateral dynamic cable deflection was 2.4 m (7.9 ft), as determined from the high-speed film analysis.

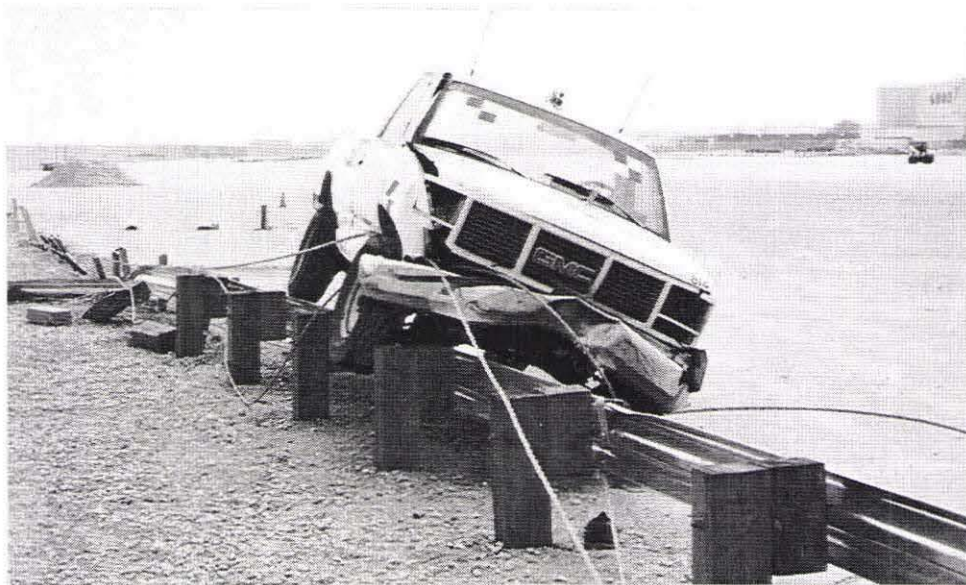
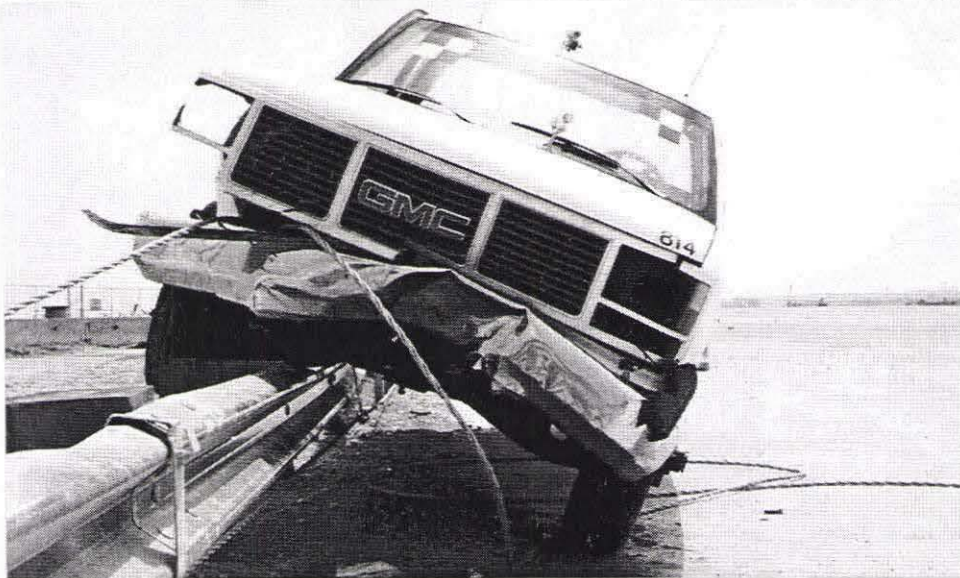
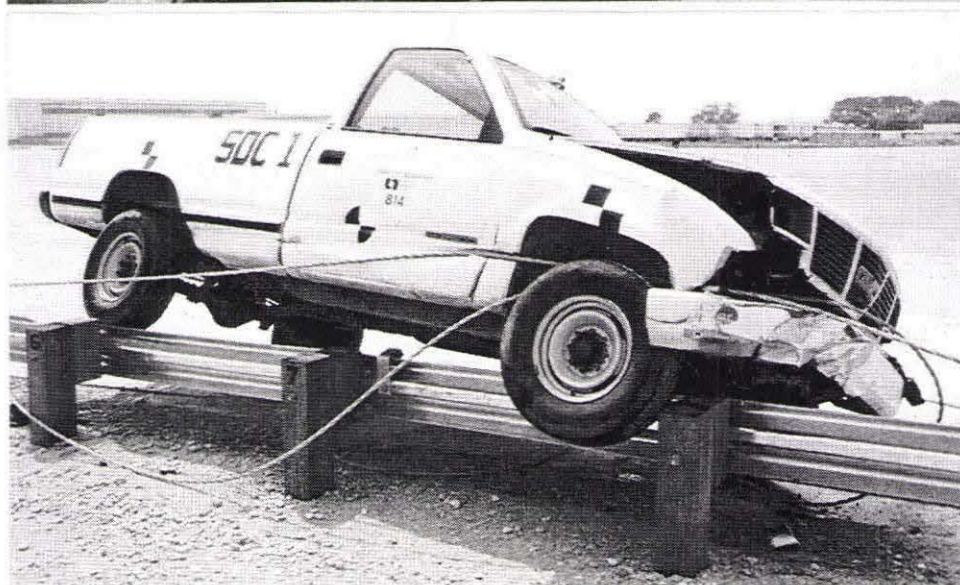
Figure 29. Vehicle Damage, Test SDC-1

Exterior vehicle damage was moderate and occurred at several body locations, as shown in Figure 29. The vehicle's front end was crushed inward due to contact with the BCT terminal and W-beam guardrail, the right-front quarter panel was crushed, and the right-side front bumper was bent back toward the engine compartment. The engine compartment was also moved backward, and the undercarriage near the front end was deformed. Very minor deformations were found on the floorboard of the occupant compartment. Evidence of vehicle-rail interlock was also found from the

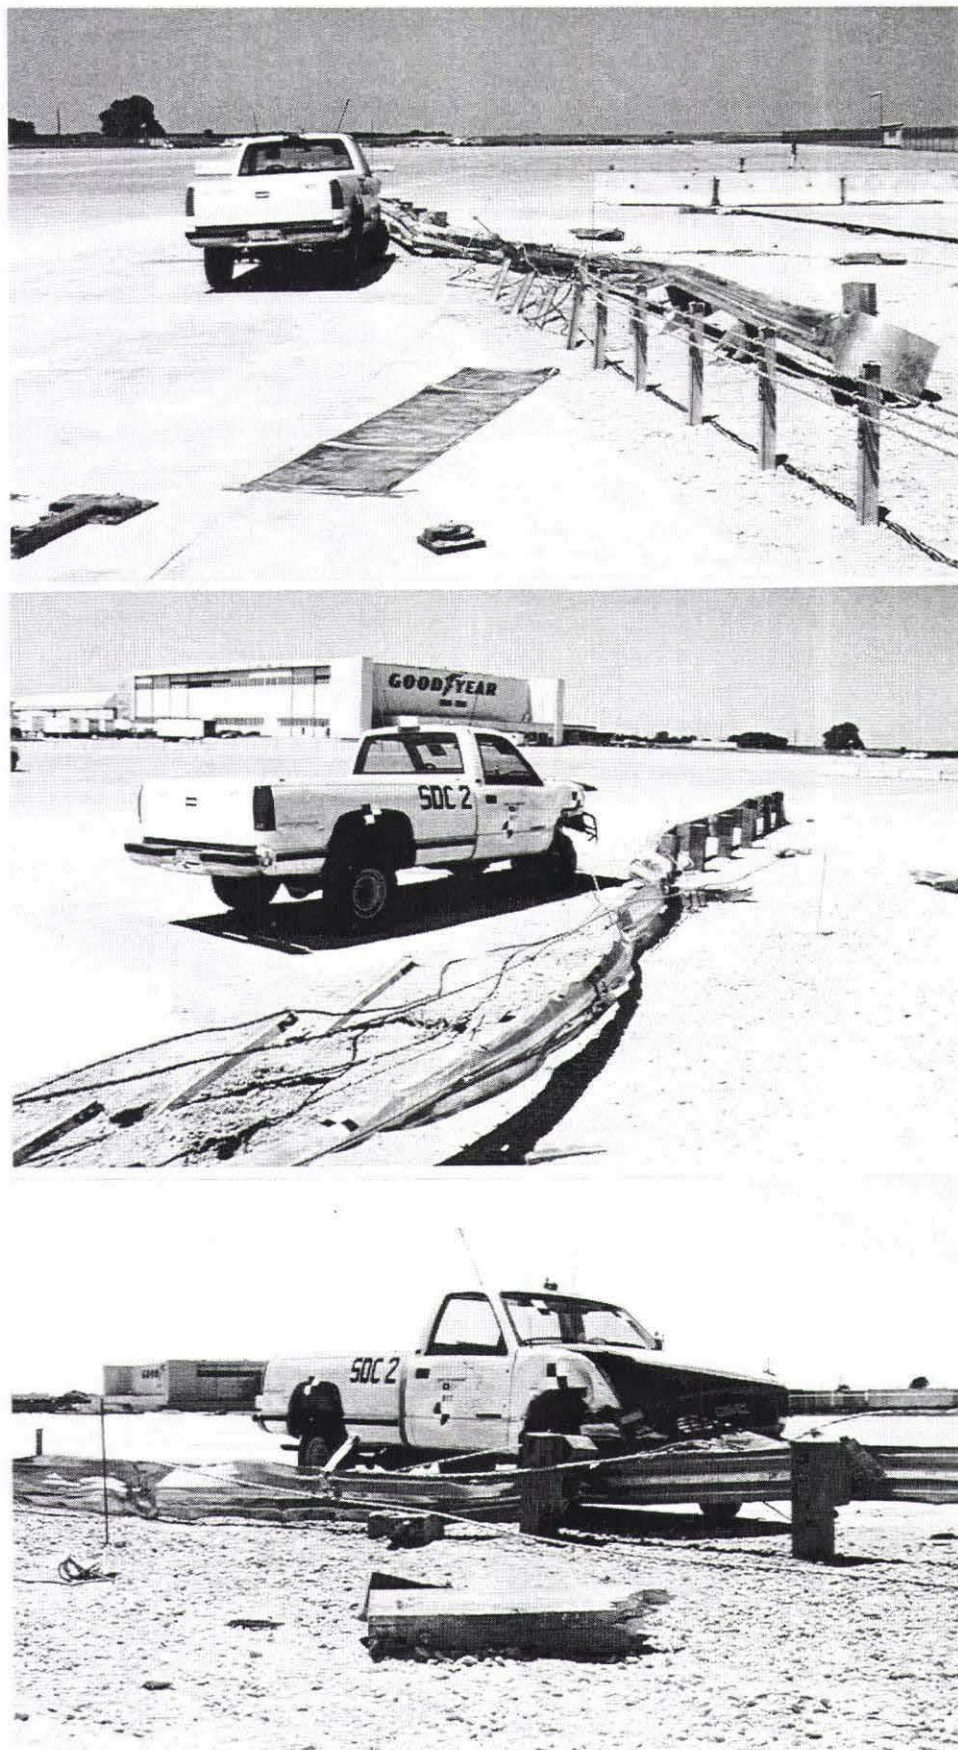
Figure 36. Cable Guardrail to W-Beam Transition Damage, Test SDC-2

Damage to the barrier was extensive, as shown in Figures 36 through 39. Barrier damage consisted mostly of deformed steel posts and W-beam, fractured wood posts, ruptured or stretched cables, and deformations to the steel anchorage hardware. Steel post nos. 1C through 3C were deformed above the ground line, while post nos. 4C through 5C were rotated in the soil. Wood post

nos. 1W through 7W were fractured, while post no. 8W was displaced, as determined either visually or by measurements taken at the ground line. The initial vehicle contact marks were found on the W-beam rail at a location 330-mm (13-in.) upstream from the midspan between post no. 3W and 4W. In addition, significant flattening of the W-beam rail occurred between post nos. 5W and 7W. The upper cable remained intact while the lower and middle cables were no longer anchored at the downstream end. The steel transition brackets located at post nos. 7W and 9W were deformed.

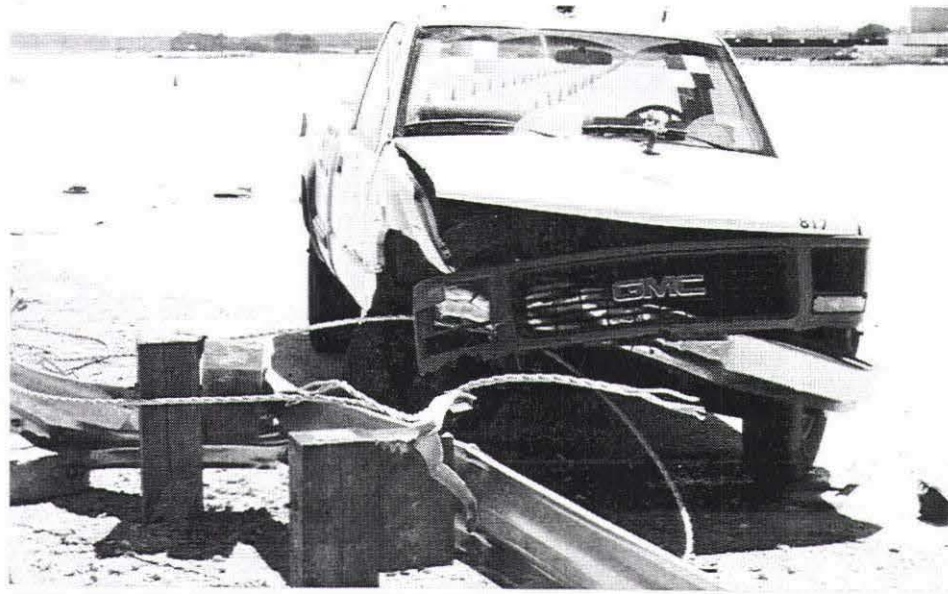
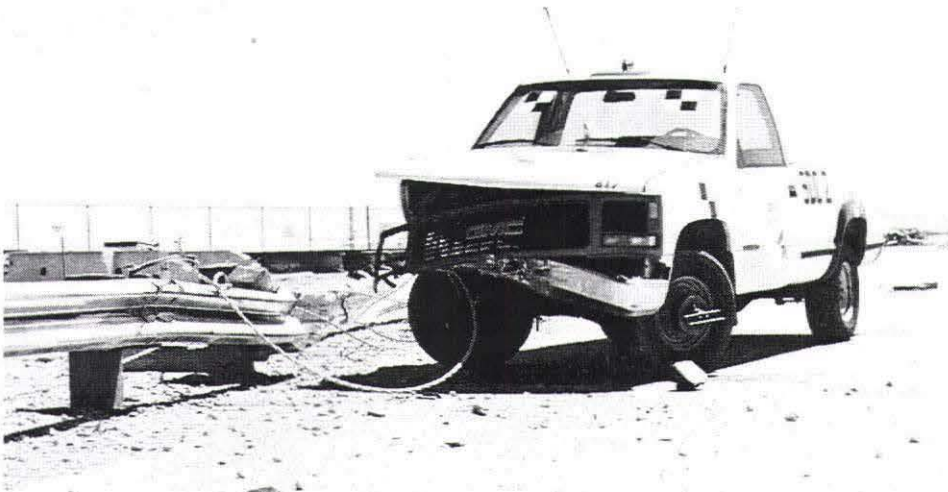
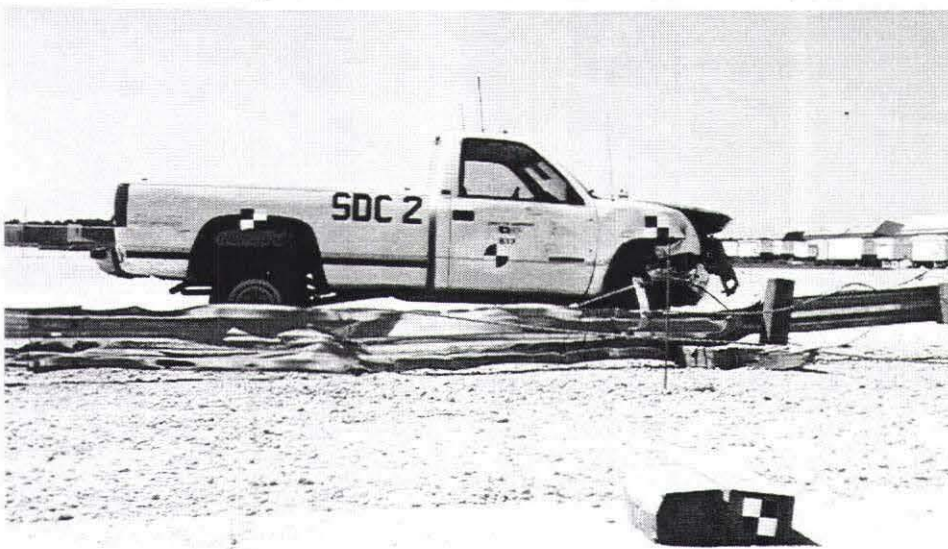
Figure 40. Vehicle Damage, Test SDC-2

Exterior vehicle damage was moderate and occurred at several body locations, as shown in Figure 40. The vehicle's front end, right-front bumper, and right-front quarter panel were crushed inward toward the engine compartment due to contact with the barrier. Components within the engine compartment and front undercarriage were either deformed or moved backward and upward. Very minor deformations were found on the right-side firewall of the occupant compartment.

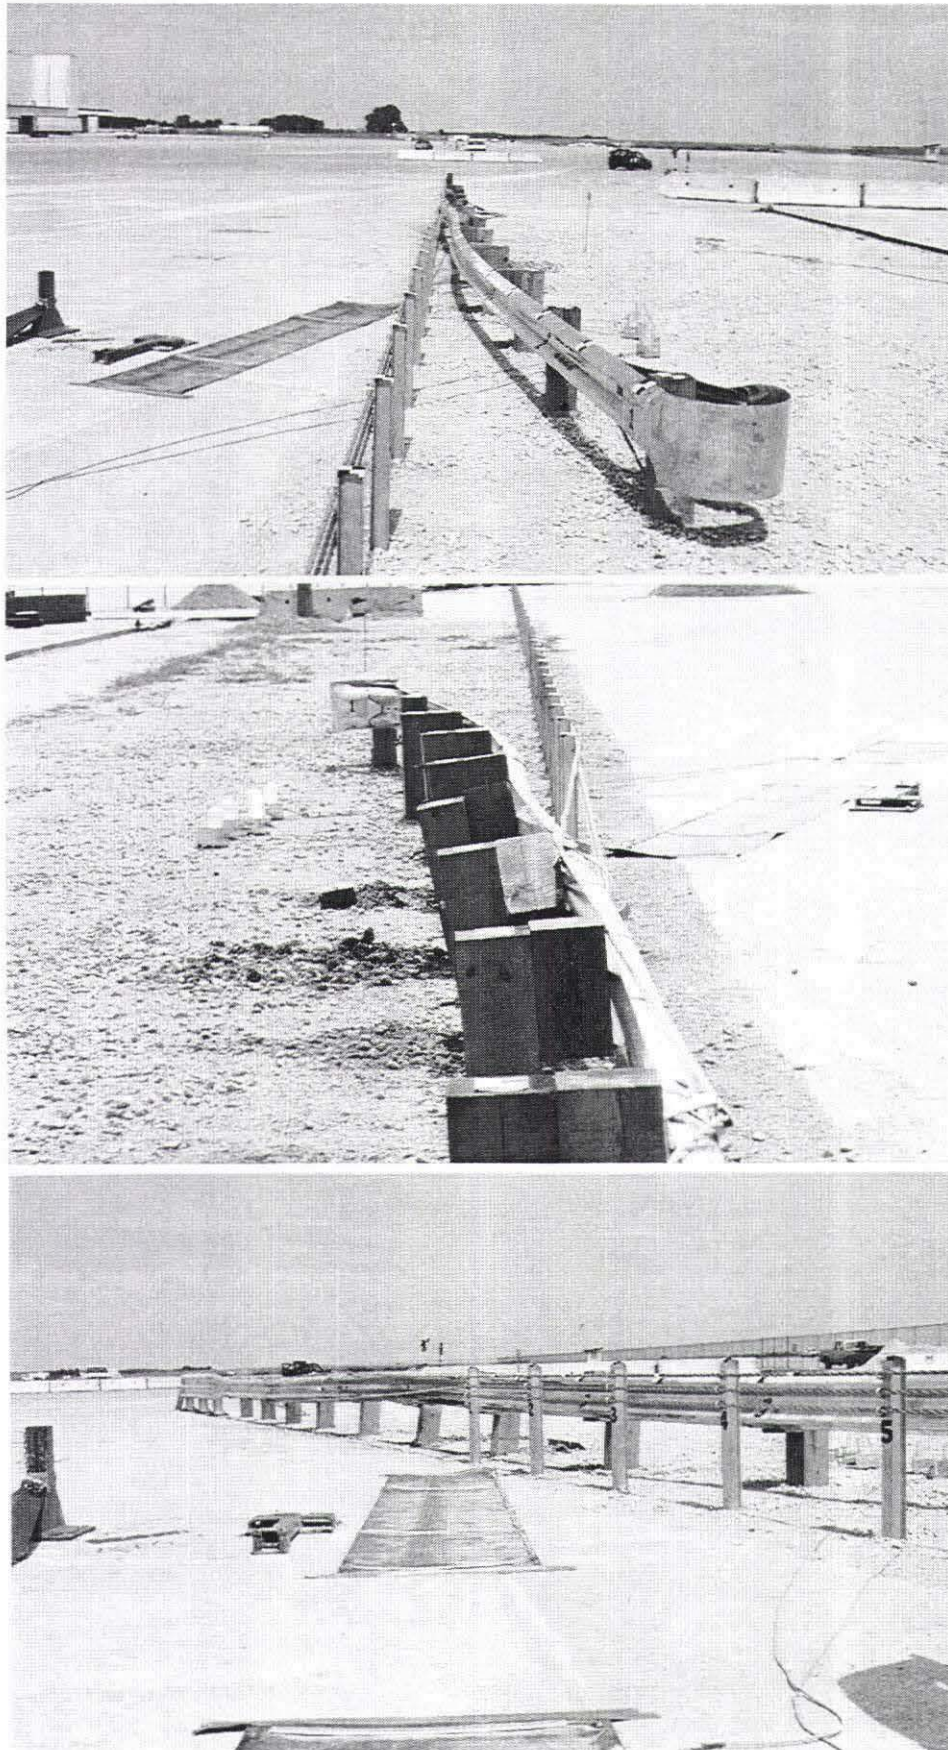
Figure 46. Cable Guardrail to W-Beam Transition Damage, Test SDC-3

Damage to the barrier was moderate, as shown in Figures 46 through 47. Barrier damage consisted mostly of deformed W-beam, displaced steel and wood posts, and stretched cables. Steel post no. 1C and wood post nos. 3W through 9W were rotated in the soil, as determined either visually or by measurements taken at the ground line. Tire contact marks were found on the front face of post no. 6W and the front and upstream side faces of post no. 7W. Vehicle contact marks were found on the W-beam rail between the post no. 5W through 152-mm (6-in.) downstream from post no. 7W. All three cables remained intact and no damage was found at either cable anchorage device. The steel transition bracket located at post no. 7W was deformed with all three cables pulled out. The maximum lateral dynamic post and W-beam rail deflection was 0.50 m (1.64 ft), as determined from the high-speed film analysis.

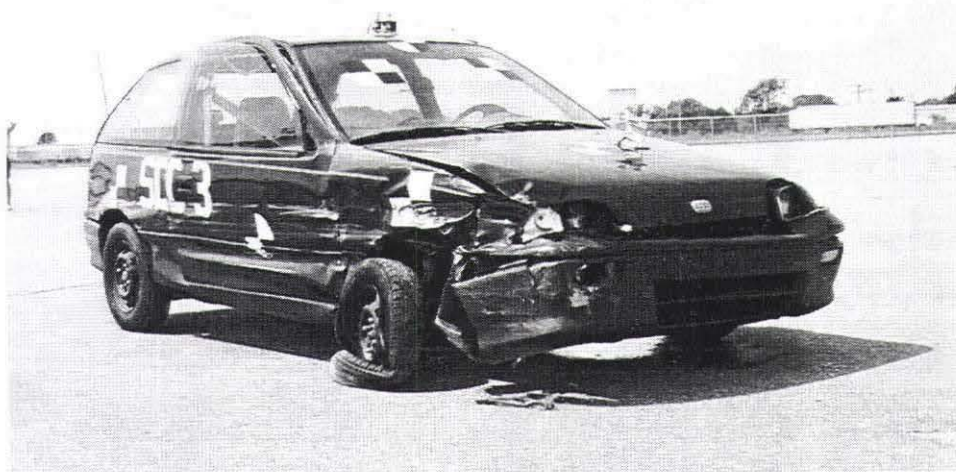
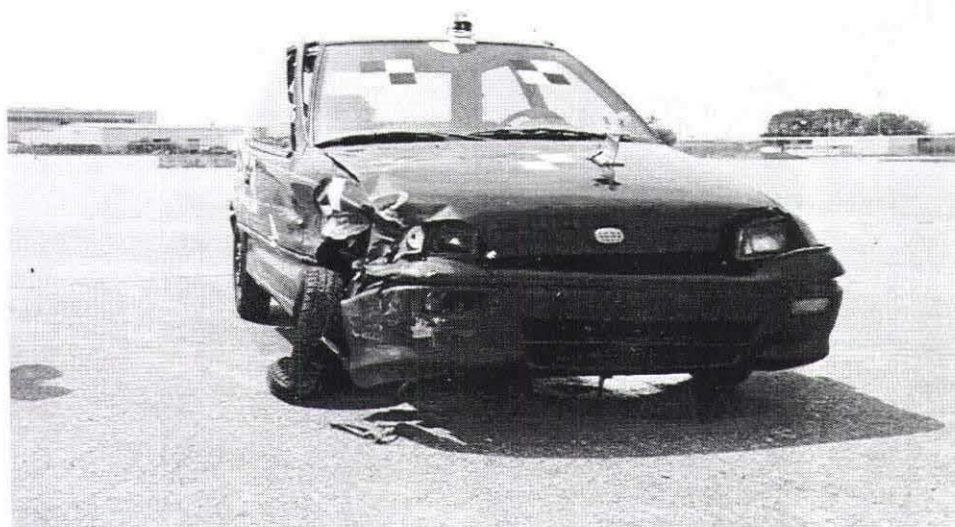
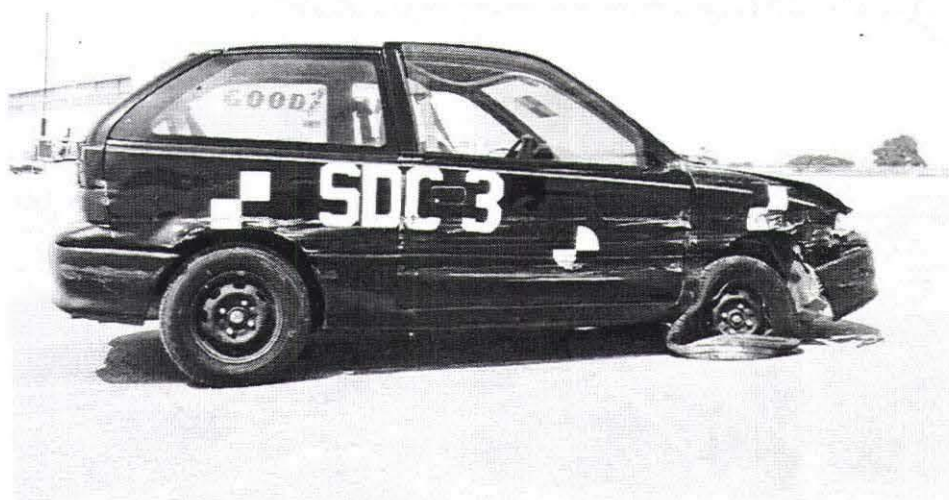
Figure 48. Vehicle Damage, Test SDC-3

Exterior vehicle damage was moderate and occurred at several body locations, as shown in Figure 48. The vehicle's front end and hood, right-front bumper, and right-front quarter panel were crushed inward toward the engine compartment due to contact with the barrier. The right-front tire was deflated while the steel rim was deformed. Evidence of vehicle-rail interlock was also found from the front end to the midpoint of the rear quarter panel. Minor deformations were found on the right-side floorboard and firewall of the occupant compartment.
