VOLUME: 1

DATE: JANUARY 14, 2025

# INCIDENT REPORTS

EVENTS REPORTED TO THE CSB UNDER THE ACCIDENTAL RELEASE REPORTING RULE

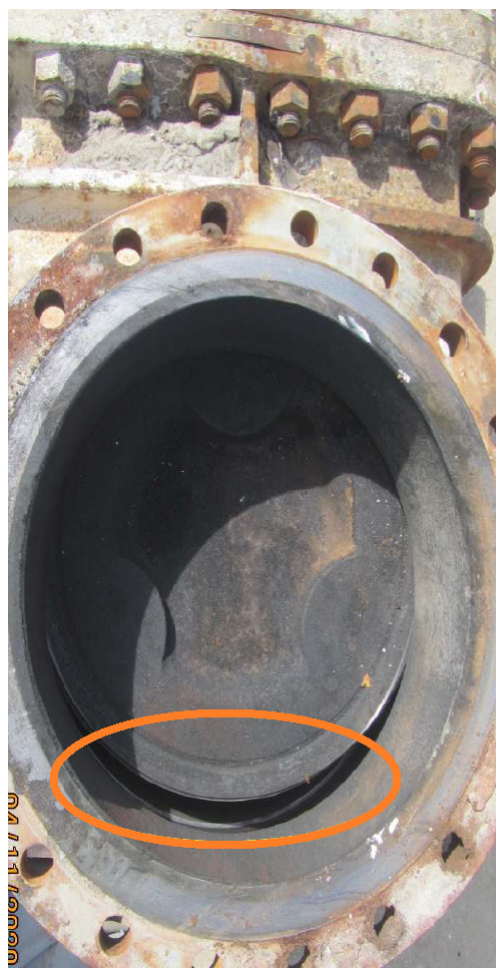
The hazard of closing the outlet valve instead of closing one of the inlet valves was not recognized. Although the two 6-inch inlet valves were designed for high-pressure conditions—2,470 pounds per square inch (psi), the 20-inch outlet valve to the flare system was rated for just 275 psi. Closing the 20-inch outlet valve would subject this valve to about 2,100 psi of pressure from the flammable vapor flowing from the cold separator, much greater than the valve's 275 psi pressure rating.

When the operations team had the outlet valve about 90 percent closed (**Figure 2**), the valve failed—releasing a high-pressure mixture of hydrogen and hydrocarbon vapor into the surrounding air. The flammable gas formed a vapor cloud, which ignited resulting in the explosion and fire.

Based on Valero's investigation, the CSB determined that the probable cause of the accidental release, explosion, and fire was the closure of the 20-inch manual isolation outlet valve (located downstream of the emergency pressure-relief valve) instead of one of the two inlet (upstream) 6-inch isolation valves that were rated for the high-pressure condition.

**Figure 2.** Nearly closed outlet valve.  
(Credit: Valero Meraux Refinery, modified by CSB)

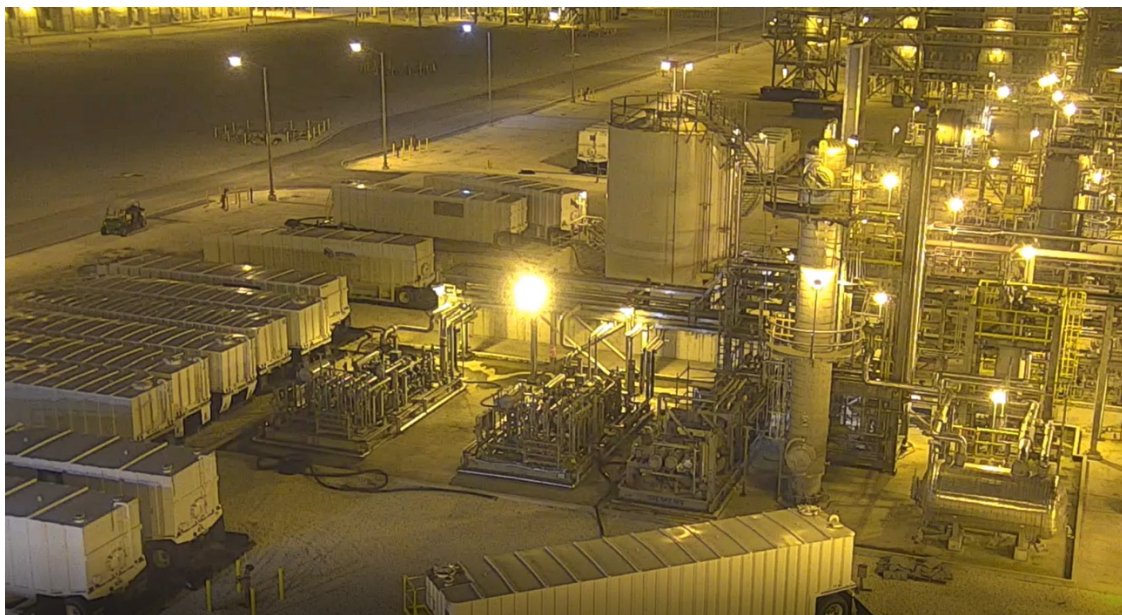
**Figure 1.** Spent Caustic Storage and Handling Equipment at the LACC Facility. (Credit: LACC)

When the operator opened the valve at the frac tank, pressurized fluid in the chemical hose flowed into the tank, erupting spent caustic from the unsecured top hatch (manway) and splashing the corrosive liquid onto the operator. The operator's personal protective equipment (PPE) did not protect from caustic liquid exposure. It took the operator about two minutes to reach the closest plant safety shower to rinse off the corrosive liquid because there was no safety shower near the frac tank, despite the site requirement for a safety shower within 25 feet of the tank. The operator then went to the control room and reported the incident. Emergency responders transported the operator to a hospital, where she was admitted for treatment of chemical burns.

Based on LACC's investigation, the CSB determined that the probable cause of the spent caustic release was pressurized fluid flowing from a chemical hose into a nearly full frac tank of spent caustic with an unsecured top hatch (manway). Contributing to the incident was the company's use of these frac tanks to address a short-term reliability issue with LACC's oxidizing reactor. Reliability problems with the oxidizing reactor resulted in the continual use of these frac tanks.

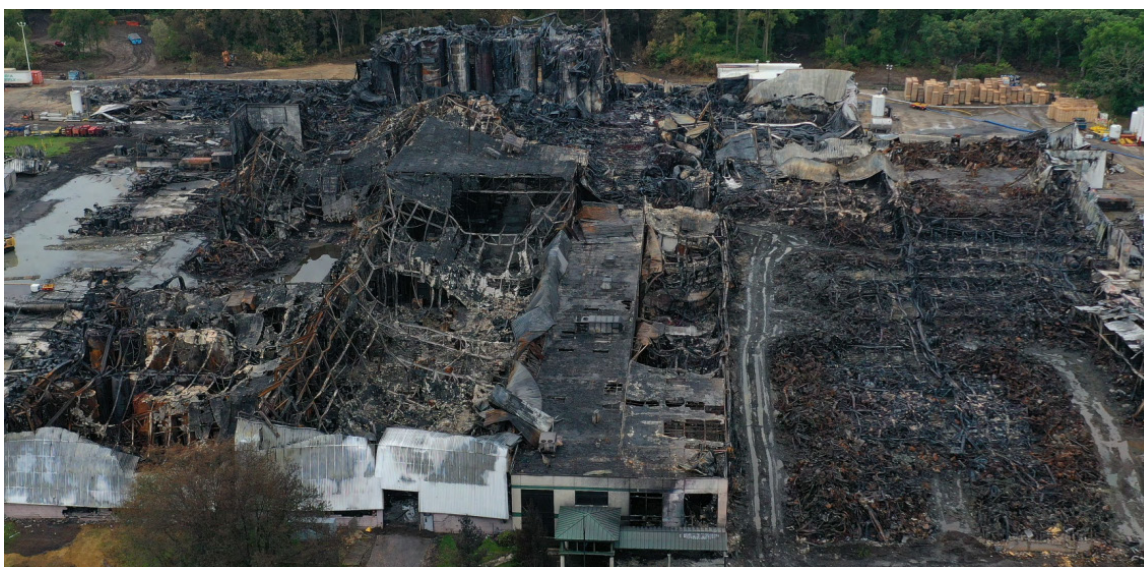
On June 14, 2021, at approximately 6:50 a.m., an accidental release of mineral oil occurred at Lubrizol's Chemtool facility in Rockton, Illinois. The mineral oil ignited and caused a fire. The event resulted in \$380 million in property damage and the permanent closure of the Chemtool facility (**Figure 1**). Before the incident, Chemtool employed approximately 200 people.

**Figure 1.** Damages After the Fire at Chemtool. (Credit: Chemtool)

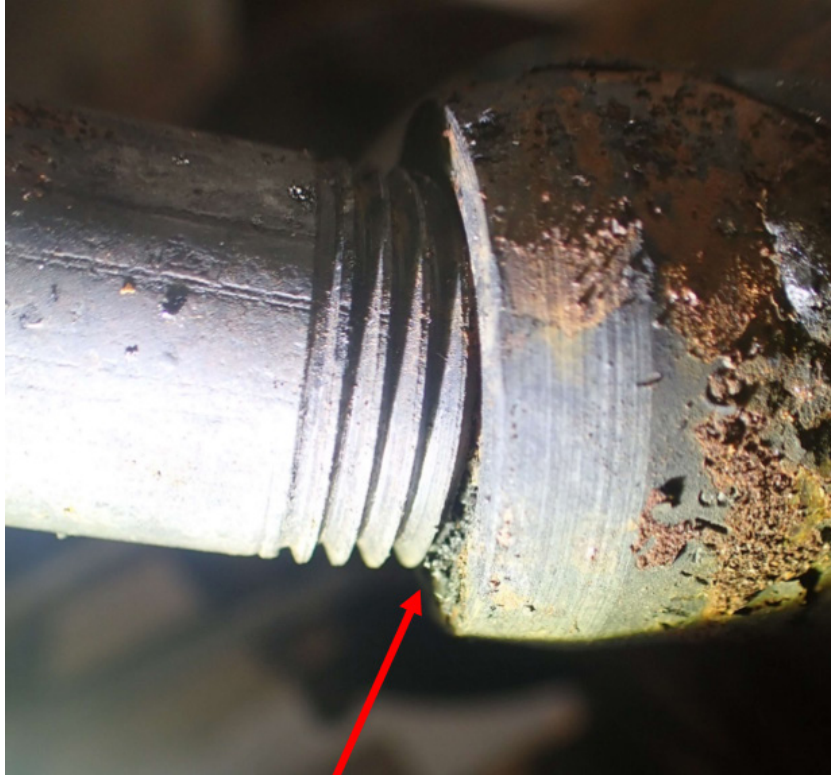
After the guardrail impacted the piping, a leak formed at the ½-inch threaded connection to the four-inch piping (**Figure 2**). The hot mineral oil, which was over 500 degrees Fahrenheit, was released as an aerosol. The mineral oil formed a white cloud and created the electrostatic conditions that most likely ignited the mineral oil.

**Figure 2.** Damaged Mineral Oil Piping. (Credit: Chemtool)

Based on Chemtool's investigation, the CSB determined that the probable cause of the mineral oil release was piping damage that resulted from force applied by the scissor lift. The flammable mineral oil was most likely ignited by static electricity. The hot oil system did not allow for the remote isolation of the damaged piping. Had Chemtool been able to stop the flow of mineral oil through remote isolation from a safe location, the incident could have been less severe.

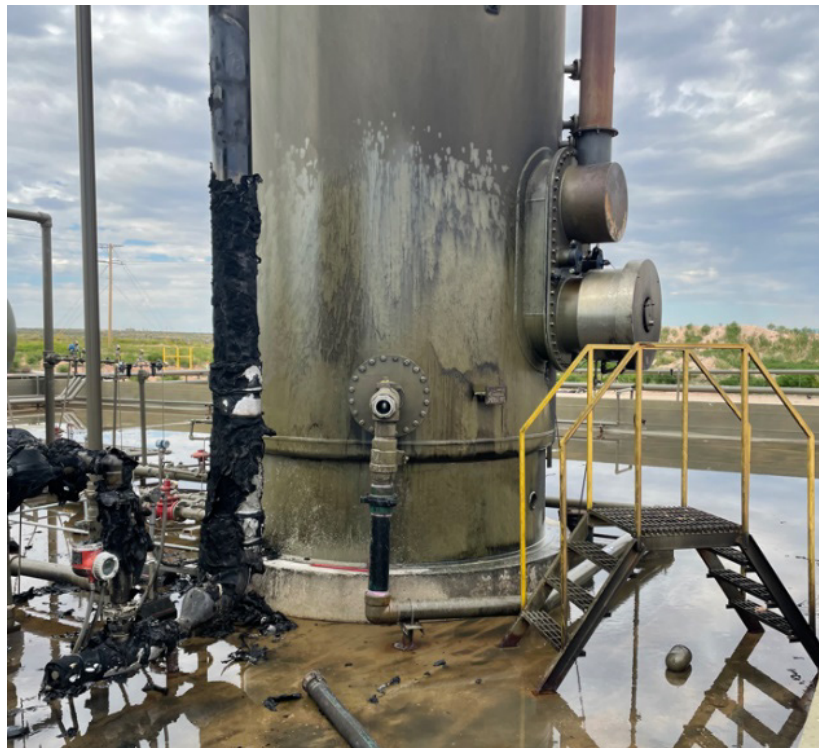
An emulsion layer periodically developed at the oil and water interface within the heater treater (**Figure 1**) at the Craig State 36B facility and grew thicker over time. The presence of the emulsion layer impaired the heater treater's efficiency. To address this problem, ConocoPhillips periodically removed the emulsion layer by transferring fluids from the heater treater to a vacuum truck.

**Figure 1.** Damaged Heater Treater After the Fire at ConocoPhillips.  
(Credit: ConocoPhillips)

The company's investigation concluded that the fired heater treater components may have been the ignition source. The heater treater burner was inadvertently left online during the vacuum truck loading operation. ConocoPhillips' investigation team did not eliminate static electricity as the potential ignition source because the hose components were non-conductive, and the truck was not electrically bonded or grounded.

Based on ConocoPhillips' investigation and CSB interviews, the CSB determined that the probable cause of the accidental release of flammable hydrocarbon vapor was disconnecting the hose while it contained hydrocarbon material and the truck's isolation valve was open. A component of the fired heater treater likely ignited the flammable vapor.

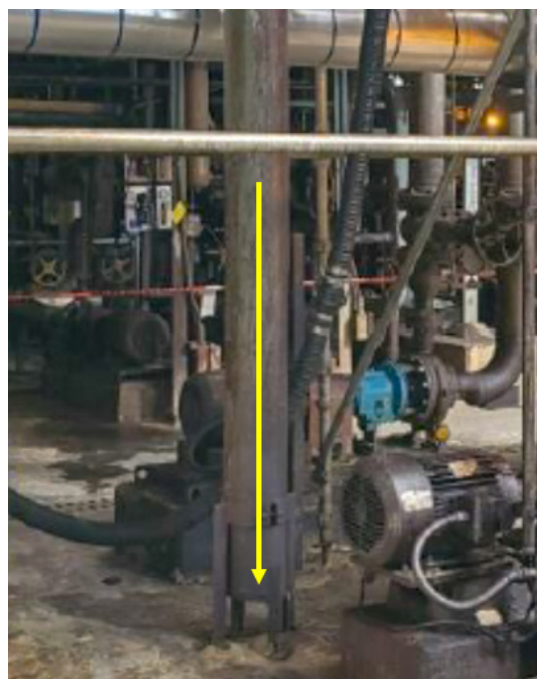
When the rupture disc activated, a 400-degree Fahrenheit mixture of liquid and vapor MDI discharged into 8-inch piping that was vertically orientated downward and ended about eight inches above the concrete floor (**Figure 1**). At the time of the incident, non-essential workers were not restricted from the area near the rupture disc discharge piping because the system was operating within the safe operating limits.

**Figure 1.** Rupture Disc Discharge Piping.  
(Credit: Rubicon with annotation by CSB)

Based on Rubicon’s investigation, the CSB determined that the probable cause of the MDI release was the activation of an emergency pressure-relief device (rupture disc). The design of the pressure-relief system, which discharged the hot MDI near workers, contributed to the severity of the incident. Had Rubicon ensured that the pressure-relief system discharged the MDI to a safe location, the incident could have been prevented.

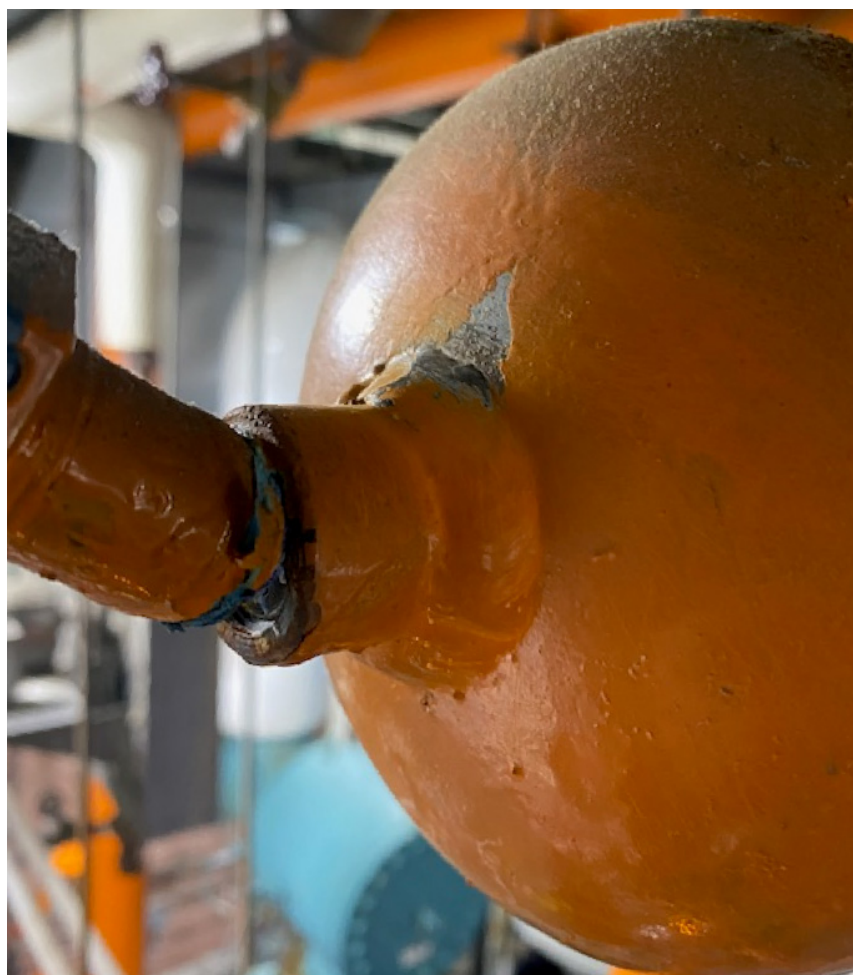
HMF had hired a contractor to install an electrical (ceiling-mounted) heater to replace an existing leaking steam heater that provided comfort heating inside the facility’s ammonia refrigeration room. The work plan included using a scissor lift to access the installation area. At the time of the incident, two contract workers were on the scissor lift to install the electric heater. While the scissor lift was in an elevated position, the lift was moved forward and then upward, impacting an ammonia refrigeration system valve (Figure 1).

Figure 1. Damaged Ammonia Piping. (Credit: HMF)

After the scissor lift impacted the piping, a leak formed at the partially severed ½-inch threaded piping connection to the larger ammonia system piping. The anhydrous ammonia was released as a vapor and engulfed the workers. Contractor 1, who was directly in front of the damaged piping, was unable to escape and was fatally injured by the release. Contractor 2, who was further away from the point of release, jumped over the lift's guardrail to escape from the area.

Based on HMF's investigation, the CSB determined that the probable cause of the anhydrous ammonia release was piping damage caused by the force applied by the scissor lift.

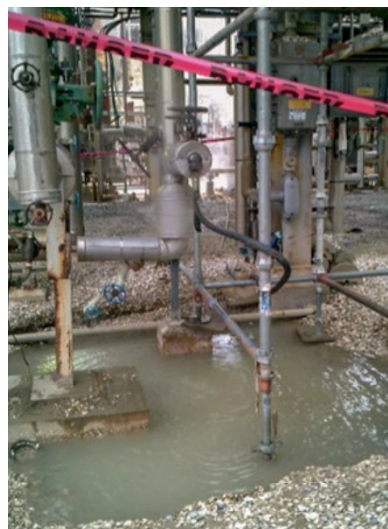
At 10:46 p.m., the control board operator observed a low boiler feedwater pressure alarm and requested an outside operator to investigate. Personnel identified that the boiler feedwater piping was the source of the low-pressure alarm and, realizing there was a leak, closed an upstream valve to stop the leak. Dow reported that 670 gallons of hot water were released. At about 11:45 p.m., an outside operator attempted to close the two open bleed valves and inadvertently stepped into a pool of the hot boiler feedwater that had accumulated in a depression (**Figure 1**). The high-pressure boiler feedwater release may have created or enlarged this hole. The operator was seriously injured when his lower leg was submerged in the hot water above the top of his rubber boot, and the hot water contacted his lower leg and foot.

**Figure 1.** Pool of Hot Water.  
(Credit: Dow)

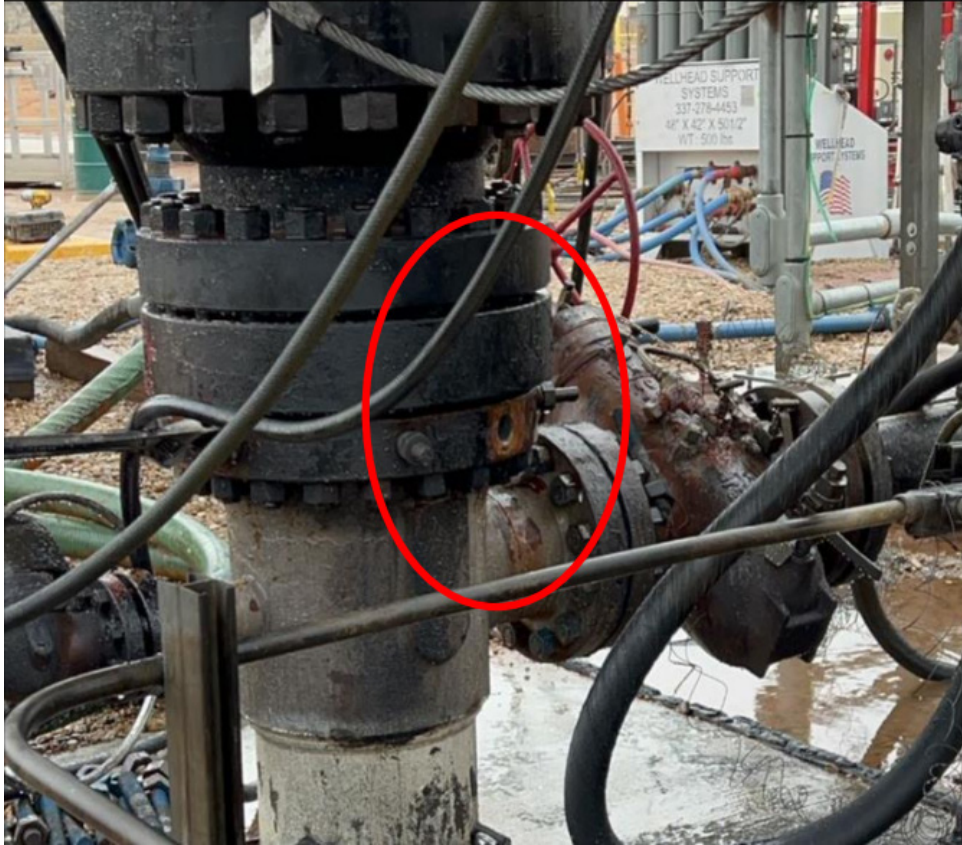
**Figure 2.** Assembly where lockdown screw was removed. (Credit: Phillips 66)

Cavern seals were in place for the maintenance work, which prevented any release from the cavern itself. When the lockdown pin was removed, the residual natural gas liquid was released from the hydraulic workover unit, referred to as a “snubbing unit,” which was being used for the maintenance operation. The pressure in the snubbing unit at the time of the incident was 400 pounds per square inch gauge.

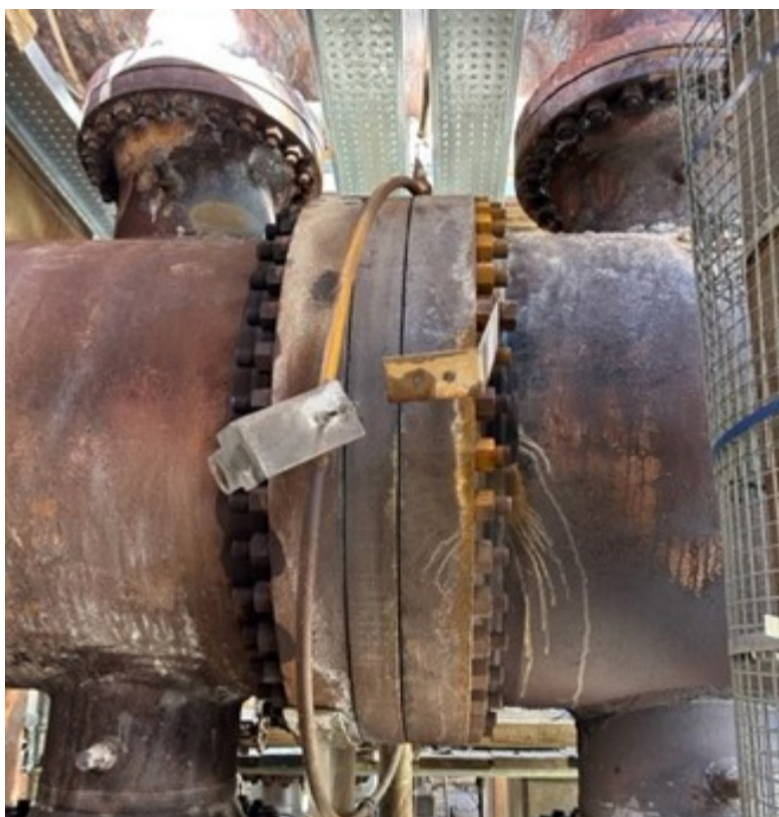
The hydrogen release originated from the flange between the heat exchanger channel and shell and occurred during unit startup (**Figure 1**). The heat exchanger was assembled in 2013 and had undergone 43 thermal cycles. During that time, the bolts had relaxed (a normal event) but had relaxed to the point that the flange could no longer contain the hydrogen within the heat exchanger. CITGO’s investigation found that the bolt torque value used to assemble the heat exchanger in 2013 was too low and should have been much higher to prevent leakage.

**Figure 1.** The Flange Where the Leak Occurred. (Credit: CITGO)

CITGO found that the assembly instructions for both the incident heat exchanger and a nearby similar heat exchanger listed incorrect torque values that were too low, as the instructions listed the wrong bolt sizes. In addition, CITGO suspected that since it is common practice at the site to assemble similar flanges to similar torque values, the incorrect torque instructions from the nearby heat exchanger may

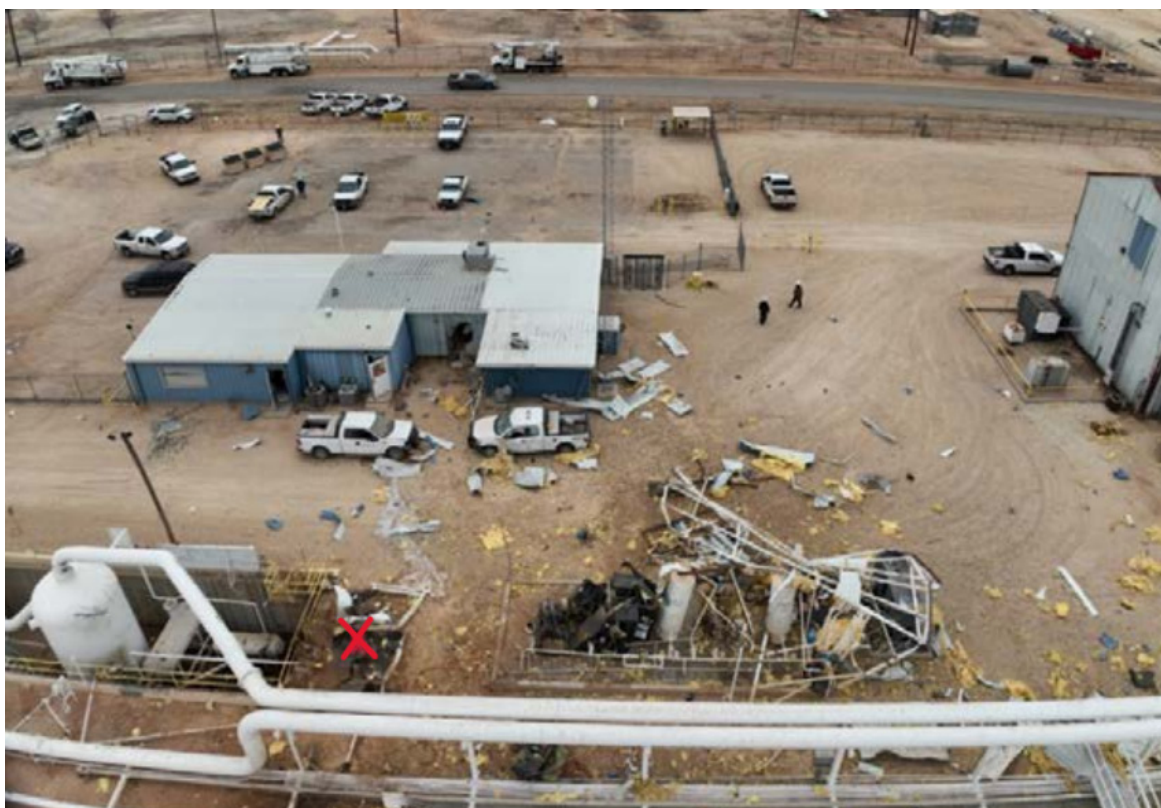
On January 31, 2023, at 6:40 a.m., an accidental release of high-pressure carbon dioxide (CO<sub>2</sub>) occurred when a vessel overpressured and catastrophically ruptured at a Kinder Morgan CO<sub>2</sub> gas plant in Snyder, Texas. Vessel fragments propelled up to 1,200 feet away and heavily damaged a control room (**Figure 1**). Kinder Morgan estimated the property damage to be over \$14 million.

**Figure 1.** Aftermath of vessel overpressure, vessel location marked with red 'X.' (Credit: Kinder Morgan, annotated by CSB)

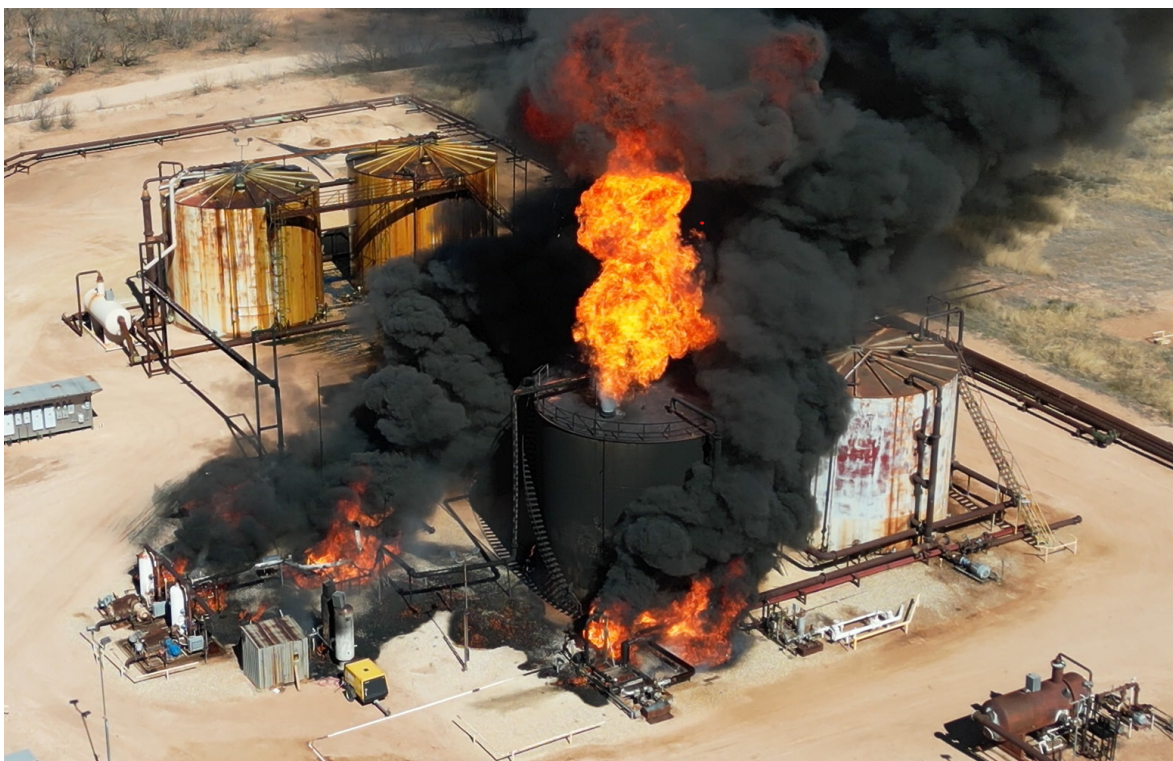
On February 11, 2023, shortly before 1:00 p.m., a pump failure released hydrocarbons (primarily crude oil) and nitrogen oxide at a Kinder Morgan crude oil production facility in Snyder, Texas. The crude oil released from the failed pump ignited, causing a fire that damaged nearby equipment and led to additional material releases (**Figure 1**). Kinder Morgan estimated the property damage from the incident to be about \$1.5 million.

**Figure 1.** Aerial view of the fire and equipment involved in the incident. (Credit: Kinder Morgan)

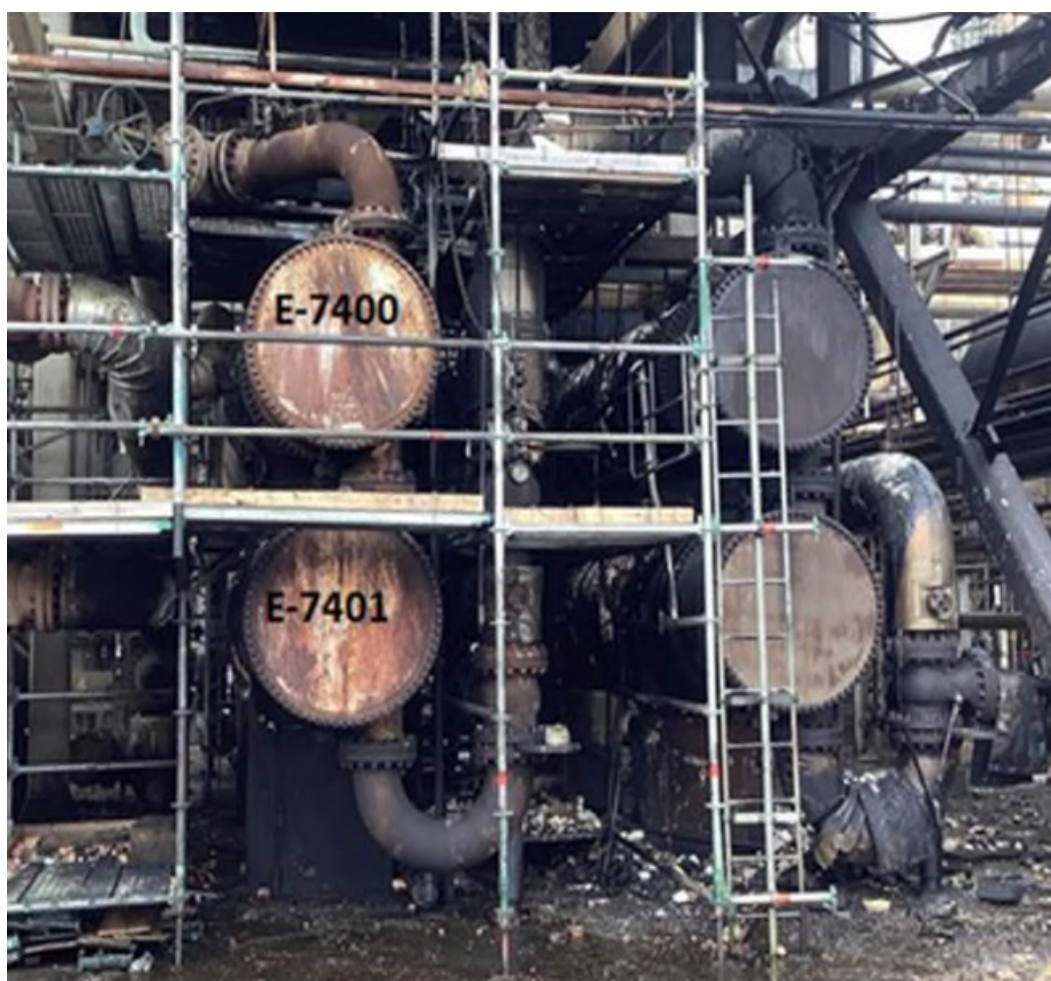
On February 23, 2023, at 8:15 p.m., an accidental release of approximately 164 pounds of hydrocarbons (pentane and heavier hydrocarbons) occurred at the PEMEX Deer Park Refinery (“Pemex”) in Deer Park, Texas. Deer Park Refining Limited Partnership operates this Pemex refinery. The hydrocarbons were released from an open bleed valve on a crude unit heat exchanger (E-7400) during startup (**Figure 1**). The hot hydrocarbons ignited (autoignition), causing a fire that damaged nearby equipment. Pemex estimated the property damage from the incident to be \$2.3 million.

**Figure 1.** Heat exchangers after the incident. (Credit: Pemex)

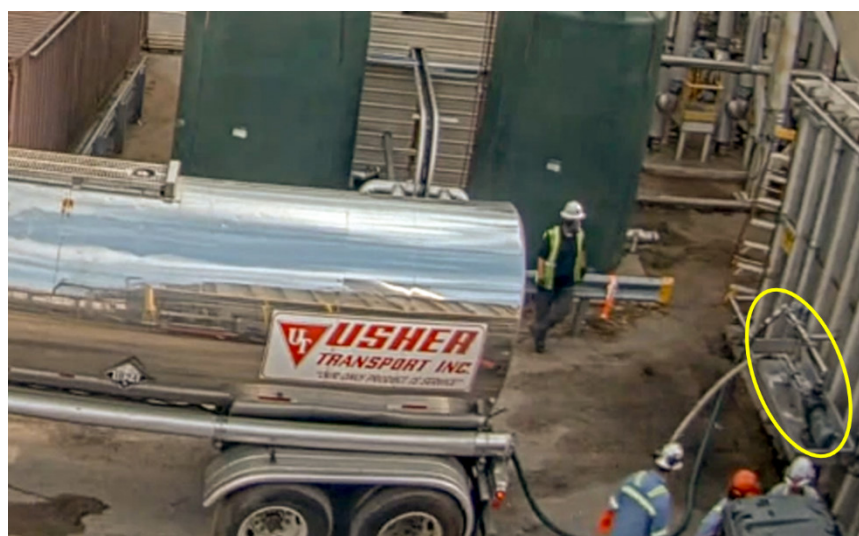
Before disassembling the pump, it was decided to flush it out with water from a fire hose (**Figure 1**). This action was taken to prevent employees from getting the caustic solution on their hands when the pump was disassembled. An employee connected a fire hose to the pump and partially opened the valve. The pump could not handle the pressure supplied by the firewater, and the plastic pump casing cracked. Caustic solution and water sprayed out of the pump, seriously injuring one employee.

**Figure 1.** Caustic Unloading Pump (yellow oval). (Credit: Georgia-Pacific)

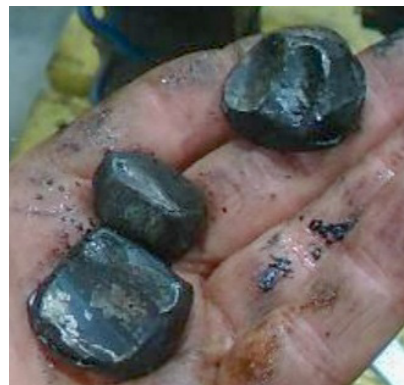
During the unit startup approximately five days before the incident, the pump (a centrifugal pump) had operated with low suction (inlet) pressure for nearly two hours due to a low liquid level in the upstream equipment. The low suction pressure caused the pump to cavitate, which vibrated the pump and damaged the pump’s bearings (**Figure 1**). Five days later, on March 14, the damaged bearings and the resulting stress on the pump’s mechanical seal caused the seal to fail. The hot hydrocarbons within the pump were released into the atmosphere and ignited, causing a fire. The material was released at 590 degrees Fahrenheit (°F) and had an autoignition temperature of 484 °F.

**Figure 1.** Damaged Pump Bearings. (Credit: Pemex)

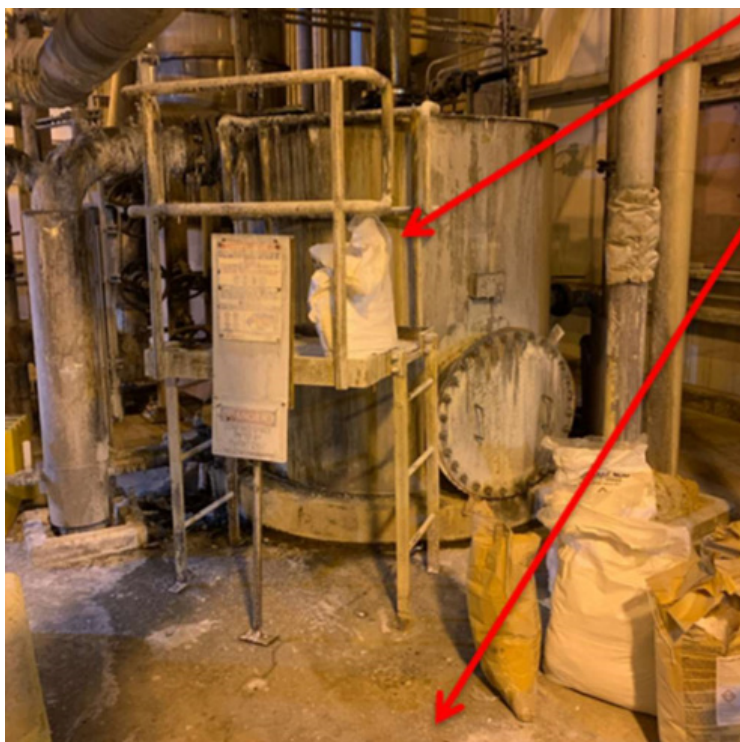
Operator 1, who was standing directly over the tank opening (**Figure 1**), lost consciousness from exposure to the hydrogen sulfide gas that evolved from the tank. Operator 3 was able to call for help over the plant radio system but lost consciousness soon after. Operator 2 was seriously injured after losing consciousness (while trying to help Operator 1), falling to the floor, rolling through a guardrail system, and falling about 11 feet to a lower area of the structure.

**Figure 1.** The Tank. The red arrows show the approximate locations of two of the operators. (Credit: Domtar)

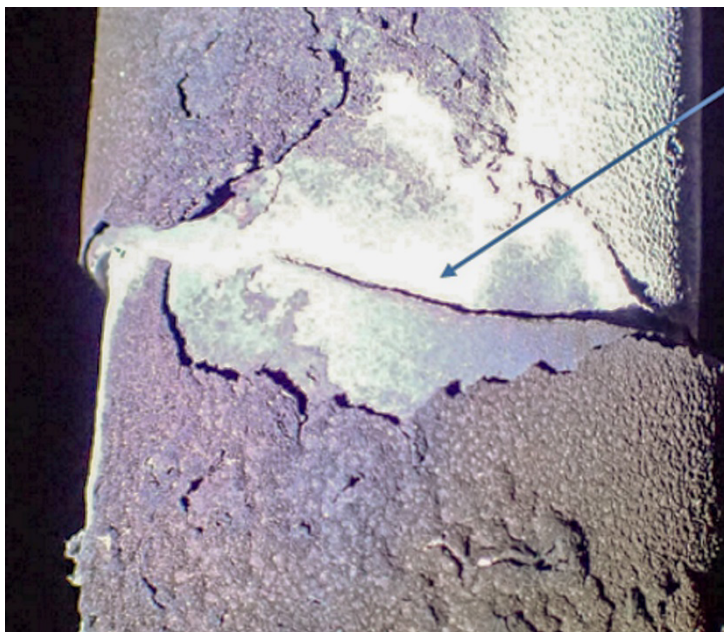
FHR determined that the accidental release resulted from a ruptured tube within the waste heat boiler of the sulfur recovery reaction furnace (**Figure 2**). The tube rupture was caused by a damage mechanism known as sulfidation corrosion (also known as high-temperature sulfidic corrosion). Under certain temperature conditions, sulfidation corrosion causes thinning in iron-containing materials over time due to a reaction between sulfur compounds and iron.

**Figure 2:** Ruptured Tube. (Credit: FHR)

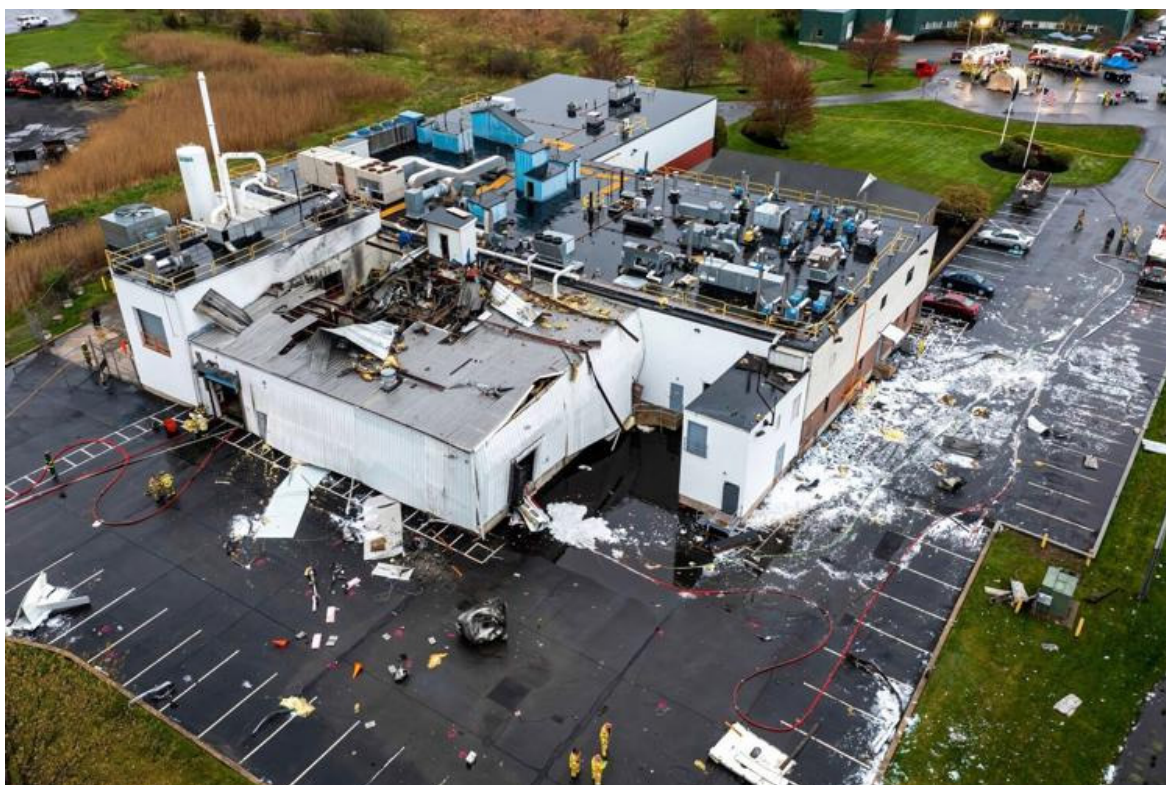
On May 4, 2023, at about 12:40 a.m., a pressure Nutsche filter vessel (“vessel”) exploded at the Polycarbon Industries, Inc. (“PCI”) facility in Newburyport, Massachusetts. The explosion and fire fatally injured one PCI operator and caused approximately \$48 million in loss from property damage, which led to the permanent closure of the facility (**Figure 1**).

**Figure 1.** Damages After Explosion at PCI. (Credit: The Salem News)

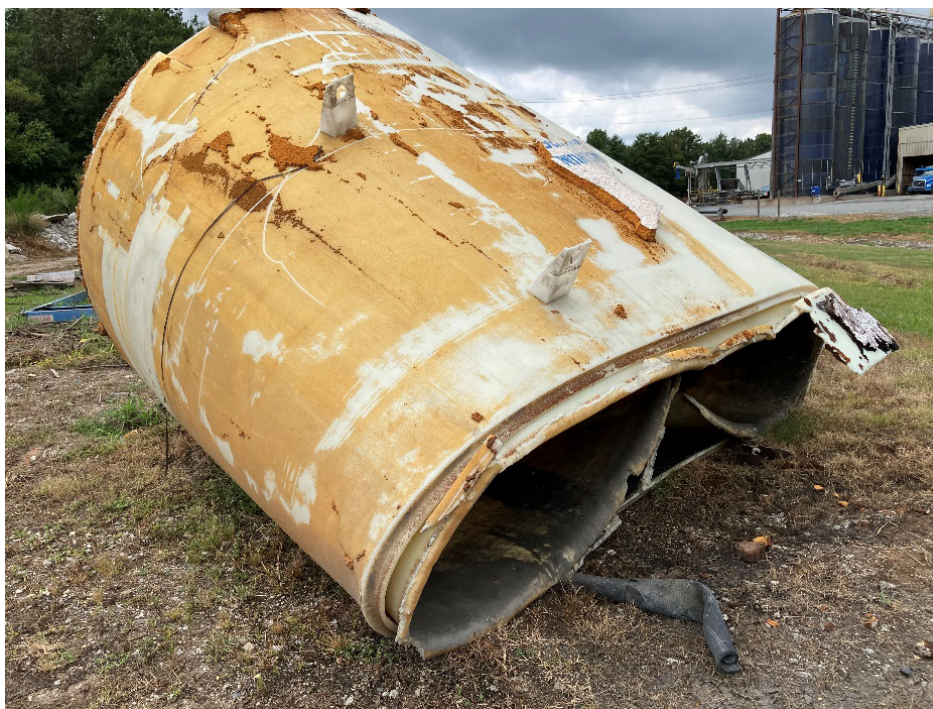
Darling’s investigation appeared to focus on the incorrect reaction rather than a reaction scenario consistent with the available evidence. Darling’s research materials pointed to the reaction between sulfuric acid and aluminum metal that generated hydrogen gas. The company concluded that the hydrogen gas was released at its autoignition temperature (over 1,000 degrees Fahrenheit (°F)) and ignited, triggering an explosion. Post-incident photographs of the damaged tank do not appear to support a scenario where the internal tank temperature reached 1,000 °F, however (**Figure 1**). The melting temperature of the polyethylene is approximately 260 °F. Therefore, the company’s reaction scenario appears inconsistent with the available evidence.

**Figure 1.** Ruptured Polyethylene Tank at Darling. (Credit: Darling)

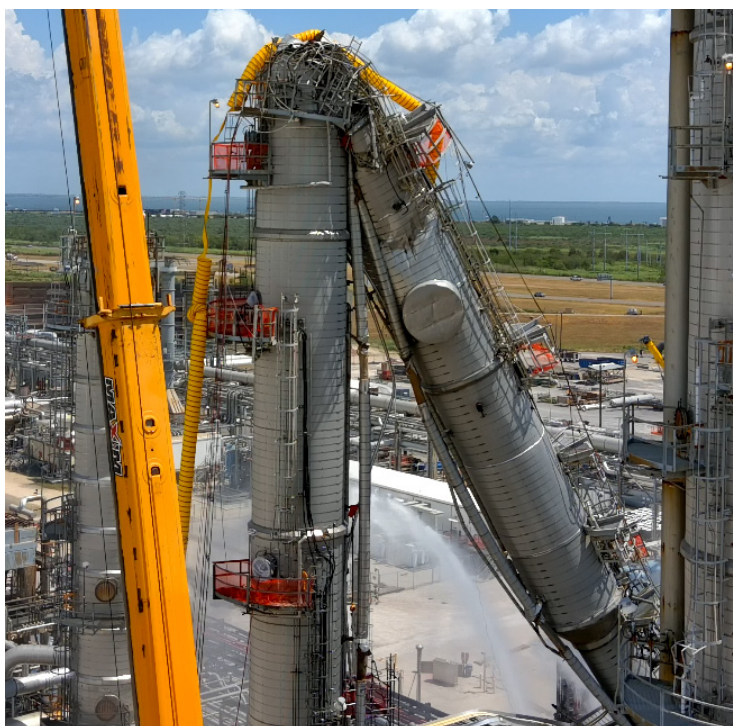
On September 5, 2023, at 11:50 a.m., a distillation tower (“Tower”) collapsed (**Figure 1**) at the BASF TOTALEnergies Petrochemical, LLC (“BTP”) facility in Port Arthur, Texas. The collapse was the result of a fire inside the distillation tower. The incident resulted in approximately \$194 million in property damage.

**Figure 1.** Collapsed Distillation Tower at BTP. (Credit: BTP)
