VOLUME: 2

DATE: MARCH 12, 2025

# INCIDENT REPORTS

EVENTS REPORTED TO THE CSB UNDER THE ACCIDENTAL RELEASE REPORTING RULE

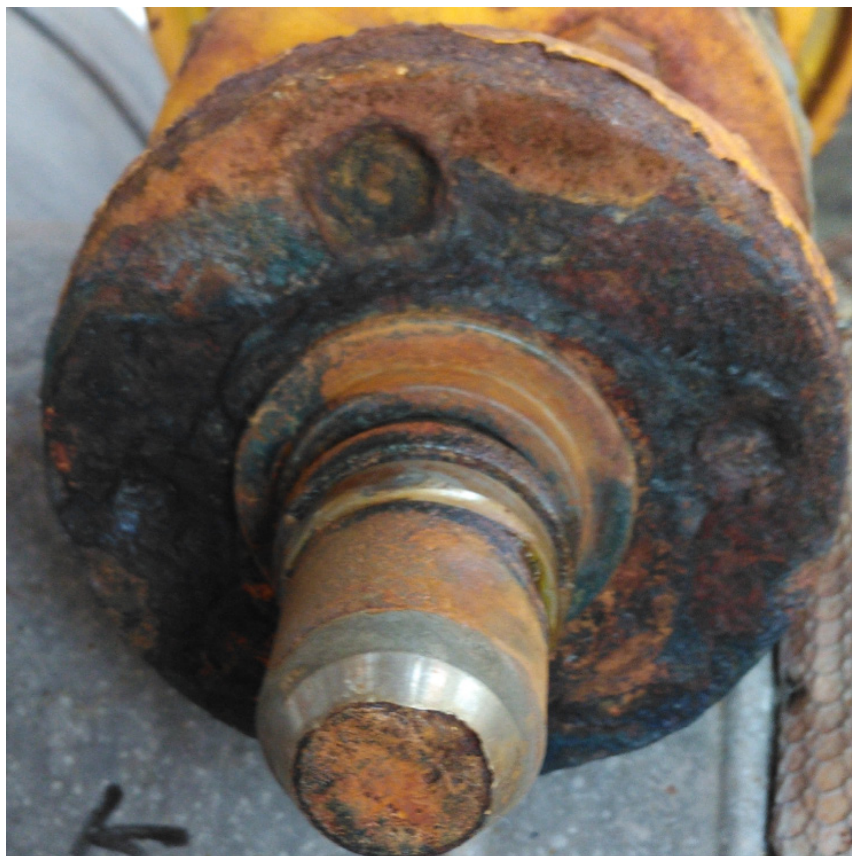
BASF's investigation found that the drain valve was severely corroded. Over time, chlorine being released from the drain valve had reacted with condensed water that had accumulated in the piping system's insulation blanket, creating hydrochloric acid that had corroded the valve and deteriorated the bolts in the valve's bonnet (**Figure 1**). After the incident, BASF discovered that three other valves were similarly corroded.

**Figure 1.** Corroded drain valve's bonnet and bolts. (Credit: BASF)

Based on BASF's investigation, the CSB determined that the probable cause of the incident was the catastrophic failure of corroded bolts in the drain valve's bonnet. The corrosion was caused by prolonged exposure to hydrochloric acid, created by the reaction between chlorine and condensed water.

Contributing to the incident was BASF's mechanical integrity program. Had BASF inspected the valve before authorizing this job, the extent of the corrosion could have been identified, and a shutdown could have been initiated to replace the drain valve instead of attempts to repair it. Contributing to the severity of the incident was BASF's respiratory protection program, which did not ensure its workers could effectively transition to the escape bottle during an emergency. Had BASF effectively trained its workers to switch to their escape bottles during an emergency, the employee should have not been exposed to the chlorine.

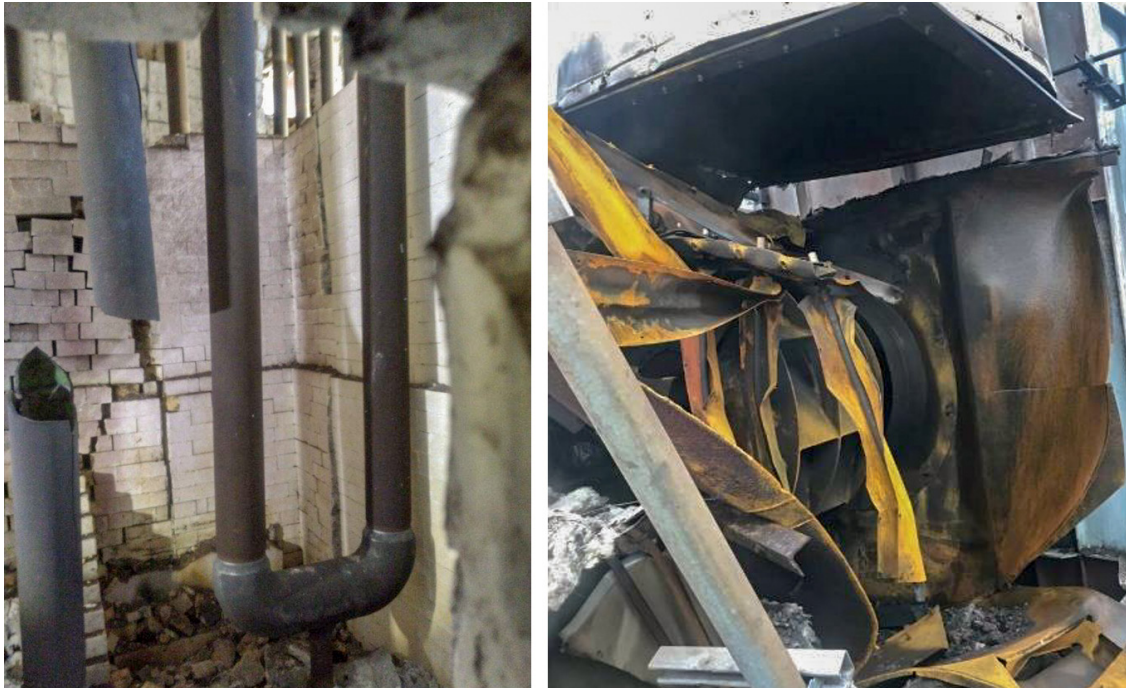
Chevron Phillips’ investigation revealed that further utility upsets caused the facility to stop all fuel gas supply and fully shut down the remaining fired heaters. During the shutdown, a valve between one of the ethylene unit’s fired heaters and downstream equipment remained open. The open valve allowed downstream flammable hydrogen and hydrocarbon gas to flow backward into the fired heater tubes. Approximately 30 minutes after this happened, a tube within the fired heater ruptured, allowing the flammable gas to enter the firebox. The gas accumulated, ignited, and exploded, causing extensive damage to the fired heater (**Figure 2**).

**Figure 5.** Fired heater explosion damage. The left image shows the broken tube and walls, and the right image shows a fan. (Credit: Chevron Phillips)

Chevron Phillips' investigation determined that the tube failure likely occurred because the fired heater tubes were shut down without decoking. Coke fouling can insulate the tube surface, resulting in local hotspots and increasing the risk of thermal shock and tube failure in fired heaters. These conditions stressed the tube's walls when the metal cooled faster than the internal coke, breaking the tube. Chevron Phillips' investigation concluded that hot insulation inside the firebox likely ignited the gas (autoignition).

Based on Chevron Phillips's investigation, the CSB determined that the probable cause of the incident was a fired heater tube failure from thermal stress due to the rapid shutdown. When the tube broke, a hydrogen and hydrocarbon gas mixture from downstream equipment flowed into the firebox. Hot insulation within the firebox likely ignited the flammable gas, resulting in an explosion. Inadequate winterization of multiple valves, instruments, and control systems contributed to the incident.

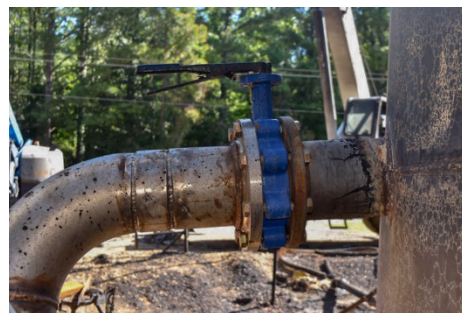
Red Hancock’s investigation found that although most of the liquid was removed from the two tanks that were not replaced, some salt water, residual hydrocarbon material, and air remained inside these tanks. At the time of the incident, seven Red Hancock employees were completing the tank replacement work, which included installing an elevated walkway between the tanks and finishing piping and structural connections. While welding piping between the two middle tanks, one of the employees opened a valve (**Figure 2**) to the older tank that contained residual crude condensate material, likely releasing some hydrocarbon vapors into the new piping being welded. The flammable vapor ignited, and flames traveled back into the

**Figure 2.** Open valve between new piping (left) and an old tank (right). (Credit: Red Hancock)

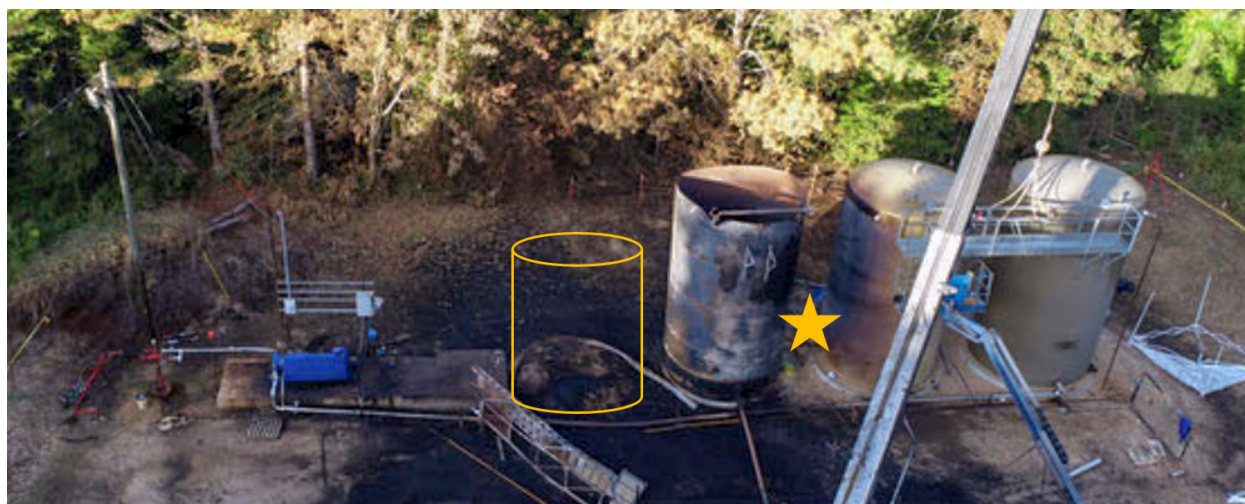
tank, resulting in an explosion and fire that ejected the top of the tank. In addition, the blast launched and forcefully propelled an adjacent tank approximately 80 feet into the woods (Figure 3).

**Figure 3.** This post-incident photo shows the location of the welding activity that triggered the explosion (gold star) and the pre-incident location of the fourth tank, which was launched by the blast and propelled into the woods shown in the background. (Credit: Red Hancock with annotations by CSB)

Based on Red Hancock's and OSHA's investigations, the CSB determined that the probable cause of the incident was the presence of flammable vapors near a welding activity being performed. Not thoroughly draining, cleaning, and purging the tanks to remove the flammable material before starting construction contributed to the incident. Had the tanks been thoroughly drained, cleaned, and purged prior to the commencement of construction, this incident likely could have been prevented.

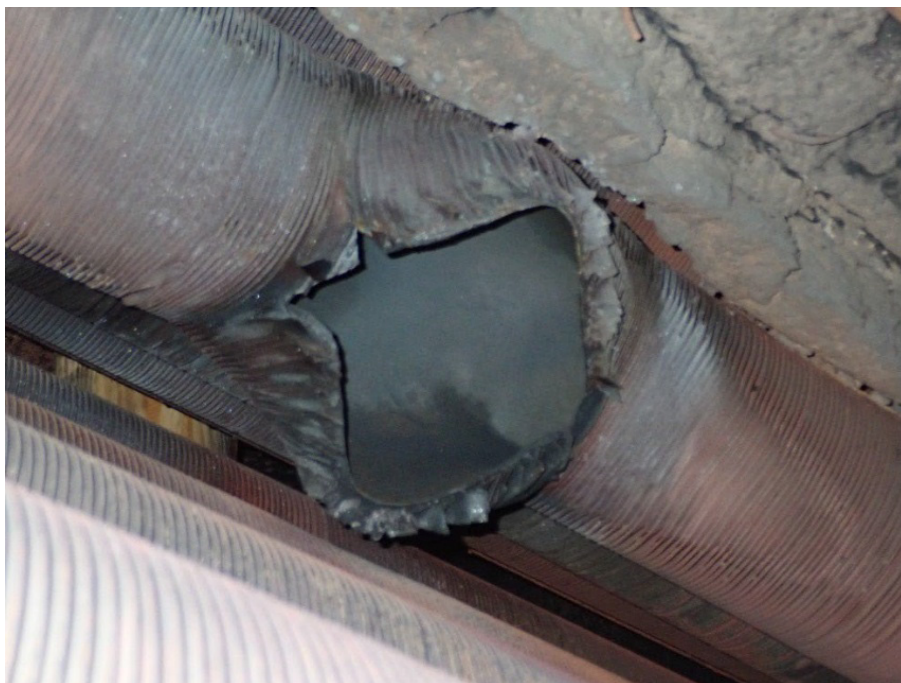
Valero's investigation of the incident found that without the fluid flowing through the fourth pass to remove heat, the tube's metal wall temperature reached 1,500 degrees Fahrenheit (°F), which exceeded the design temperature limit. After the operations supervisor noticed the high temperature, field operators were sent to inspect the heater tubes. The field operators reported that some tubes were "glowing red hot," and consequently they manually turned off two of the fired heater's eight burners. The field operators then reduced the flow through the first three passes to help drive feed material into the fourth pass. Although operators reported hearing material flowing in the fourth pass, the meter indicated no flow. The Valero operations team concluded that the flow meter was malfunctioning.

Less than an hour later, a convection section tube in the fourth pass ruptured due to short-term overheating (**Figure 2**), releasing a flammable mixture of hydrogen and hydrocarbons into the firebox. Flames from the gas-fired burners ignited the mixture, resulting in a large fire.

**Figure 7.** Ruptured fired heater tubing. (Credit: Valero)

Based on Valero’s investigation, the CSB determined that the probable cause of the incident was a ruptured fired heater tube from short-term overheating. Flames from the fired heater’s gas-fired burners ignited these flammable chemicals, resulting in the fire. The lack of automated safeguards that did not prevent the burners from being ignited before the minimum flow was established through each of the four tube passes contributed to the incident. Had Valero had such automated safeguards in place, this incident likely could have been prevented.

Additionally, Valero found that the fired heater lacked engineered safeguards to prevent the burners from being lit before establishing flow in each of the four passes. In response to the incident, Valero modified its automated burner controls to help ensure that the flow rate through every pass exceeds a predetermined minimum flow rate before operators can ignite a burner.

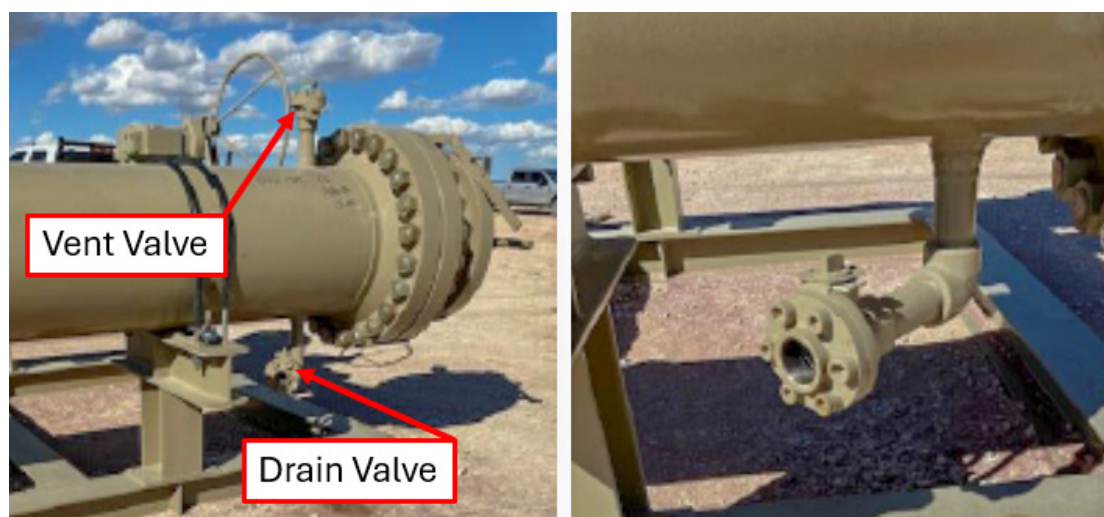
When the two workers went to remove the pig from the receiver, the pressure in the receiver was above 1,150 pounds per square inch (“psi”). To safely remove the pig, the pressure needed to be reduced by relieving it through a vent valve located at the top of the receiver. The contractor initially tried to remove the plug from the vent valve to relieve the pressure but found that the plug could not be removed with hand tools. This indicated that there could be pressure between the valve and the plug, forcing the threads tightly against each other. The contractor concluded that the vent valve might be leaking and decided to relieve the pressure inside the receiver using the drain valve instead, which was located at the bottom of the receiver (**Figure 1**).

**Figure 1.** Orientation of the vent valve and drain valve (left) and post-incident position of the drain piping after opening the valve (right). (Credit: XTO, edited by the CSB)

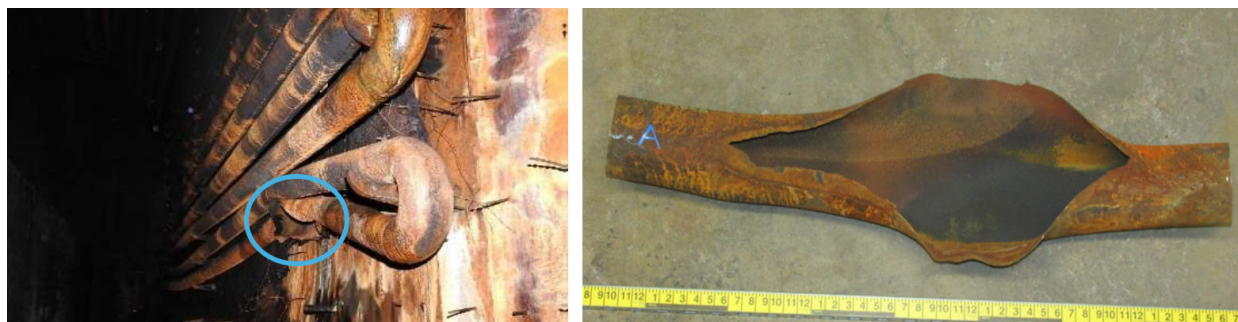
Delek's investigation identified that ambient temperatures at the facility dropped to 12 degrees Fahrenheit by 11:00 p.m. on the night of the incident. This cold weather caused operational issues with some instruments and controls, leading to low hydrocarbon flow through the tubes of a fired heater. The decreased flow resulted in reduced heat transfer, which likely caused the metal temperatures in the tubes to rise significantly. This high-temperature condition ultimately caused a tube to rupture (**Figure 2**), releasing flammable hydrocarbons into the firebox, where the existing burner flame ignited them. Delek commissioned a metallurgical examination and found that the tube ruptured due to creep damage (which results from prolonged exposure to stress at elevated temperatures) and short-term overheating.

**Figure 9.** The ruptured tube within the fired heater (left) and after removal (right). (Credit: Delek)

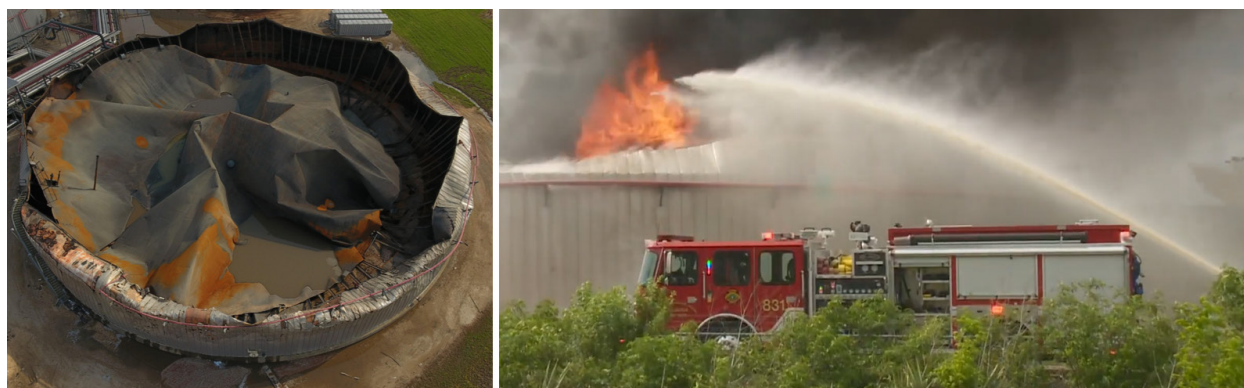
(Figure 2). Flammable hydrocarbon liquid burned in the tank for about nine hours before emergency responders extinguished the fire.

**Figure 13.** Post-incident photo of the damaged tank (left, Credit: IMTT) and the emergency response to the tank fire (right, Credit: WWL-TV).

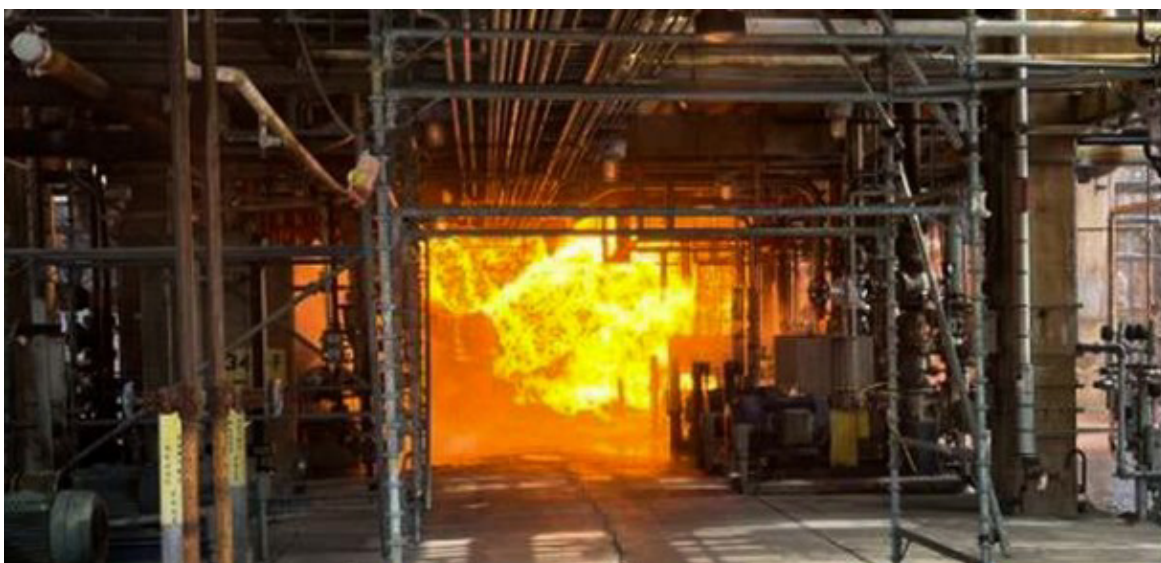
On the morning of the incident, two Marathon employees were completing an equipment oil change on an elevated platform above a pump that was supplying naphtha to downstream equipment. The pump’s coupling failed, reducing outlet flow and creating high vibration that broke a small bore ( $\frac{3}{4}$ -inch) piping section, releasing flammable naphtha. Employee 1 was on the platform cleaning up the work area while Employee 2 was carrying a bucket of oil down the stairs from the platform. Employee 2 smelled the released hydrocarbon and saw what looked like a steam cloud. Within minutes of the release, the flammable vapor ignited (**Figure 1**).

**Figure 14.** Fire from breached piping. (Credit: Marathon)

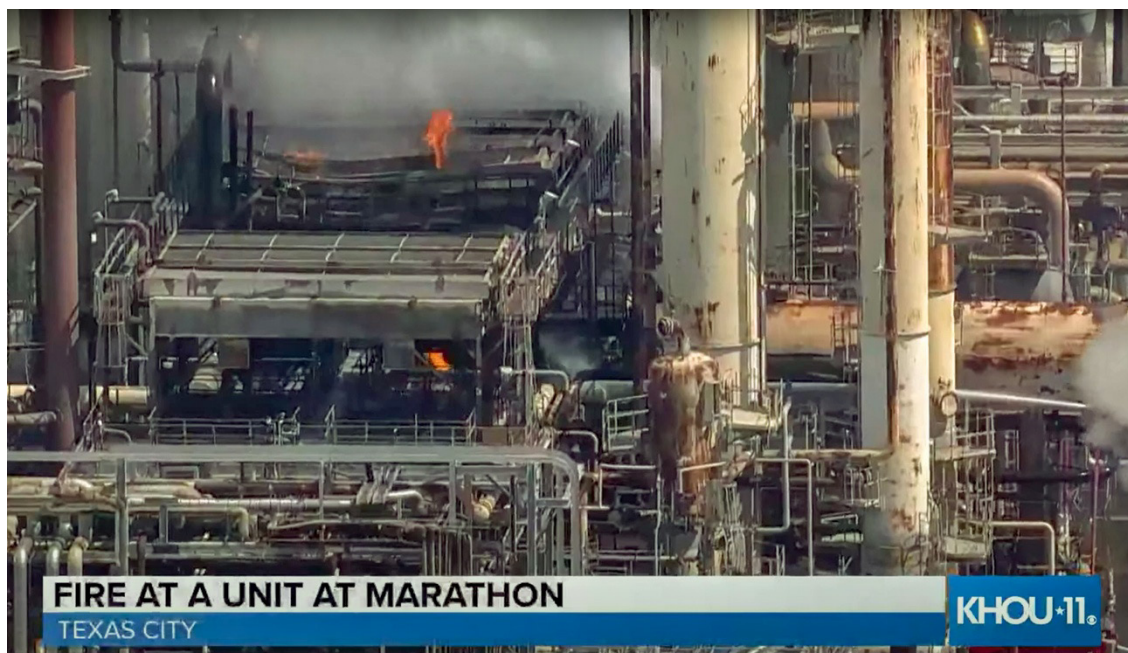
The heat from the fire ruptured piping and damaged other equipment (**Figure 2**). Employee 2 was able to exit the unit before the flammable naphtha ignited. Employee 1 did not escape from the elevated platform and was fatally injured by the fire.

**Figure 15.** Fire impacting elevated platforms. (Credit: KHOU 11 News)

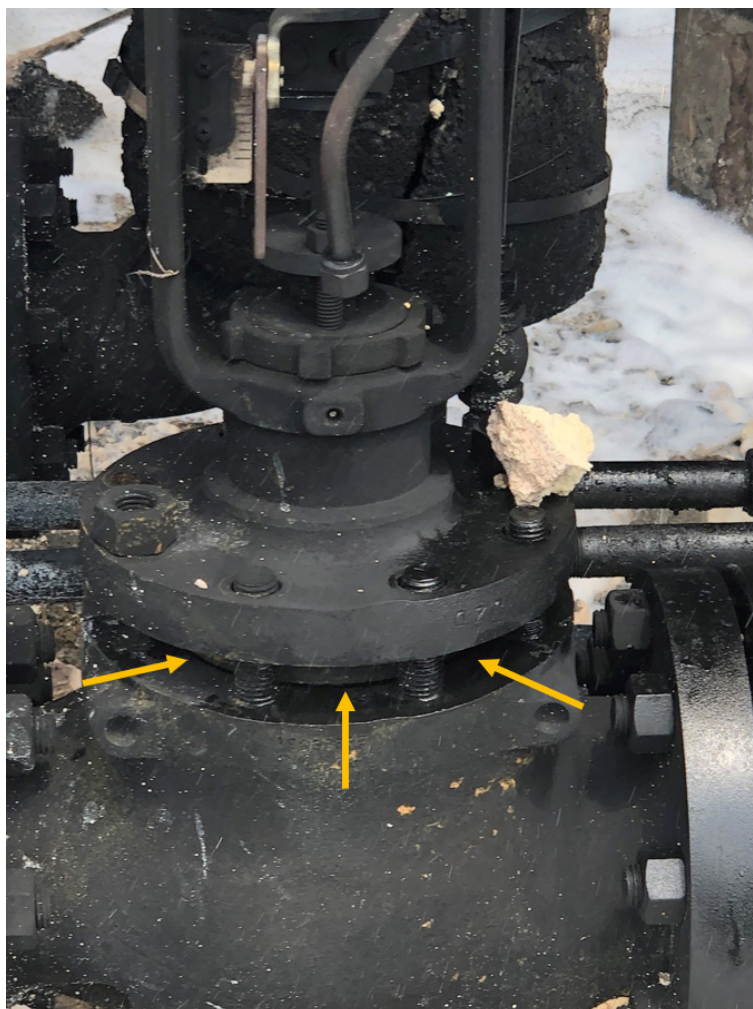
The investigation revealed that six of the eight nuts had been removed from the control valve's bonnet flange, which was the typical practice at the refinery when preparing to access the internal components. The control valve's bonnet flange had been partially disassembled while its downstream isolation valve was open, and it contained naphtha at 250 pounds per square inch gauge pressure and 425 degrees Fahrenheit. It is unknown whether the maintenance employees thought the system was safe to disassemble the control valve or did not recognize the hazard of disassembling the pressure-retaining components.

**Figure 2.** Naphtha release point (gold arrows). (Credit: CVR Energy with annotations by CSB)

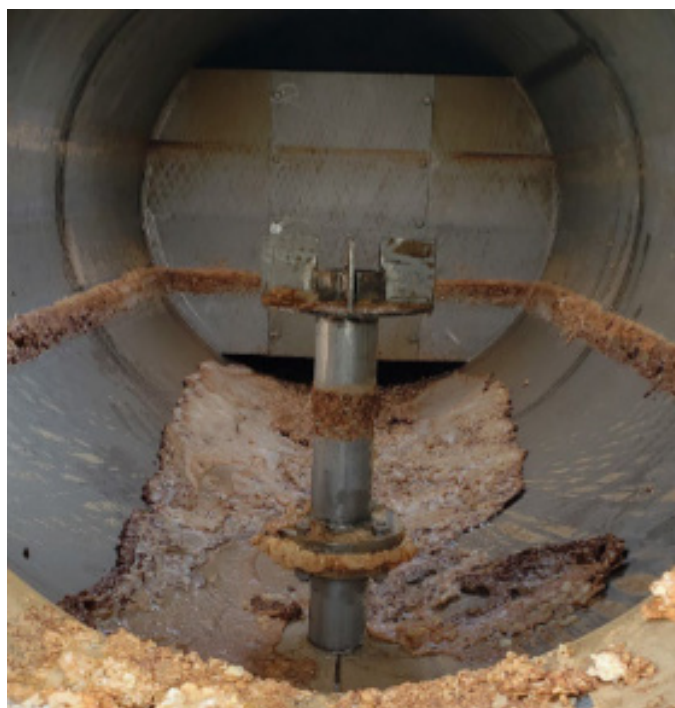
The incident occurred in SABIC’s latex production area during a maintenance shutdown. Employees were tasked with removing an internal part (a “baffle”) at the back of the horizontal tank (which was approximately five feet in diameter and nine feet in length). SABIC’s procedure stated that the tank should be cleaned using high-pressure water to remove any accumulated solids before entry. However, this procedure was not followed, and residual solids remained in the tank and potentially contained some butadiene (**Figure 1**). The work inside the tank disturbed these solids, which likely released about two pounds of butadiene vapor, creating a flammable atmosphere within a portion of the tank. In addition, while continual monitoring of the confined space was taking place during the entry, the end of the air monitor hose was not near the bottom of the tank where the solids were located, and this likely prevented the 5-gas detector from identifying the presence of flammable butadiene vapor.

**Figure 1.** Tank Containing Solids at SABIC. (Credit: SABIC)

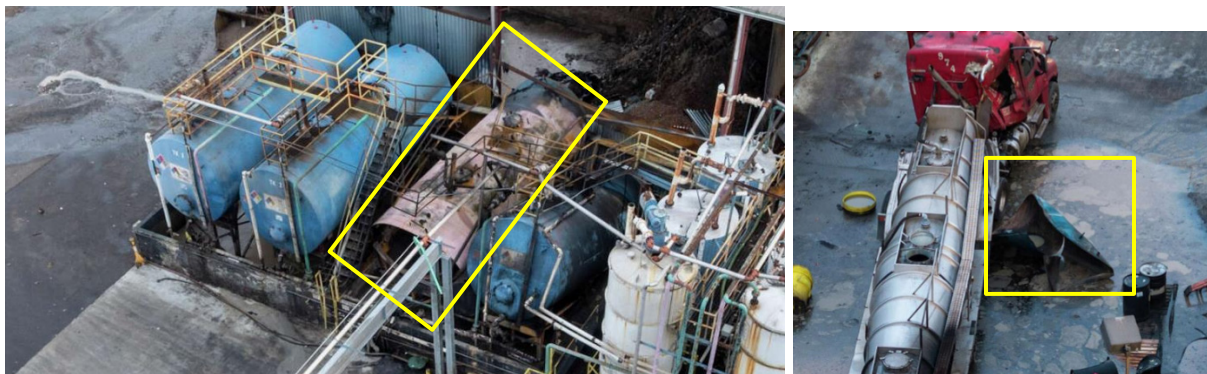
**Figure 1.** The tank that exploded (left). A portion of the tank after the explosion (right) (Credit: Tradebe, annotated by the CSB).

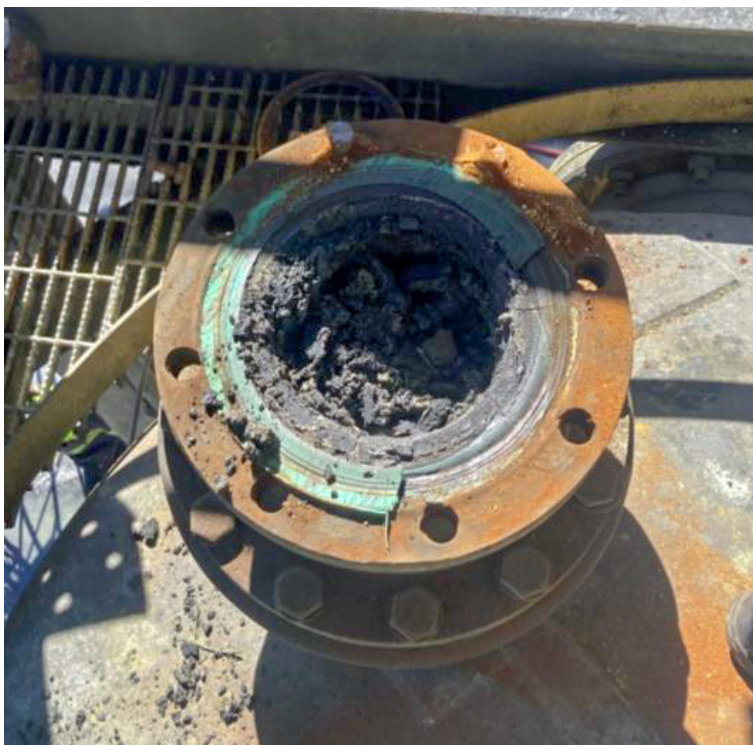
Tronox’s investigation determined that the high-pressure condition inside the water tank was created by a violent chemical reaction between titanium tetrachloride and water that generated hydrogen chloride vapor and heat. Liquid titanium tetrachloride had accumulated within the plugged piping from an upstream spray injection system. When the workers cleared the solids from the piping into the water tank, the liquid titanium chloride also entered the water tank, triggering the chemical reaction. Although the water tank was equipped with a rupture disc to protect the equipment from high-pressure conditions, the rupture disc did not activate during the incident because its inlet piping was blocked with solids (**Figure 2**). The investigation also found that although previous high-pressure events had occurred, Tronox’s employees were not required to wear respiratory protection for the pipe-clearing activity.

**Figure 2.** Solids in the rupture disc inlet piping. (Credit: Tronox)

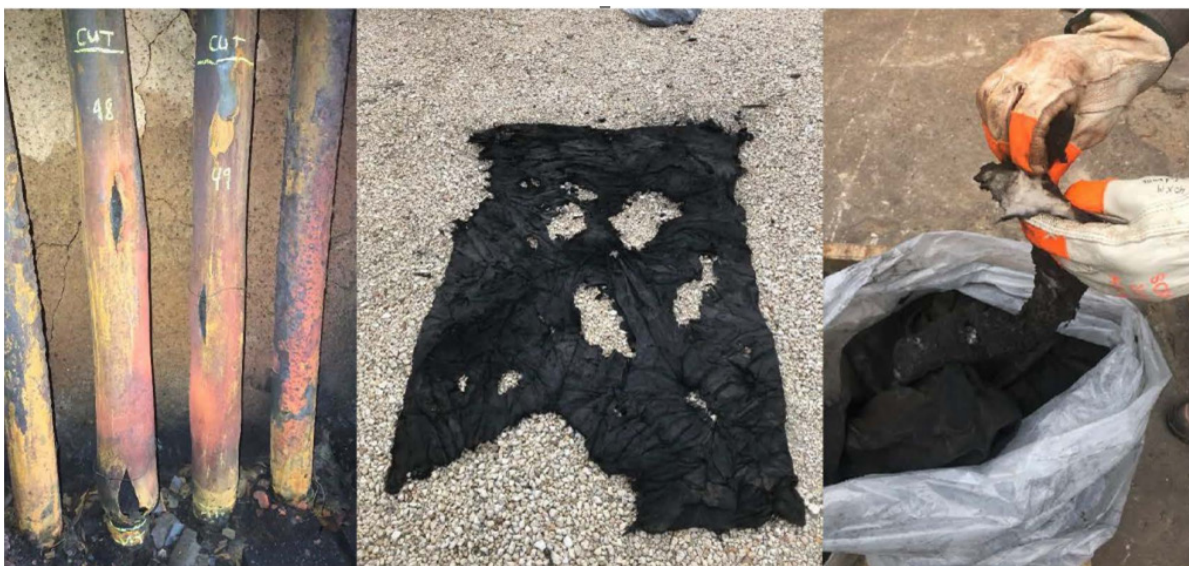
tubes ruptured because of a combination of creep damage (which results from prolonged exposure to stress at elevated temperatures) and short-term overheating.

**Figure 17.** Failed fired heater tubes (left) and debris removed post-incident (center and right).  
(Credit: ExxonMobil)

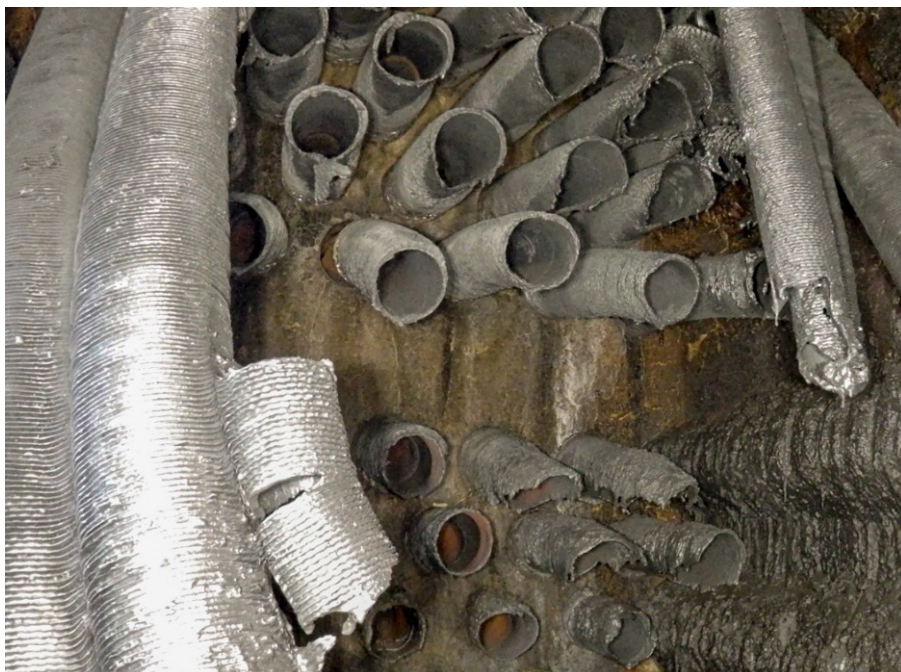
**Figure 19.** Broken fired heater tubes. (Credit: LyondellBasell)
