CIVIL AERONAUTICS AUTHORITY
Technical Development Division

NOTE NO. 14

SUPERFICIAL CORROSION ATTACK ON THE SURFACES
OF ALCLAD SHEETS

DECEMBER 1938

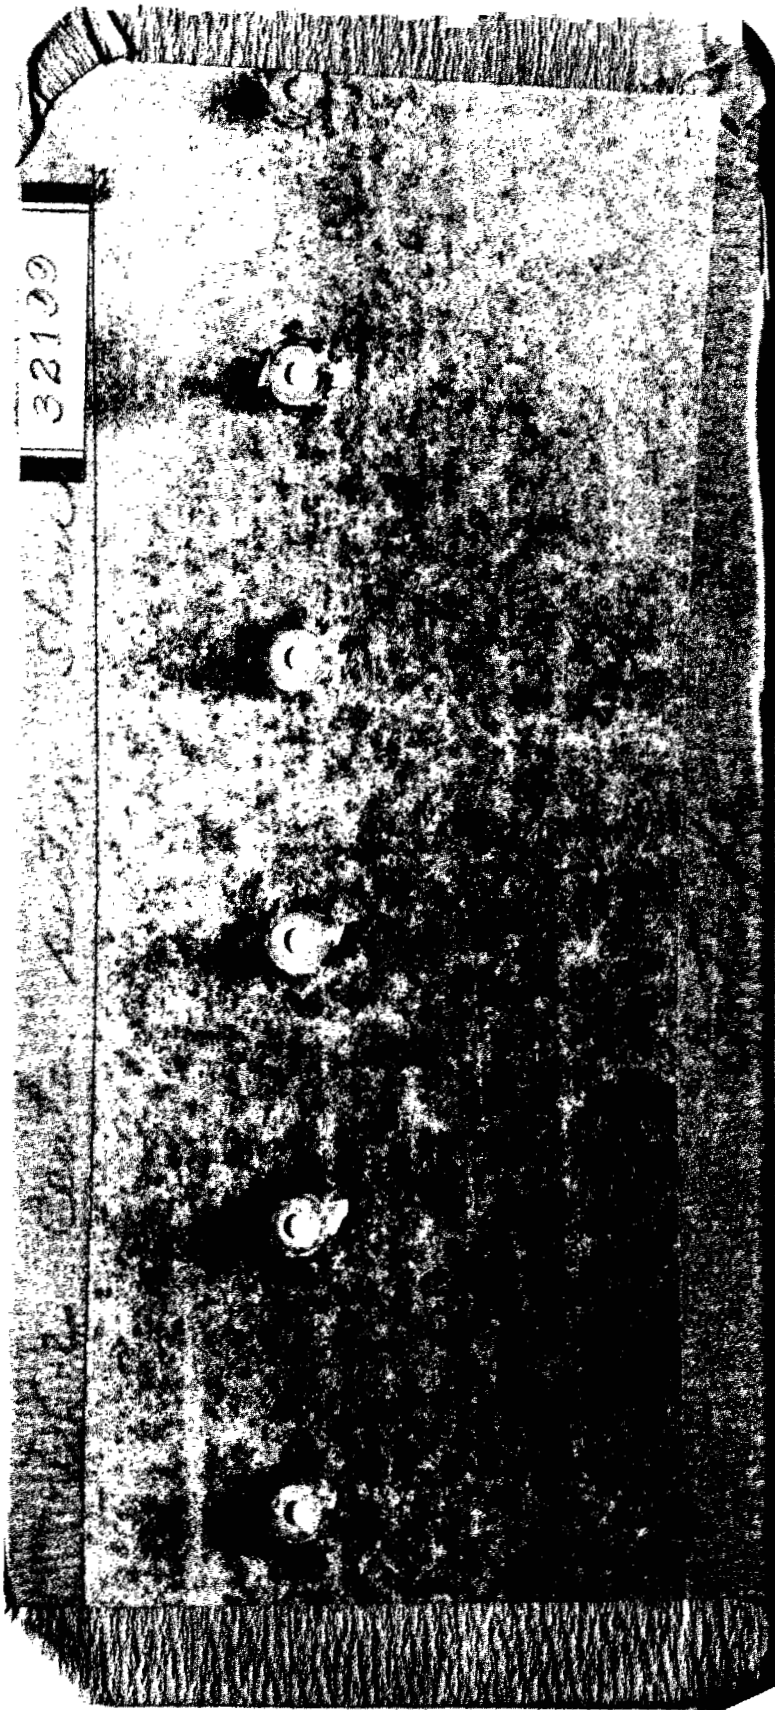
So far we have discussed theoretical considerations only. Fig. 4 (Neg. 207160) shows the surface (photographed actual size) of a piece of Alclad 24S-T sheet which was taken from a location in a plane subjected to exhaust fumes, after 7600 hours of service. Fig. 5 (Neg. 20801) shows a cross section through this piece of sheet and reveals the extent of the surface corrosion. The tooth-like appearance of the surface coating remaining is typical of

These results show that the mechanical properties after this service are well above the minimum specification values and the superficial corrosion has had no appreciable effect on the mechanical properties of this piece of sheet.

Fig. 4 Actual size.
This photograph shows the stained and roughened appearance of the Alclad 24S-T sample from the center section of a plane. The staining was largely superficial because most of it could be removed by cleaning.

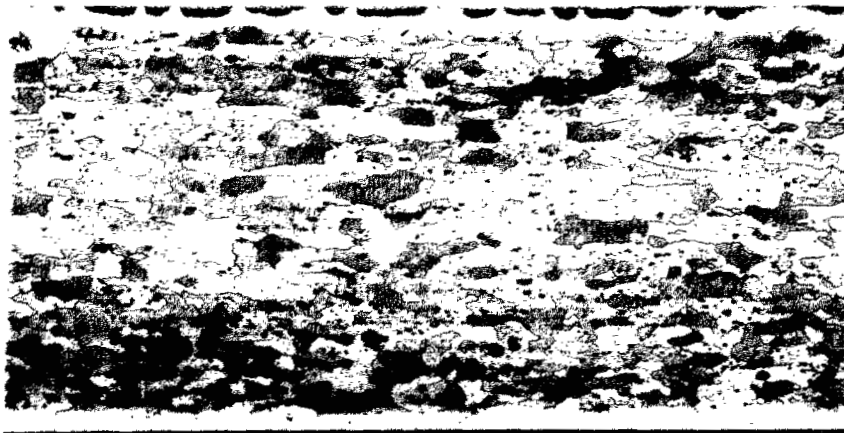
Fig. 5 Mag. 100X Etch: HF-HCl-HNO₃

that previously described and schematically illustrated in Fig. 2. Corrosion had not reached the core in any place examined in this sample. Standard A.S.T.M. tensile specimens cut from the full thickness of this sheet exhibited the following properties:

This micrograph shows a complete cross section of the Alclad 24S-T sheet from the center section of a plane. The surface of the Alclad sheet which was exposed to the action of the exhaust gases is at the top of the micrograph. The roughening of the surface was the result of pitting that was confined entirely to the high purity coating layer. The pitting extended approximately half way through the coating.

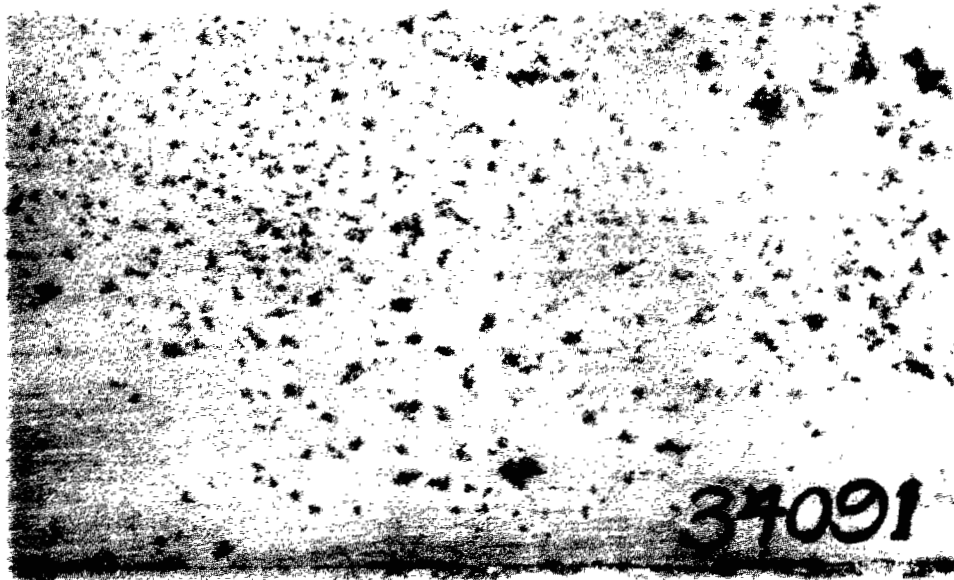
Fig. 7

This shows the characteristic appearance of the surface of the Alclad 24S-T skin covering in an area which had corroded from exposure to exhaust fumes and moisture. Actual size.

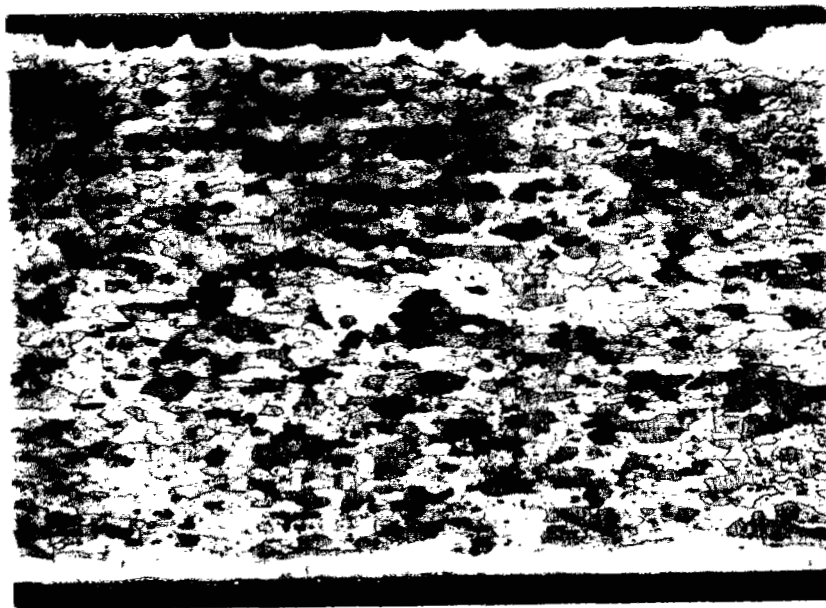
Fig. 8

This shows a full cross section through a corroded portion of the sheet similar to that shown in Fig. 7. The corrosion attack was limited to the high purity coating and did not penetrate the diffusion zone. The peaks in the coating represent areas where the diffusion along the grain boundaries in the coating was greater than that through the boundary of the grain.
