NOTE NO. 24

SERVICE TESTS ON SEADROME LIGHTS

November 1940

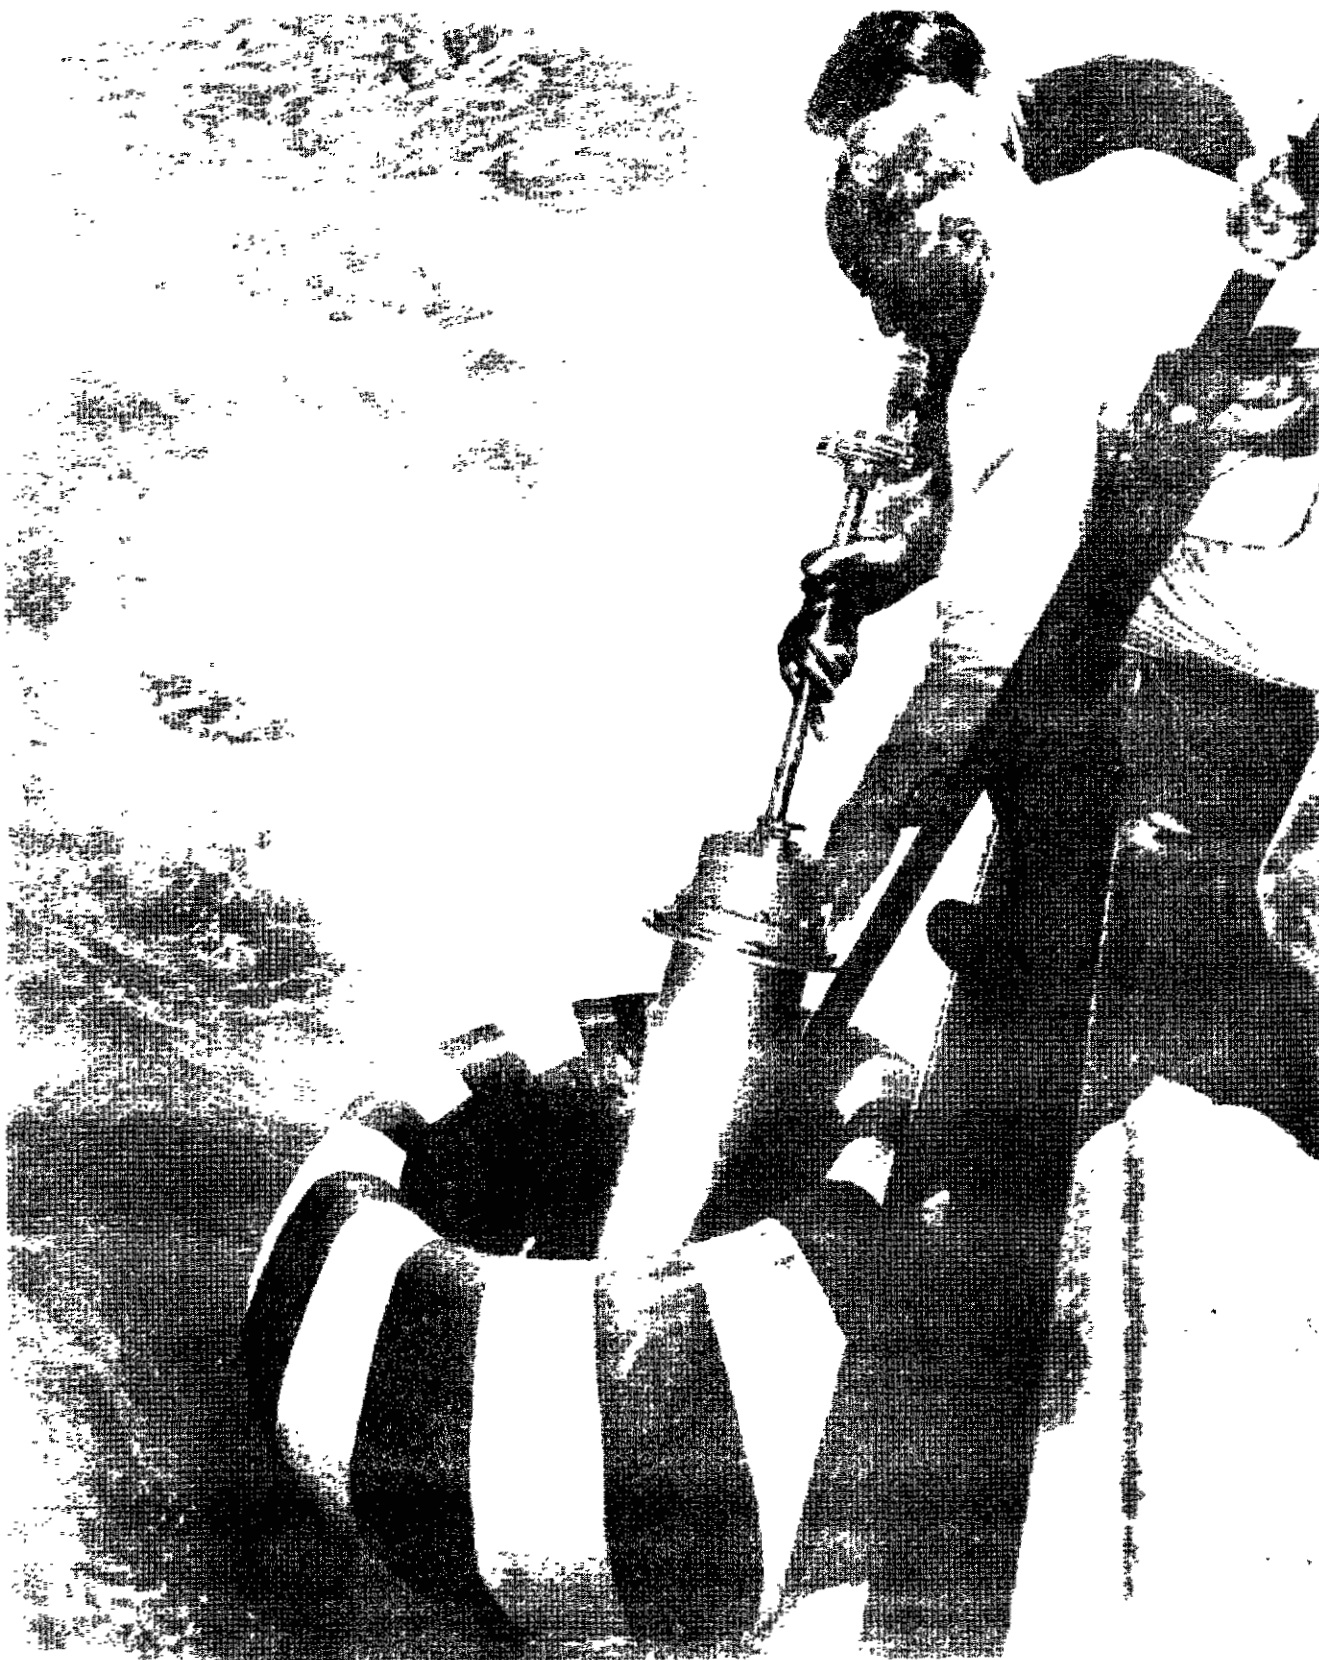
INSTALLING LIGHT UNIT IN RUBBER BUOYS
