**DEVELOPMENT OF AIRCRAFT  
WINDSHIELDS TO RESIST IMPACT  
WITH BIRDS IN FLIGHT  
PART II**

**INVESTIGATION OF WINDSHIELD  
MATERIALS AND METHODS OF  
WINDSHIELD MOUNTING**

Pell Kangas and George L. Pigman  
Aircraft Development Division

Technical Development Report No 74

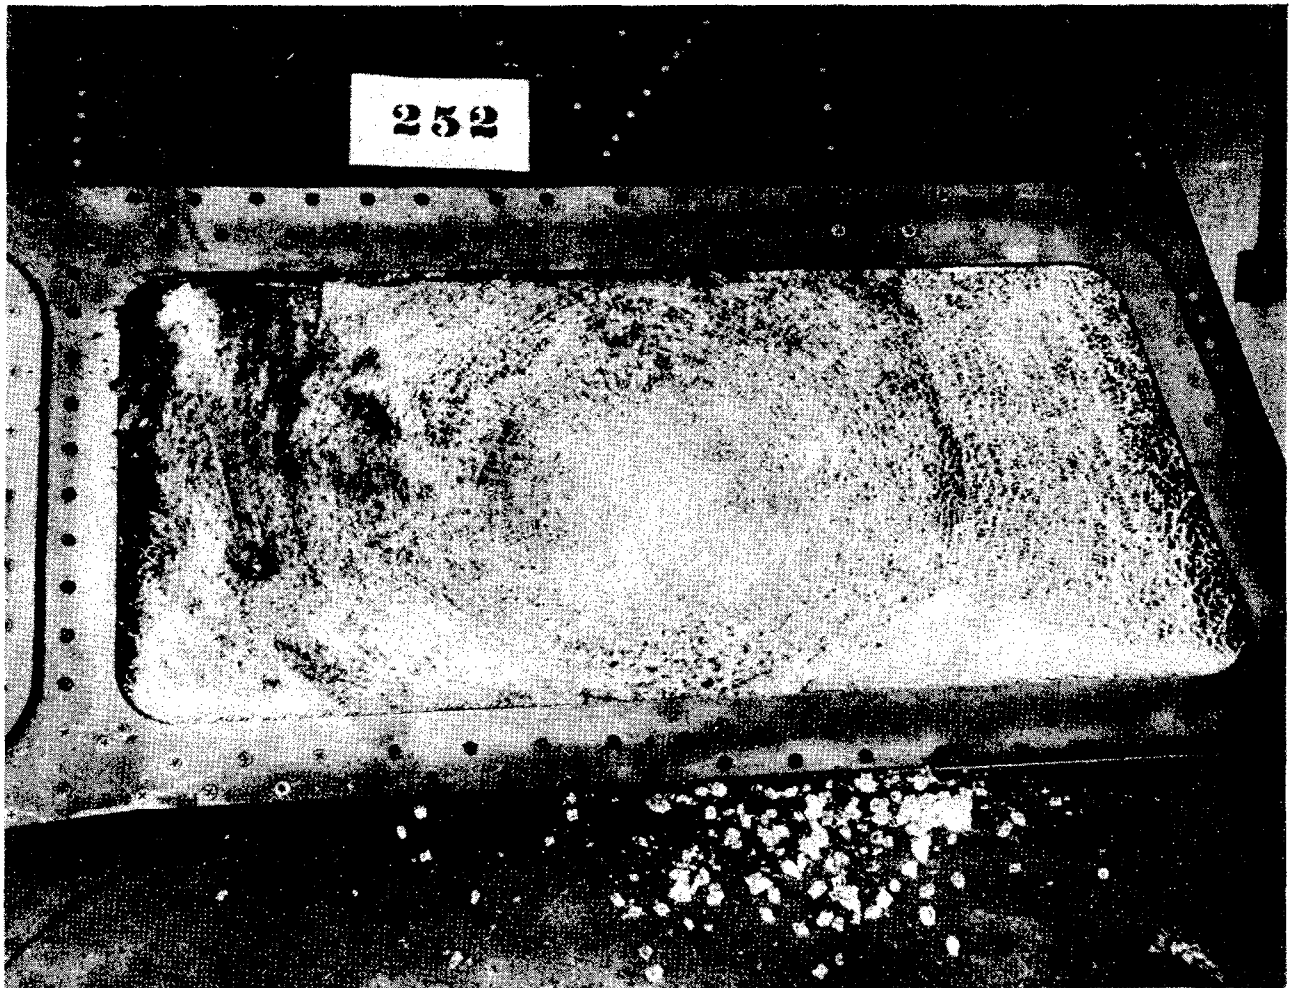
faces, with relatively high tensile strength and elongation. The energy absorbed by a sheet of such plastic before failure, therefore, is very large. In Fig 12 is shown double-pane type windshield No 4124 from Table IV, which utilized 0.188-in butyral interlayer in the rear panel and withstood penetration of a 4-lb carcass projected at a velocity of 300 mph at a pane temperature of 80° F.

Fig. 12 Impact Test Resulting in Nonfailure of a Douglas DC-6 Windshield Utilizing 3/16-in. Polyvinyl Butyral Interlayer Tested With 4-lb. Chicken Carcass at 300 mph

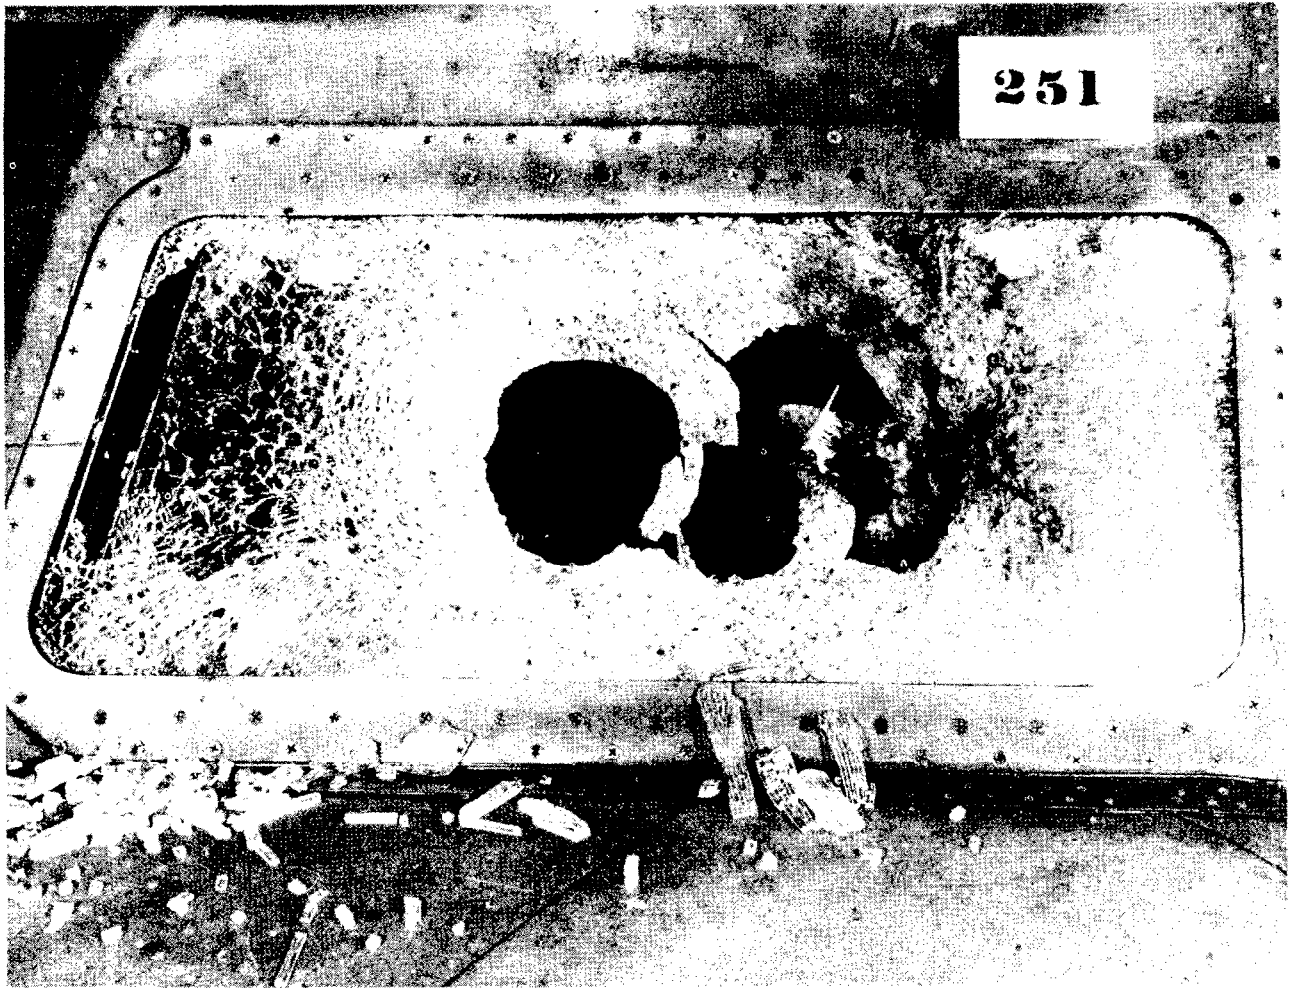
The type of failure occurring at excessive carcass velocities in a windshield panel with adequate edge mounting is shown in Fig. 19, with the plastic interlayer absorbing

Fig. 19 Example of Failure at Center of Laminated Pane With Polyvinyl Butyral Interlayer

maximum energy before tearing. This type of failure indicates optimum butyral plastic temperature and sufficient strength in the edge mounting of the panel and the frame attaching the panel to the cockpit structure.

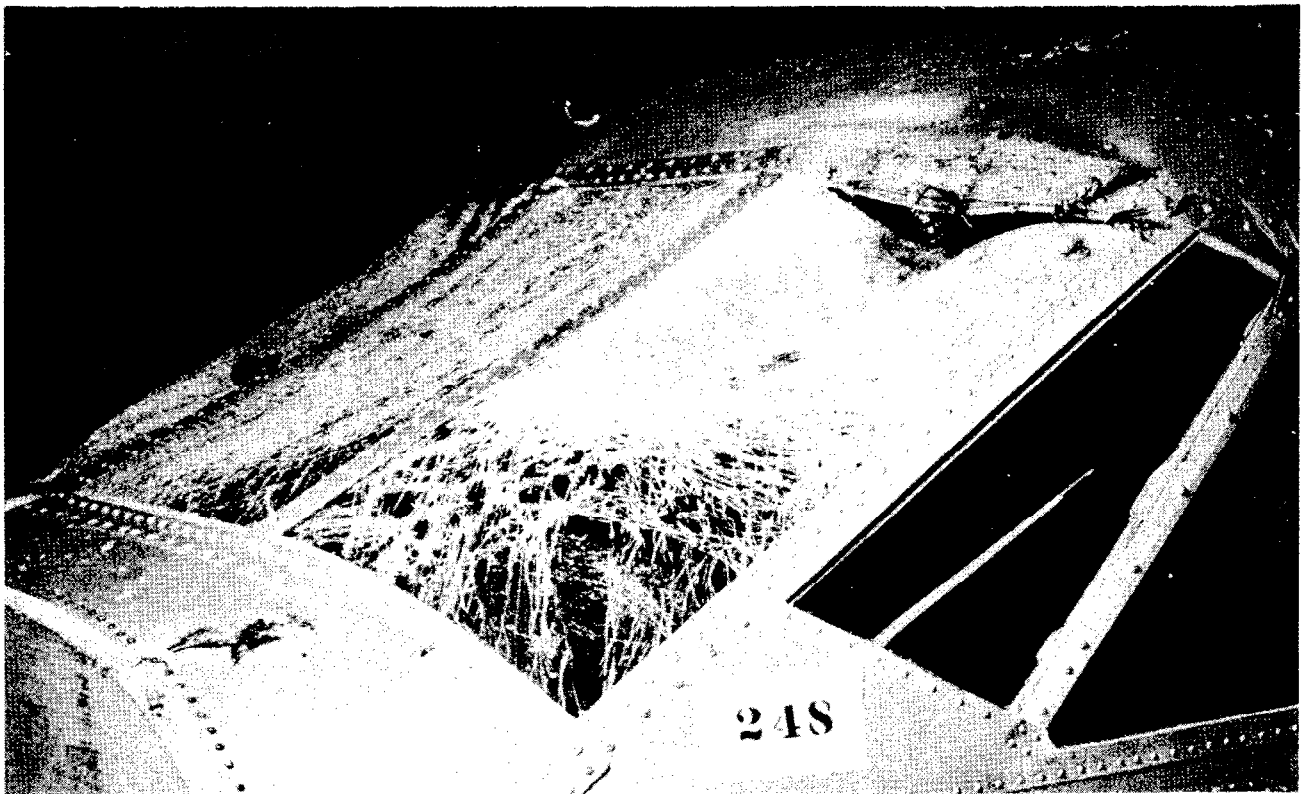
In the second category of failures in Table V are shown some test results where the butyral plastic laminated pane sheared at the line of metal insert, indicating in several cases excessive thickness in the metal insert.

This type of failure is shown in Fig. 21. Rigidity of the supporting structure, and lack of adequate width of the insert so that it does not extend a sufficient distance between the glass faces, also contribute to this type of failure. The effect of rigidity of the supporting structure will be discussed later.

Fig. 21 Example of Failure Resulting From Impact Test Where Plastic Interlayer Sheared Along Inner Edge of Metal Insert

It may be concluded that the thickness of 24S-T aluminum alloy metal insert strip should be between one-sixth and one-quarter

the thickness of the butyral plastic interlayer, where the plastic interlayer thickness is 0.188-in. or less. It appears desirable to use a minimum thickness of metal insert for the thinner plastic interlayers.

With regard to width of the metal insert strip, it has been found that satisfactory results are obtained if the metal insert strip extends at least 0.25-in. between the two glass faces of the pane. If the strip does not extend between both glass faces in this manner, a strong tendency exists for failure of the plastic interlayer in shear along the inside edge of the strip.

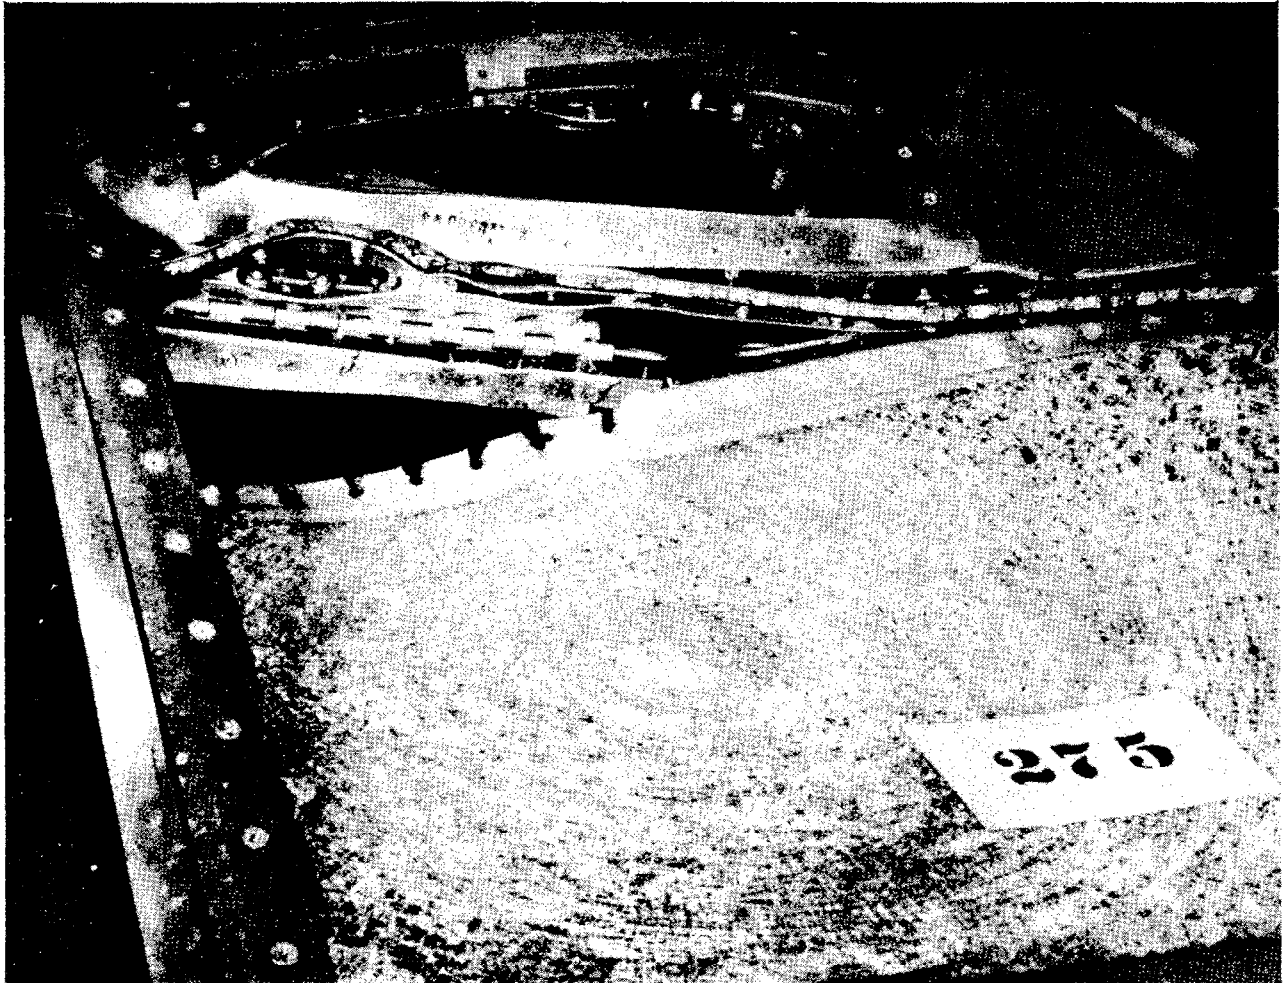
the mounting bolts, indicates either lack of insert or insufficient thickness of insert when the mounting bolt size, spacing, and edge distance are satisfactory. An example of failure due to lack of adequate insert thickness is shown in Fig. 22.

Fig. 22 Example of Failure Resulting From Impact Test Where Plastic Edge and Metal Insert Sheared at the Mounting Bolts

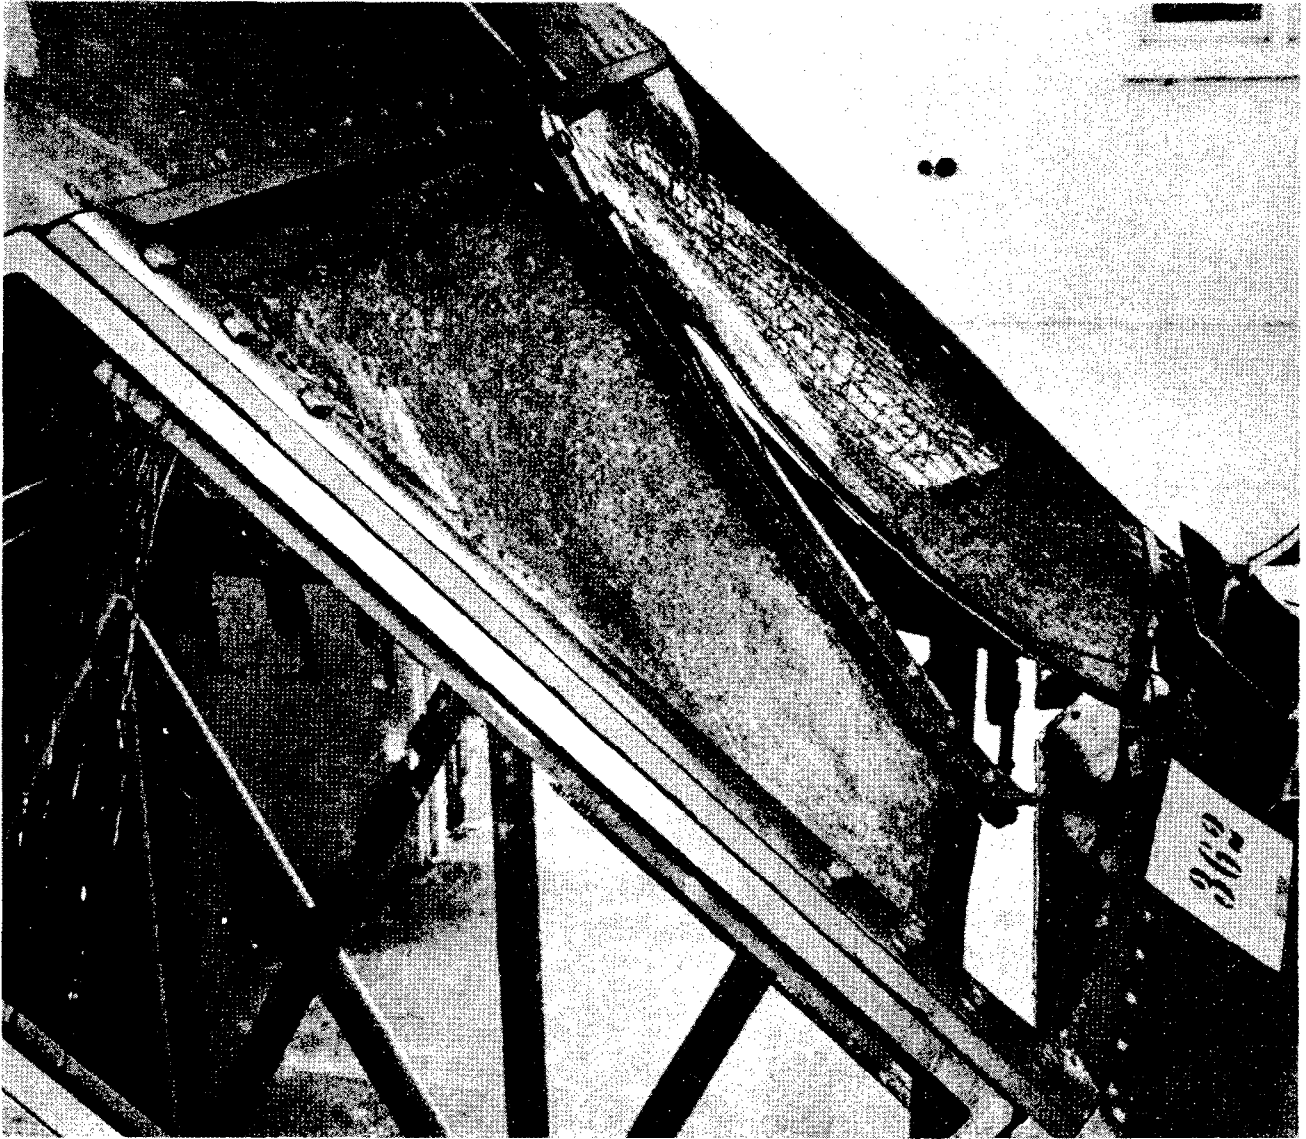
data relating to specific practical designs which may be generally applicable to other designs. An example of failure of supporting structure resulting from impact on the windshield panel is shown in Fig. 23.

Fig. 23 Example of Failure Resulting From Impact Test of the Structure Supporting the Windshield Frame

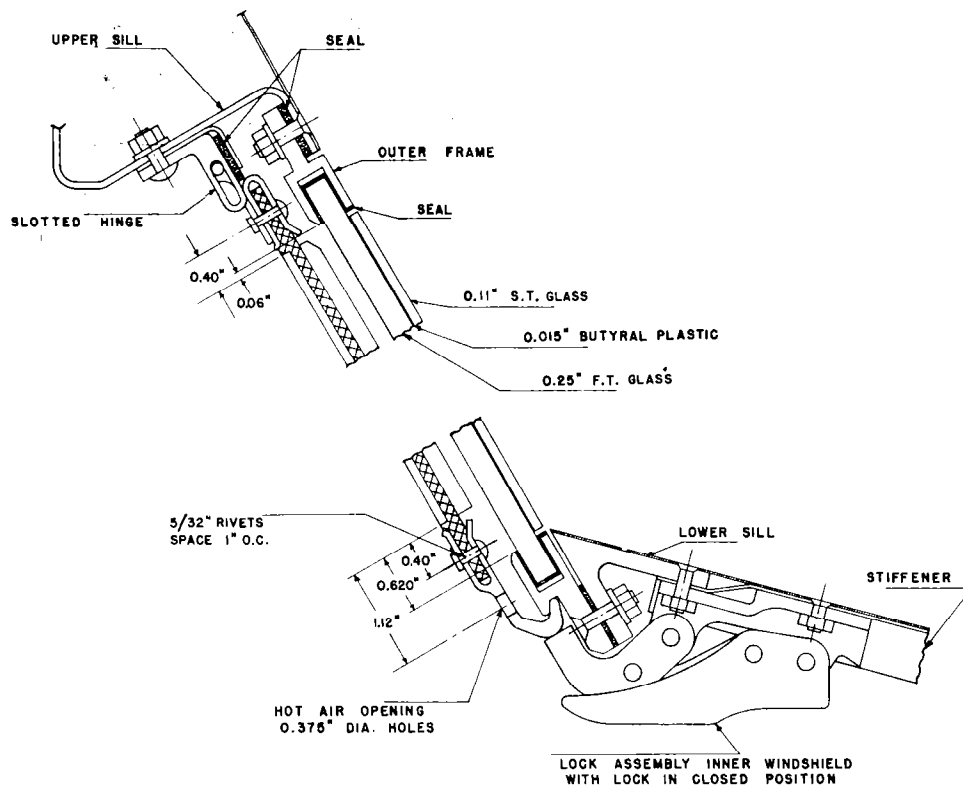
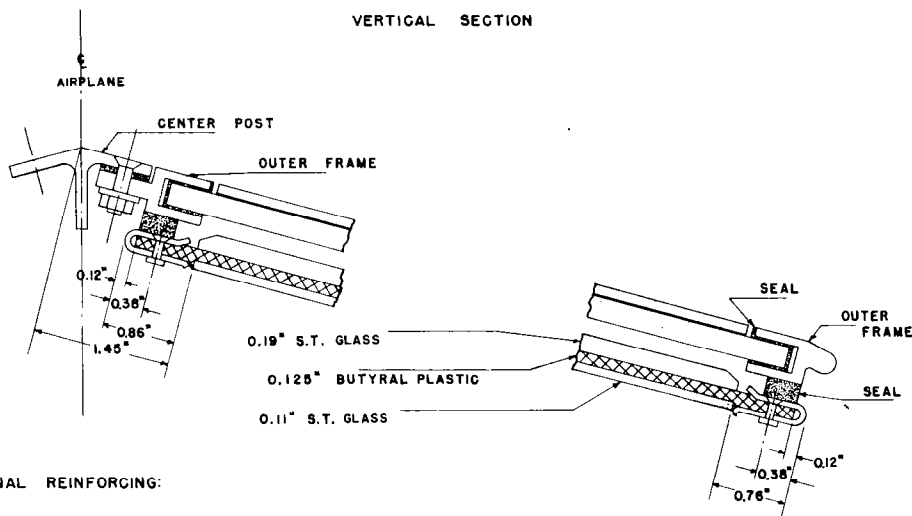
Fig. 26 Section Details and Impact Test Data of Curtiss-Wright C46E Windshield

PRINCIPAL WEAKNESS OCCURRED AT EXTENDED EDGE OF PANE WHERE THE PLASTIC SHEARED AT THE RIVETS. THIS FAILURE WAS DUE TO THE LACK OF A METAL INSERT IN THE EDGE OF THE PANE.

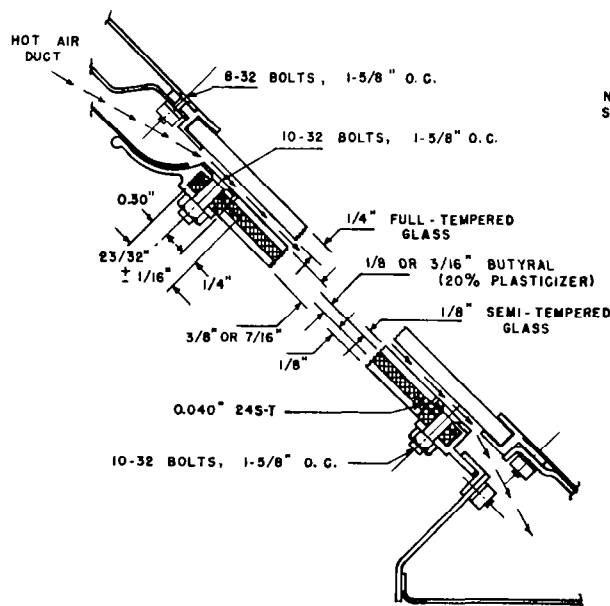
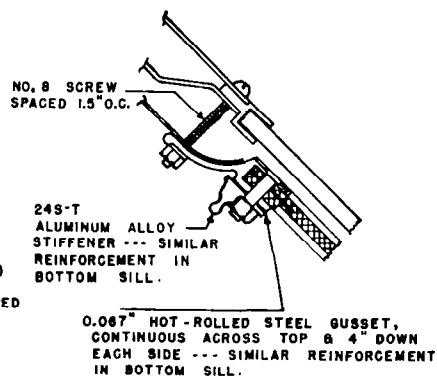
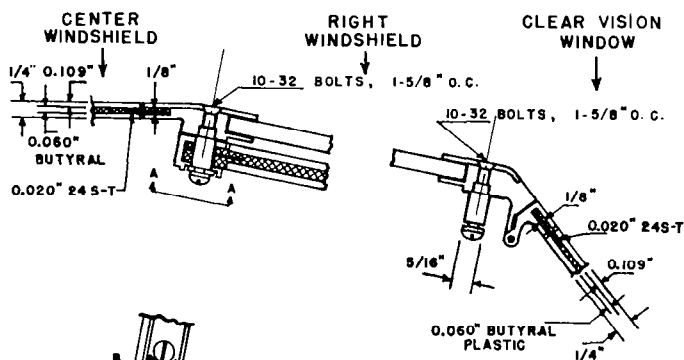
Fig. 28 Section Details and Impact Test Data of Beech Model 34 Windshield

CORNER GUSSETS ON REAR PANE  
HORIZONTAL FRAME MEMBER LACKED  
STIFFNESS  
VERTICAL POSTS FAILED AT POINTS  
OF INTERSECTION WITH COCKPIT  
STRUCTURE
