TECHNICAL DEVELOPMENT REPORT NO. 106

AN INVESTIGATION OF THE EFFICACY OF THE
XF9F-3 FIRE SCREEN INSTALLATION

Power Plant Branch
Aircraft Division
April 1950

CIVIL AERONAUTICS ADMINISTRATION
TECHNICAL DEVELOPMENT
AND EVALUATION CENTER
INDIANAPOLIS, INDIANA

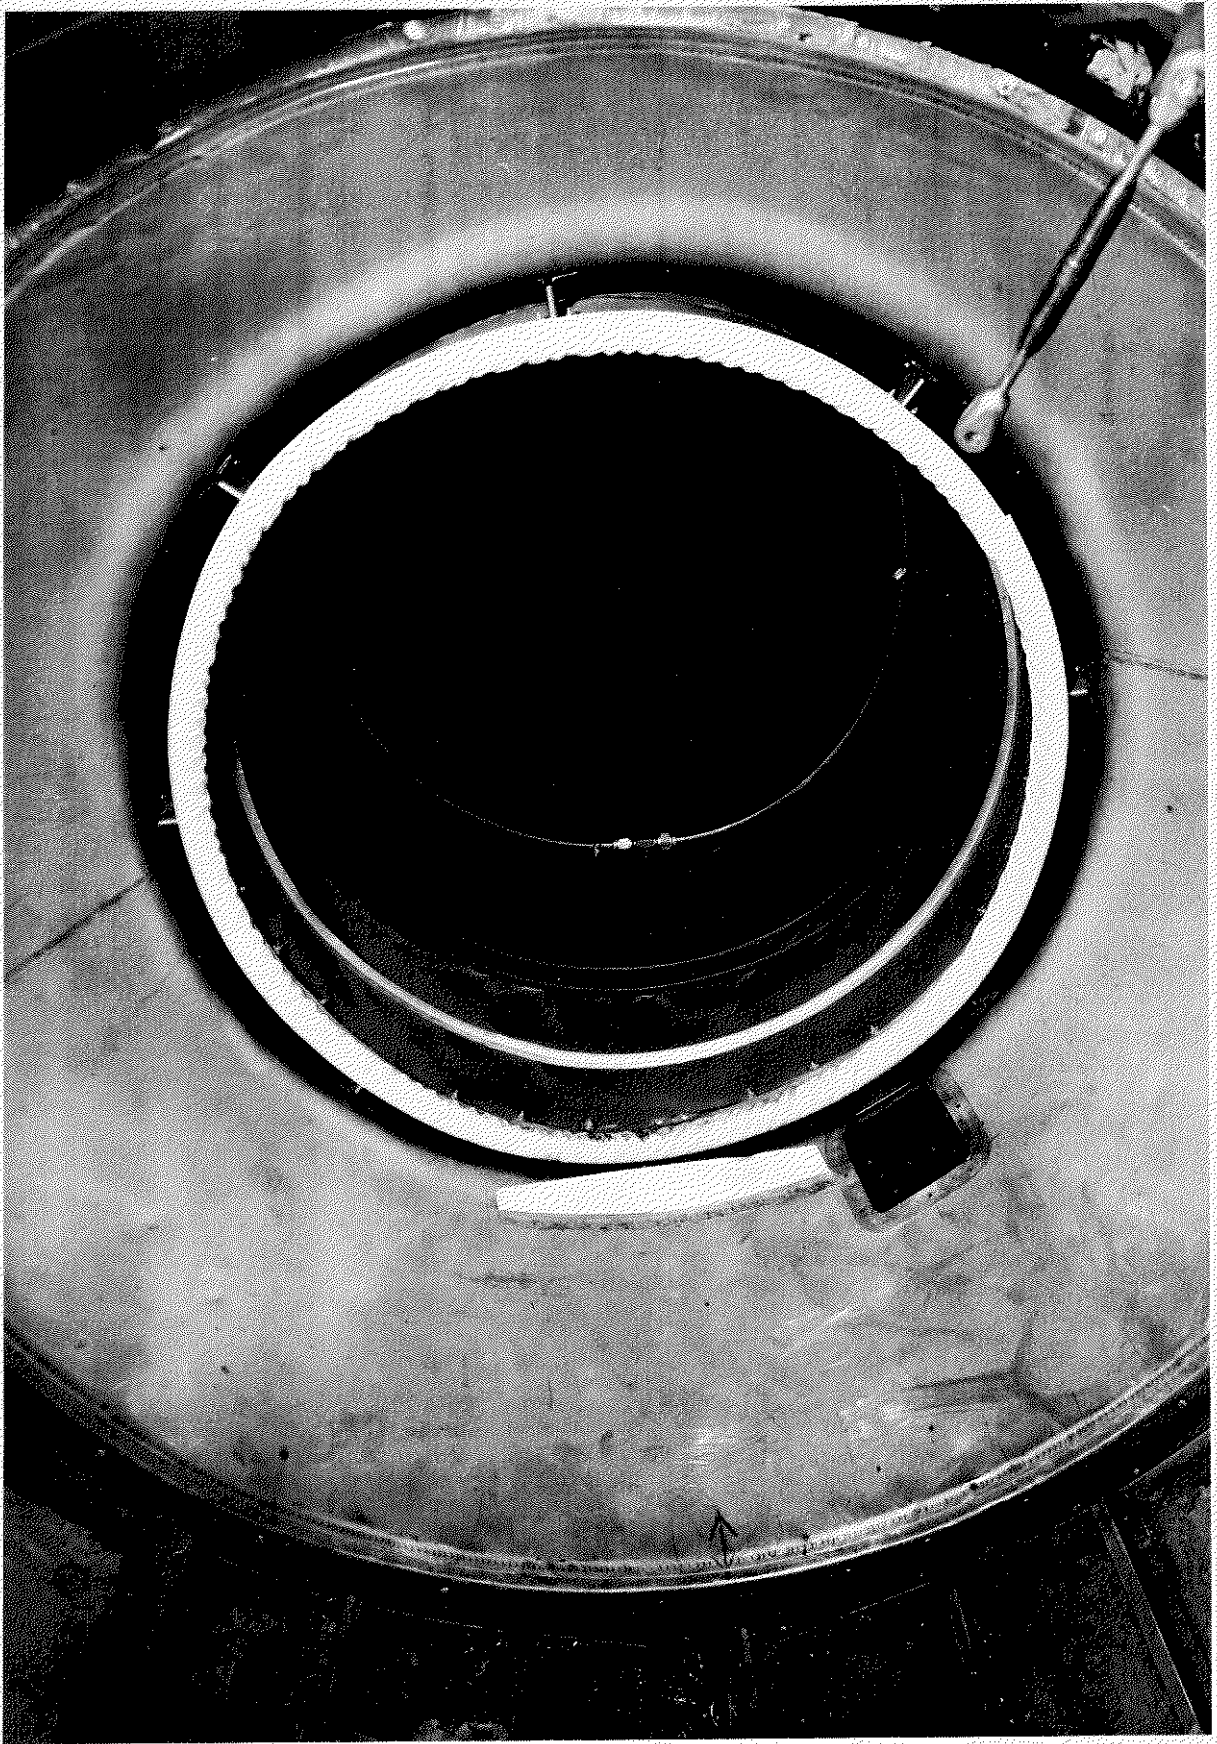
1. The fire screen installation does not prevent backflash or upstream travel of fire from the rear compartment to a source of fuel located in the forward compartment.
2. The fire screen installation does not prevent fire, ignited in the forward compartment, from traveling downstream into the rear compartment.
3. The fire screen installation is subject to early material failure when local spots are exposed to intermittent fire and cooling air.

FIG. 3 PHOTOGRAPH OF FIRE SCREEN INSTALLATION
IN XF9F-3 TAIL SECTION

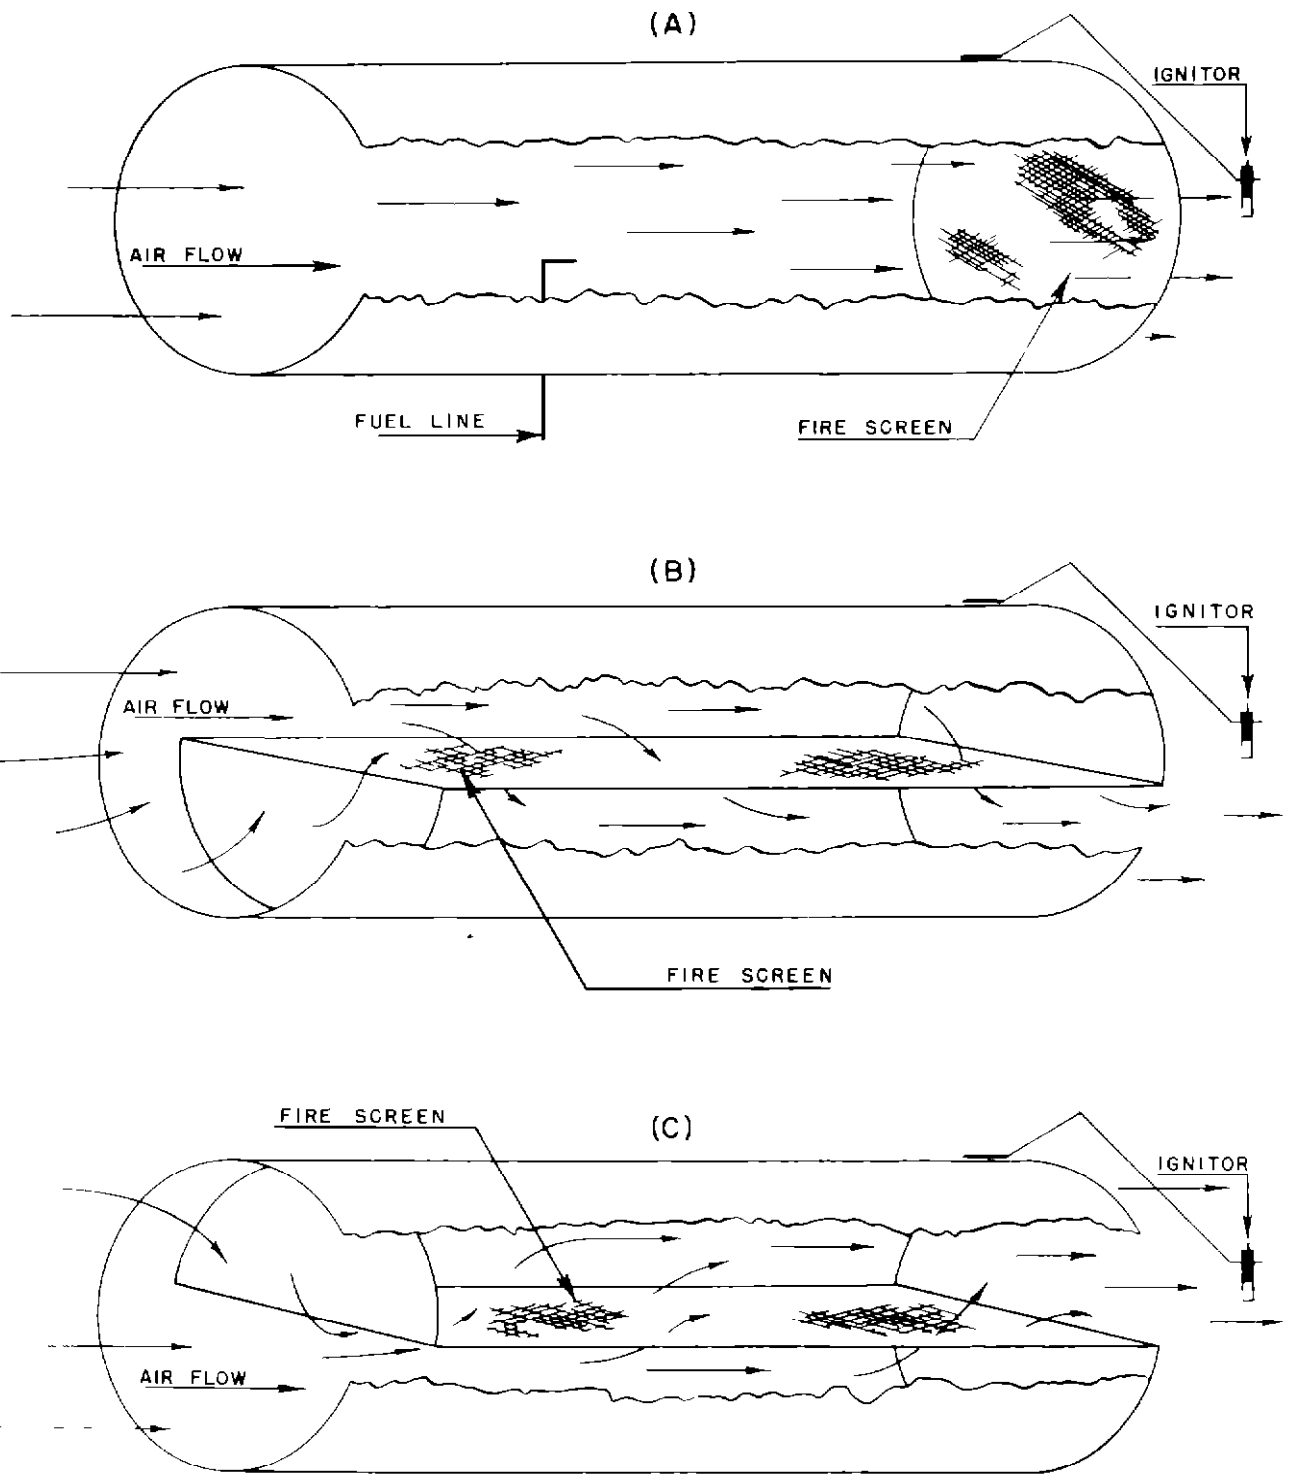
A brief study of fire screen characteristics was made by installing 30-mesh monel metal screens in an 18-inch air duct. One of these was installed normal to the direction of air flow at the end of the duct as shown in Figs. 7 and 8A. Also, two horizontal screen arrangements were installed in the duct as shown in Figs. 8B and 8C. The horizontal screens represent roughly the configuration of the upper and lower portions of the XF9F-3 installation in the sense that the screen at those locations is horizontal and mounted parallel to the general direction of air flow. A turbulent condition in the vicinity of the screens for this configuration is probable.

- (1) the screen installed normal to the direction of air flow through the duct, prevented backflash.
- (2) the screens installed horizontally and parallel to the direction of air flow through the duct (sec B, and C, Fig. 8) did not prevent backflash.
- (3) at duct velocities exceeding approximately 15 mph, the fire would not travel in free air upstream to the screen.

FIG 8 CUTAWAY VIEWS OF FIRE SCREEN INSTALLATIONS
USED IN SUPPLEMENTARY TESTS

Results of the supplementary tests on fire screens installed in an 18-inch air duct indicated that a screen was most effective in preventing upstream travel of fire when installed normal to the general direction of air flow. Tests also indicated that high air velocities and the absence of turbulence at the screen are desirable and improve the effectiveness of the screen.

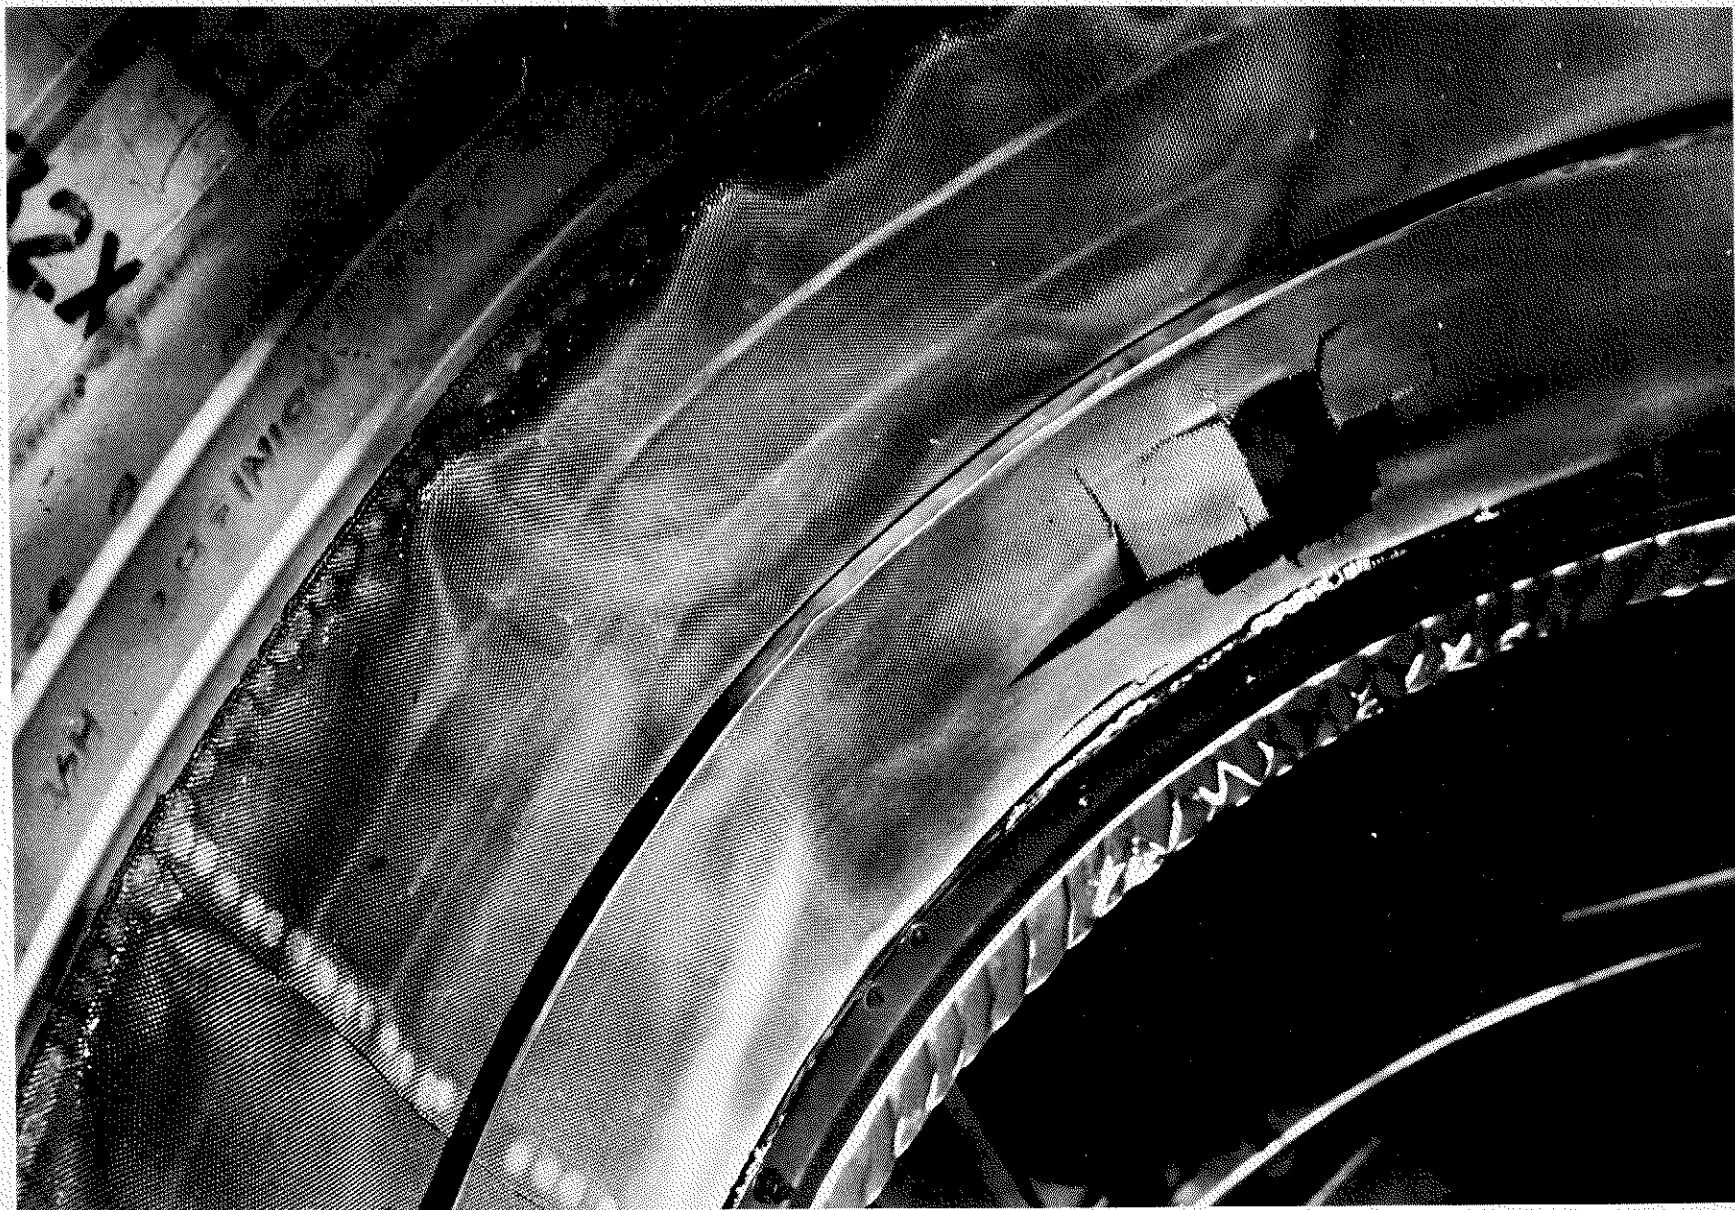
After completion of the tests on the XF9F-3 fire screen installation, supplementary tests were conducted to determine the reason for the occurrence of material failure of the screen after approximately six exposures to fire of about ten seconds duration each (see Figs. 9 and 10), and the apparent complete failure of the screen installation to prevent backflash of fire. A brief study of the material failure was made by constructing a 4 by 8 inch panel of new 30-mesh monel screen welded to a steel angle frame and testing it by

Five minutes of steady heating appeared to have no effect on the screen. Five cycles of heating and quenching in water did not result in failure. After ten cycles of heating and quenching with compressed air, the screen had developed a failure approximately three-fourths inches long. The failure appeared to have resulted from the combined heating and cooling, which was noted to cause considerable local expansion and contraction. Screening taken from the area of failure was highly oxidized and had very low strength and ductility, as compared with new screen material.

FIG 9 FIRE SCREEN FAILURE RESULTING FROM A FEW TEST FIRES
— RESTRICTED —

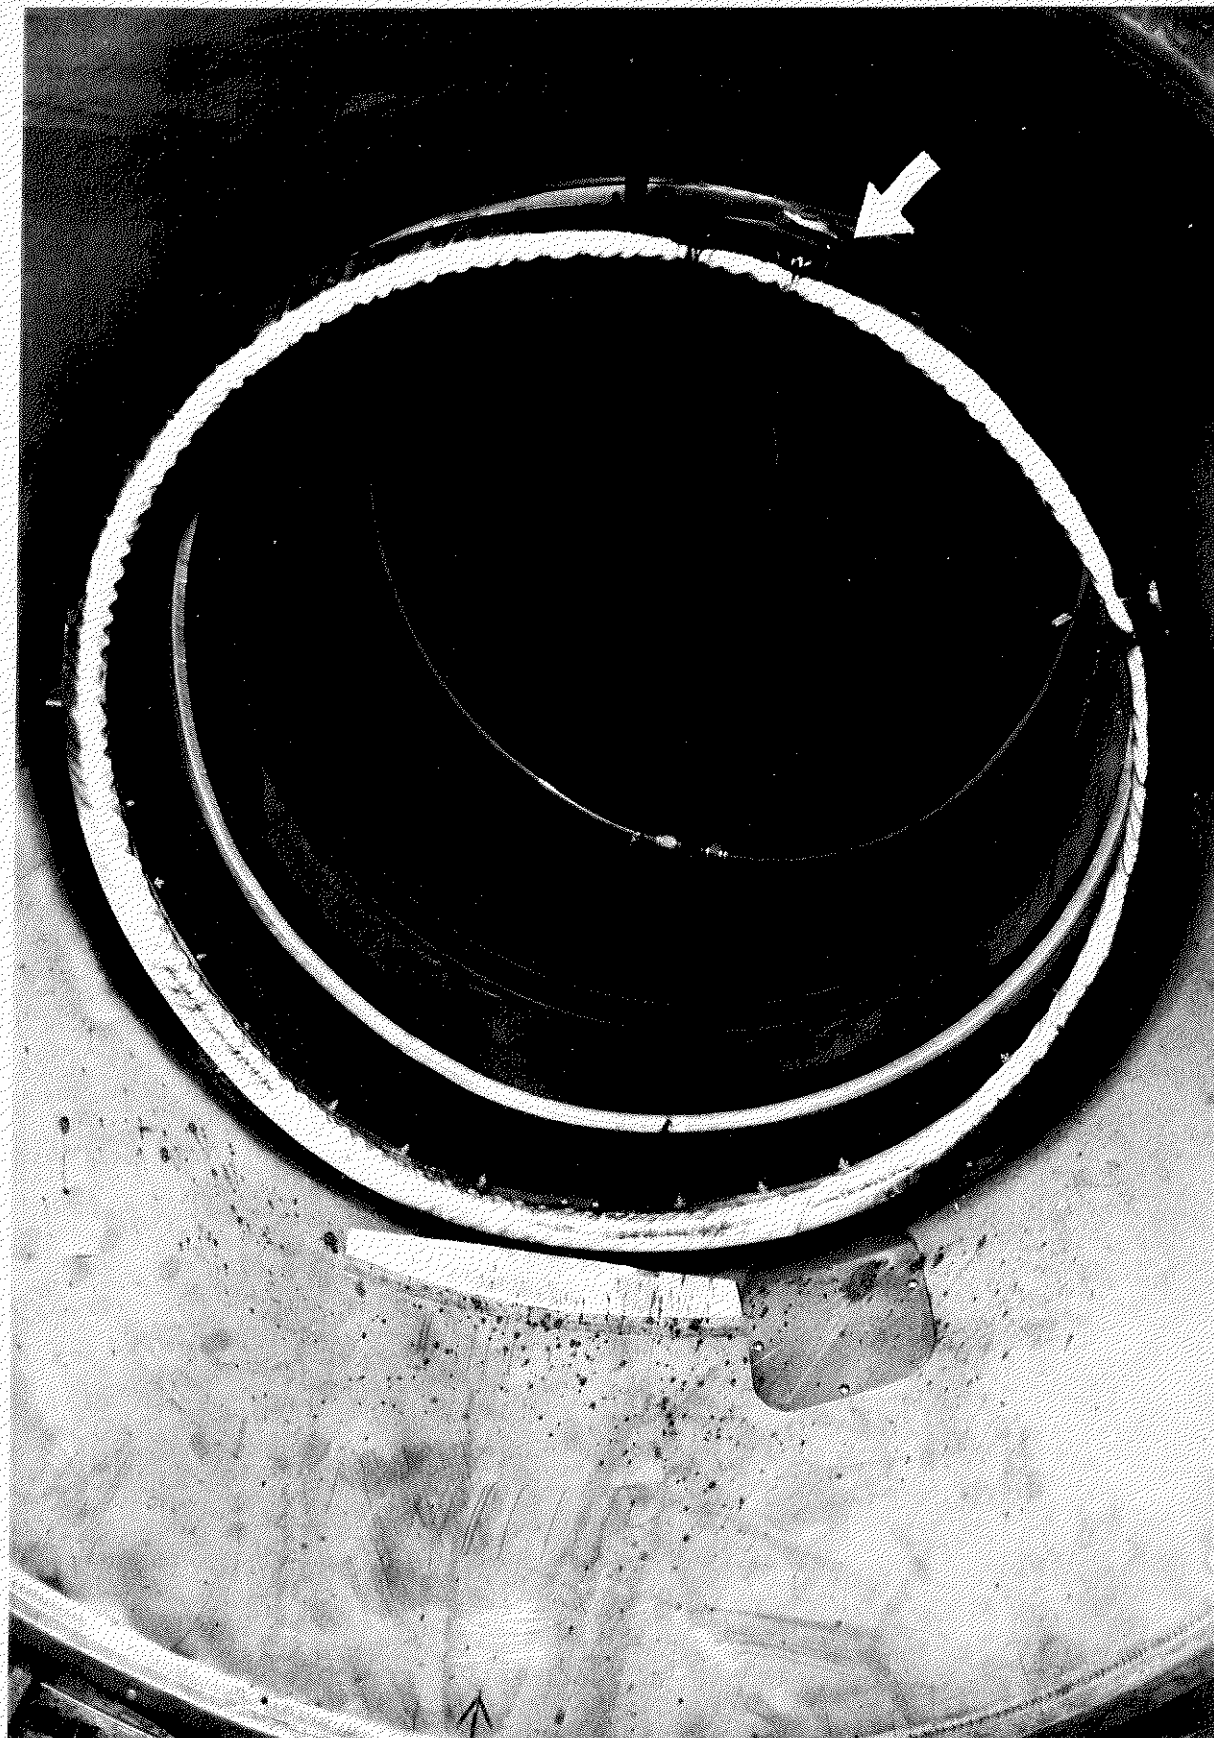
FIG.10 VIEW OF SCREEN SHOWING LOCATION OF FAILURE
— RESTRICTED —
