**DETERMINATION OF MEANS TO
SAFEGUARD AIRCRAFT FROM
POWER PLANT FIRES IN FLIGHT
PART IV**

THE BOEING B-29

By
Lyle E Tarbell and H R Keeler
Aircraft Division

Technical Development Report No 107

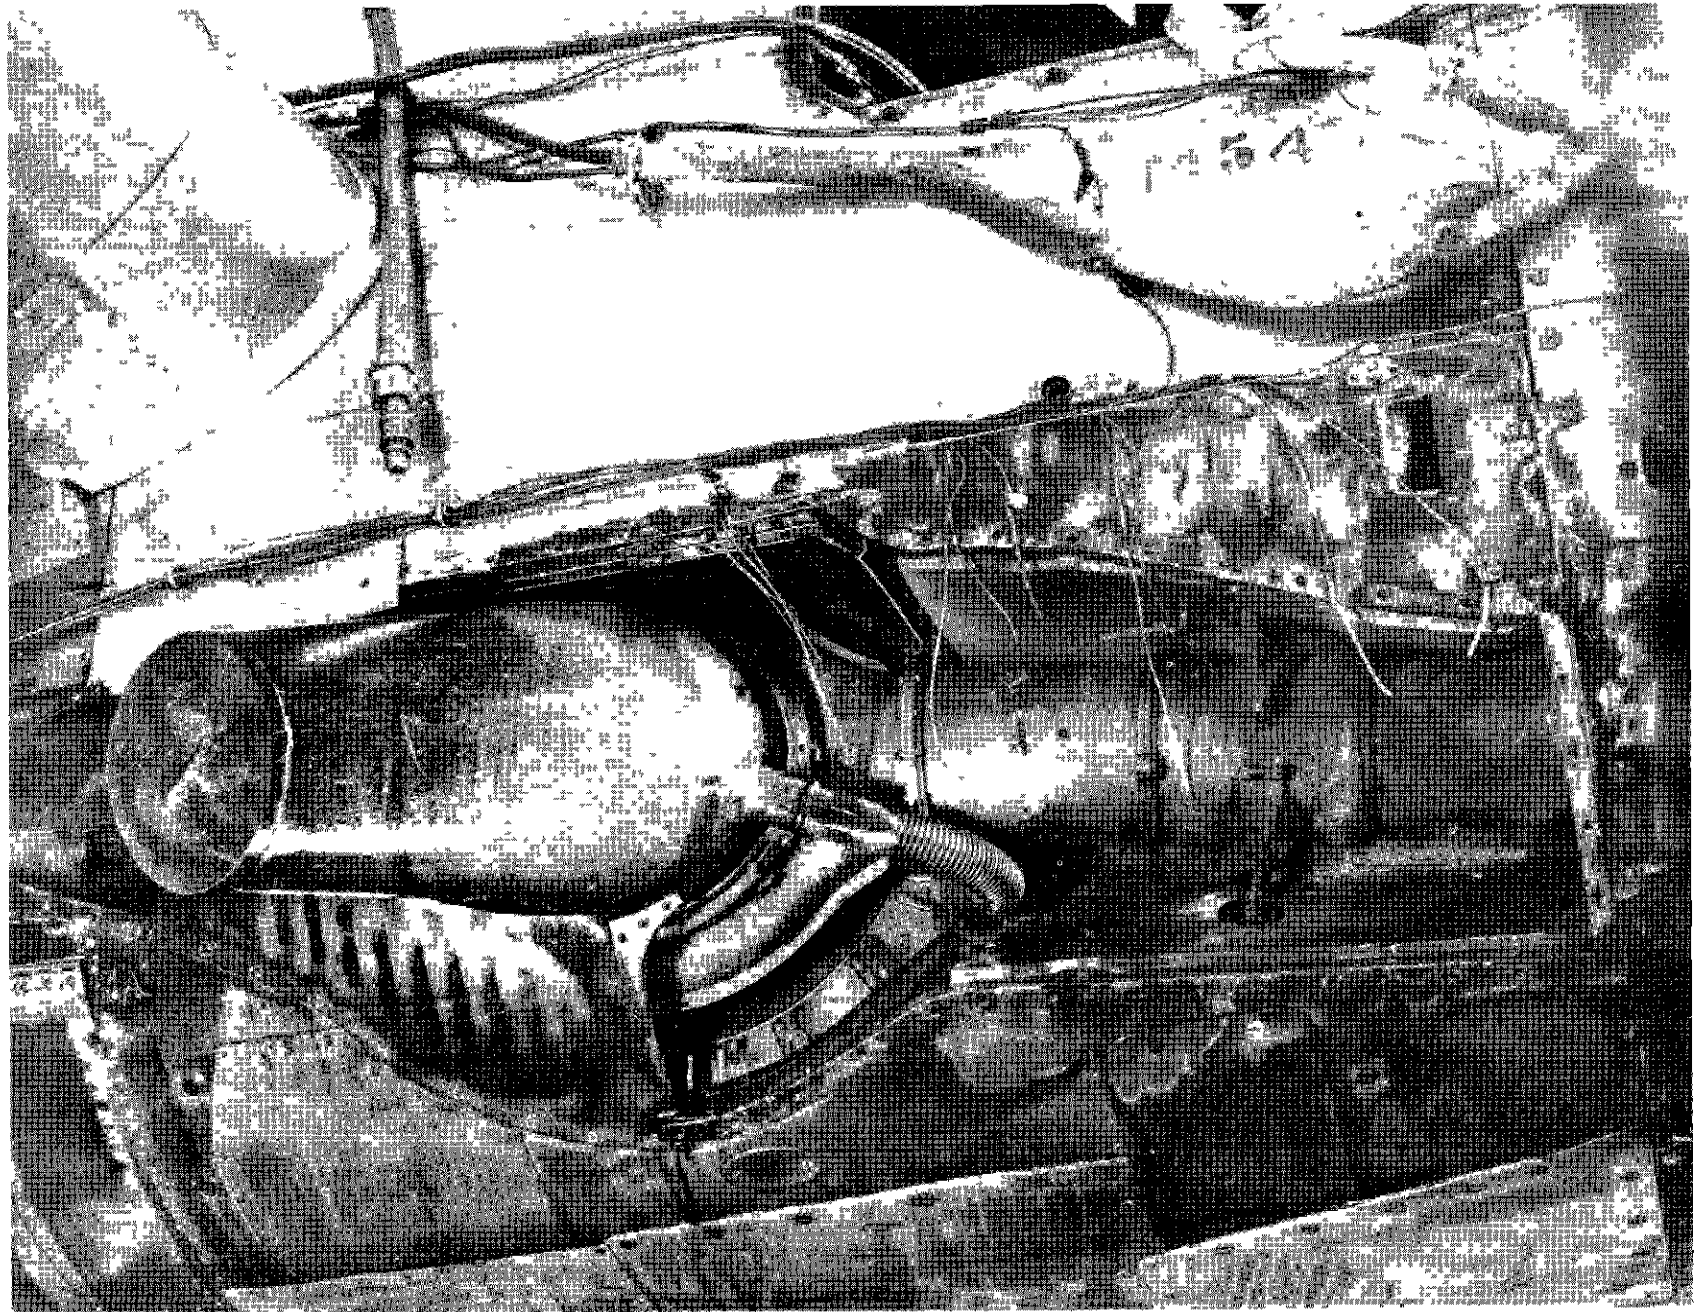
Fig 6 View Inside Exhaust Stack Well Showing Double Shroud Wall

This is near the place where one layer of steel shrouding is discontinued for about 2 in just above the junction between the exhaust stack and turbosupercharger, Fig 6. This spot consistently was about 100° F hotter than the rest of the shroud. The temperature was not duplicated at No 7 thermocouple on the right side because this thermocouple could not be located at an exactly comparable spot on the shrouding.

Fuel released above the joint in the stack shroud just forward of the turbosupercharger (Fig 6), flowed profusely through the joint down onto the stack and shroud, where ignition frequently occurred. It is possible that the excessive temperature to which the shroud had been subjected due to exhaust gas leakage below it had warped the shroud and opened the joint wider than normal. Although this is a contingency to be reckoned with in practice, for these tests the joint was restored to normalcy as nearly as possible, with additional bolts to draw the overlapped parts together. Fire which was ignited in this manner nearly always spread into the interior of the accessory section.

Unfortunately, the propeller feathering oil tank, the turbosupercharger lubricating oil tank, and the gasoline and oil lines along the sides of the accessory section are so located that if a failure should occur in any of them, the flammable fluids which they contain might conceivably seep through the hazardous lap joint and become ignited. A general relocation and rerouting of these items in the accessory section would be a desirable modification.
