TECHNICAL DEVELOPMENT REPORT NO. 121

NANTUCKET MOR ADJUSTMENTS
AND FLIGHT TESTS FOR THE
EVALUATION PROGRAM

Electronics Division
Technical Development
September 1950

CIVIL AERONAUTICS ADMINISTRATION
TECHNICAL DEVELOPMENT
AND EVALUATION CENTER
INDIANAPOLIS, INDIANA

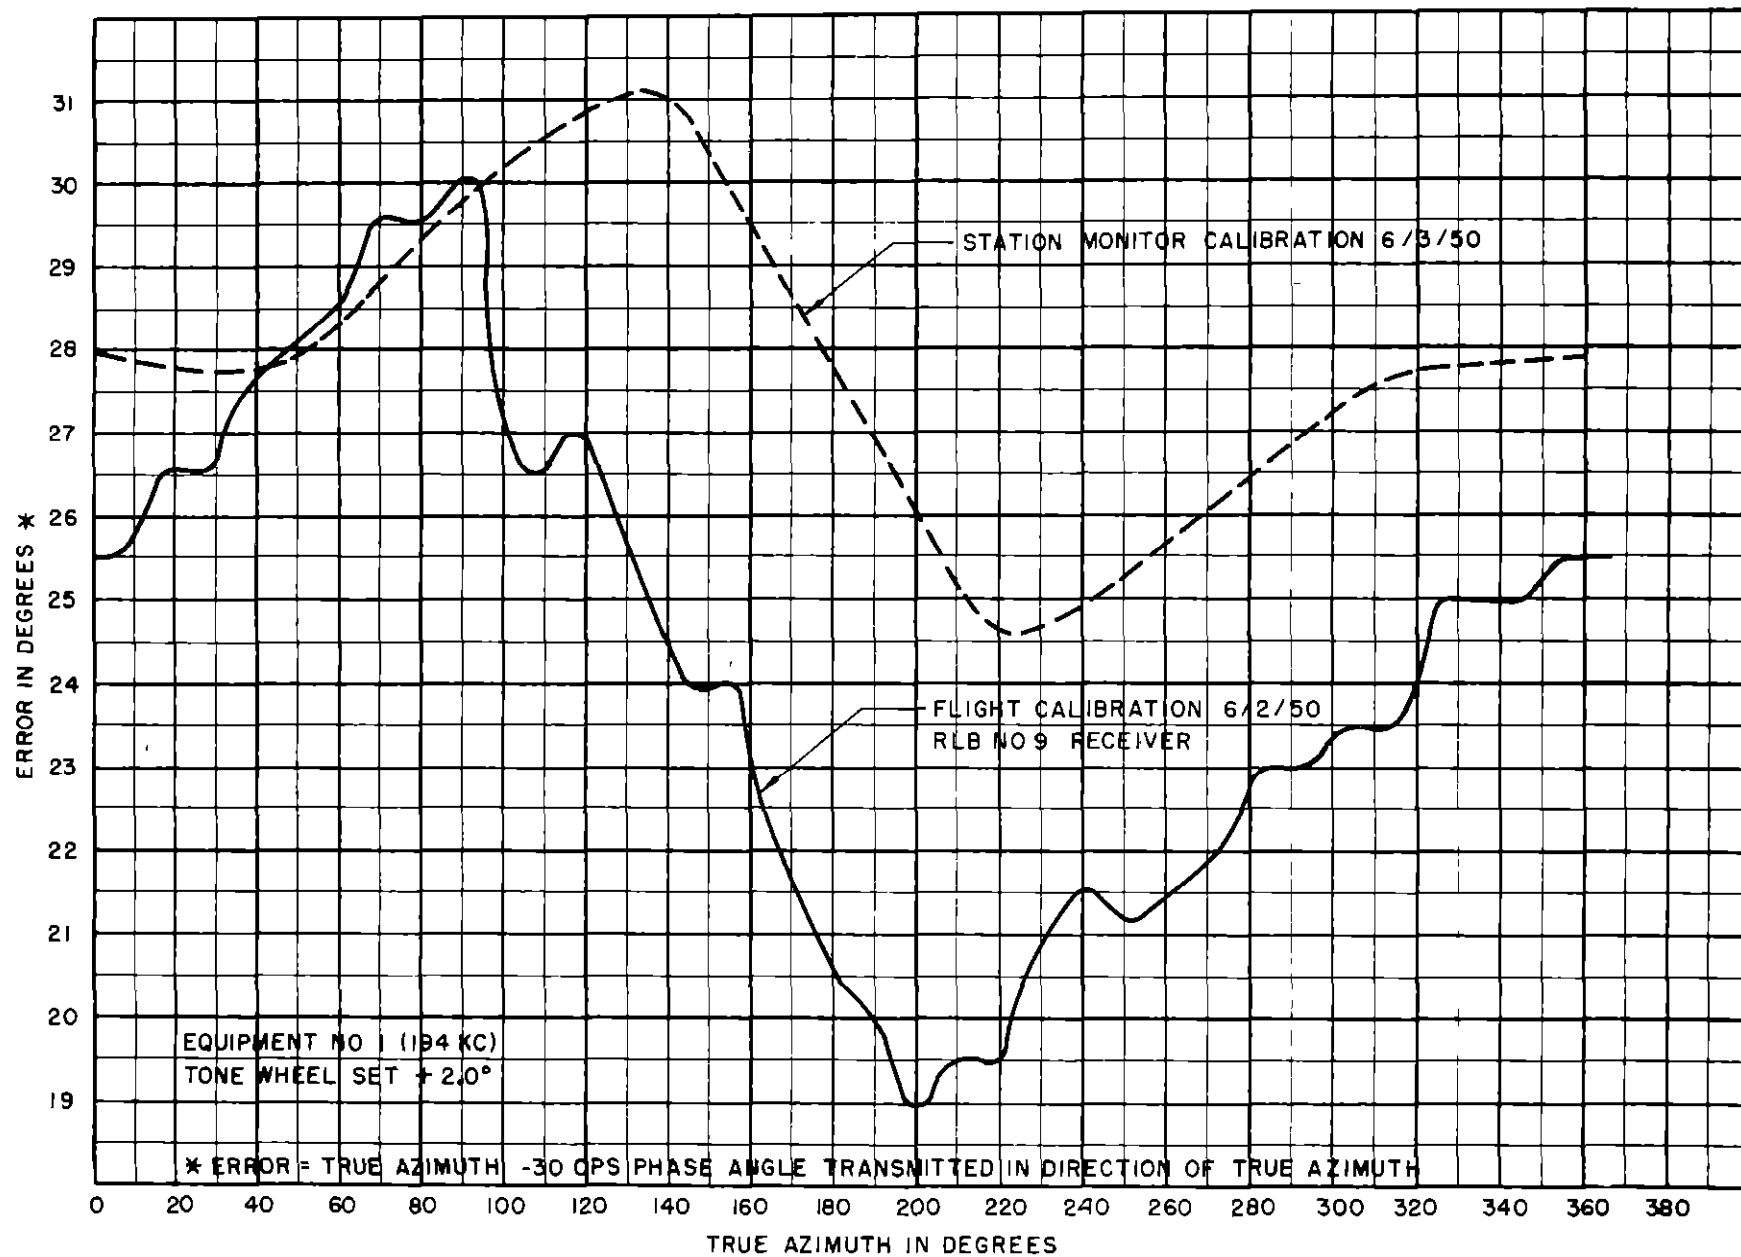
FIGURE 1 NANTUCKET MOR-MEASURED ERROR
VERSUS TRUE AZIMUTH

Immediately upon arrival at Nantucket, a flight calibration was made using equipment No. 1. Fig. 1 is a calibration of the No. 1 equipment made by flight test and with the station monitor. The two curves did not coincide, indicating that a theodolite calibration is necessary in calibrating MOR stations. The station monitor can be used only to check the stability of the station. This is the first weakness discovered in the monitoring equipment.

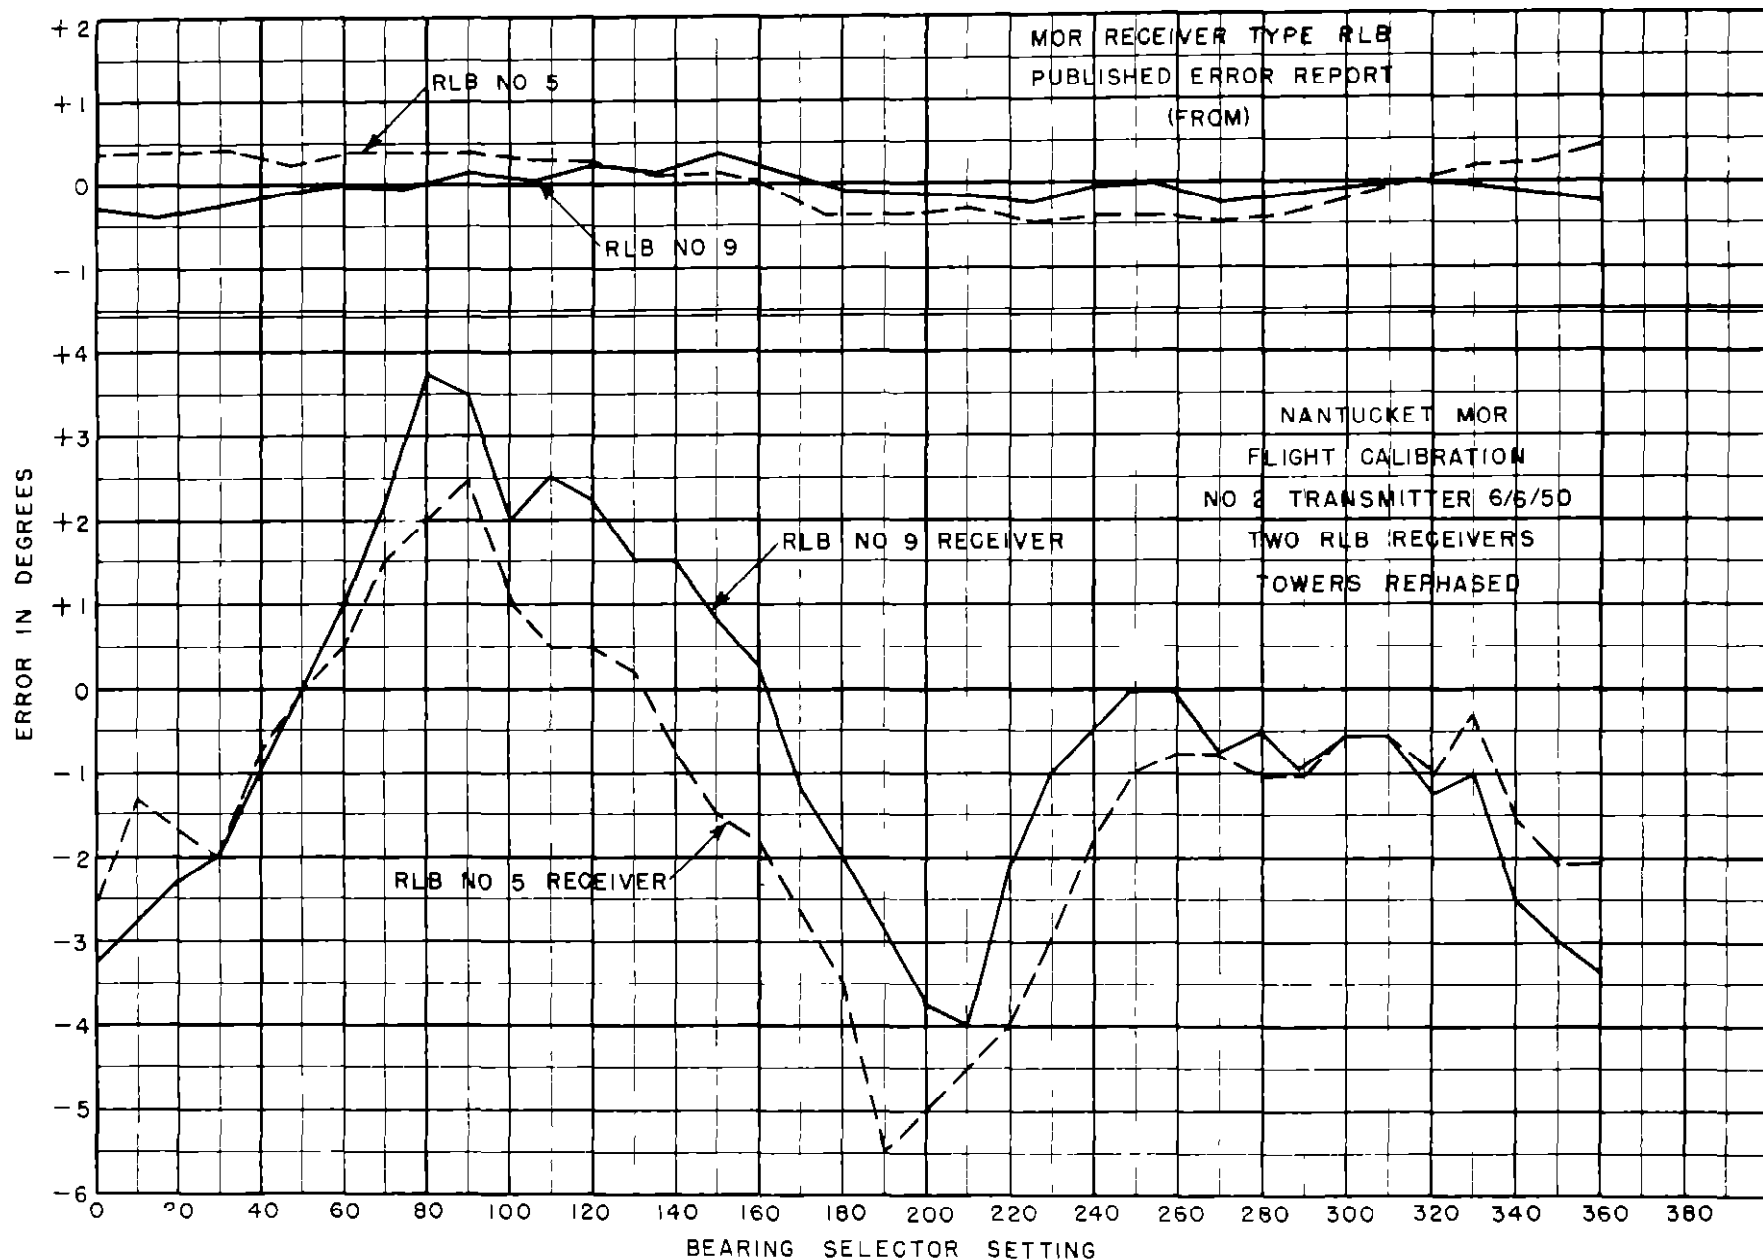
FIGURE 2 PUBLISHED ERROR CURVE AND
NANTUCKET MOR FLIGHT CALIBRATION

The center antenna match had changed since the original tune up from $70 + j0$ to $57.4 + jx$ ohms. The center antenna was rematched for $70 + j0$ ohms. Fig. 2 compared with Fig. 1 shows the effect of these adjustments on the flight calibration curve. The tone-wheel pick up had been set prior to recording data for Fig. 2.

A flight calibration made after rephasing the towers and reducing parasitic currents is shown in Fig. 2. One circle was flown with each of two RLB receivers to determine how well these receivers had been calibrated. An error curve published by Radio Receptor Co. for each of these receivers is included in the same illustration. Comparing these error curves it may be noted that at 120 degrees and at 310 degrees the receiver errors are the same. Since the flight calibrations, made an hour apart and using the same station equipment, show a difference of 1.75 degrees at an azimuth of 120 degrees; and since it is possible to repeat flight calibration data to within 0.5 degrees, it appears that the published calibration curves for RLB equipment may be in error by one degree under actual flight conditions.

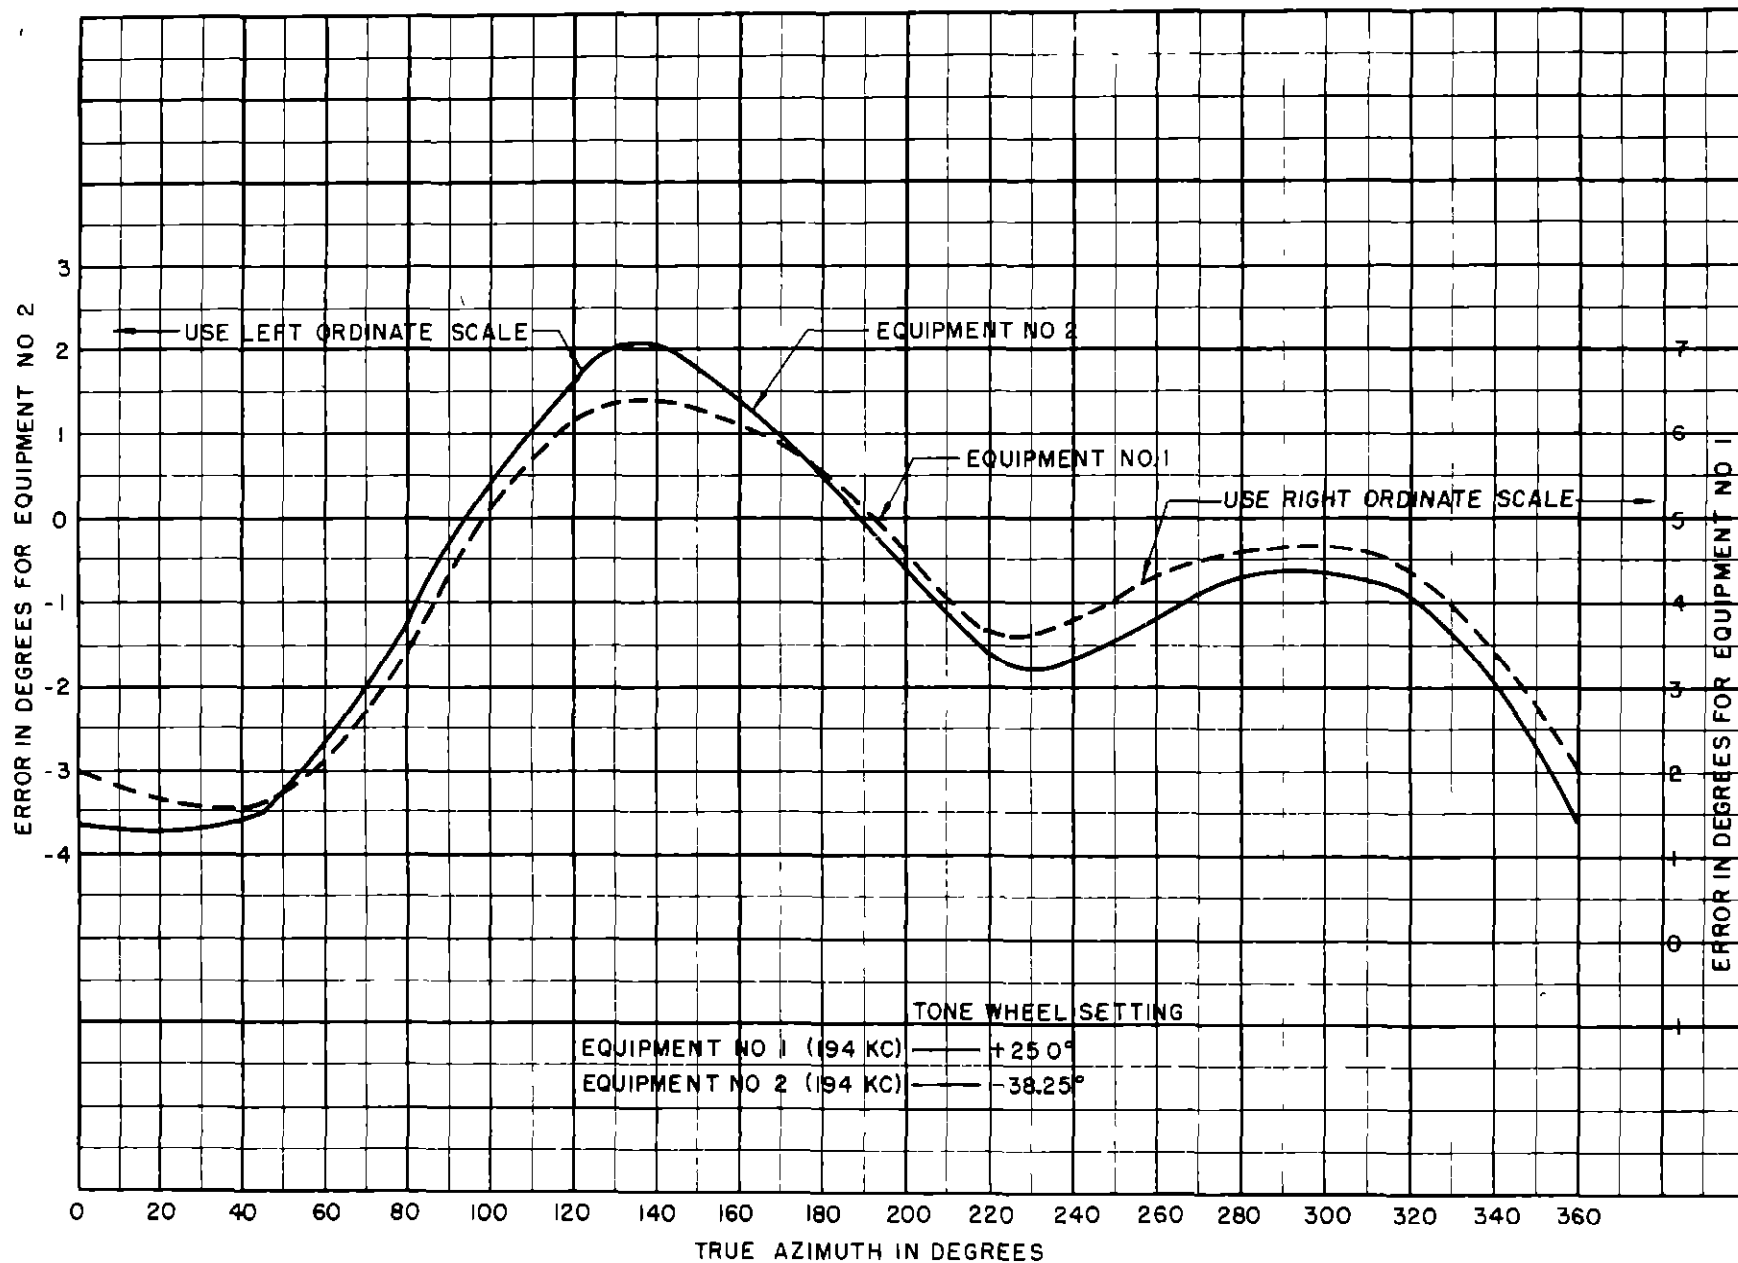
FIGURE 3 NANTUCKET MOR-STATION MONITOR
CALIBRATION OF STATION 6/9/50

Final calibration curves were taken. Fig. 3 shows station monitor curves, and Fig. 4 shows flight curves. The curves of Fig. 3 have been plotted to make them coincide as nearly as possible, but the ordinates are not coincident by five degrees. Yet, the curves of Fig. 4 show both equipments to be practically identical. This indicates a second weakness in the station monitor. The equipments (Nos. 1 and 2) appear to be different by five degrees to the station monitor, while they appear identical to the aircraft receiver. The station monitor probably picks up more stray signal from the No. 1 equipment than from the No. 2 equipment.

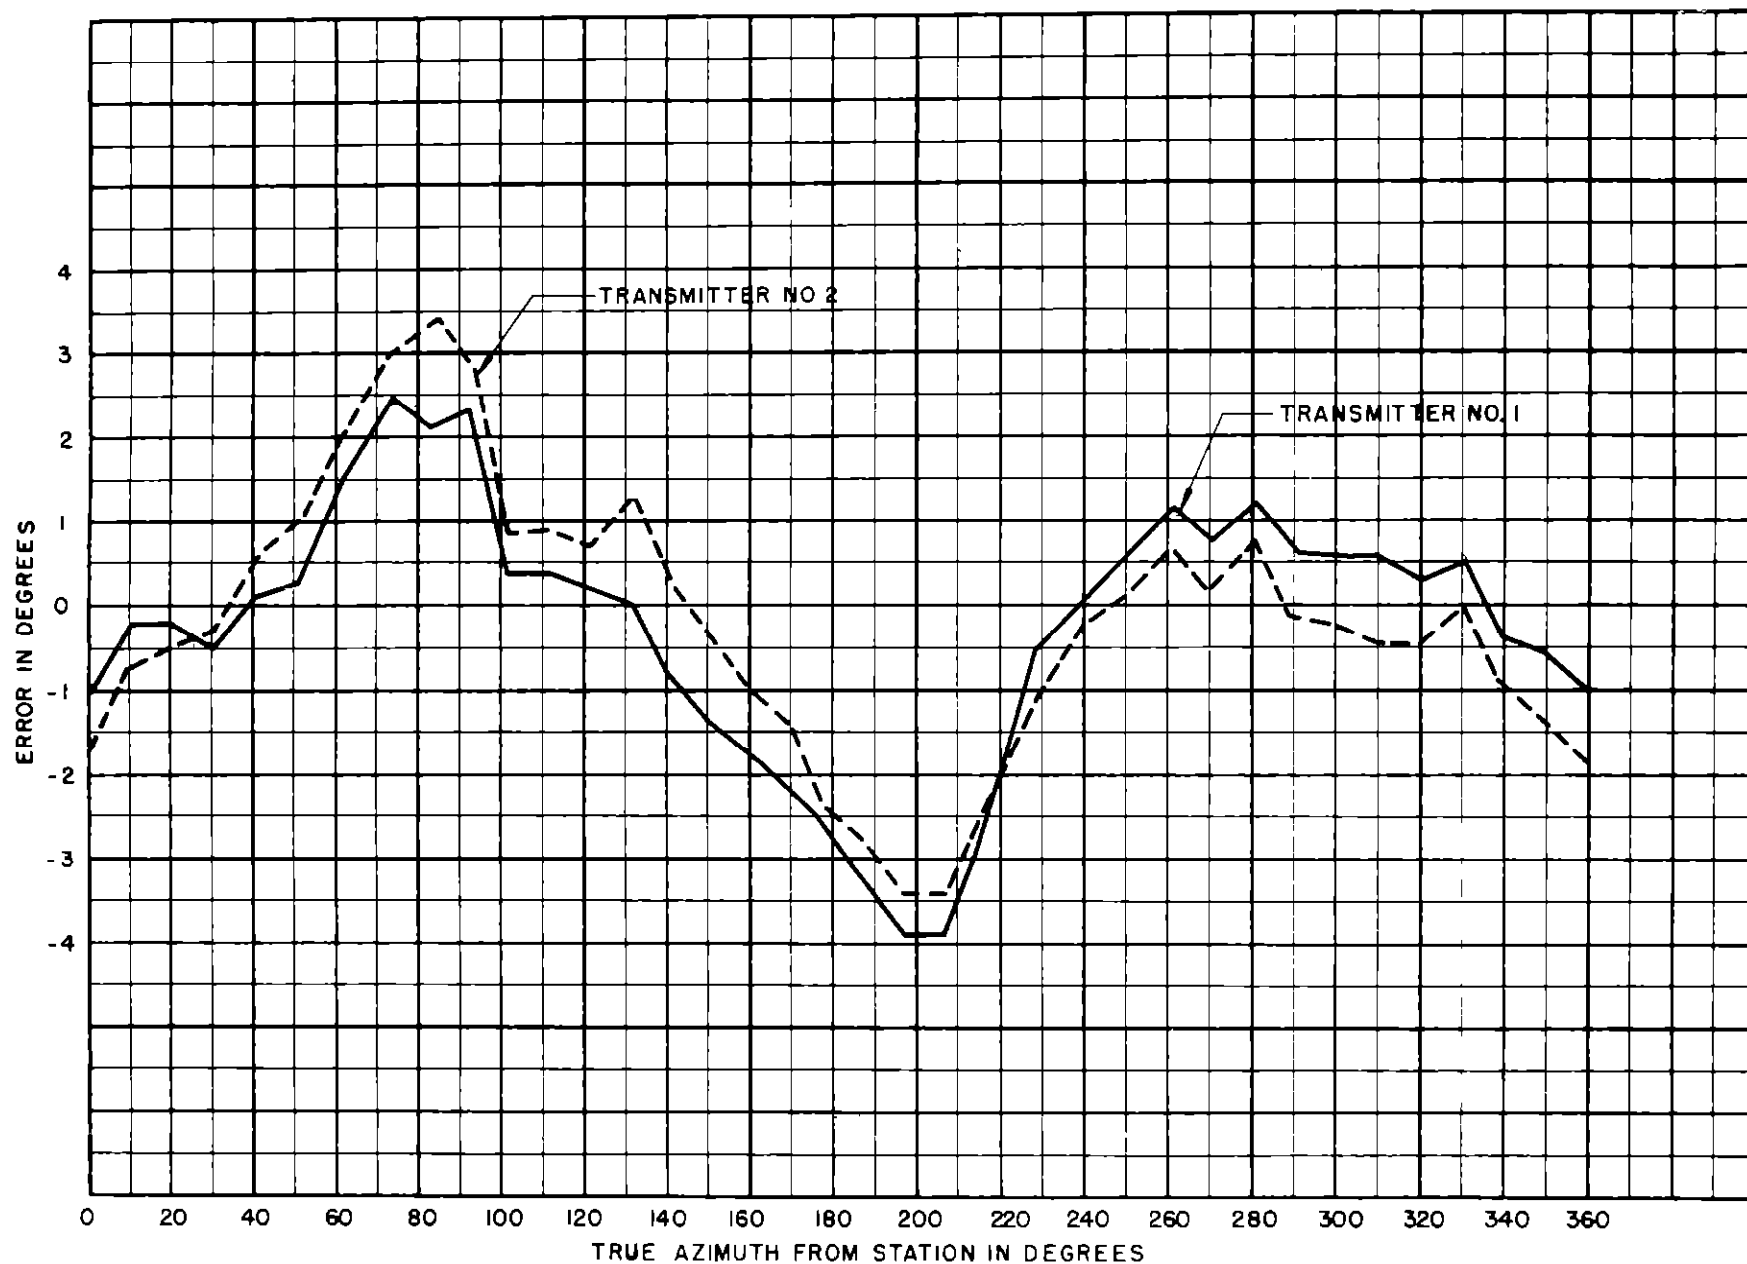
FIGURE 4 NANTUCKET MOR-STATION ERROR CURVE-PUBLISHED
RECEIVER ERROR REMOVED-RLB NO 9 RECEIVER 6/9/50

After a new transformer had been installed in the center tower and the towers had been rephased again, two more flight calibration circles were made, one with each transmitter and goniometer. See Fig. 7. A final flight calibration of each equipment, after tone wheel adjustment was made on June 9, 1950, to bring the curves together, is shown in Fig. 4. This curve may

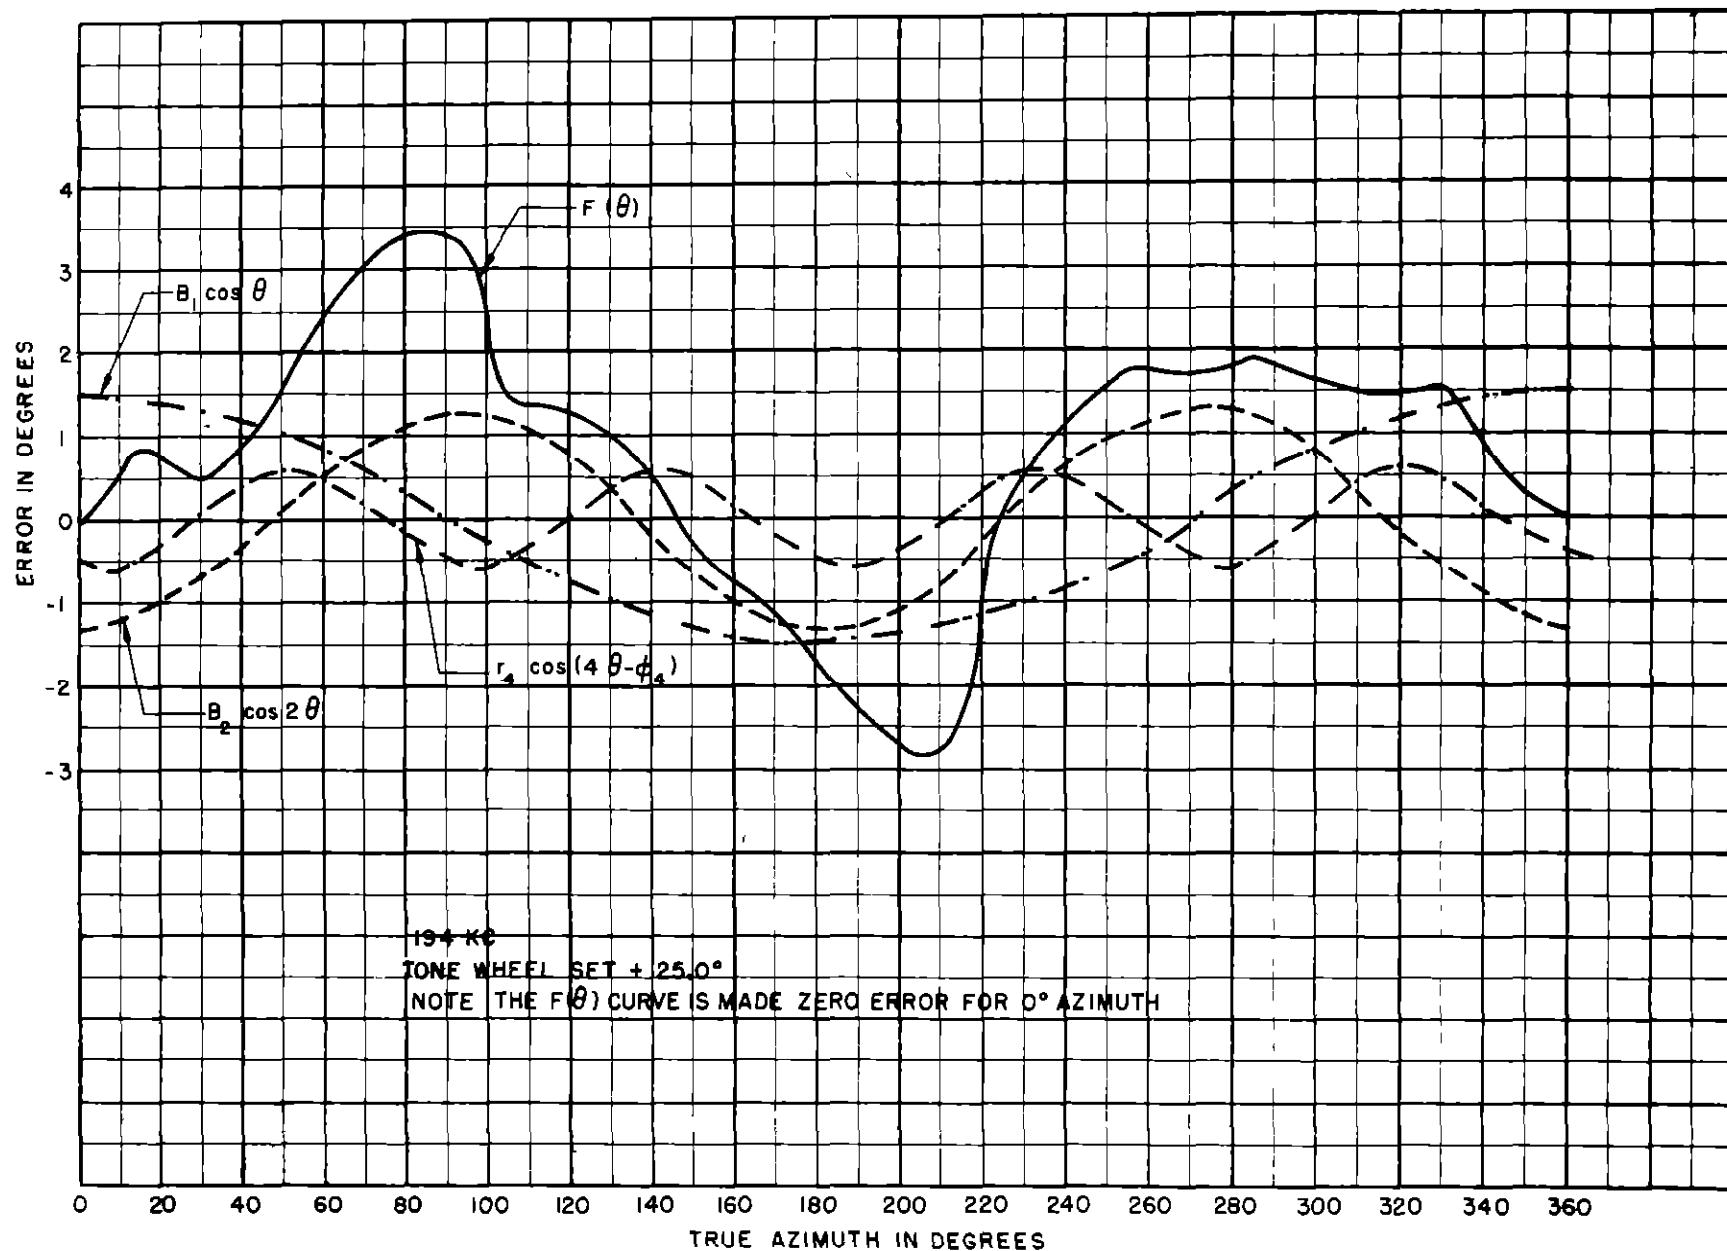
FIGURE 5 NANTUCKET MOR-EQUIPMENT NO 1 STATION ERROR
 CURVE AND SIGNIFICANT TERMS OF A FOURIER ANALYSIS
 OF STATION ERROR CURVE

Fig. 5 is a plot of the flight calibration curve, $F(\theta)$, of the No. 1 equipment and the larger terms of an approximate Fourier analysis. Table I shows the magnitudes of the various terms and possible causes of error. The analysis indicates that the measured error curve is rather complex and is caused by a number of faults.

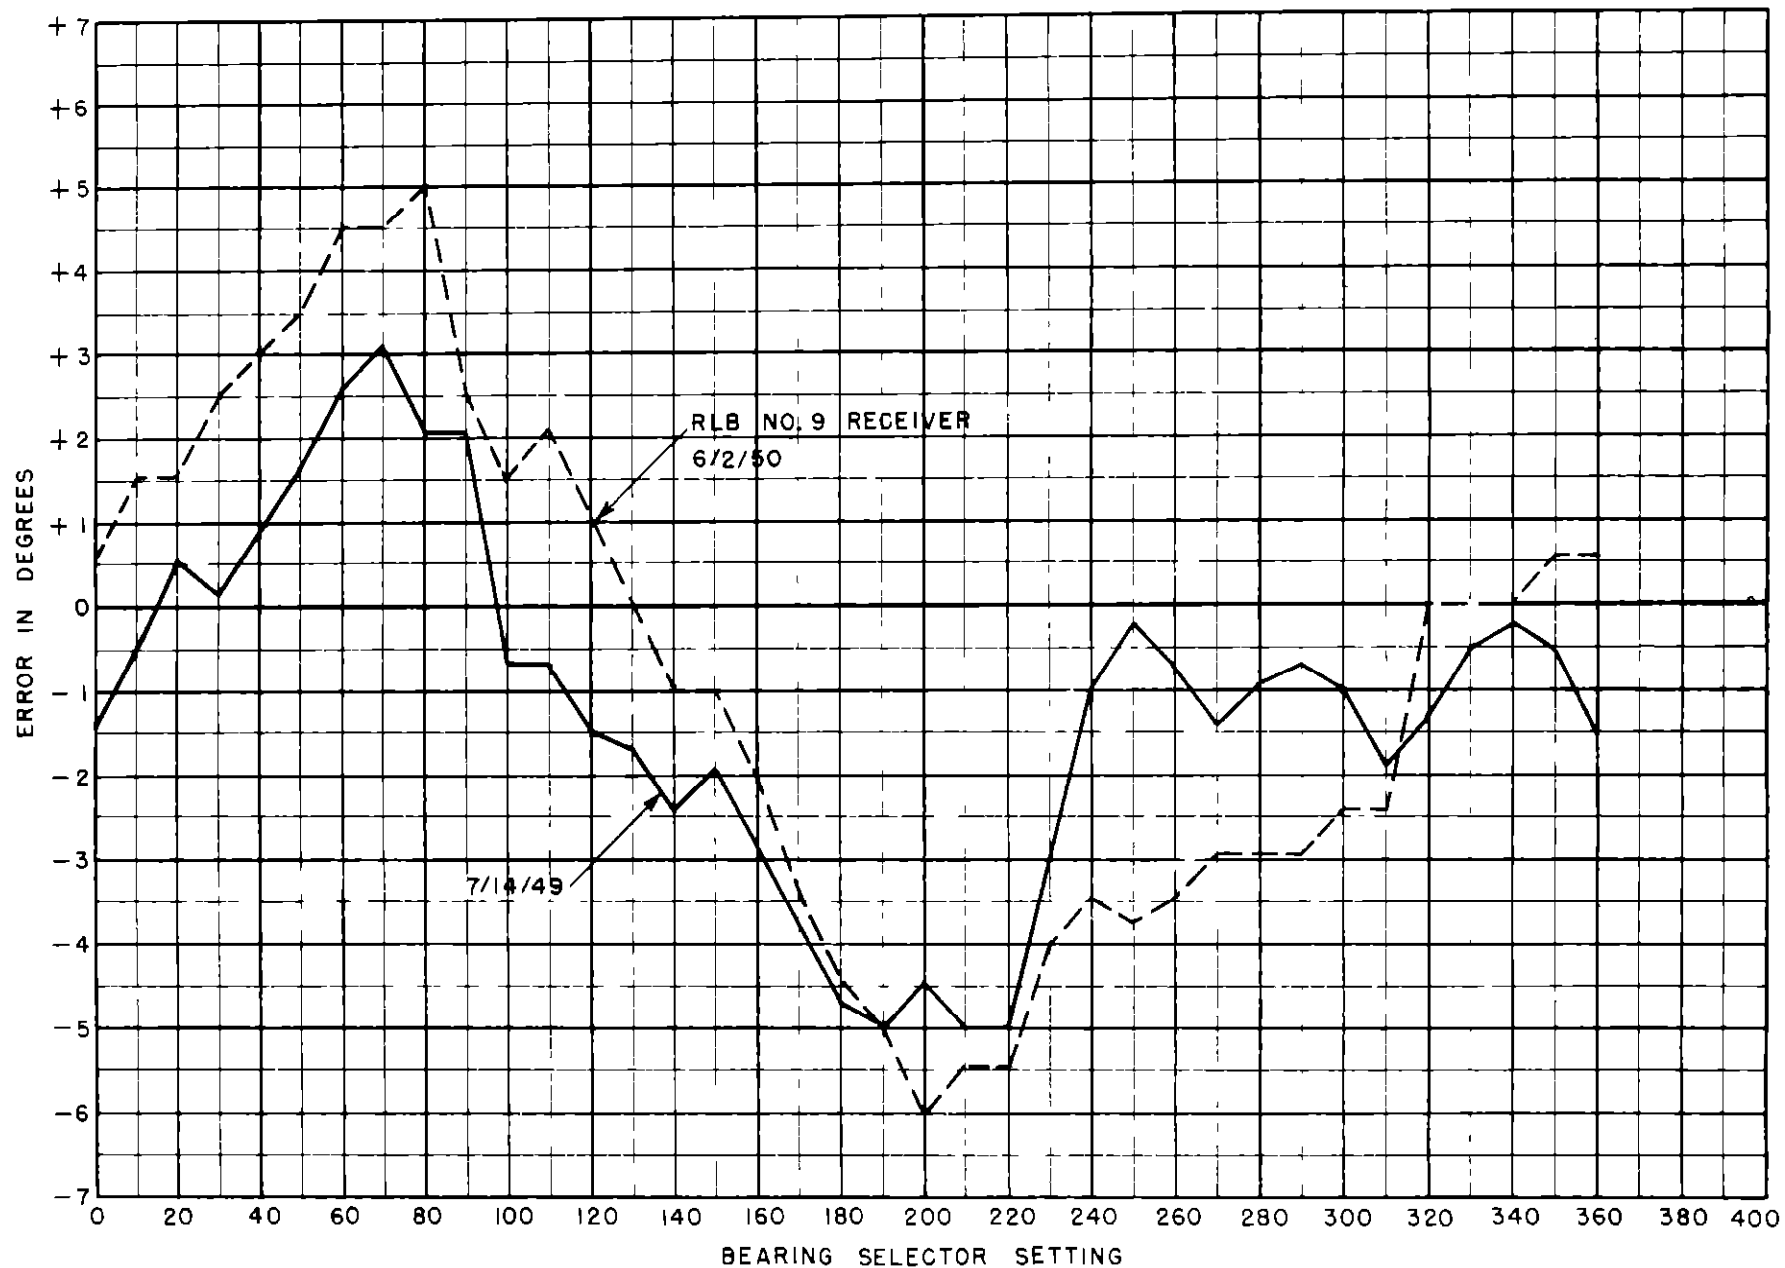
FIGURE 6 NANTUCKET MOR FLIGHT CALIBRATION

On arrival at Nantucket, a flight calibration of the station was made immediately to determine how well the flight calibration of July 14, 1949 had held. These curves are shown in Fig. 6 for comparison.
