# **HAILSTONE IMPACT TESTS ON AIRCRAFT STRUCTURAL COMPONENTS**

By  
Pell Kangas  
Aircraft Division

Technical Development Report No. 124

**CIVIL AERONAUTICS ADMINISTRATION  
TECHNICAL DEVELOPMENT AND  
EVALUATION CENTER  
INDIANAPOLIS, INDIANA**

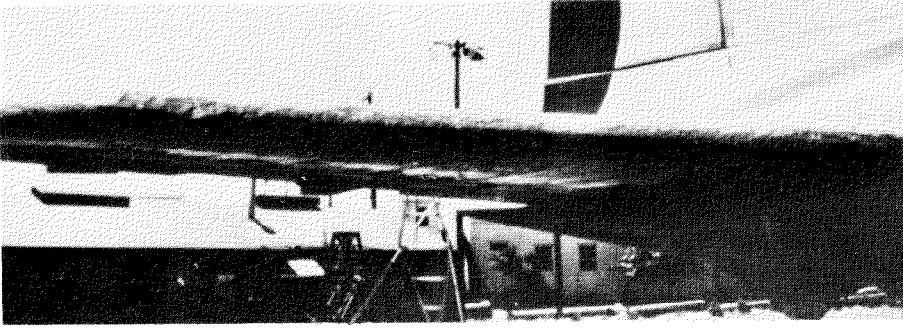
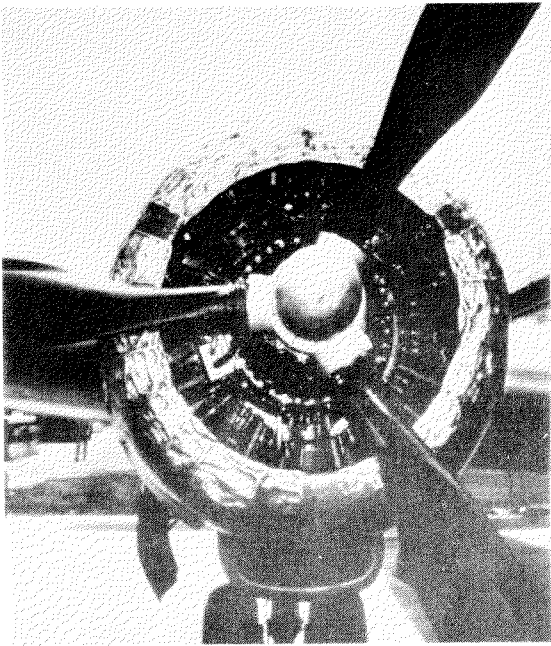
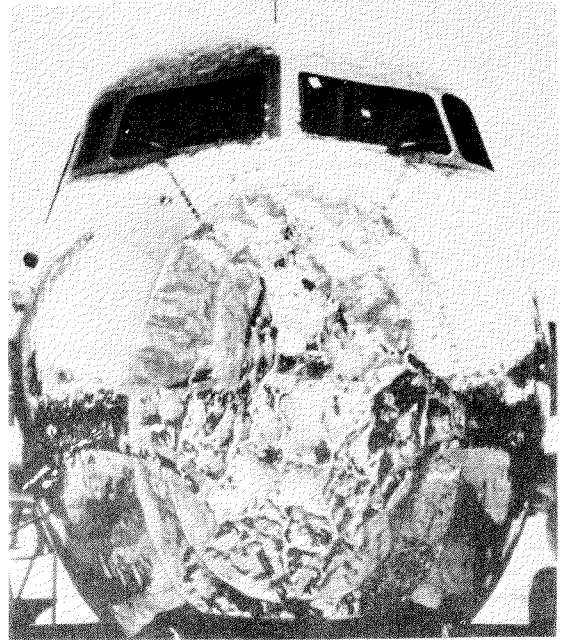
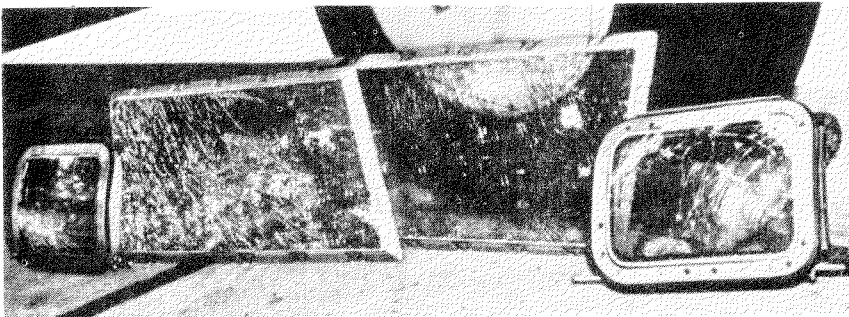
Fig. 1 Examples of Hailstone Damage on the Aircraft Structure

No study of the frequency of occurrence of airplane hail damage has been made by this office. A few reports of hailstone damage to aircraft have been submitted voluntarily by some of the airline operators. The hailstone damage shown in Fig. 1 is typical of the most severe cases and indicates the extent and general character of the damage which can result from a single hailstorm of short duration.

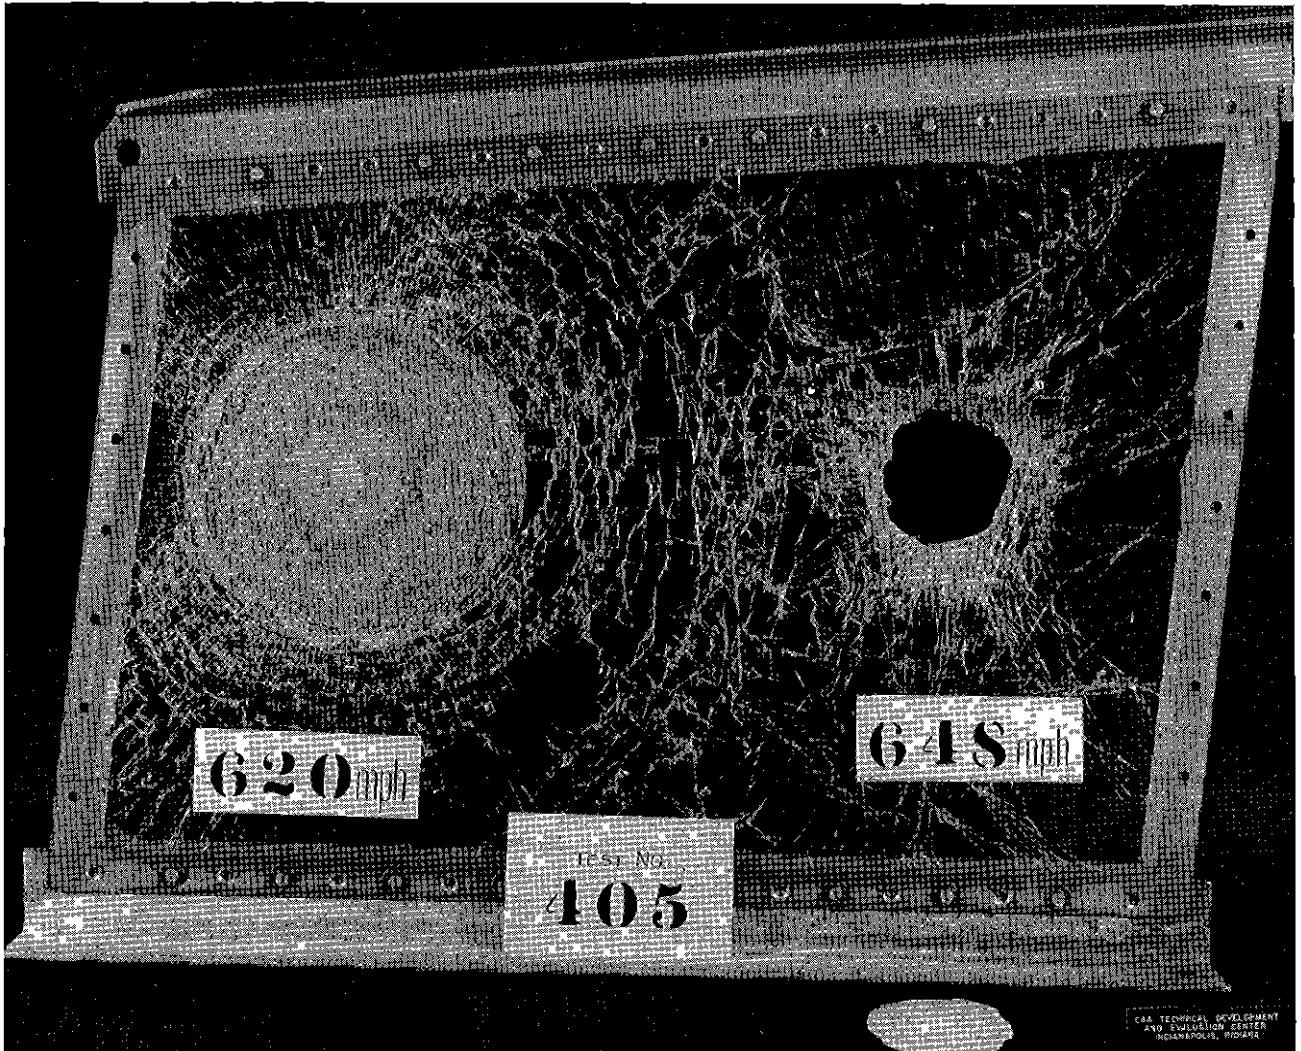
Fig 5 Results of Tests With 1 88-Inch Ice Spheres on a 0 188-Inch Vinyl Plastic Laminated Windshield Pane at 80°F and 0° Slope

There are shown in Fig 5 the results of tests with 1 88-inch ice spheres on a 0 188-inch vinyl plastic laminated windshield pane tested at 0° slope. Projecting the ice pellet at 620 mph caused no failure in the plastic, whereas at 648 mph total penetration occurred. The median between these two values, or 634 mph, is considered to be the approximate penetration velocity at 0° slope.

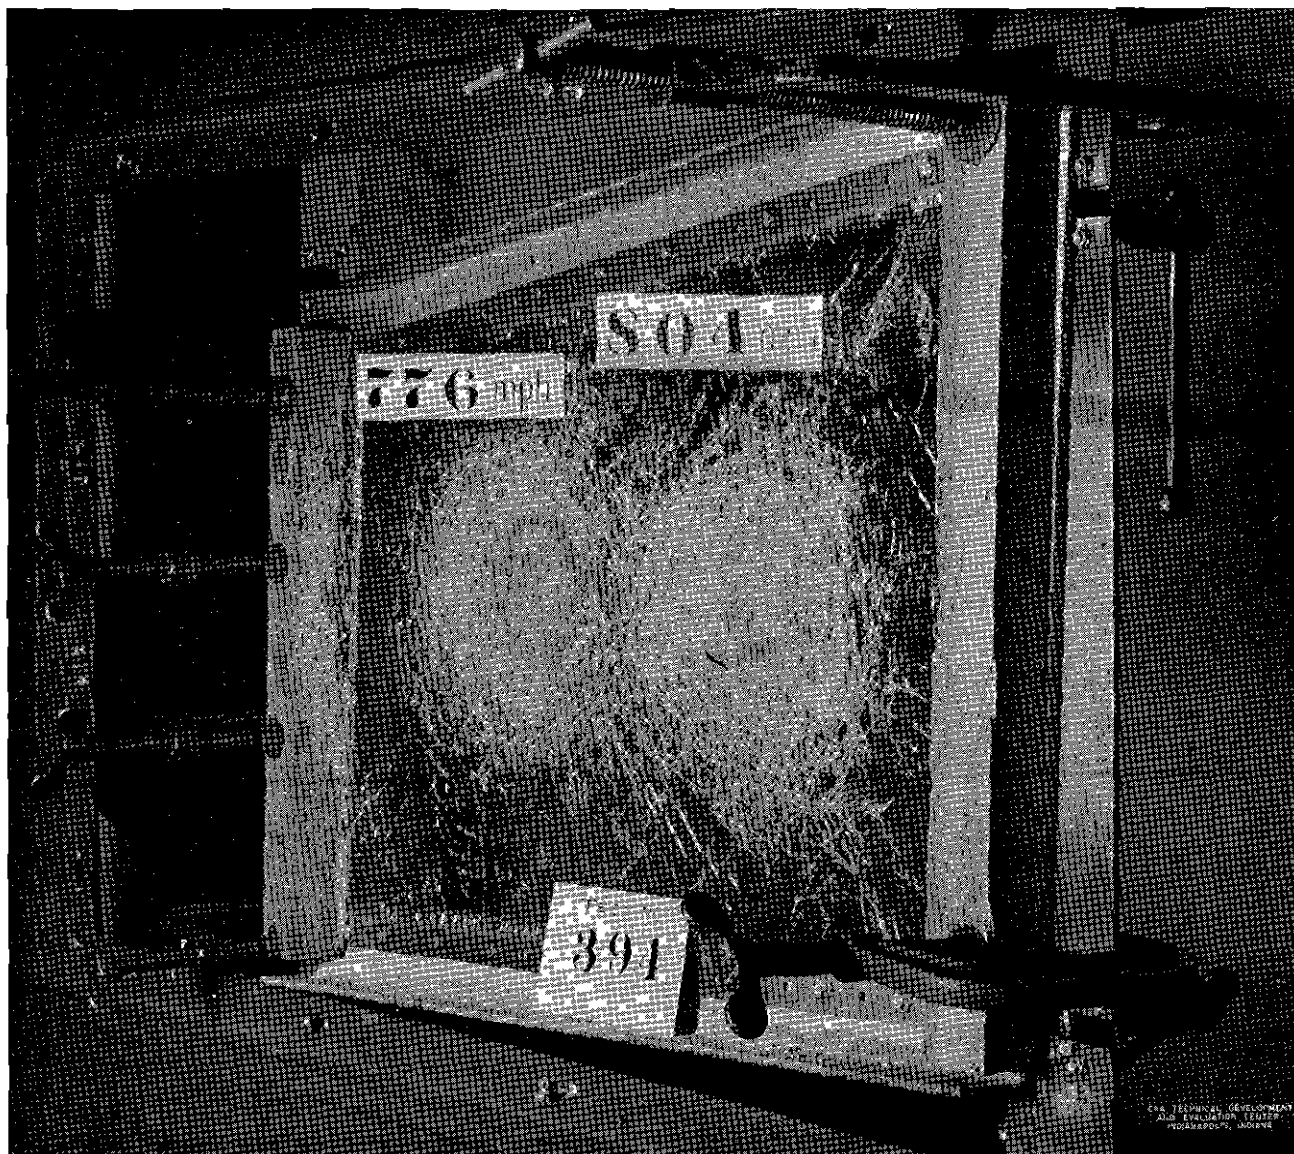
Fig 6 Results of Tests With 1 88-Inch Ice Spheres on a 0 188-Inch Vinyl Plastic Laminated Windshield Pane at 80°F and 60° Slope

In Fig 6 are shown results of tests on this pane with the angle of slope increased to 60°. The small tear resulting from impact at 804 mph is considered to be a borderline failure, and consequently was recorded as the value of penetration velocity.

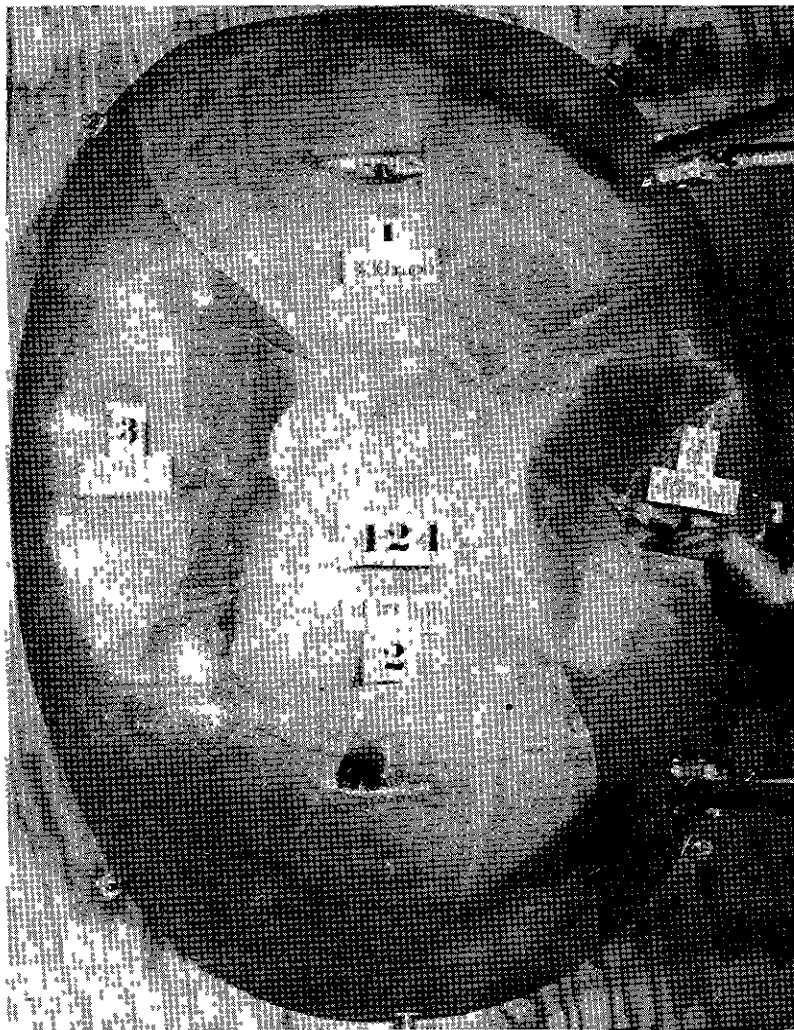
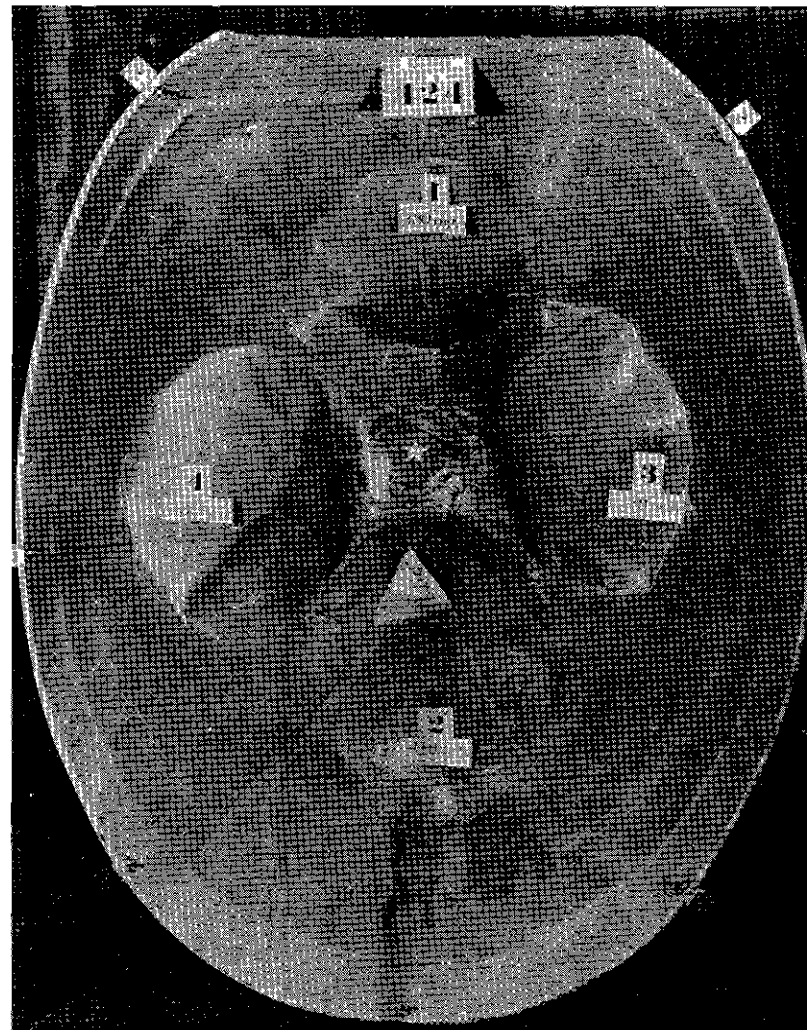
Fig 8 Results of Hailstone Impact Tests on Radome C, Front and Rear Views

**Radome C** - This radome nose section withstood complete penetration from impact at a  $90^\circ$  angle of incidence of a single 2-inch ice sphere at velocities as great as 480 mph. Penetration occurred only in the front or outer membrane at speeds ranging from 380 to 480 mph, as shown in Table IV. In Fig 8 is shown the manner in which the rear or inner membrane was not penetrated, but instead was forced to bulge inward at these velocities. No real difference as to extent of damage was noted between the four tests of this radome, except for Test 424-3, Table II, where no penetration of the outer membrane occurred.

The strength of Radome C was significantly increased over that indicated by Radome B. The penetration velocity for Radome C was not determined because only partial failure was recorded at 480 mph. The in-

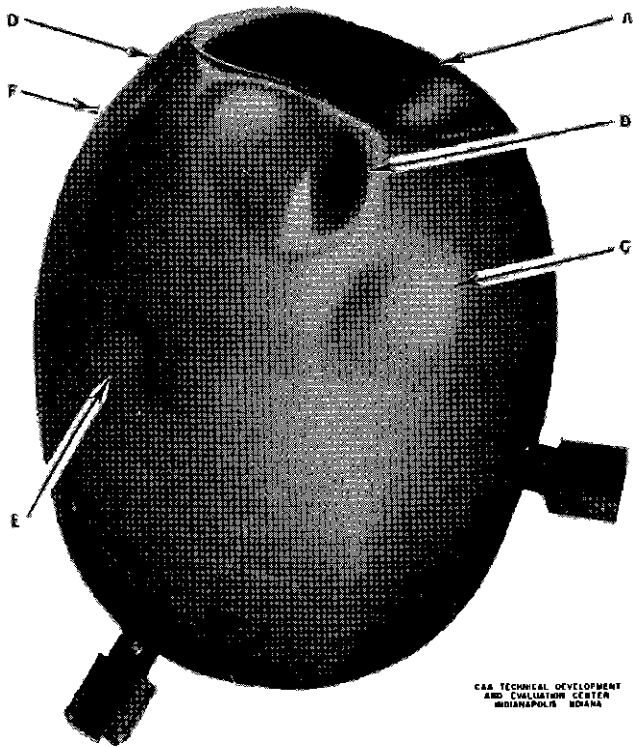
Fig 9 Results of Impact Tests With Ice Spheres on DC-6 Propeller Dome

Impact tests on the DC-6 propeller dome were made with 0.75-, 1.25-, and 1.88-inch ice balls at velocities ranging from 302 to 360 mph. The 1.88-inch diameter ice ball projected at 317 mph caused an indentation 1.33 inches deep. At approximately 300 mph, the 1.25-inch ice ball formed a dent 0.46 inch deep and the 0.75-inch ice ball formed a dent 0.14 inch deep. The 0.75-inch ice balls were also shot at 338 mph to form a dent 0.13 inch deep and, at 360 mph to form an indentation of 0.28 inch.

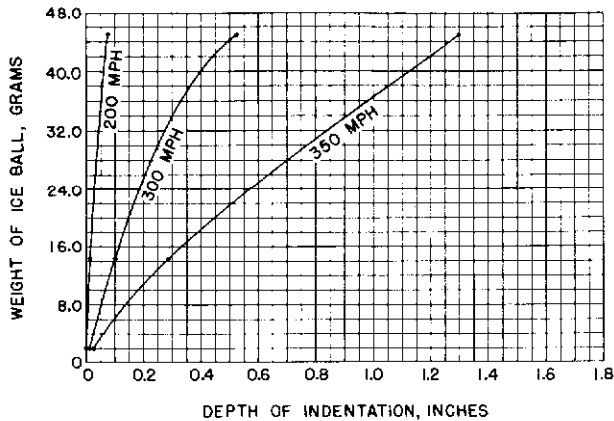
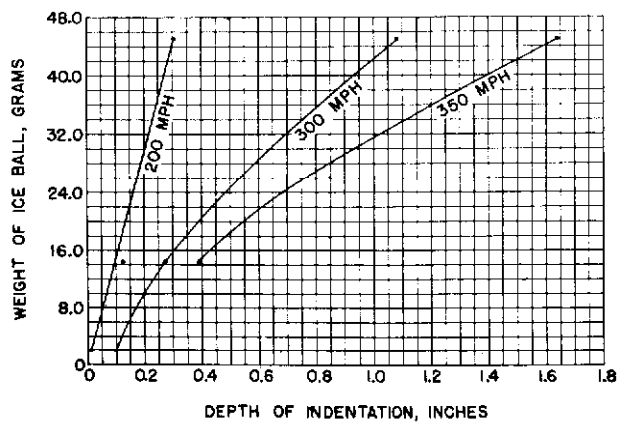
Fig. 14 Effect of Impact Velocity on the Extent of Damage to Aluminum Wing Section

The effect of mass of the hailstone on the extent of damage, as measured by the depth of indentation at various impact velocities, is shown in Figs. 14A and 14B.

The 0.75-inch diameter ice ball, weighing about 2.3 grams, caused indentations in the wing sections of less than 0.1 inch in the 0.040-inch, 75S-T aluminum at velocities up to 400 mph. The 0.045-inch, 24S-T material, similarly tested, showed comparable indentations at velocities of about 100 mph less.

stone, weighing about 14.5 grams, caused initial indentations of 0.1 inch to occur at approximately 300 mph in the 75S-T material and at 180 mph in the case of the 24S-T specimen. At higher velocities, the depth of indentations was nearly the same for similar velocities. For example, a 0.5-inch deep indentation occurred at approximately 380 mph for both materials.

The curves in Figs. 14A and 14B, which are based on the tests with the 1.88-inch diameter ice spheres weighing about 45 grams, were less steep than those obtained with the lighter weight ice balls. In other words, with slight increases in impact velocity, the depth of indentation is increasingly greater. Initial indentations measured at 0.1 inch occurred at about 200 mph for the 75S-T material and at 120 mph for the 24S-T material. For a 1-inch indentation, the ice ball velocity for the 75S-T materials was 330 mph and at 350 mph the depth of indentation was doubled to two inches. The corresponding values for 24S-T specimen were 300 mph for 1-inch indentation and about 350 mph for 2-inch indentation, or the same velocity as that required for a 2-inch indentation in the 75S-T aluminum.

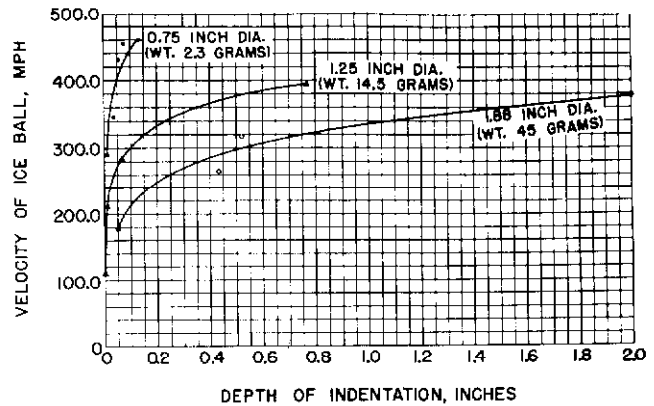
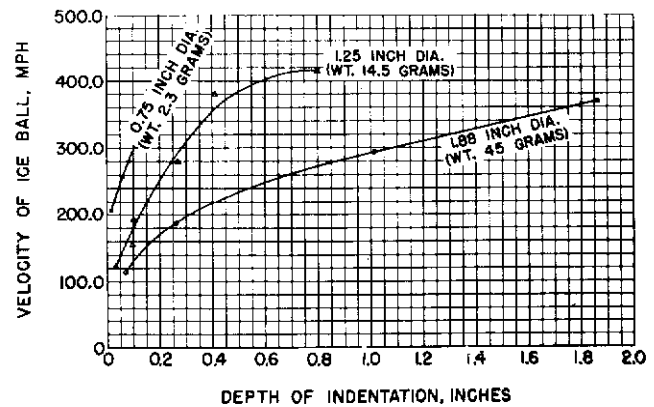
Fig. 15 Effect of Mass of Ice Spheres on Extent of Indentation on Aluminum Wing Section

limited to dents less than 0.1 inch deep for ice balls weighing up to 45 grams projected at the 75S-T aluminum, and similarly, the dents were limited to less than 0.3 inch deep for the 24S-T specimen. The 300-mph curves show proportionately greater indentation with increasing ice-ball weight, and a corresponding difference between the two materials, however, at 350 mph the difference between the extent of indentation caused by similar size ice balls on the two types of aluminum appears to be very slight.

tent of damage with ice balls of various weights is shown in Figs 15A and 15B. At a velocity level of 200 mph, the extent of damage was
