TECHNICAL DEVELOPMENT REPORT NO. 158

AN INVESTIGATION OF TEMPERATURE CONDITIONS
IN THE PROXIMITY OF JET AIRCRAFT
EXHAUST SYSTEM FAILURES

By
Charles A. Hughes

CIVIL AERONAUTICS ADMINISTRATION
TECHNICAL DEVELOPMENT
AND EVALUATION CENTER
INDIANAPOLIS, INDIANA

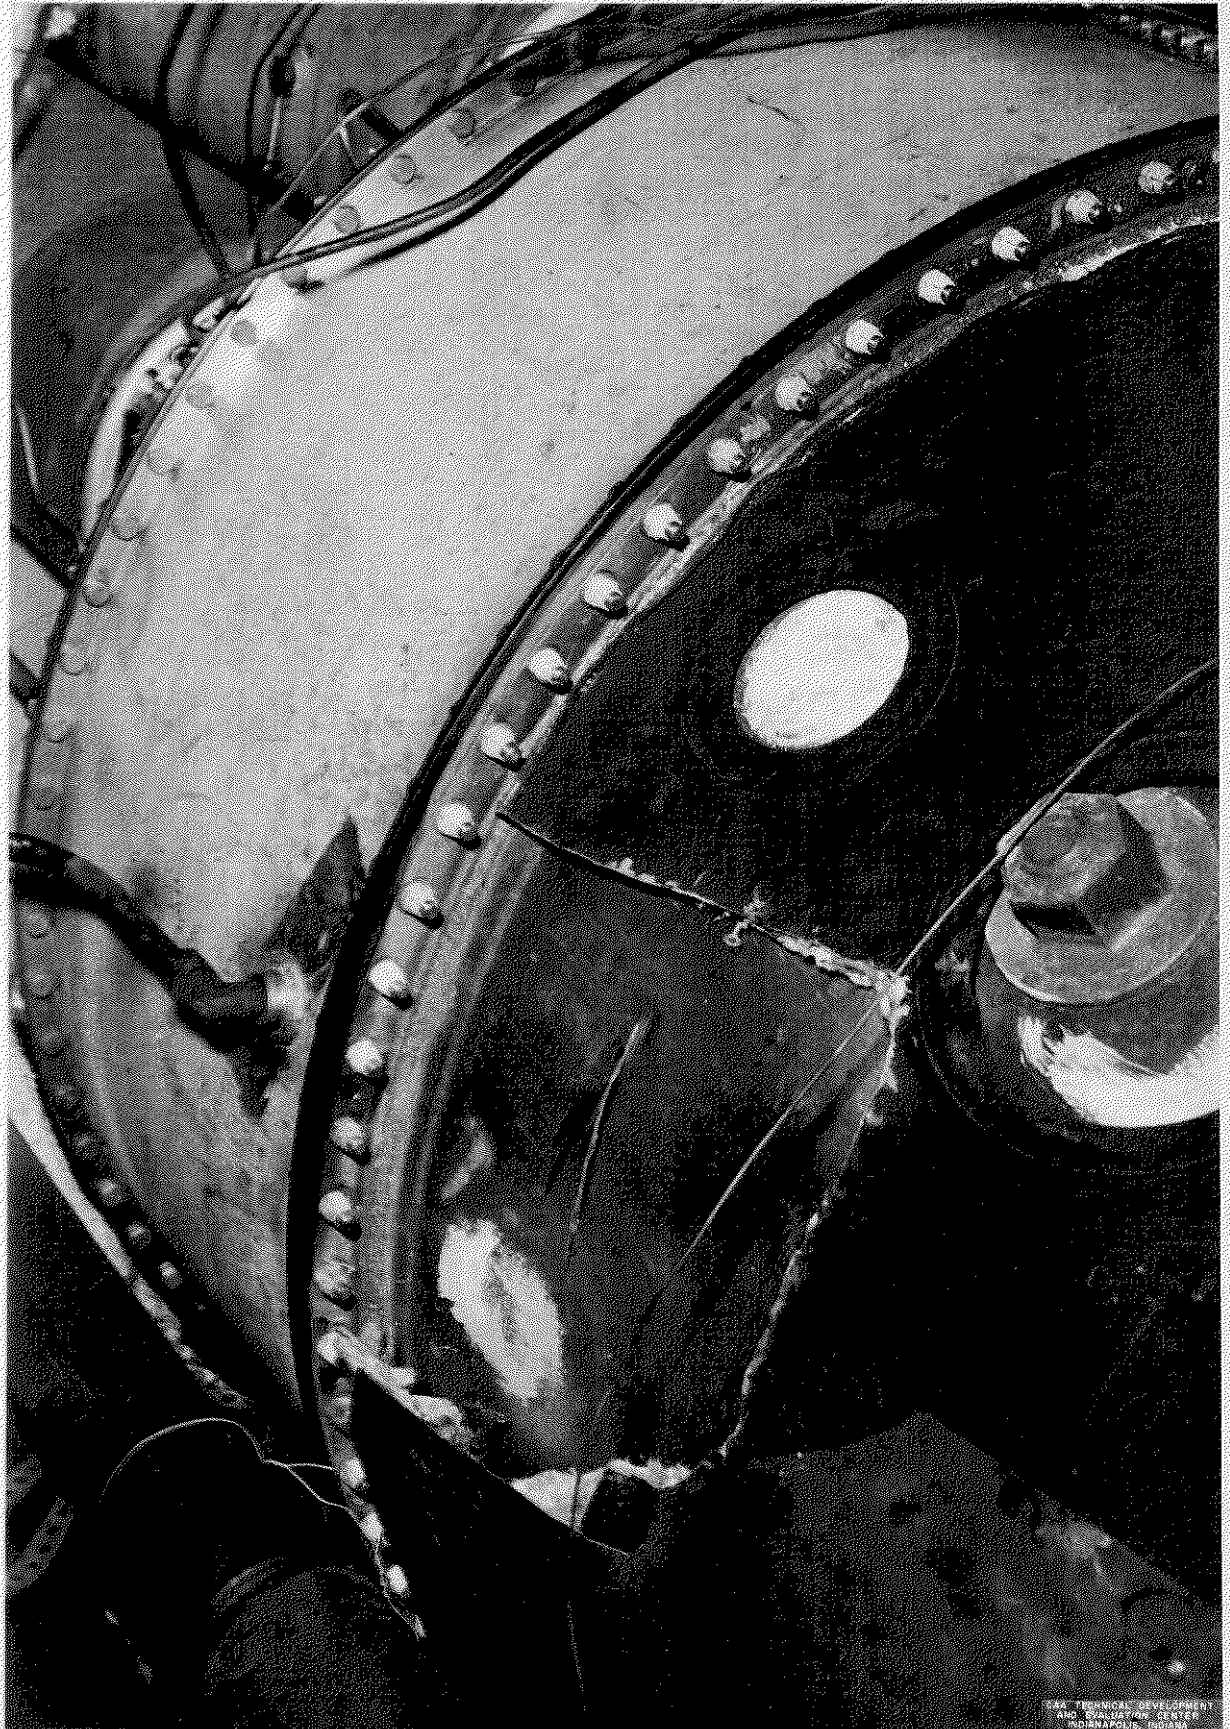
Thermocouple Locations	Maximum Recorded Temperature (°F)		
	No Crack	4 in. x $1/32$ -in. Crack	4 in. x $3/32$ -in. Crack
Adjacent to crack in tail cone	300	500	610
4 in. aft of crack	300	460	515
8 in. aft of crack	300	375	320
12 in. aft of crack	300	330	310

Thermocouple Locations	Maximum Rate of Temperature Rise ($^{\circ}\text{F}/\text{sec.}$)		
	No Crack	4 in. x 1/32-in. Crack	4 in. x 3/32-in. Crack
Adjacent to crack			
in tail cone	2.5	7.5	11.5
4 in. aft of crack	2.5	6.5	10.0
8 in. aft of crack	2.5	4.5	5.0
12 in. aft of crack	2.5	3.8	2.5

FIG. 1 4" x $\frac{1}{32}$ " SIMULATED CRACK IN TAIL CONE

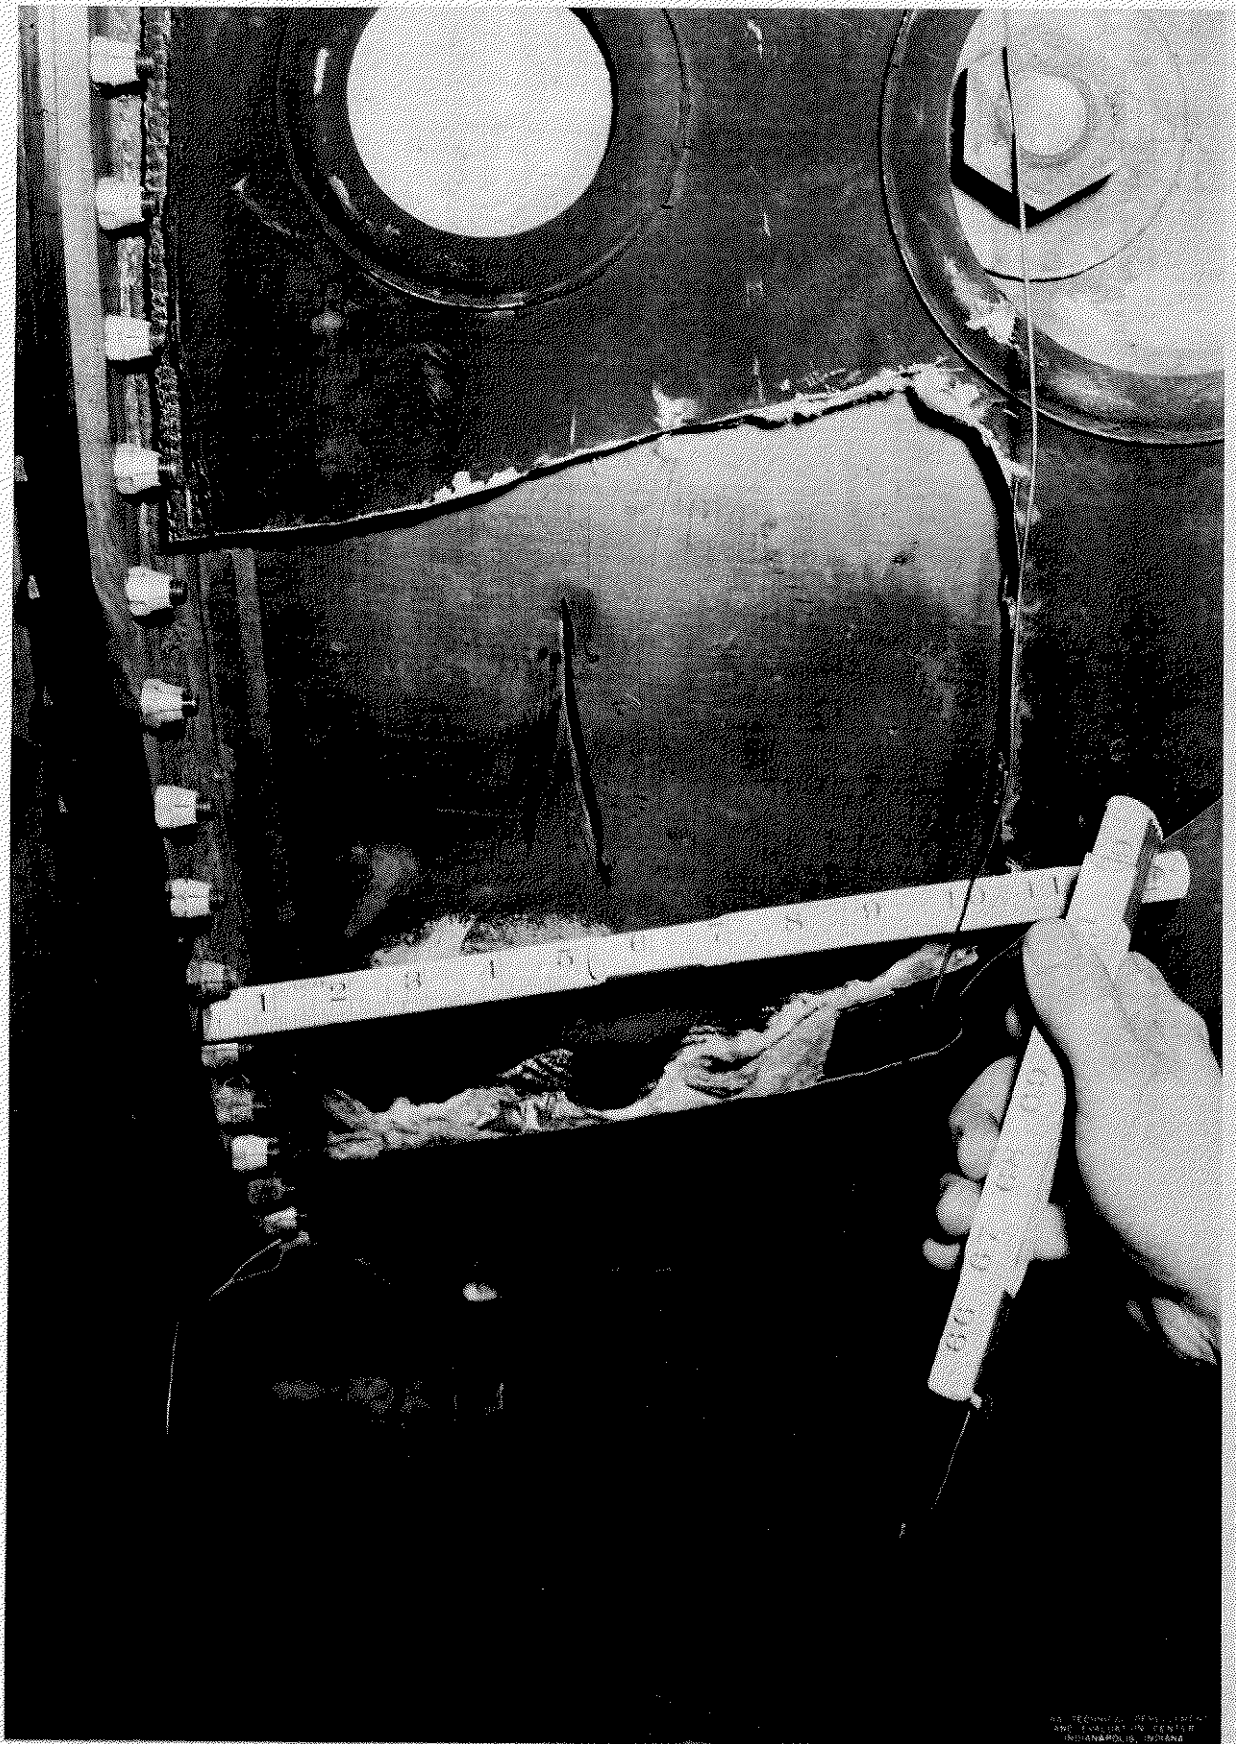
Thermocouple Locations	Maximum Recorded Temperature ($^{\circ}\text{F}$)		
	No Crack	4 in. x 3/32-in. Crack	9 in. x 5/32-in. Crack
Adjacent to crack			
in tail cone	315	680	700
4 in. aft of crack	315	470	575
8 in. aft of crack	315	400	345
12 in. aft of crack	315	380	315

FIG. 2 4" X $\frac{3}{32}$ " SIMULATED CRACK IN TAIL CONE

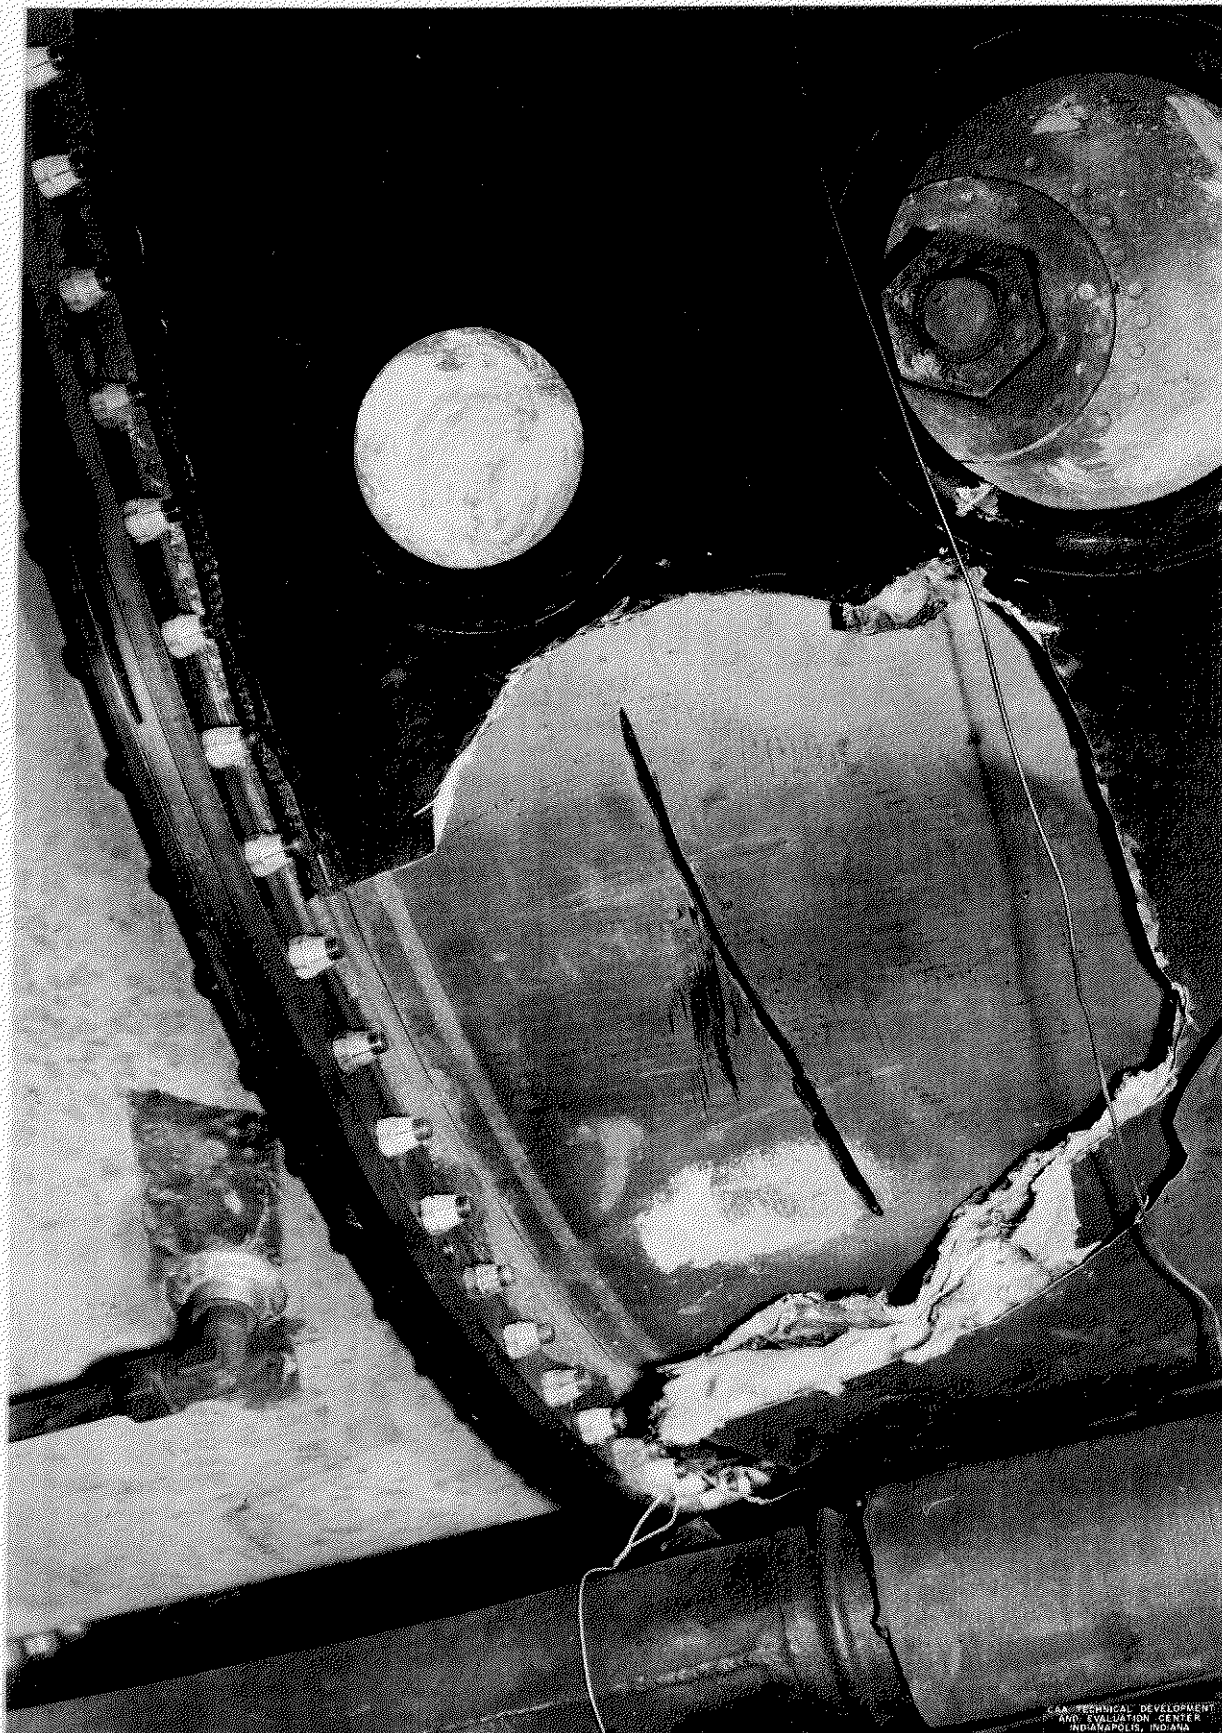
FIG. 3 9" x $\frac{5}{32}$ " SIMULATED CRACK IN TAIL CONE

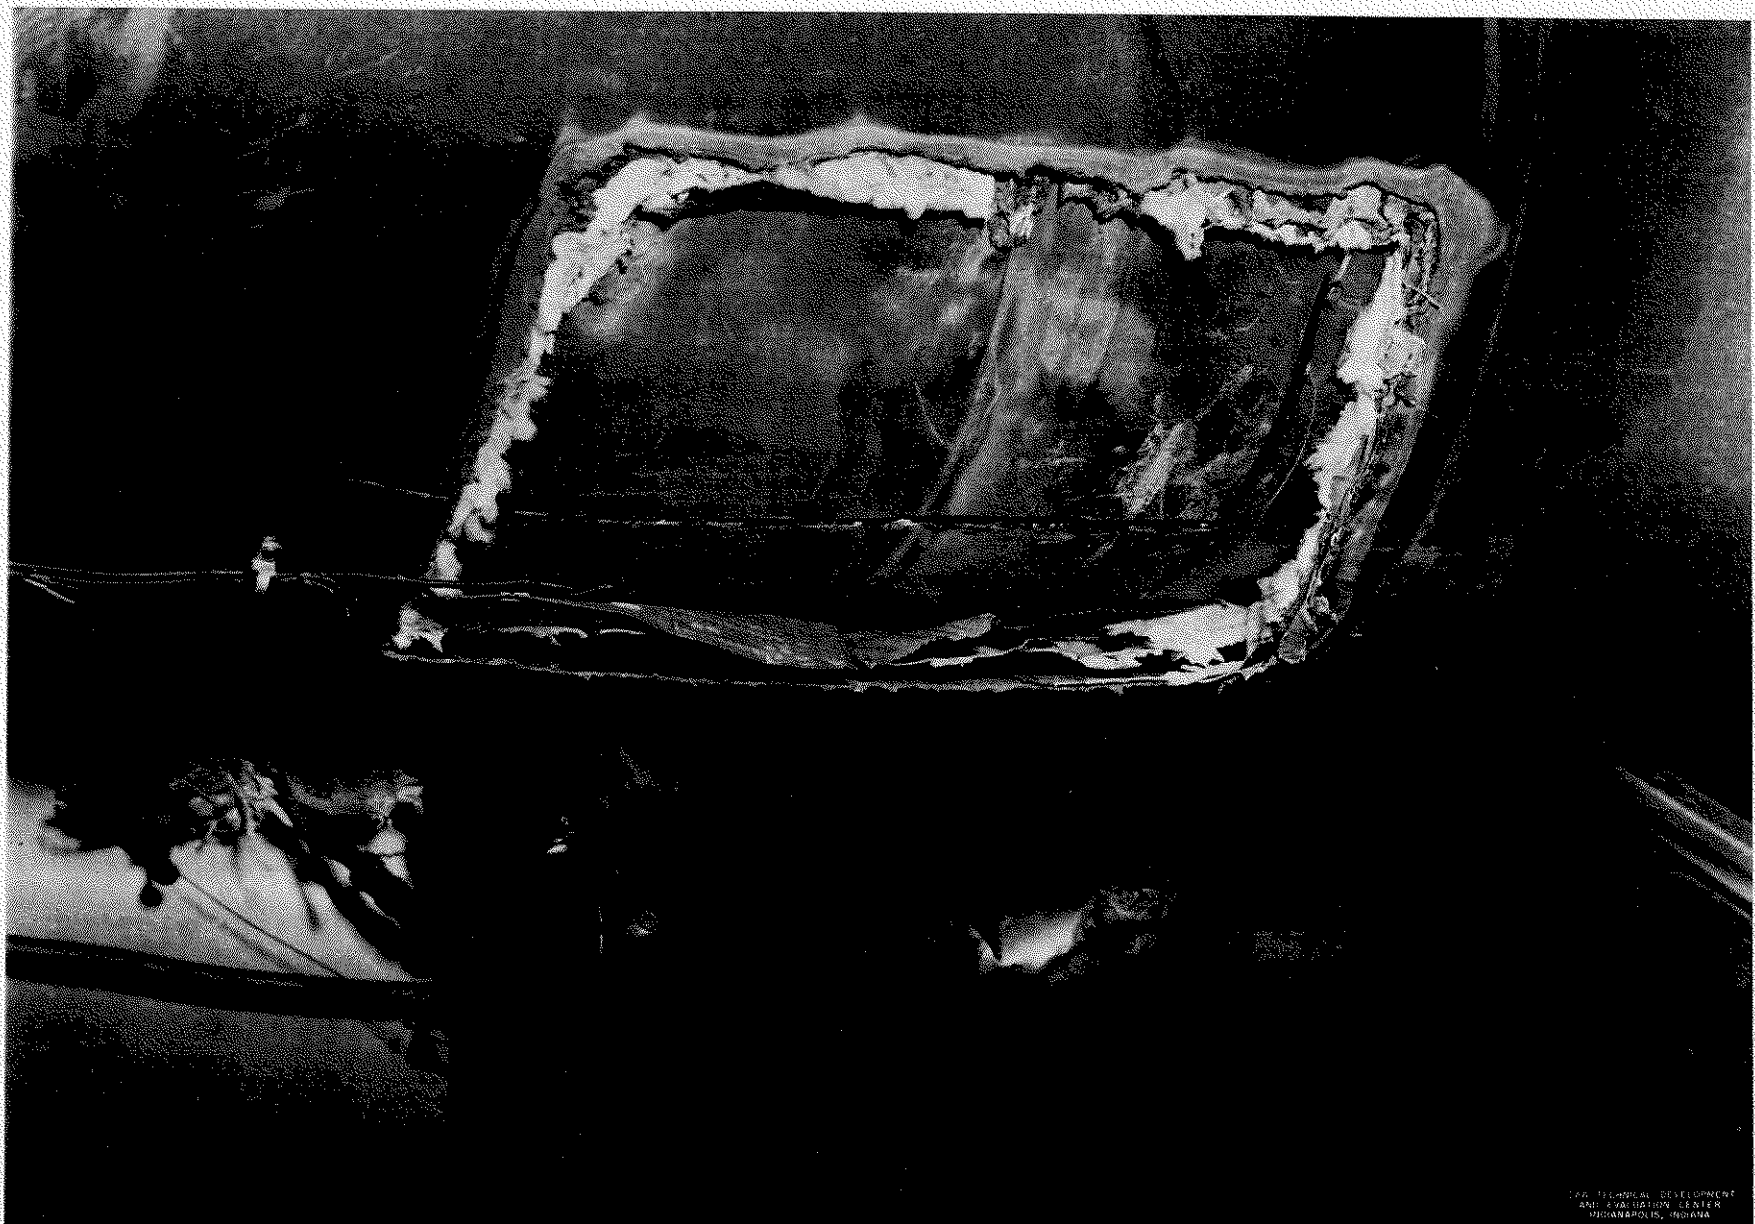
Thermocouple Locations	During Engine Starting				Flight Conditions	
	Max. Temp. (°F)		Max. Rate of Temp. Rise (°F/sec)		Max. Temp. (°F)	
	No Crack	Tee Crack*	No Crack	Tee Crack	No Crack	Tee Crack
Adjacent to bottom of tee crack in tail pipe	250	825	2.5	18.0	265	770
4 in. aft of bottom of tee crack	250	750	2.5	14.6	265	730
8 in. aft of bottom of tee crack	250	510	2.5	12.5	265	700
12 in. aft of bottom of tee crack	250	455	2.5		265	490

*Dimensions of tee crack was 10 in. by 12 in. by 5/32 in.

FIG. 4 "TEE" SHAPED SIMULATED RUPTURE IN TAIL PIPE

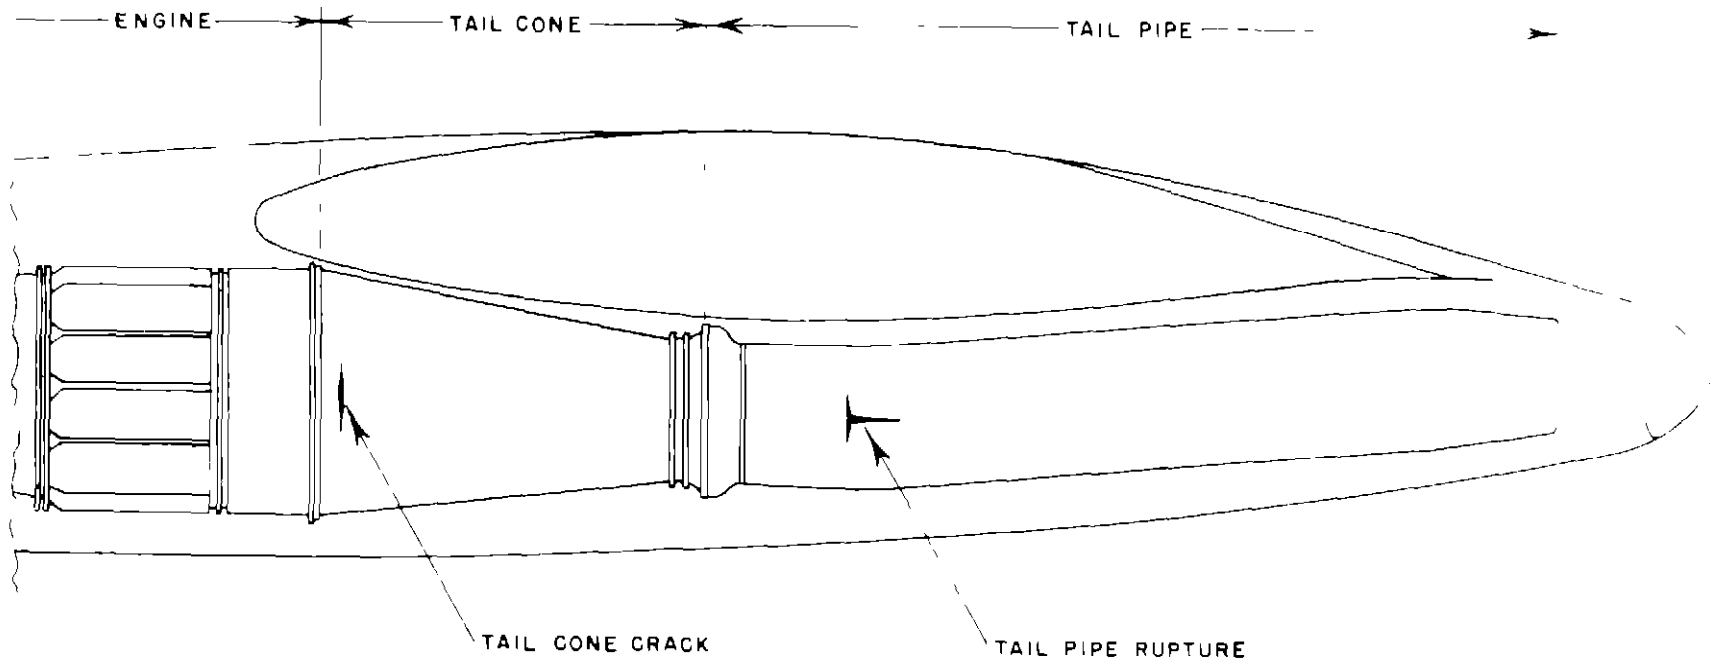
FIG 5 LOCATIONS OF SIMULATED FAILURES (AFT COMPARTMENT, XB-45 NACELLE)
