FIRE DETECTION STUDIES IN THE CONVAIR-340 POWER PLANT

By
L. A. Asadourian

Technical Development Report No. 250

November 1954

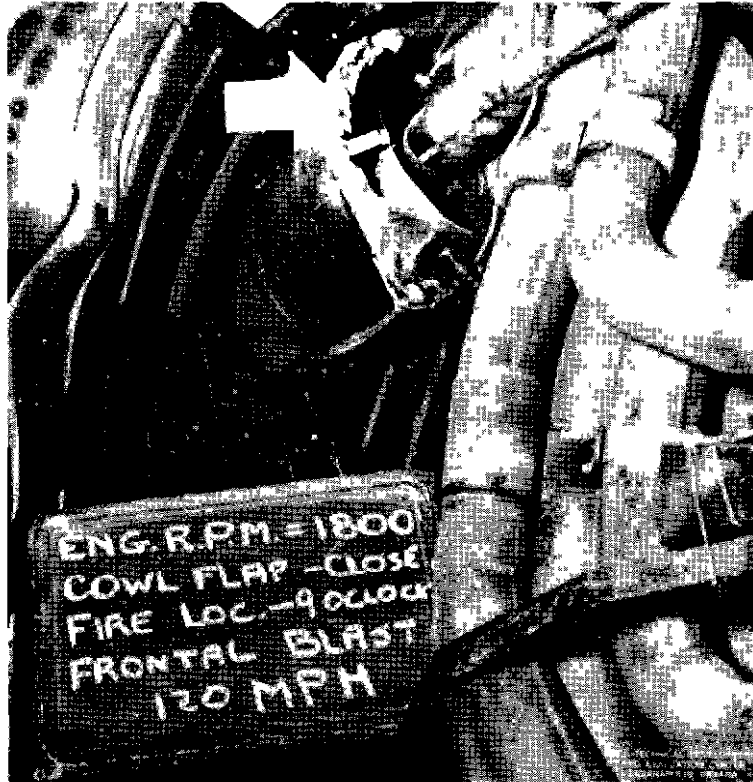
Fig. 2 View of Right-Hand Bellmouth (Burned area of copper screen defines flame path and extent)

Figure 2 is a view of the test installation and shows the right augments bellmouth after a single fire had burned a hole through the screen. The fire originated aft of the cylinders at the 9 o'clock position. The hole made by the fire is approximately seven inches long. The test conditions are shown on the slate. Figure 3 shows the extent of the screen destruction caused by fires originating at the 8-, 9-, and 10-o'clock positions. These established the range within which fire detectors would be most effective in the right bellmouth. Approximately one-half of the screen outboard of the exhaust stacks was burned away.

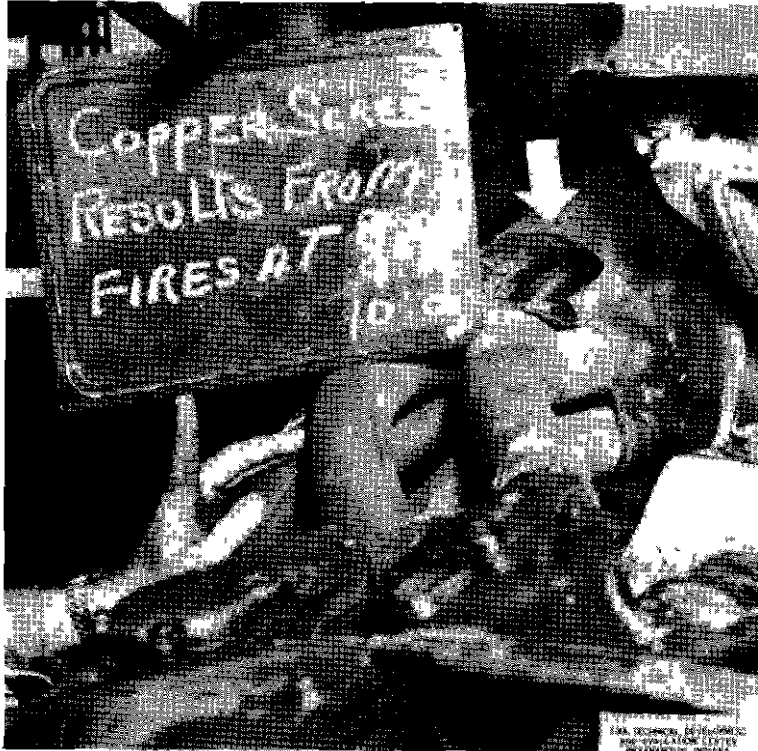
Fig. 3 View of Right-Hand Bellmouth (Burned area of copper screen shows flame paths from fires on right side of engine)

The upper limiting location for a detector unit in the right bellmouth was established by a cylinder-head fire originating at 11 o'clock. Fires originating near the cylinder heads tended to spread farther around the top than those originating at the crankcase. Subsequent tests established the fact that fires starting at the 12-o'clock position could be detected more quickly by the detectors located on each side of the engine-shroud carburetor bonnet than by

units in the bellmouths. Fires at the 7-o'clock point of origin were more satisfactorily detected by a unit located in the lower right cowl-flap opening. Fires originating on the left side of the engine burned through the outboard side of the screen on the left bellmouth. The fire-path limits were approximately from 11 30 clockwise to 6 30 o'clock in the left augments and from 11 30 counterclockwise to 4 30 o'clock in the right augments.

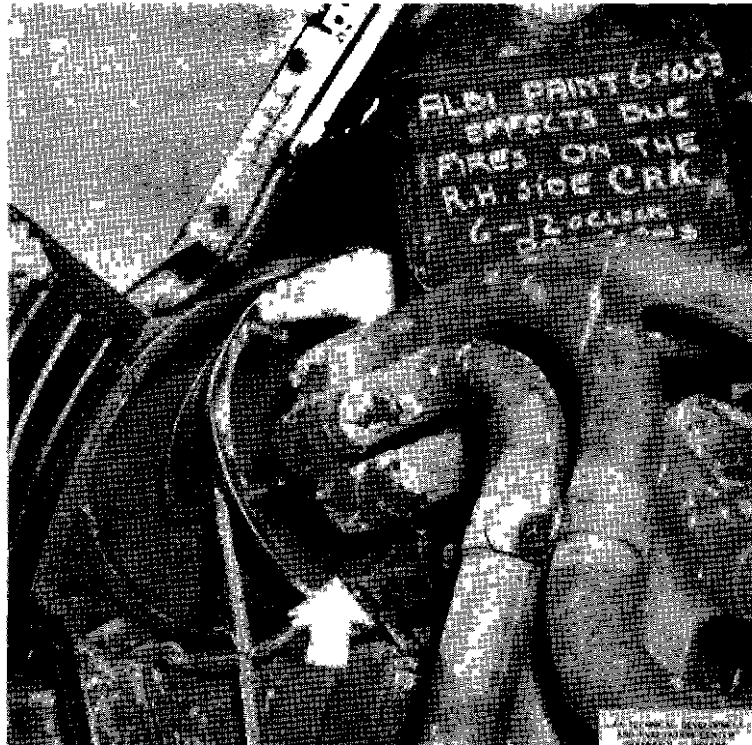
Fig. 4 View of Right-Hand Bellmouth (Area where white paint is burned away shows flame paths from fires on right side of engine crankcase)

Fire detectors were located in the bellmouths in accordance with the results obtained in the tests. Additional tests were then conducted to observe the operation of the detectors. As an added check of the fire paths during this period, the bellmouths and adjacent areas were painted with Albi-RX. Figure 4 shows the right bellmouth with detectors mounted in it. The photograph also shows that the Albi-RX was affected in approximately the same area where the screen was burned away in the previous tests. Albi-RX at the top and inboard sides of the bellmouths was only moderately affected by the flames. With the detectors mounted in the bellmouths, the units in the upper cowl-flap openings were not necessary and were removed. However, the two units in the lower cowl-flap openings were retained without change. The two units originally mounted on the left and right side panels of the engine shroud were moved upward to the left and right sides of the carburetor bonnet. The final recommended detector locations in Zone 1 are shown in Figs. 5 and 6.

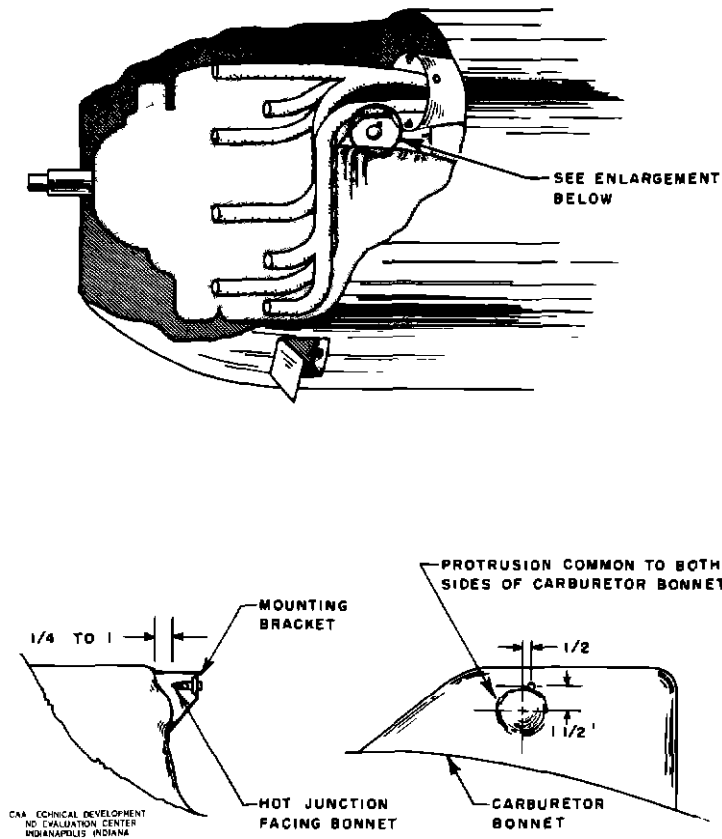
Fig. 6 Carburetor Bonnet Detector Location (One detector on each side of bonnet)

6. The main paths of fires leading into the augmenters are outboard of the exhaust stacks.
7. Detectors originally mounted on the side panel of the engine shroud are more effective when relocated on the sides of the carburetor bonnet.
8. Detecting units mounted on the bellmouths of the augmenters showed no tendency to alarm falsely because of propeller reversal.
9. Detection is much improved in Zone 2 by placing units near the oil cooler.
10. The TDEC-recommended system is more efficient than the Convair-revised system.

1. Any system incorporating detectors in the augmenter bellmouths should be flight-tested before being adopted for general use on CV-340 or other similar types of aircraft.
2. Any changes to the currently used system should be made in accordance with the revised recommendations shown in Figs. 5, 6, and 7.

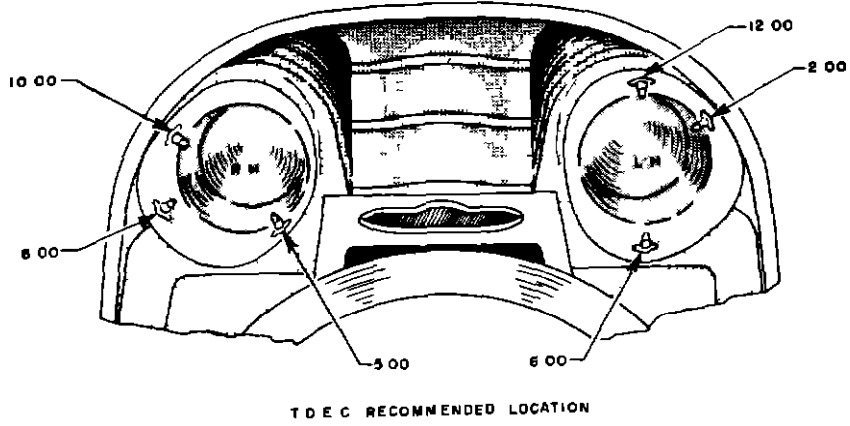
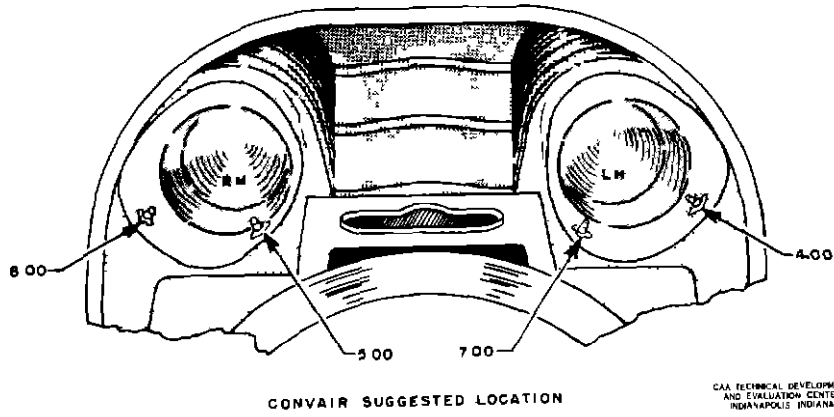
Fig. 7 Locations of Detector Units in the Augmenter Bellmouths of the Convair-340

The system as modified was considered suitable for installation and flight tests in an operational aircraft. In attempting to make an installation, however, the manufacturer encountered some difficulties and as a result suggested some changes in the detector locations in the bellmouths. Figure 7 shows how the manufacturer's proposed arrangement differed from the TDEC-recommended arrangement. Further tests were arranged to test the two configurations simultaneously. A comparison of the results obtained on a percentage basis for 135 test fires is shown in Table VI.

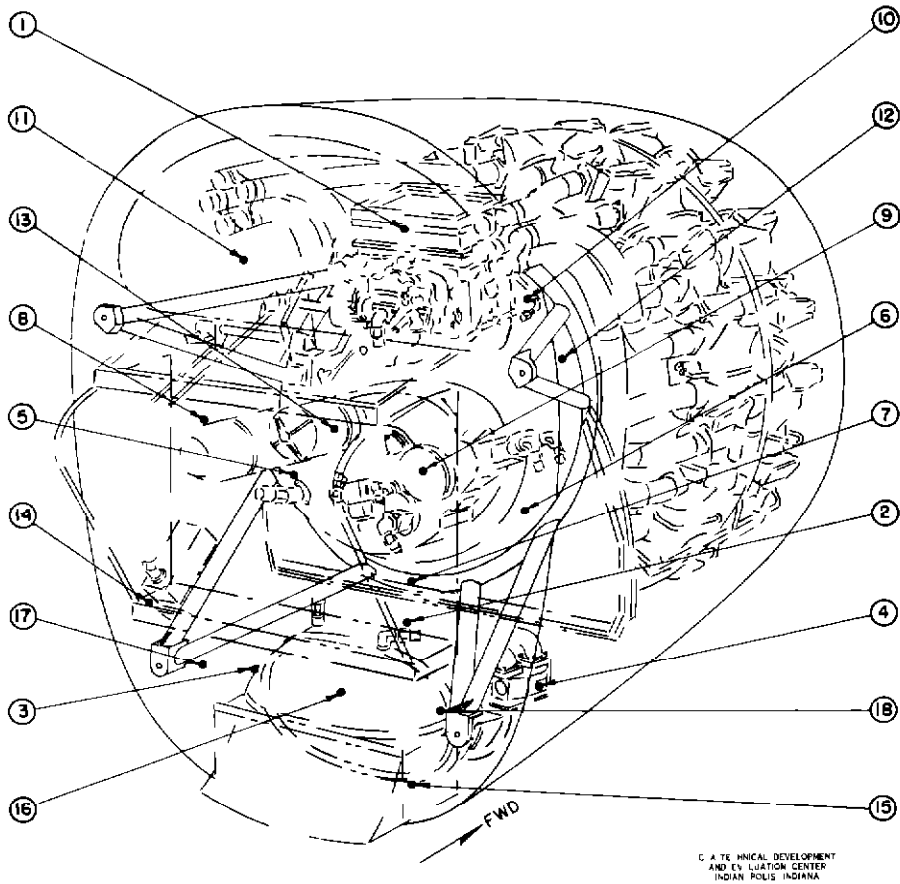
Fig. 8 Test Fire Locations in Zone 2

The testing and modifications required to obtain a satisfactory detection system for Zone 2 were less extensive than for Zone 1. Detection of all fires originating at the points shown in Fig. 8 was successful except for fires originating at points marked 3, 4, 15, 16, 17, and 18. Thermocouples used in the Zone 2 tests helped to establish the most effective locations for the individual units. Figure 9 shows where the detectors were originally located and the changes that were recommended as a result of the tests. Rapid rates of temperature rise were observed in the vicinity of the rear mount brackets for the oil cooler although no detector units were mounted there originally. It was further observed that fires originating in the upper half of the zone were more quickly detected by the two detectors located in the vent door or in the chimney (detectors 1 and 2) than by the detectors located at points 3 and 6. The latter detector units therefore were relocated on the rear mount brackets of the oil cooler. Additional tests showed that the revised arrangement of units in Zone 2 was satisfactory.
