FIRE-RESISTANCE STUDIES OF THE CONVAIR-340 POWER PLANT

Technical Development Report No 266

CIVIL AERONAUTICS ADMINISTRATION

June 1955

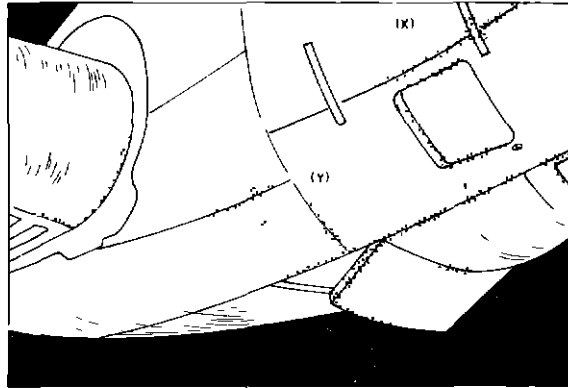
(B)

the cowl. Figure 2B shows the dye pattern on the outside surface of the nacelle as viewed from the right, near the propeller. This test was conducted with closed cowl flaps. The dye stain at the upper right corner, X, of the sketch was not caused by leakage through the seals between the horizontal mating surfaces. This stain was produced by the dye which first entered Zone 1, then passed between the inner and outer skin of the bottom cowl panel by leaking around the scupper drainpipe in the bottom of the cowl. The dye traveled thence to a hole in the horizontal mating surface, where it emerged at the outside surface. The loose fit of the scupper drain at the inner liner of the cowl would have gone unnoticed except for the dye. Such a loose fit is a potential hazard because flammable fluids and explosive gases can collect in the interior space of the cowl panel. The dark stain immediately below, at Y, was produced by the dye which passed through the scupper drain itself. Although the dye adhered to the skin that encloses Zone 3, there is little reason to believe that fire at the exit of the scupper drain would cause damage in this area. Tests have indicated that such a fire would be wiped off immediately by the air stream.

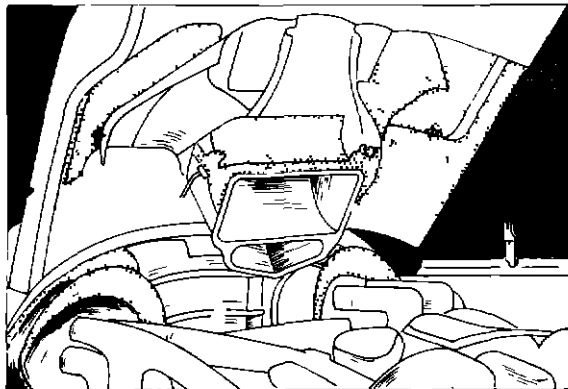
(C)

Inside Zone 1, dye was deposited on the bell-mouths of the augmentor tubes and on the closed cowl flaps. There was also a heavy deposit on the forward side of the carburetor intake duct, as shown in Fig. 2C.

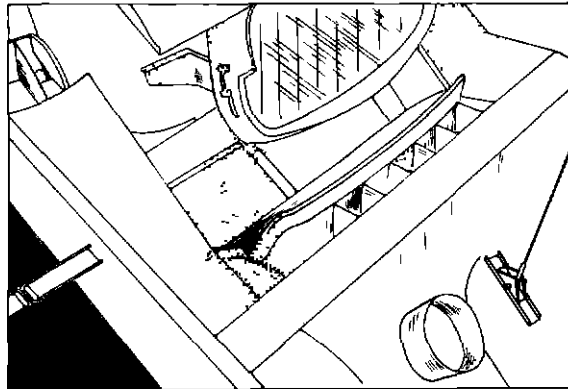
(D)

Dye introduced at the intake to Zone 2 was deposited mainly at the lower right side, as shown in Fig. 2D. The left interior of Zone 2 was comparatively free from dye deposits. There was a large deposit of dye on the right side of the Zone 2 access door but no penetration of the seal around this door into Zone 3.

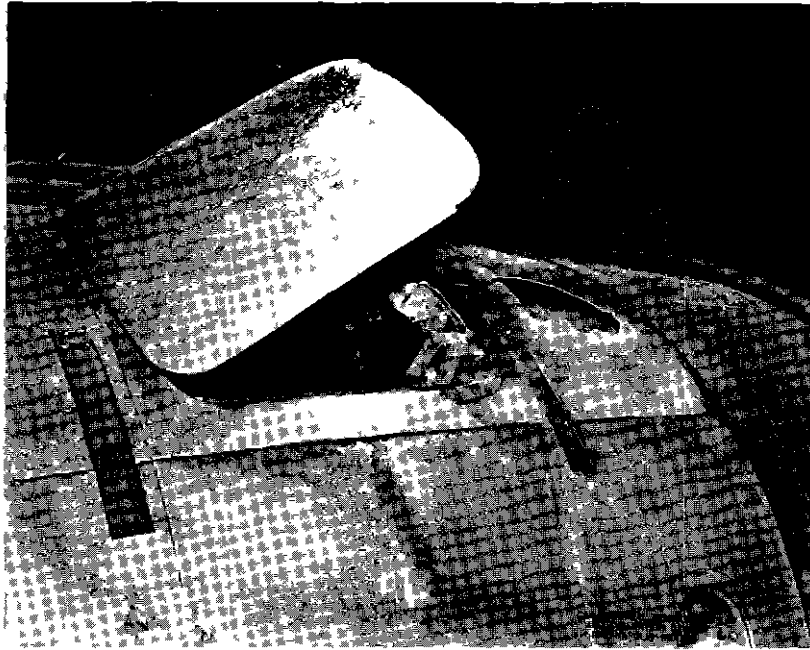
Fig. 3 Hole Burned in Cowling by Fire Leaving Cowl-Flap Port

When a fire of 20 seconds' duration was started high in Zone 1 near the partially open cowl flaps, the flames hugged the skin aft of the flaps and burned through the duraluminum outer skin. The damage is shown in Fig. 3. The port was also damaged, but the inner skin of the cowling remained intact because it was fabricated of stainless steel. The flames extended beyond the cowl hinge line, which marks the location of the fire wall, and impinged on the duraluminum skin covering Zone 3. Since there is no protective inner lining for Zone 3, stainless steel was used during the tests to cover this area to prevent its being penetrated by fires.

4. Fire passing through cowl flaps which are partially open will impinge on the metal ports and on the downstream skin.
5. The top-wing exhaust arrangement reduces fire-ignition hazards.

3. Exterior nacelle surfaces downstream of flaps be protected with materials which are more fire-resistant than aluminum alloy.
4. The seals around the oil cooler be fabricated of materials having a maximum of fire resistance together with the necessary degree of flexibility.
