TECHNICAL DEVELOPMENT REPORT NO. 301

BIRD-IMPACT TESTS OF THE  
BOEING MODEL 707 AIRPLANE WINDSHIELD

February 1957

CIVIL AERONAUTICS ADMINISTRATION  
TECHNICAL DEVELOPMENT CENTER  
INDIANAPOLIS, INDIANA

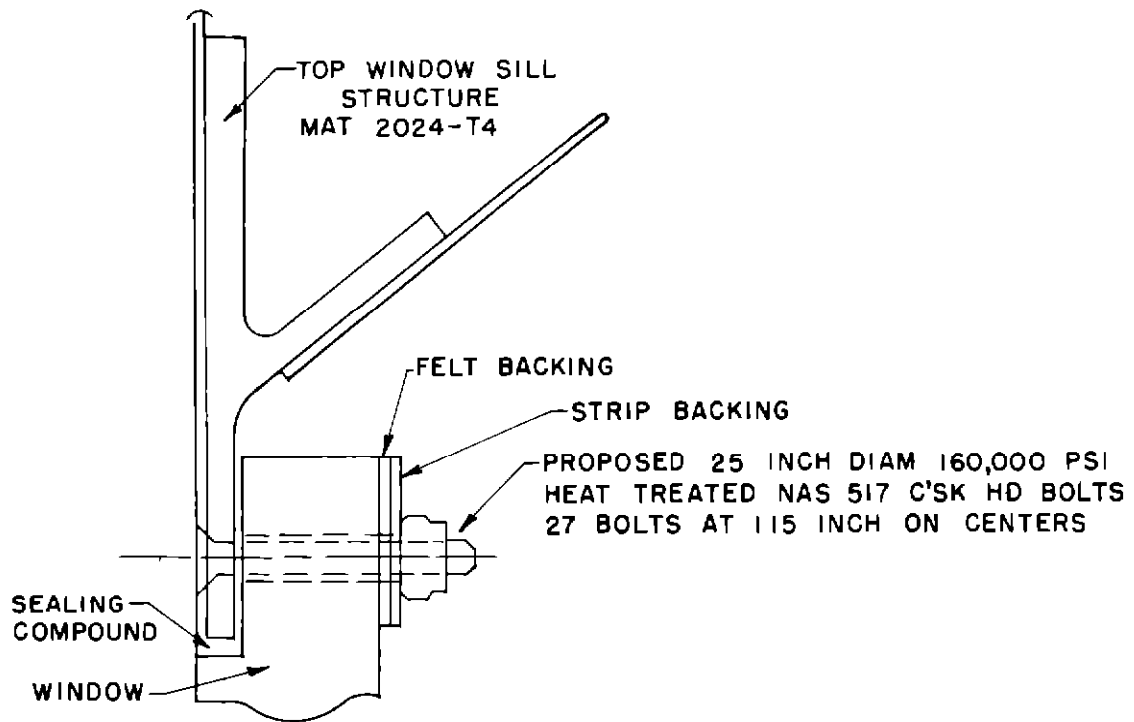
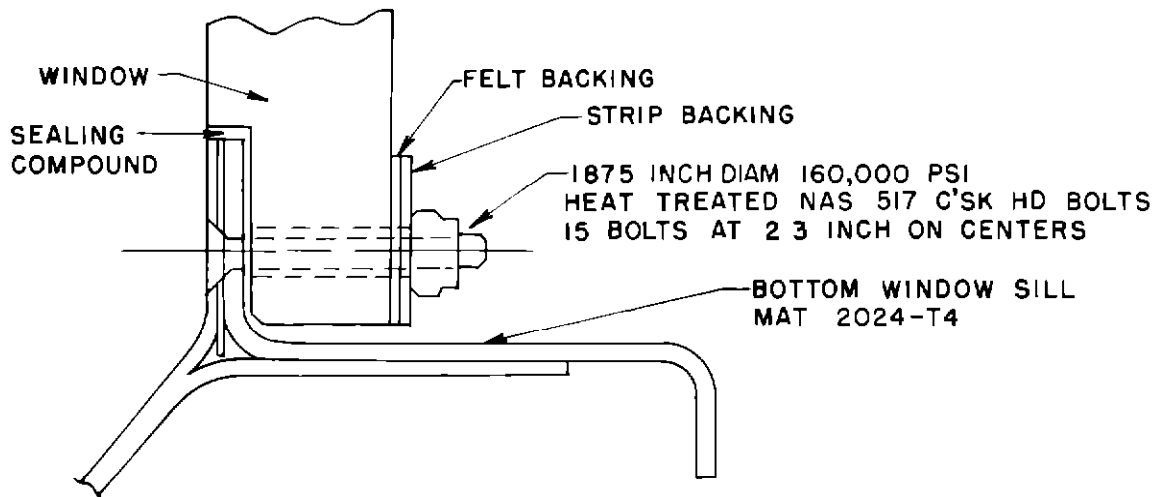
FIG 1 UPPER AND LOWER SILL AND WINDOW  
ARRANGEMENT - NO 1 WINDOW

The pilot No. 1 and co-pilot No. 1 windows are mounted by bolting the semirigid, extended vinyl, metal insert and laminated phenolic combination edge directly to the top and lower windowsills and the centerpost. The bolting arrangement consisted originally of a row of 0.1875-inch-diameter, 160,000 psi, heat-treated, NAS-517 countersunk head bolts spaced at 1.15 inches on centers along the top sill, and a row of 0.1875-inch-diameter, 160,000 psi, heat-treated, NAS-517 countersunk head bolts spaced at 2.30 inches on centers along the centerpost and lower windowsills. This mounting arrangement is shown in Figs. 1 and 2. The cornerpost window edge is retained by a series of equally spaced rectangular retainers protruding from the inside of the cornerpost sill. Upon fitting the cornerpost window edge over the rectangular retainers, the edge is held in place by an L-shaped backup bar which fits snugly against the innermost surface of each retainer and is bolted in place. This arrangement for retaining the cornerpost window edge is shown with a proposed revision in Fig. 2.

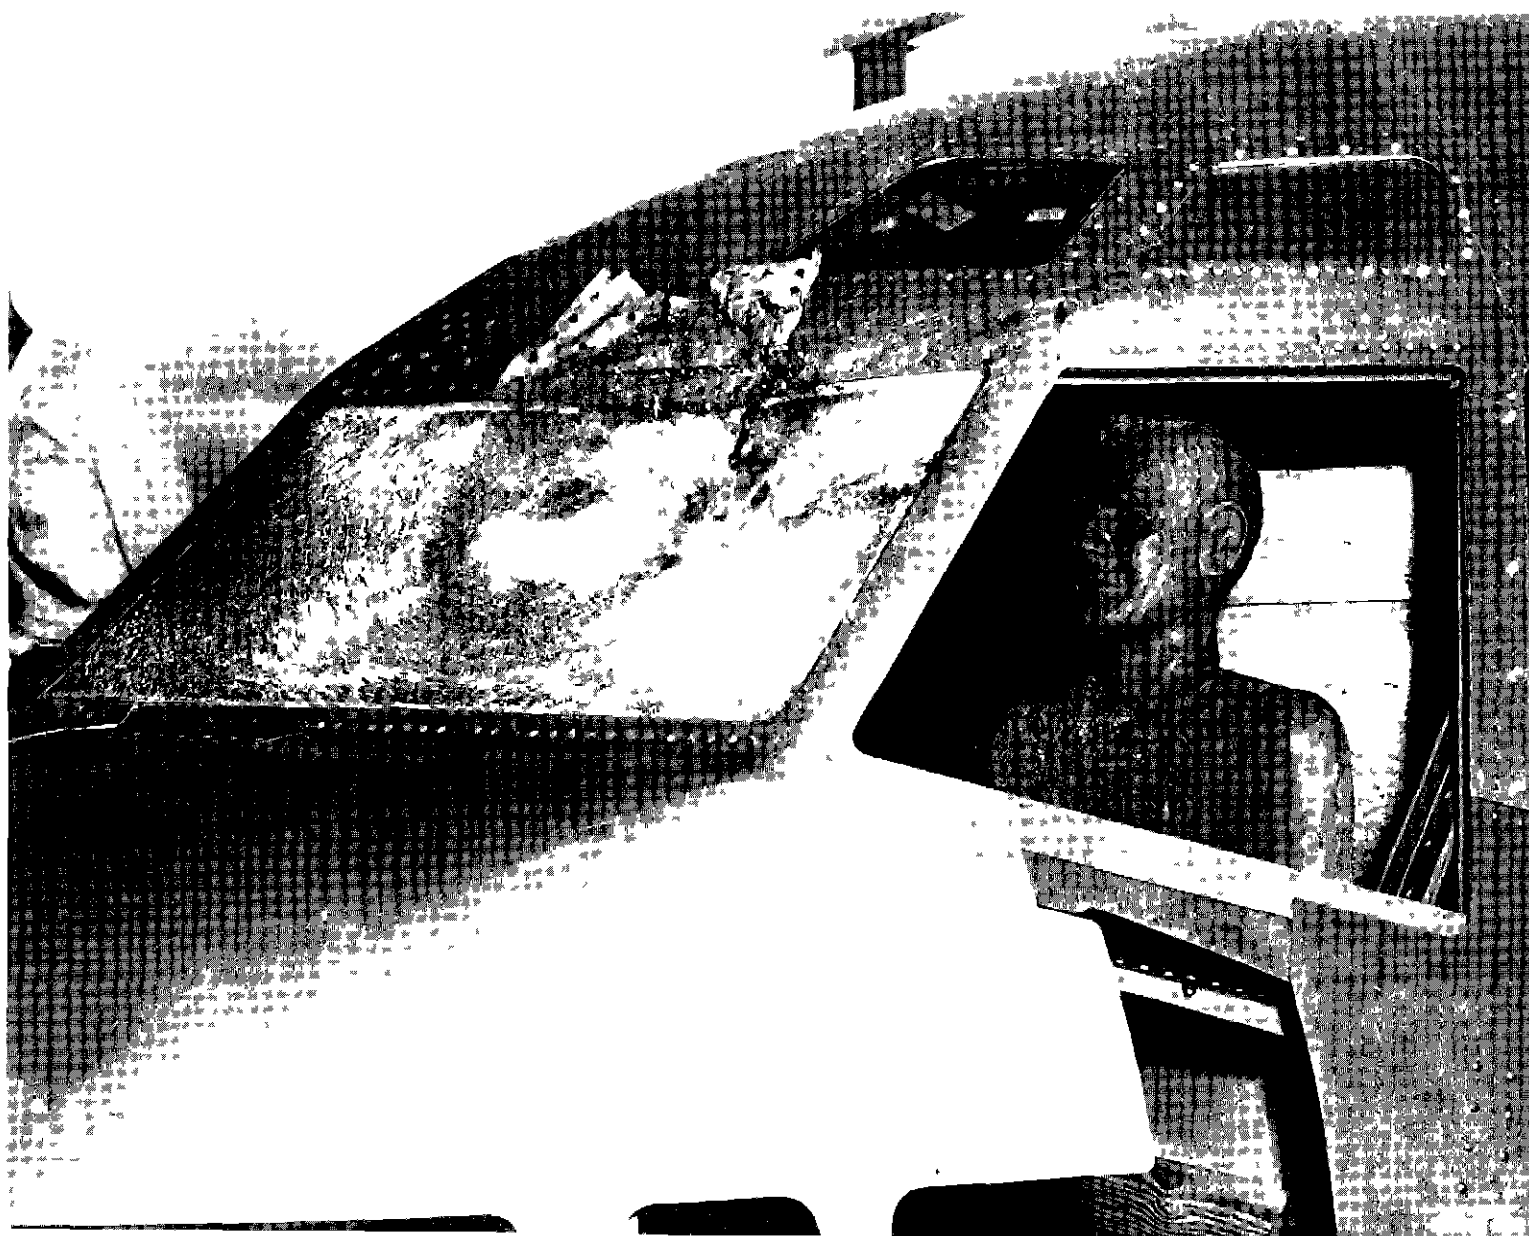
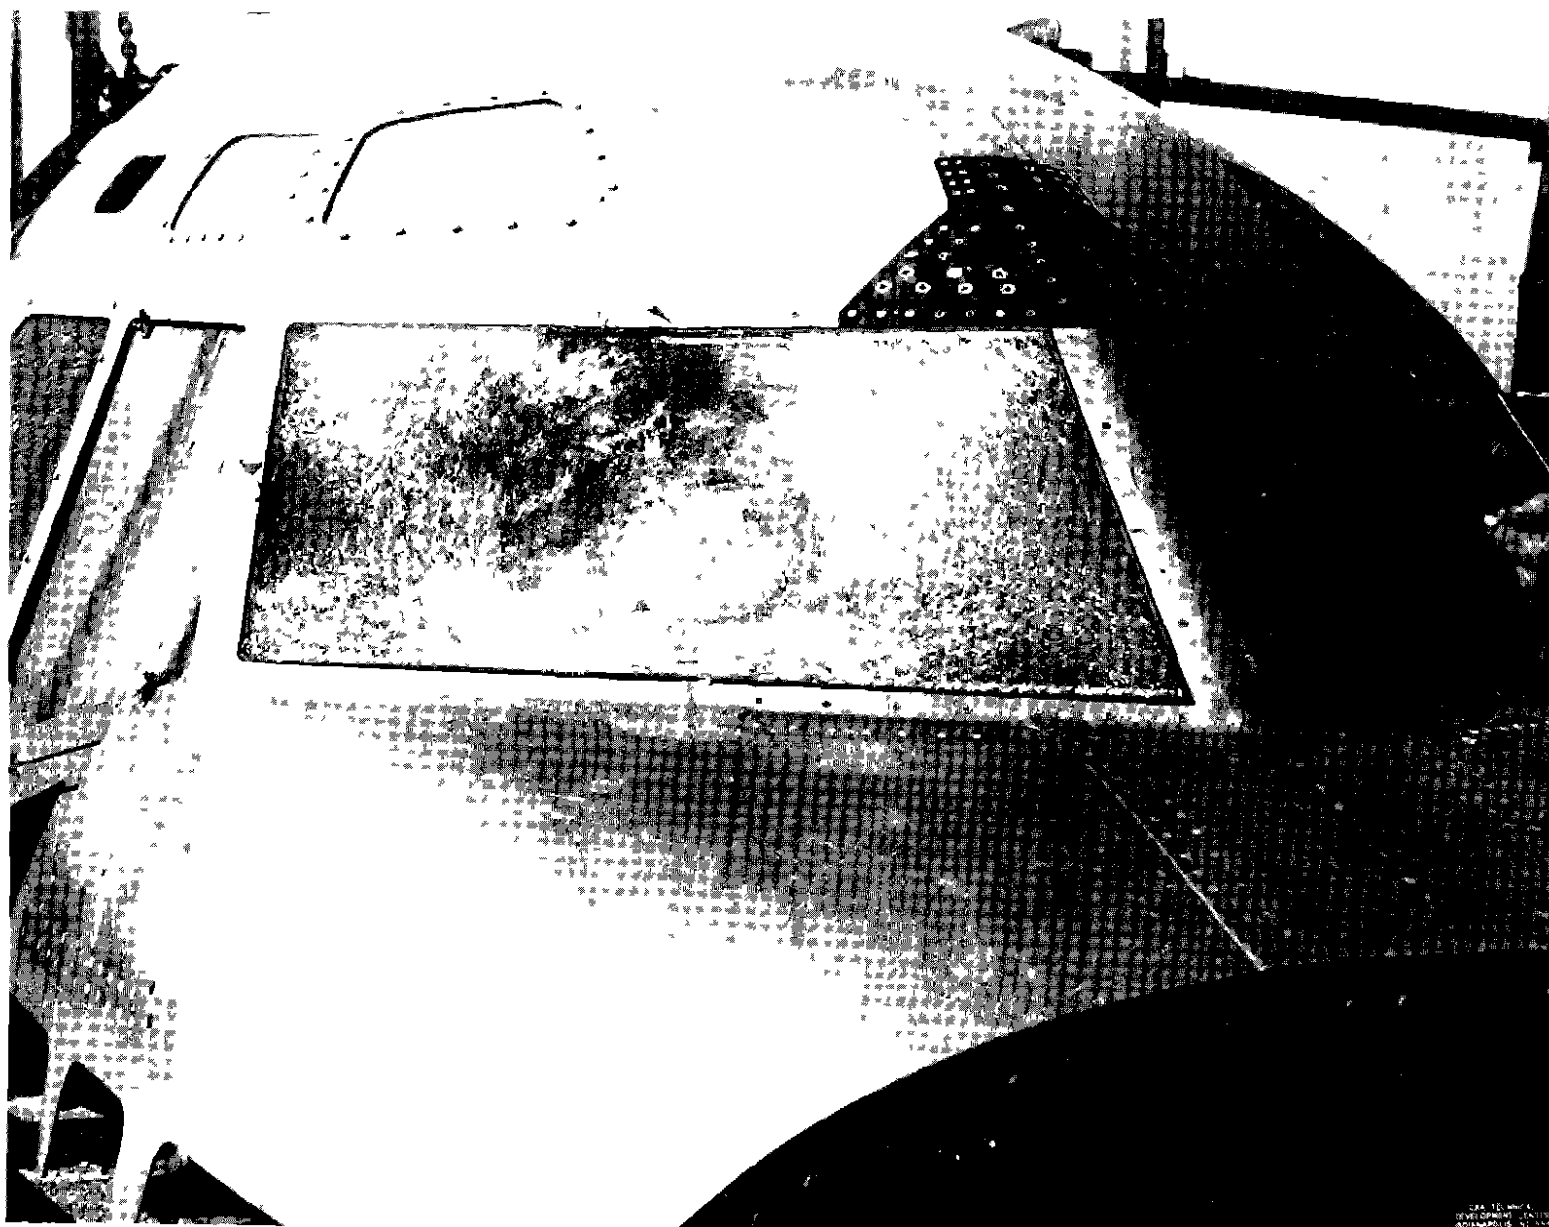
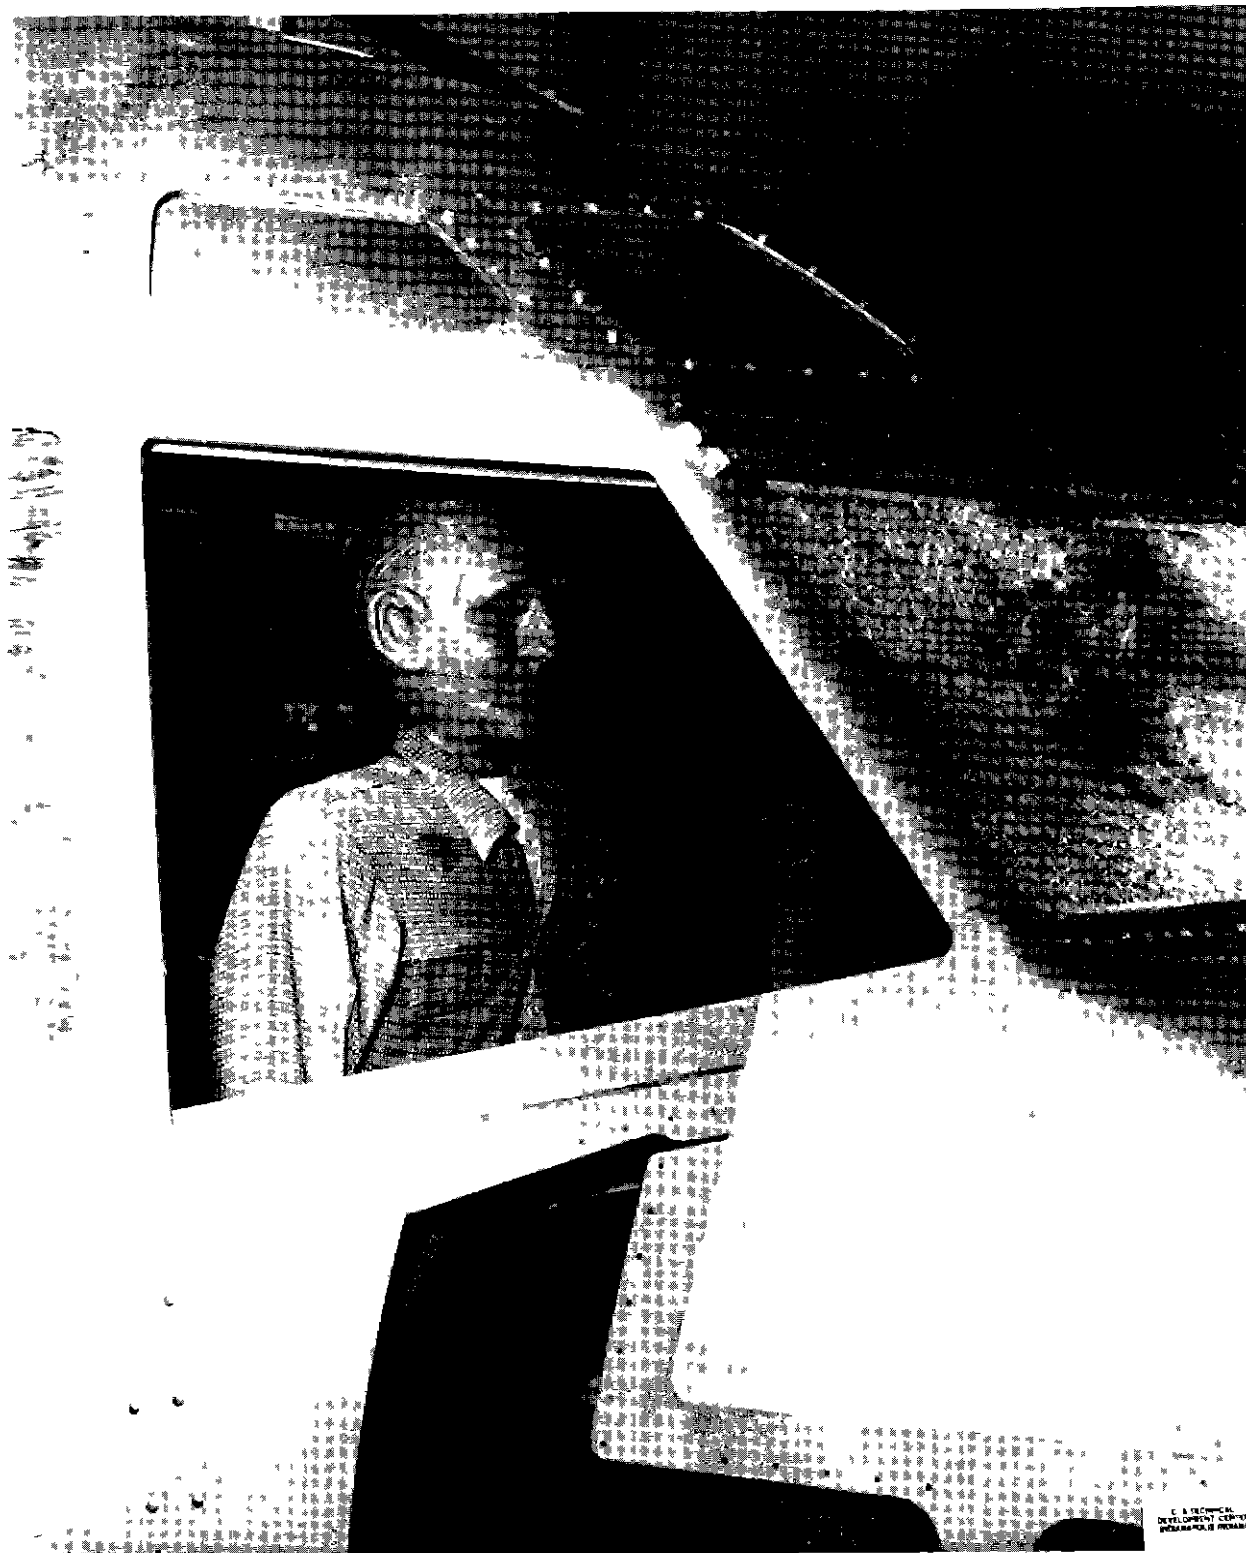
The carcass hit on the vertical centerline of the window approximately 1 1/2 inches below the horizontal centerline. There was no penetration of the windshield. The upper windowsill was bent inward slightly. Small flake-like particles of glass impinged upon the face of the clay dummy. These could be brushed away. The left shoulder and arm area of the dummy was penetrated by chunks of glass averaging about 1/4 inch on edge. The glare shield again was bent downward by the force of the impact. Results of this test are shown in Figs. 10 and 11.

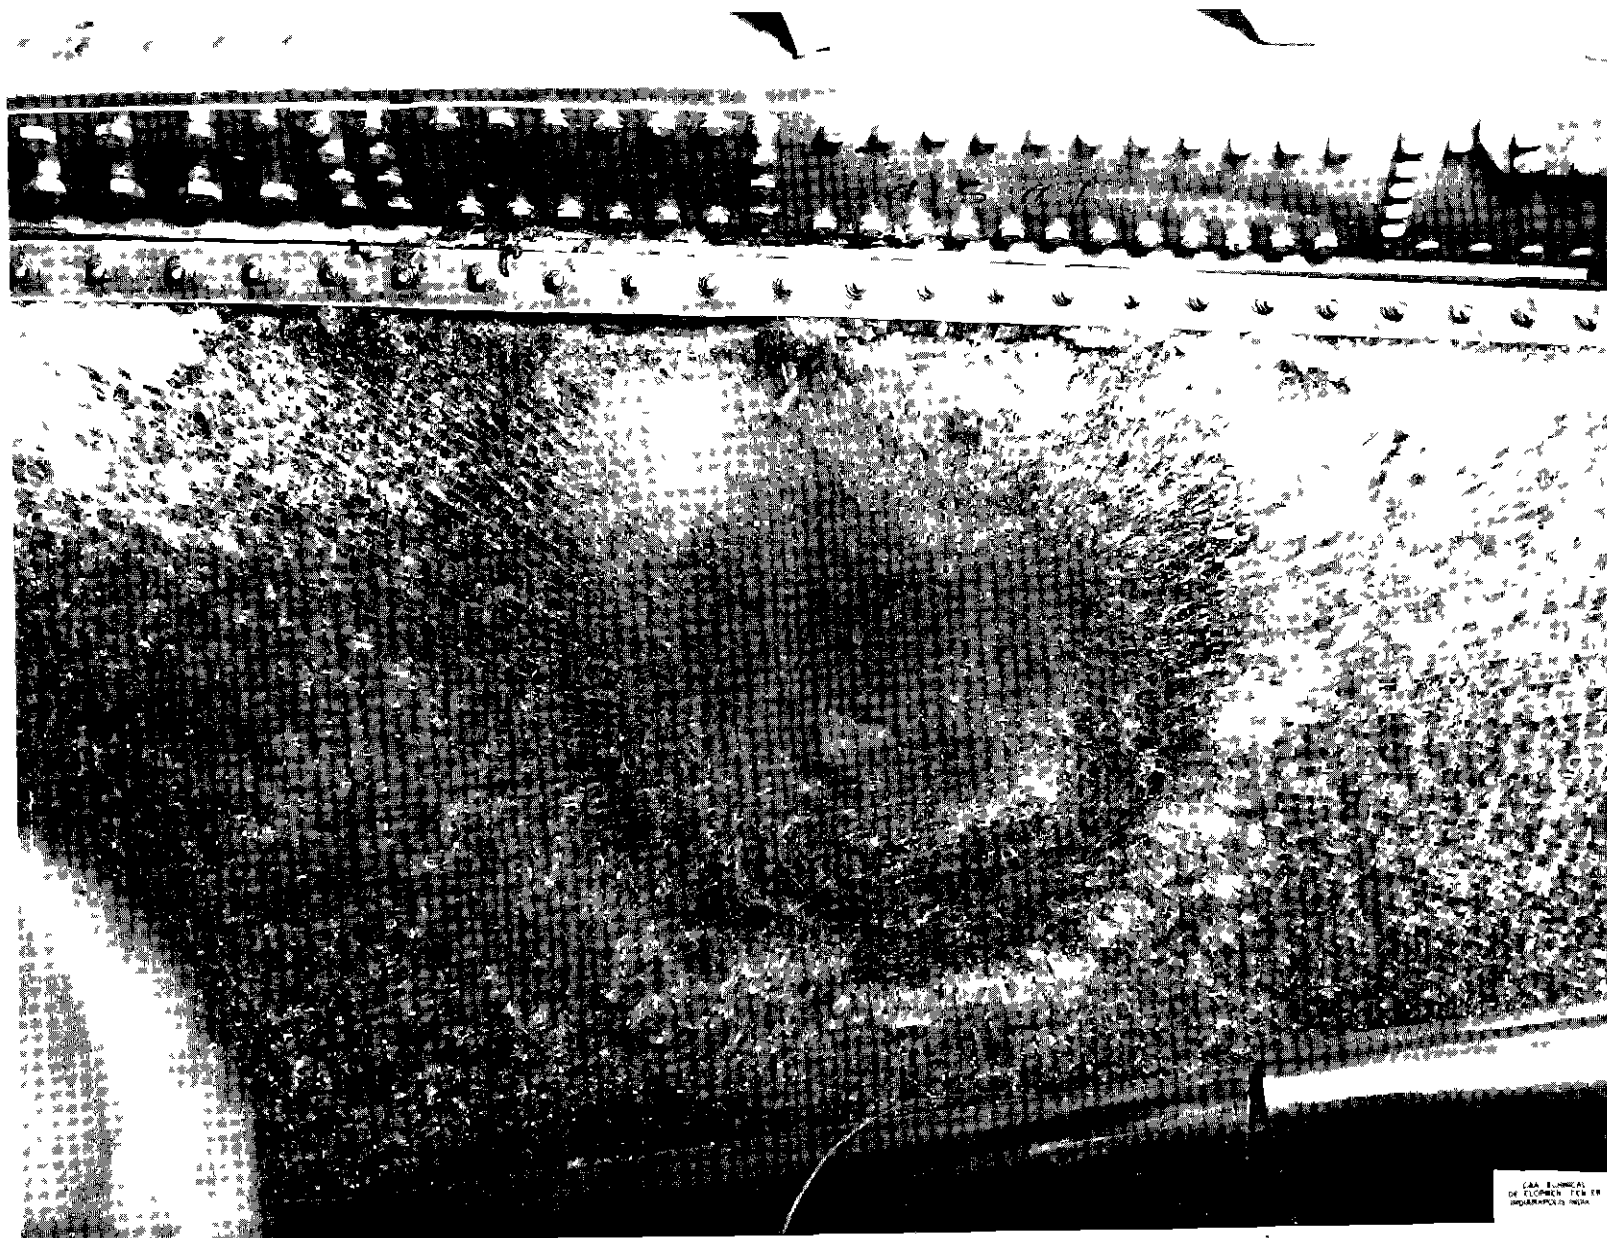
FIG 6 TEST NO 4 - 7/13/56 - BIRD-CARCASS VELOCITY 380 mph

The carcass hit approximately 2 inches above the target point. The upper sill cracked open horizontally, allowing penetration of an undetermined amount of the carcass, and the fuselage skin was peeled back directly above the cracked section of the sill as shown in Fig. 5. There was slight penetration of the vinyl through a small tear near the upper sill as shown in Fig. 6. The clay dummy received a heavy concentration of glass particles in the upper chest and right arm area. Much of this glass merely impinged upon the clay, and it is doubtful that the apparently heavy damage shown in Fig. 5 would have occurred if the dummy had been clothed. A few particles of glass and a small amount of bird entrails hit the clay dummy's face. The glare shield again was buckled downward as in the previous test. Vinyl temperature for this test was considered too low for best results.

During tests Nos. 2 and 6, the upper sills of the pilot No. 1 and co-pilot No. 1 windows cracked, and an 0.125-inch-thick 75-ST Alclad doubler plate was incorporated as shown in Figs. 16 and 31 to stiffen the weakened sills. The cracks which developed in both of these upper windowsills are not considered to be due to weakness on their part, but were due to continuous cold working of the sill material as it was deformed and straightened during successive impact tests.

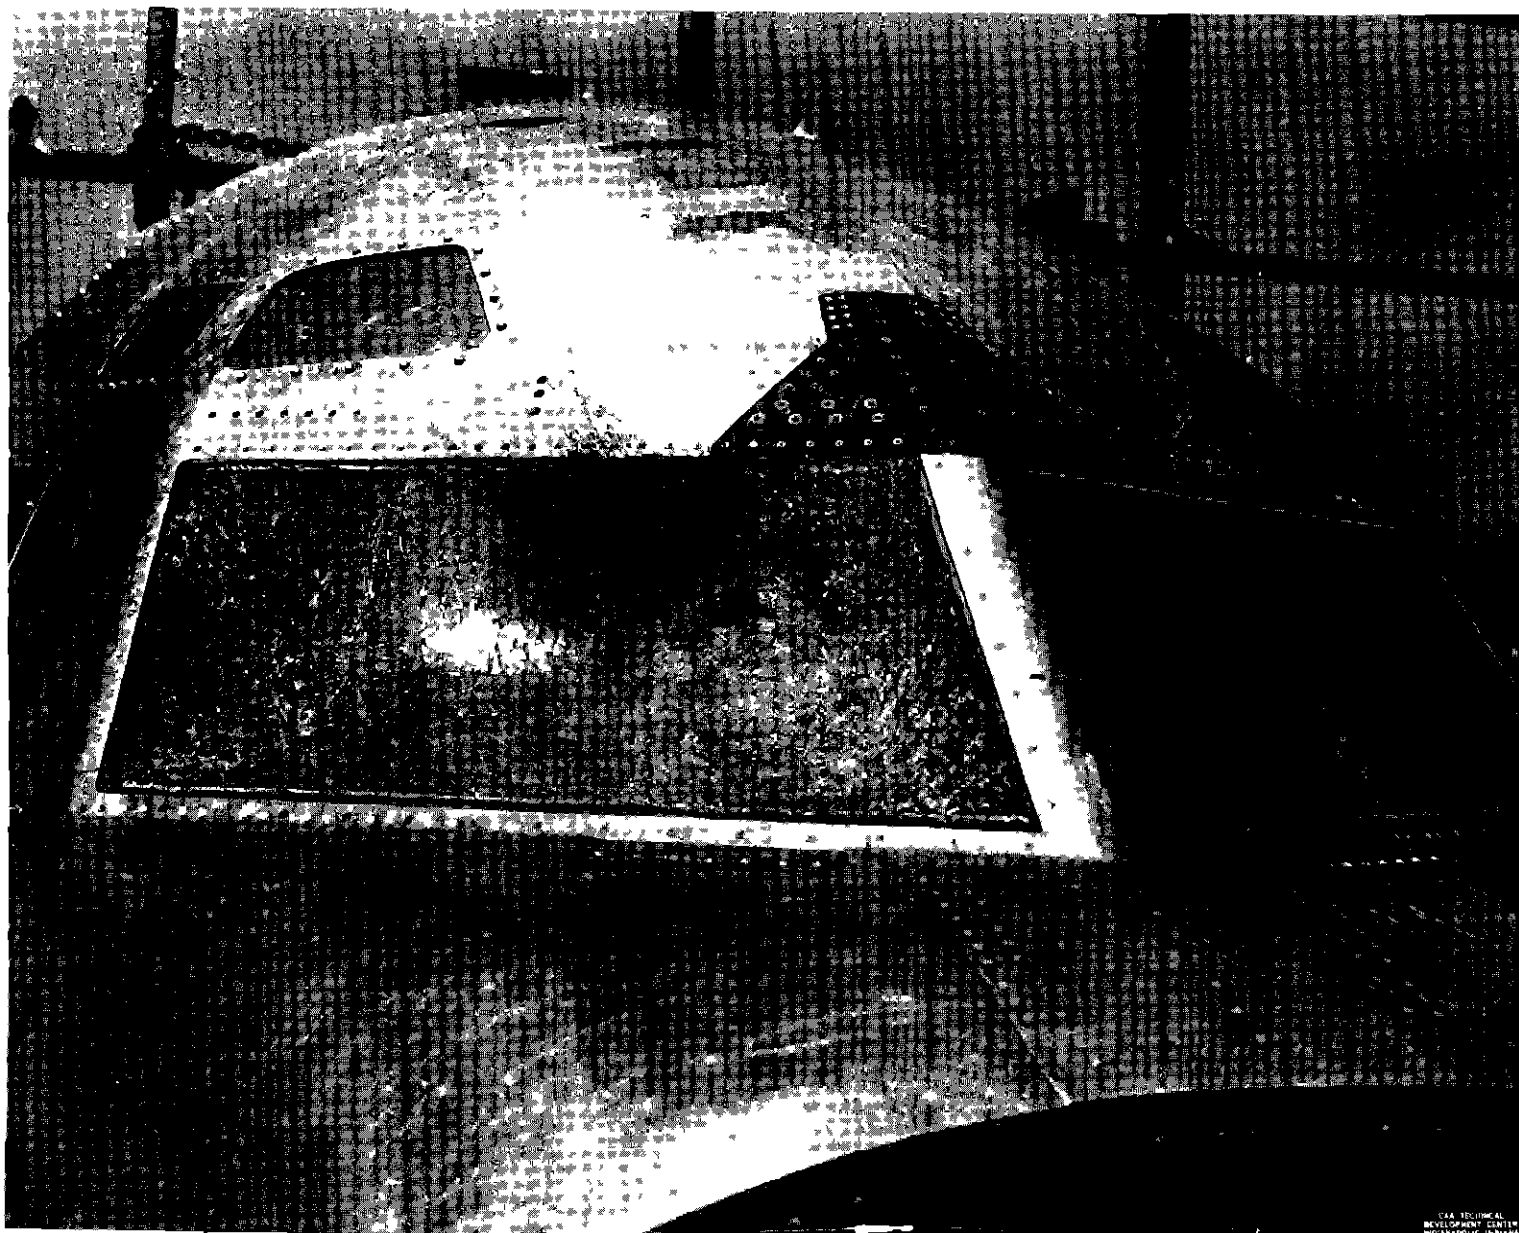
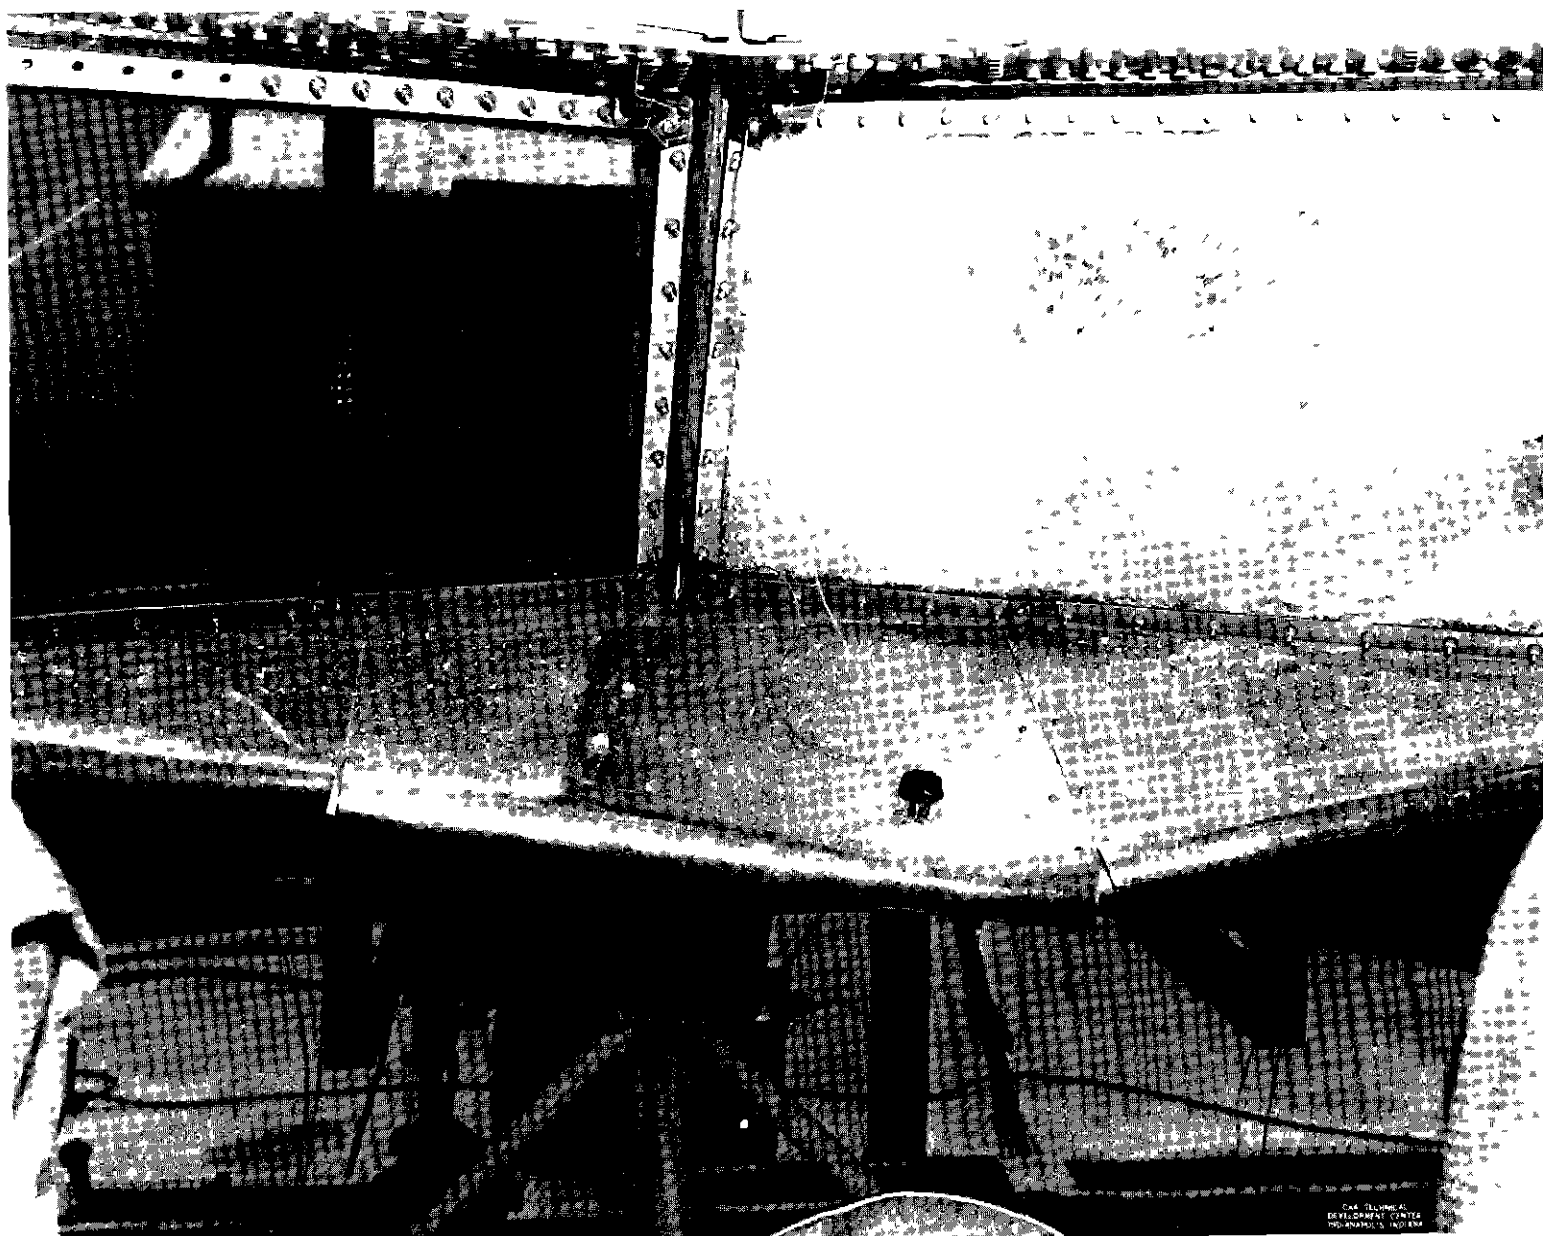
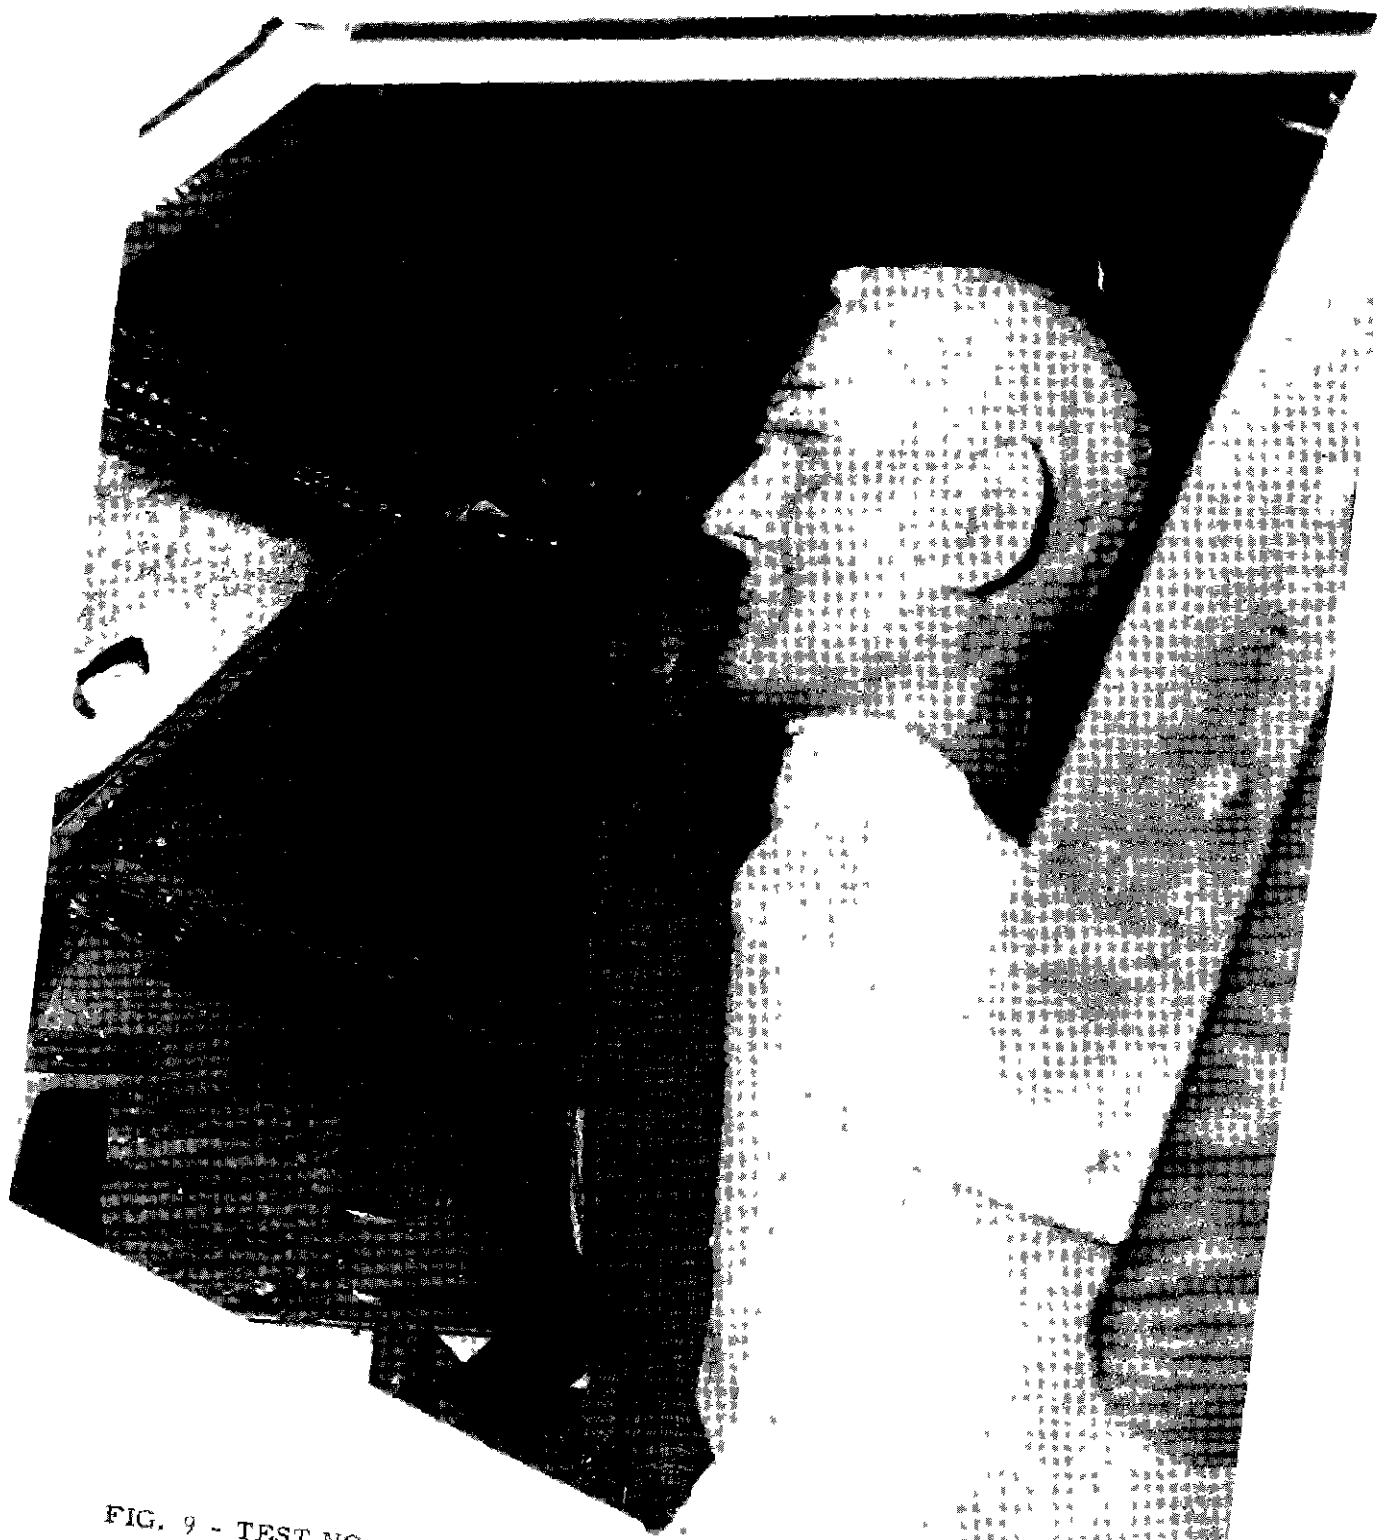
The actual strike position was 6 inches outboard of centerpost and 1 inch below the horizontal centerline. There was no penetration of either the No. 1 window or supporting structure. The upper sill was bent inward slightly. The clay dummy in the co-pilot's position was unmarked by flying glass. Small flake-like particles which could be brushed off impinged upon the dummy's clothing. The glare shield again was forced downward by the heavy concentration of glass departing from the inside face of the window. Figs. 7, 8, and 9 show the results of this test.

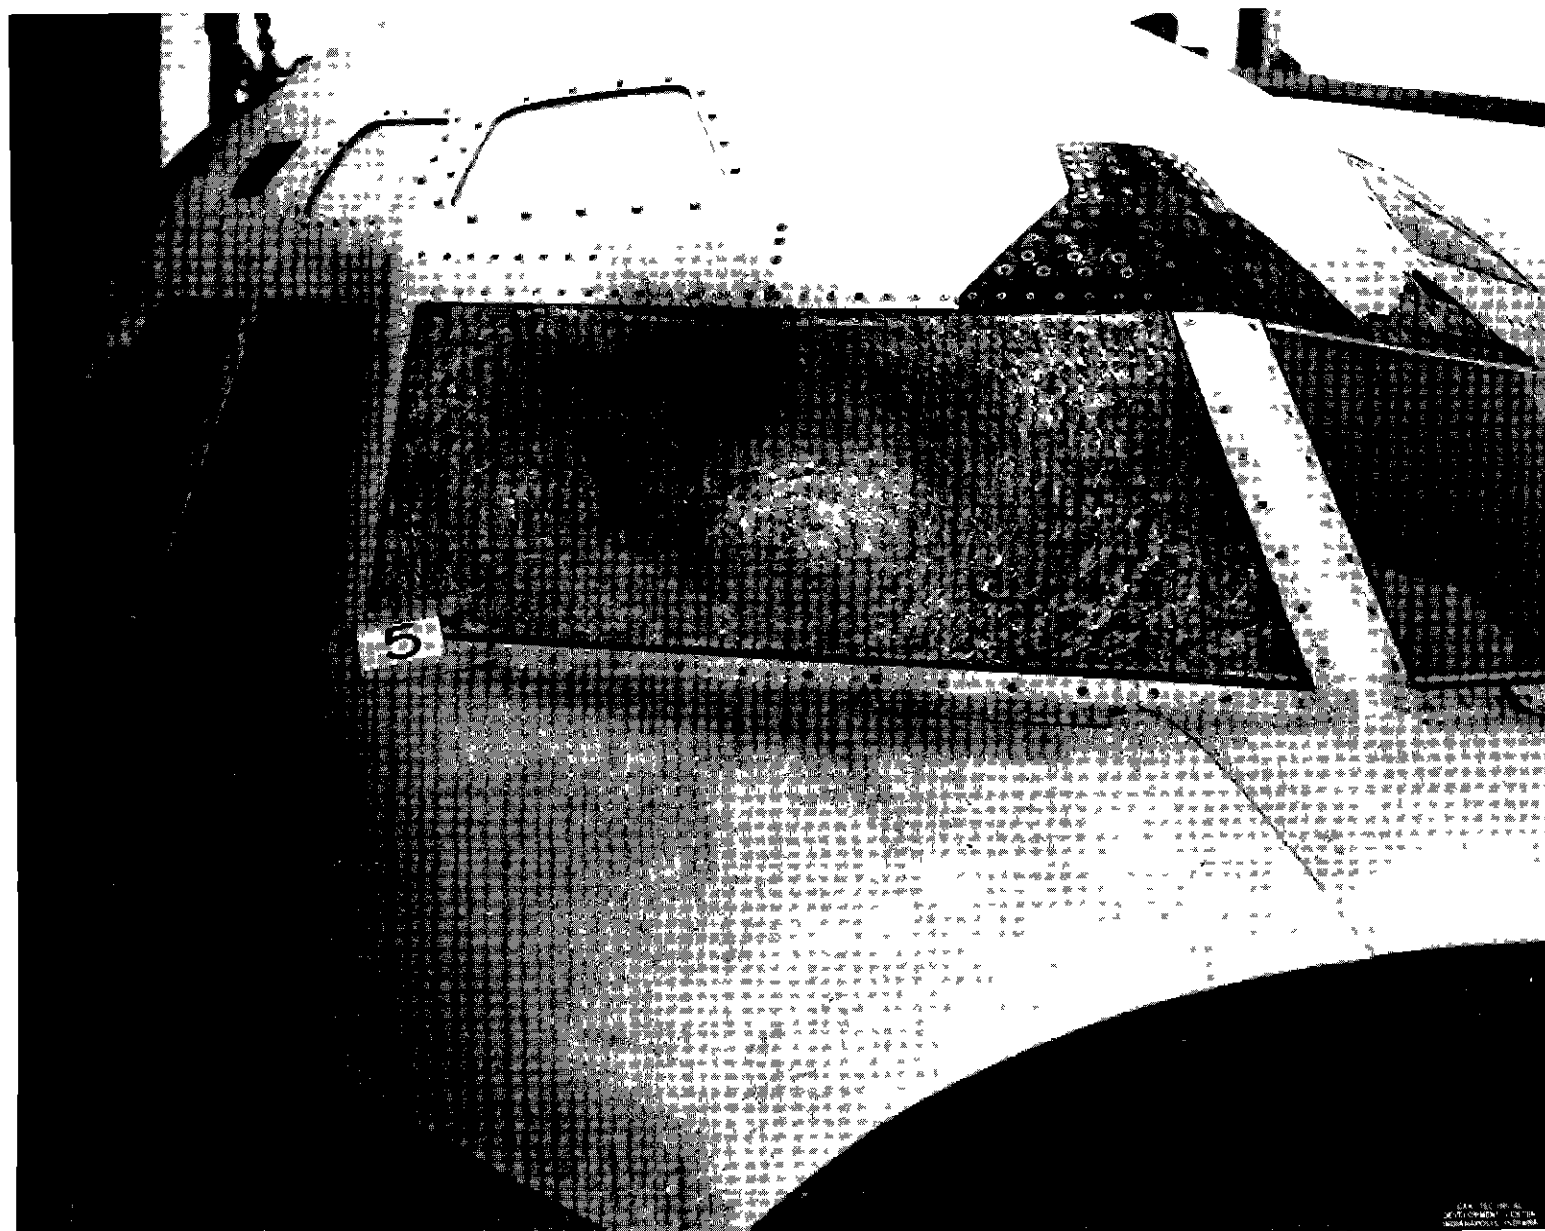
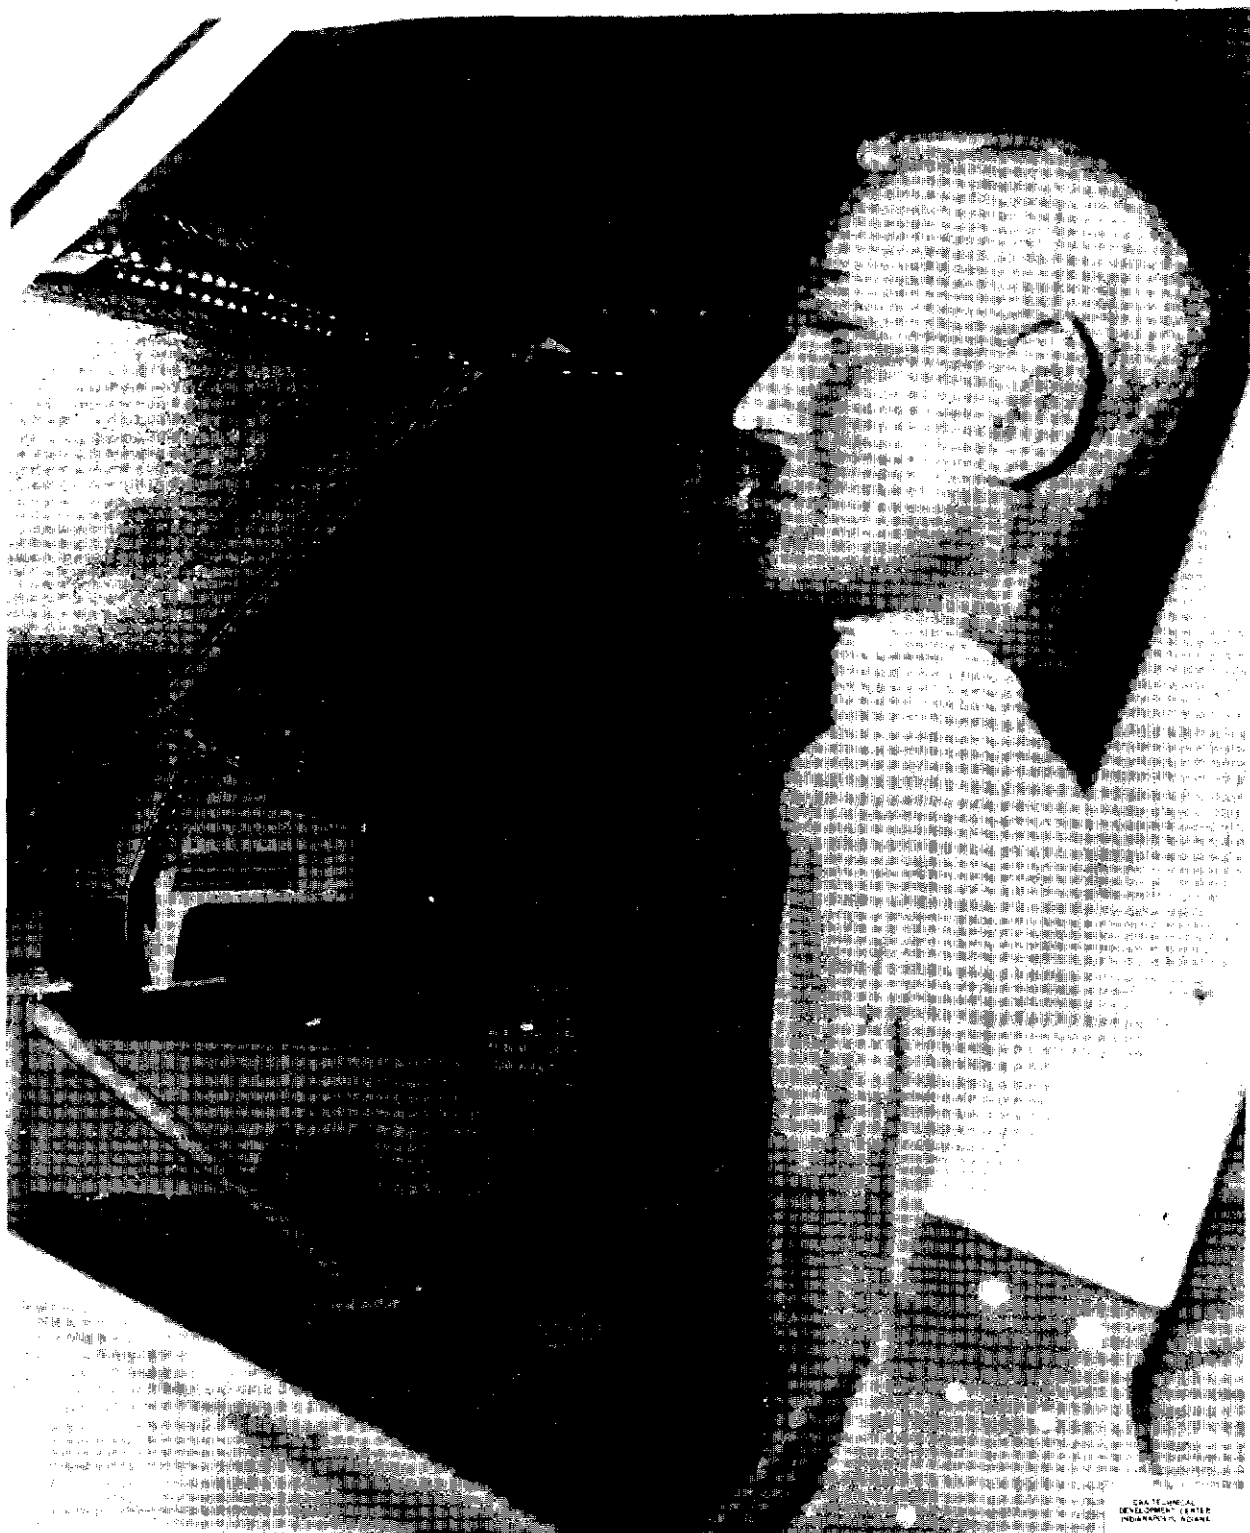
The carcass hit on the vertical centerline about 1 1/2 inches below the horizontal centerline. There was no penetration of the windshield. The upper sill again was bent inward. Two chunks of glass, cubic in general shape and about 1/4 inch along the edge, penetrated the face of the dummy, one below the left eyebrow and one at chin level on the left side. All other particles of glass which impinged upon the dummy's face and clothes could be removed by gentle brushing. The glare shield had been removed prior to this test because it was damaged beyond repair in previous tests. Results of this test are shown in Figs. 12 and 13.
