TECHNICAL DEVELOPMENT REPORT NO. 301

BIRD-IMPACT TESTS OF THE  
BOEING MODEL 707 AIRPLANE WINDSHIELD

February 1957

CIVIL AERONAUTICS ADMINISTRATION  
TECHNICAL DEVELOPMENT CENTER  
INDIANAPOLIS, INDIANA

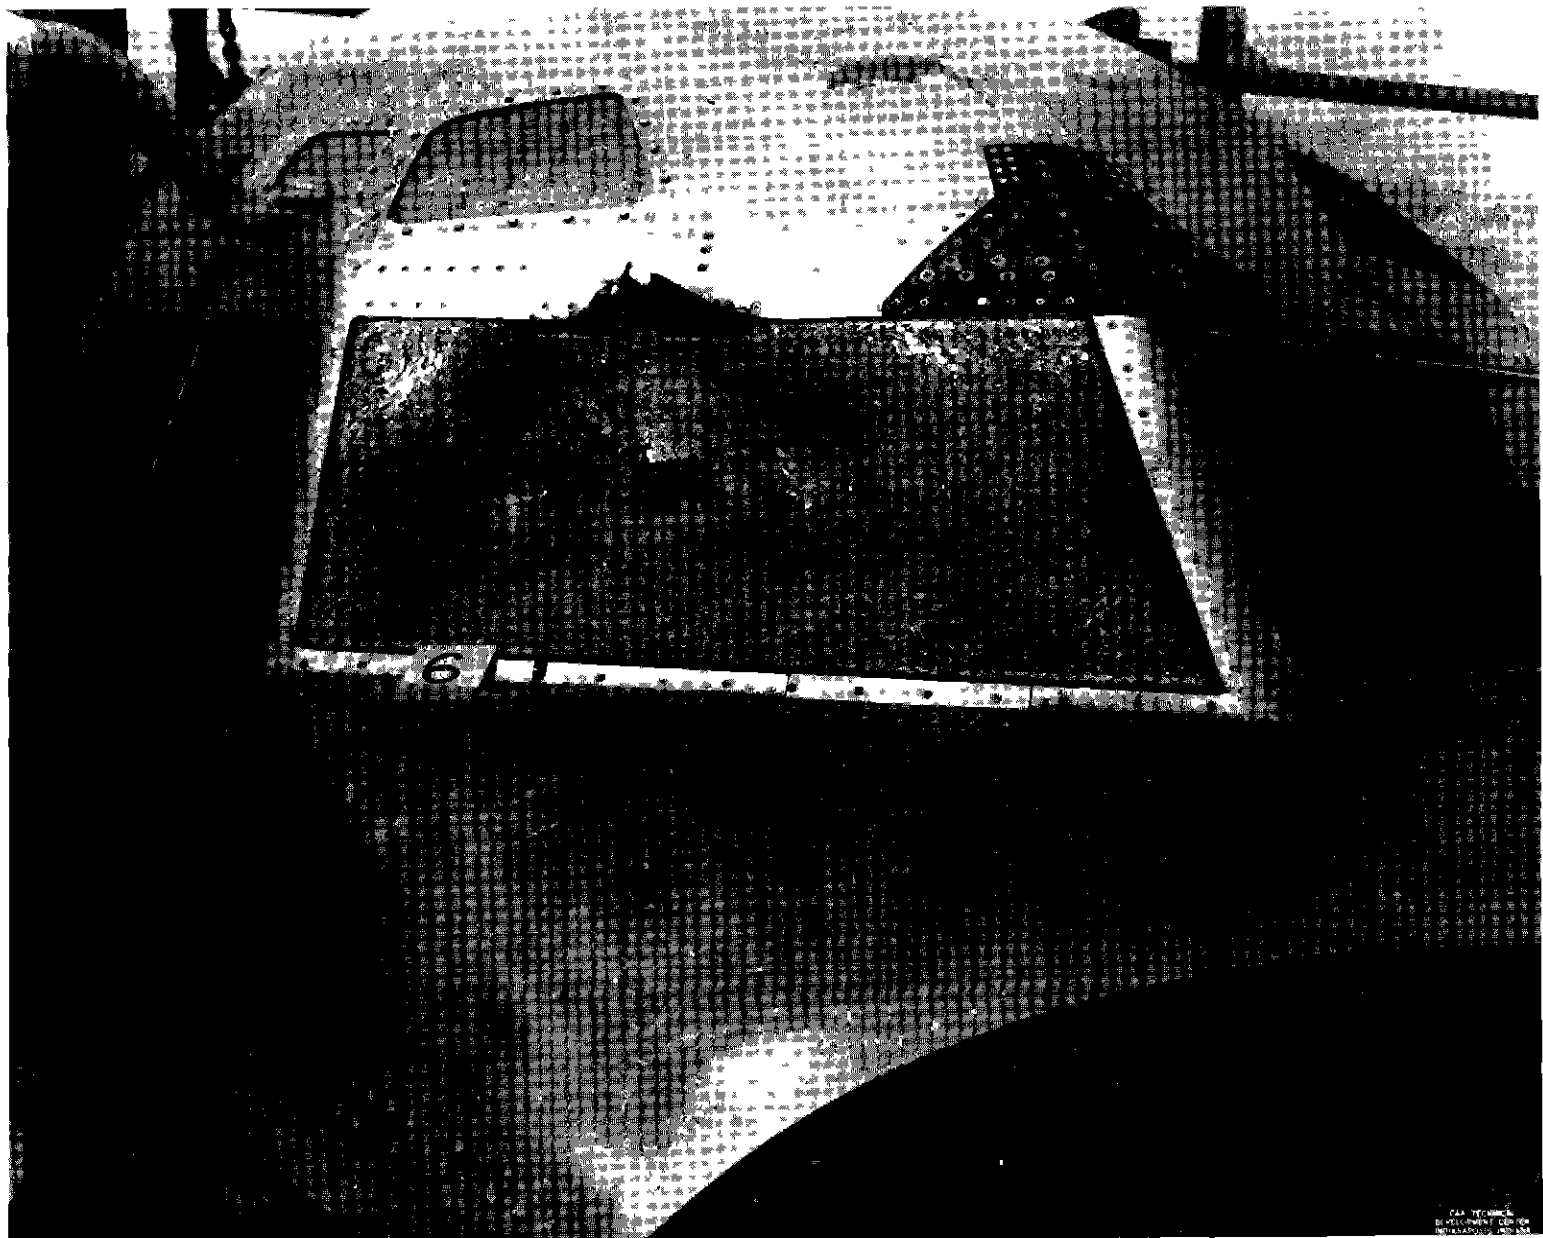
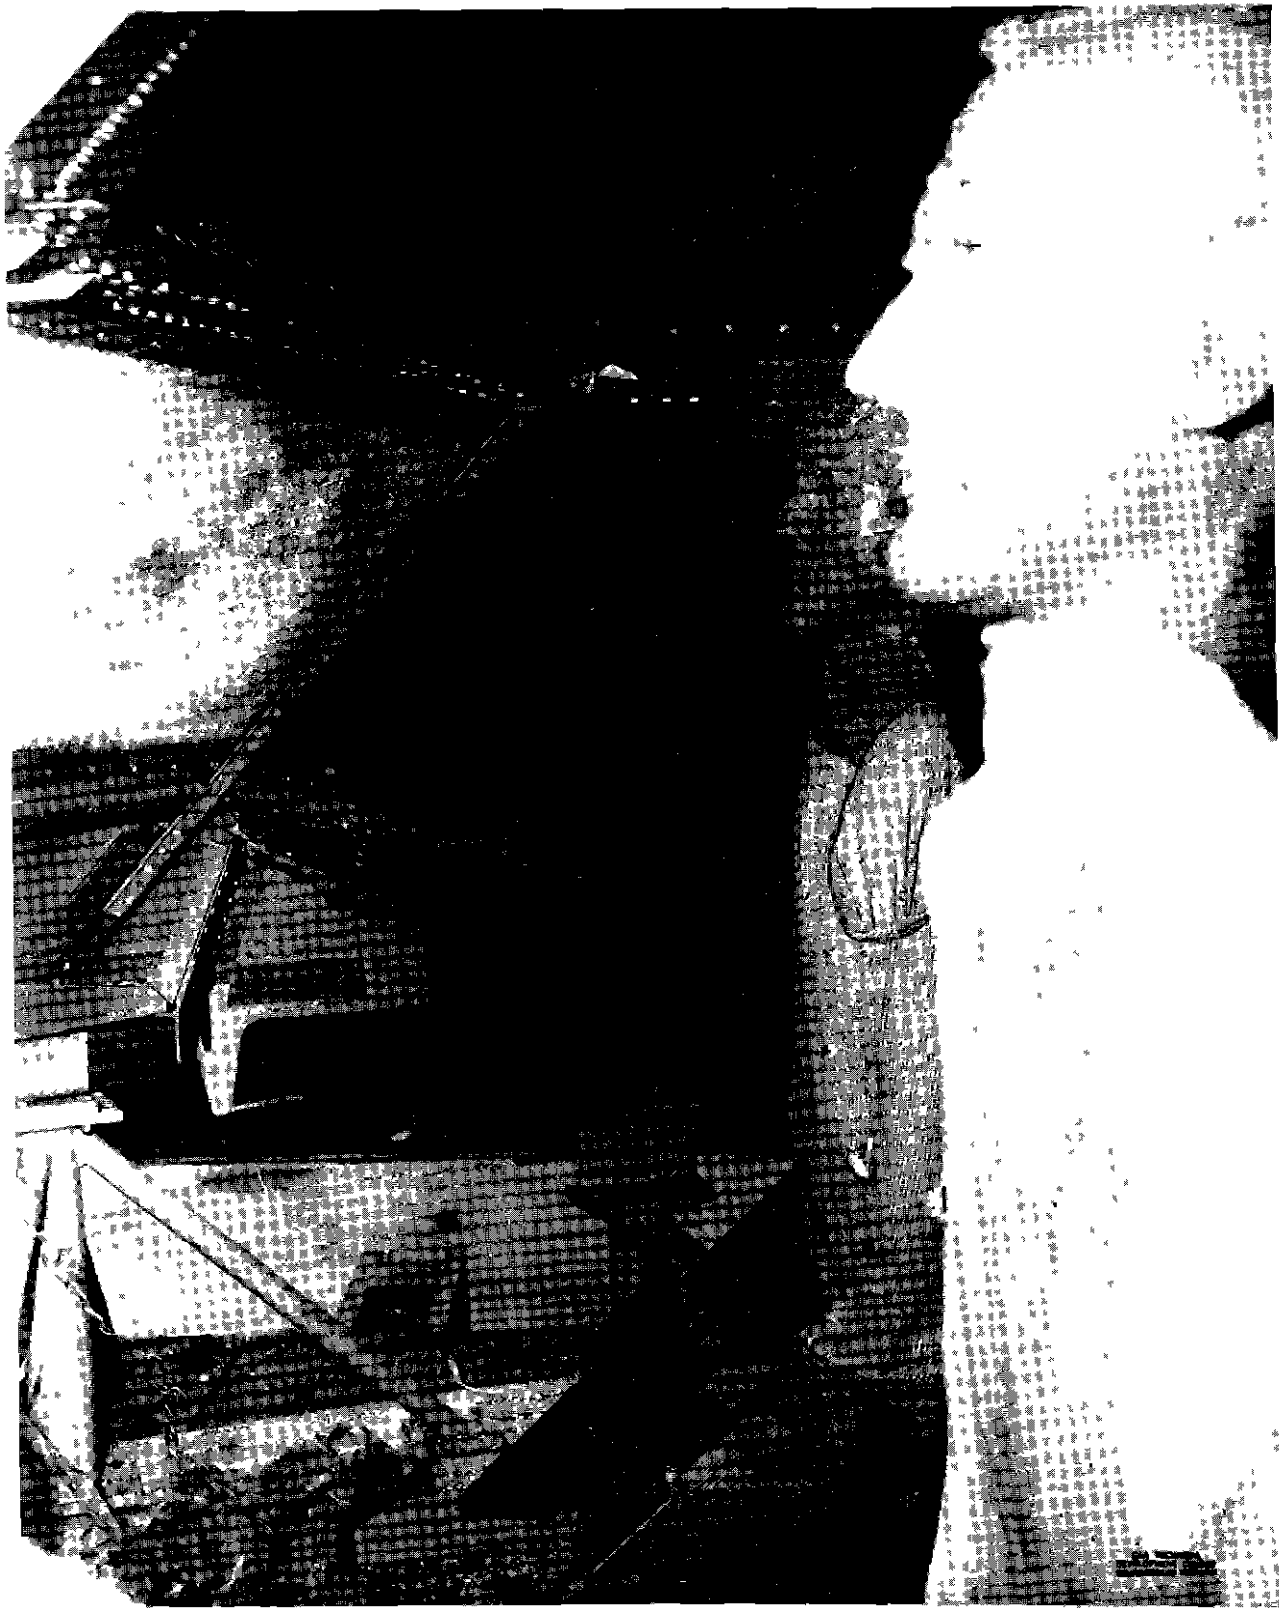
The carcass hit on the horizontal centerline slightly outboard of the vertical centerline. There was no penetration of the windshield. The top windowsill was bent inward and had developed a crack. Action of the bird carcass as it traveled up the windshield caused tearing of the fuselage skin above the top windowsill. The clay dummy received a face full of glass

chunks, many of which were imbedded as much as 1/4 inch in the clay. In addition, the left side of the clay dummy from the neck to the waist area contained numerous chunks of glass which had torn through the dummy's clothing. Results of this test are shown in Figs. 14 and 15.

During tests Nos. 2 and 6, the upper sills of the pilot No. 1 and co-pilot No. 1 windows cracked, and an 0.125-inch-thick 75-ST Alclad doubler plate was incorporated as shown in Figs. 16 and 31 to stiffen the weakened sills. The cracks which developed in both of these upper windowsills are not considered to be due to weakness on their part, but were due to continuous cold working of the sill material as it was deformed and straightened during successive impact tests.

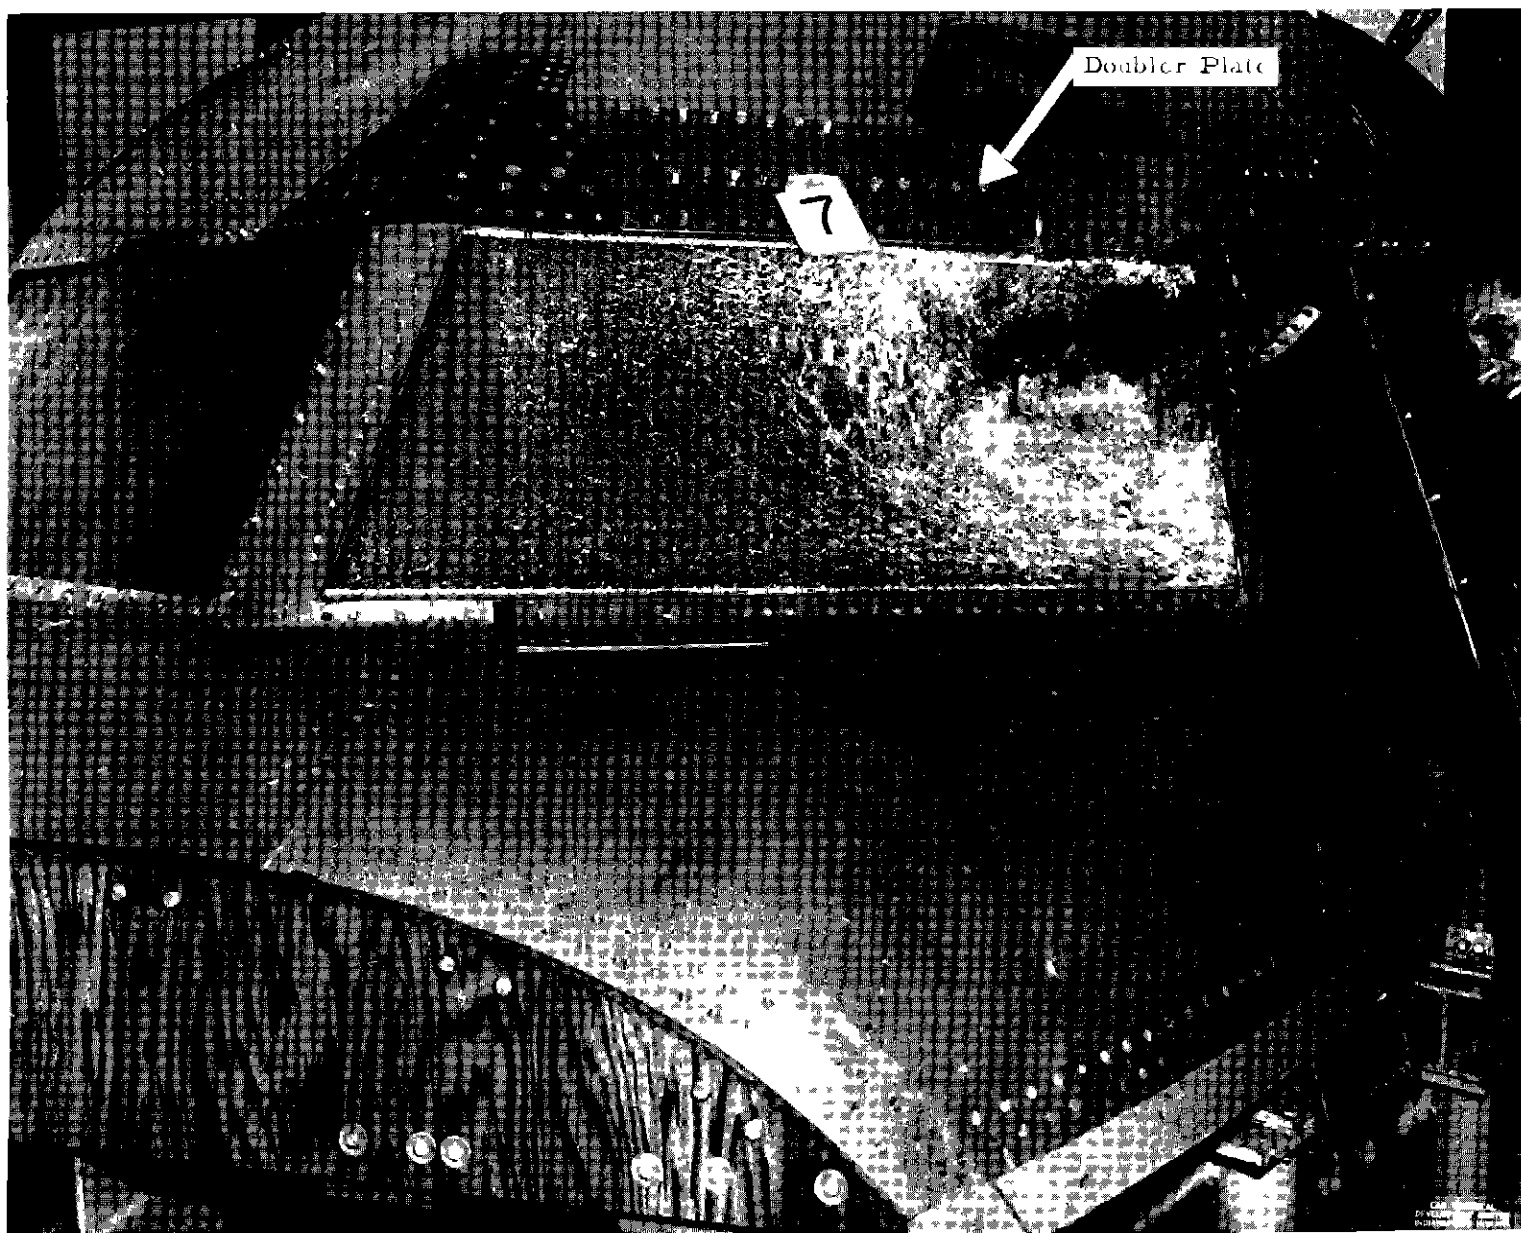
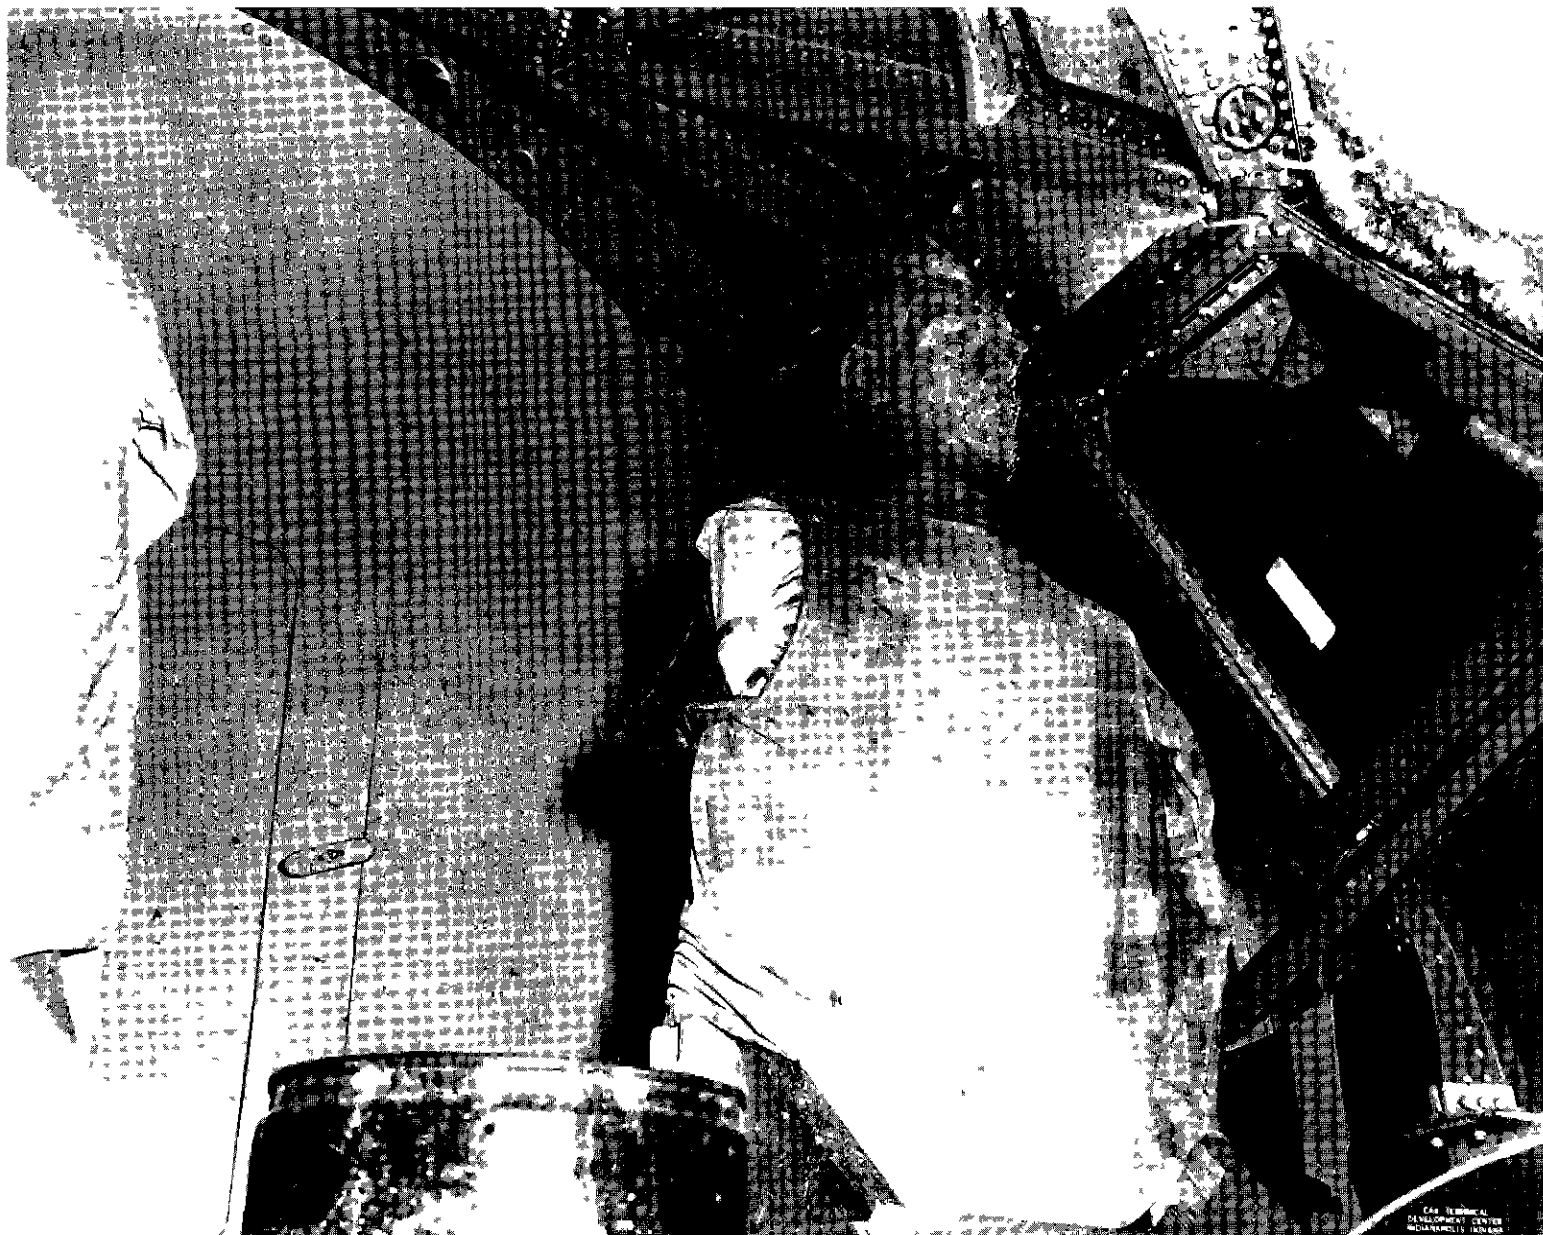
The carcass hit the vertical centerline of the pane 6 inches in-board of the cornerpost. There was no penetration of the window. Apparent damage to the supporting structure of the window was superficial in nature in that the aluminum skin covering the cornerpost peeled off. Hidden damage included shearing of one of the cornerpost window edge rectangular retainers. The face and left side of the clay dummy received quite a few chunks of flying glass which penetrated the clothing and imbedded themselves in the clay. Results of this test are shown in Figs. 16 and 17.

3. Windshield strength near the centerpost is considered equal to or better than that of the upper outboard corner. See Item 2.
4. For an impact at the geometric center of the windshield, flying glass will strike the face of the pilot crew member seated behind the target window at impact velocities approaching 440 mph. The resulting glass-impingement pattern for a center impact position will be essentially the same as shown on the clay dummies in Figs. 11, 13, and 15 for carcass velocities of 415, 422, and 440 mph respectively. In the event of an upper outboard corner impact the pilot crew member seated behind the target window will be struck in the face by flying glass at velocities as low as 380 mph. See Test Nos. 7, 10, and 13. The glass-impingement pattern for an upper outboard corner impact is shown on the dummy of Fig. 17 for a carcass velocity of 380 mph.

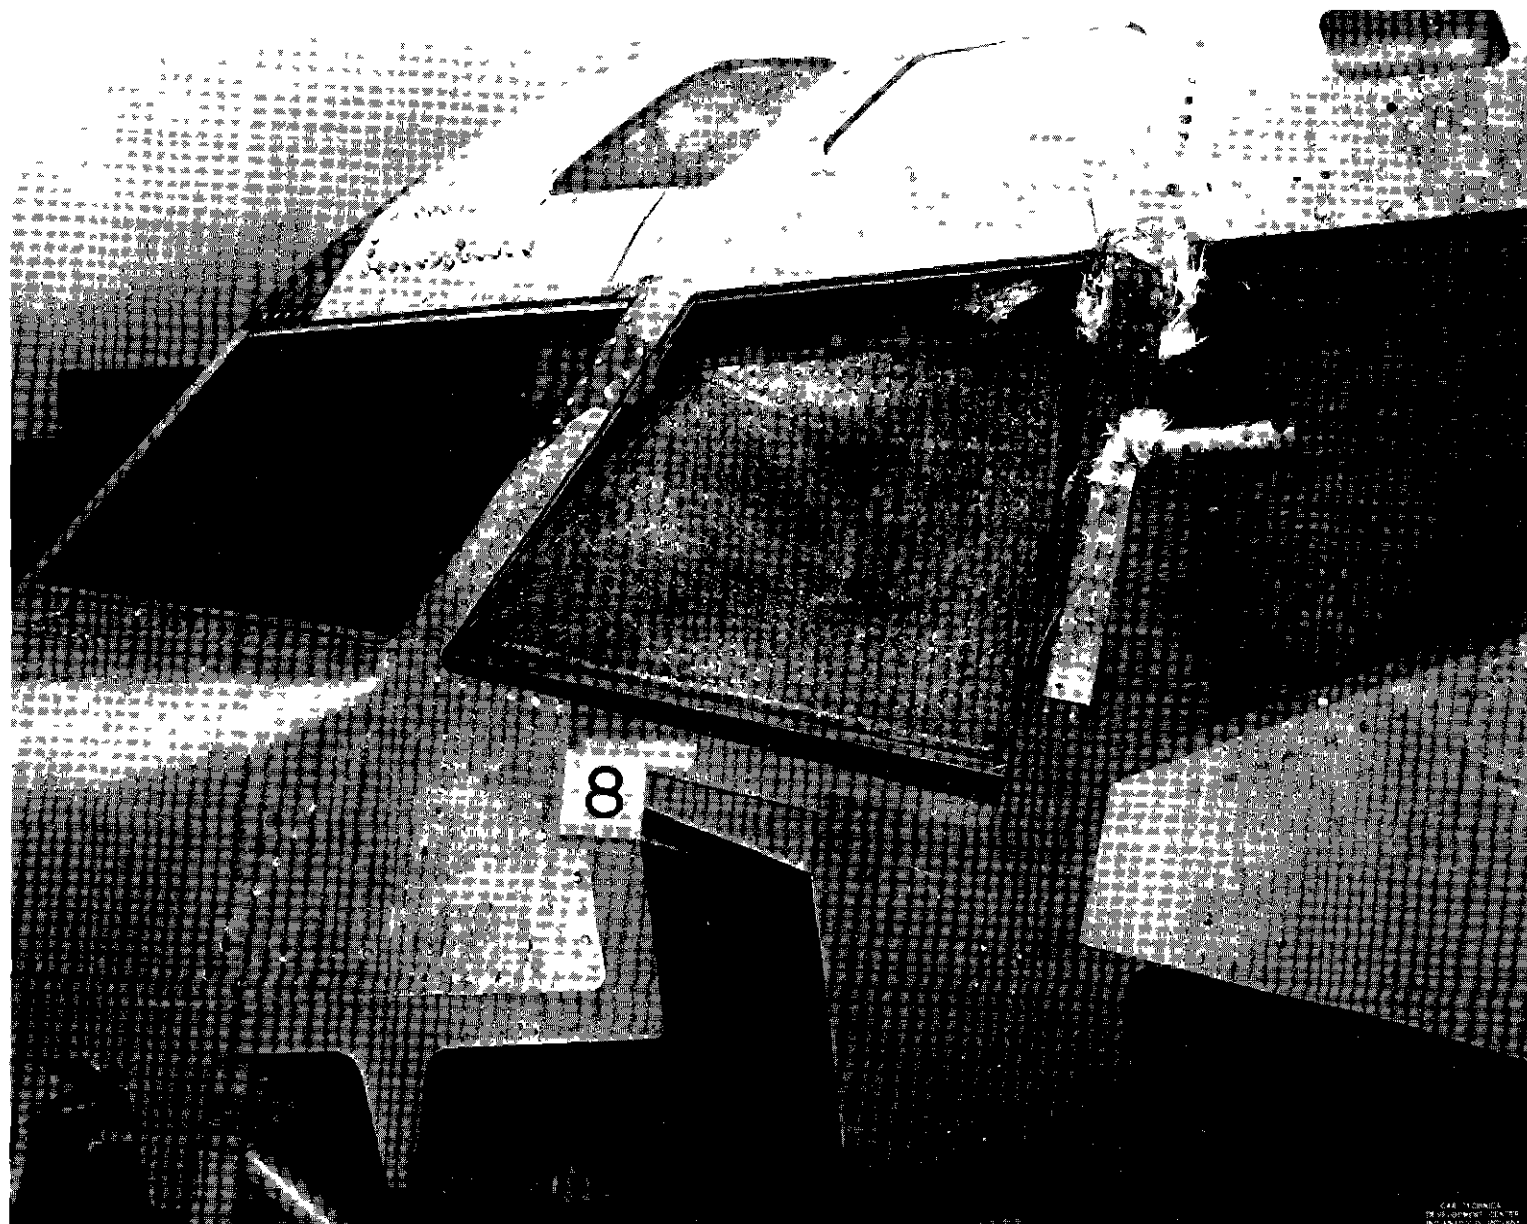
The center of impact was on the horizontal centerline approximately 4 inches aft of the forward windowsill. There was no penetration of the window. The upper aft window-frame retaining structure failed, allowing the window frame to rotate inward and strike the clay dummy on the left side of the head. In addition, the left side of the clay dummy's head and neck was penetrated by numerous particles of glass which were not deeply imbedded. Results of this test are shown in Figs. 18 and 19.

1. The upper aft retaining arrangement for the sliding window failed at an impact velocity of 378 mph, allowing the window frame to rotate inward about its two lower track-level retaining points, striking the clay dummy on the side of the head just above the ear. See test No. 8. In order that the sliding window may successfully withstand a 4-pound bird impact, the upper and lower aft retaining arrangements should be increased in strength to equal that of the lower forward retaining arrangement.

The pilot No. 2 sliding window was revised as shown in Fig. 24 prior to test No. 11 as a result of failure of the upper aft retaining point during test No. 8.

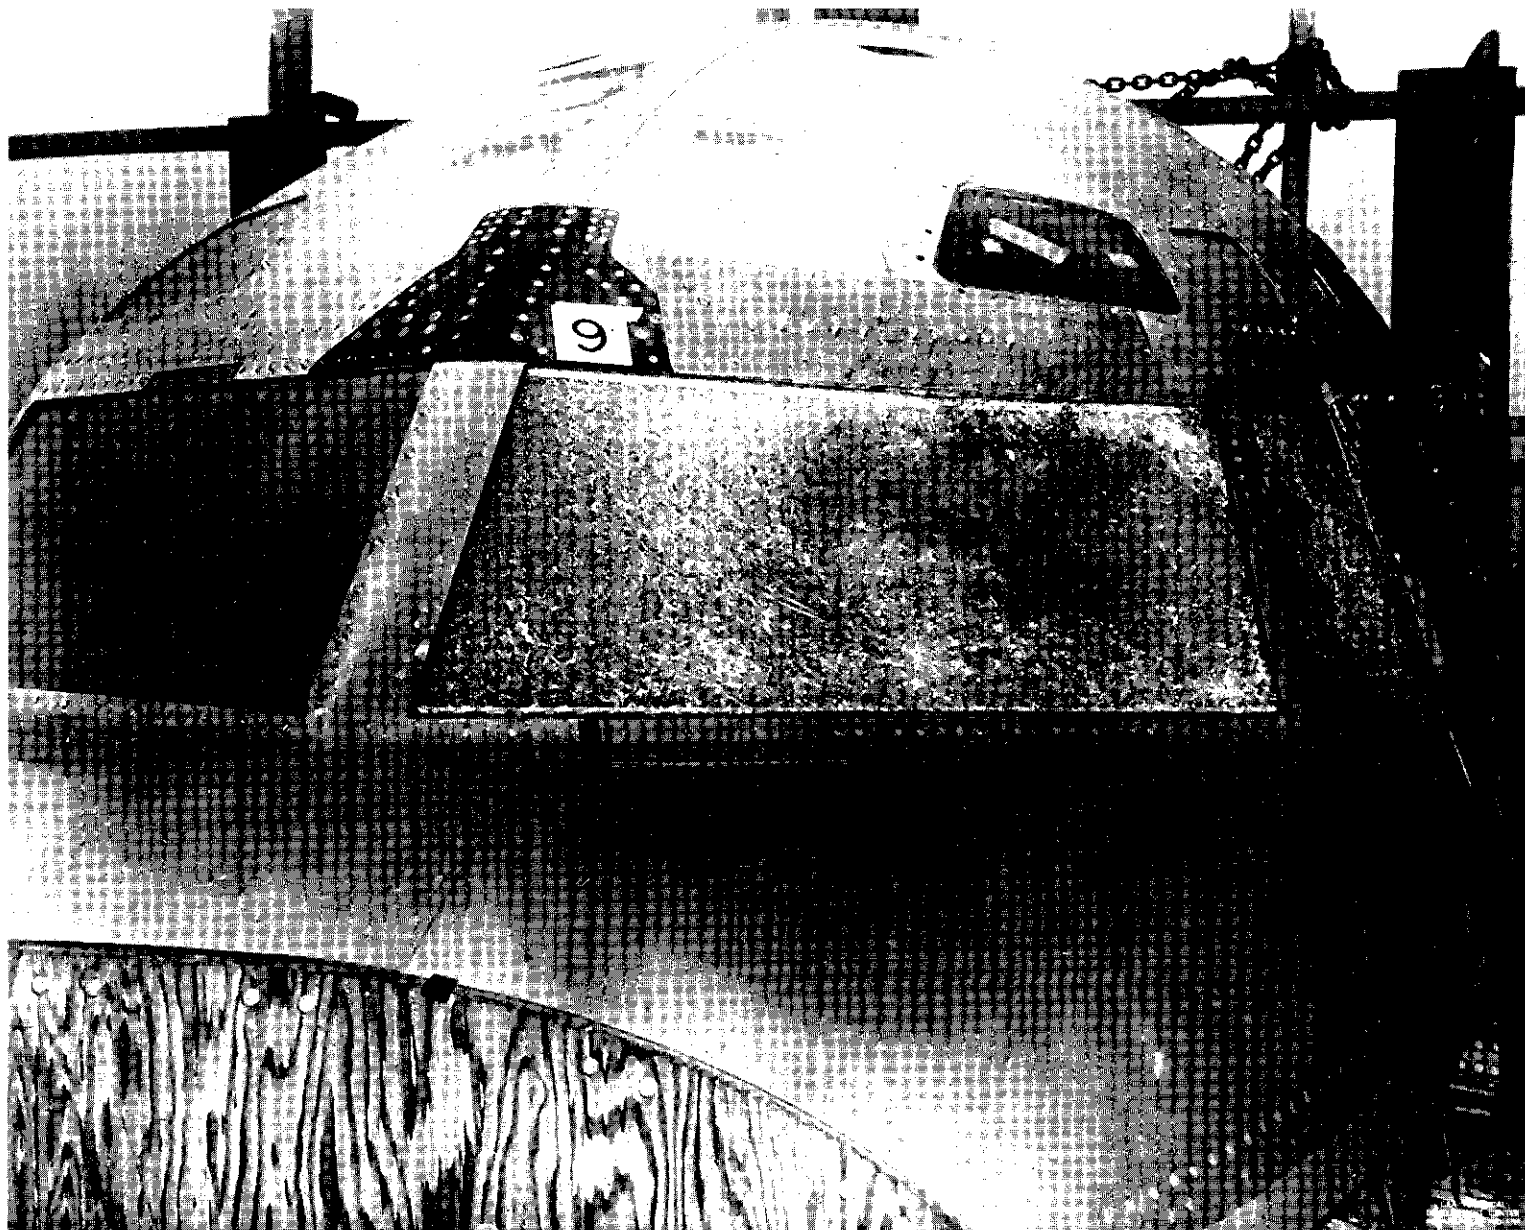
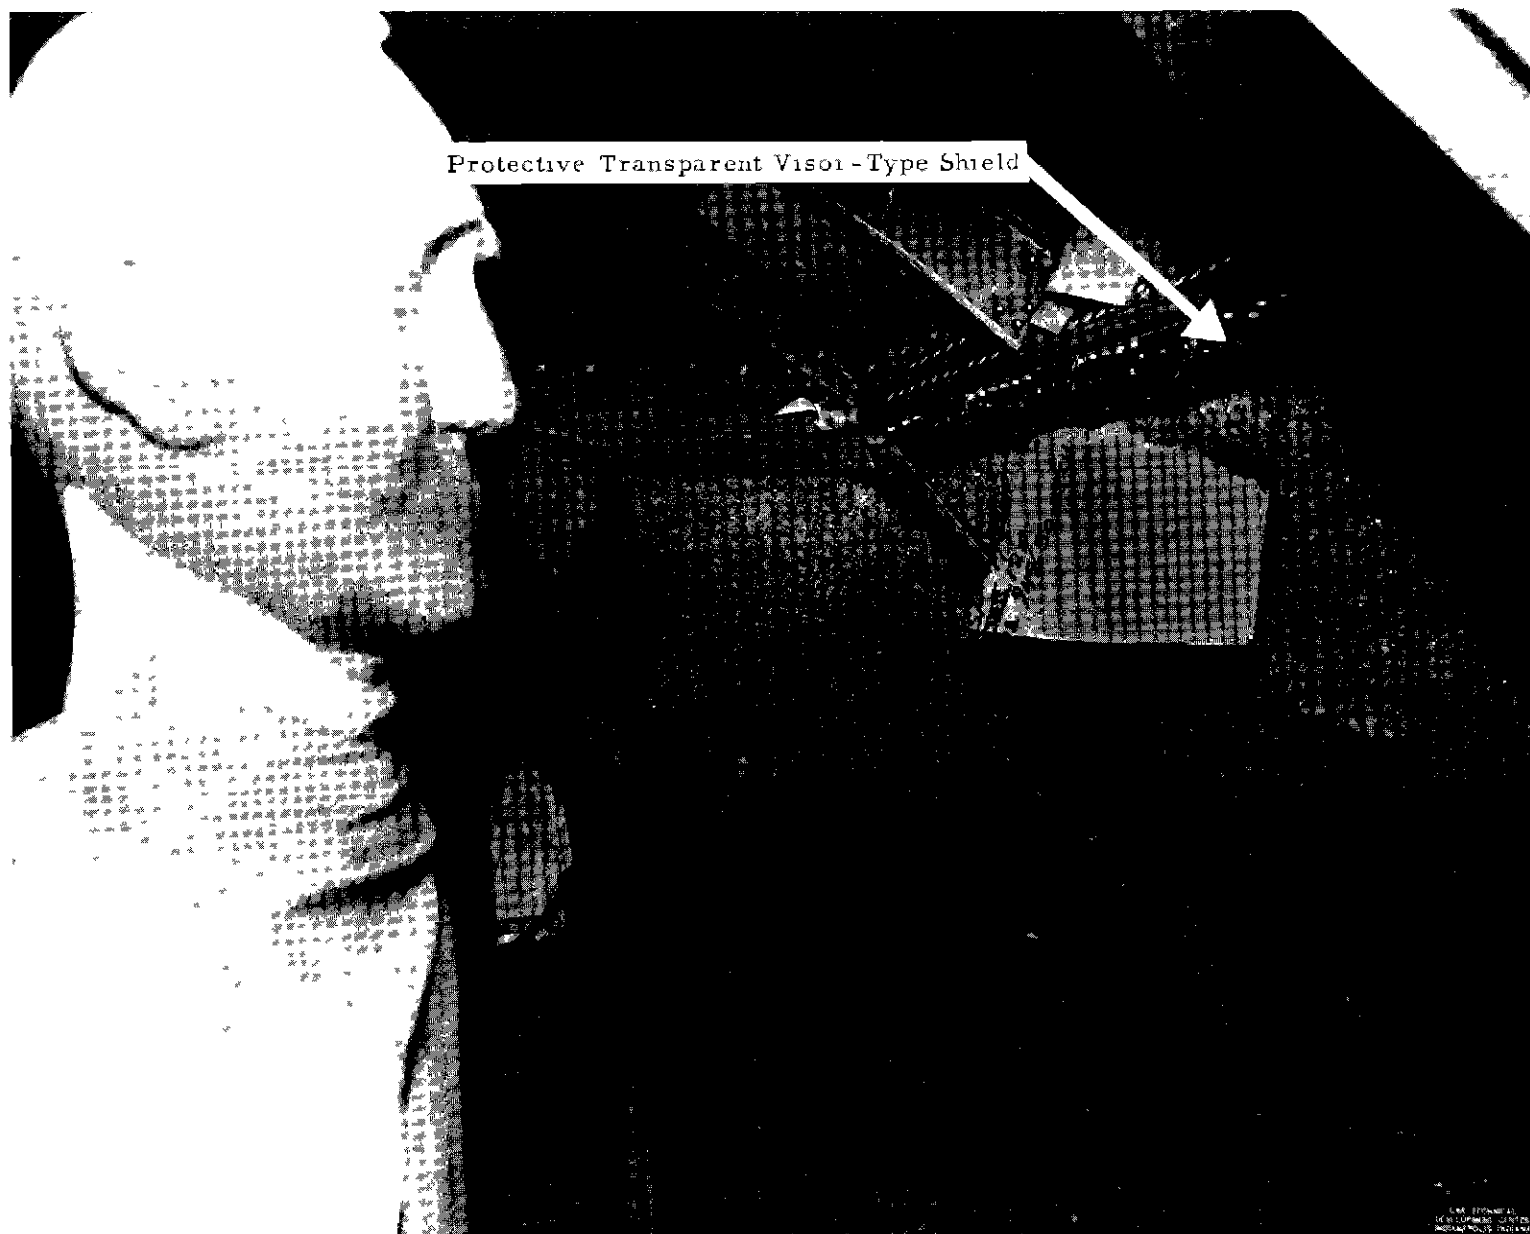
The center of impact was extremely close to the geometric center of the window. There was no penetration of the windshield. A visor-type transparent acrylic shield mounted adjacent to the window shattered upon impact. The right side of the dummy's face and neck was cut by flying plastic. Results of this test are shown in Figs. 20 and 21.

To protect the pilot against flying glass, a protective transparent visor-type shield was employed during tests Nos. 9, 10, and 14 as shown in Figs. 21, 22, and 35. For test No. 9, an 0.125-inch-thick sheet of stretched plex-55 acrylic was used; for tests Nos. 10 and 14, an 0.125-inch-thick sheet of cellulose acetate was used. These shields were retained at one edge only, and they were mounted adjacent to the inside face of the window as shown in the appropriate figures.

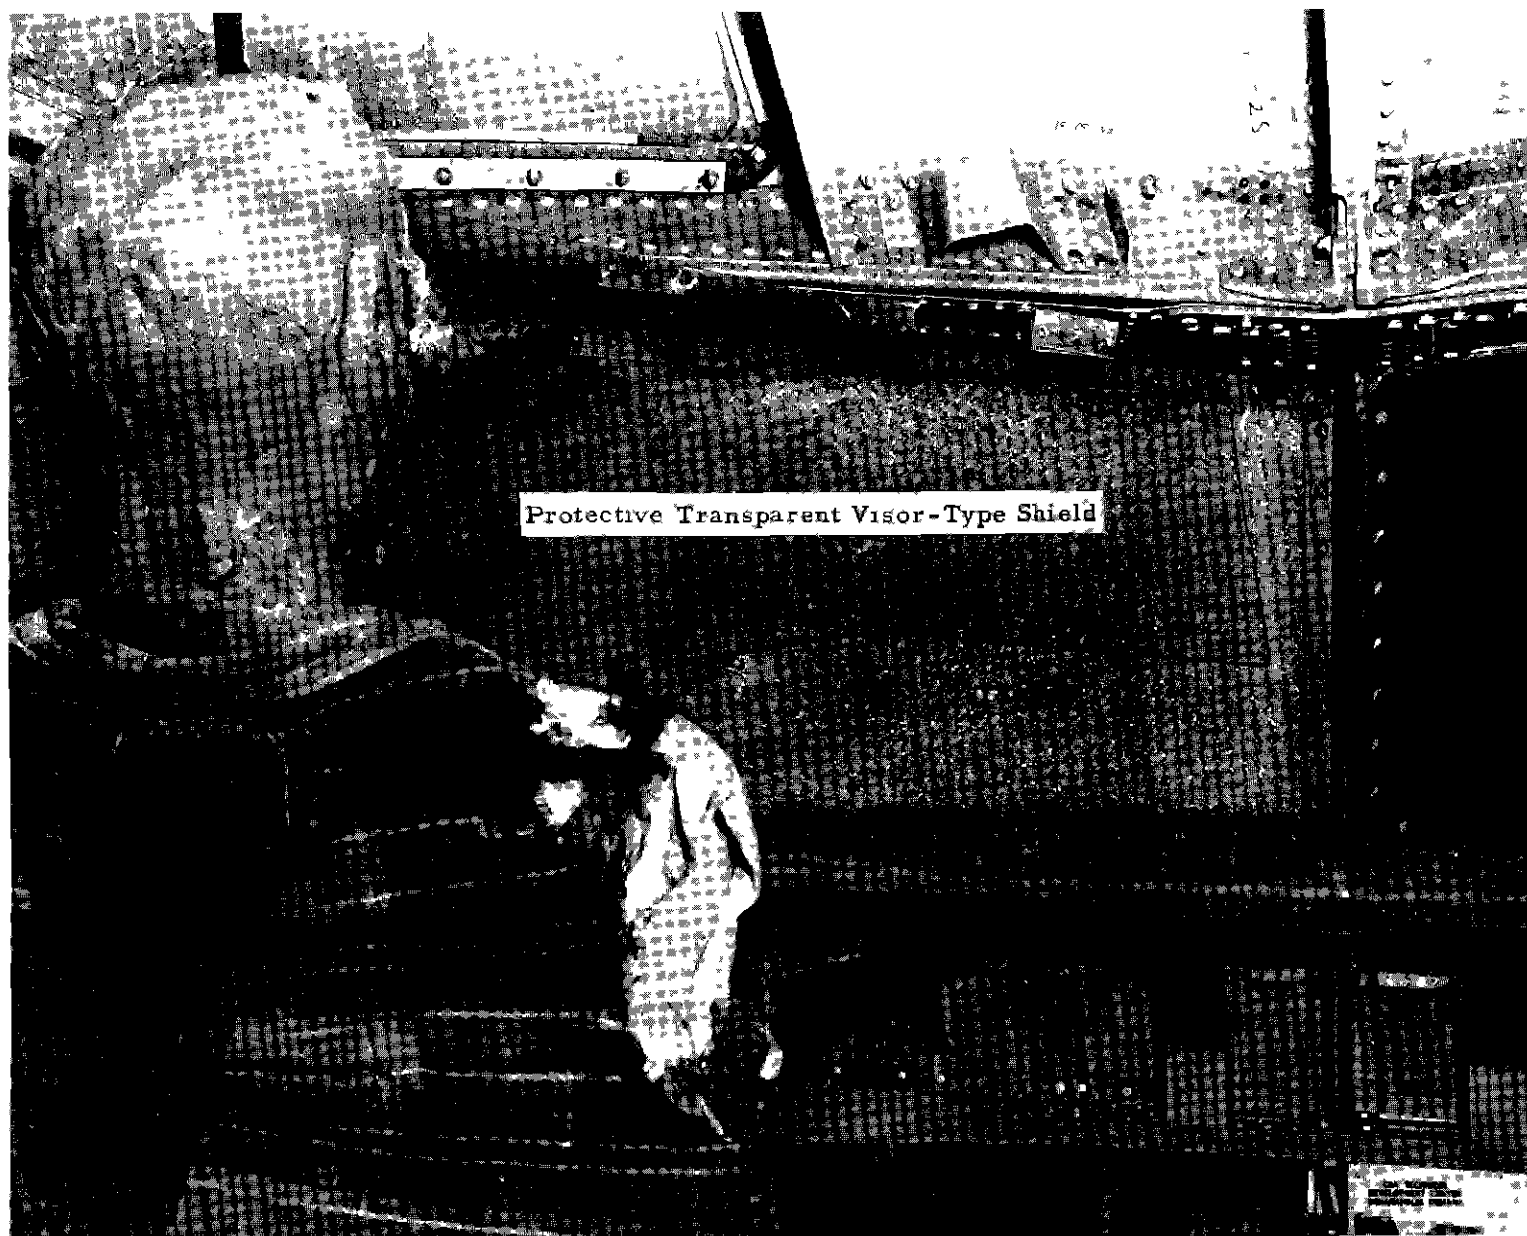
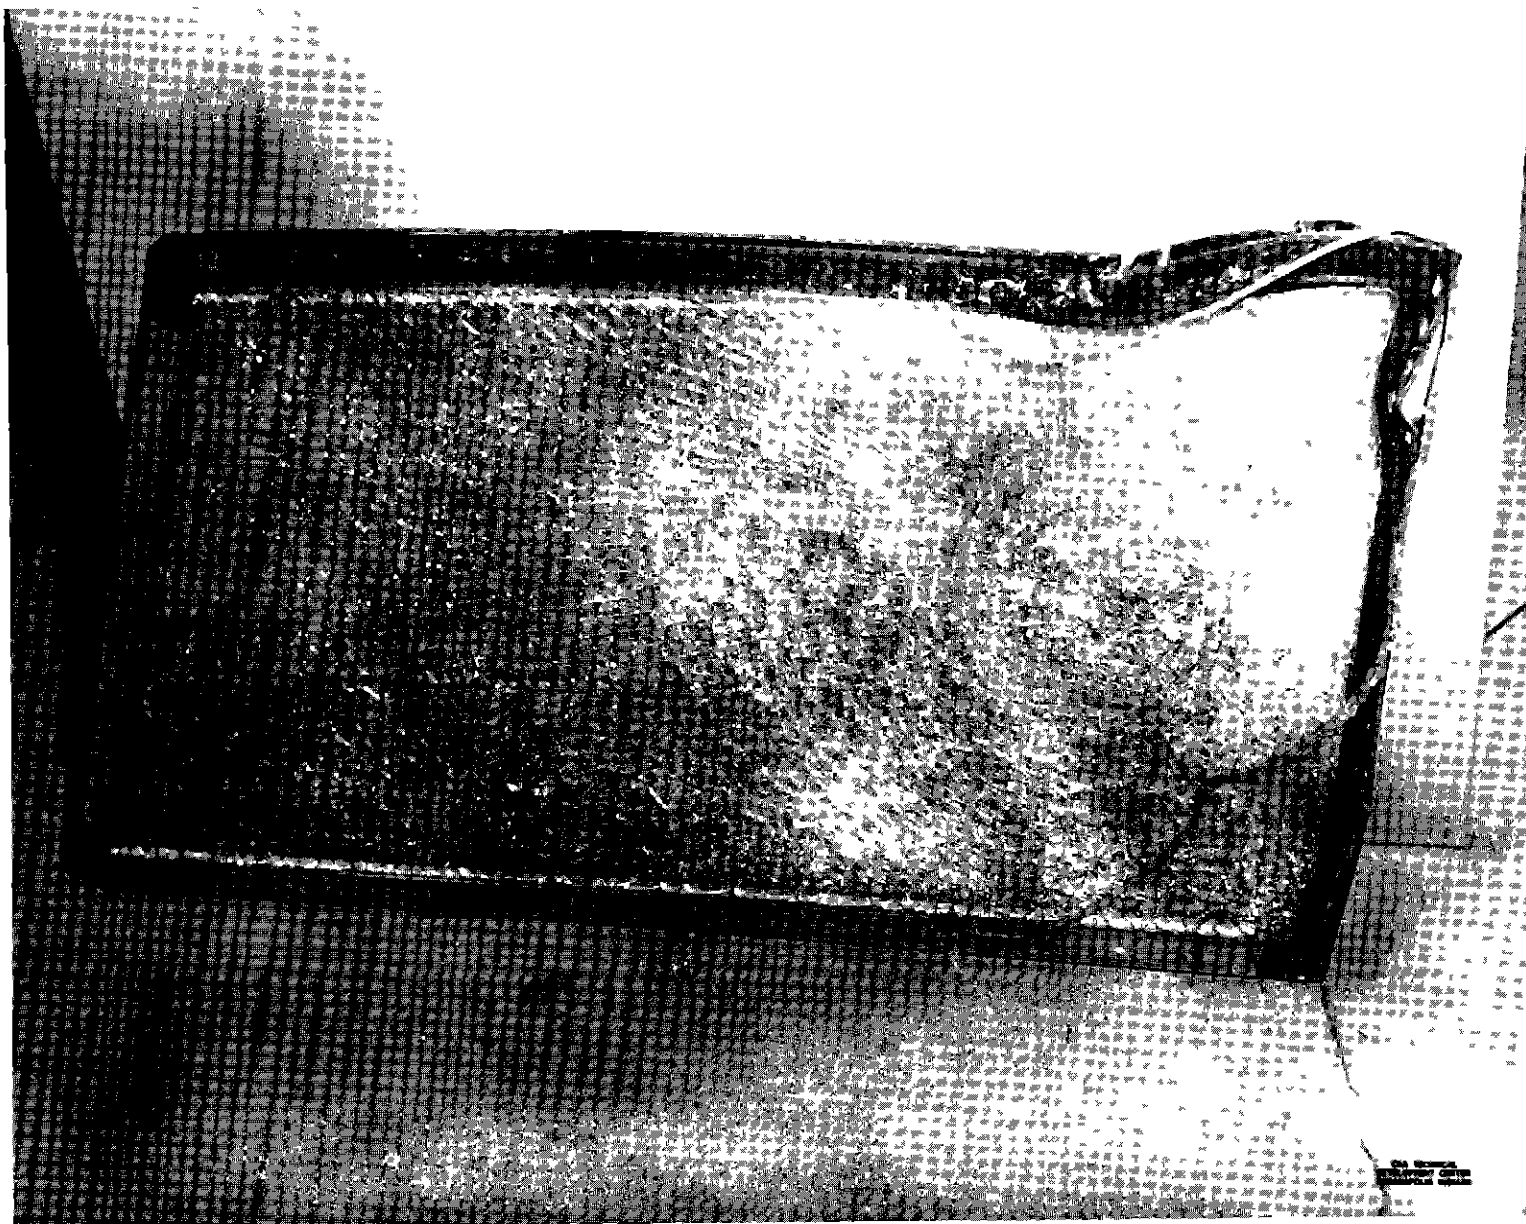
The center of impact was on the horizontal centerline approximately 8 inches inboard of the cornerpost. There was no penetration of the window, although failure of the cornerpost retaining member and the upper sill bolts allowed part of the bird carcass to enter the cockpit. The 0.125-inch cellulose acetate visor mounted as shown in Fig. 22 apparently was forced back across the face of the dummy upon impact. The clay dummy's face was covered with bird entrails and chunks of glass which penetrated into the clay. Results of this test are shown in Figs. 22 and 23.

Because of failure of the upper sill bolts during test No. 10, which was an upper aft corner strike at 460 mph, the first seven upper sill bolts counting inboard from the cornerpost were increased to 0.25-inch-diameter prior to test No. 13 as shown in Fig. 31. In addition, to provide for more positive retaining of the upper cornerpost window edge during test No. 13, the L-shaped backup bar (Part No. 5-71769-3005) was increased in length as shown in Fig. 2.
