TECHNICAL DEVELOPMENT REPORT NO. 301

BIRD-IMPACT TESTS OF THE  
BOEING MODEL 707 AIRPLANE WINDSHIELD

February 1957

CIVIL AERONAUTICS ADMINISTRATION  
TECHNICAL DEVELOPMENT CENTER  
INDIANAPOLIS, INDIANA

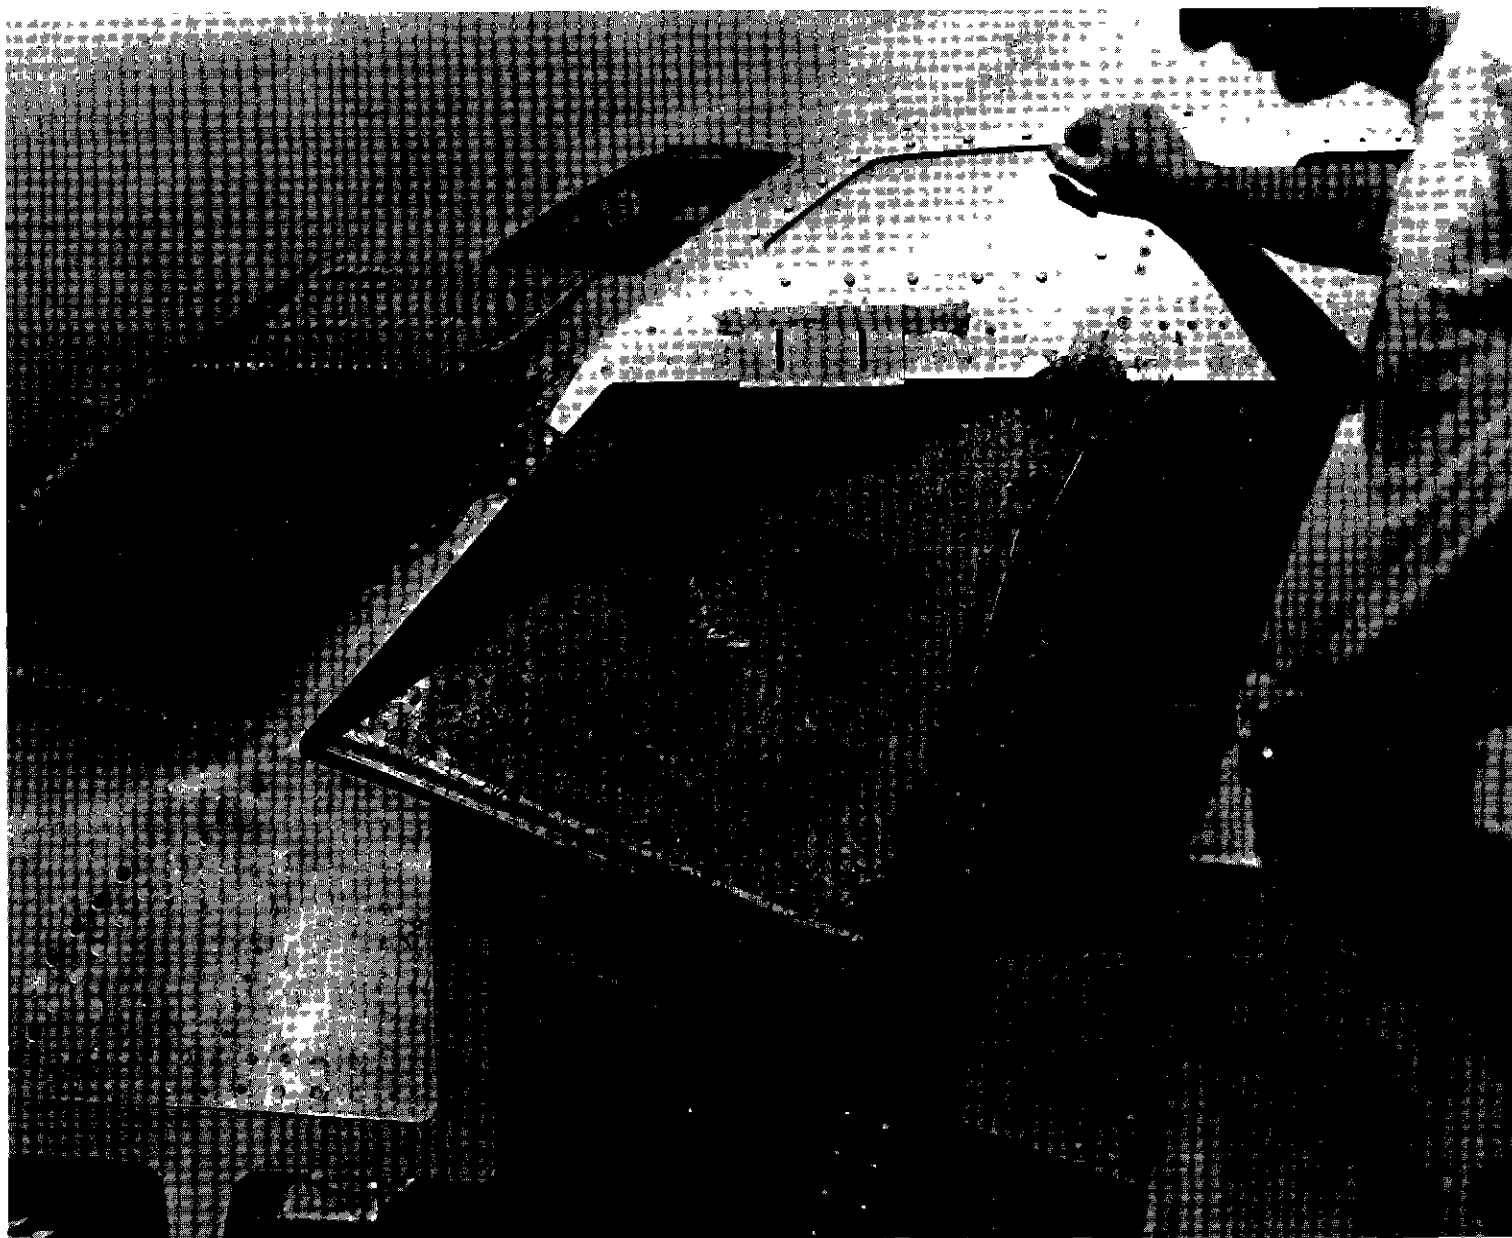
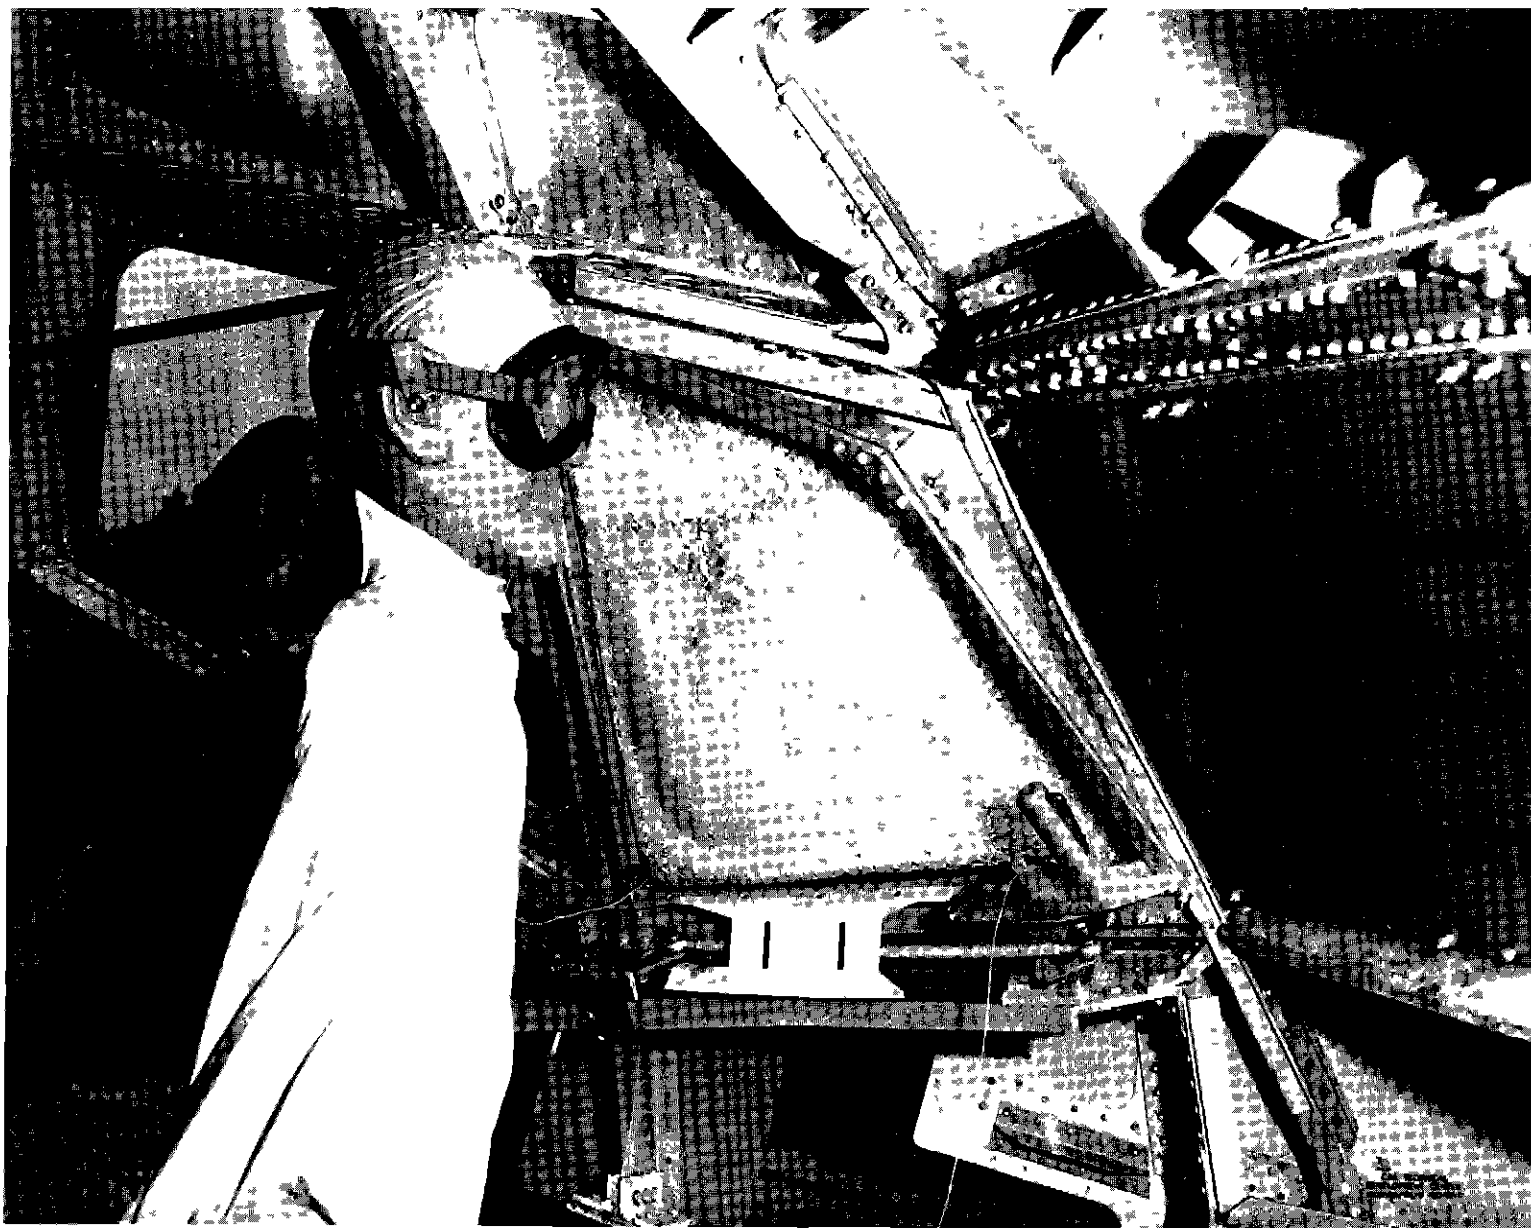
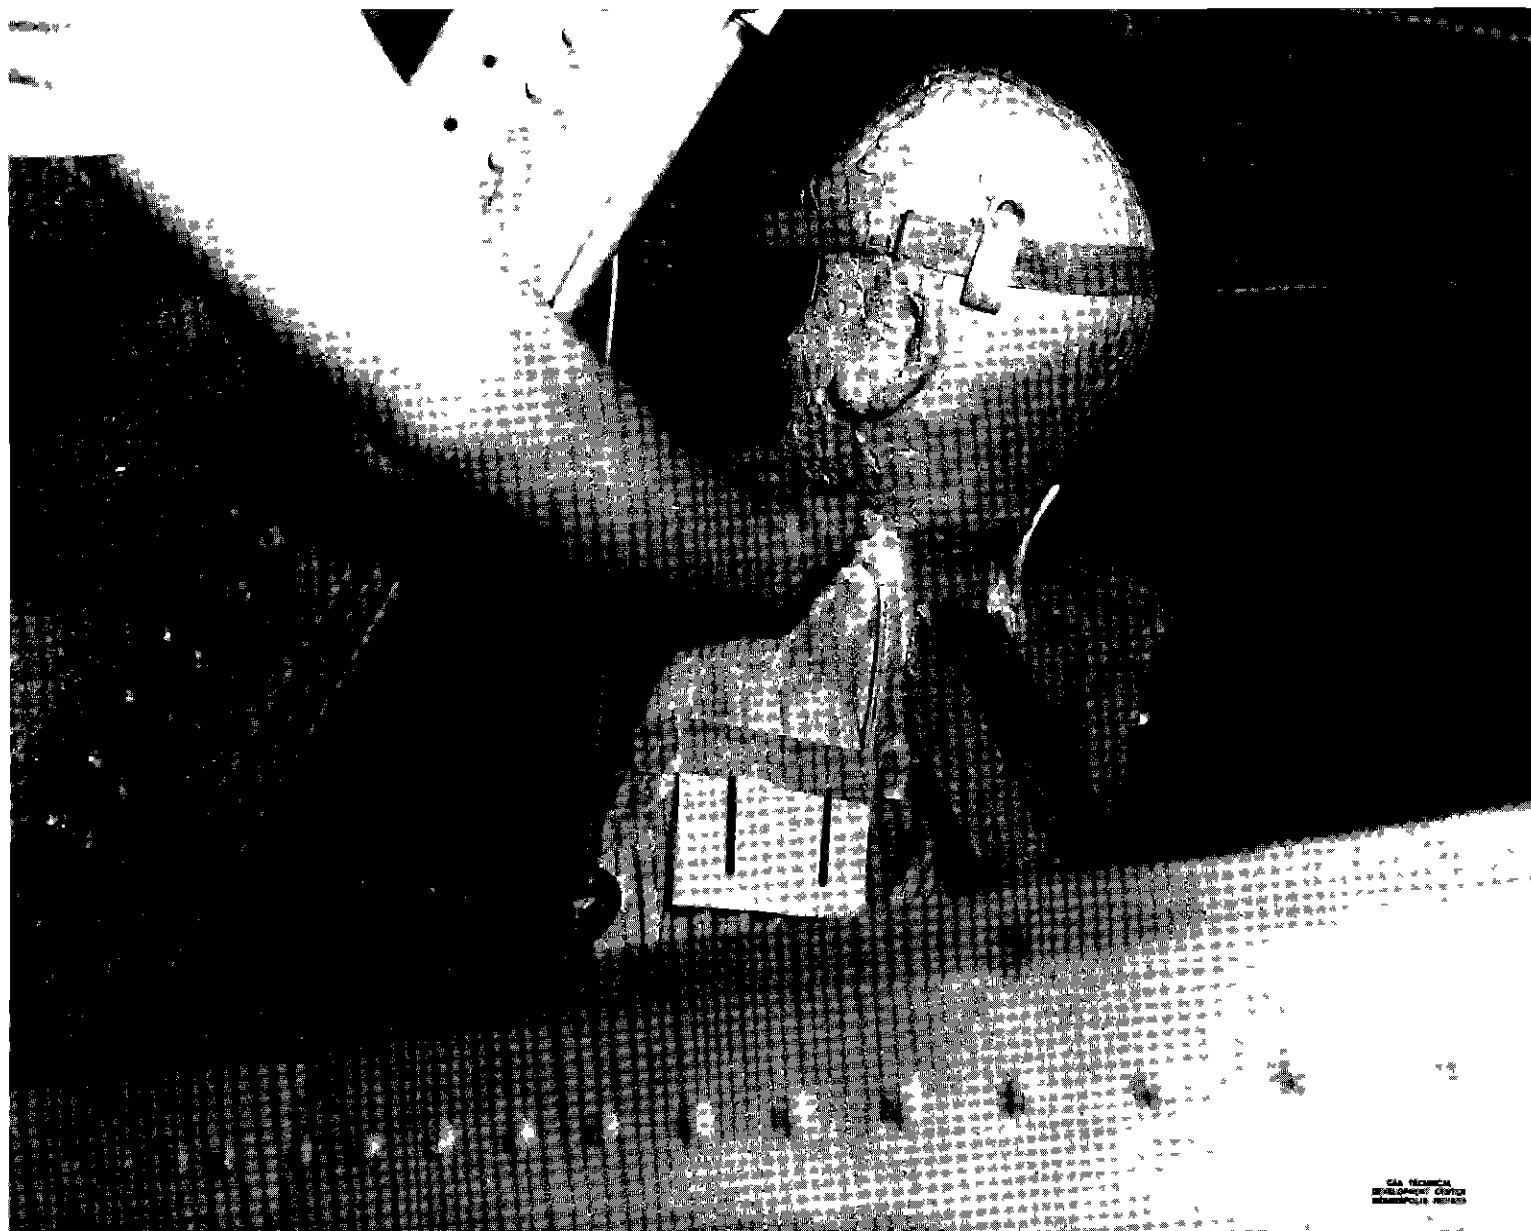
The center of impact was on the horizontal centerline approximately one-third of the distance from the fore window's edge to the aft edge. The upper forward corner of the window frame was pushed inward, but no failure of the frame resulted. The carcass did not penetrate the window. The sidepost sill was bent slightly and the sidepost doubler plate strip was peeled off. The reinforced upper aft and lower aft window frame retaining arrangement remained intact. The left side of the clay dummy's head and neck area was eroded quite severely by flying glass, although the Navy-type plastic goggles which were employed protected the dummy's eye area. The window prior to testing and results of this test are shown in Figs. 24, 25, 26, and 27.

2. An analysis of the flying glass problem indicates that the pilot crew member seated adjacent to this window will be struck by glass particles at bird-impact velocities as low as 378 mph. Both the amount and energy of glass emitted from sliding windows in the direction of the pilot's face are negligible at 378 mph. As impact velocities increase, however, the problem becomes more critical as indicated by the condition of the clay dummy's face following an impact test at 420 mph. See test No. 11.

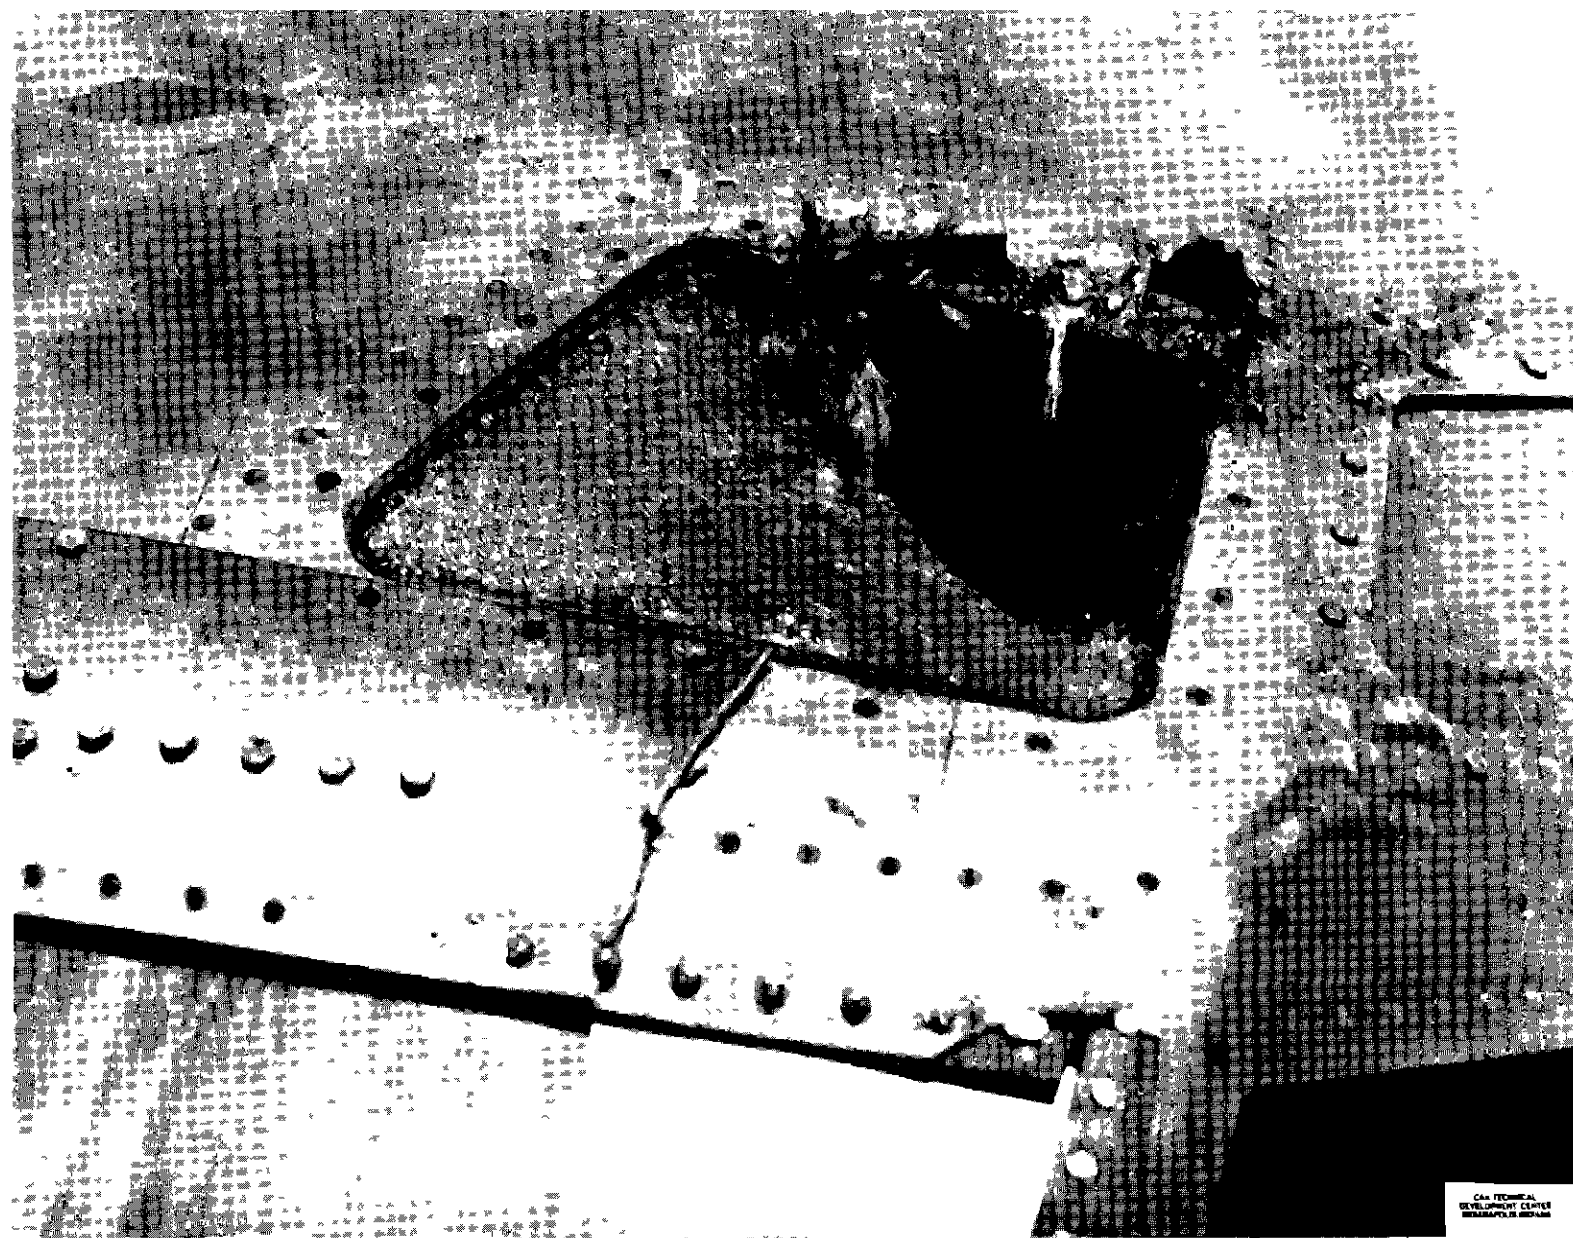
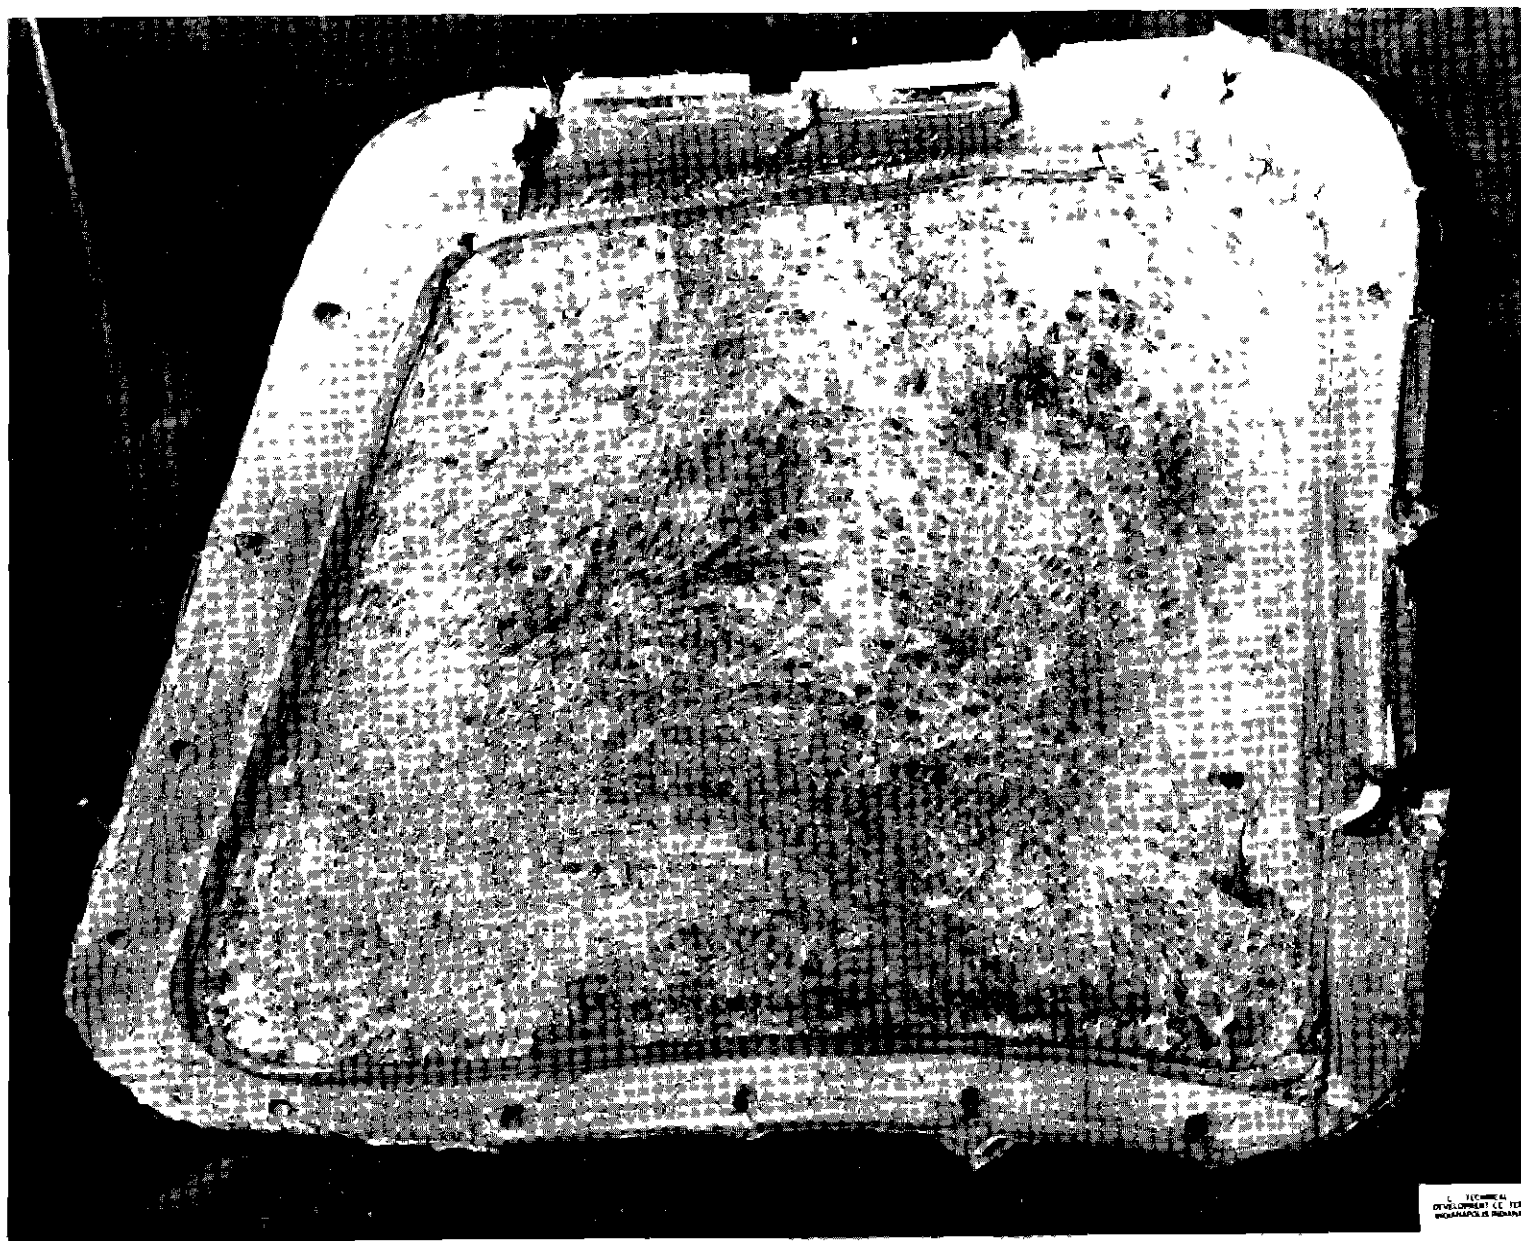
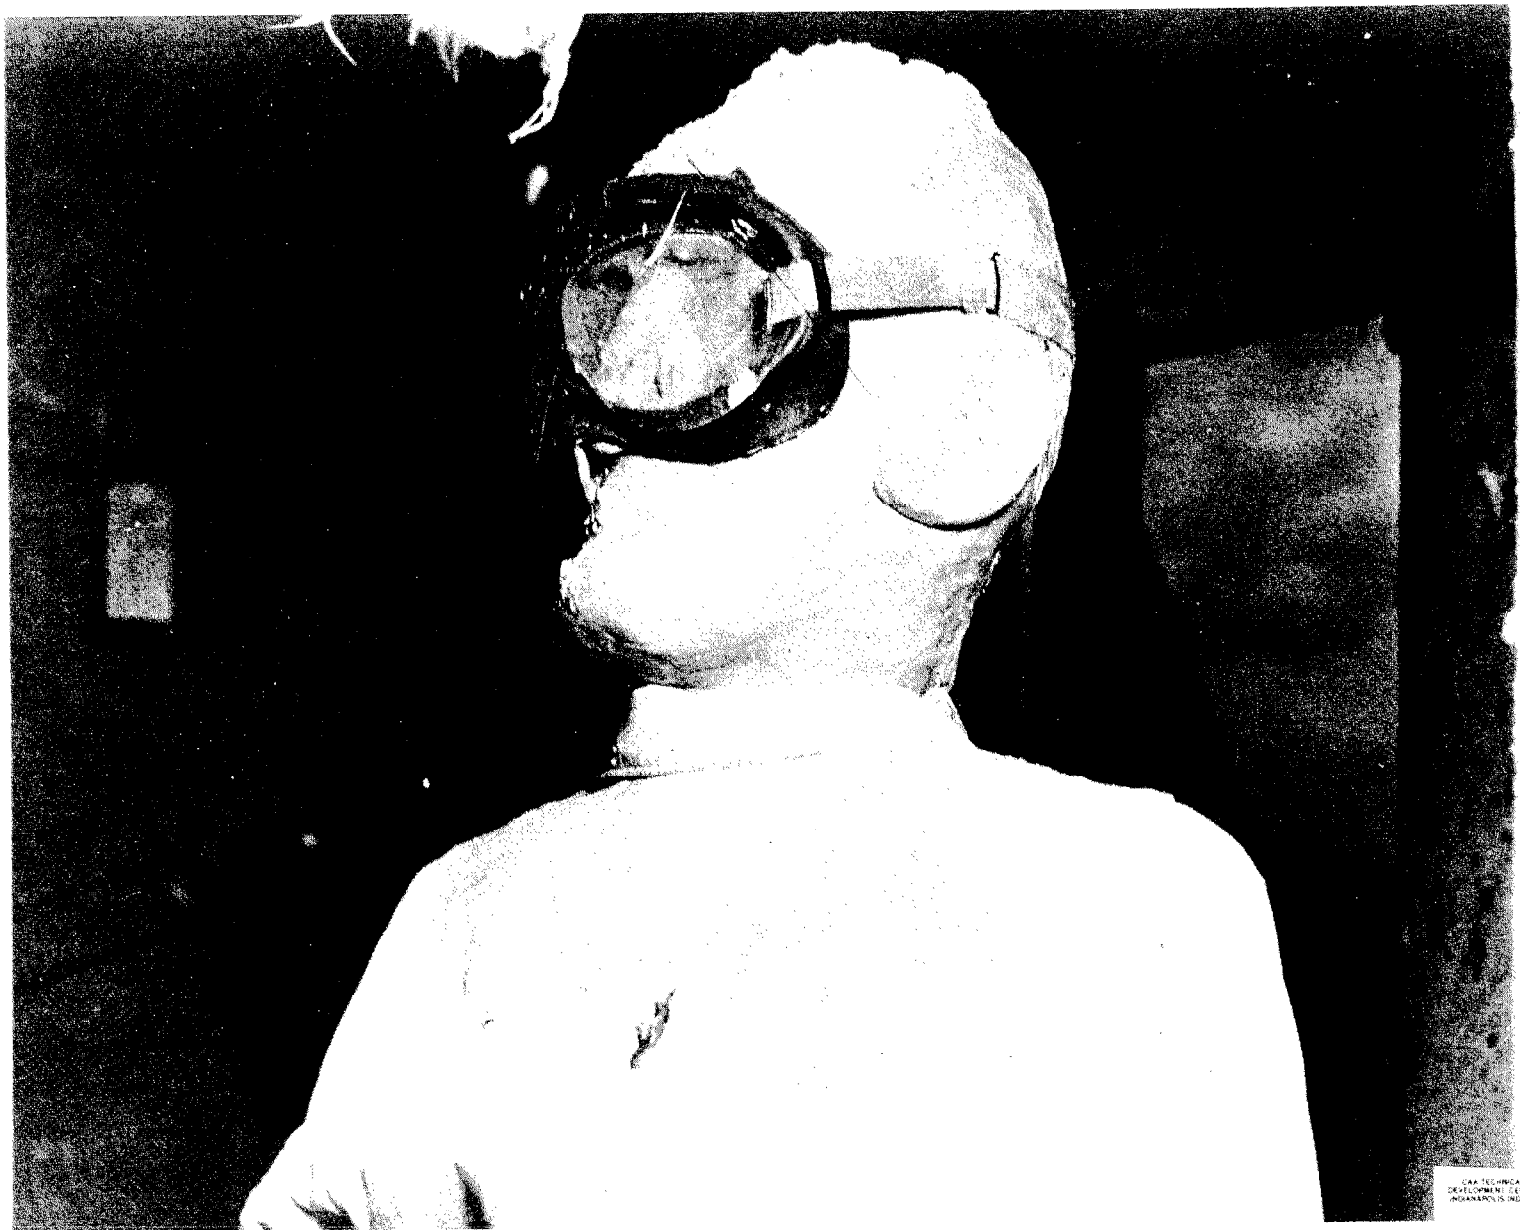
The center of impact was within 1/4 inch of the geometric center of the window. The upper sill and outboard side-sill retaining bolts tore through the window edge, allowing part of the carcass to pass into the cockpit over the head of the clay dummy. The clay dummy received a severe blow on the forehead apparently from a concentration of glass particles which departed from the inner face of the window upon impact. The Navy-type goggles with plastic lens protected the clay dummy's eye area from severe damage. Results of the test are shown in Figs. 28, 29, and 30.

2. An analysis of the flying glass problem indicates that a particularly dangerous hazard to the pilot or co-pilot exists upon bird impact of an eyebrow window at velocities at or lower than 393 mph. See tests Nos. 12 and 14.

The pilot No. 4 eyebrow window retaining arrangement was revised by doubling the number of bolts and increasing their size to 0.25-inch diameter prior to test No. 14. This revision, shown in Figs. 34 and 35, was prompted by the failure of this window during test No. 12.

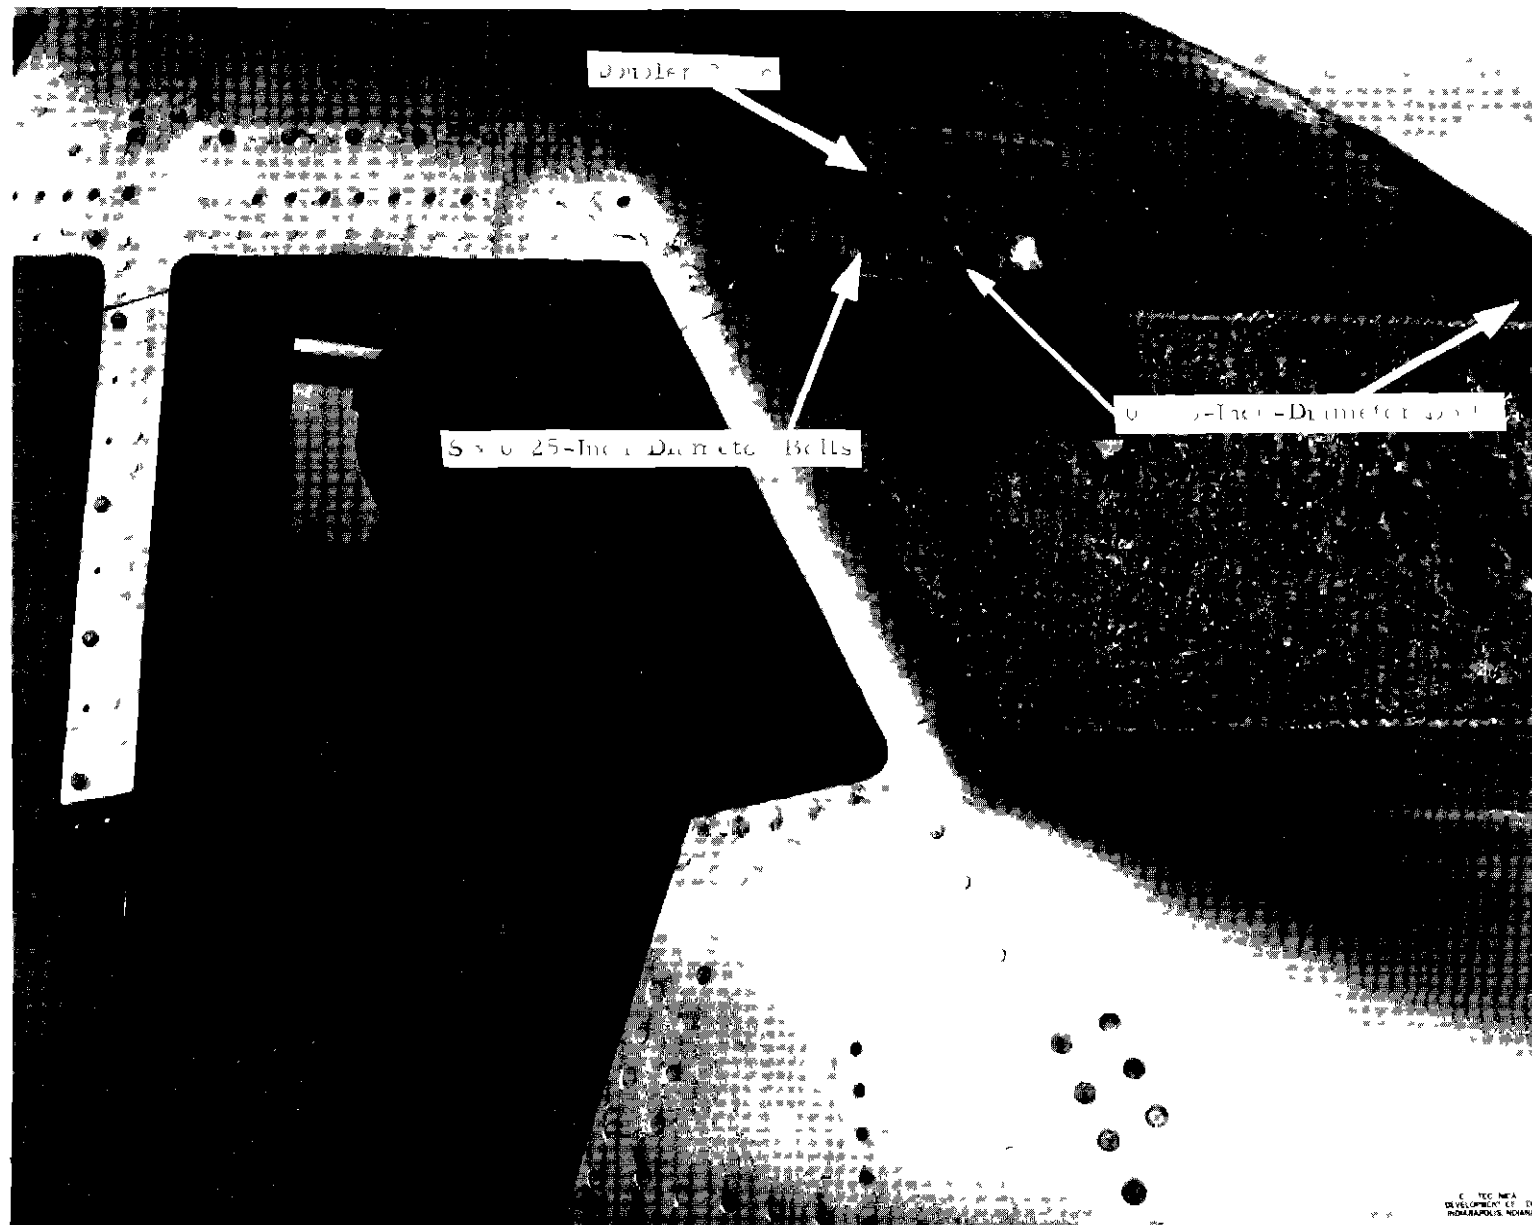
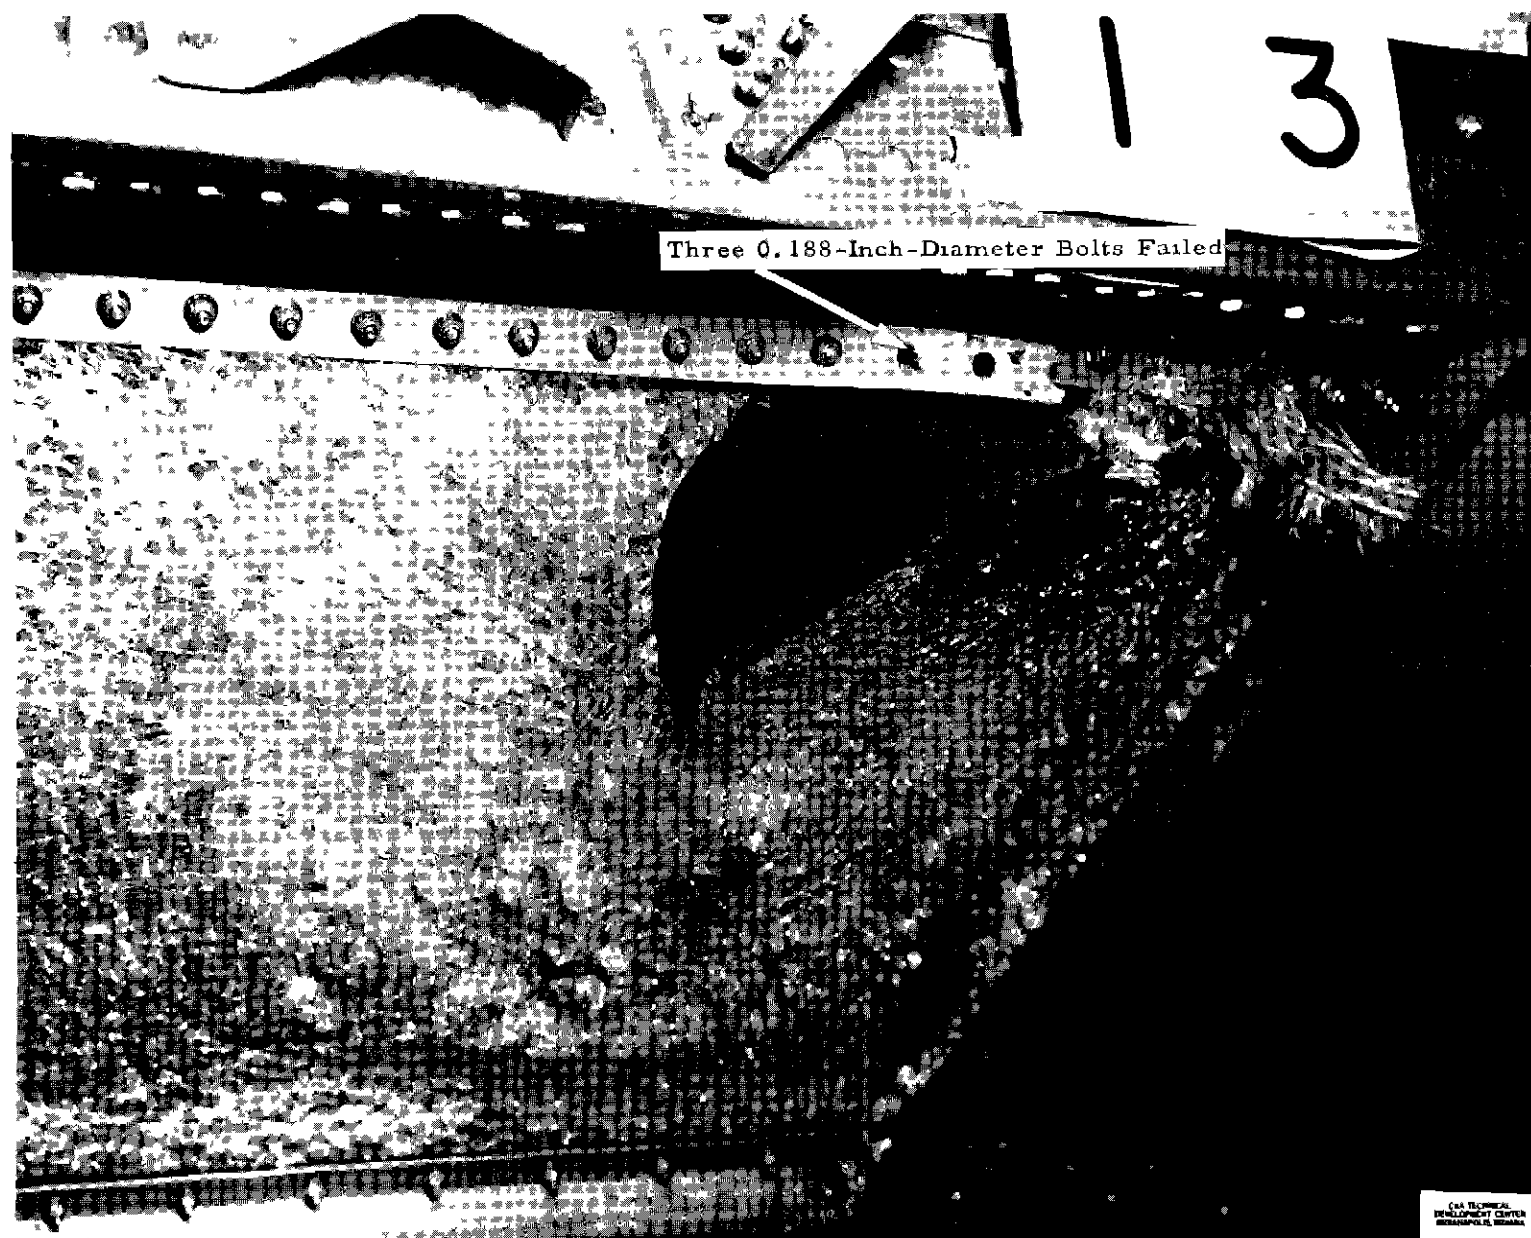
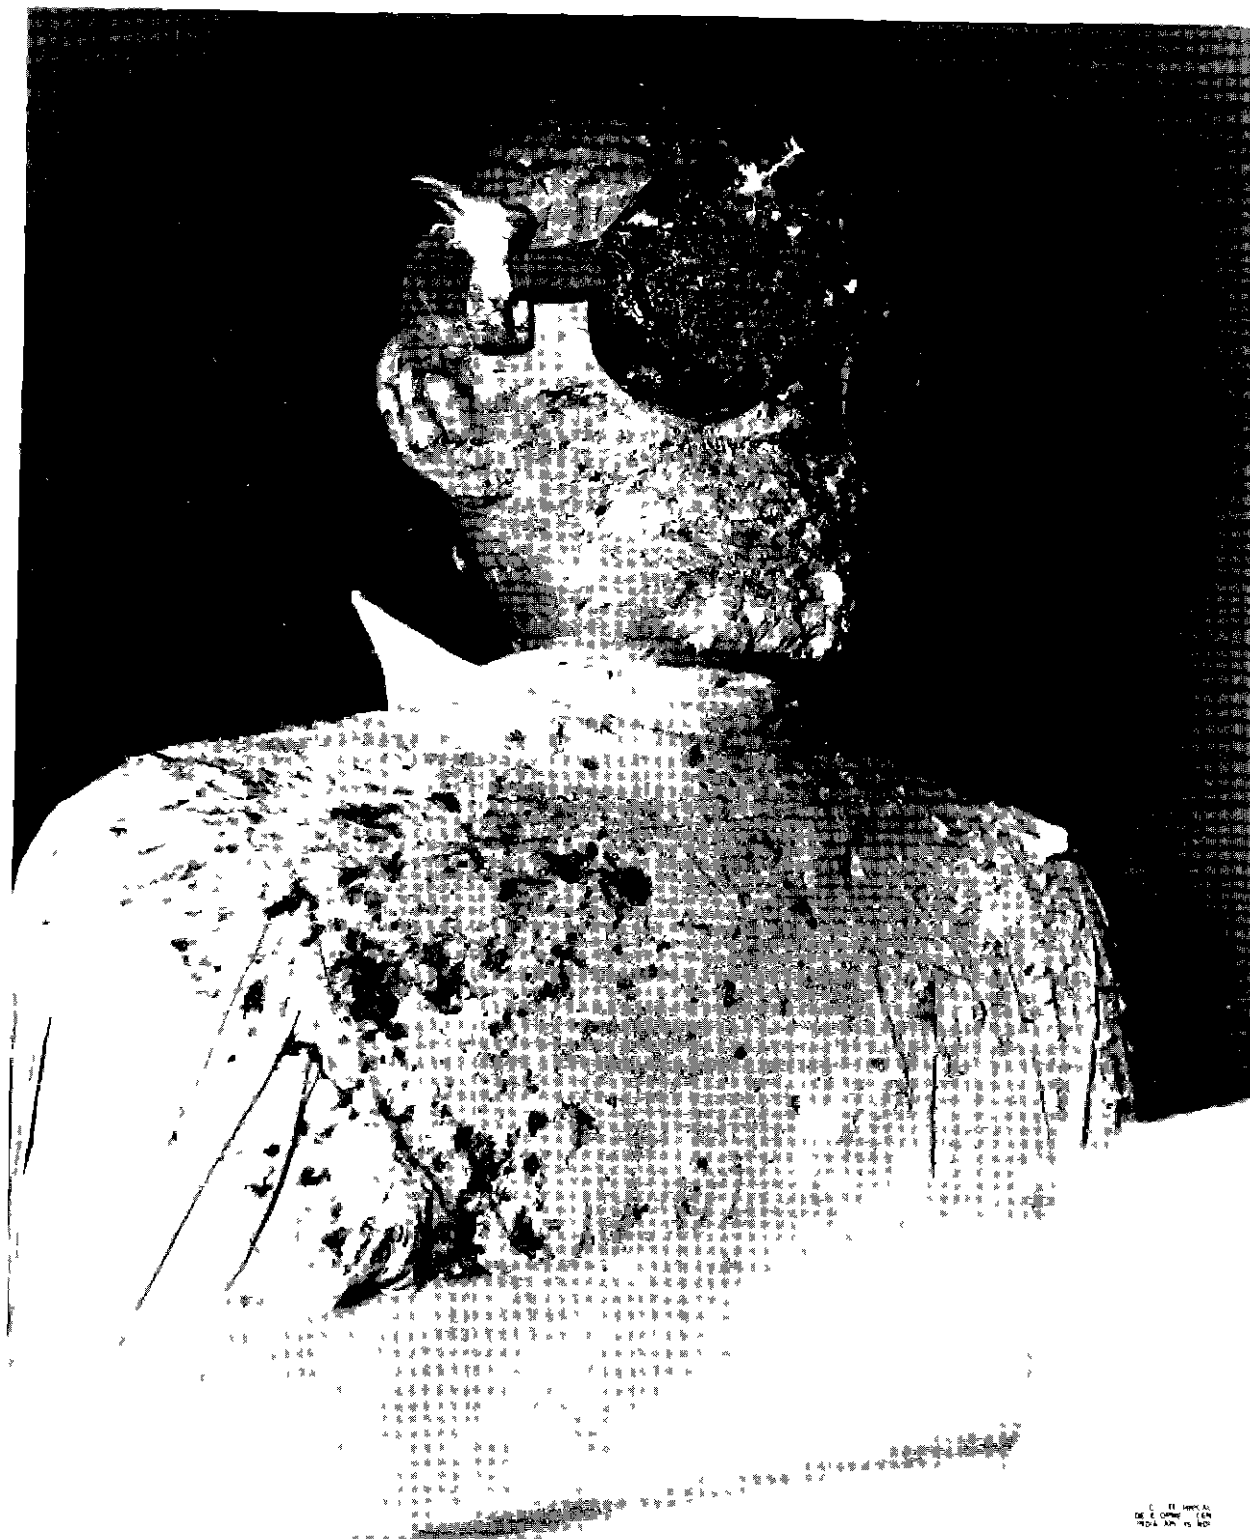
The actual strike area was approximately 8 inches inboard of the cornerpost and 6 inches below the top windowsill. The force of the impact resulted in failure of two 3/16-inch-diameter top sill retaining bolts in tension directly above the point of impact. The six 1/4-inch-diameter bolts outboard of the 3/16-inch-diameter bolts remained intact. A third 3/16-inch-diameter bolt did not fail, but the nut pulled through the backup stripping. Failure of the windowsill attachment in this manner allowed the window edge to be forced inward from its normal position, thereby tearing the vinyl from the window edge downward into the center of impact area. Part of the bird carcass passed through this opening, hitting the face of the clay dummy. Numerous chunks of glass eroded and became lodged in the clay dummy's head from the chin level up to the forehead level. The Navy-type goggles which were employed deflected much of the glass and bird entrails at the dummy's eye level. Results of this test are shown in Figs. 31, 32, and 33.

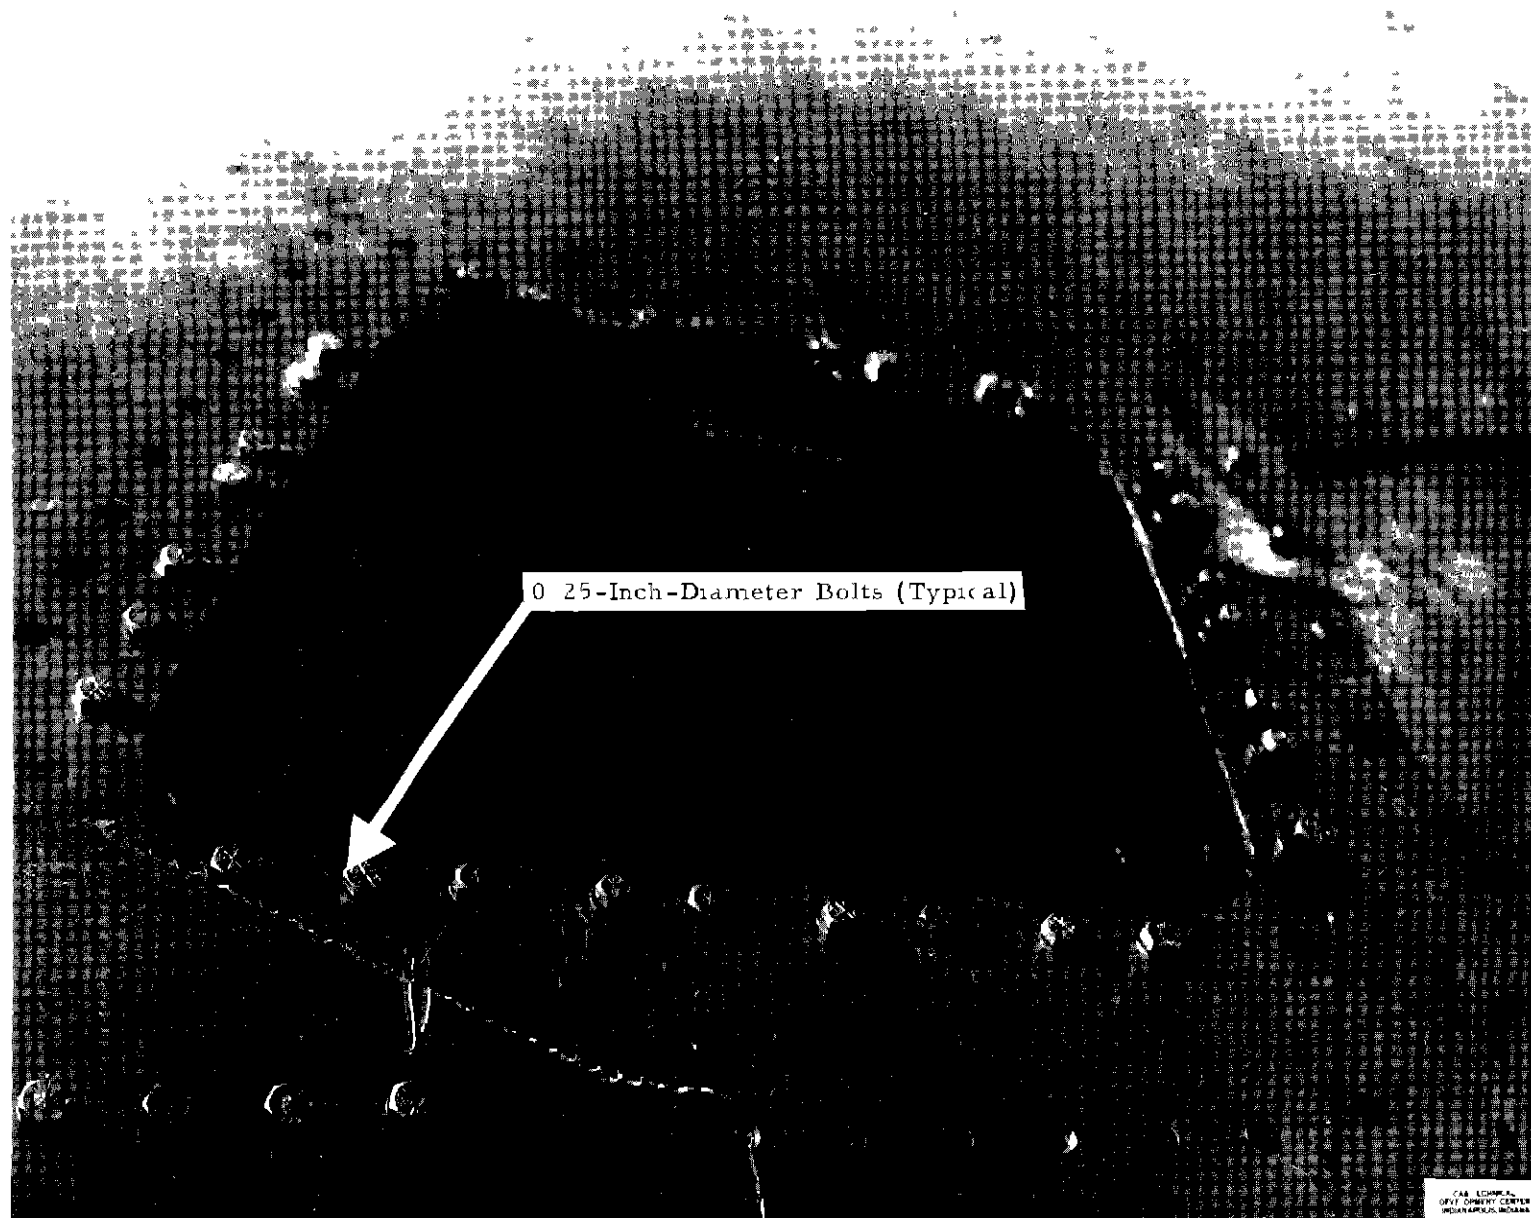
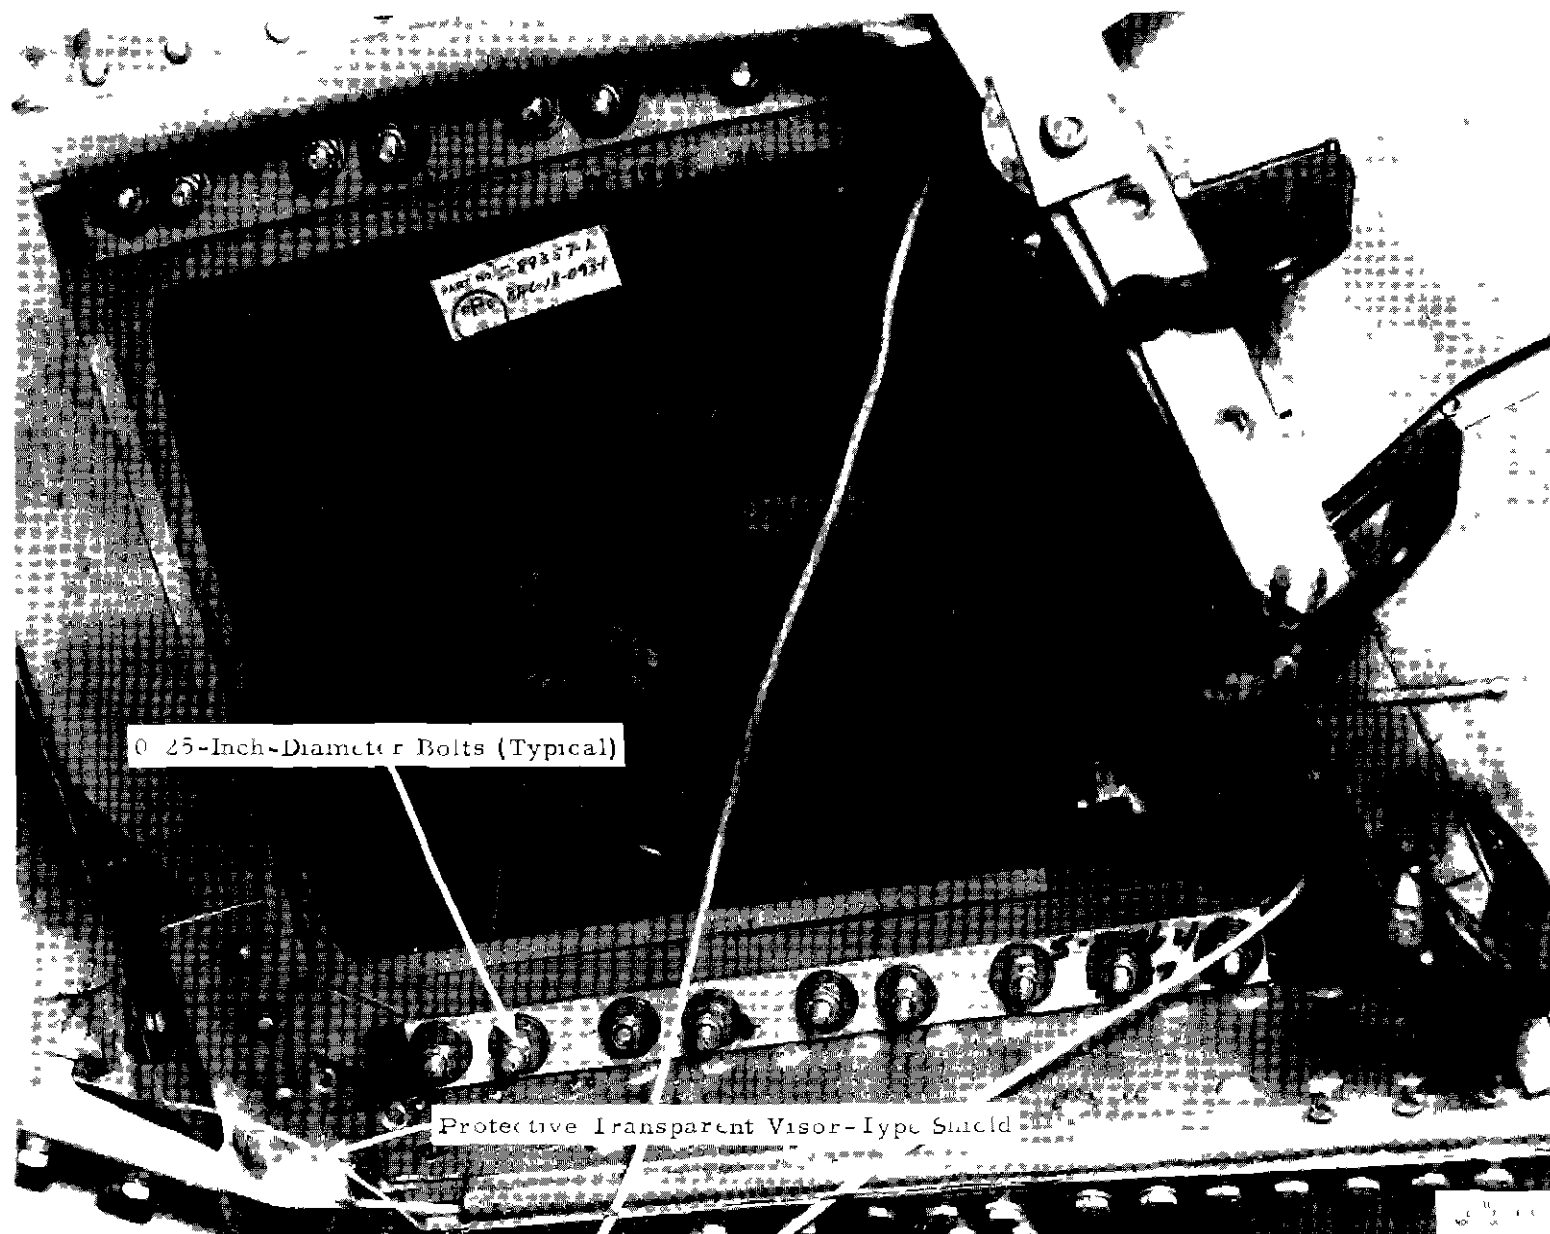
1. The eyebrow window will withstand a 4-pound bird impact at a velocity of slightly more than 405 mph, provided the number of retaining bolts is doubled and if they are increased in size to 1/4 inch. This is shown in Figs. 34 and 35.
