TECHNICAL DEVELOPMENT REPORT NO. 301

BIRD-IMPACT TESTS OF THE  
BOEING MODEL 707 AIRPLANE WINDSHIELD

February 1957

CIVIL AERONAUTICS ADMINISTRATION  
TECHNICAL DEVELOPMENT CENTER  
INDIANAPOLIS, INDIANA

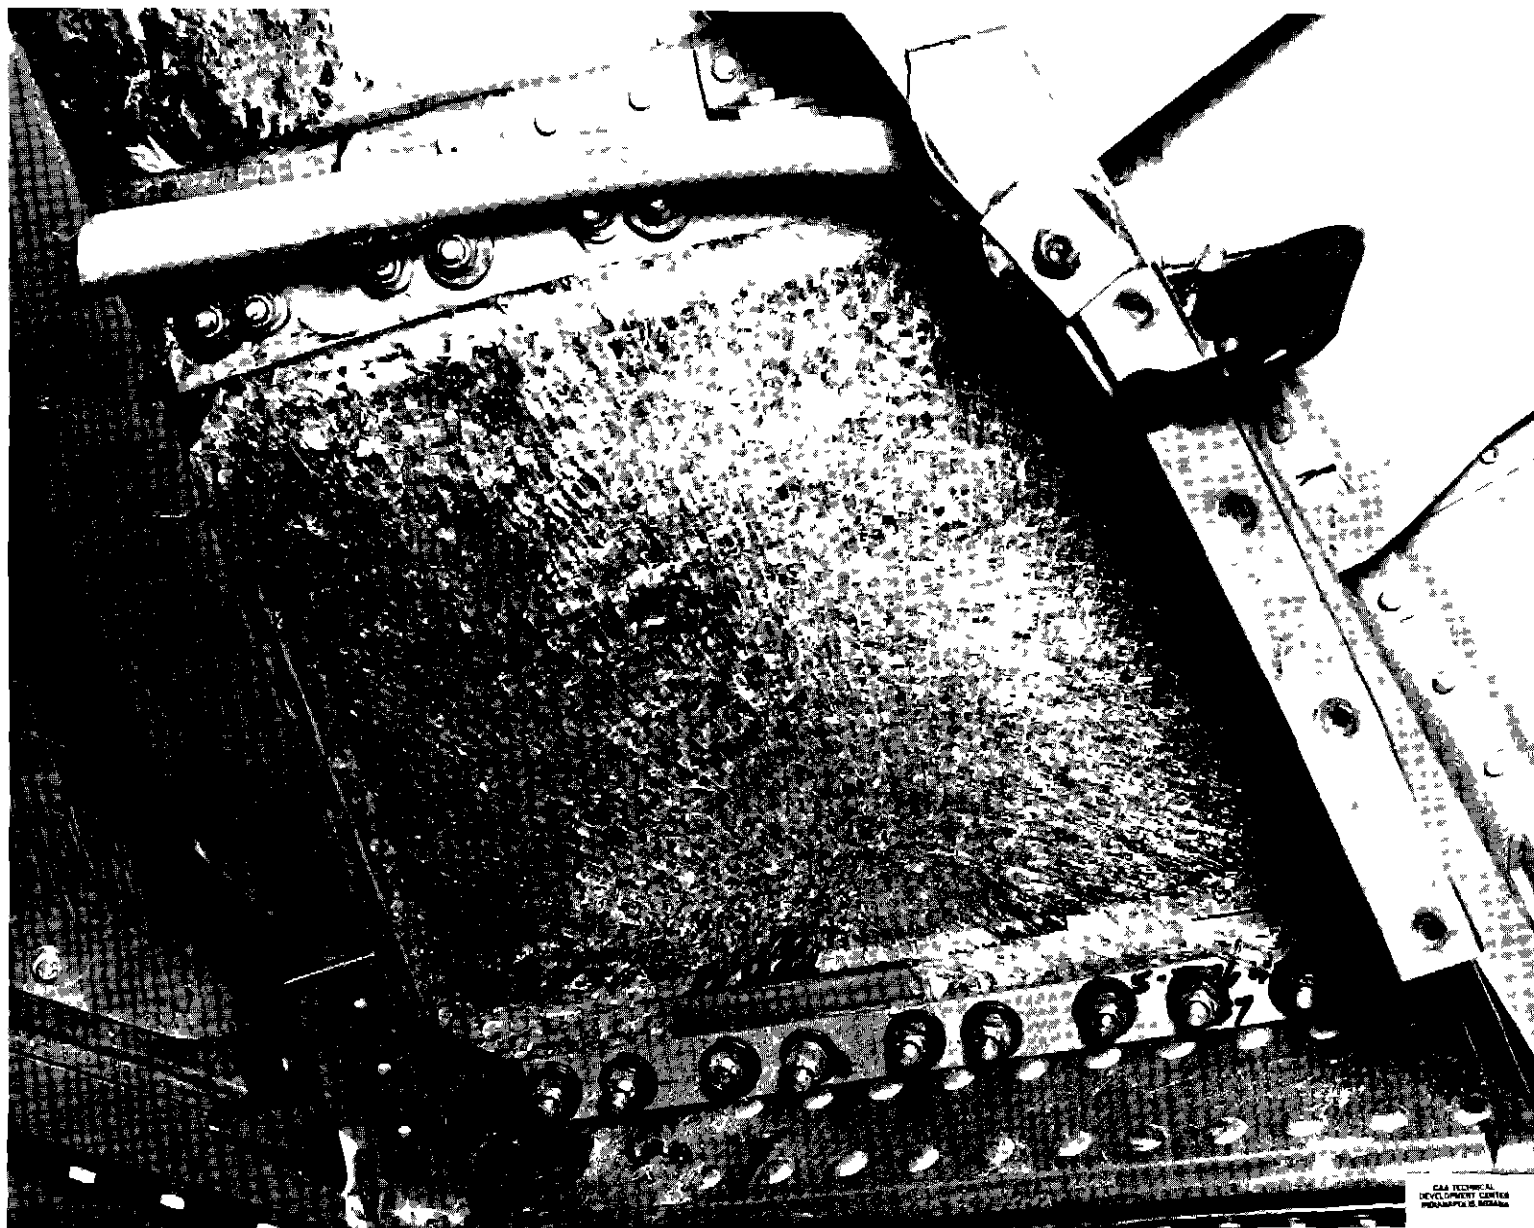
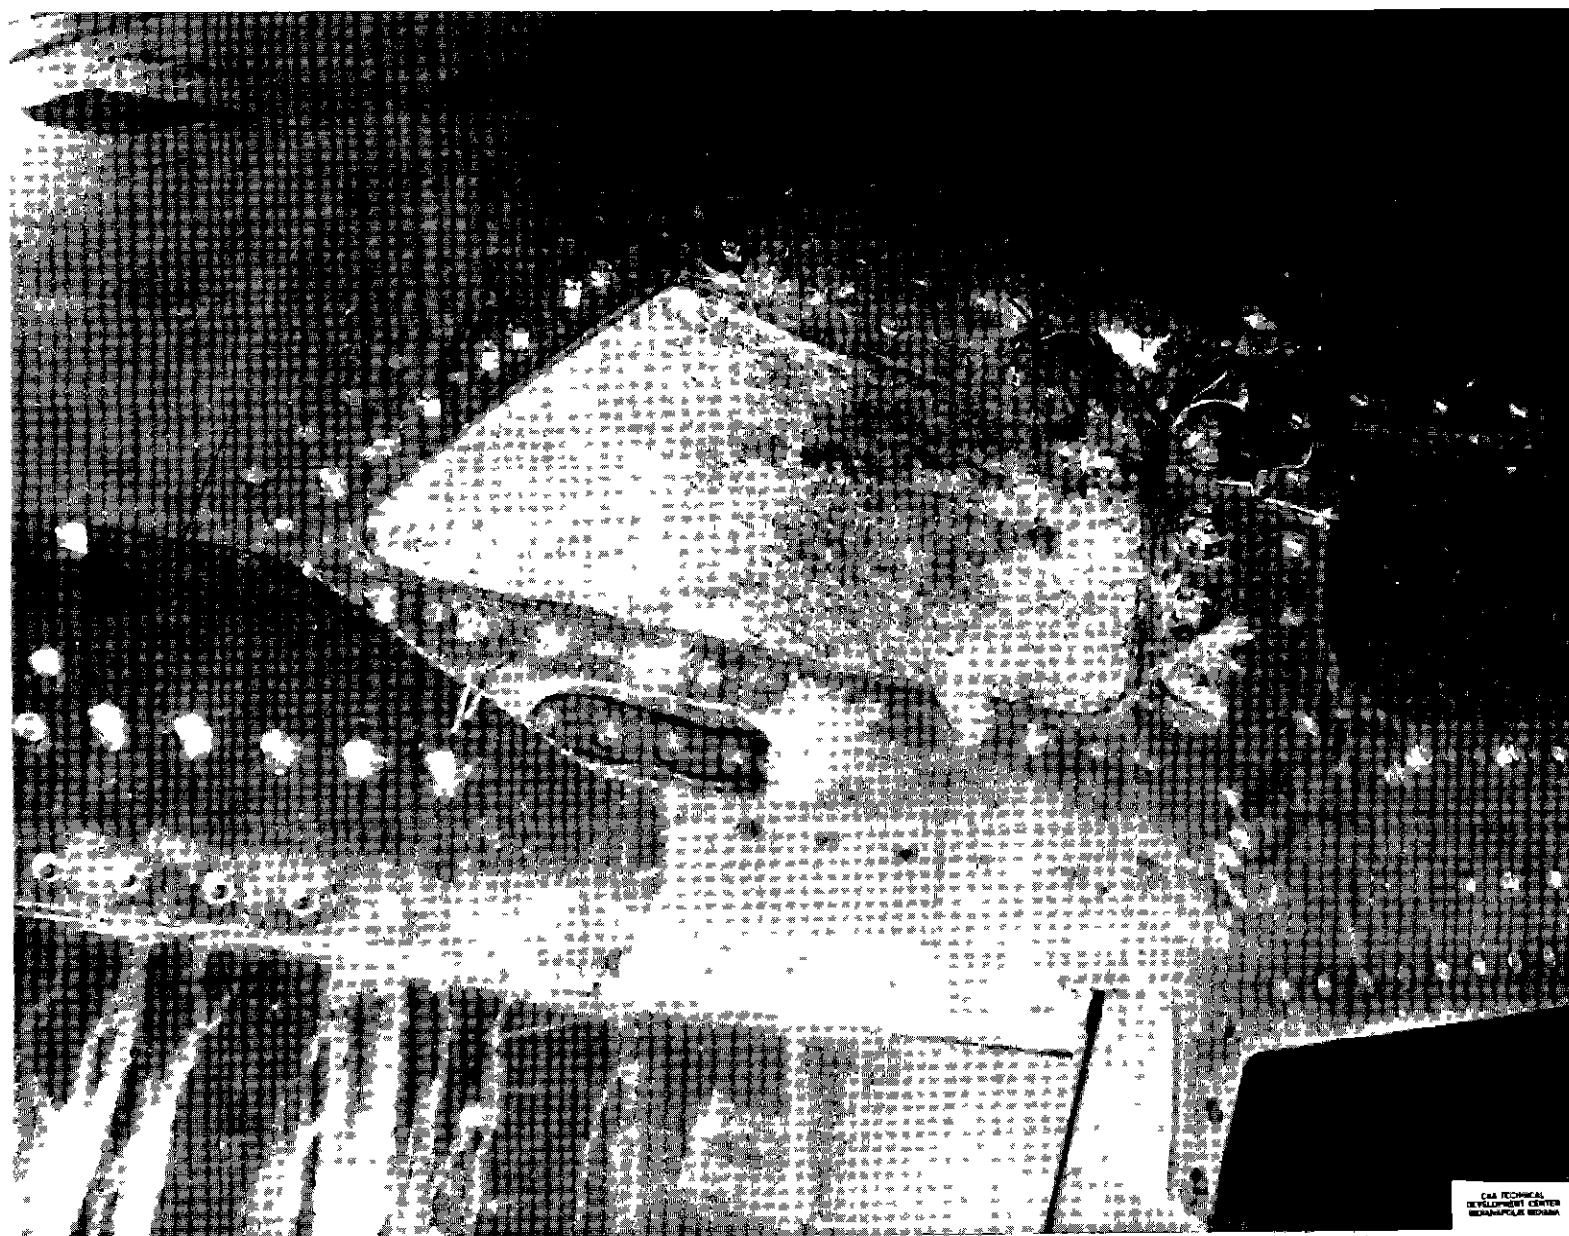
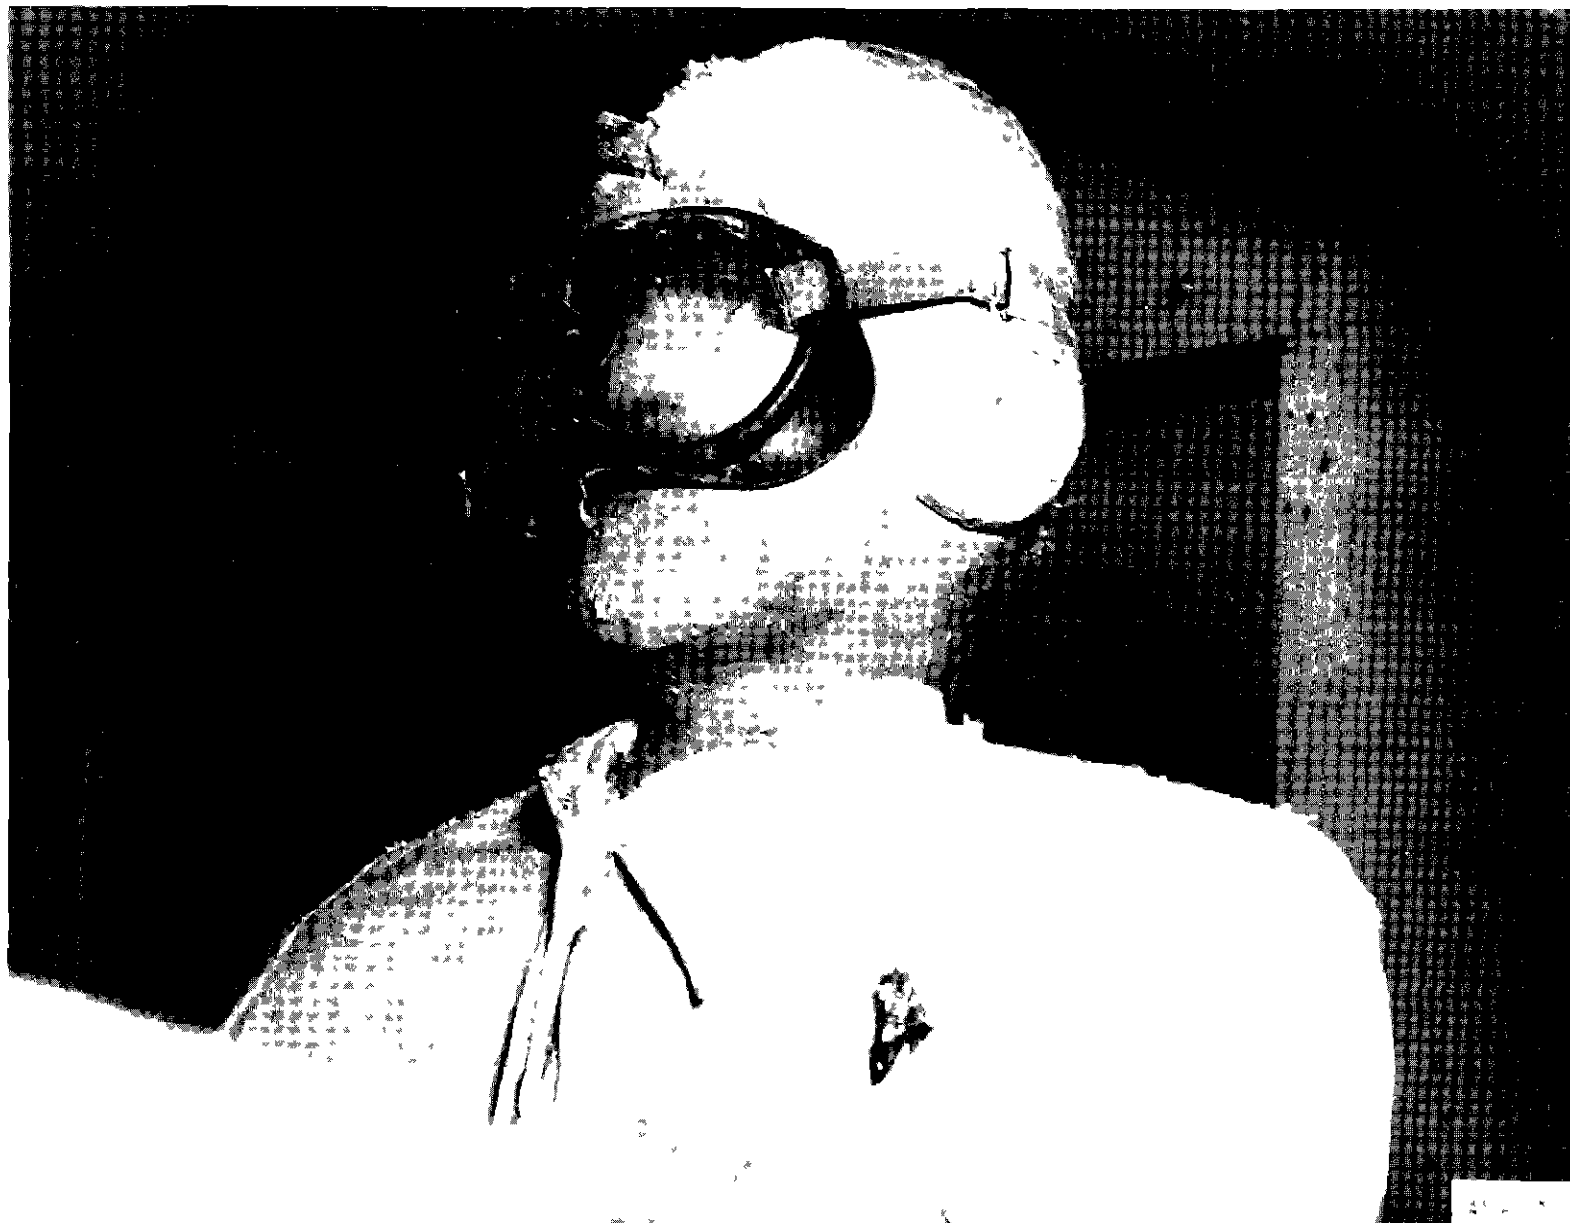
The center of impact was near the lower edge of the window. There was no penetration of the window. The upper sill failed, allowing part of the carcass to pass into the cockpit over the clay dummy's head. The force of a concentration of flying glass from the inside face of the window shattered the cellulose acetate shield, a piece of which imbedded itself in the clay dummy's forehead. In addition, the forehead of the clay dummy was badly eroded by an apparently severe blow although the force of this blow was not as great as that of test No. 12. The window prior to testing and results of this test are shown in Figs. 34, 35, 36, 37, and 38.
